Blue Planet Knitwear Ltd. (Extension)

Mulaid,Tengra,Mawna, Sreepur, Gazipur
(23.8972559240, 90.431362578)
28 March 2023

Building Information

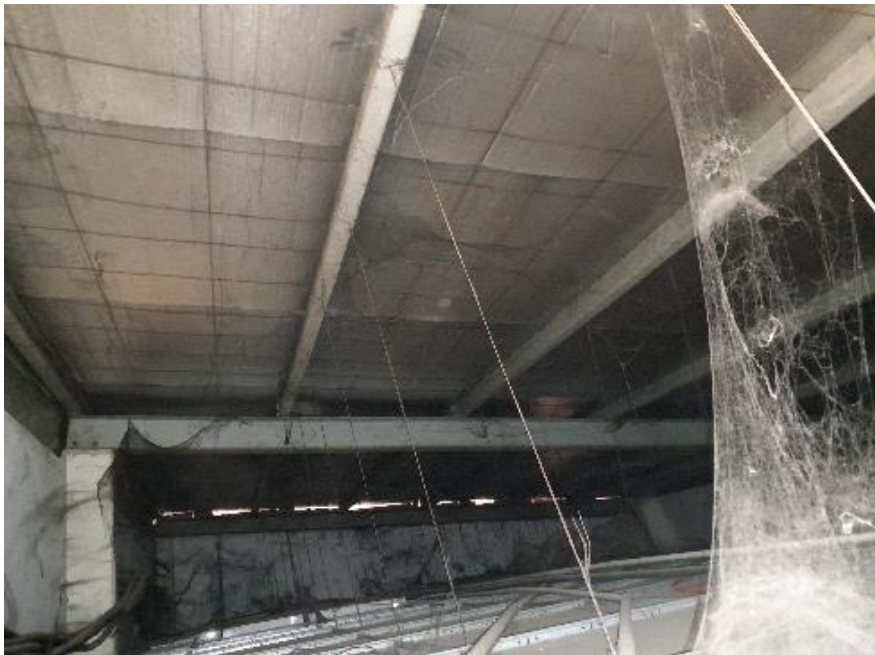
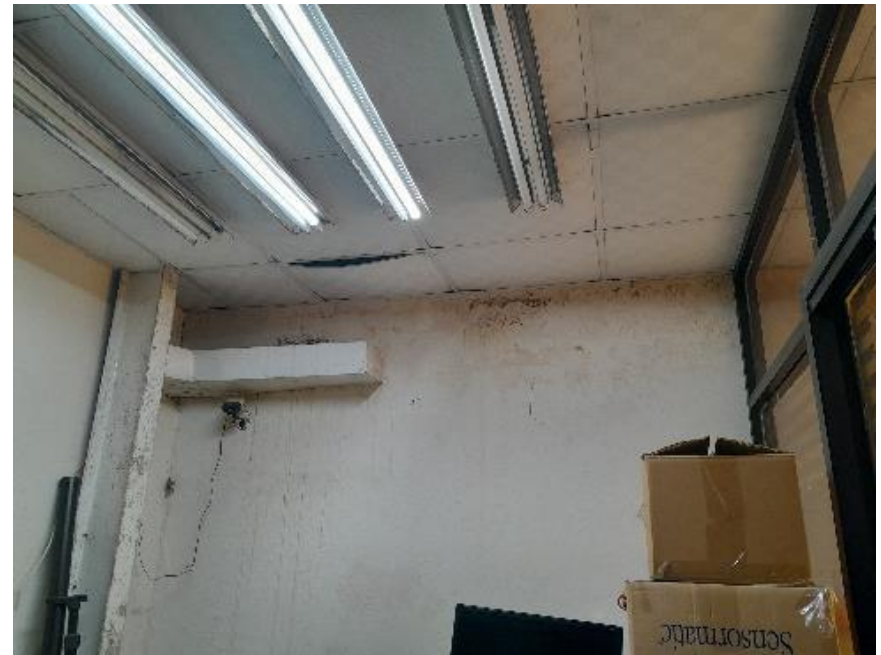
Absence of bracing system

Absence of horizontal and vertical bracing at Inspection shed.

Building engineer is required review the stability system and suggest horizontal and vertical bracing of the shed.

Item 1: Absence of bracing system. (Inspection shed & Fire pump room)

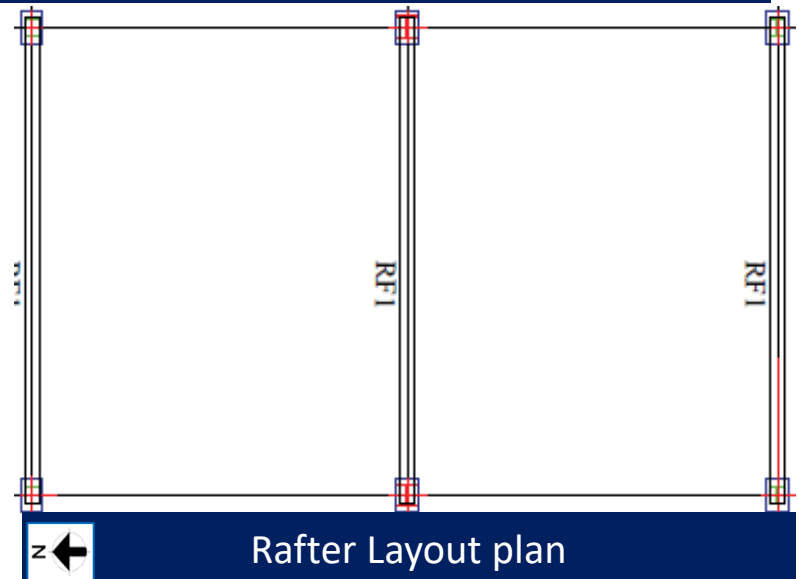
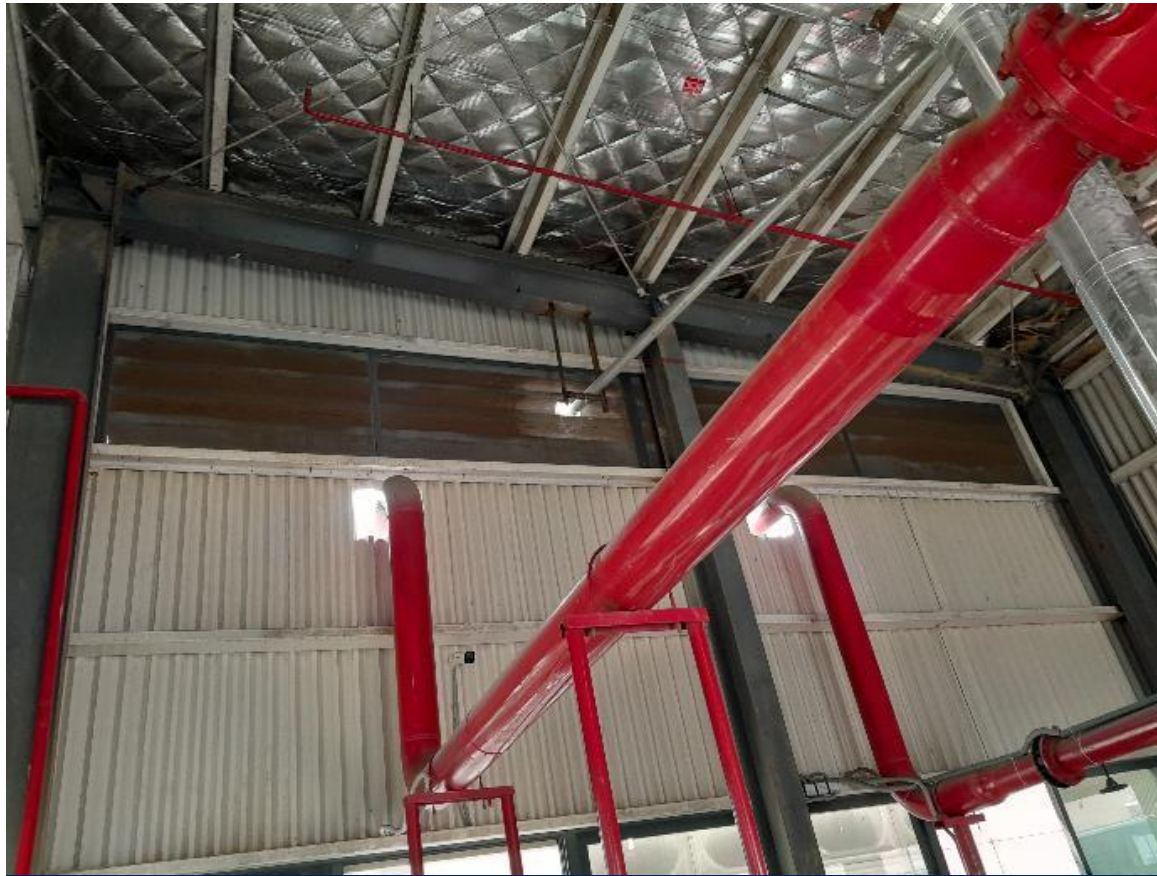
Absence of vertical bracing at Fire pump shed.

Building engineer is required review the stability system and suggest horizontal and vertical bracing of the shed.

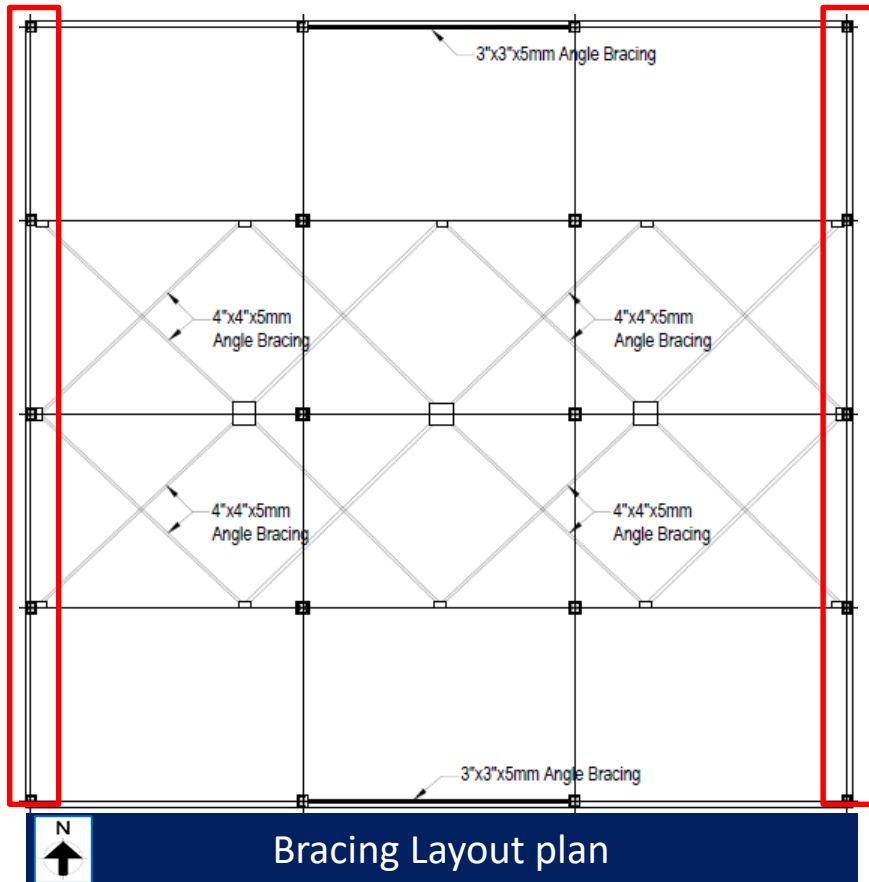
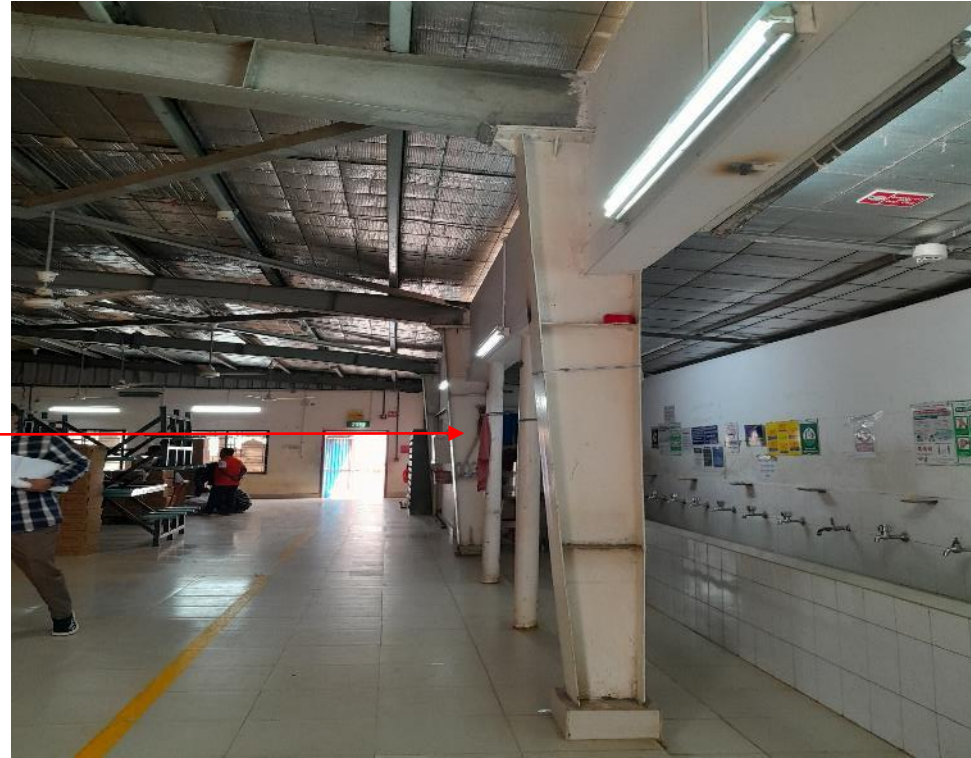
Observation: Dinning warehouse

Lack of lateral stability system

Absence vertical bracing along out of plane of portal frame in north-south direction of the shed.

Building engineer is required to check the lateral stability system of the shed and suggest the necessary vertical bracing where required.

Item 2: Lack of lateral stability system. (Dinning Warehouse)

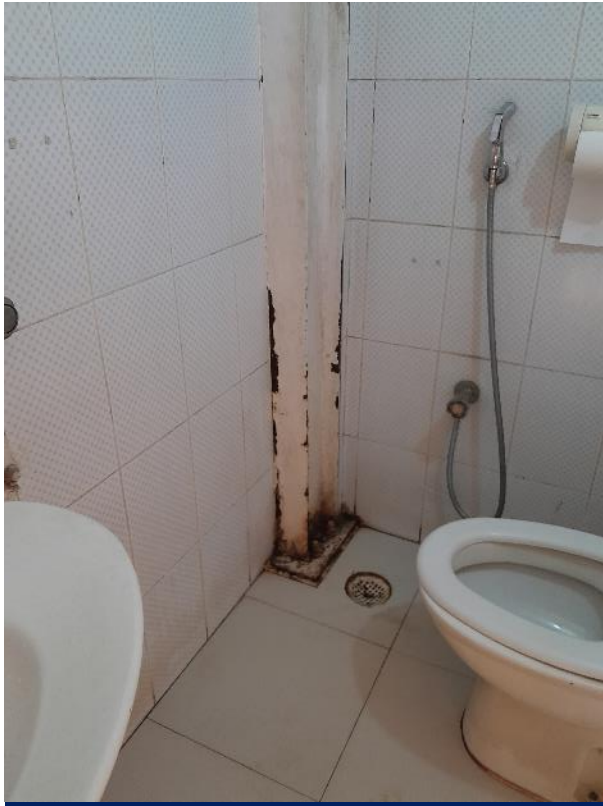
Corrosion (Inspection shed)

Corrosion was observed on steel column at toilet area of all sheds. The factory is required to remove the rust and apply suitable anti-corrosive coating on the steel members.

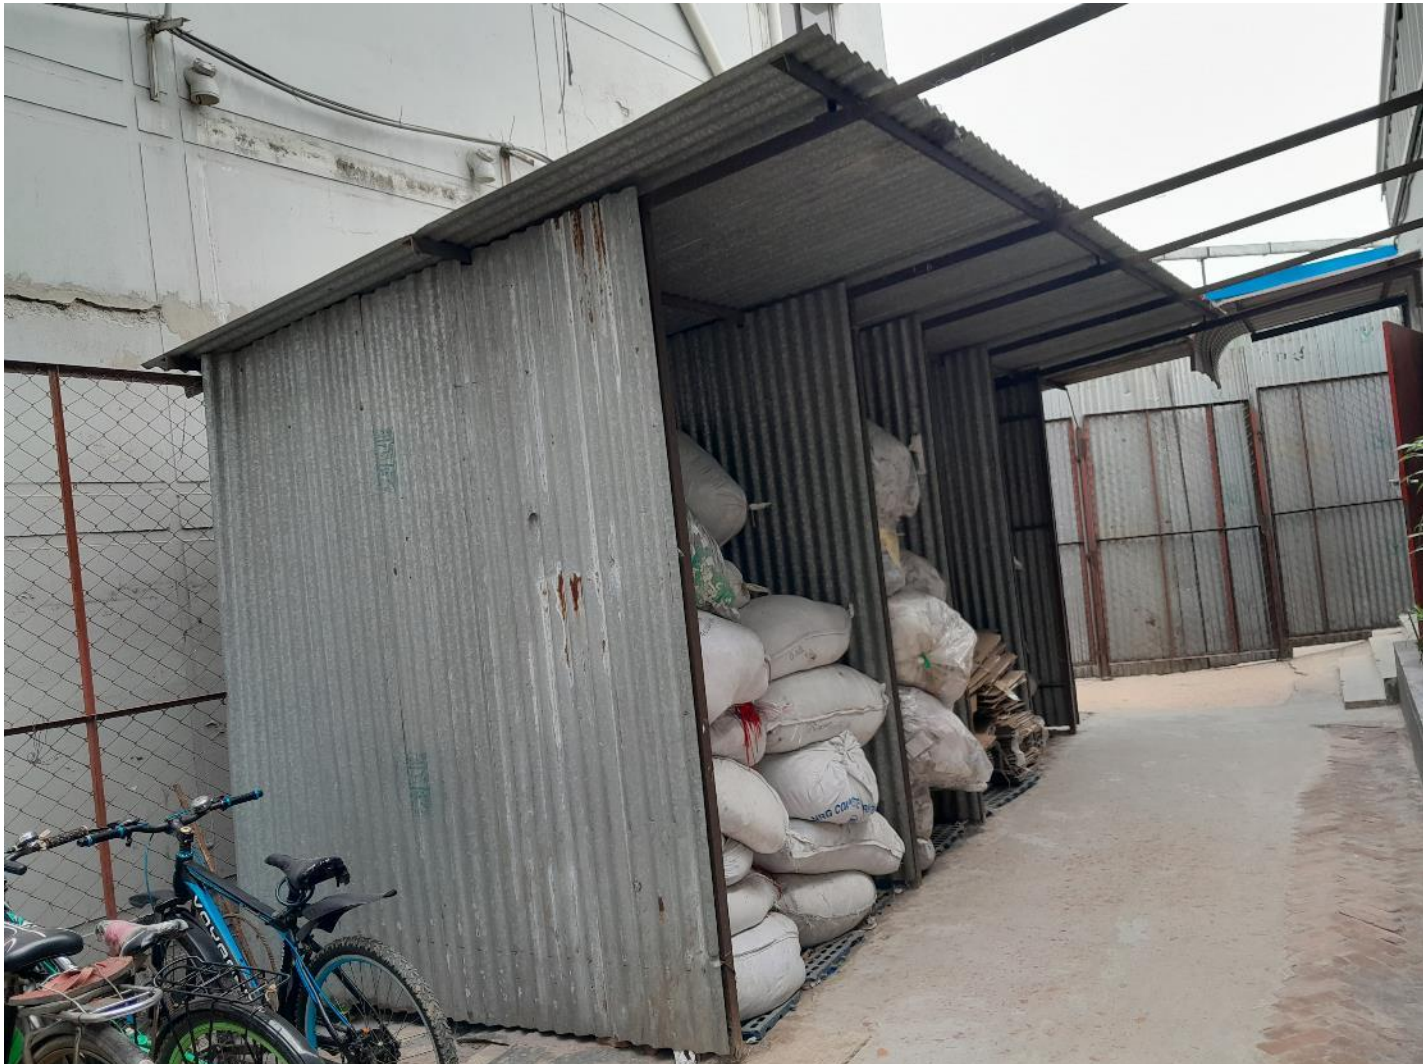
Observation: Wastage Shed

Non-engineered wastage shed

Non engineered wastage shed observed. Building engineer is required to replace the non engineered shed.

Item No.	Observation	Recommended Action Plan	Recommended Timeline
06	Non-engineered wastage shed.	Building engineer is required to replace the non-engineered wastage shed with engineered structure.	6-months
