# Southern Services Ltd (Extension)

DOCTOR BARI, ZIRABO, ASHULIA, SAVAR, DHAKA

19 March 2023

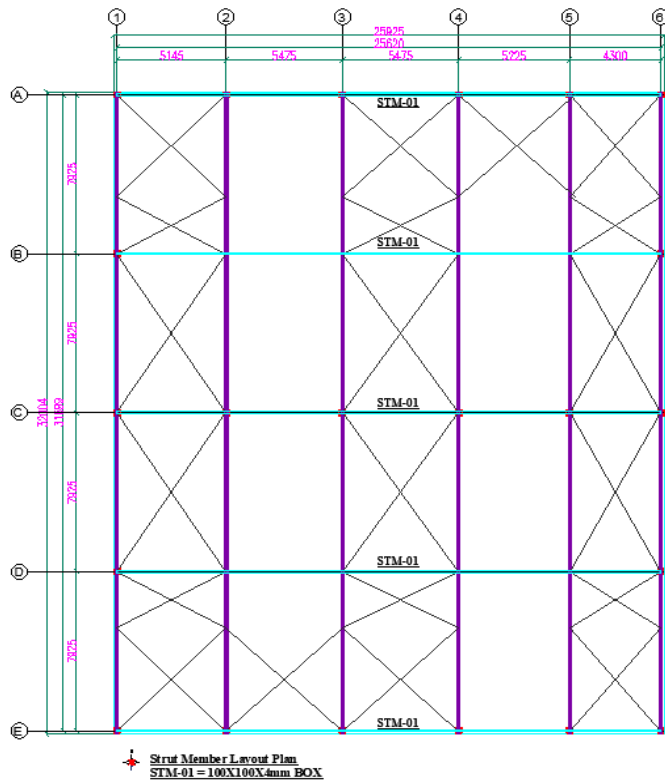
**Lack of lateral stability in long direction**

Continuous compression member  
shown in the as-built drawing

The building engineer is required to review the lateral stability of the shed.

| Item No. | Observation | Recommended Action Plan | Recommended Timeline |
|---|---|---|---|
| 01 | Lack of lateral stability in long direction. | Building engineer is required to review the lateral stability of the shed and suggest necessary remedial action. | 6-weeks |
| 02 | Lack of lateral stability in long direction. | Carry out remedial works where required. | 6-months |

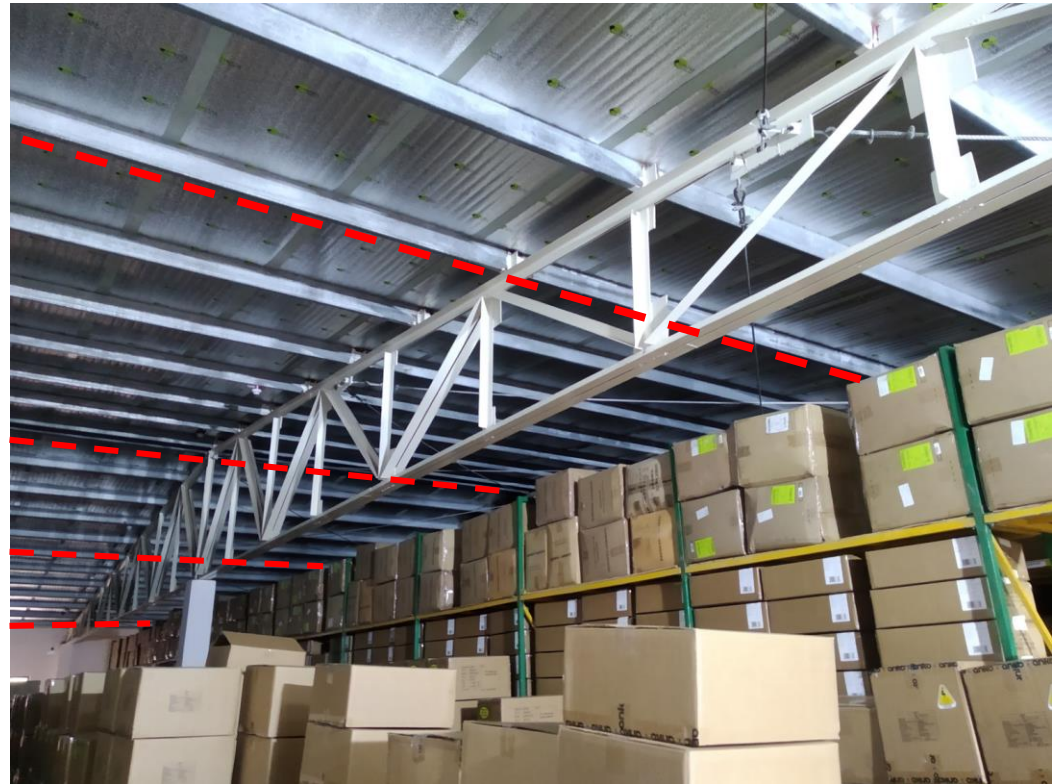
Absence of continuous compression member at the shed

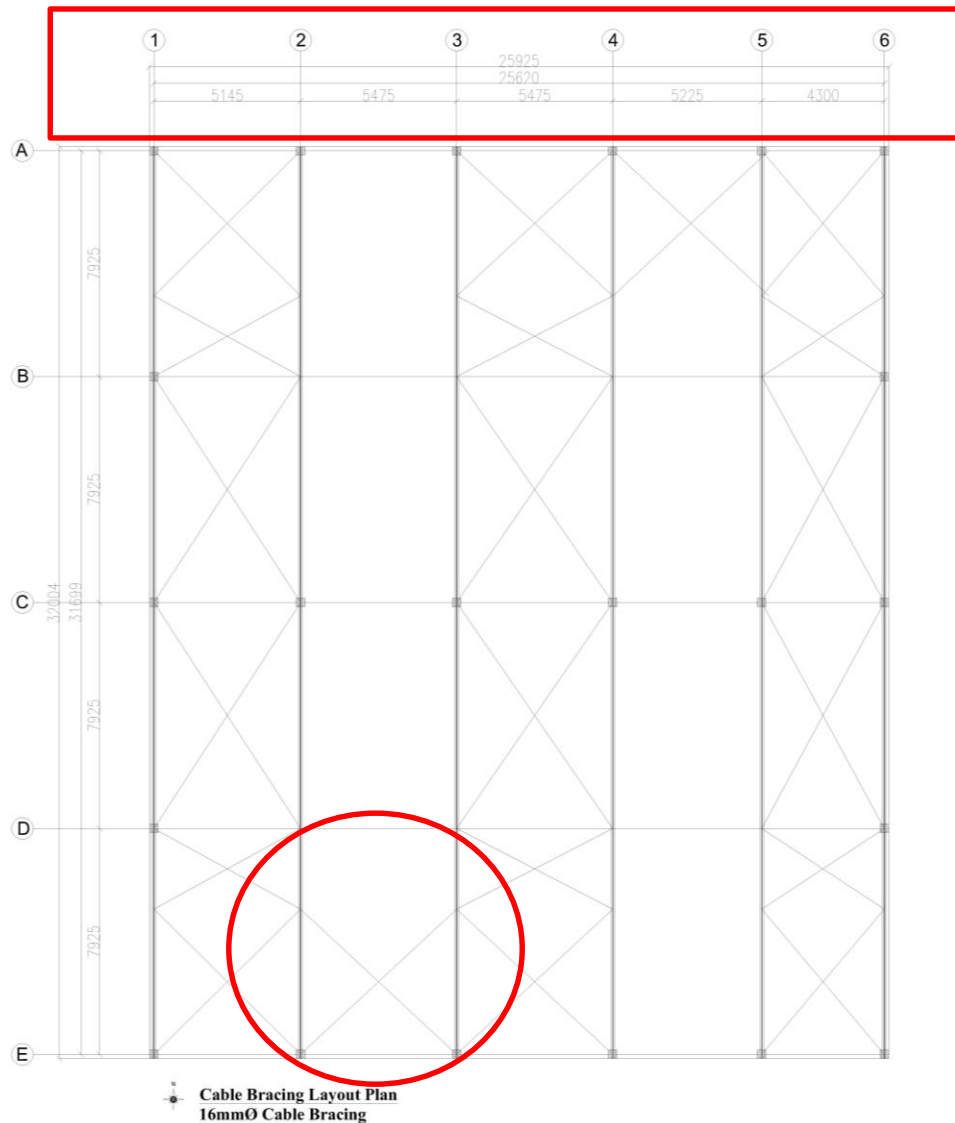
Grid dimension not  
matched with the drawing

| Item No. | Observation | Recommended Action Plan | Recommended Timeline |
|---|---|---|---|
| 03 | Inconsistences in as-built drawing. | Building engineer is required to survey the whole structure and prepare as-built drawings. | 6-weeks |

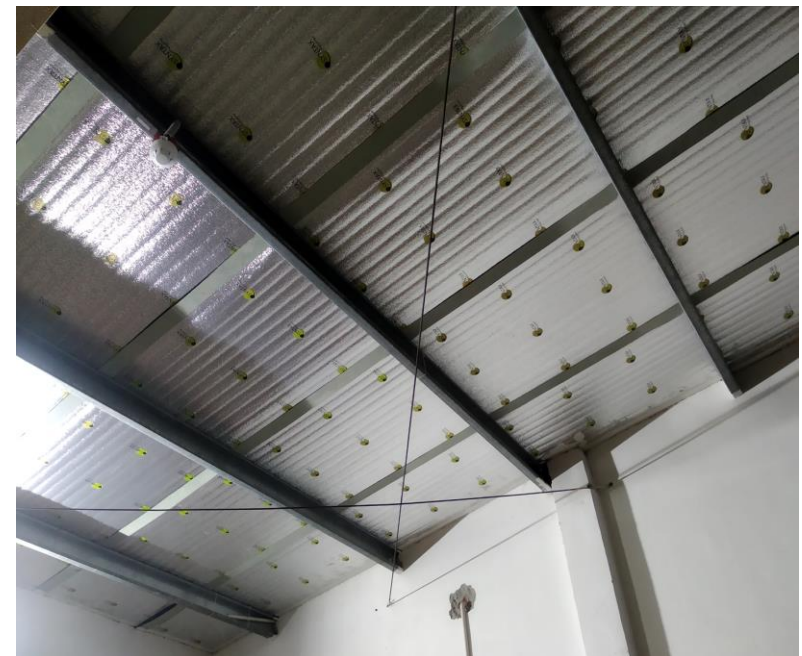
16 mm cable bracing shown in drawing but on site  
12 mm bracing found

12 mm Cable Bracing

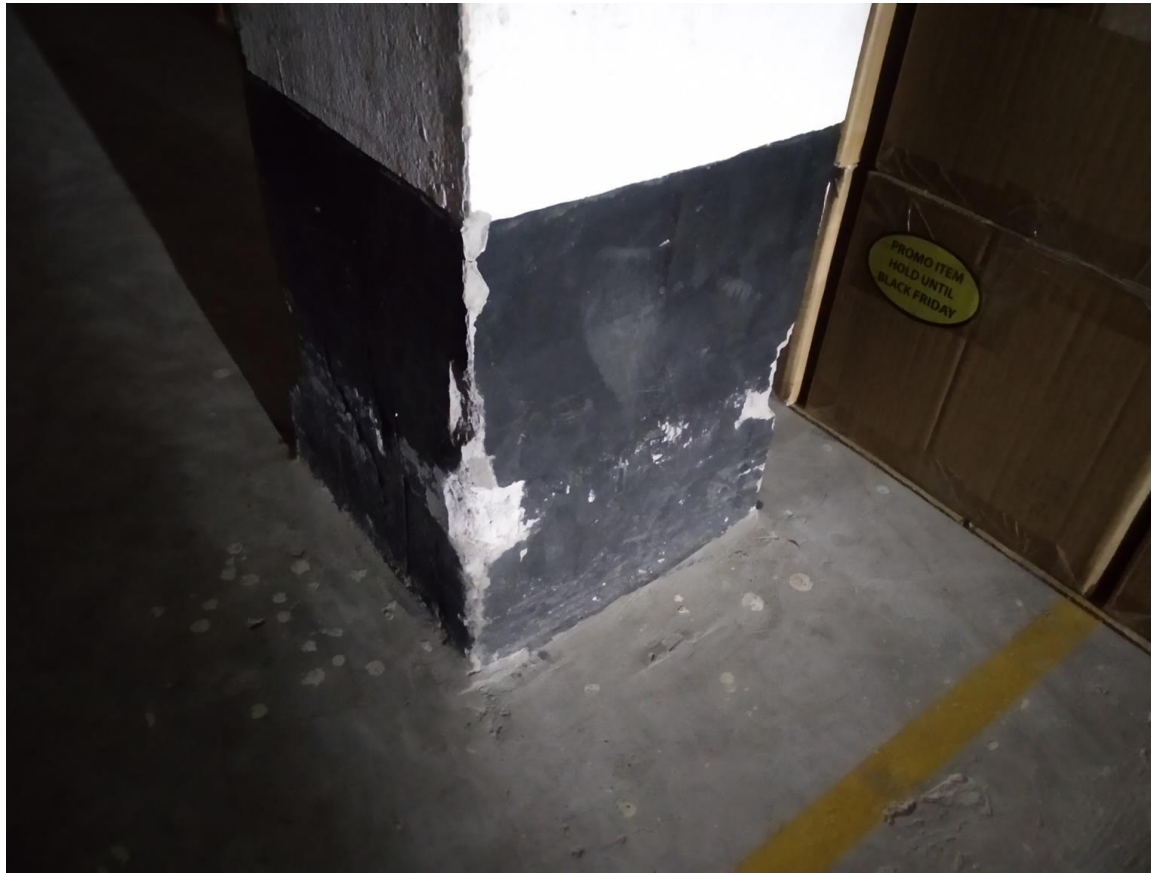
Column damaged by the trolley movement

Trolley impact was observed in the columns. Building engineer is required to repair the damaged columns and provided safety barrier surrounding the columns.

| Item No. | Observation | Recommended Action Plan | Recommended Timeline |
|---|---|---|---|
| 04 | Trolly impact on columns. | Building engineer is required to repair the damaged columns and provided safety barrier surrounding the columns. | 6-weeks |

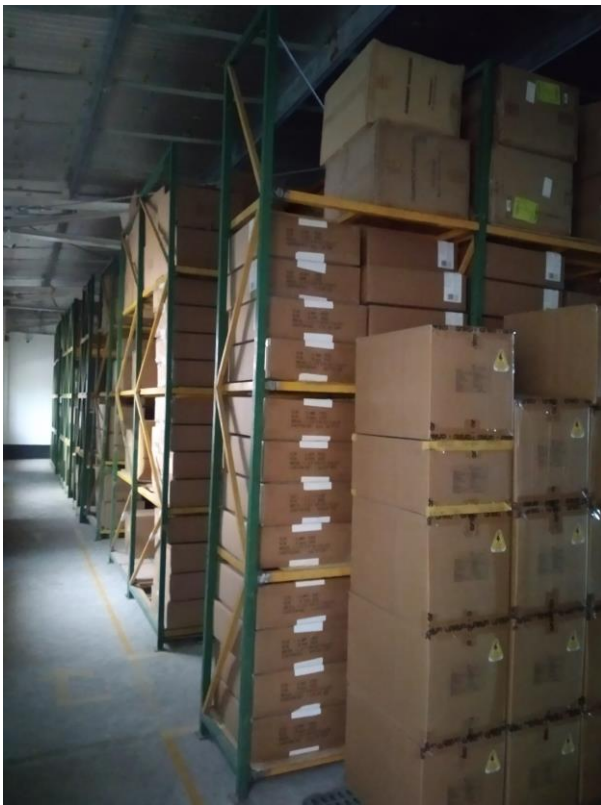
Storage Rack

**Storage rack not anchored or braced**

| Item No. | Observation | Recommended Action Plan | Recommended Timeline |
|---|---|---|---|
| 05 | Storage rack not anchored or braced. | Building engineer is required to anchor the storage racks with ground floor slab properly. | 6-weeks |

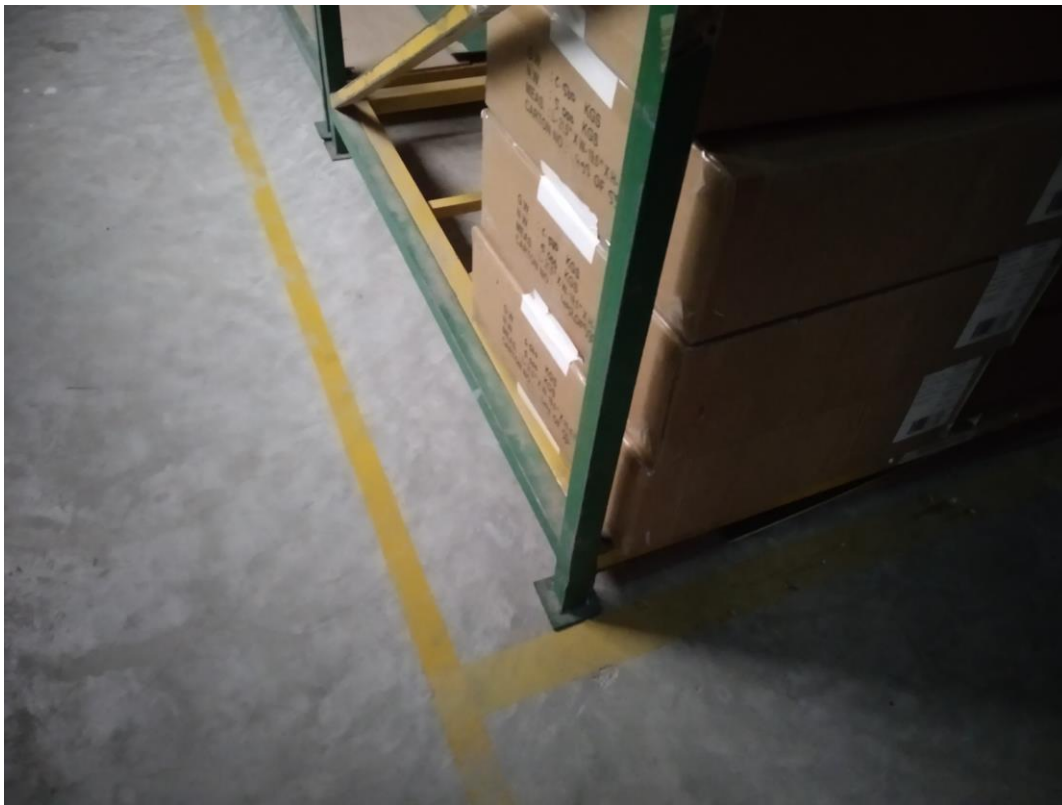
Storage Rack not anchored with ground floor slab

Storage rack not anchored with ground floor slab to protect the thrust of earthquake. Building engineer is required to anchor the storage racks with ground floor slab properly.
