# Textil Fashions Ltd. (Extension)

Holding No-6/1, Plot No-168, Choydana, National University, Gazipur.

29 March 2023

# Building Information

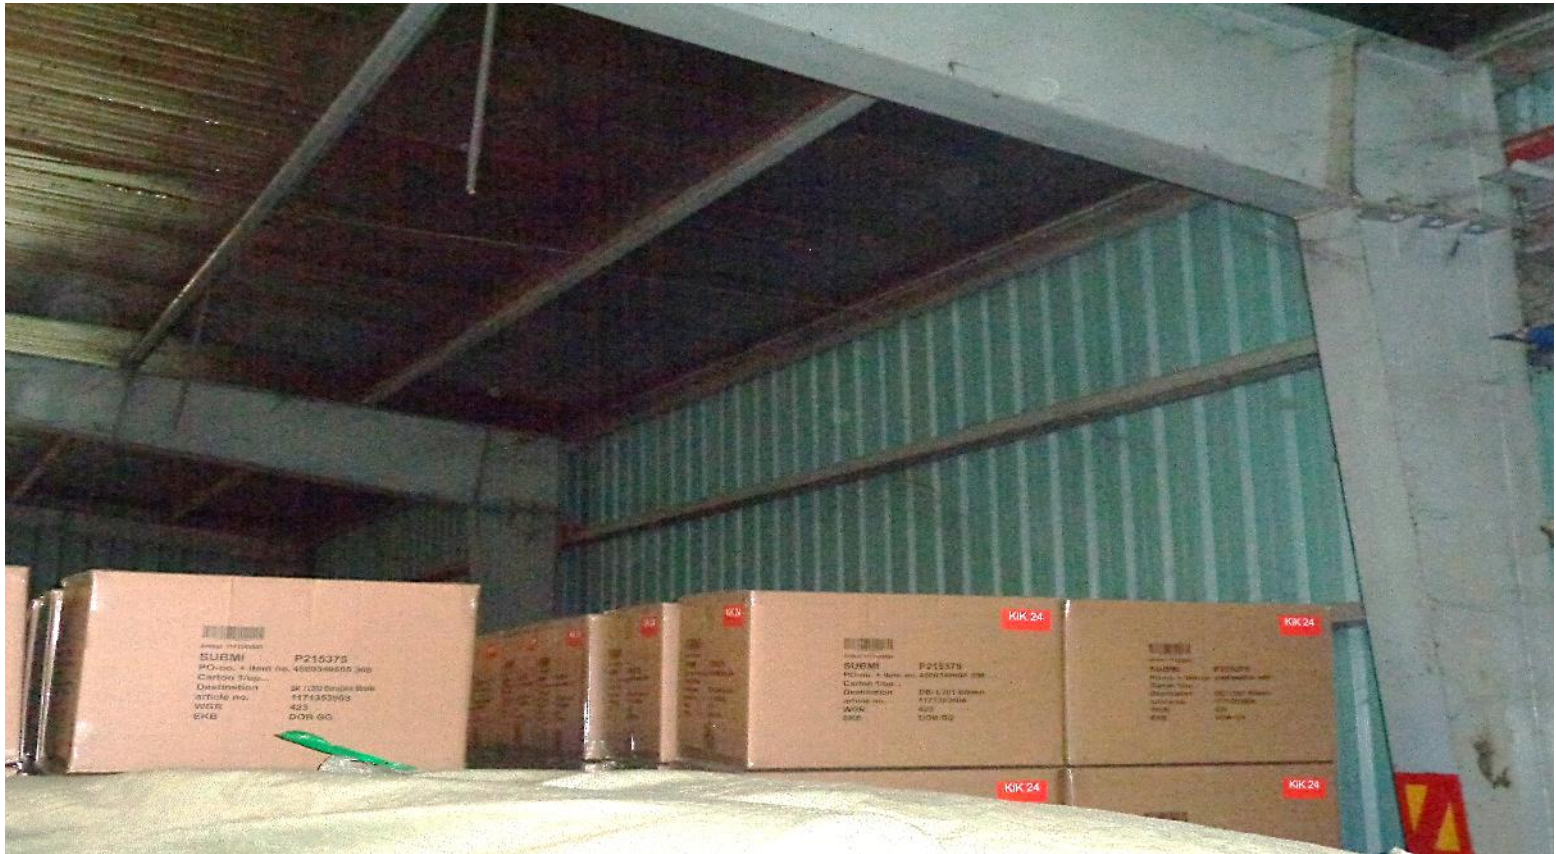
# Lack of lateral stability

Load transfer media (comp. strut) is missing along lateral direction of portal frame

Without compression strut only tension bracings are provided along lateral direction of the portal frames which makes the lateral load resisting system inactive. Building engineer is required to check the lateral stability of the structure and propose necessary remediation measure.

Item No.	Observation	Recommended Action Plan	Recommended Timeline
01	Lack of lateral stability (Warehouse Shed)	Building engineer is required to carry out Engineering Assessment (EA) to check the lateral stability of the structure and suggest necessary remedial action in the design report.	6-weeks
02	Lack of lateral stability (Warehouse Shed)	Implement remediation work if required.	6-months
03	Missing approval drawing from local authority (Warehouse Shed)	Factory is required to seek approval from the local authority for the structure.	6-months
04	Significant connection gap and bolt missing (Warehouse Shed)	Factory engineer is required to install the missing bolt.	6-weeks
05	Significant connection gap and bolt missing (Warehouse Shed)	Factory engineer is required to take proper measure to fill up the gap in connections.	6-weeks
06	Crack in brick wall (Warehouse Shed)	Factory is required to repair the cracked area as per guidance by the building engineer.	6-weeks

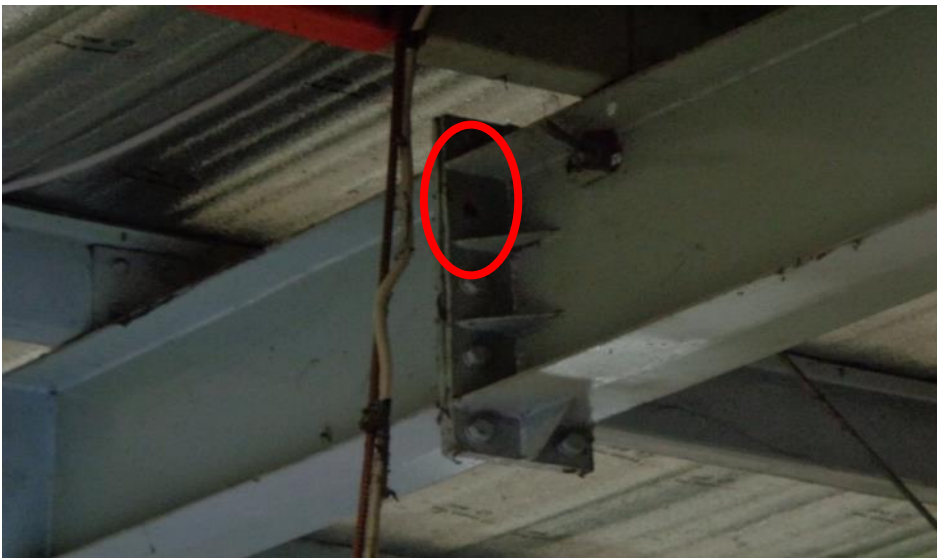
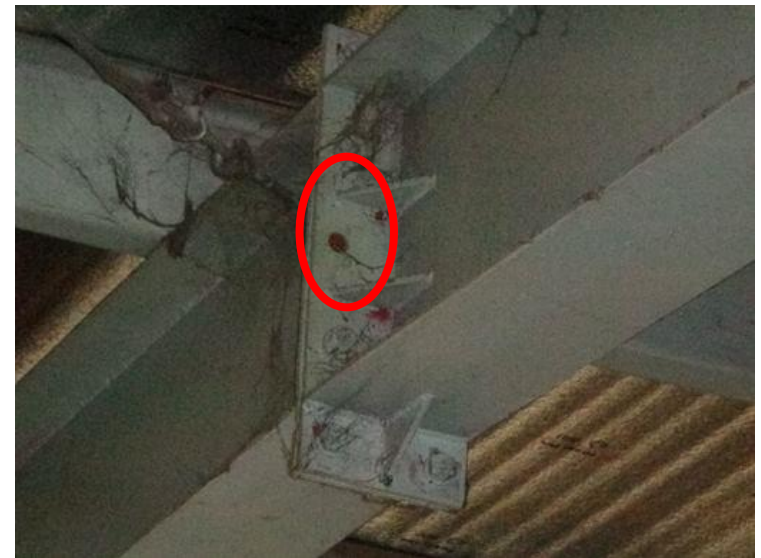
Bolt missing at several locations

Bolt missing and significant connection gap was observed at several locations. Factory engineered is required to

- Install the missing bolt
- Take proper measure to fill up connection gap.

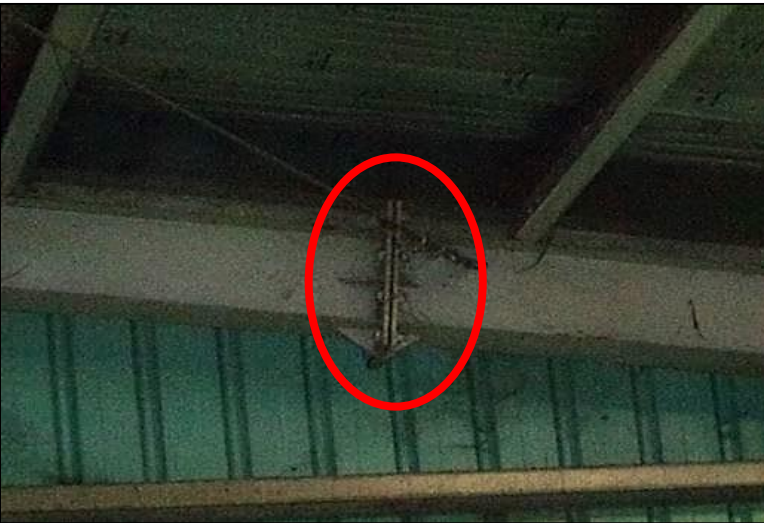
Significant connection gap

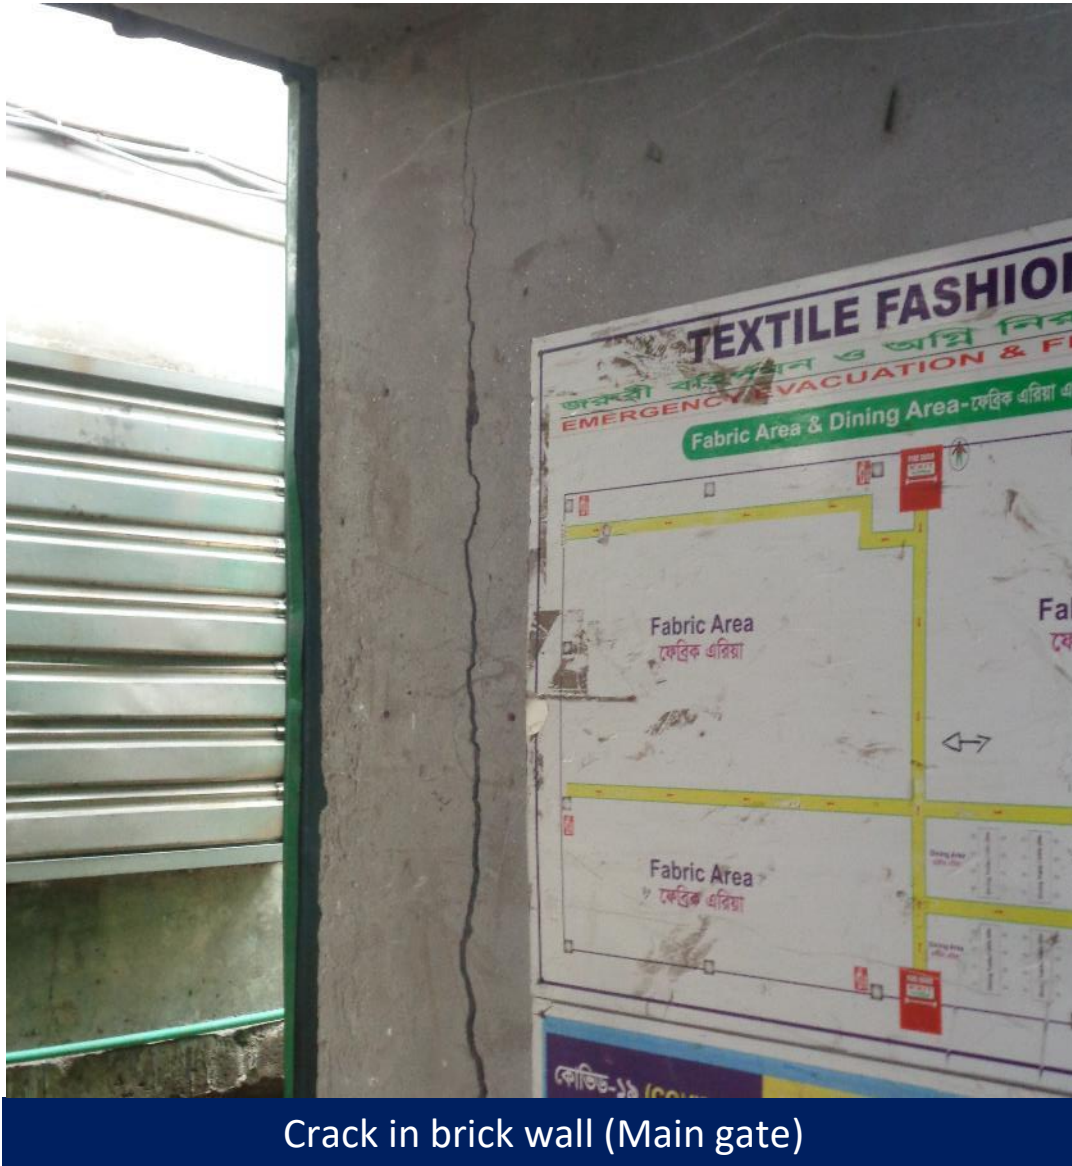
Crack in brick wall (Main gate)

Crack was observed in brick wall at main gate. Factory is required to repair the cracked area as per guidance by the building engineer.
