# South East Textiles (Pvt.) Ltd (Extension)

Gorai, Mirzapur, Tangail.  
(24.094944, 90.166985)  
05 March 2023

# Observations

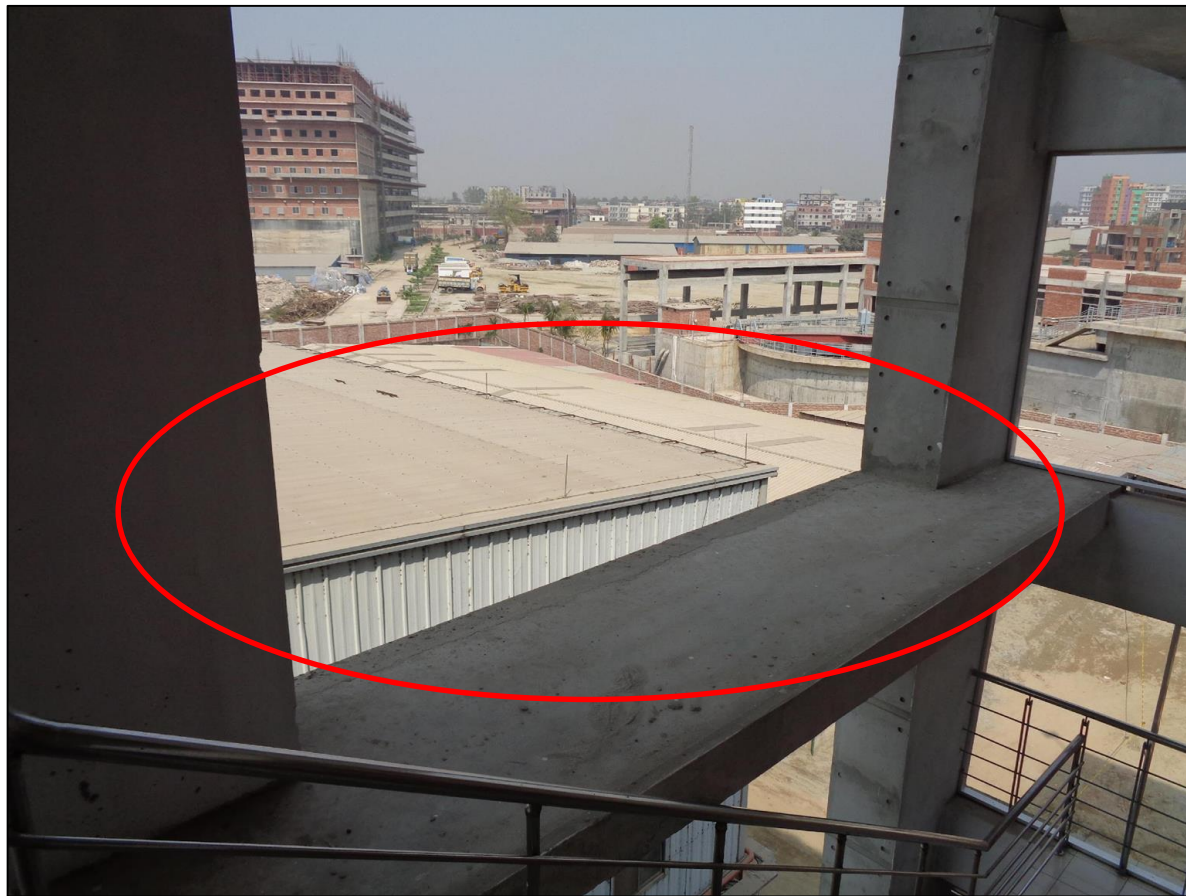
Opening at staircase

There were no barrier/walls on the 3<sup>rd</sup> floor stair area which may cause falling hazard. The factory is required to provide adequate barrier/railing/walls on the stair to protect possible falling hazard.

| Item No. | Observation | Recommended Action Plan | Recommended Timeline |
|---|---|---|---|
| 01 | Lack of fall protection. (ETP Building) | Building engineer is required to provide adequate barrier/walls on the 3rd floor stair area to protect possible falling hazard. | 6-weeks |

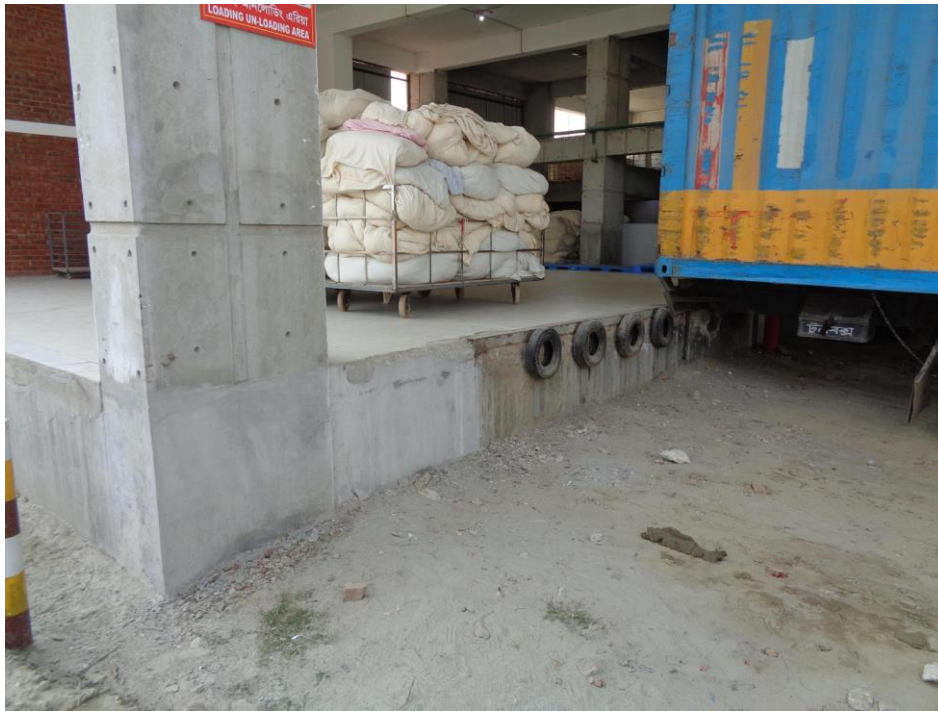
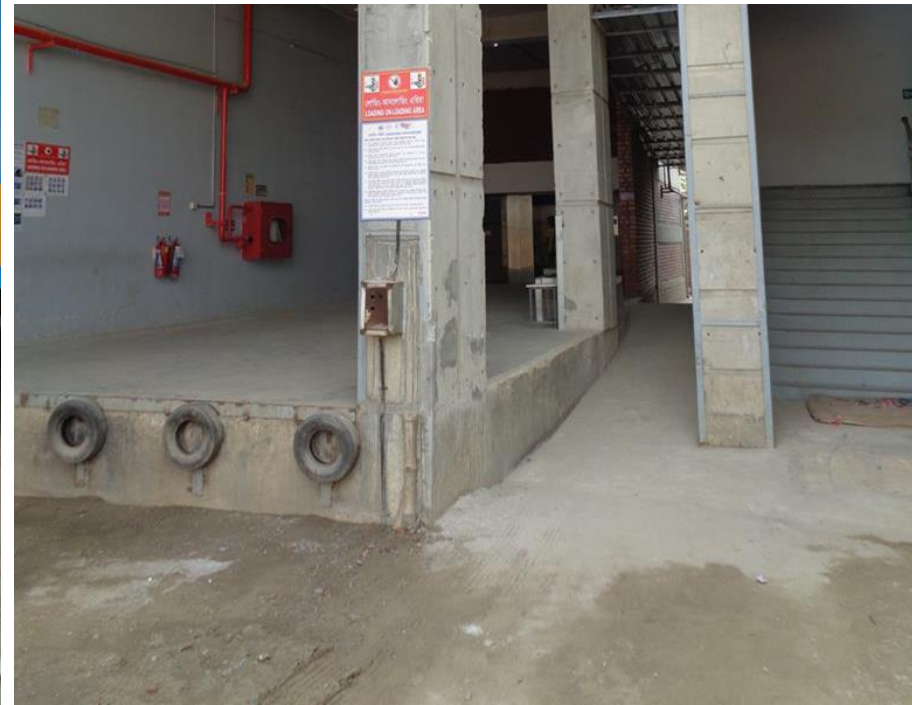
No proper protection barrier at ground floor columns

During inspection, no proper protection barrier was observed at the ground floor and basement columns to protect the vehicle impact. Building engineer is required to provide the safety barrier surrounding the column to protect vehicle impact.

| Item No. | Observation | Recommended Action Plan | Recommended Timeline |
|---|---|---|---|
| 02 | Possible vehicle impact. (ETP Building) | Building engineer is required to provide the safety barrier surrounding the column to protect vehicle impact. | 6-weeks |

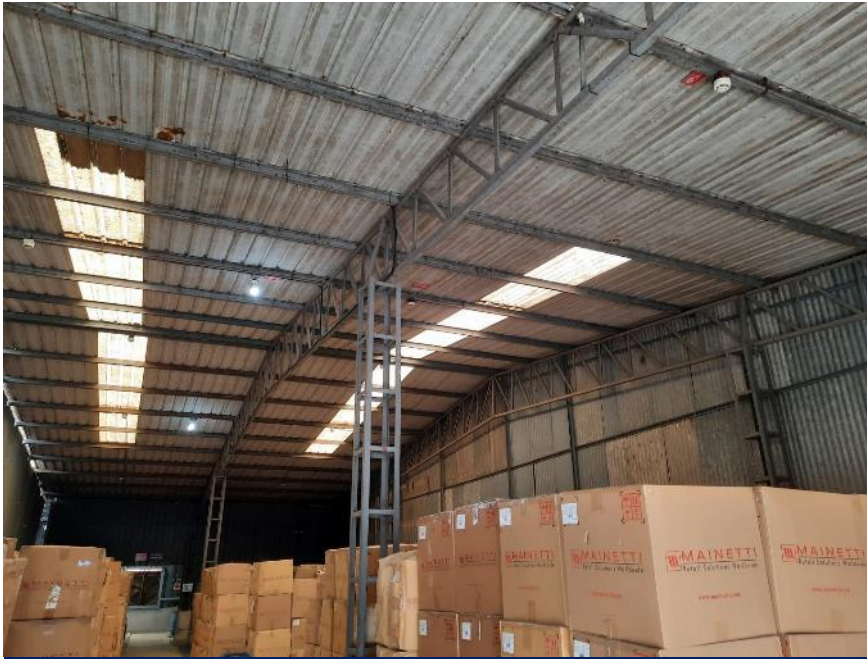
No roof & wall bracing provided

Bracing and lateral load transfer media was not observed in the structure. Also, poor connection between steel members were observed. Building engineer is required to check the lateral stability system of the structure and suggest necessary remedial actions accordingly.

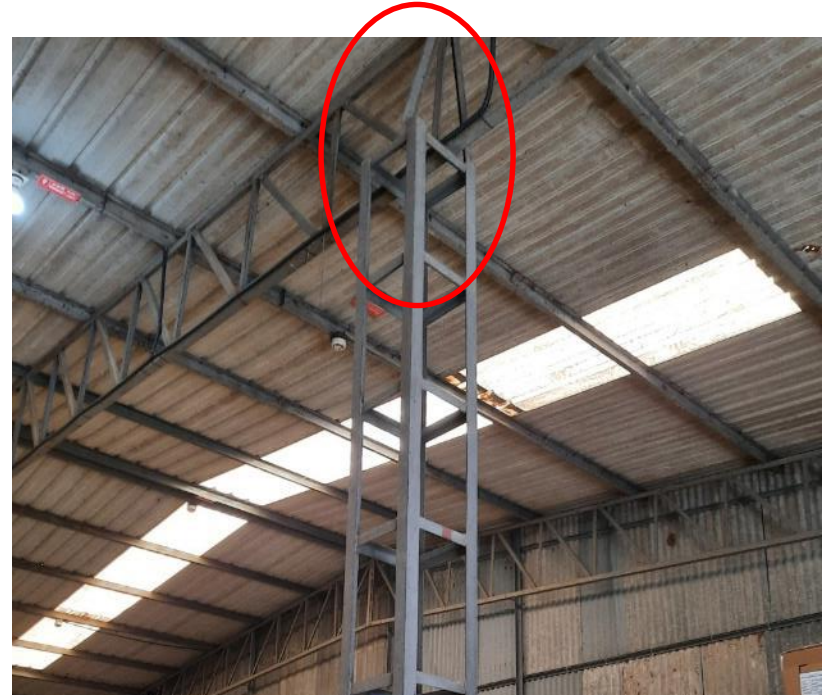
Poor connection system

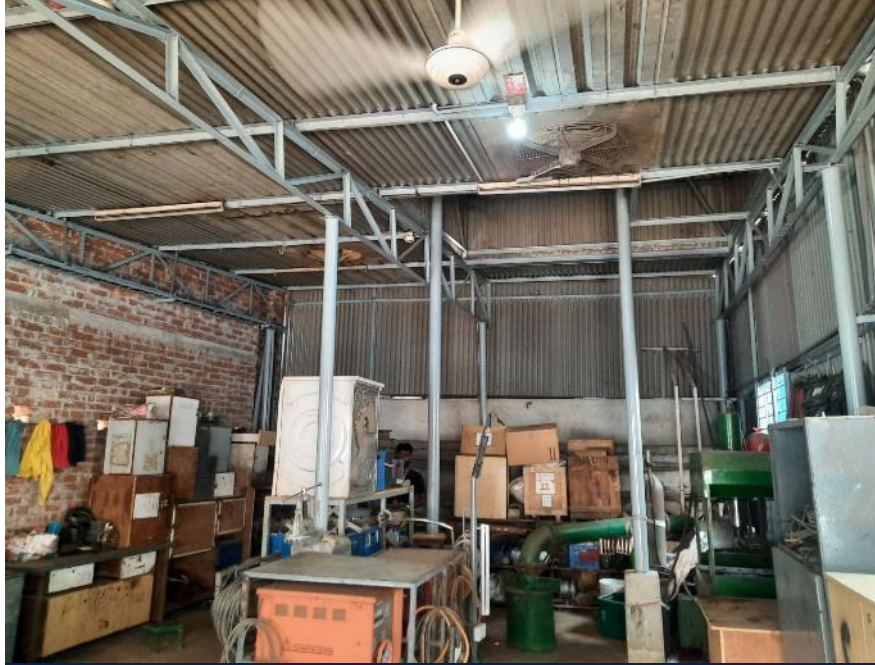
No roof & wall bracing provided

Bracing and lateral load transfer media was not observed in the structure. Also, poor connection between steel members were observed. Building engineer is required to check the lateral stability system of the structure and suggest necessary remedial actions accordingly.

| Item No. | Observation | Recommended Action Plan | Recommended Timeline |
|---|---|---|---|
| 03 | Apparently lack of lateral stability. (Store Shed) | Building engineer is required to check the lateral stability of the structure and suggest necessary remedial actions accordingly. | 6-weeks |
| 04 | Apparently lack of lateral stability. (Store Shed) | Implement remediation work where required. | 6-months |

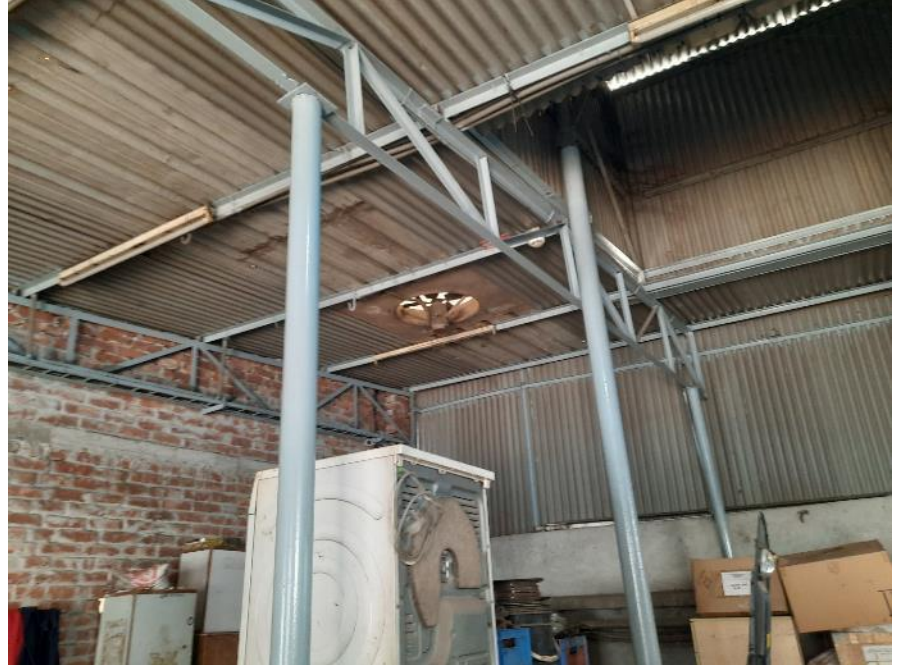
Column support out of node

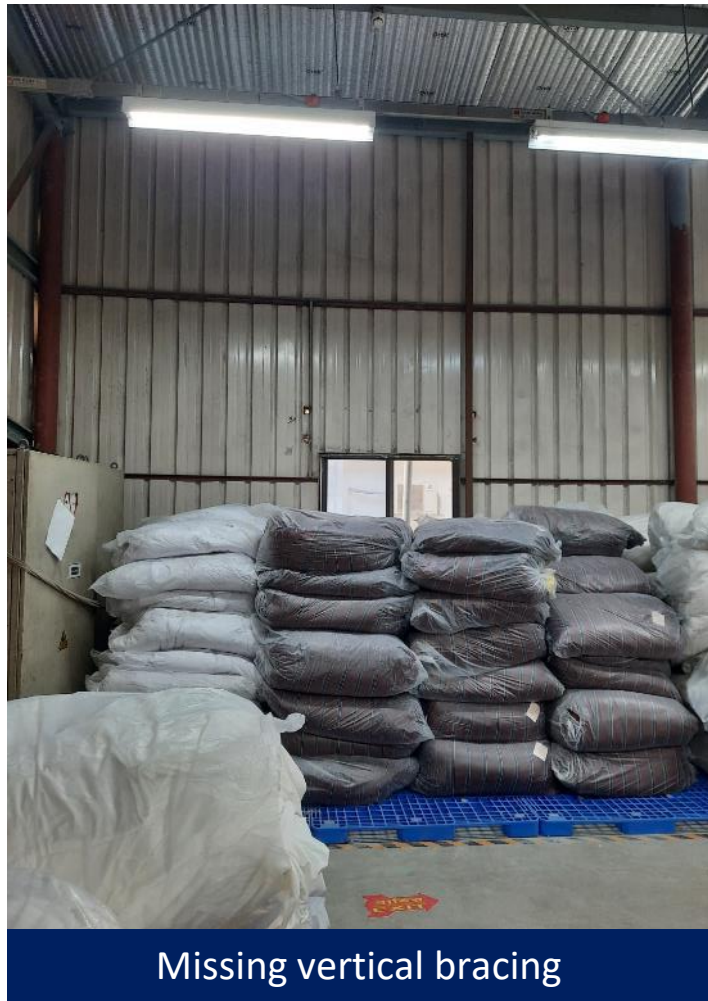
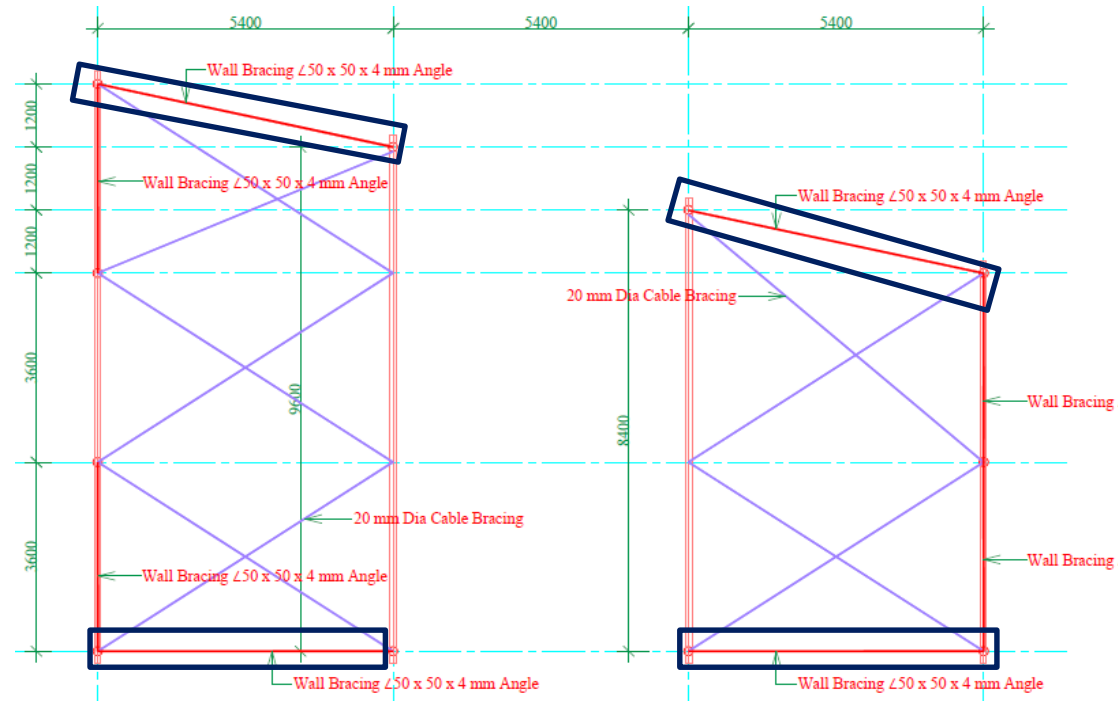
Bracing layout

Vertical bracing missing in long direction and compression member was absent. Building engineer is required to check the lateral stability system of the shed and suggest necessary remedial action.

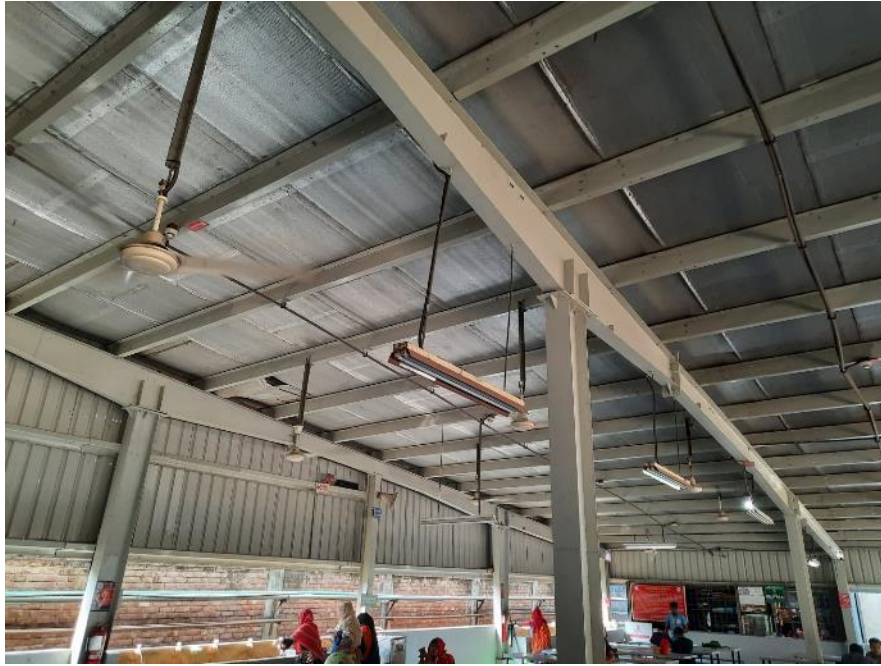
Portal frame action only in N-S direction,  
stability system absent in E-W direction

Only portal frame action along N-S direction but bracing and lateral load transfer media was not observed along E-W direction. Building engineer is required to check the lateral stability of the structure and suggest necessary remedial actions accordingly.

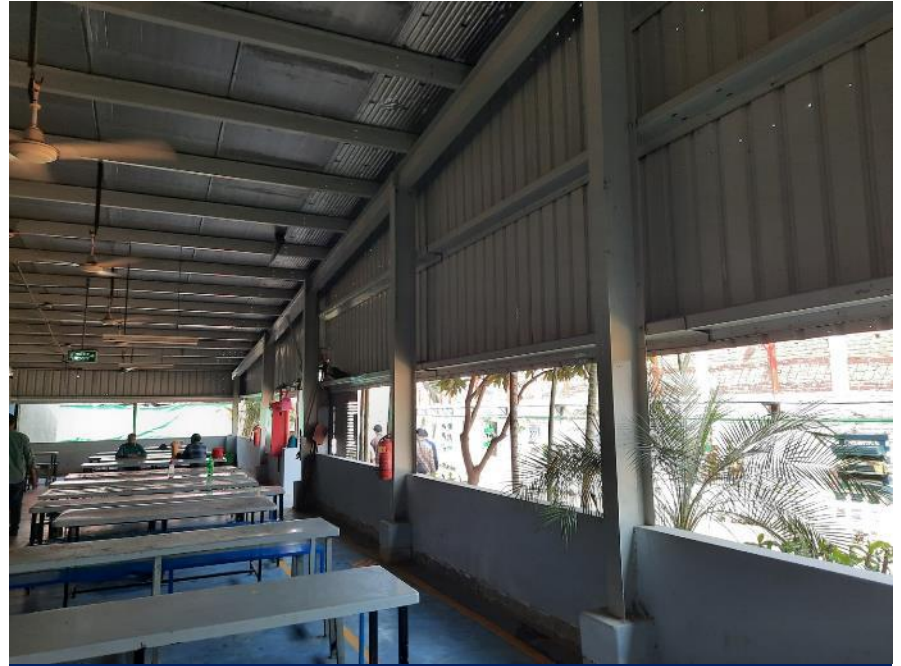
No roof & wall bracing provided

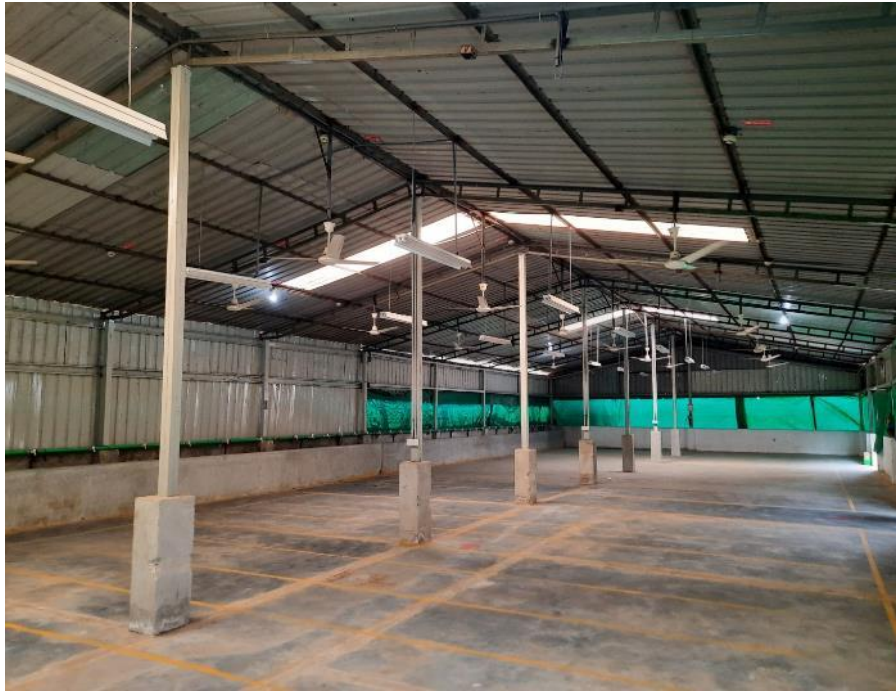
Only frame action in short direction

No roof and wall bracing is provided, and no-load transfer media was also present from frame to frame to transfer the lateral load. Also, poor connection between steel members were observed. Building engineer is required to check the lateral stability of the structure.

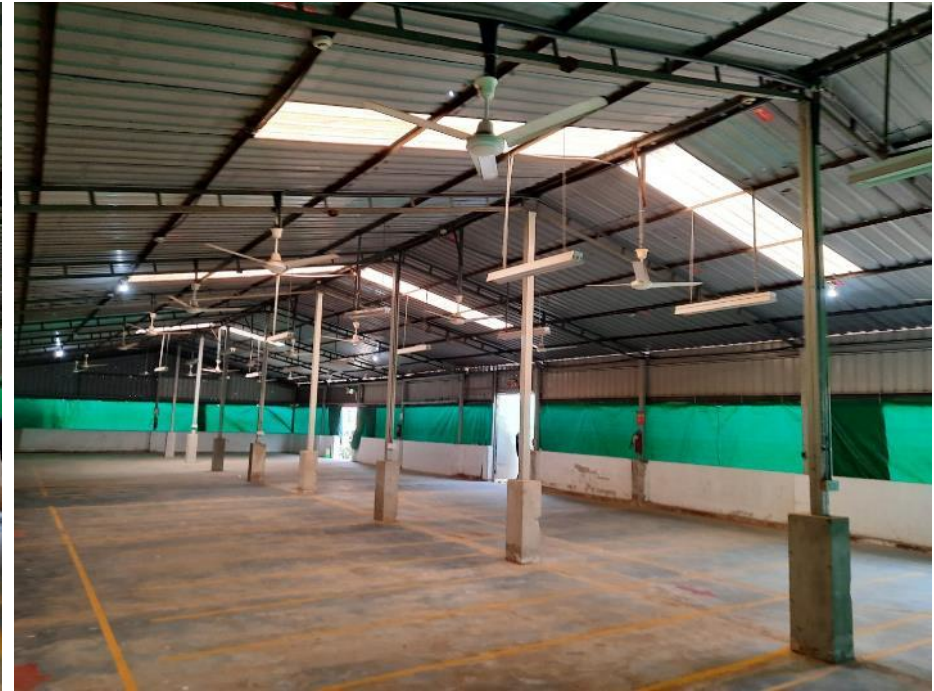
No roof & wall bracing provided

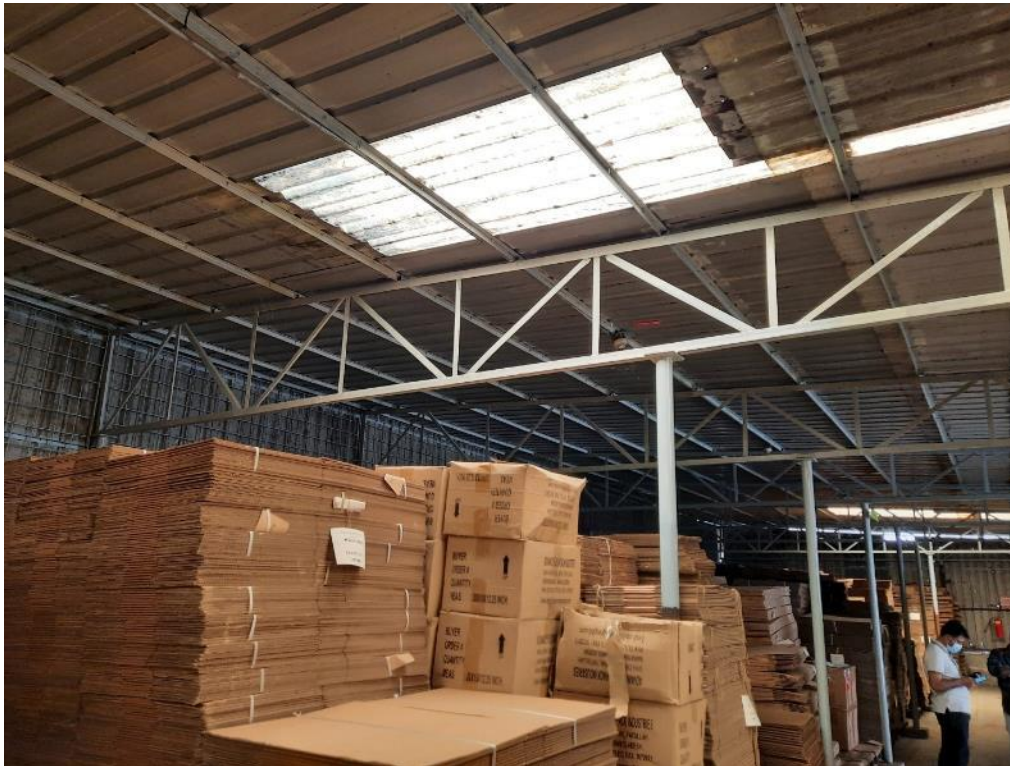
No roof & wall bracing provided

No roof and wall bracing is provided, and no-load transfer media was also present from frame to frame to transfer the lateral load. Also, poor connection between steel members were observed. Building engineer is required to check the lateral stability of the structure.

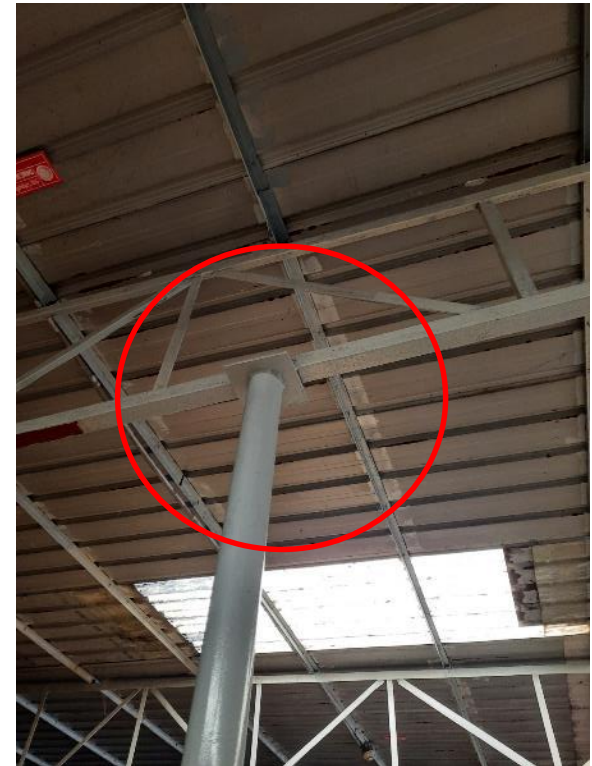
Poor connection system

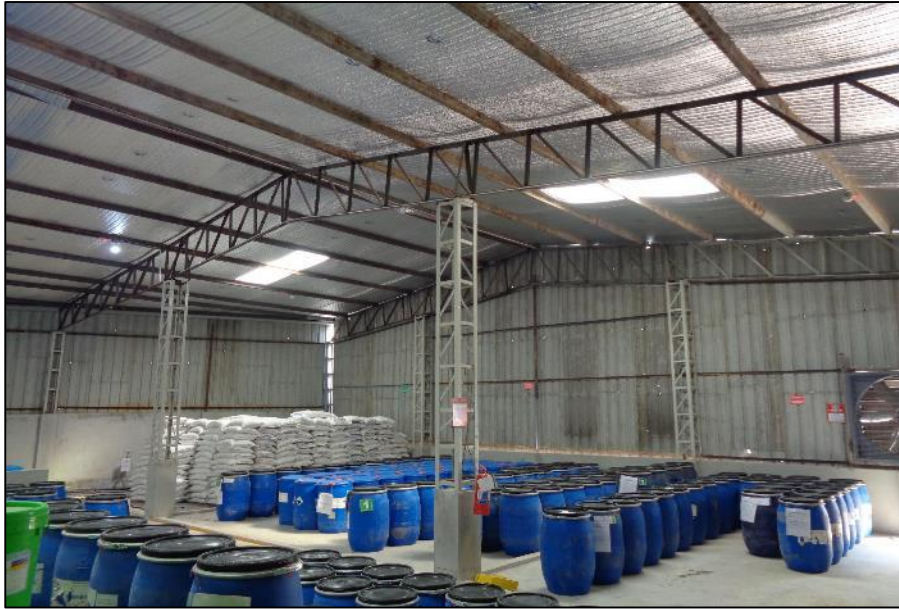
No roof & wall bracing provided

No roof and wall bracing is provided, and no-load transfer media was also present from frame to frame to transfer the lateral load. Also, poor connection between steel members were observed with no joint plates. Building engineer is required to check the lateral stability of the structure.

| Item No. | Observation | Recommended Action Plan | Recommended Timeline |
|---|---|---|---|
| 13 | Apparently lack of lateral stability. (Empty cartoon store) | Building engineer is required to check the lateral stability of the structure and suggest necessary remedial actions accordingly. | 6-weeks |
| 14 | Apparently lack of lateral stability. (Empty cartoon store) | Implement remediation work where required. | 6-months |

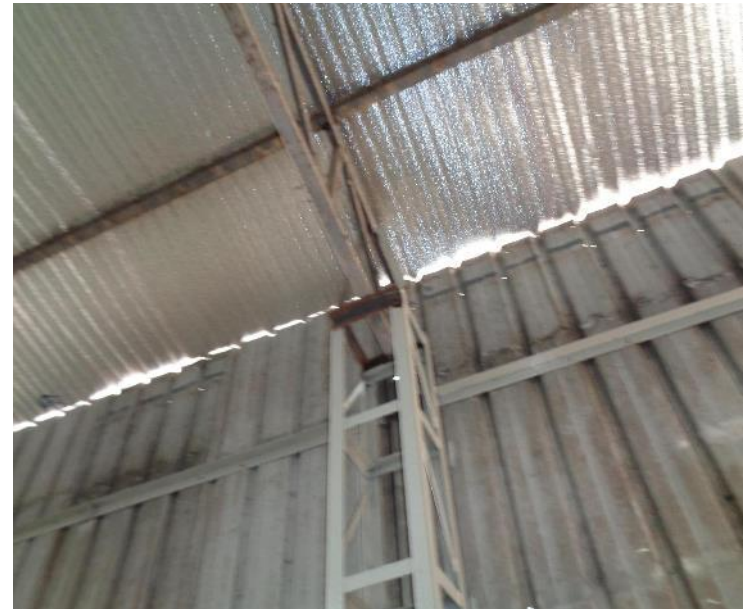
Poor connection system
