# SHOVON KNITWEAR LTD (Extension)

West Masdair, Fatullah,, Narayangonj  
(23.626566, 90.486408)  
12 April 2023

1. Effluent Treatment Plant (ETP) (G+2)
2. Substation Building (G+1)
3. Medical & Childcare Room (single storied)

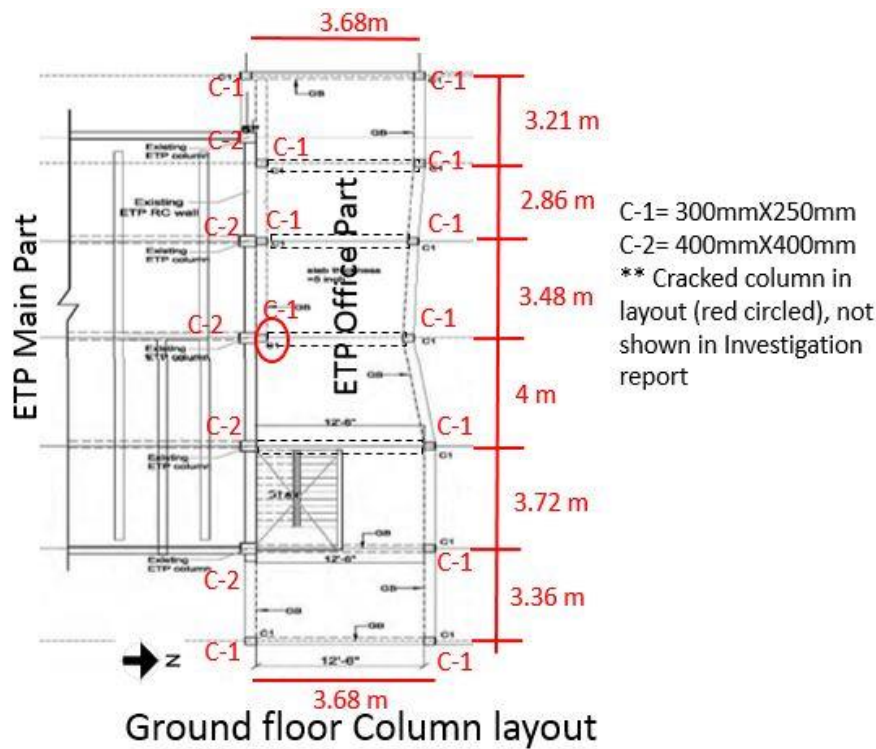
Cracked column in layout

At the time of inspection, crack was found on column surface in ground floor at marked location (see layout). The factory must immediately engage a consultant to investigate the extent and reason of cracks, prepare a detailed investigation report with proper remediation methodology and submit to RSC for review.

| Item No. | Observation | Recommended Action Plan | Recommended Timeline |
|---|---|---|---|
| 01 | Crack on ground floor column, brick wall and beam column joint (Effluent Treatment Plant (ETP)) | The factory must immediately engage a consultant to investigate the extent and reason of cracks, prepare a detailed investigation report with proper remediation methodology and submit to RSC for review. | Immediate |

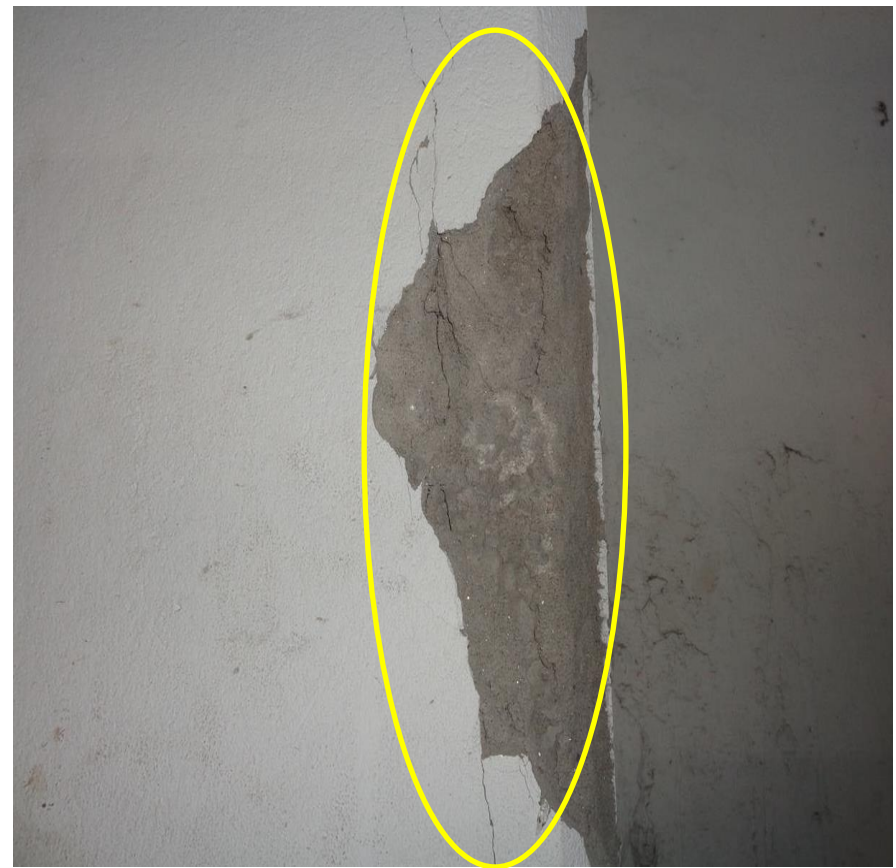
Crack on column surface

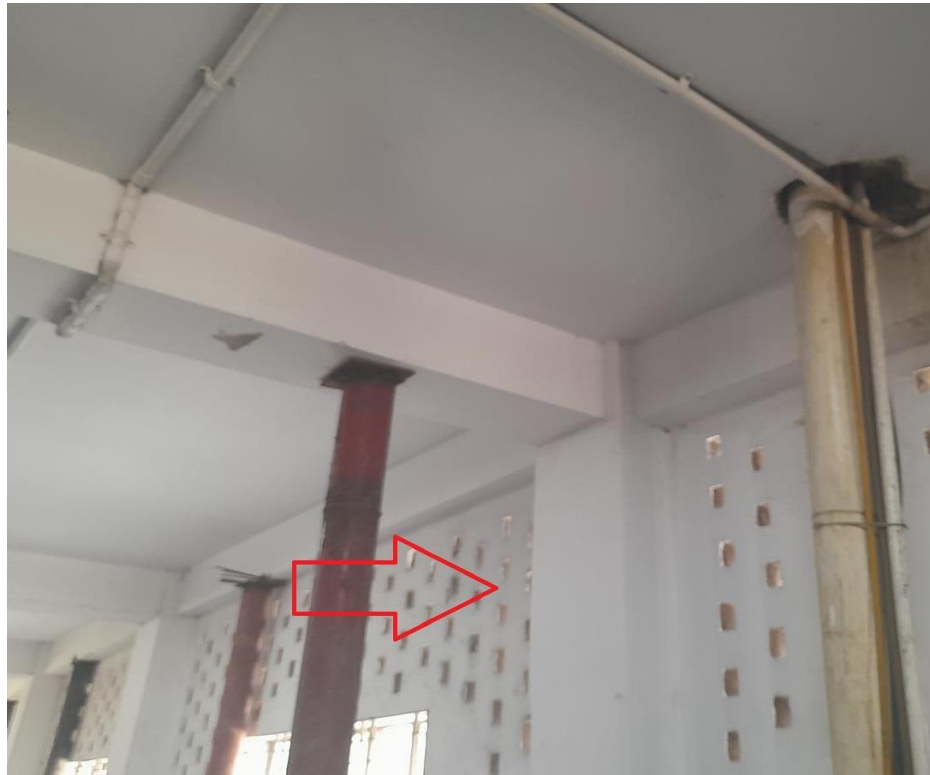
Locally repaired crack on column

A crack investigation report was available on site, which shows horizontal cracks in two columns at the ground floor. However, those cracks in columns have been locally repaired by plaster and paint. Further, in the investigation report those cracks were mentioned as structural cracks without chipping the cracked surface. The factory must immediately engage a consultant to investigate the cracks in depth, prepare a detailed investigation report with proper remediation methodology and submit to RSC for review.

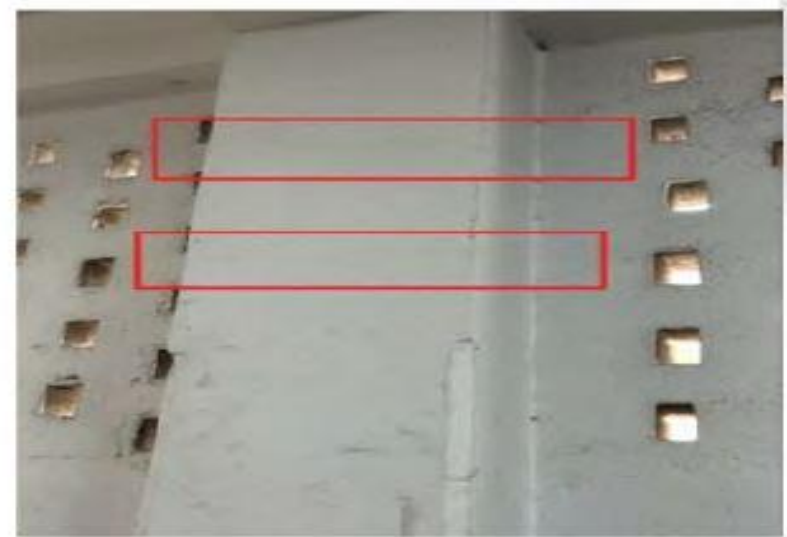
Fig: Pictorial evidence of Crack -1

Horizontal crack shown on column in Investigation report

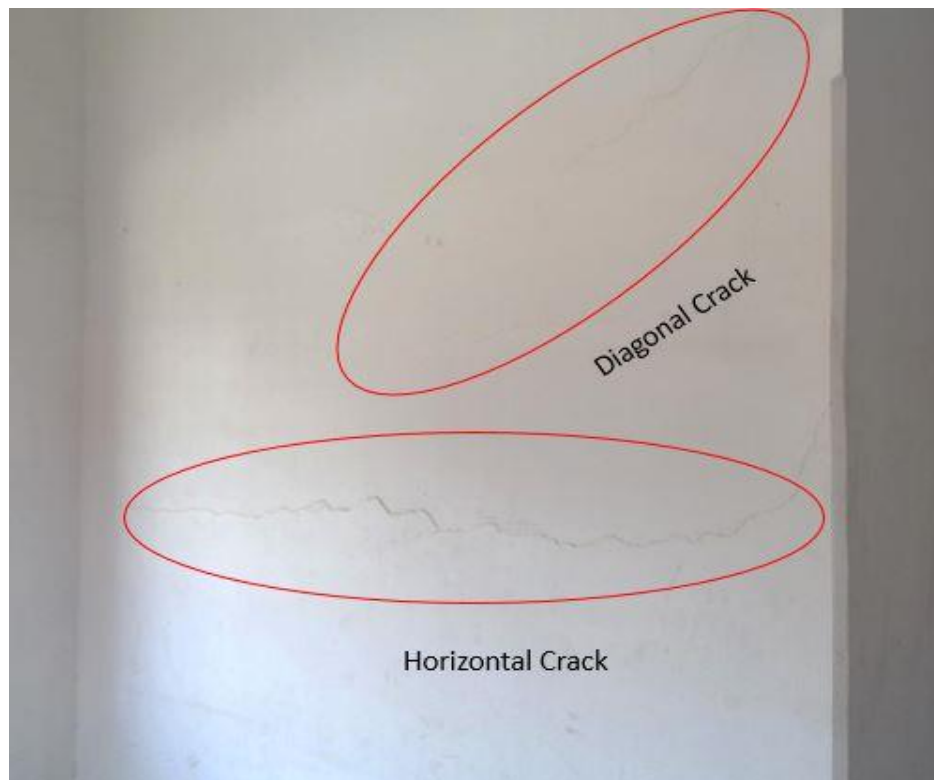
Horizontal and diagonal crack found on brick wall

Some cracks on wall were still visible in different locations and some were found repaired locally by plaster and paint. Also, crack was observed in beam-column joint at ground floor. The factory must immediately engage a consultant to identify the reason of cracks, prepare a detailed investigation report with proper remediation methodology and submit to RSC for review.

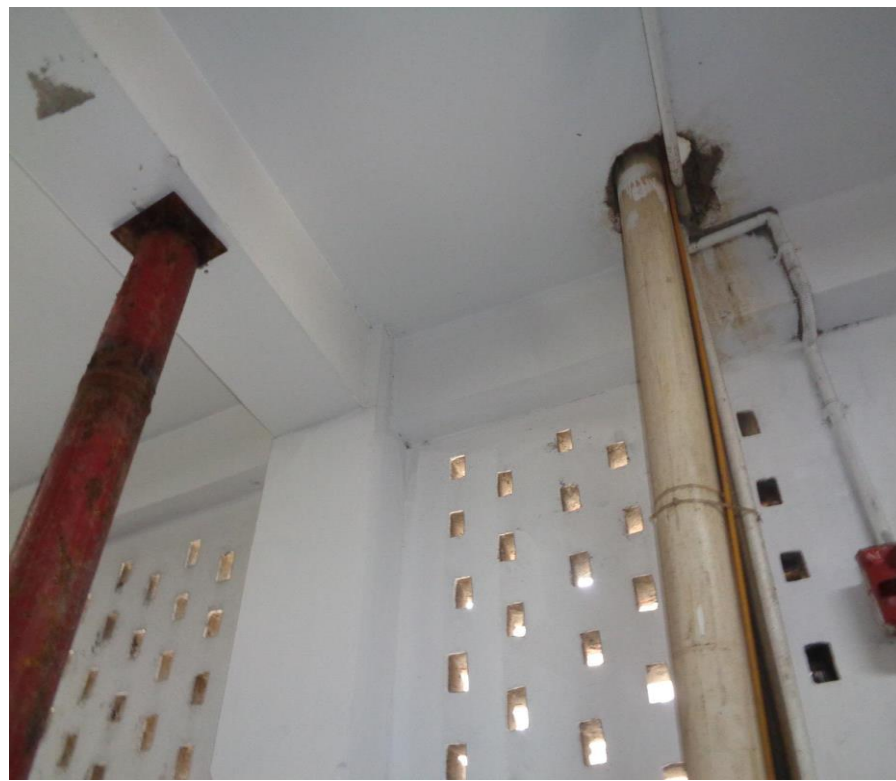
Crack on beam-column joint

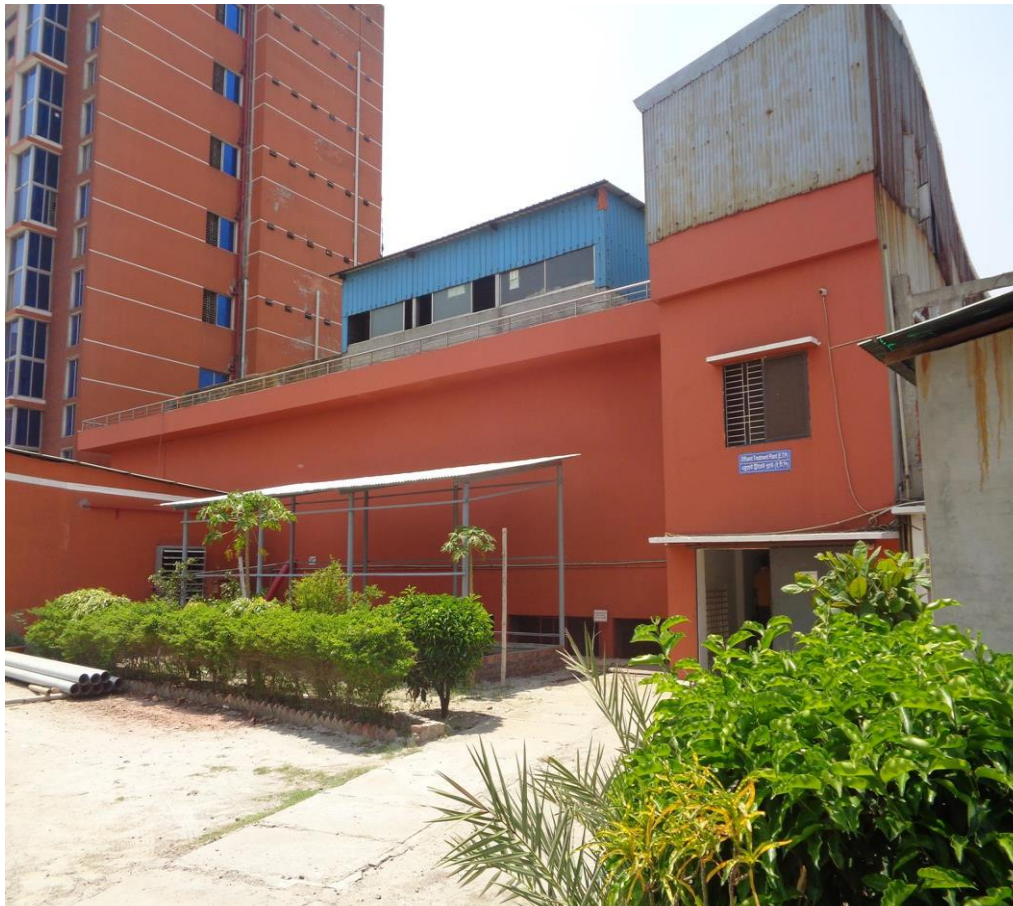
Effluent Treatment Plant (ETP)

As per BNBC, every building or structure designed shall have its design documents prepared in accordance with the provision of Section 1.9.1. The design document shall include a design report, and a set of structural drawings, which shall be prepared in compliance with section 1.9.1.1 and section 1.9.1.2 as per BNBC. At the time of inspection, design report was not available. Also, structural drawing was not available for the office part. Building engineer is required to prepare a design report and a full set of as-built drawing in compliance with section 1.9.1.1 and section 1.9.1.2 (BNBC, part-6).

| Item No. | Observation | Recommended Action Plan | Recommended Timeline |
|---|---|---|---|
| 03 | Absence of design documents and lack of information in as-built drawing (Effluent Treatment Plant (ETP)) | Building engineer is required to prepare a design report and a full set of as-built drawing in compliance with section 1.9.1.1 and section 1.9.1.2 (BNBC). | 6-weeks |

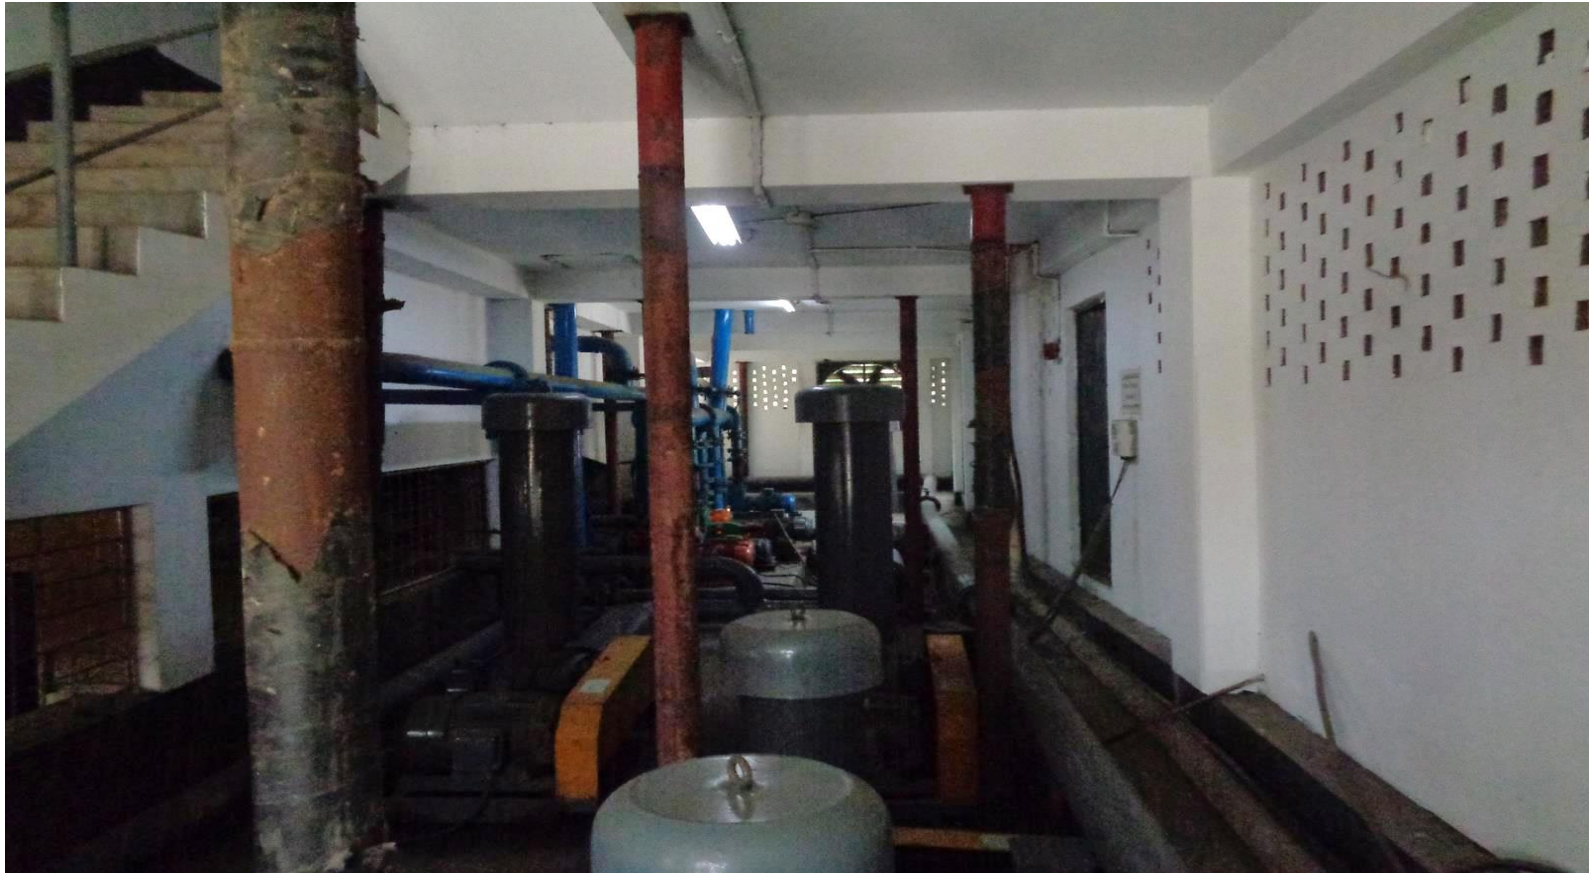
Heavy vibration at ground floor near blower machine

Significant vibration felt at ground floor near the blower machine which may developed crack in structural elements due to the dynamic effect. Building engineer is required to investigate the area and propose a suitable remediation plan to avoid any hazardous situation in future.

| Item No. | Observation | Recommended Action Plan | Recommended Timeline |
|---|---|---|---|
| 05 | Significant vibration at ground floor (Effluent Treatment Plant (ETP)) | Building engineer is required to investigate the area and propose a suitable remediation plan to avoid any hazardous situation in future. | 6-weeks |

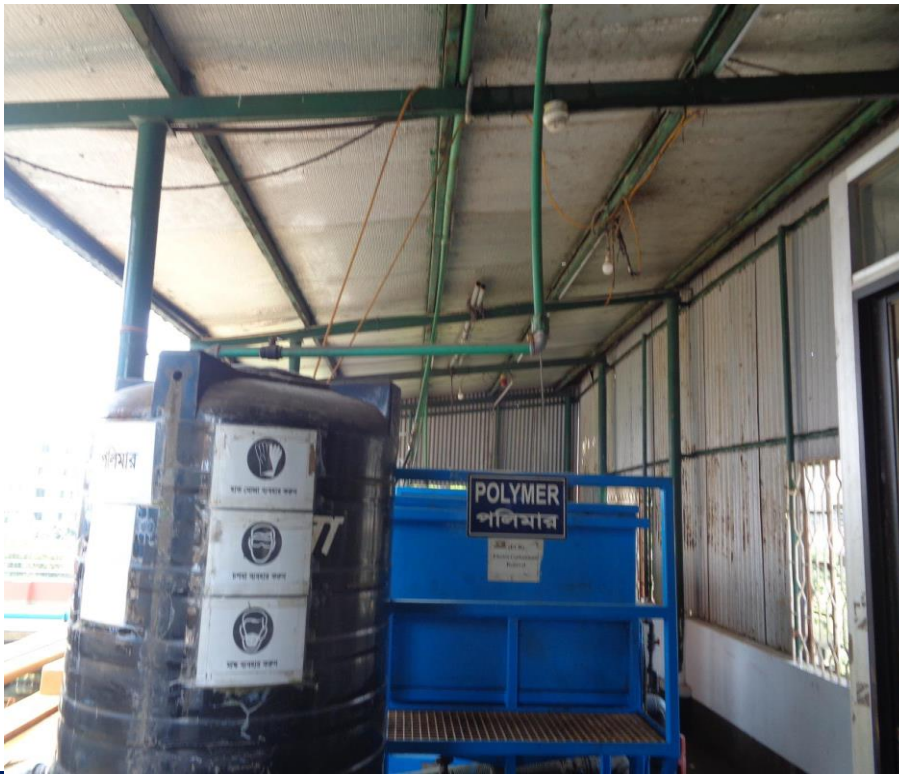
Rooftop Shed-1

Both Shed-1 and Shed-2 were appeared to be non engineered due to lack of lateral stability system and apparently inadequate member sizes. The building engineer is required to check the lateral stability of the sheds against lateral forces.

| Item No. | Observation | Recommended Action Plan | Recommended Timeline |
|---|---|---|---|
| 07 | Apparently non engineered shed (Effluent Treatment Plant (ETP)) | The building engineer is required to check the lateral stability of the sheds against lateral forces. | 6-weeks |

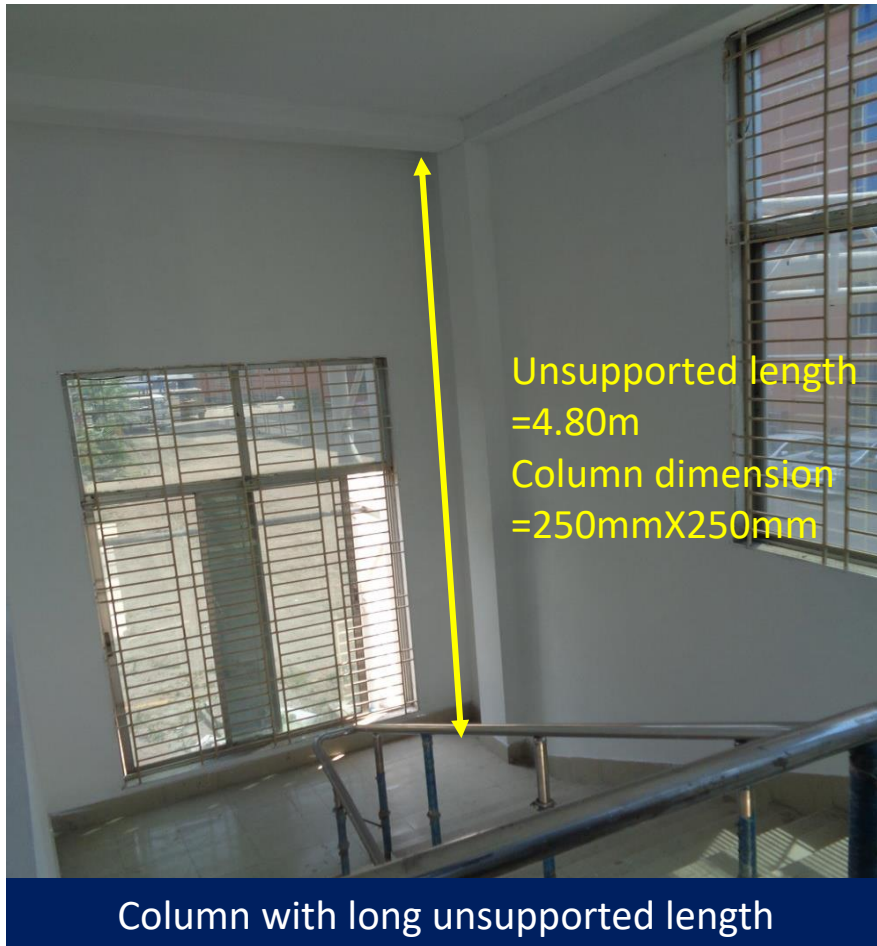
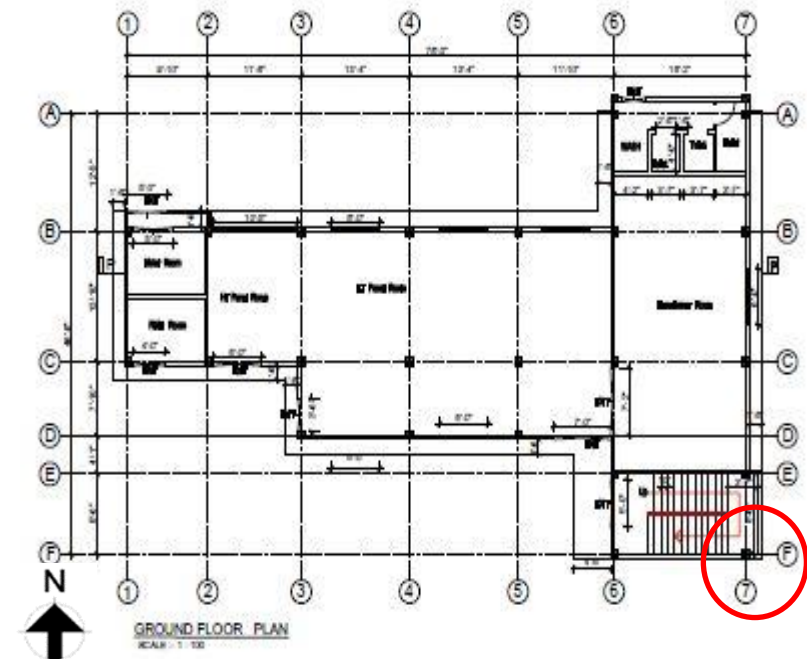
Long columns in layout

The column is 4.80m long with least dimension 250 mm which may be critical for slenderness effect. Building engineer is required to check the adequacy of the highlighted columns considering slenderness effect.

| Item No. | Observation | Recommended Action Plan | Recommended Timeline |
|---|---|---|---|
| 09 | Columns appear to be slender (Substation Building) | Building engineer is required to check the adequacy of the highlighted columns considering slenderness effect. | 6-weeks |

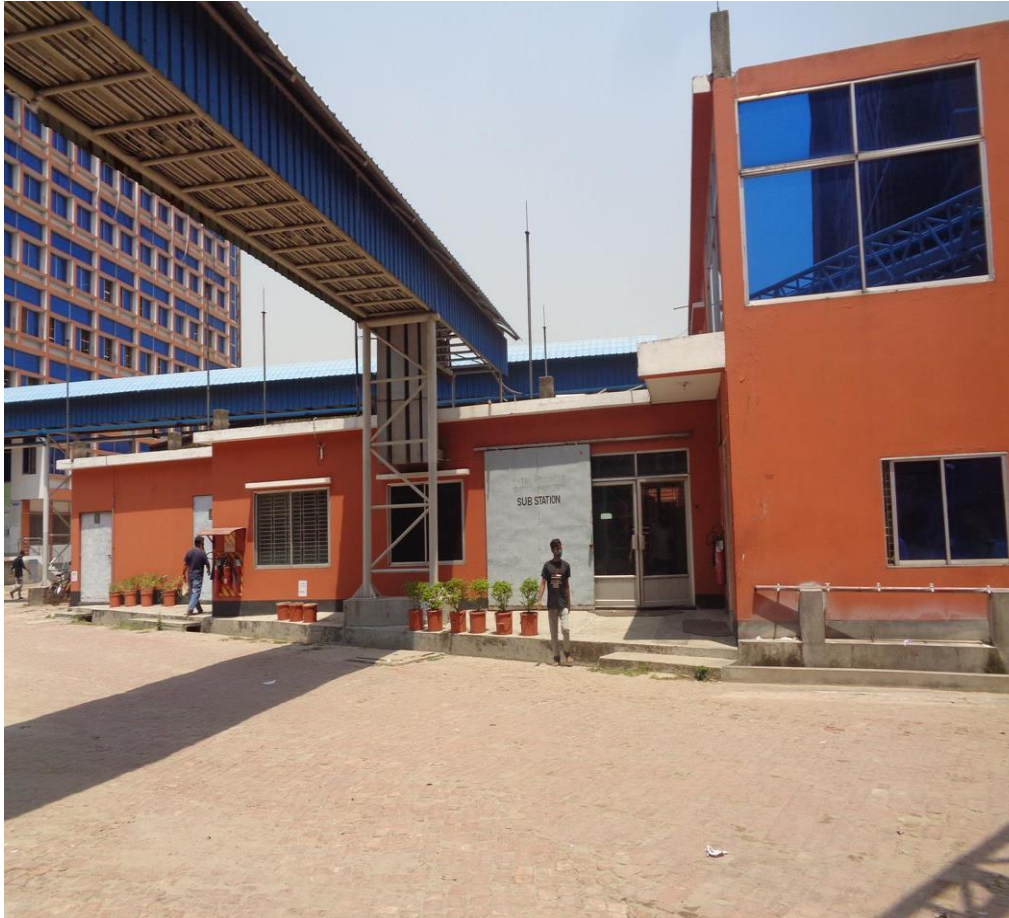
Substation Building

As per BNBC, every building or structure designed shall have its design documents prepared in accordance with the provision of Section 1.9.1. The design document shall include a design report, and a set of structural drawings, which shall be prepared in compliance with section 1.9.1.1 and section 1.9.1.2 as per BNBC. At the time of inspection, no design report was available. Building engineer is required to prepare a design report and a full set of as-built drawing in compliance with section 1.9.1.1 and section 1.9.1.2 (BNBC, part-6).

| Item No. | Observation | Recommended Action Plan | Recommended Timeline |
|---|---|---|---|
| 11 | Absence of design documents (Substation Building) | Building engineer is required to prepare a design report in compliance with section 1.9.1(BNBC). | 6-weeks |

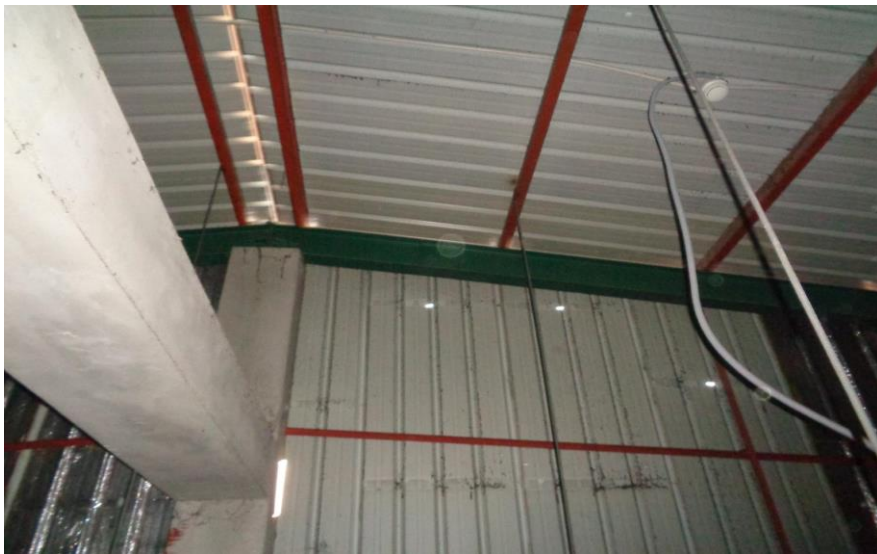
A tie beam in short direction only at one grid

A tie beam is provided in short direction only at one grid. Tie beam is not provided along the long direction where the unsupported eave height is 5.48 m. Also, no bracing system is provided to resist the lateral loads. Building engineer is required to check the lateral stability of the shed and suggest proper remedial measure accordingly (where required).

| Item No. | Observation | Recommended Action Plan | Recommended Timeline |
|---|---|---|---|
| 13 | Lack of lateral stability (Medical & Childcare Room) | Building engineer is required to check the lateral stability of the shed and suggest remedial measures accordingly. | 6-weeks |

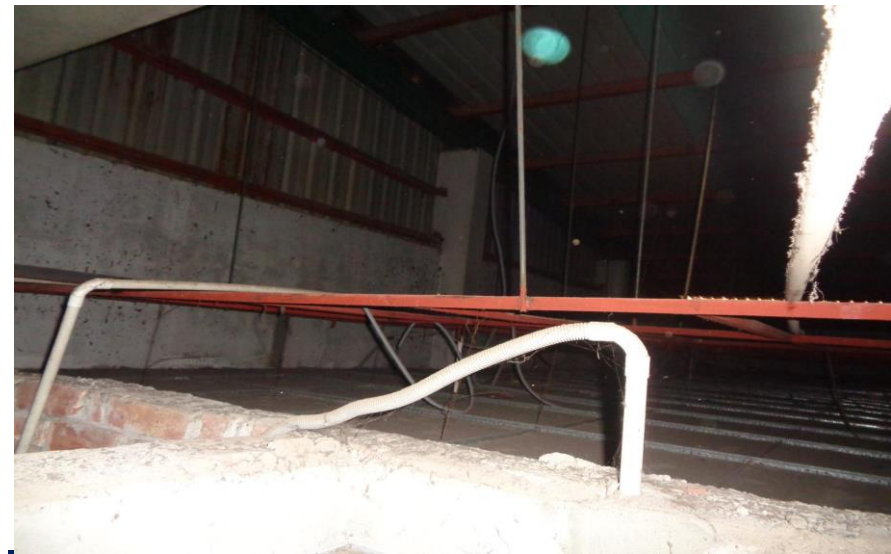
No tie beam in short direction at all grid

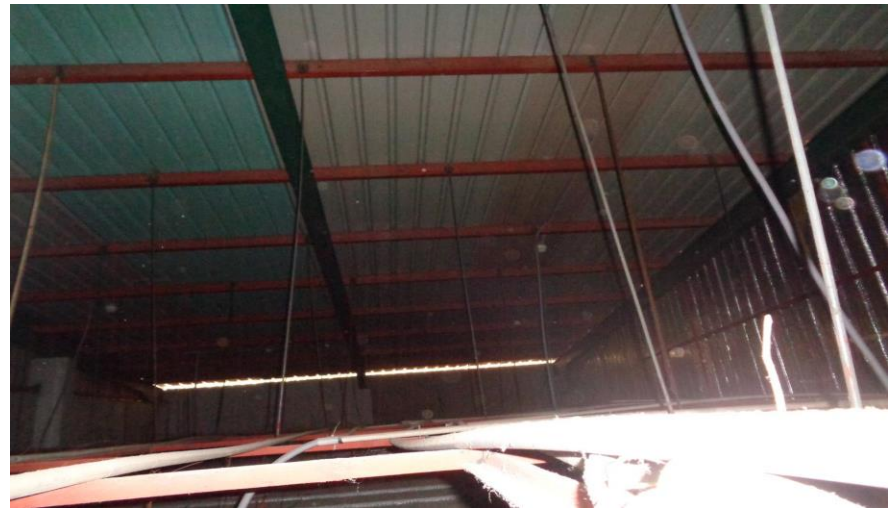
No bracing system is provided

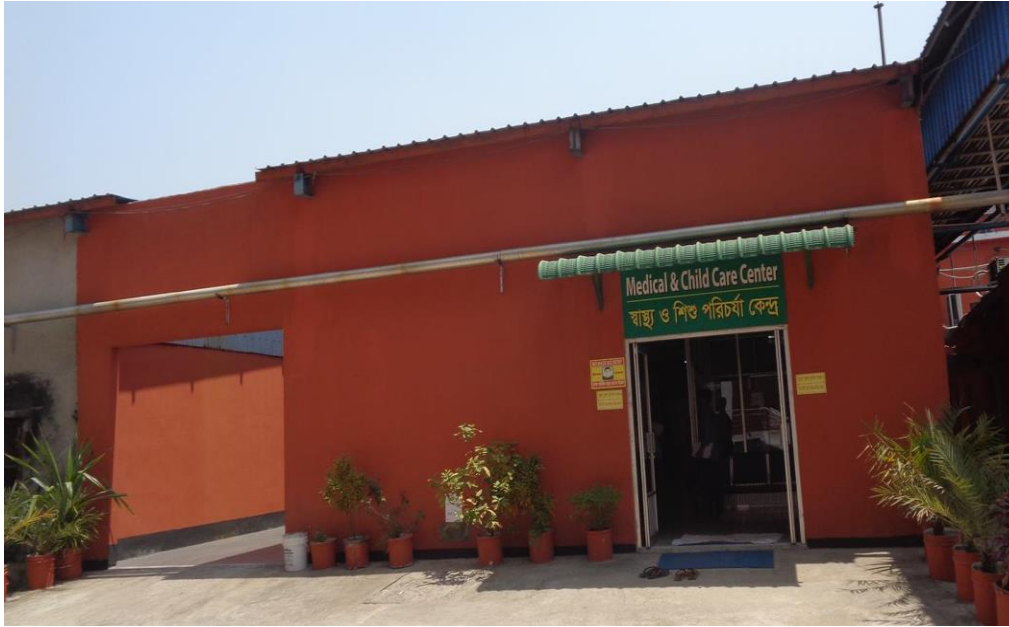
Substation Building

As per BNBC, every building or structure designed shall have its design documents prepared in accordance with the provision of Section 1.9.1. The design document shall include a design report, and a set of structural drawings, which shall be prepared in compliance with section 1.9.1.1 and section 1.9.1.2 as per BNBC. At the time of inspection, no design report was available. Building engineer is required to prepare a design report and a full set of as-built drawing in compliance with section 1.9.1.1 and section 1.9.1.2 (BNBC, part-6).

| Item No. | Observation | Recommended Action Plan | Recommended Timeline |
|---|---|---|---|
| 15 | Absence of design documents (Medical & Childcare Room) | Building engineer is required to prepare a design report in compliance with section 1.9.1 (BNBC, part-6). | 6-months |

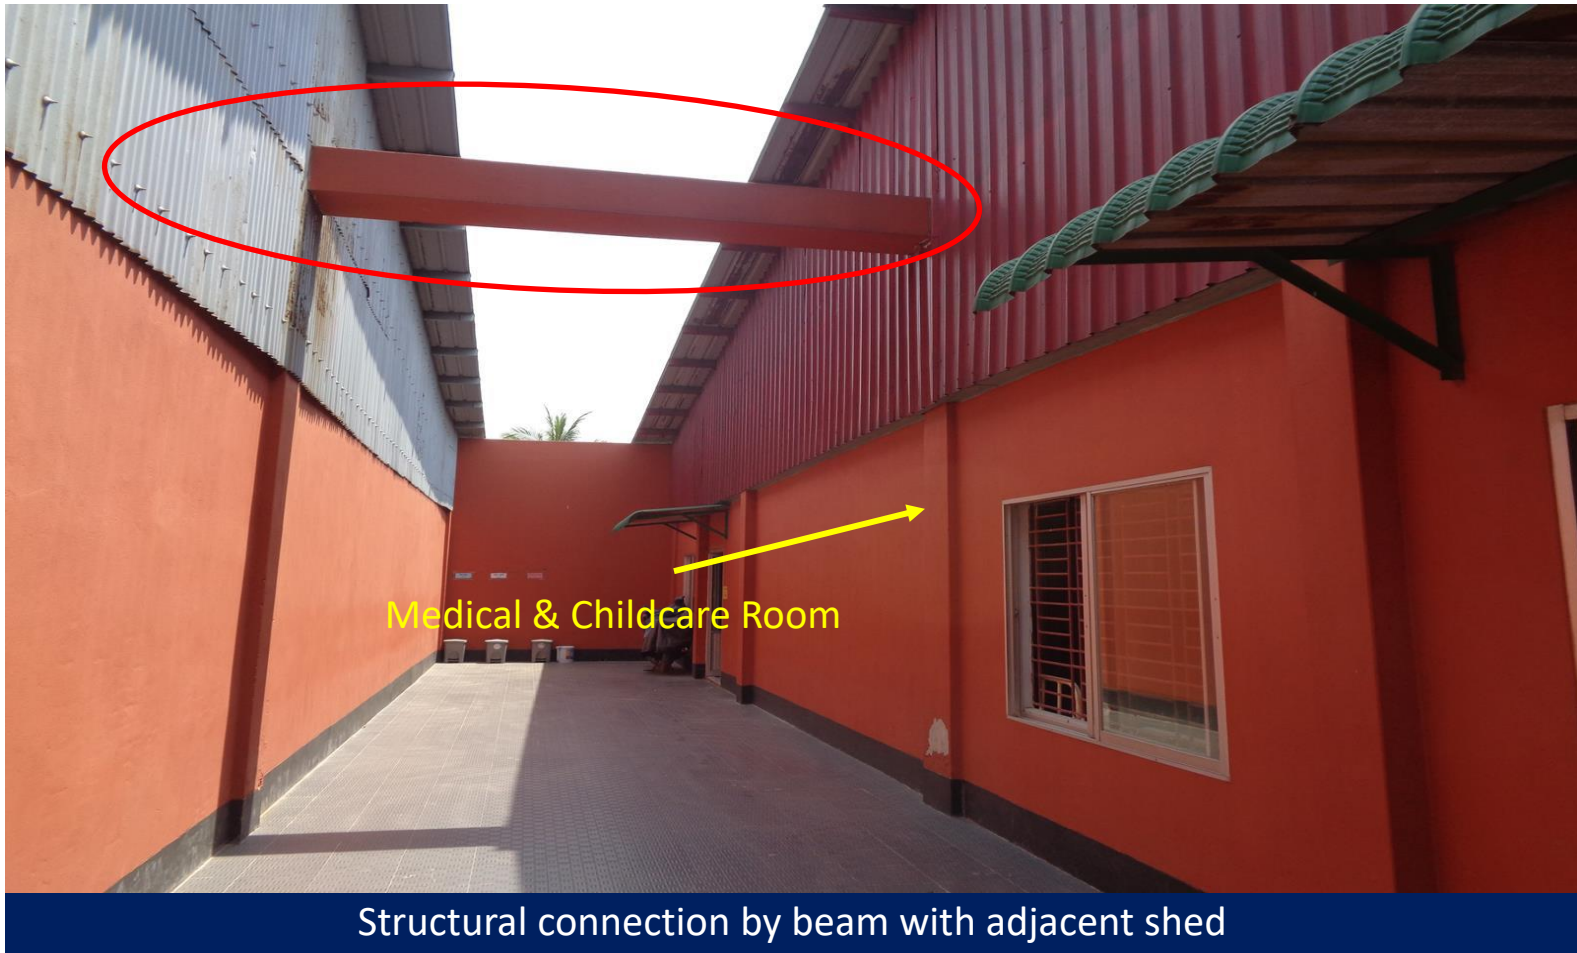
The shed is structurally connected by beam with another shed. Building engineer is required to consider the lateral connections with adjacent shed during the structural analysis. And carry out remedial action if suggested by the building engineer.

| Item No. | Observation | Recommended Action Plan | Recommended Timeline |
|---|---|---|---|
| 17 | Structural connection with adjacent shed (Medical & Childcare Room) | Building engineer is required to consider the lateral connections with adjacent shed during the structural analysis. | 6-weeks |

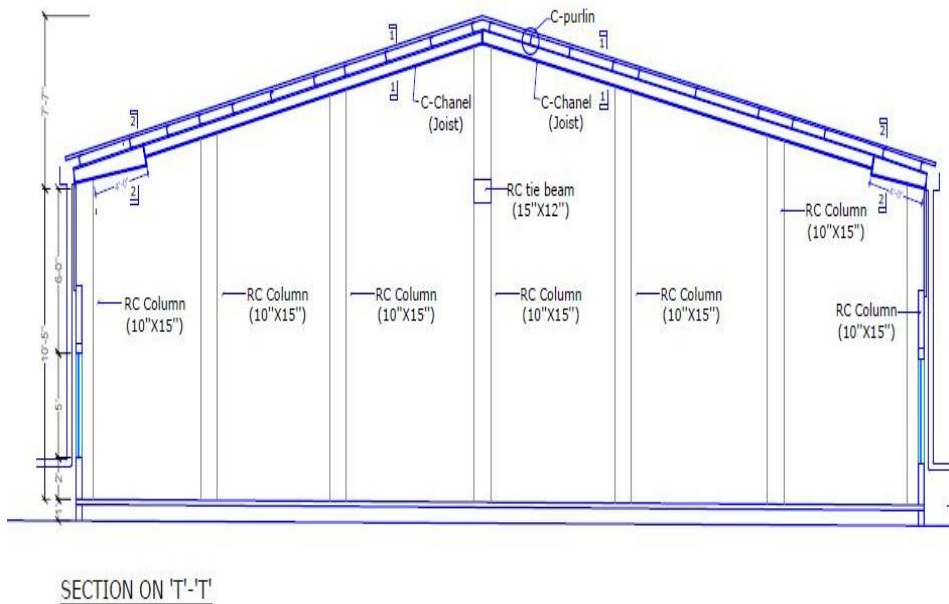
C-shaped rafter section in the as-built drawing

C-shaped rafter section shown in the as-built drawing but I-shaped rafter found onsite. However, the building engineer is required to survey the structural system and update the as-built drawing.

| Item No. | Observation | Recommended Action Plan | Recommended Timeline |
|---|---|---|---|
| 19 | Discrepancy in as-built drawing (Medical & Childcare Room) | Building engineer is required to update the as-built drawing as per onsite condition. | 6-months |

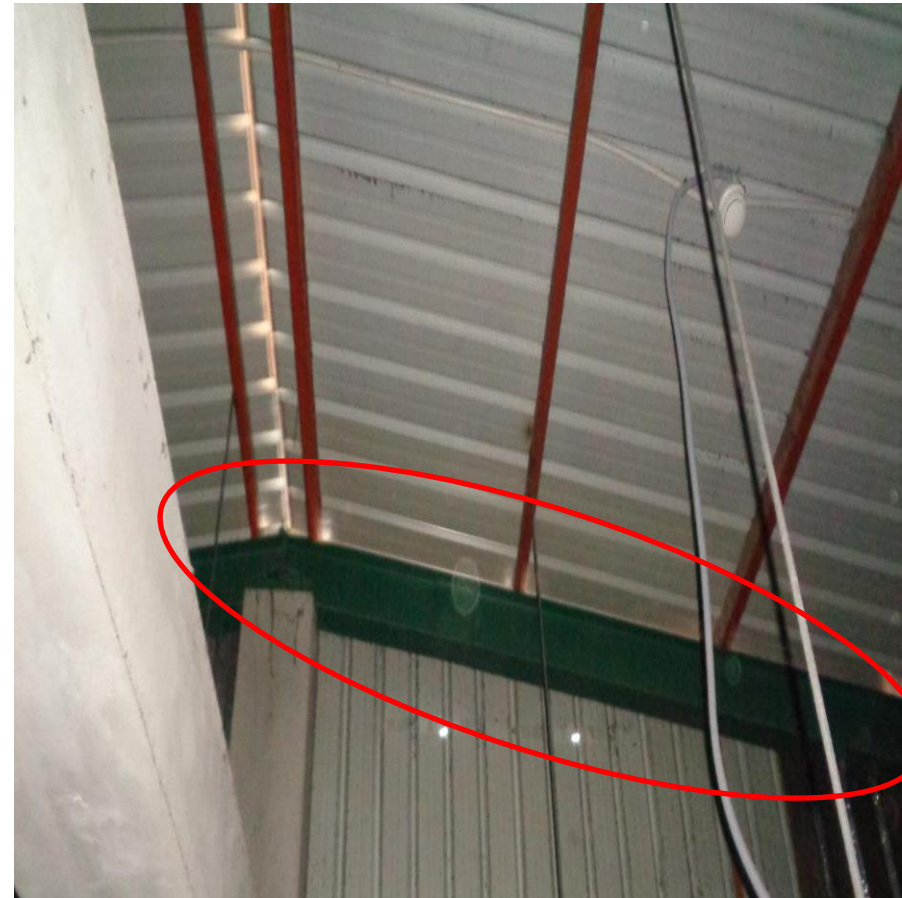
I-section rafter found onsite
