Daeyu Bangladesh LTD (Extension)

731, Bhannara Mouchak, Gazipur.

02 May 2023

Observations

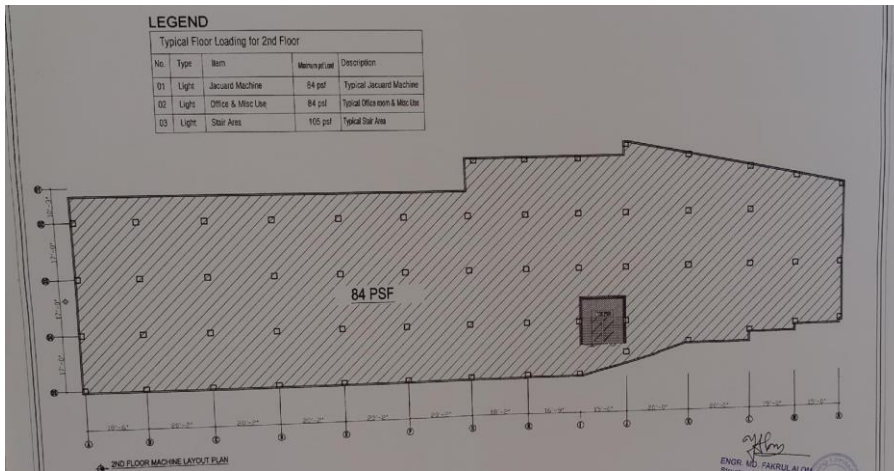
**Load plan & design report not comply
with BNBC requirements**

Currently, the 2nd floor of the building is being allotted for fabric store. As per BNBC, the minimum floor live load for light storage is 6 kN/m² (125 psf). But the storage (temporary store as per factory management) area of the building is designed for 4 kN/m² live loads. Building engineer is required to revise the storage live load limit and related design documents based on BNBC requirement.

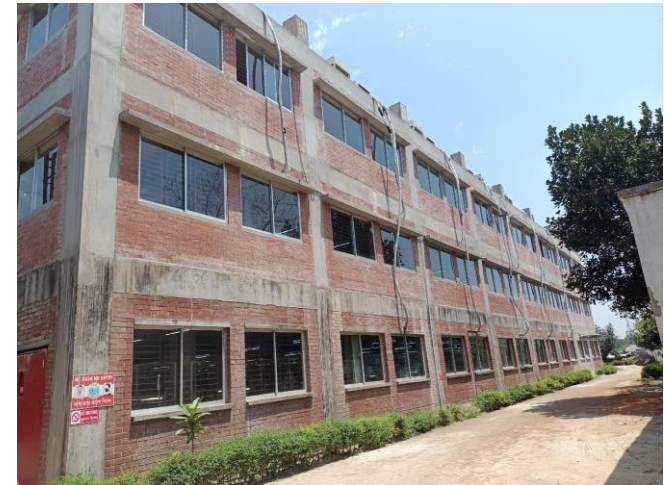
Proposed 5-Storeyed Production building

Compressive strength and floor load on design report

In the design report concrete compressive strength for column $f'c = 33.0 \text{ Mpa (4770 psi)}$ has been considered. But no cylinder test report was found from ground floor column. Building engineer is required to confirm the concrete strength by taking core from lower tier of column and updated the design report accordingly.

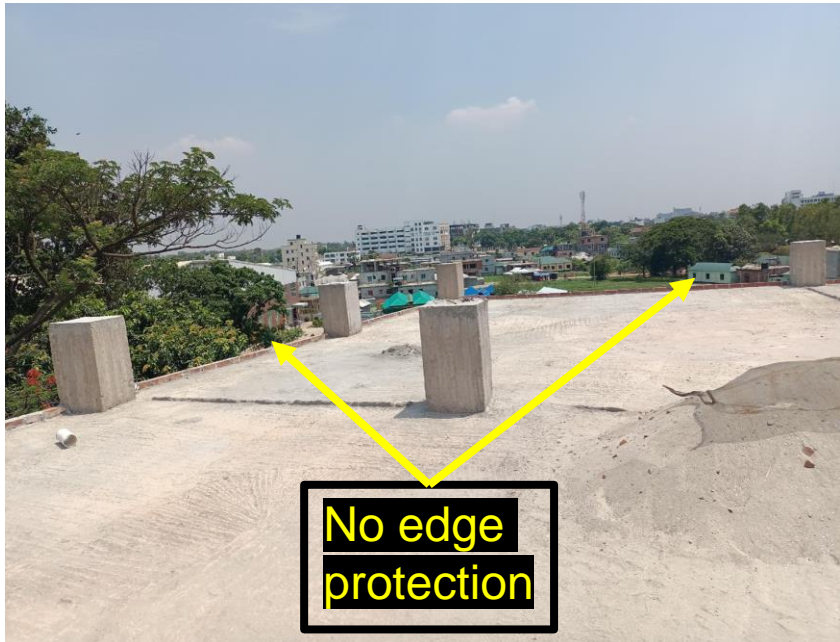
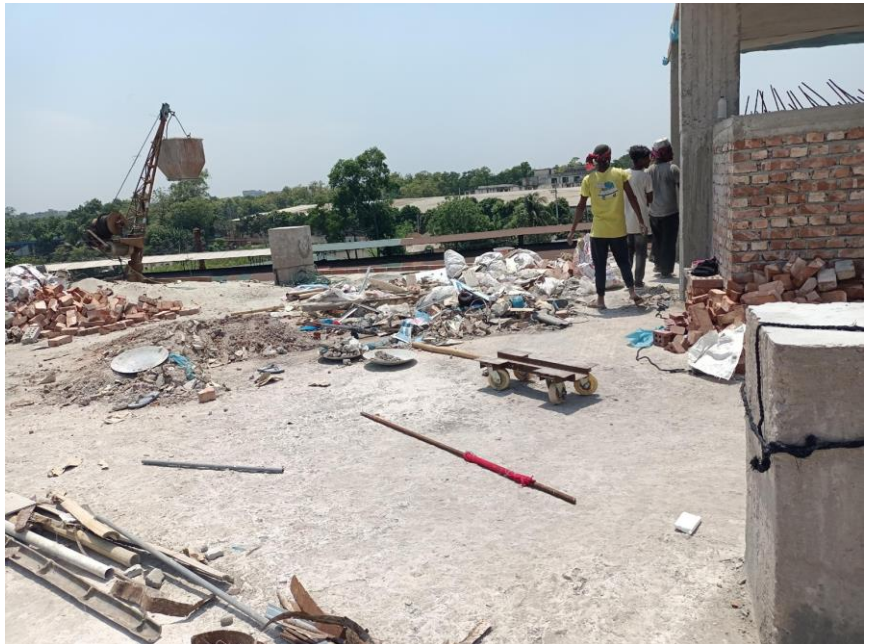
Current roof

Lack of construction safety measures

Necessary safety measures were not observed on the roof. No barrier was provided at roof to mitigate the falling hazard. Building engineer is required to take necessary measures to provide and install construction safety barrier.

Item No.	Observation	Recommended Action Plan	Recommended Timeline
06	Lack of construction safety measures. (Proposed 5-Storeyed Production building).	The factory engineer is required to take necessary measures to provide and install construction safety barrier as per BNBC Part 7.	6-weeks
07	Overloading on the floor. (4-storeyed Production Building).	Produce and actively manage a set of floor loading plan within the factory building considering foundation, column and floor capacity.	6-weeks
08	Overloading on the floor. (4-storeyed Production Building).	Implement floor load plan.	6-Months
09	Mismatch in drawings. (4-storeyed Production Building)	Building Engineer is to survey the whole structure and update as-built drawings representing accurate site condition.	6-weeks
10	Design report required to be revised. (4-storeyed Production Building).	Factory engineer is required revise the design report considering actual size and strength of concrete & steel materials.	6-weeks

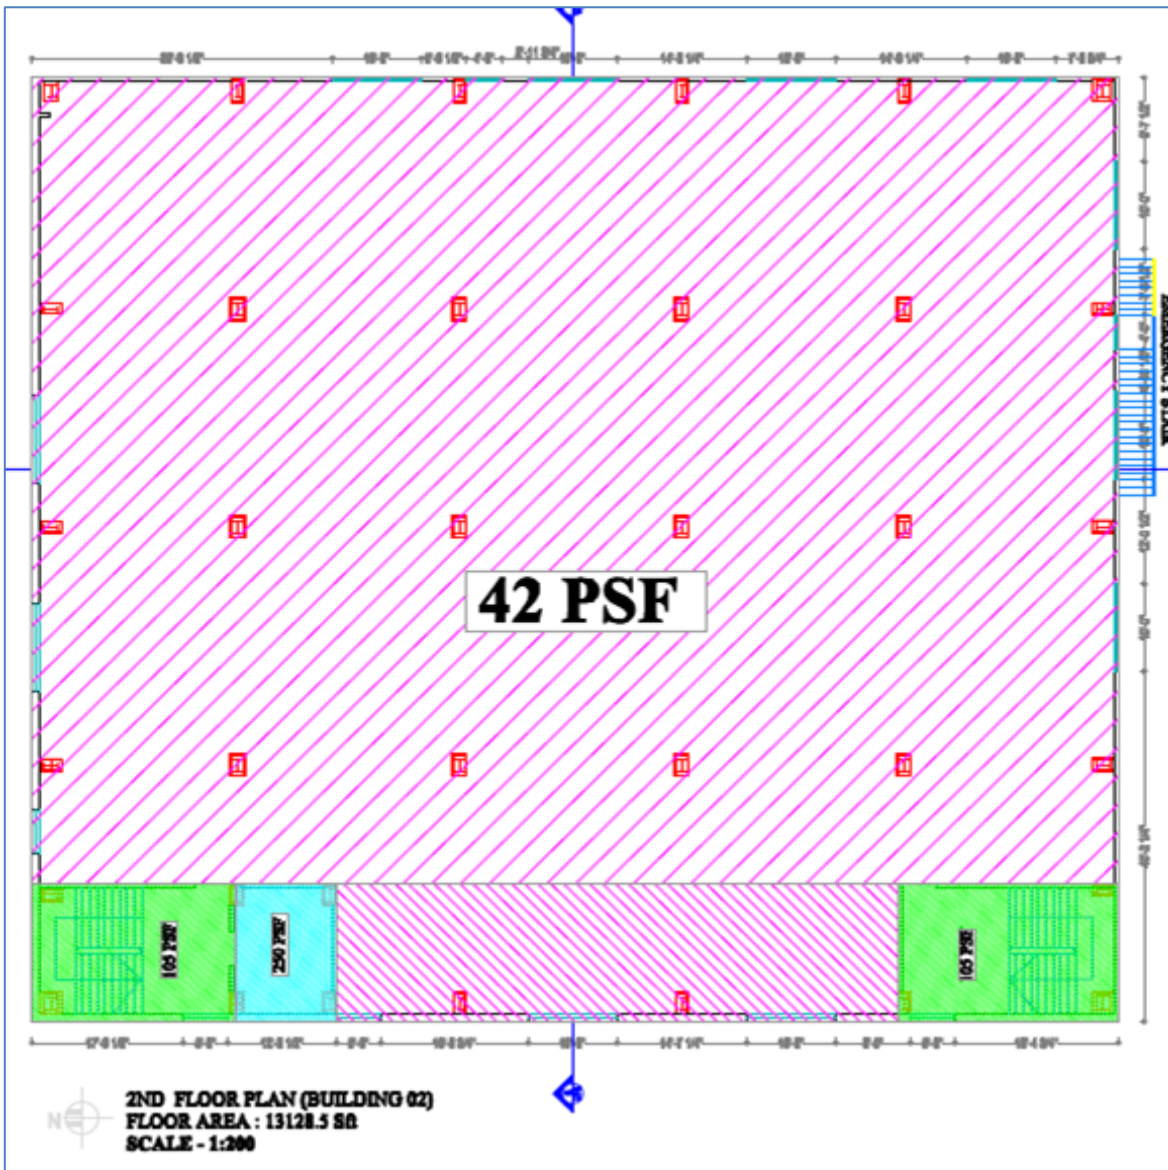
Floor Load Plan

Overloading on the floor

As per load plan and provided design report the building is design for 42 psf live load on typical floor. But during the inspection floor loading was found almost 84 psf in storage areas.

Building engineer is required to be revised the floor load plan considering floor slab, Column and footing capacity.

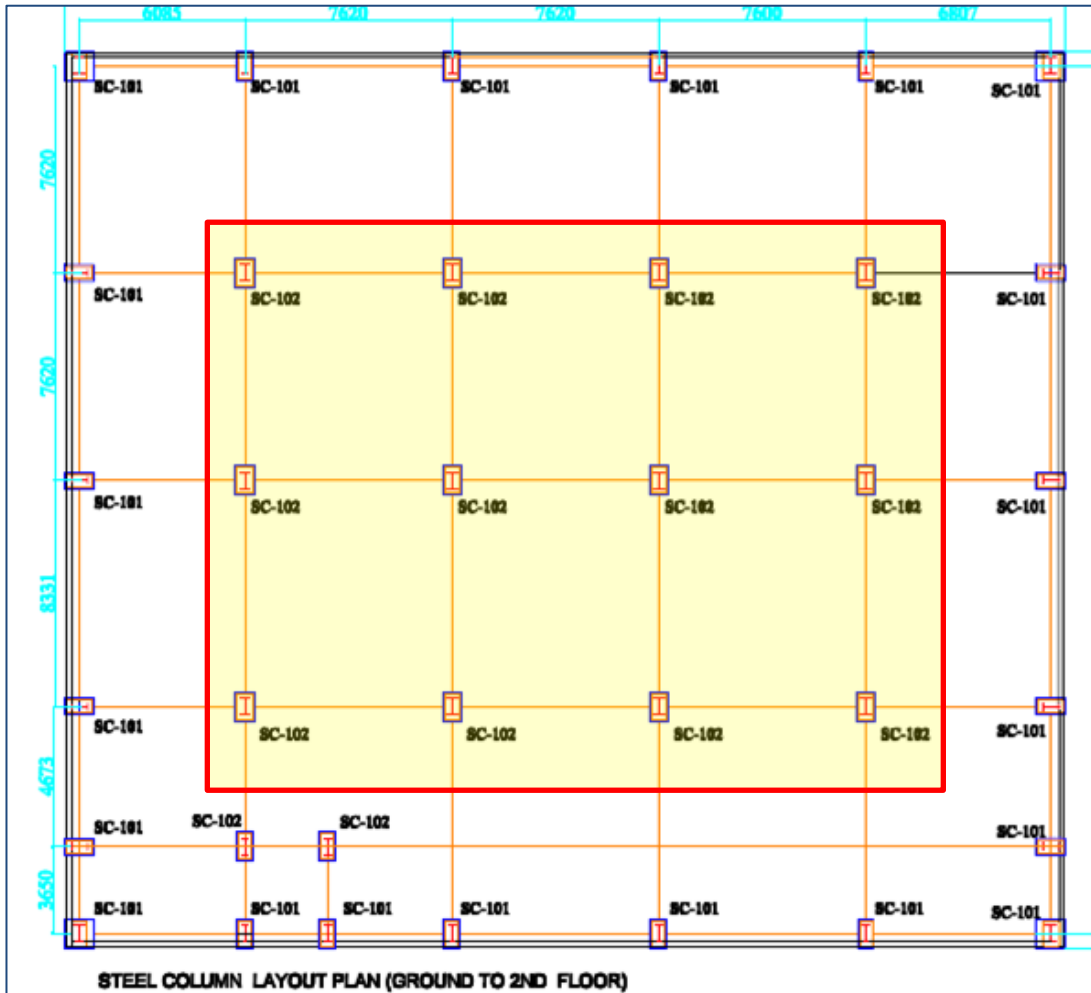
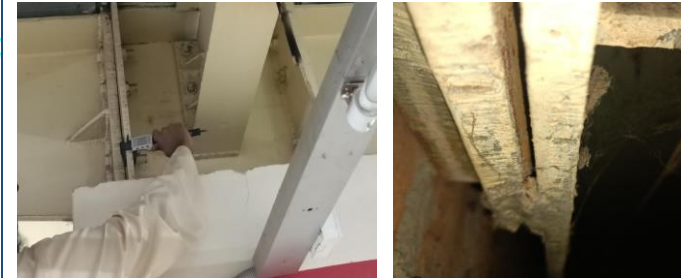
Mismatch in as built drawing

Column sizes are not match with the as built condition. Flange thickness of SC-102 type column was found 20 mm instead of 24 mm at GF level and 12 mm instead of 20 above 2nd floor level.

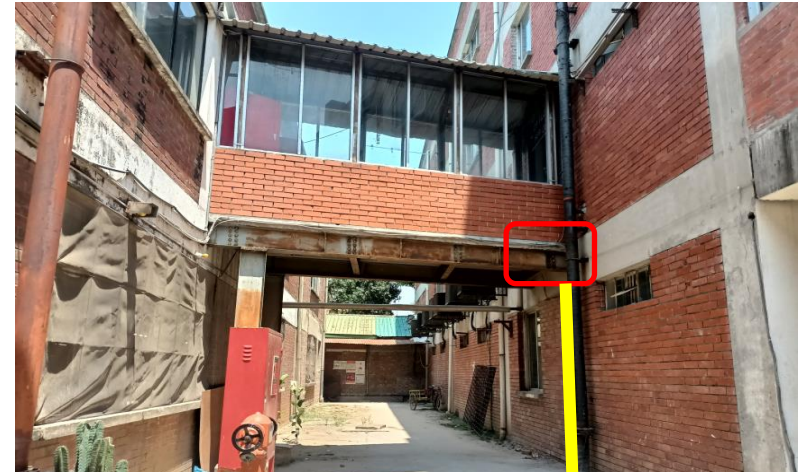
Connection Bridge

Steel beams of connection bridge are directly connected with main beam of production building. Which is not considered in the design report. Building engineer is required revised the design report considering actual size and strength of materials.

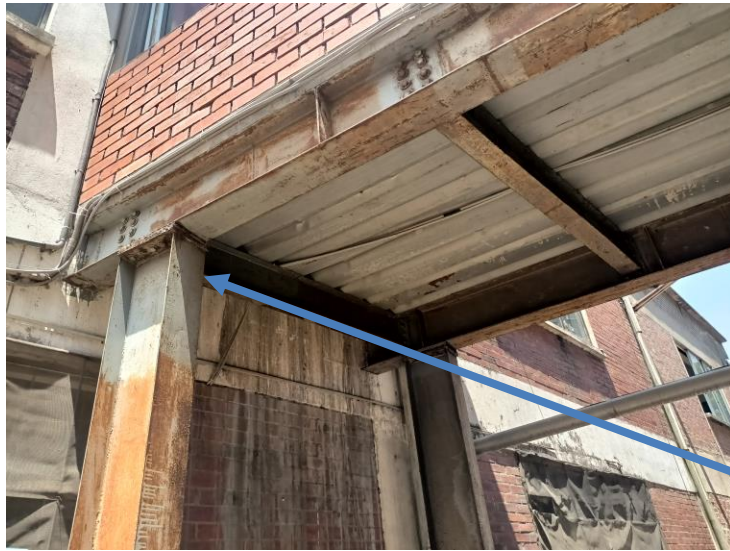
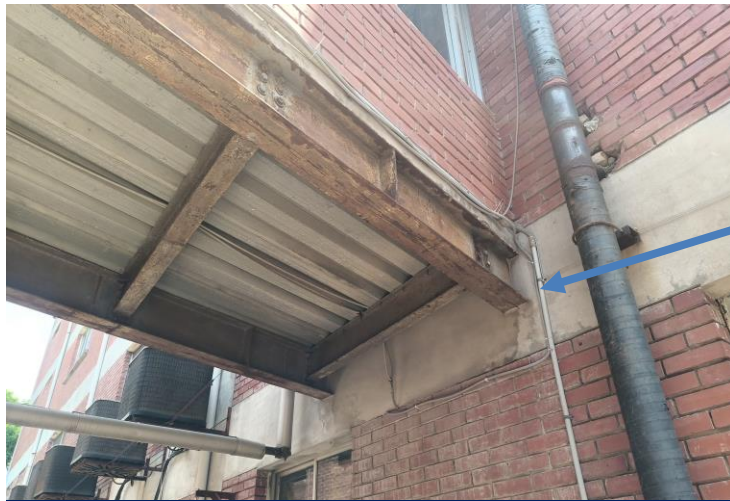
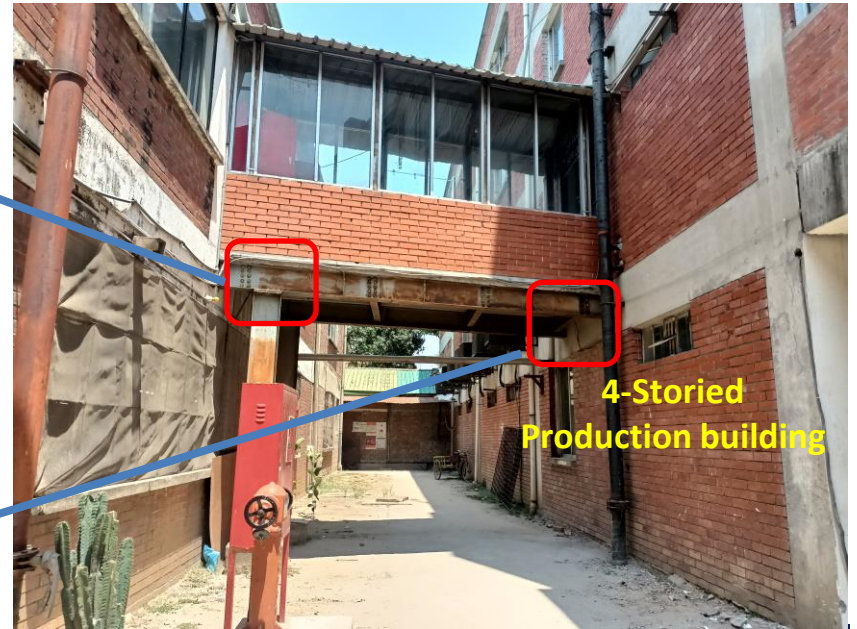
Lack of drawings

No drawing documents were available for the connection bridge. Factory is required prepared full set of as-built drawings for the structure.

Item No.	Observation	Recommended Action Plan	Recommended Timeline
12	Lack of drawings. (Connection Bridge)	Building Engineer is to survey the whole structure and prepare as-built drawings representing accurate site condition.	6-weeks
13	Incomplete bracing system. (4-storied Production Building)	Install missing bracing where necessary.	6-weeks
14	Absence of design documents. (Utility Building, UPS & Compressor Room)	Factory engineer is required to prepare the design documents including a design report, and a set of structural drawings in compliance with section 1.9.1.1 and section 1.9.1.2, part-6 of BNBC and submit it to RSC for review.	6-weeks
15	Absence of design documents. (Utility Building, UPS & Compressor Room)	Carry out remedial works (if any) after review by RSC.	6-Months
16	Apparently inadequate connection. (ETP Shed)	Building engineer is required to check the connection of the steel shed for the uplift pressure of wind.	6-weeks

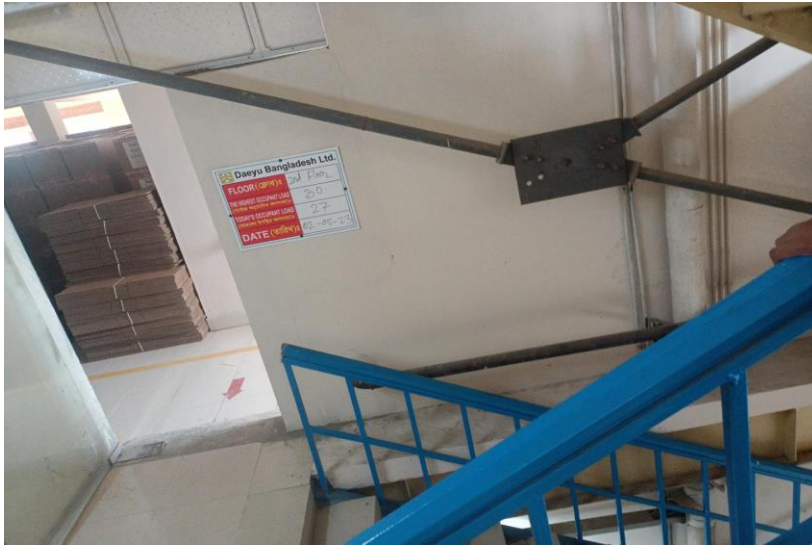
Incomplete bracing system was found at stair zone of 4-Storeyed Production building. One leg was found missing in the diagonal cross bracing at stair zone.

Incomplete bracing at the stair zone

Factory engineer is required to install the missing bracing where necessary.

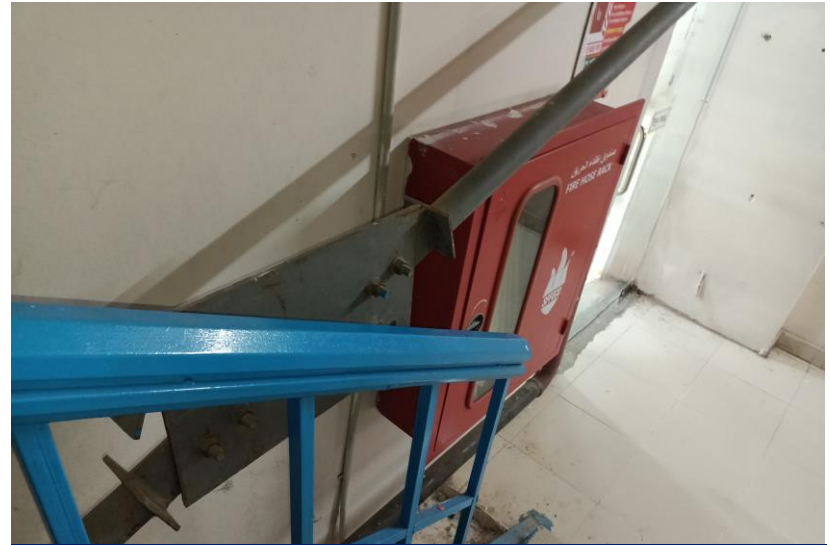
Incomplete bracing at the stair zone

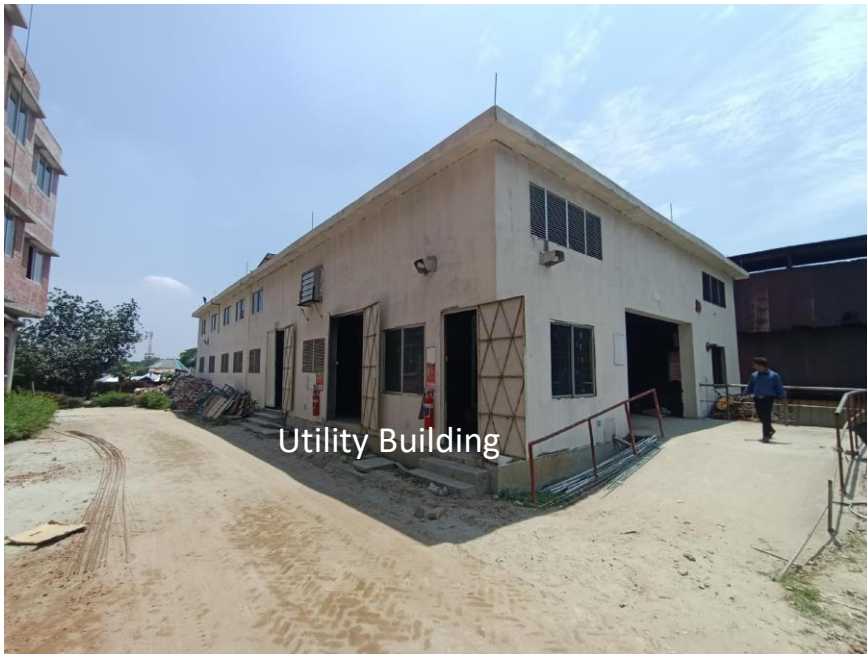
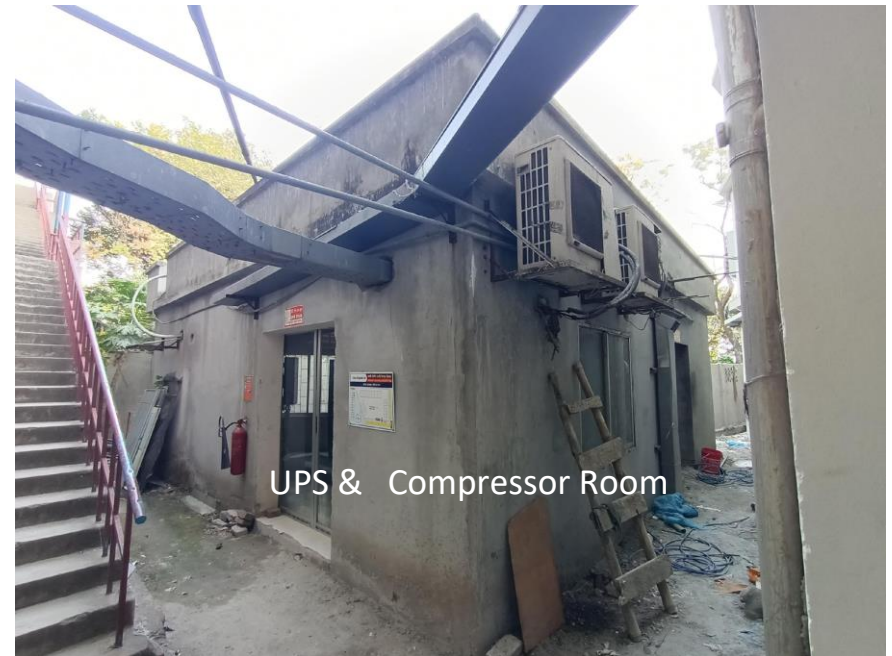
As per BNBC, every building or structure designed shall have its design documents prepared in accordance with the provision of Section 1.9.1. The design document shall include a design report, and a set of structural drawings, which shall be prepared in compliance with section 1.9.1.1 and section 1.9.1.2, part-6 of BNBC. At the time of inspection, only as-built drawing and geotechnical report were available, but no design report & load plan were available which are required to be prepared in compliance with section 1.9.1.1 (part-6, BNBC).

No design report was available for Utility Building, UPS & Compressor Room

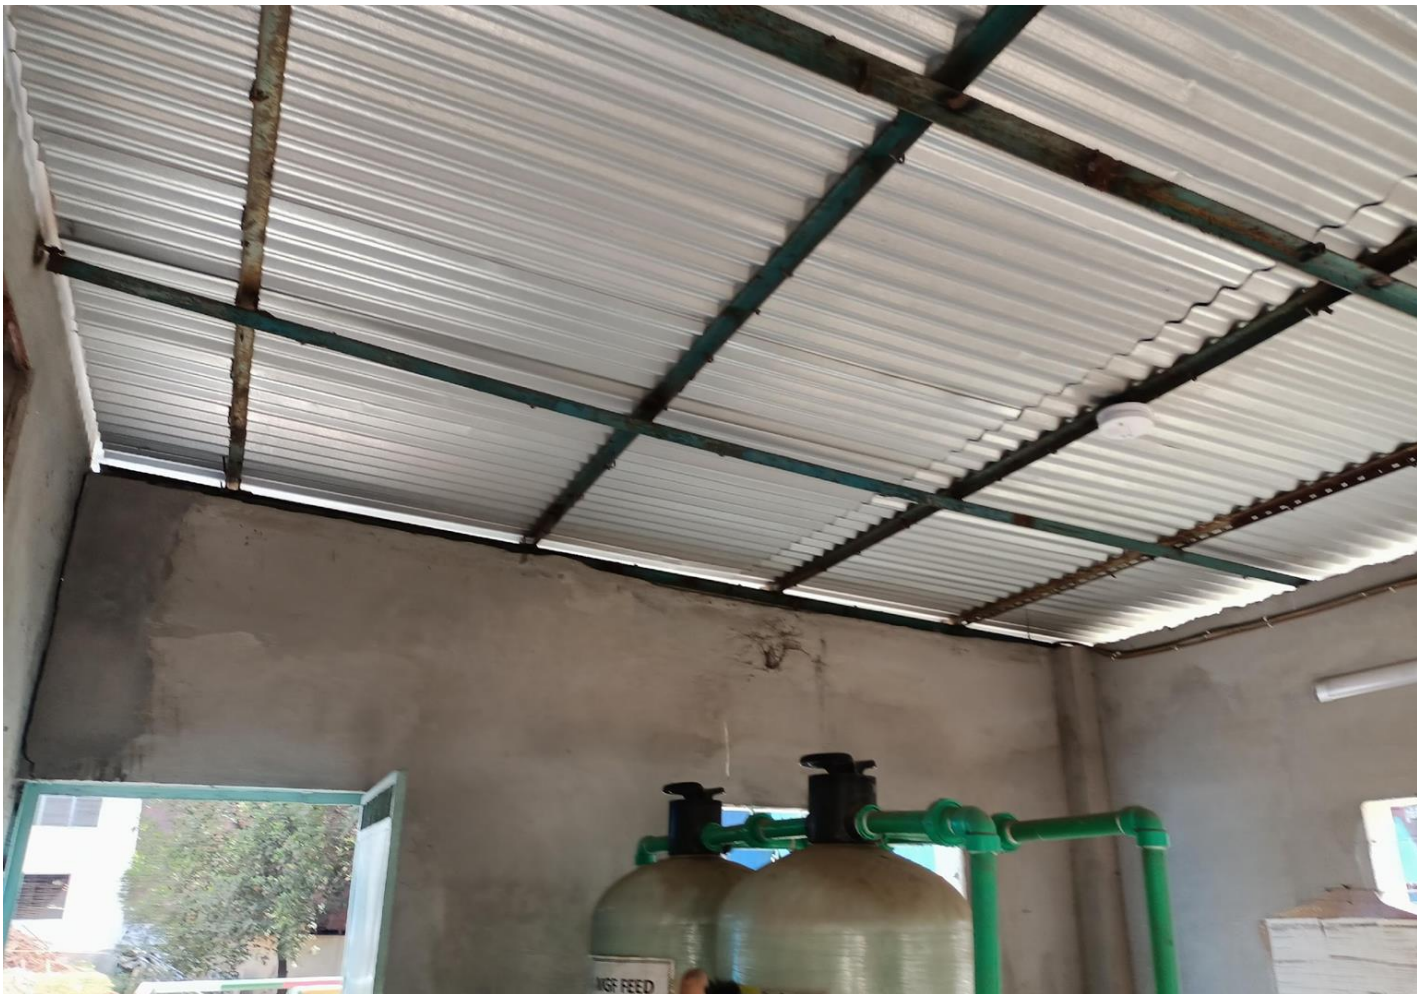
Connection steel members to brick wall

Steel rafter are inserted to brick wall therefore connection of steel members to brick wall is appeared to be inadequate. Building engineer is required to check the connection adequacy for uplift forces of wind.

17	Apparently inadequate connection. (ETP Shed)	Implement remediation work where required.	6-Months

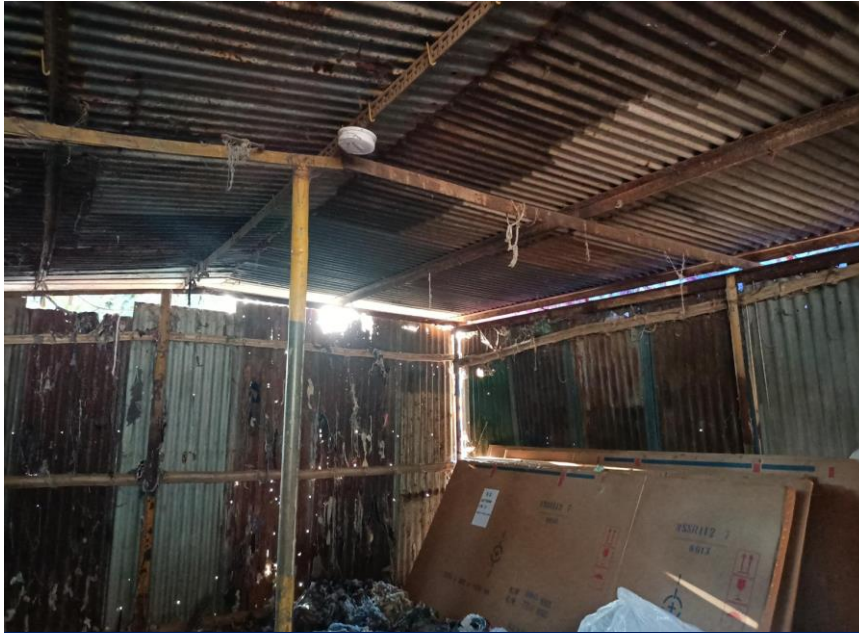
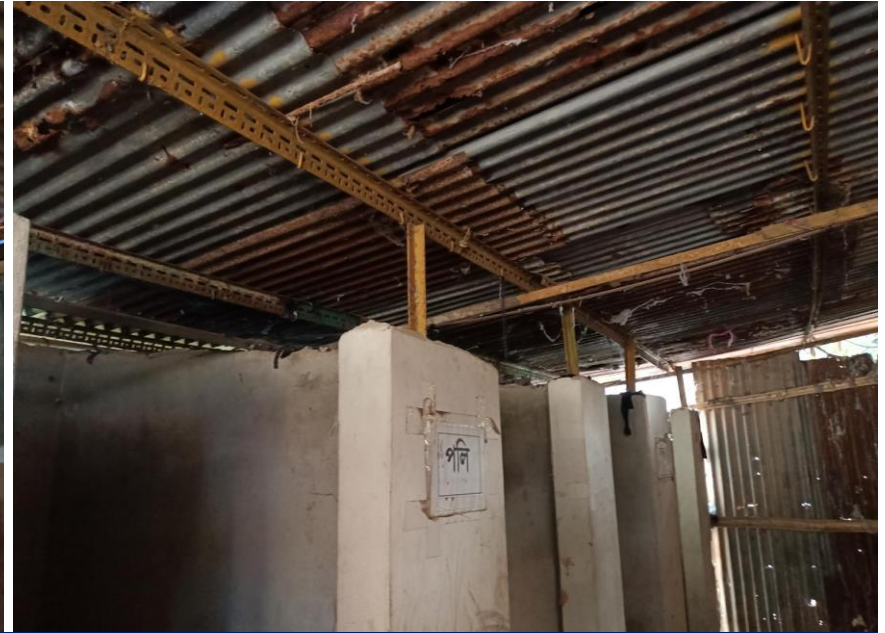
Inside of wastage shed

The structure was appeared to be non engineered due to lack of apparent load path, poor connection and apparently inadequate member size. Building engineer is required to carry out member adequacy & lateral stability check of the wastage shed.

Item No.	Observation	Recommended Action Plan	Recommended Timeline
18	Apparently non-engineered Shed. (Wastage Shed)	Factory engineer is required to carry out member adequacy & lateral stability check of the wastage shed.	6-weeks
19	Apparently non-engineered Shed. (Wastage Shed)	Implement remediation work where necessary or replace the wastage shed with a properly designed structure.	6-Months
20	Lack of as built drawings. (All ancillary structures)	Building Engineer is to survey the whole structure and prepare as-built drawings representing accurate site condition.	6-weeks

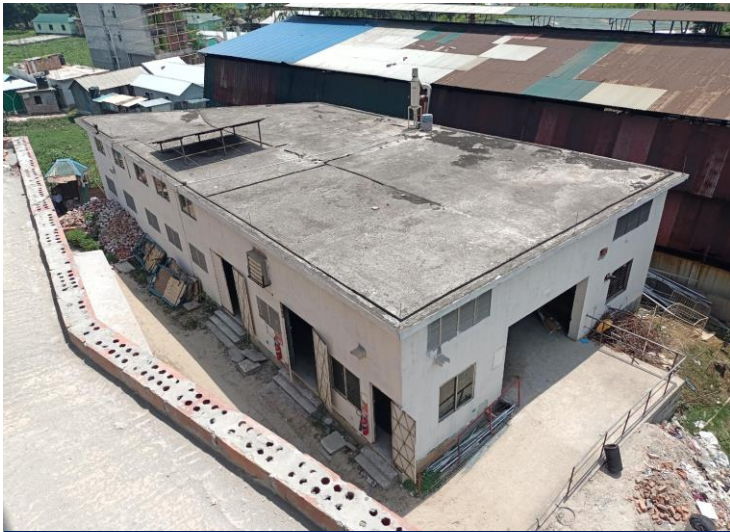
Utility Building

At the time of inspection, no drawing documents were available for the mentioned structures. Factory is required prepared full set of as-built drawings for all the structures.
