# Fashion Flash Ltd

149, Shah Kabir Mazar Road, Dakkin Khan, Azampur, Uttara, Dhaka  
(23.86819N, 90.41251E)

5<sup>th</sup> April 2014

# Observations

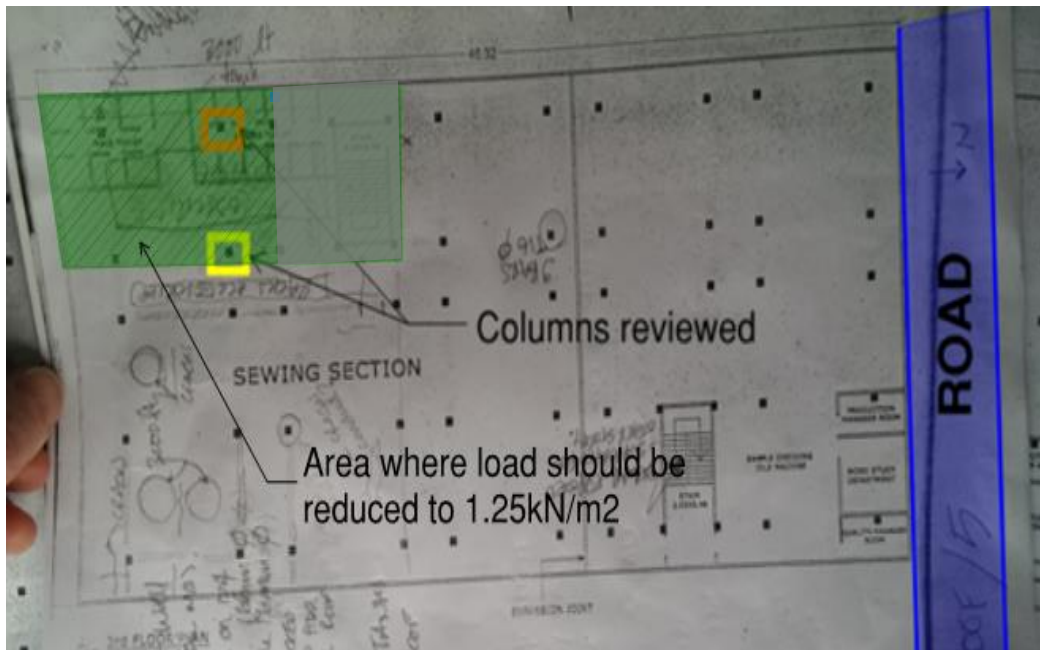
# Highly stressed Columns

Preliminary calculations indicate that columns in toilet area working stress is at a high level.

Engineer is to perform detailed calculations on columns in area highlighted based on as constructed dimensions and concrete tests to prove column size and (if required) :

- Reduce loads by vacating floors and removing additional structures
- Reinforce columns

Loading in Area highlighted green (toilet and adjacent area) to be reduced to  $1.25\text{kN/m}^2$

| Item No. | Observation | Recommended Action Plan | Recommended Timeline |
|---|---|---|---|
| 1 | Verify the structural adequacy of columns at all levels based on as built dimensions, material properties and verified reinforcement content | Loading to be reduced to 1.25kN/m <sup>2</sup> , pending verification of column capacity by the Building Engineer, in toilet areas highlighted previously | <b>Immediate - Now</b> |

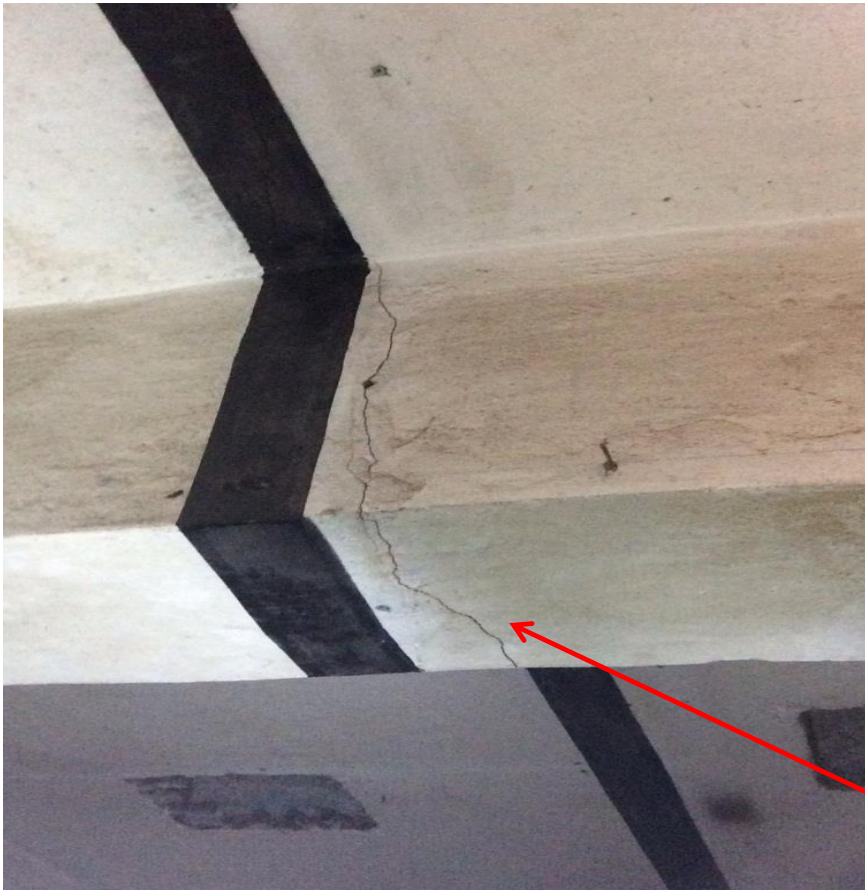
## Construction Joint

Construction joint generally covered and cannot be inspected. Structural drawings show beams are continuous through joint. Engineer to confirm that beams and slab are designed and detailed separate as cantilevers

First floor cantilever beam at movement joint (observed from ground floor level) cracking observed.

Remove plaster and concrete locally to inspect concrete condition.

| Item No. | Observation | Recommended Action Plan | Recommended Timeline |
|---|---|---|---|
| 6 | Cracking in Slabs at Construction Joint | Engineer to check existing structure and confirm that beams and slab are designed and detailed as cantilevers each side of the joint on each level | 6-weeks |

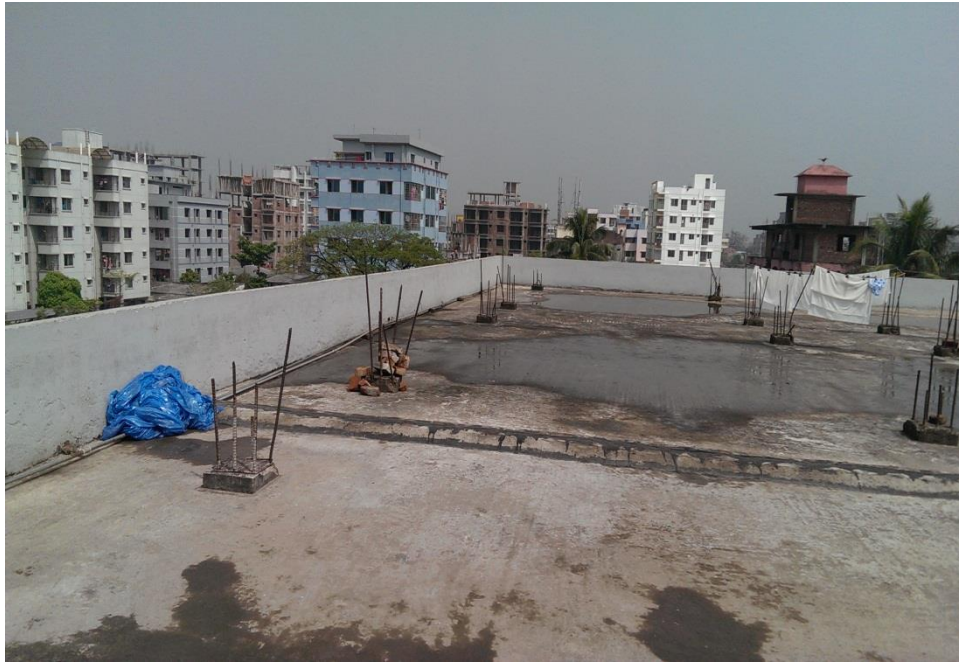
## Construction Joint

Construction joint generally covered and cannot be inspected. Structural drawings show beams are continuous through joint. Engineer to confirm that beams and slab are designed and detailed separate as cantilevers

Ensure joint is sealed at roof level to prevent water ingress

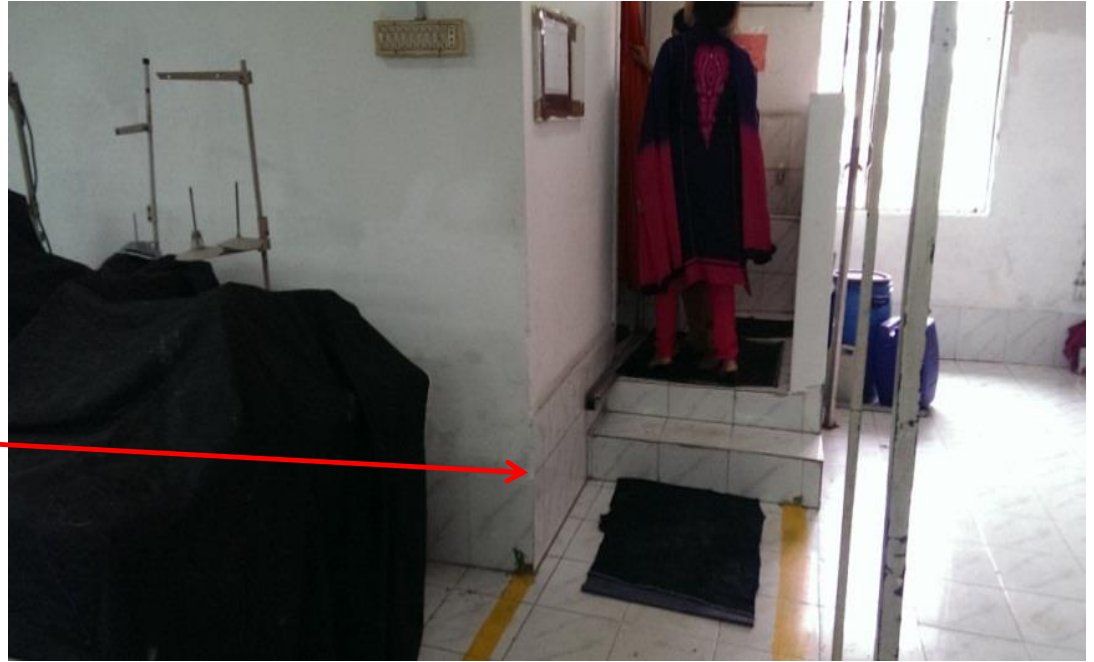
# **Cantilever Slab Supporting Heavy Floor Loading in Toilet areas**

**The cantilever floor slabs in the toilet areas at each level are supporting up to 280mm of additional floor build up.**

**The extent of plinth loading within toilet areas to be surveyed and the capacity of floor slab should be assessed by the building Engineer**

| Item No. | Observation | Recommended Action Plan | Recommended Timeline |
|---|---|---|---|
| 7 | Design check required for plinth loading in toilet areas to confirm slab load capacity | Extent of plinth loading within toilet areas to be surveyed and capacity of floor slab to be assessed | 6-weeks |

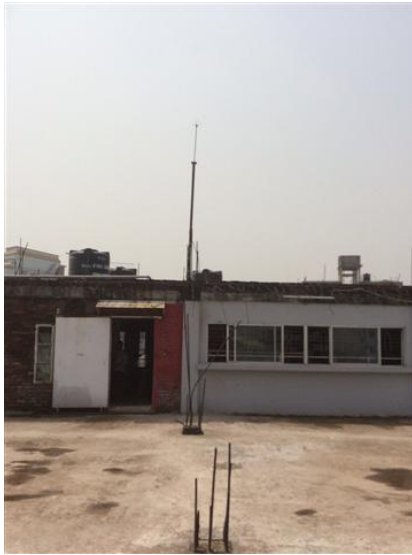
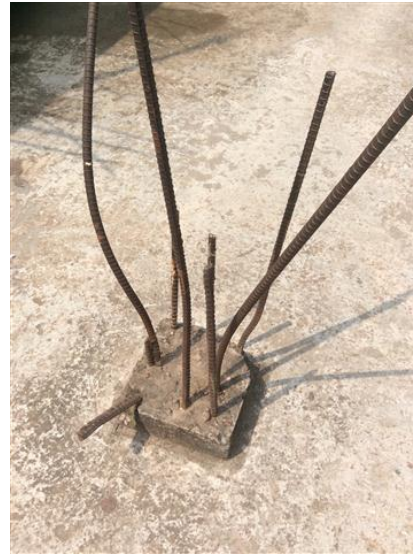
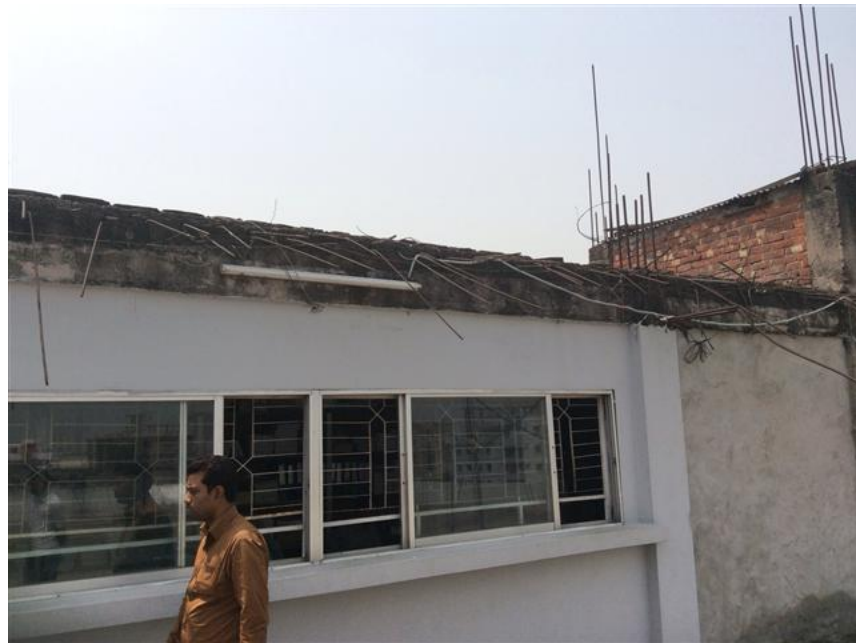
## Partially constructed fifth floor

Building permit has been granted for six storey, currently fifth floor is only partially built.

Preliminary calculations indicate that column stresses are high for existing structure. Further construction should not be carried out until a Detailed engineering assessment is carried out to prove that the structure is capable of carrying additional loads prior to construction of additional storey.

Reinforcement for future columns to be adequately fixed / lapped with existing structure. In some case, fixing to existing bars will not provide sufficient anchorage and mechanical couplers will be required.

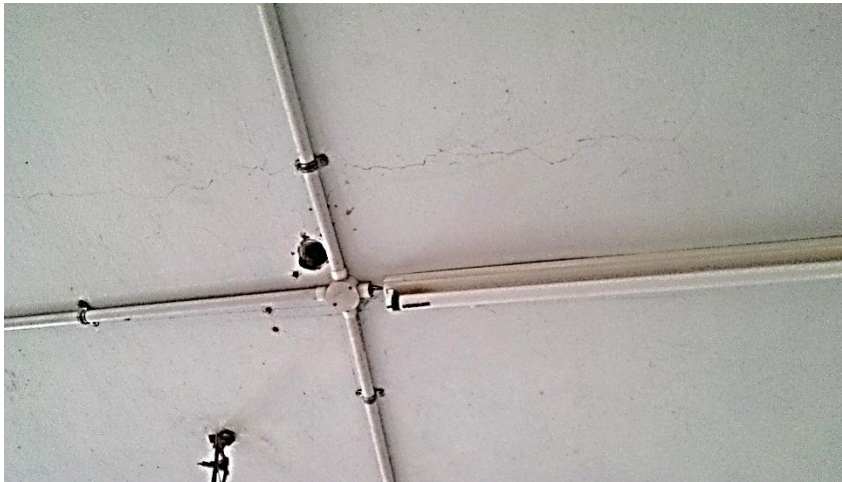
# Cracking to fifth floor slab

Cracking observed on soffit of fifth floor slab below water tanks (3no. 1000l tanks).

- Engineering assessment to confirm roof slab capacity.
- Building owner to reduce water level to meet design loading.
- Reposition water tanks so they are located over column heads (subject to shear checks being carried out by factory engineer)

| Item No. | Observation | Recommended Action Plan | Recommended Timeline |
|---|---|---|---|
| 10 | Cracking to slab soffits and beams | Building Engineer to check storage and water tank support to ensure the structure is not loaded beyond capacity | 6-weeks |

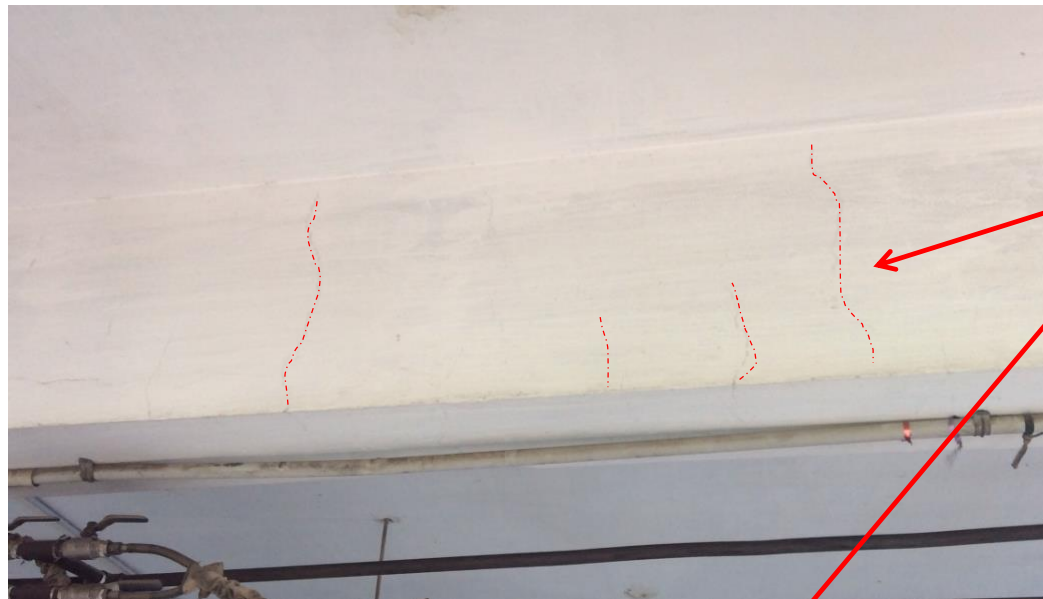
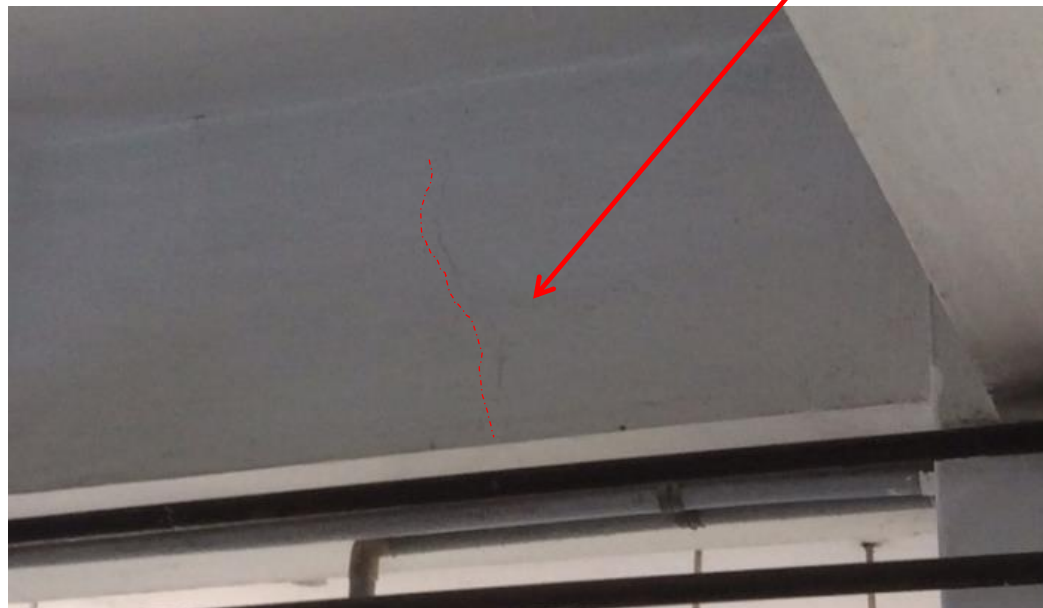
# Cracking at beam ends

**Cracking observed at beam supports throughout the building.**

Engineering check required to confirm shear capacity of beams.

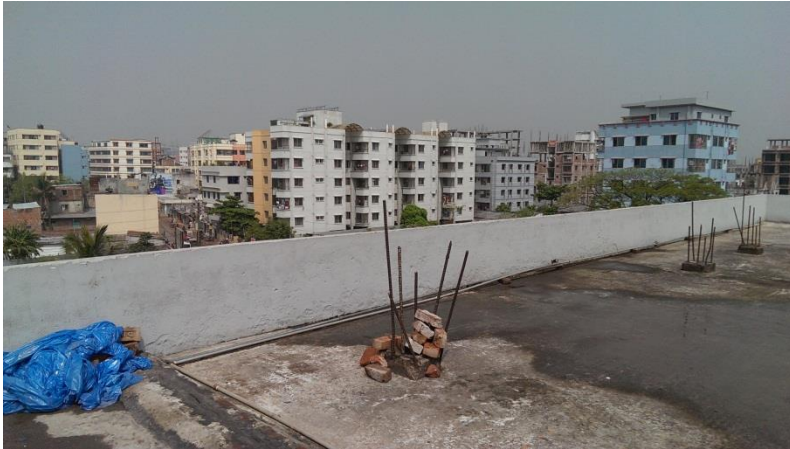
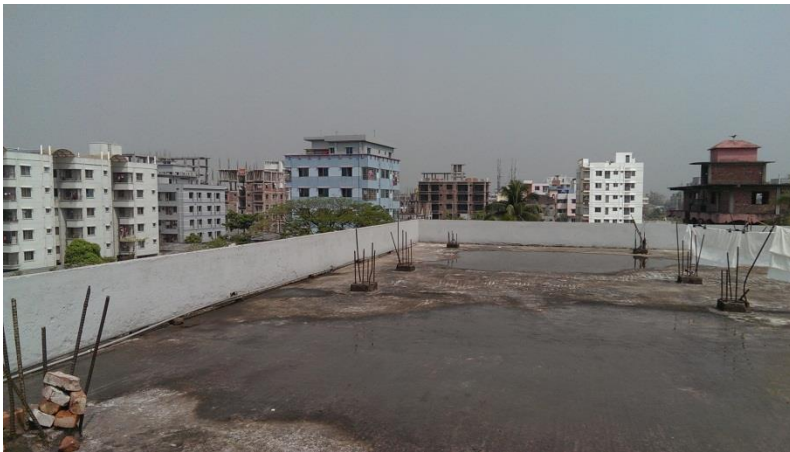
# Unrestrained roof parapet

**Single leaf masonry parapet wall  
unrestrained at roof level.**

Design check required to confirm lateral  
stability under wind load.

| Item No. | Observation | Recommended Action Plan | Recommended Timeline |
|---|---|---|---|
| 13 | Unrestrained Parapet at Roof Level | Building Engineer to check the Parapet to ensure lateral stability under wind load or imposed lateral load | 6-weeks |

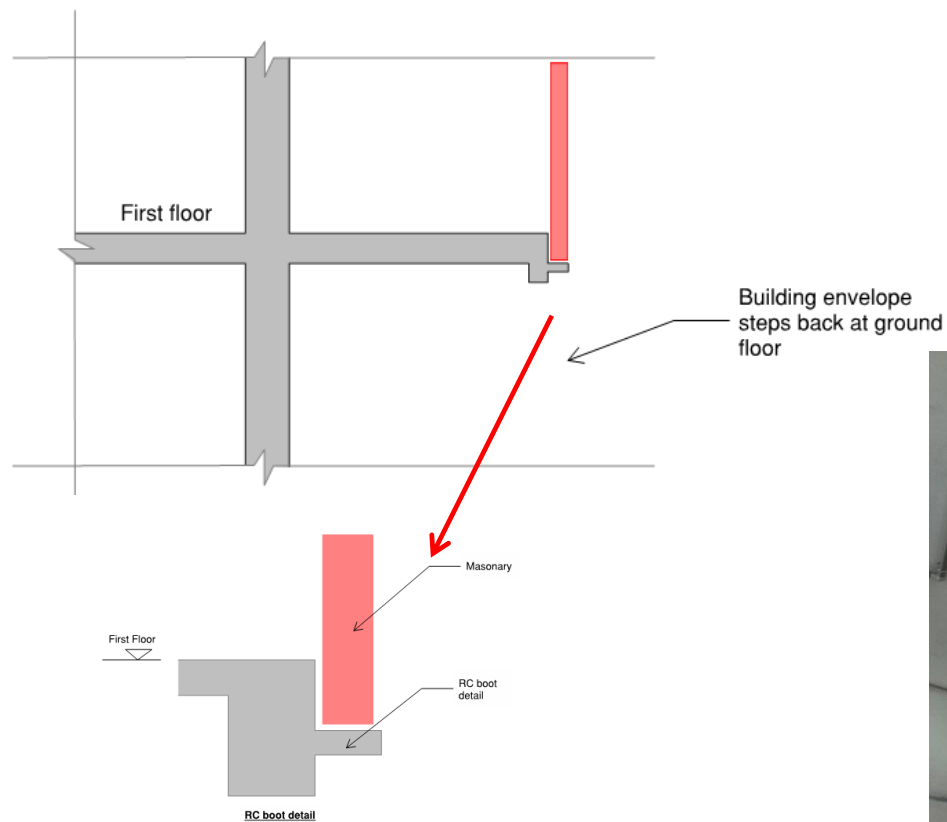
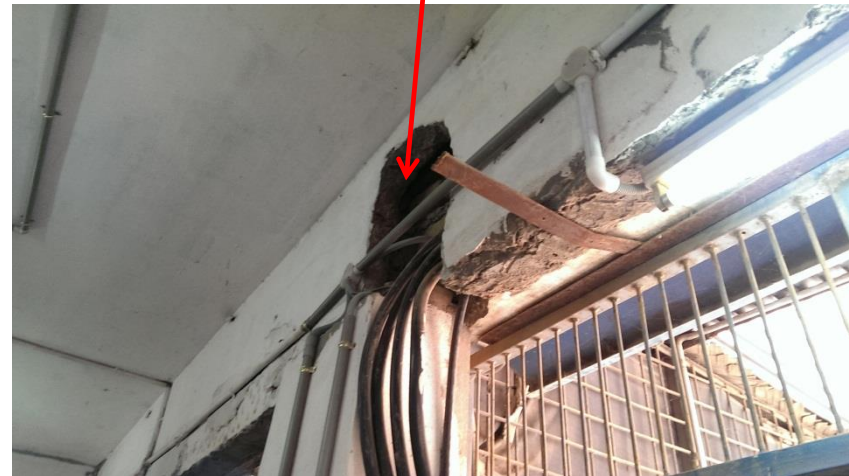
## First floor façade support

In one location nib has been broken out to allow service penetration from generator room below.

Single leaf masonry façade to first floor appears to be supported by hanging boot with shallow nib to support brickwork. In one location nib has been broken out to allow service penetration from generator room below. Engineering assessment required to check that nib can support masonry

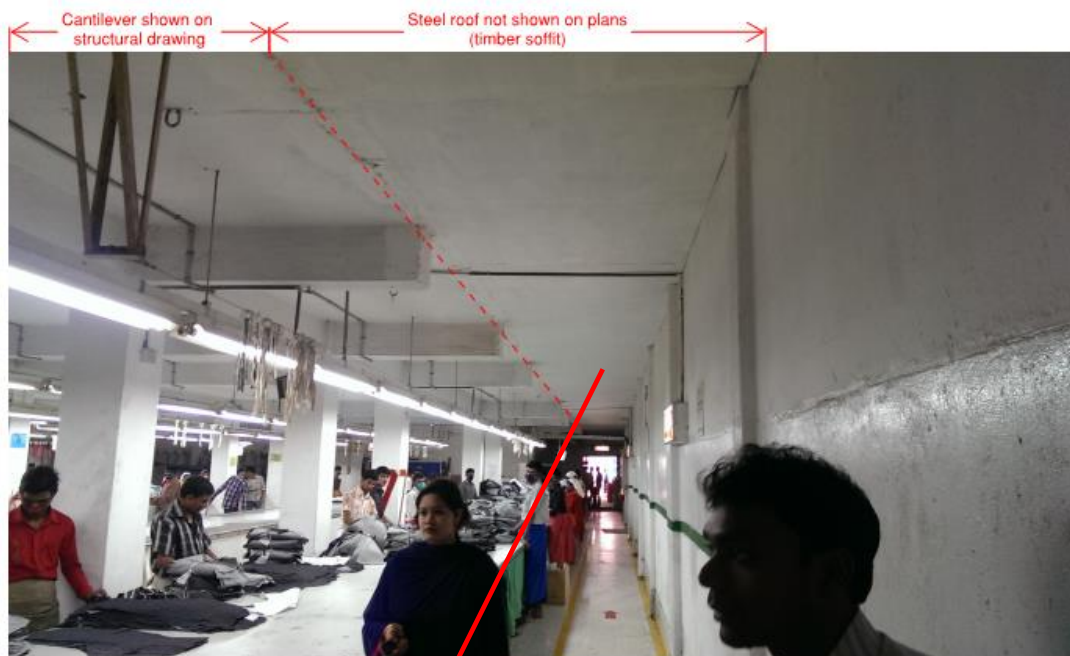
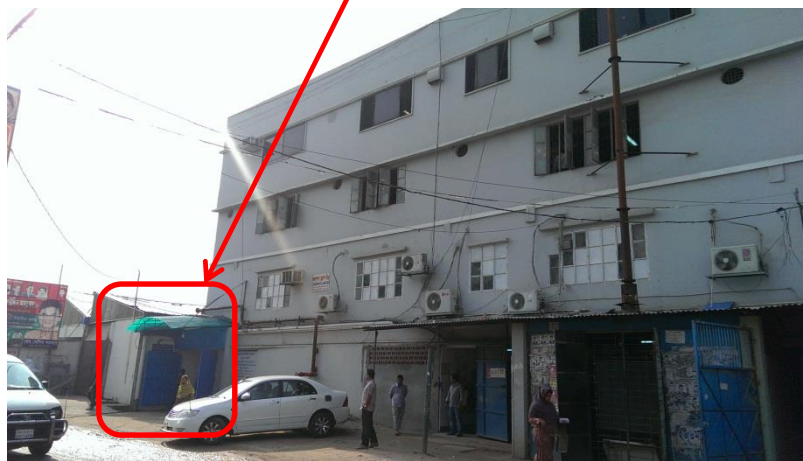
**Non engineered steel roof**

At ground floor a lightweight, non-engineered steel roof spans between the edge of the cantilever and wall to the adjacent building. This is not shown on engineering drawings.

Design check required for steel roof and supporting wall. Engineering drawings to be updated to suit as built layout

| Item No. | Observation | Recommended Action Plan | Recommended Timeline |
|---|---|---|---|
| 15 | Inconsistent information provided on structural design drawings | Design check required for steel roof and supporting wall at ground floor and Engineering drawings to be updated to suit as built layout | 6-months |
