# INITIAL STRUCTURAL INTEGRITY ASSESSMENT REPORT (SIAR)

Factory Name: **Your Fashion Sweater Ltd.**

Assessor: **EIMS**

Date: **22 Apr 2014**

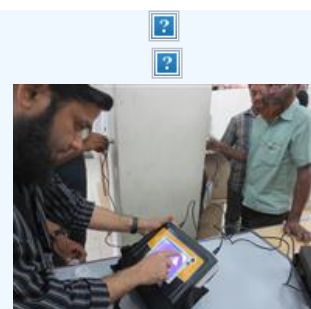
| Description: | In-situ testing (UPV) was performed during inspection. But no core test result was available. |
| Source of Findings: | Visual Assessment: Photograph of UPV testing at column |

| Suggested Plan of Action: | Have a qualified structural engineer assess the durability aspects as suggested in Alliance Standard Part 7 Section 7.2 and take appropriate remedial measures. This assessment should include destructive core testing to verify the concrete compressive strength of columns. |
