# Integra Apparels (Bangladesh) Ltd- Extension

742, Dhour, Nayanagar, Turag, Dhaka-1230  
(23.88675, 90.37658)

15 May 2023

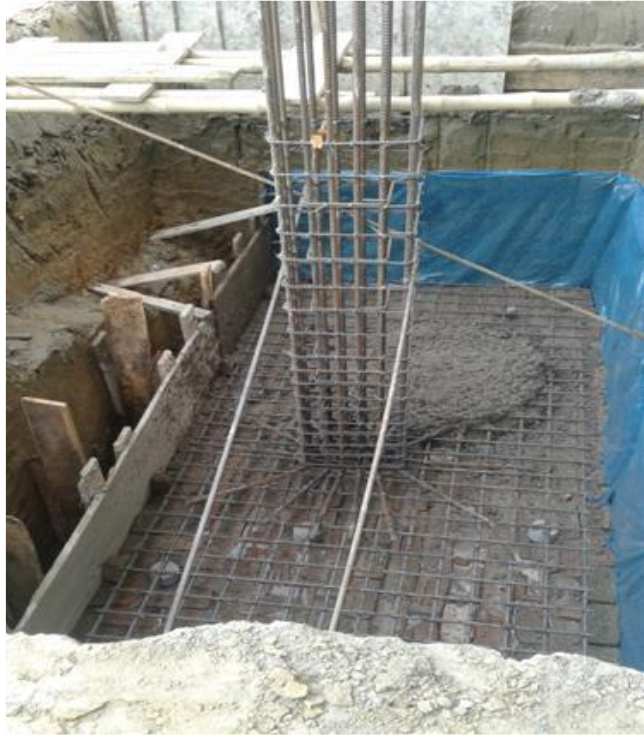
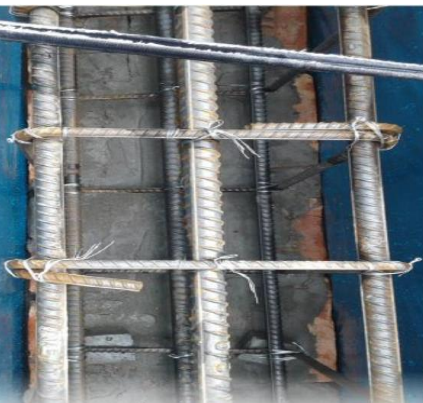
Response Modification Factor (RMF)  $R$  is considered for IMRF

As per construction work evidence, the rebar detailing does not meet the Intermediate Moment Resisting Frame (IMRF) requirements. However, the building engineer considered IMRF for seismic base shear calculation. Building engineer is required to review the design of the seismic requirements of the building.

During construction photo provided by the factory

90 deg. Hook

| Item No. | Observation | Recommended Action Plan | Recommended Timeline |
|---|---|---|---|
| 01 | Seismic design consideration of the building. (Extension Building) | Building engineer is required to check the detailing of moment framing system and review the design of the seismic requirements of the building. | 6-weeks |
| 02 | Seismic design consideration of the building. (Extension Building) | Implement suggested remediation work if required. | 6-months |

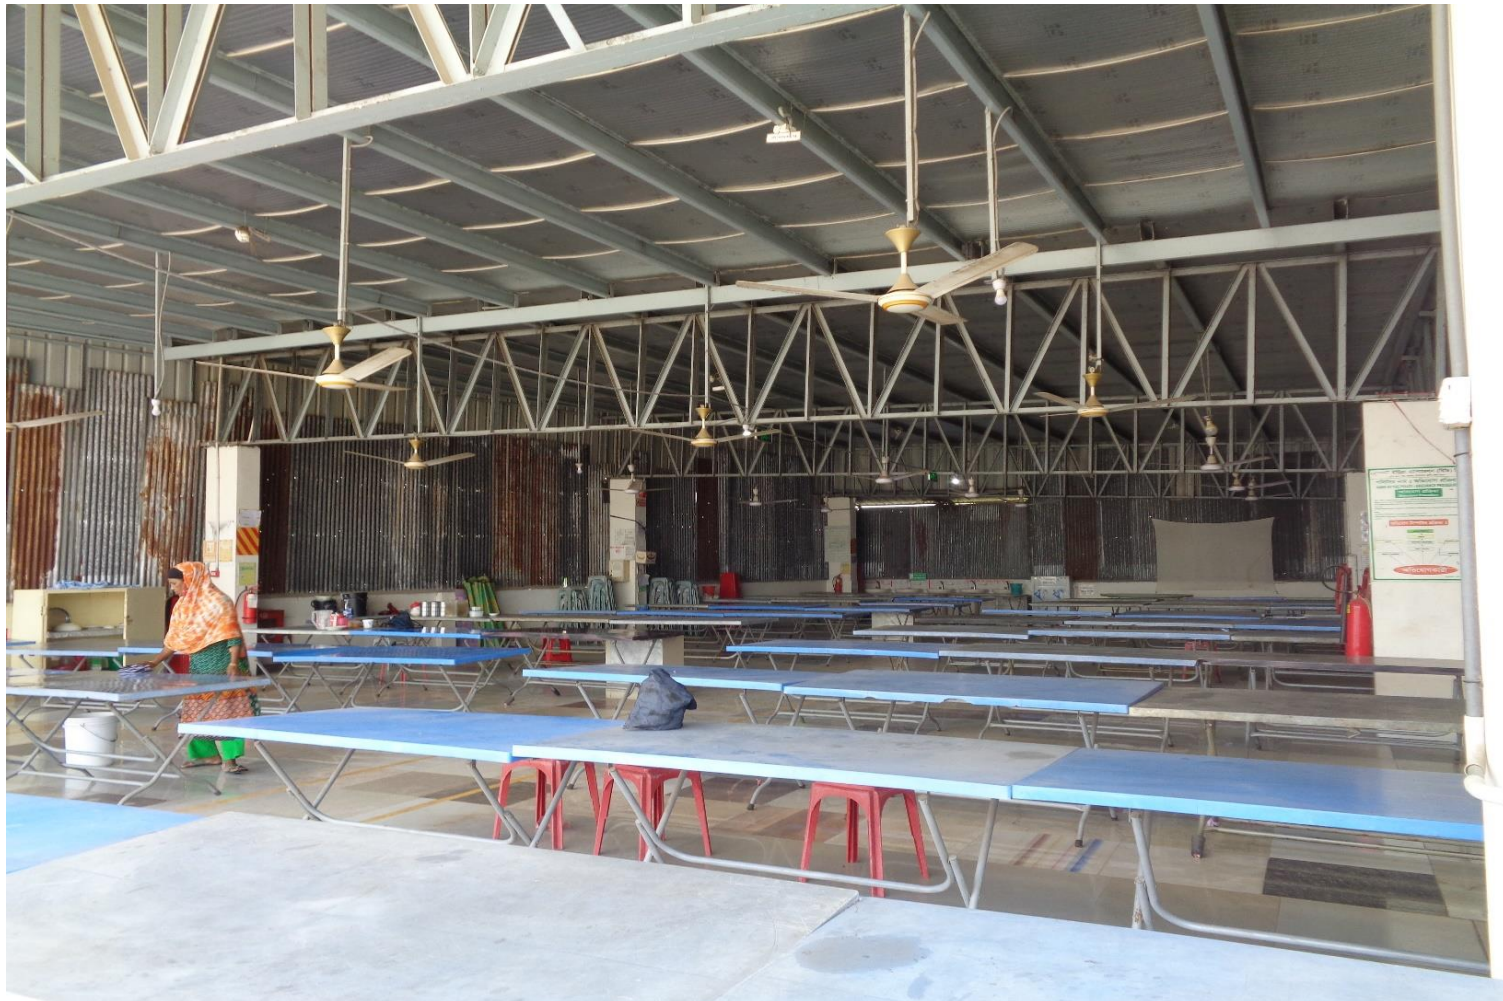
No lateral bracing system provided for roof shed

No lateral framing provided for the truss frame to transfer the lateral load in long direction. Building engineer is required to check the lateral stability of the roof shed.

| Item No. | Observation | Recommended Action Plan | Recommended Timeline |
|---|---|---|---|
| 03 | Lack of lateral stability of roof shed. (Extension Building) | Building engineer is required to check the lateral stability of the roof shed and suggest necessary remedial action. | 6-weeks |
| 04 | Lack of lateral stability of roof shed. (Extension Building) | Implement suggested remedial work where required. | 6-months |

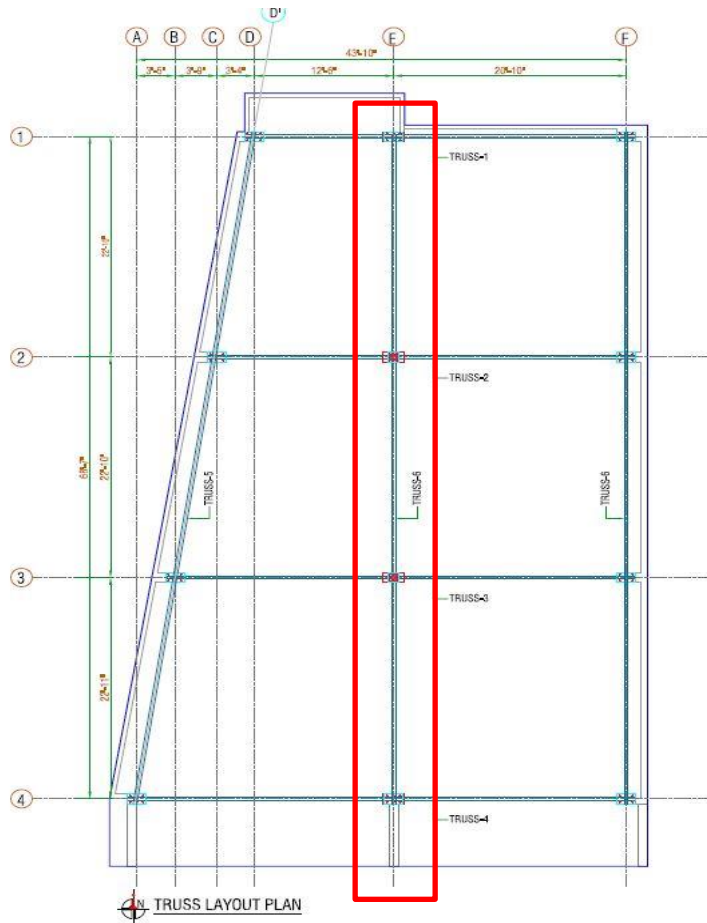
Truss frame and column shown in as-built drawing

Truss frame and column shown in as-built drawing but not found on site. Building engineer is required to update the as-built drawing.

| Item No. | Observation | Recommended Action Plan | Recommended Timeline |
|---|---|---|---|
| 05 | Discrepancy in as-built drawing (Extension Building) | Building engineer is required to prepare accurate as-built drawing. | 6-weeks |

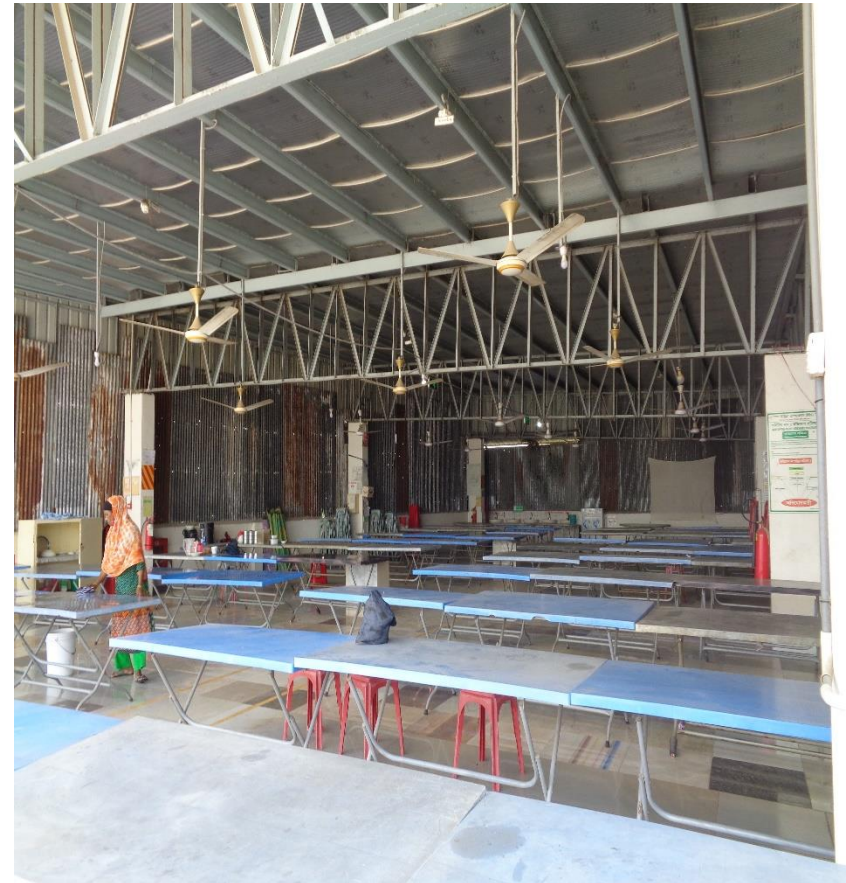
Truss frame and column not found on site

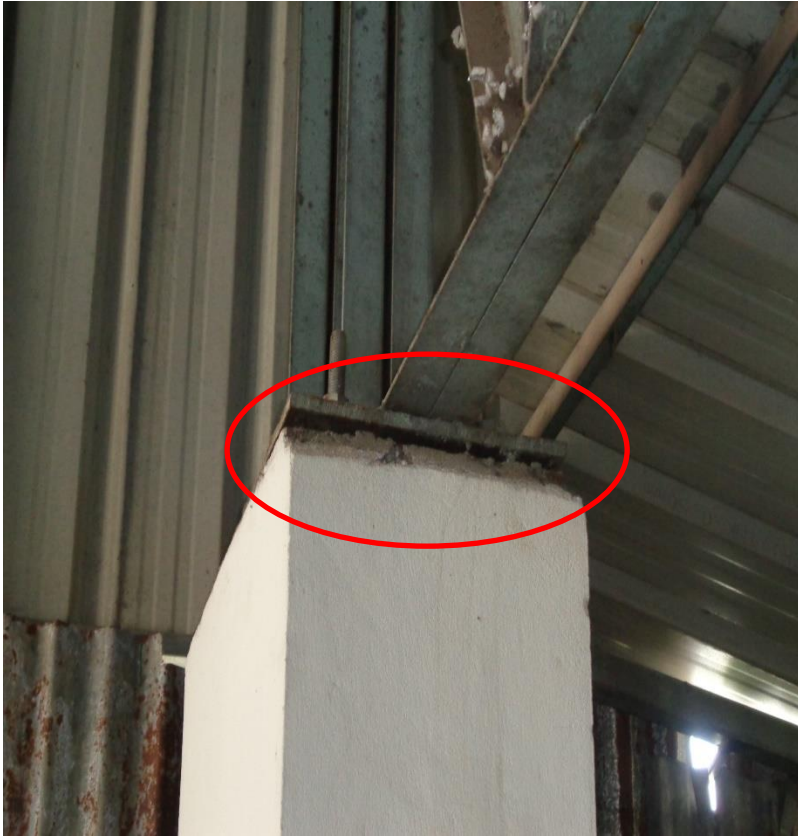
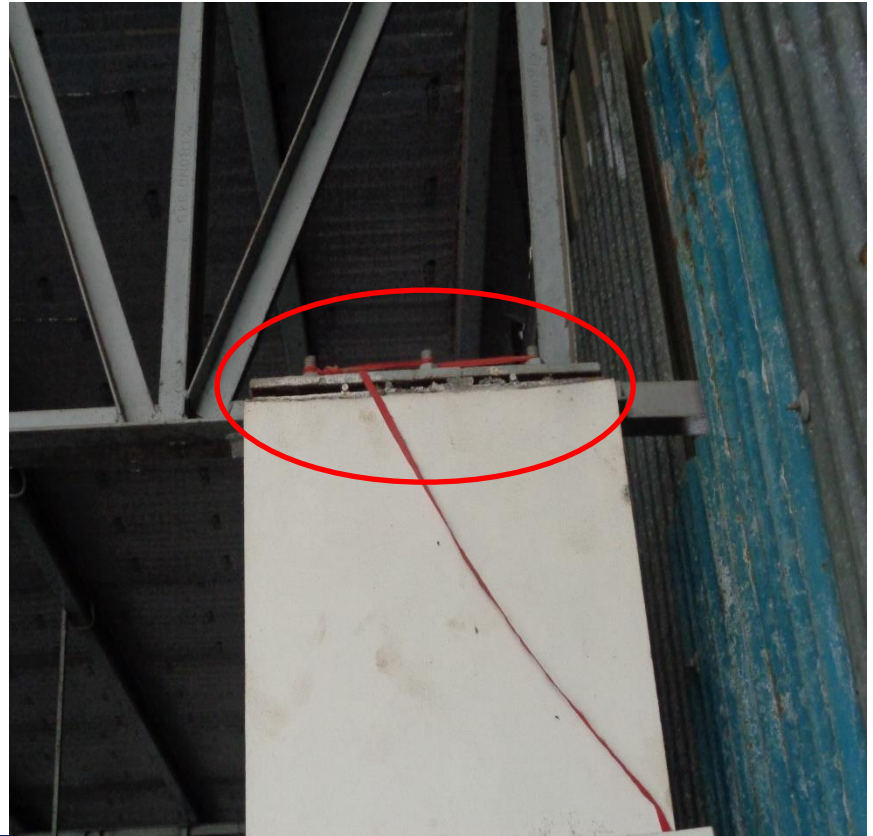
Gap between truss and RC column

Gap was observed between truss and RC column at several locations. Building engineer is required to repair the connection gap with a suitable method.

| Item No. | Observation | Recommended Action Plan | Recommended Timeline |
|---|---|---|---|
| 06 | Gap in connection (Extension Building) | Building engineer is required to repair the connection gap with a suitable method. | 6-weeks |

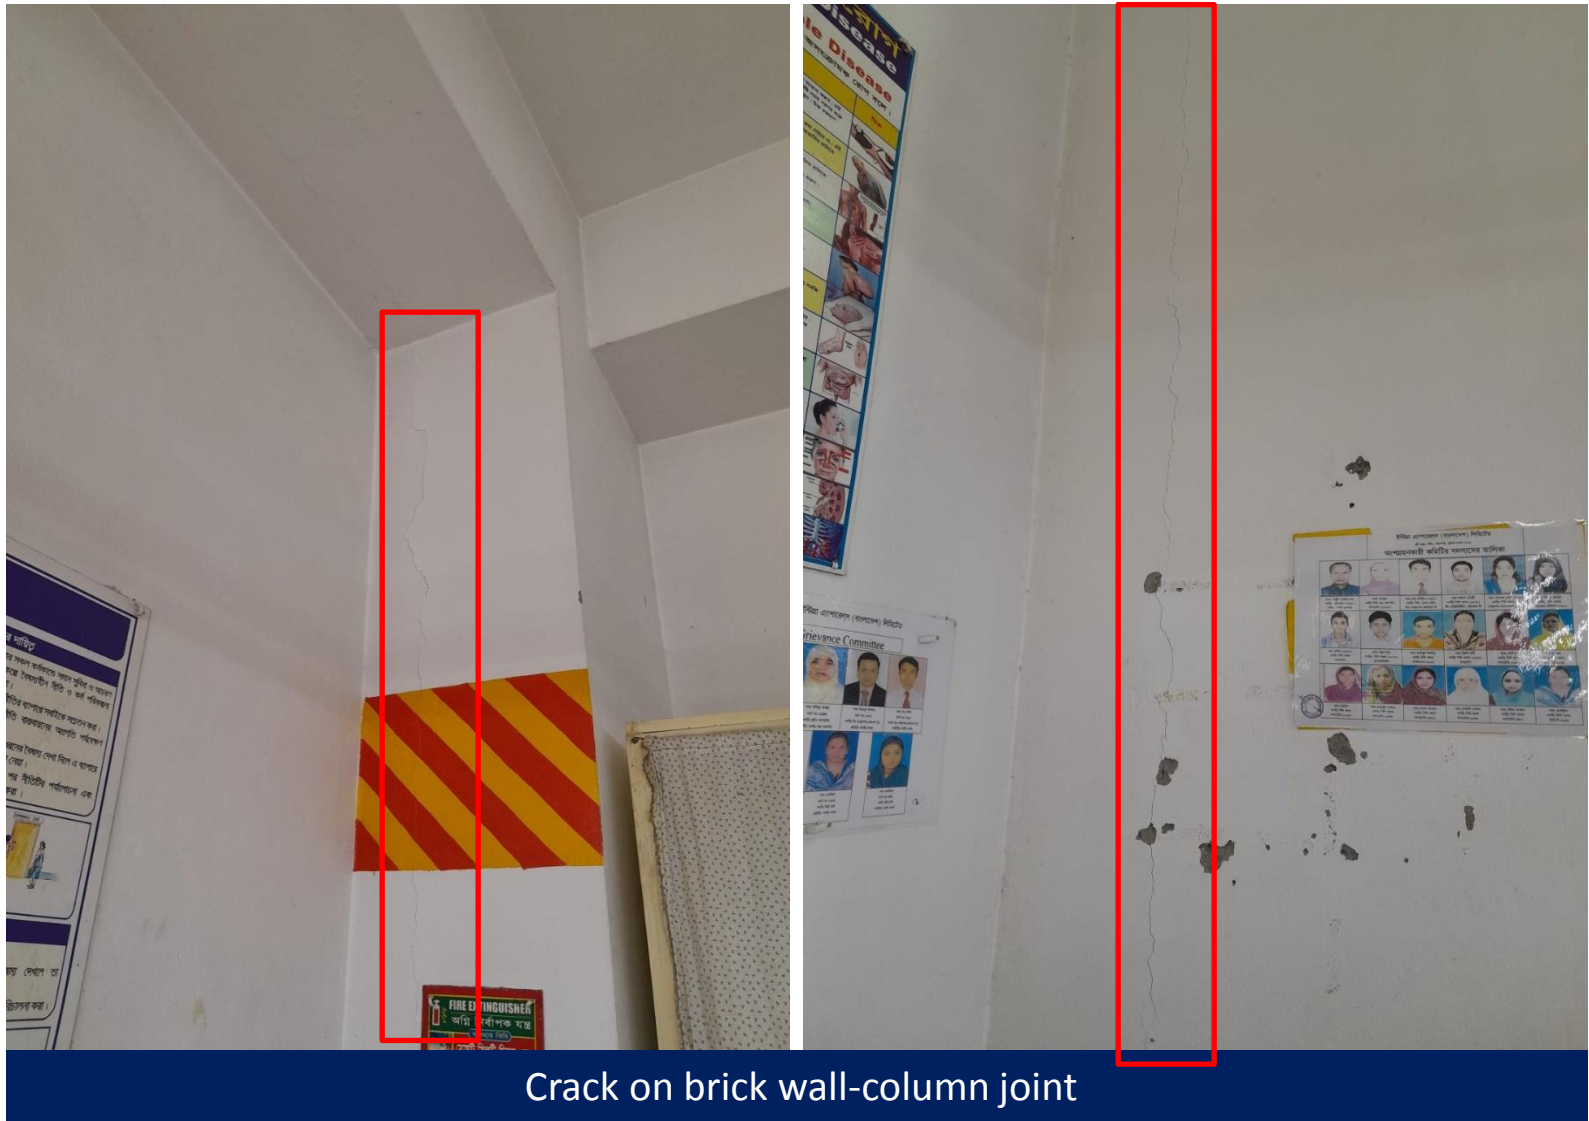
Crack on brick wall-column joint

Crack was found on brick wall-column joint at several locations. Building engineer is required to investigate the cause of cracks and suggest any remediation required.

| Item No. | Observation | Recommended Action Plan | Recommended Timeline |
|---|---|---|---|
| 07 | Crack on brick wall-column joint (Extension Building) | Building engineer is required to investigate the cause of the cracks and suggest proper remediation accordingly. | 6-weeks |
| 08 | Crack on brick wall-column joint (Extension Building) | Carry out remedial works where required. | 6-weeks |

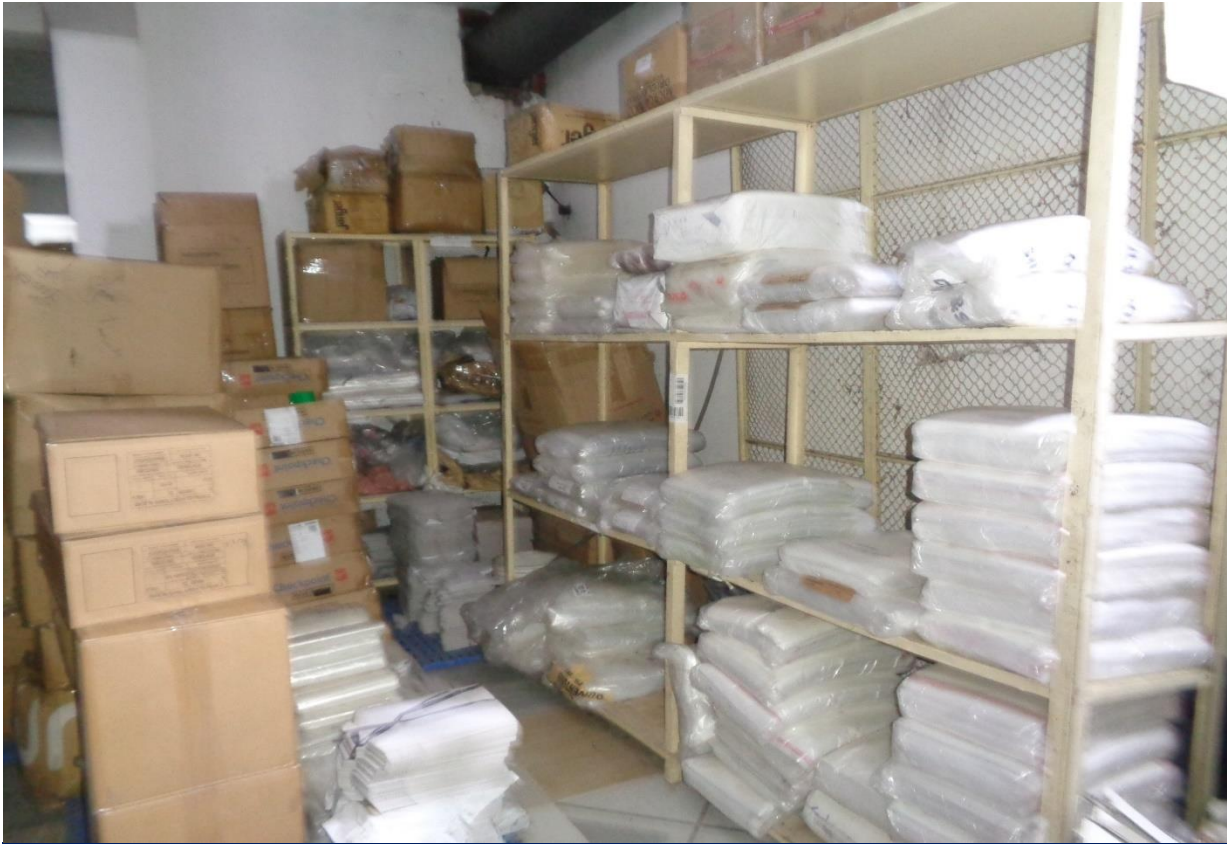
Storage rack found within the building without braced/anchored

Building engineer is required to brace/anchor all non structural elements.

| Item No. | Observation | Recommended Action Plan | Recommended Timeline |
|---|---|---|---|
| 09 | Non-structural elements found unbraced/not anchored (Extension Building) | Building engineer is required to brace/anchor all nonstructural elements. | 6-weeks |

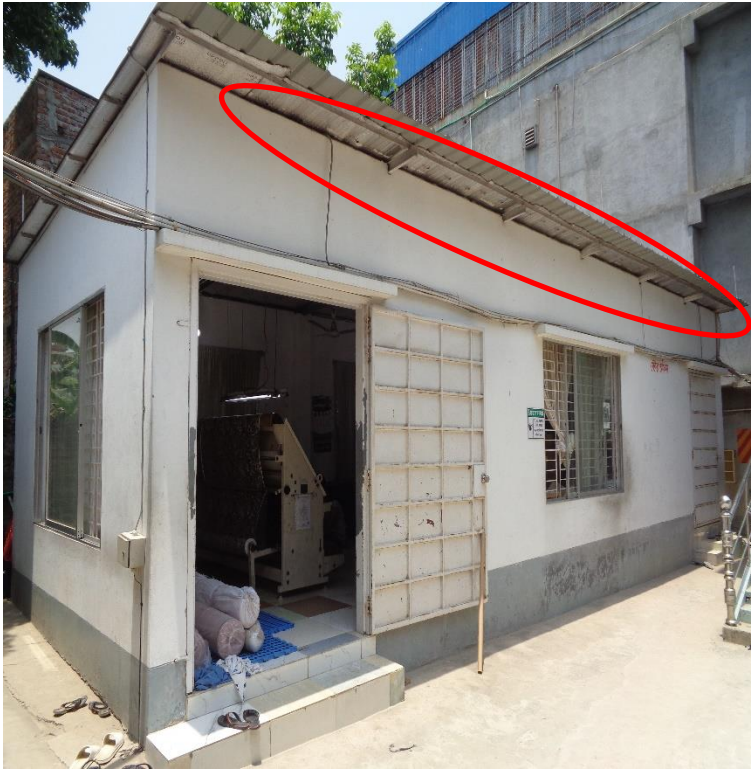
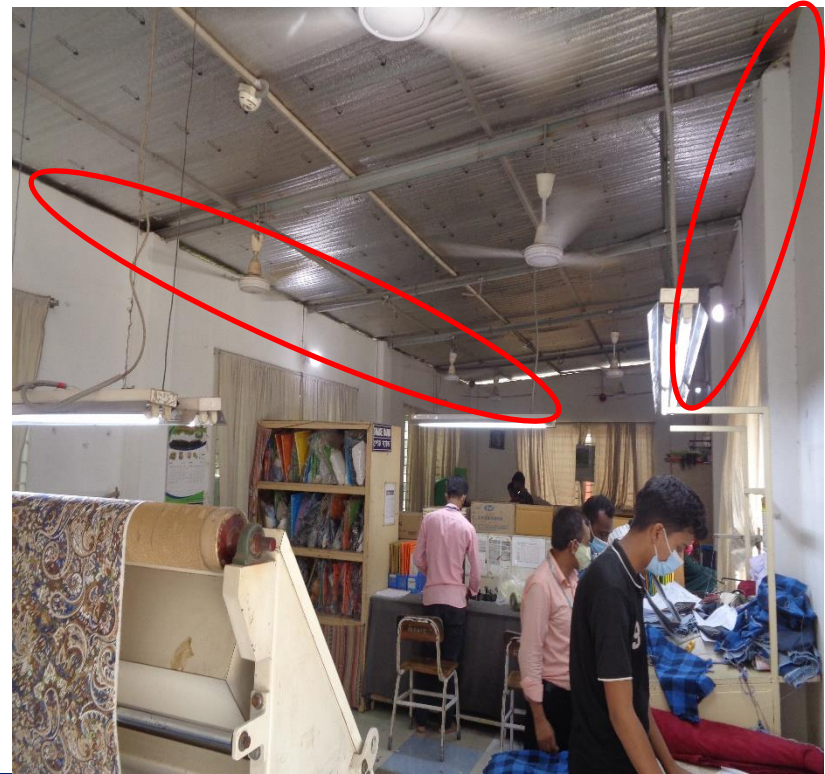
Steel rafters are inserted into brick wall

Steel rafters are inserted into brick wall therefore the connections are appeared to be inadequate. Building engineer is required to check the connection adequacy and implement remediation work where required.

| Item No. | Observation | Recommended Action Plan | Recommended Timeline |
|---|---|---|---|
| 10 | Apparently inadequate connection. (Store Office) | Building engineer is required to check the connection adequacy for uplift forces. | 6-weeks |
| 11 | Apparently inadequate connection. (Store Office) | Implement remediation work where required. | 6-months |

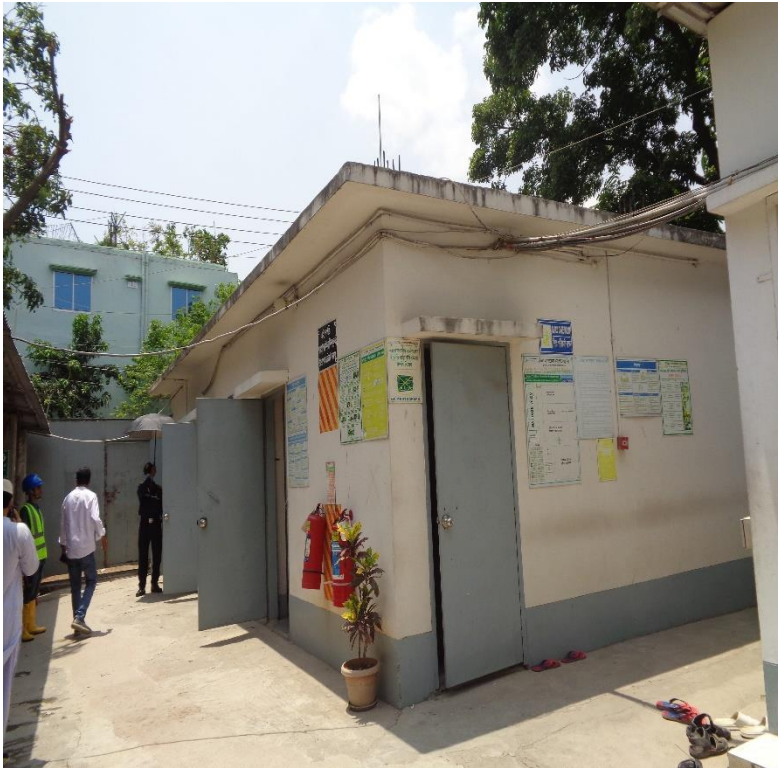
Medical and Childcare

As-built drawing was not available for these structure. Building engineer is required to produce as-built drawing..

| Item No. | Observation | Recommended Action Plan | Recommended Timeline |
|---|---|---|---|
| 12 | Lack of as-built drawing (Medical and Childcare Building; Store Office) | Building engineer is required to produce as-built drawing. | 6-weeks |
