ELECTRICAL SAFETY INSPECTION REPORT

GREEN TEXTILE LIMITED (UNIT-3)_EXPANSION.

Inspected on: May 24, 2023

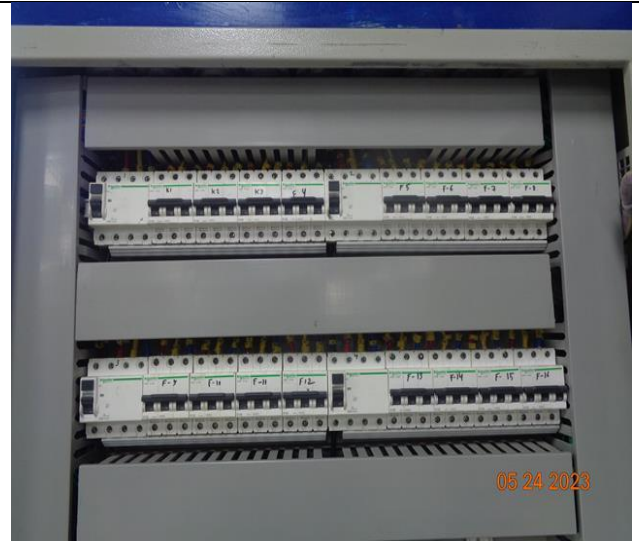
FINDING NO:	E - 3
CATEGORY:	DISTRIBUTION BOARD/PANEL
FINDING:	
Non rated and non-certified comb bar used for powering multiple MCB.	
RECOMMENDATION:	
For connecting multiple MCB use rated and listed comb bar.	
PRIORITY:	P2
REMEDIATION TIME FRAME:	2 MONTHS

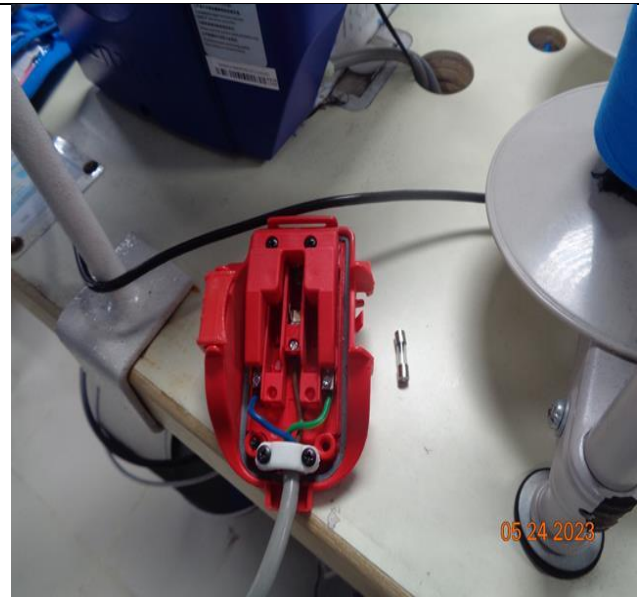
FINDING NO:	E - 4
CATEGORY:	WIRING SYSTEM
FINDING:	
Individual overload protection missing/ inadequate for motor above 376W.	
RECOMMENDATION:	
Every electric motor having a rating exceeding 0.376 kW shall be provided with individual control equipment incorporating means of protection against overcurrent.	
PRIORITY:	P2
REMEDIATION TIME FRAME:	2 MONTHS
