# R&G (BD) Garment Ltd

Bhabanipur, Gazipur Sadar, Gazipur  
(24.147350585, 90.421449636)  
30 April 2023

# Building Information

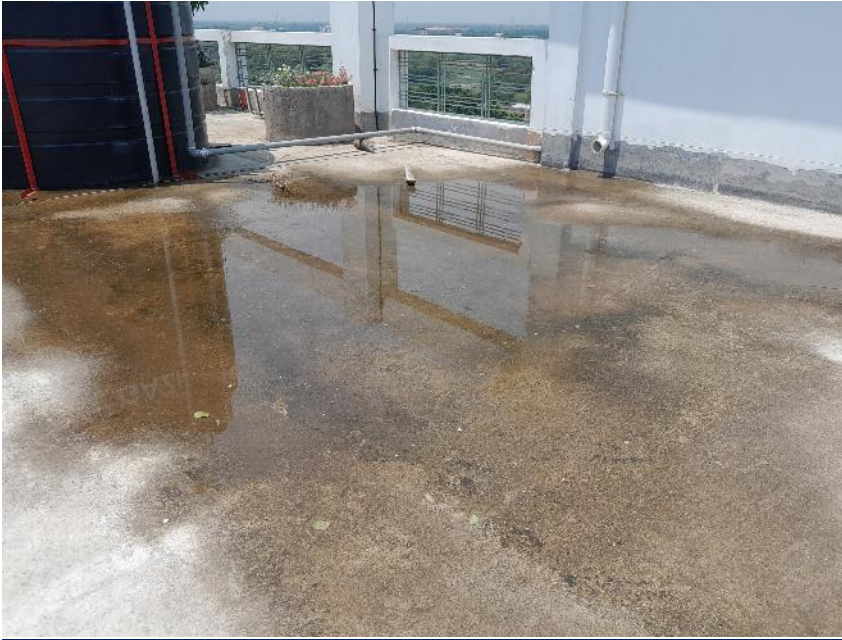
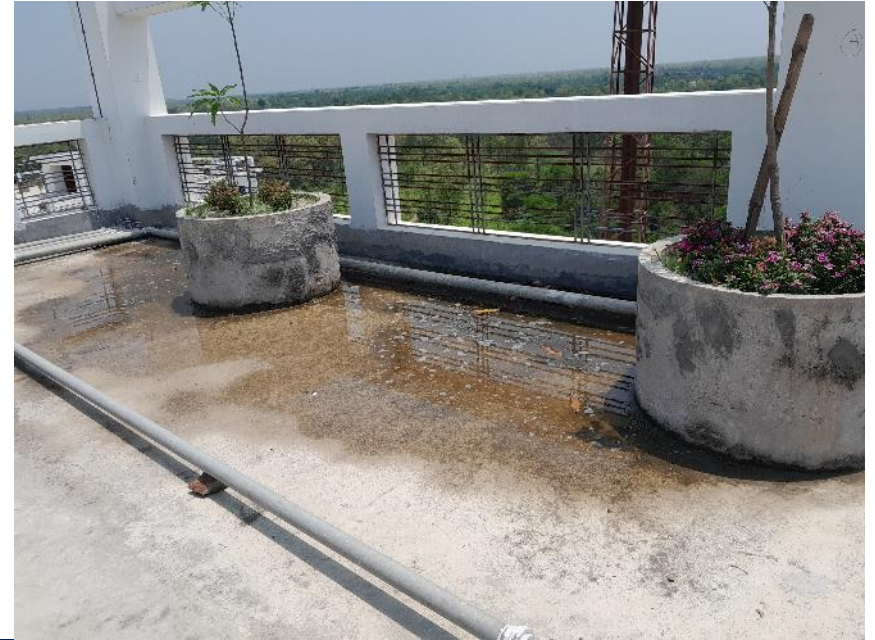
Water ponding was found at roof floor due to rainwater and leakage of pipeline of water.

Building engineer is required to provide adequate drainage system to avoid water ponding on the roof.

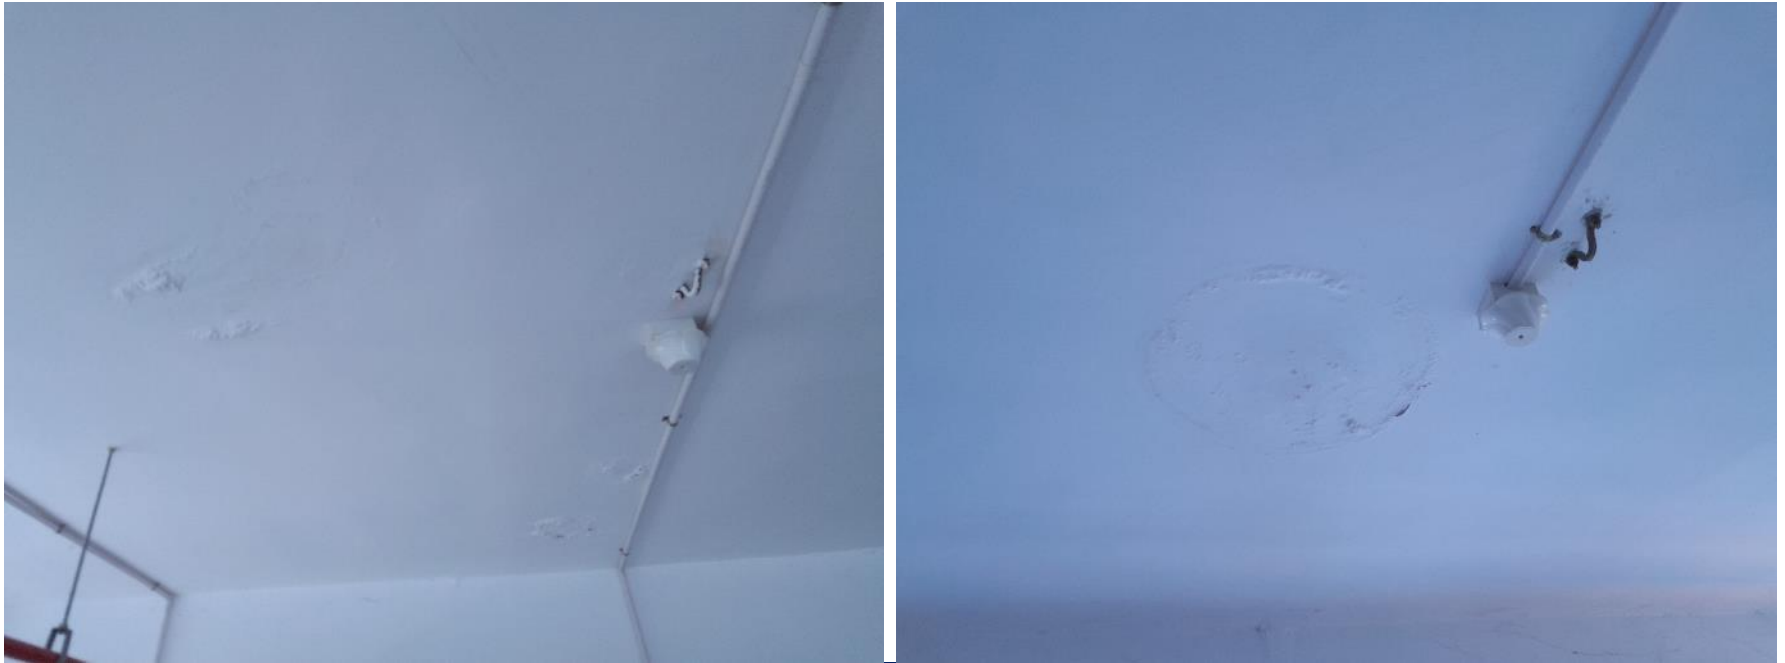
Dampness on slab soffit

During inspection, dampness found at several place of roof slab. Building engineer is required to investigate the reason & extent of dampness and provide remedial measure accordingly.

Item No.	Observation	Recommended Action Plan	Recommended Timeline
06	Dampness found in roof slab. (Main Building)	Building engineer is required to investigate the reason & extent of dampness and provide remedial measure accordingly.	6-weeks
07	FoS of some isolated footing in below the limit. (Canteen Building)	Building engineer is required to review the design of foundation load and stresses.	6-weeks
08	FoS of some isolated footing in below the limit. (Canteen Building)	Carry out remedial works where required.	6-months
09	Design code consideration. (Canteen Building)	Building engineer is required to evaluate the building as per BNBC 2020 code.	6-weeks
10	Design code consideration. (Canteen Building)	Carry out remedial works where required.	6-months

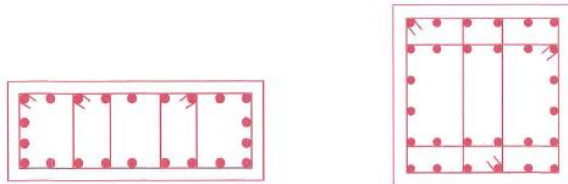
During inspection, mismatch found in column schedule of C5 column. As per provided as built drawing 22-20 mm re-bar shown in C5 column at ground floor, but in construction drawing 28-20 mm re-bar shown in C5 column at ground floor. Building engineer is required to survey the full building and update the as-built drawing accurately.

Item No.	Observation	Recommended Action Plan	Recommended Timeline
11	Inconsistency in as-built drawing. (Canteen Building)	Building engineer is required to prepare accurate as-built drawing.	6-weeks
12	Tested area not filled with specification. (All Structure)	Building engineer is required to fill the tested areas by suitable method.	6-weeks

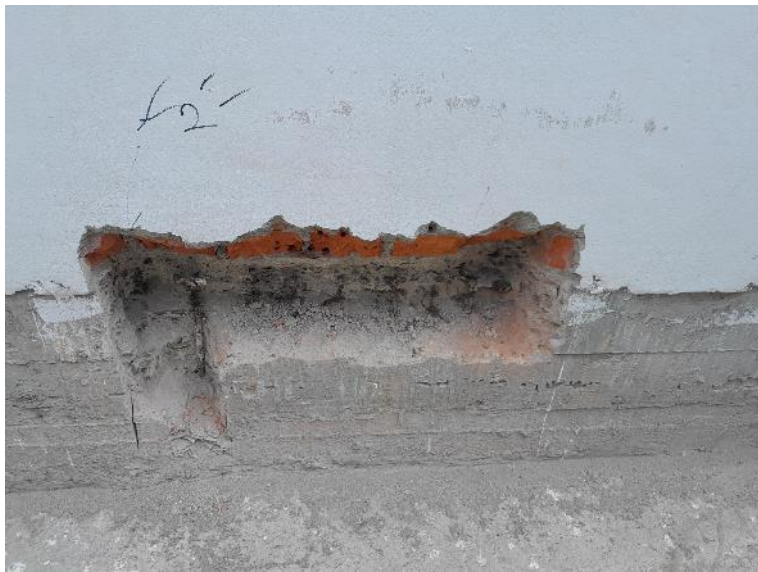
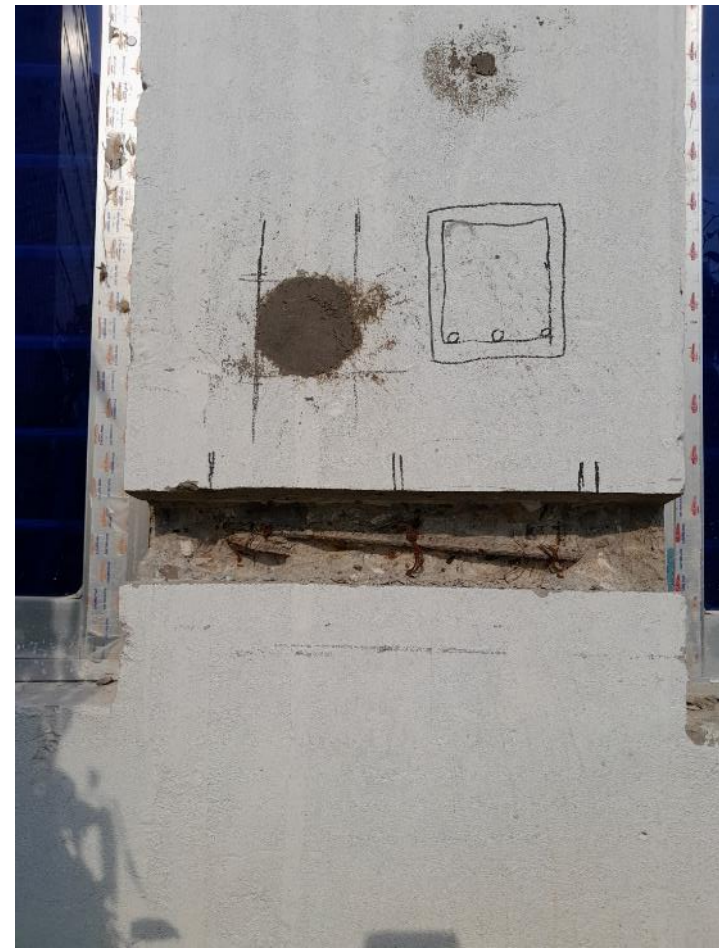
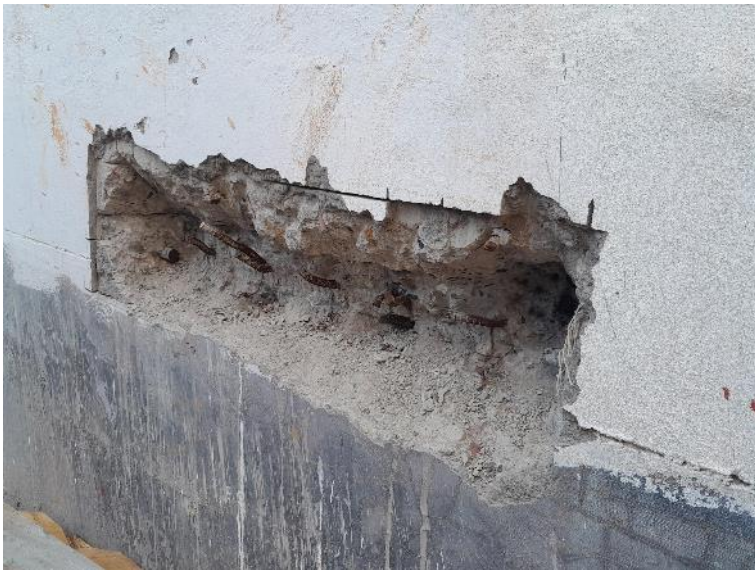
Tested areas found unfilled in all buildings.  
Building engineer is required to fill all the  
tested area by suitable method.
