# MAMUN KNITWEAR LTD.

AMBAGH ROAD, KONABARI, NILNAGAR, GAZIPUR-1700, BANGLADESH.  
(24.014711, 90.320712)

29 May 2023

**Building 11 (Mamun Knit):** is a seven storied (G+6) reinforced concrete (RC) building.

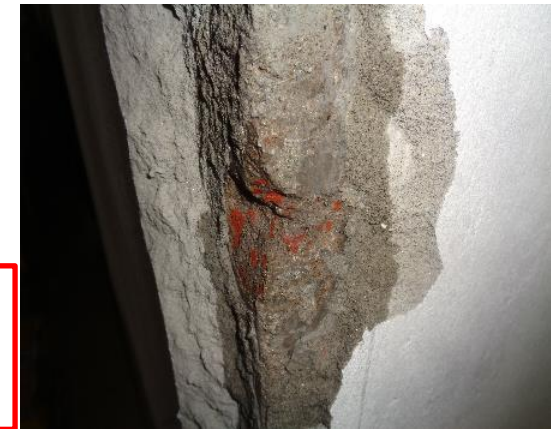
Brick chip on 6<sup>th</sup> floor

As per “Detailed Engineering Assessment Report” four concrete cores were taken from above fifth floor and brick chip was found in column at sixth floor. During inspection, neither any core sample nor test report was available on site for those cores. Building engineer is required to investigate the issue and clarify accordingly. However, consider all test results in the DEA report.

| Item No. | Observation | Recommended Action Plan | Recommended Timeline |
|---|---|---|---|
| 02 | “Detailed Engineering Assessment Report” needs to be updated (Building 11) | Building engineer is required to investigate the missing 6th floor concrete cores & reports and include all the test results in the DEA report. | 6-weeks |

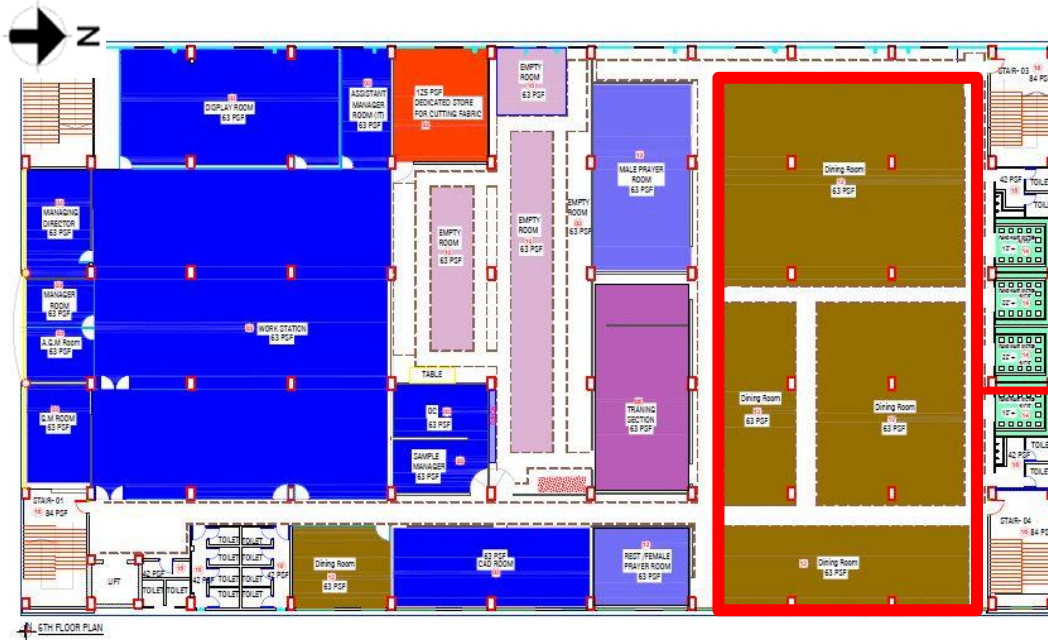
Live load plan- 6<sup>th</sup> floor

Storage on 6<sup>th</sup> floor was found instead of dining. As per BNBC-Part 6, live load for light storage areas is required to be considered minimum 6 kPa. However, the building engineer is required to revise the load plan as per BNBC requirement and check the design accordingly.

| Item No. | Observation | Recommended Action Plan | Recommended Timeline |
|---|---|---|---|
| 04 | Undesignated storage on 6th floor (Building 11) | The building engineer is required to revise the load plan as per BNBC requirement and check the design report accordingly. | 6-weeks |

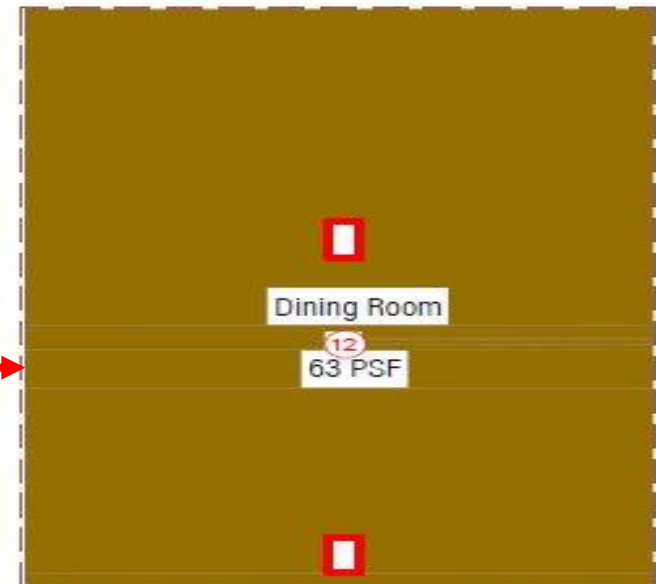
Dining (Live load considered 3 kPa)

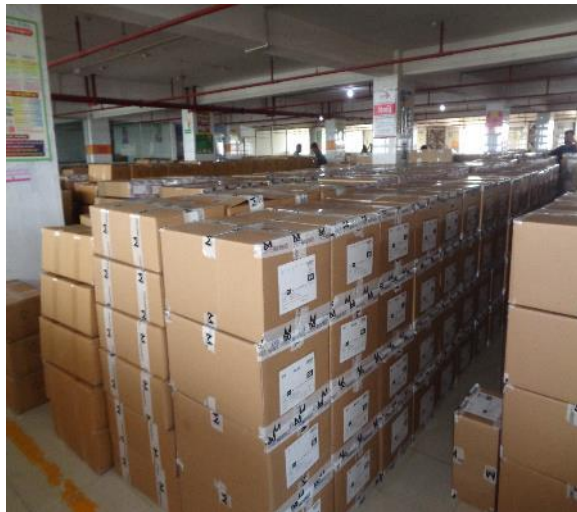
Storage on 6<sup>th</sup> floor

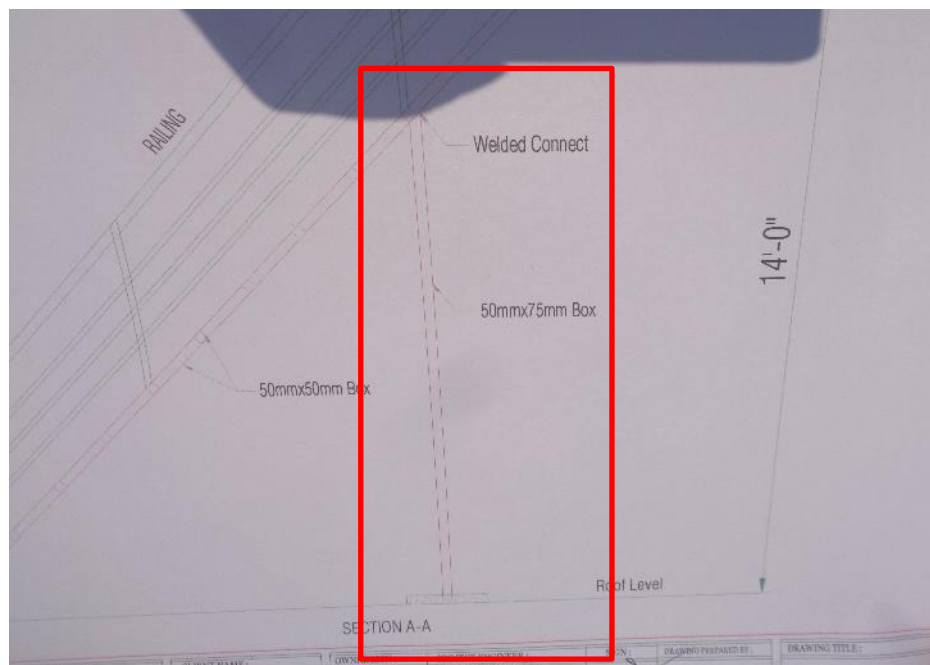
Support of ladder shown as 50mmX75mm box

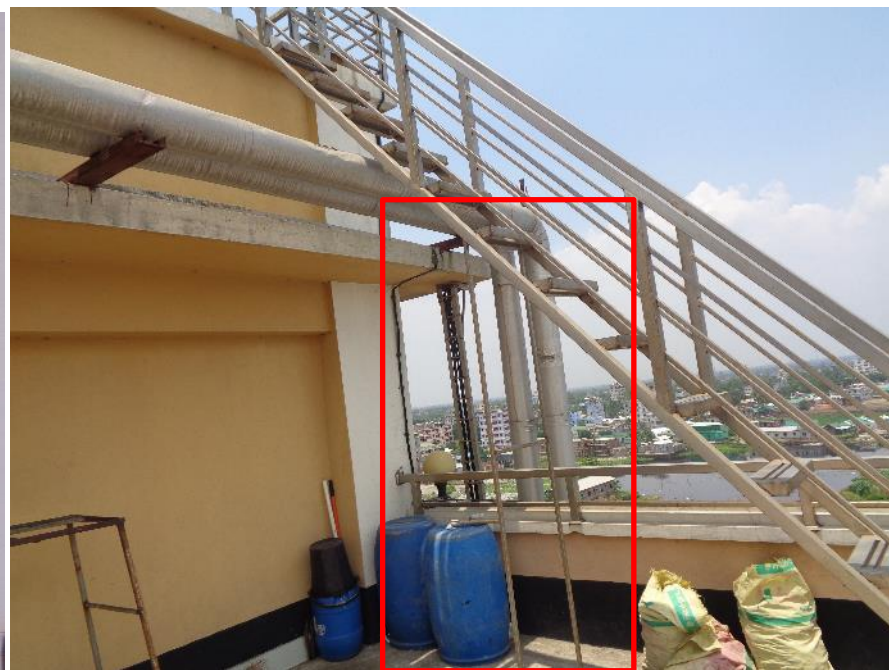
Support of ladder found as 20mmX20mm box

Support of steel stair found as 20mmX20mm box instead of 50mmX75mm box. Building engineer is required to update the as-built drawing.

| Item No. | Observation | Recommended Action Plan | Recommended Timeline |
|---|---|---|---|
| 06 | Discrepancy in as-built drawing (Building 11) | Building engineer is required to update the as-built drawing. | 6-weeks |

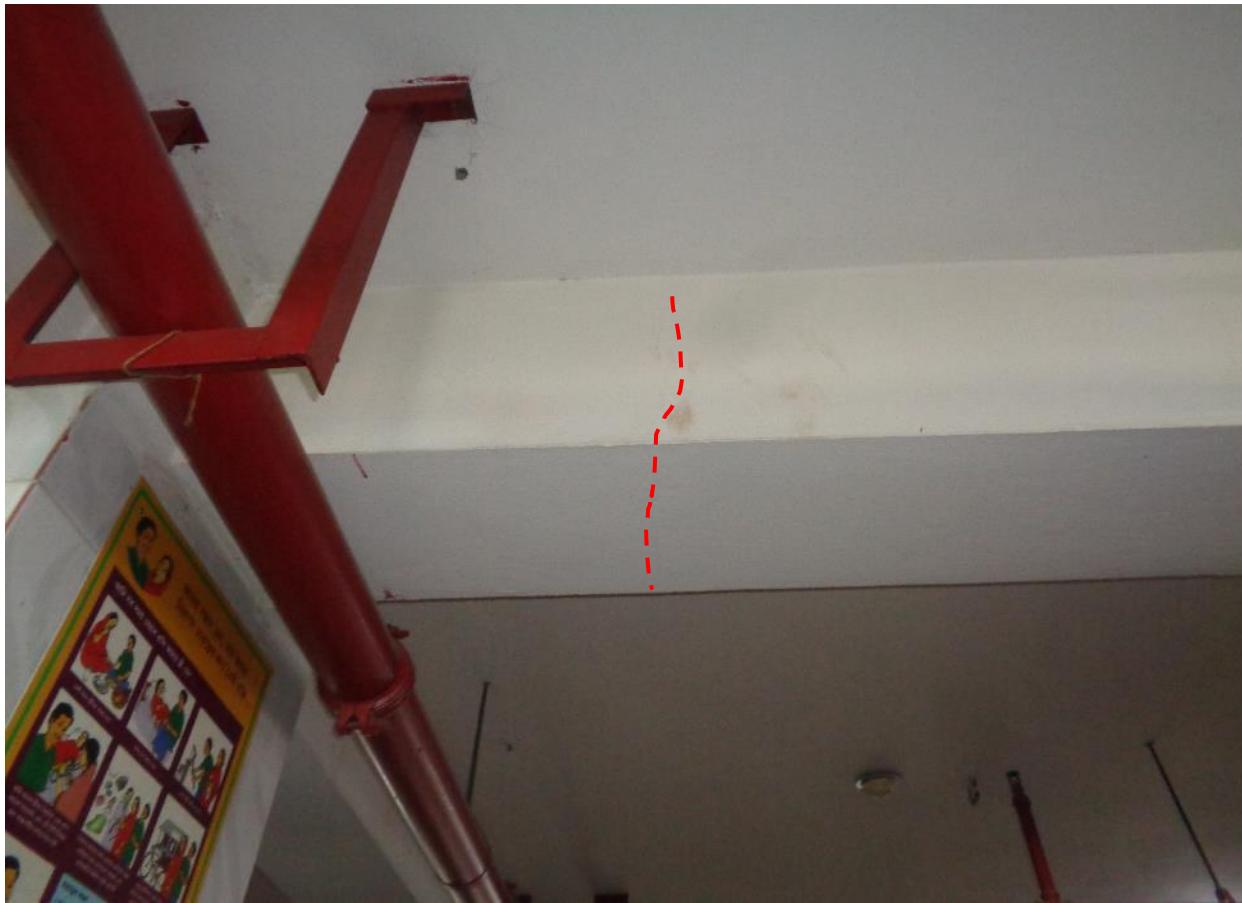
Hairline crack on beam under roof

Cracks were observed on roof beams. Building engineer is required to check the cracks and carry out suitable repair work.

| Item No. | Observation | Recommended Action Plan | Recommended Timeline |
|---|---|---|---|
| 07 | Cracks on roof beam (Building 11) | Building engineer is required to check the cracks and carry out suitable repair works. | 6-weeks |

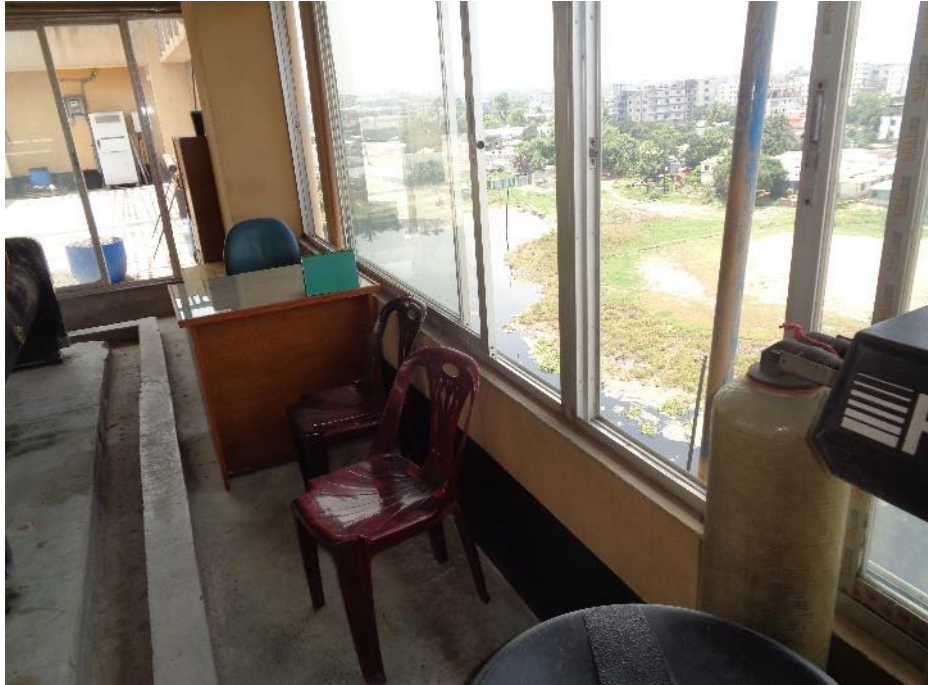
Low parapet height (700mm) at roof level

Low parapet/wall height (700mm) was found at floor & roof level which may cause falling hazard. Factory is required to increase the parapet/wall height to prevent possible falling hazard in future.

| Item No. | Observation | Recommended Action Plan | Recommended Timeline |
|---|---|---|---|
| 08 | Low height of parapet/wall (Building 11) | Factory is required to increase the parapet/wall height to prevent possible falling hazard. | 6-weeks |

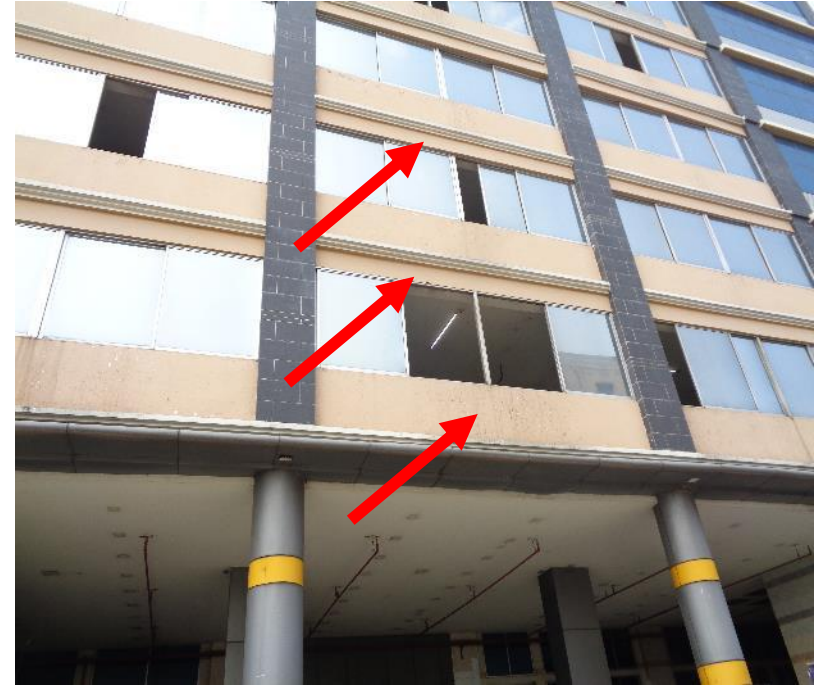
Low wall height (700mm) at front edge

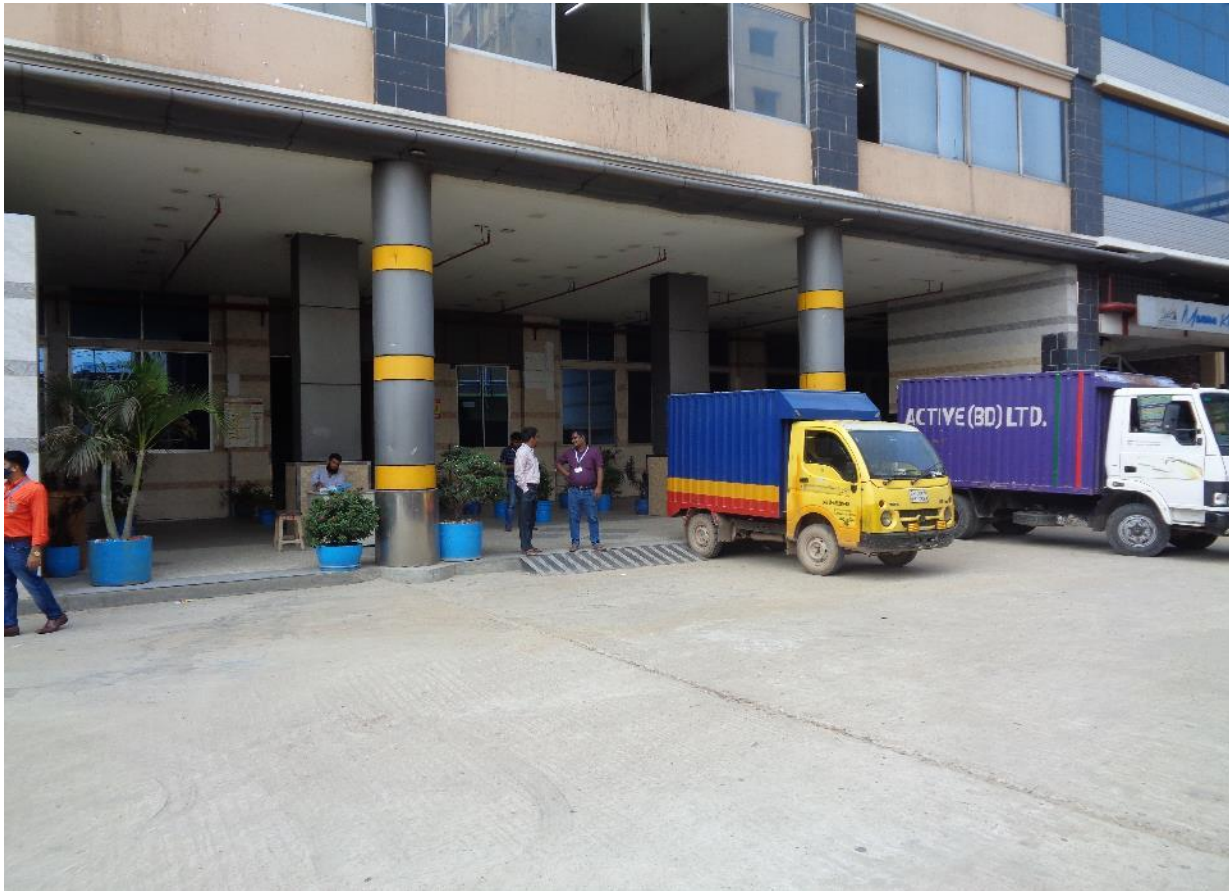
No barrier provided for columns at ground floor

Columns at ground floor are prone to possible vehicle impact. Factory is required to provide barrier around the columns at ground floor to prevent from possible vehicle impact.

| Item No. | Observation | Recommended Action Plan | Recommended Timeline |
|---|---|---|---|
| 09 | Possible vehicle impact for column (Building 11) | Factory is required to provide barrier around the columns at ground floor to prevent from possible vehicle impact. | 6-weeks |
