# Debonair Limited Unit-2 (Extension)

Plot # 356, Shorifpur, Ozarpara, National University, Joydebpur, Gazipur.

9 April-2023

# Observations

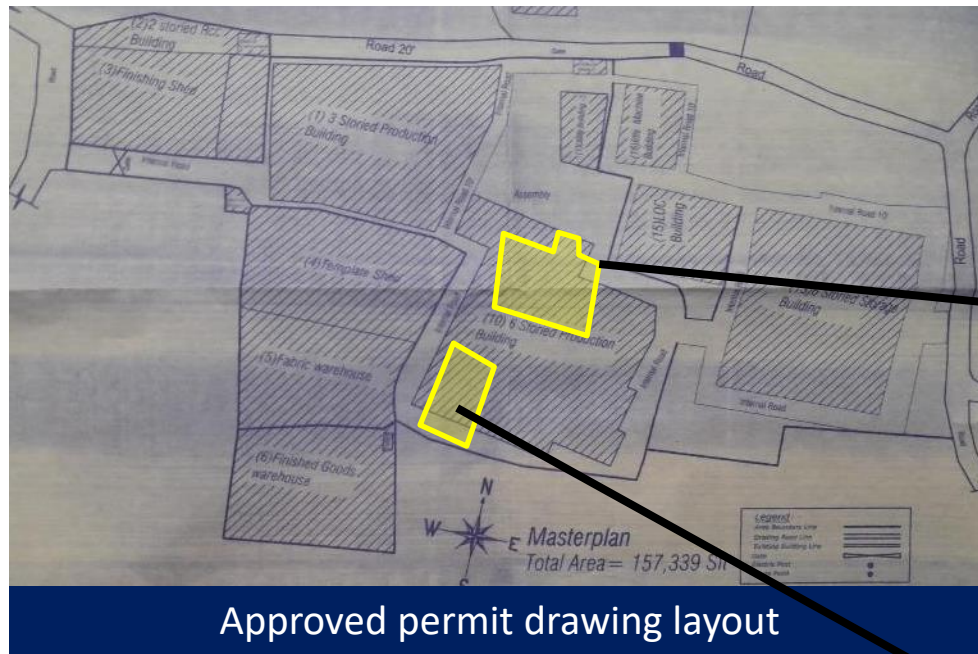
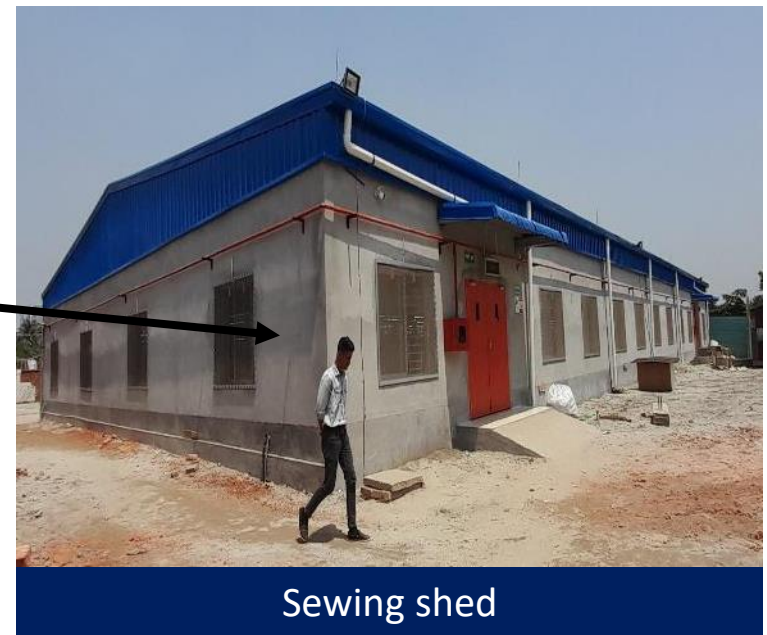
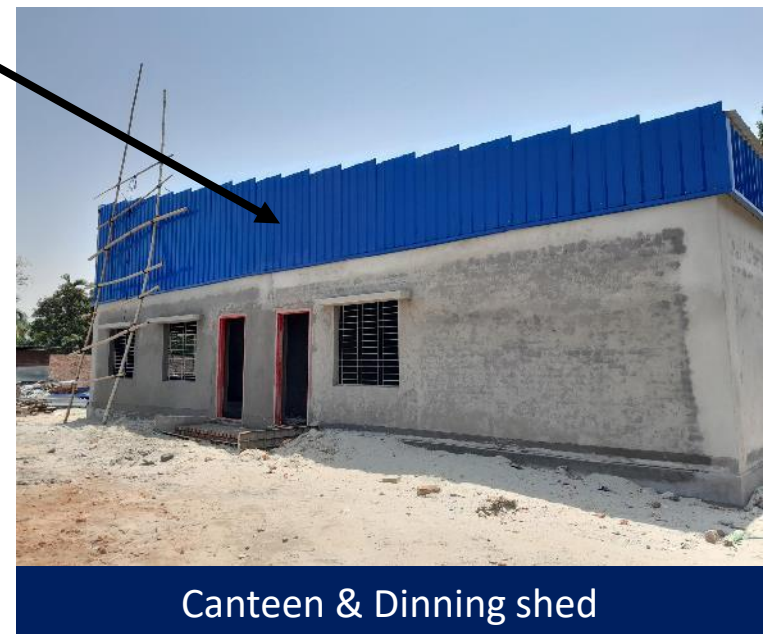
**Missing approval drawing from local authority.**

Factory had a building permit drawing for 6 storied production building. But the factory built two single storied sheds (Sewing Shed and Dining & Canteen Shed) at the location of proposed 6 storied building. However, approval drawing for the Sewing Shed and Canteen & Dining Shed was not available. Building engineer is required to seek approval from the local authority for the structures.

| Item No. | Observation | Recommended Action Plan | Recommended Timeline |
|---|---|---|---|
| 01 | Missing approval drawing from local authority. (Sewing Shed and Dining & Canteen Shed). | Building engineer is required to collect building permit drawings from government authorized local institutions. | 6-months |

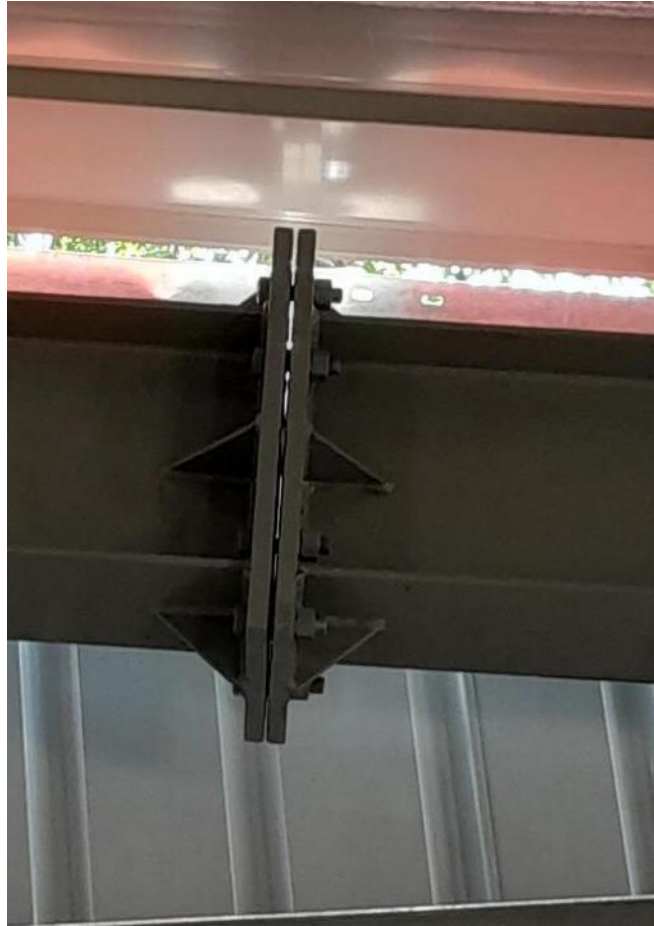
## **Gap between connection plates**

Connection gap found between steel connection plates of rafter. Building engineer is required to fill all the steel connection gap with suitable method.

| Item No. | Observation | Recommended Action Plan | Recommended Timeline |
|---|---|---|---|
| 04 | Gap between connection plates. (Sewing Shed and Dining & Canteen Shed) | Building engineer is required to fill all the steel connection gap with suitable method. | 6-weeks |

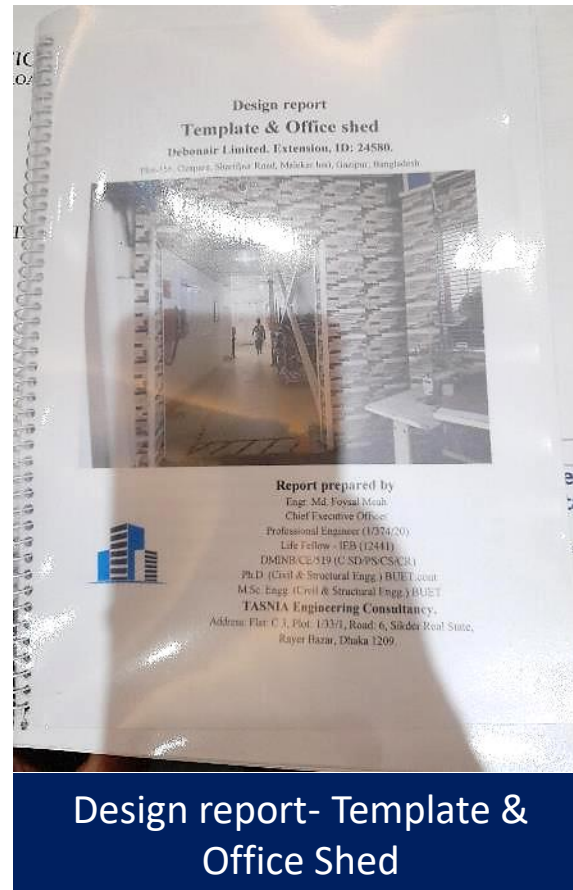
**Design report need to be updated**

Design report was available on site. Proper connection adequacy check was not incorporated in the design report. However, the building engineer is required to incorporate the proper connection design check in the design report.

| Item No. | Observation | Recommended Action Plan | Recommended Timeline |
|---|---|---|---|
| 05 | Design report need to be updated. (Template & Office Shed) | Building engineer is required to incorporate the proper connection adequacy check in the design report. | 6-weeks |

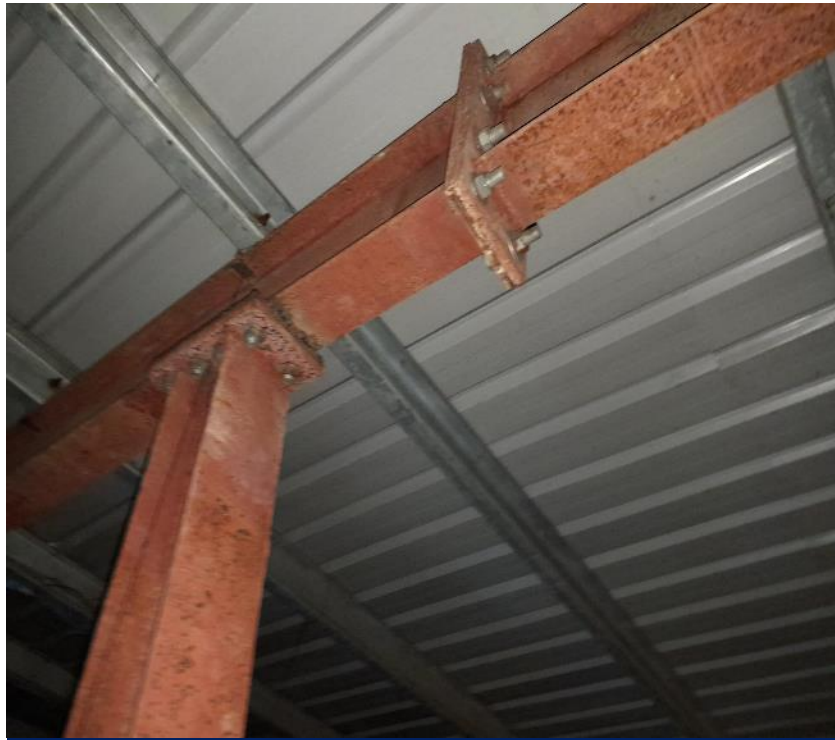
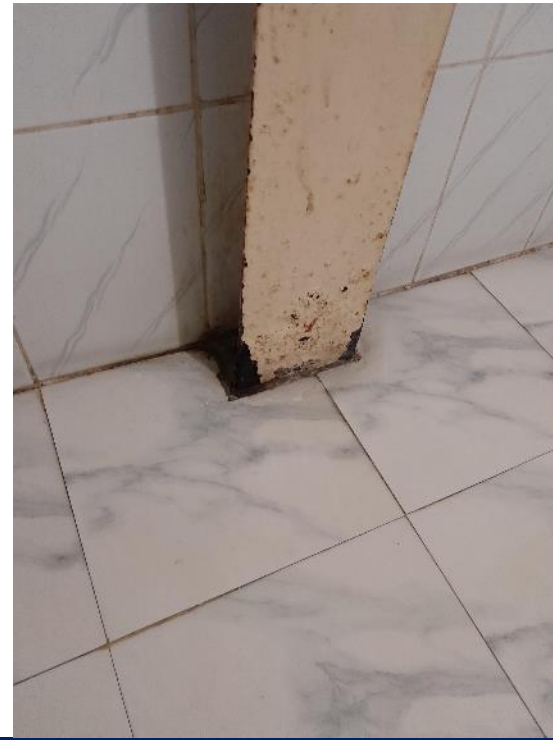
corroded steel member

Building is required to identify all corroded member, remove the corrosion and apply suitable anti-corrosive coating to the affected steel members.

| Item No. | Observation | Recommended Action Plan | Recommended Timeline |
|---|---|---|---|
| 07 | Corrosion on steel member. (Template & Office Shed) | Building engineer is required to identify all corroded member, remove the corrosion and apply suitable anti-corrosive coating to the affected steel members. | 6-months |

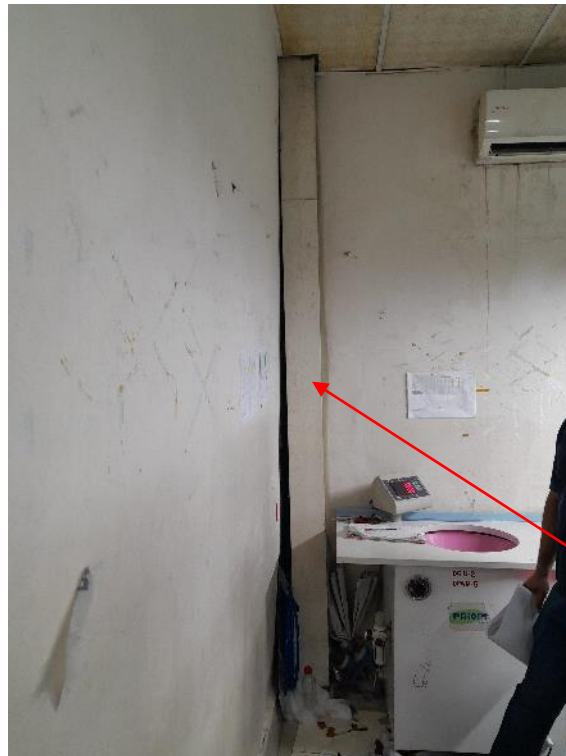
Steel column out of plumb

Indicated column was found vertically inclined which may occur due to poor fabrication work. Building engineer is required to check the column alignment and suggest necessary alternatives.

| Item No. | Observation | Recommended Action Plan | Recommended Timeline |
|---|---|---|---|
| 08 | Steel column out of plumb. (Template & Office Shed) | Building engineer is required to check the column alignment and suggest necessary alternatives. | 6-months |

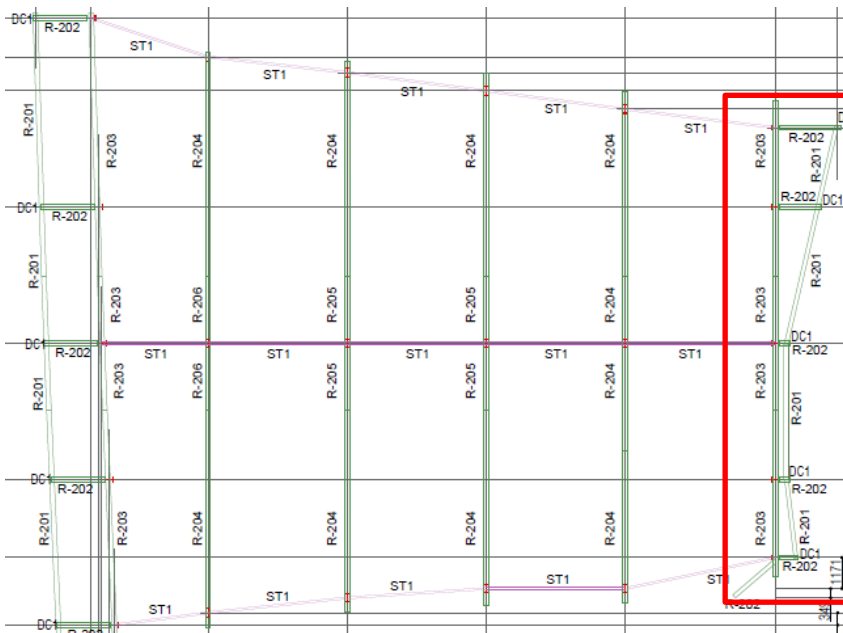
Rafter Layout: Irregular column layout and beam arrangement

Building engineer is required to revise the design report considering non-compact section due to discontinuous welding and actual framing arrangement.

| Item No. | Observation | Recommended Action Plan | Recommended Timeline |
|---|---|---|---|
| 09 | Irregular framing system and discontinuous welding in the steel column. (Fabric Warehouse Shed) | Building engineer is required to revise the design report considering non-compact section due to discontinuous welding and actual framing arrangement. | 6-weeks |

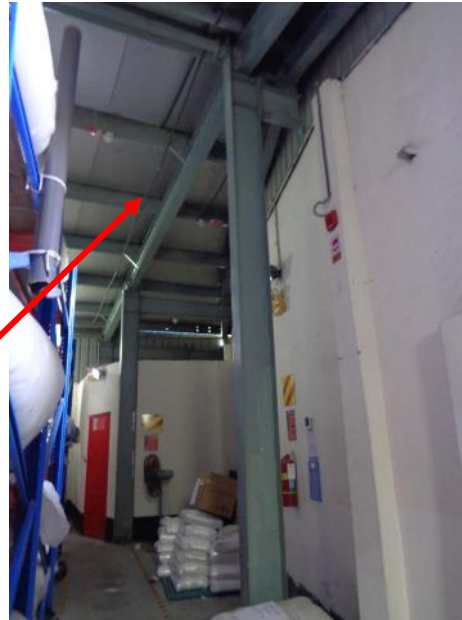
Irregular column and beam

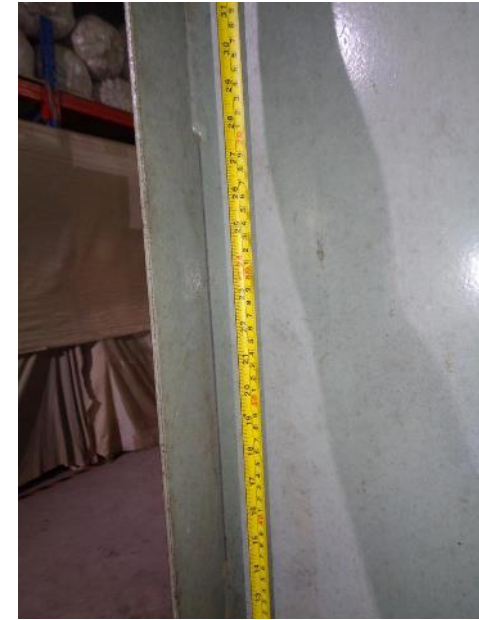
Tack welding- 350 mm spacing

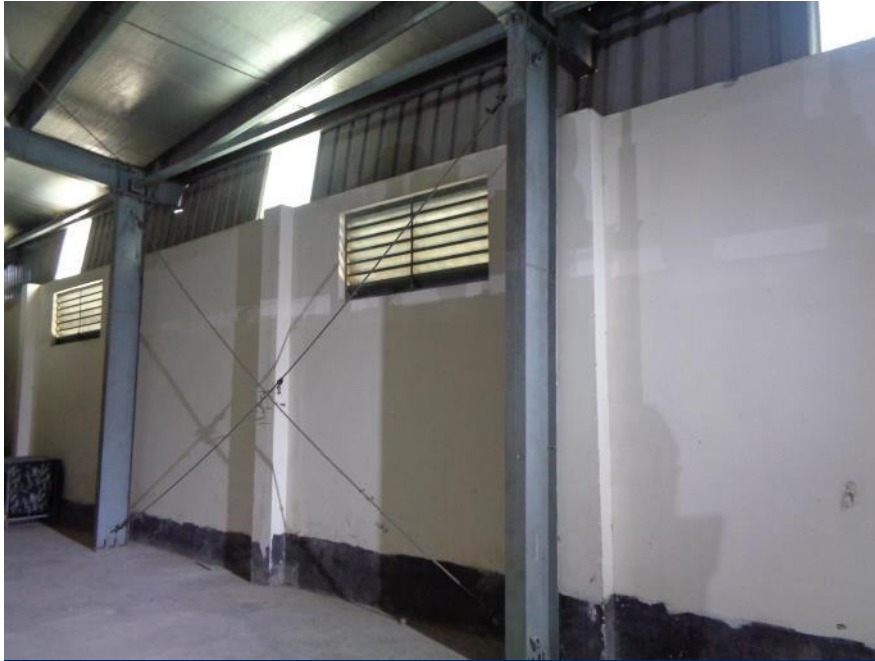
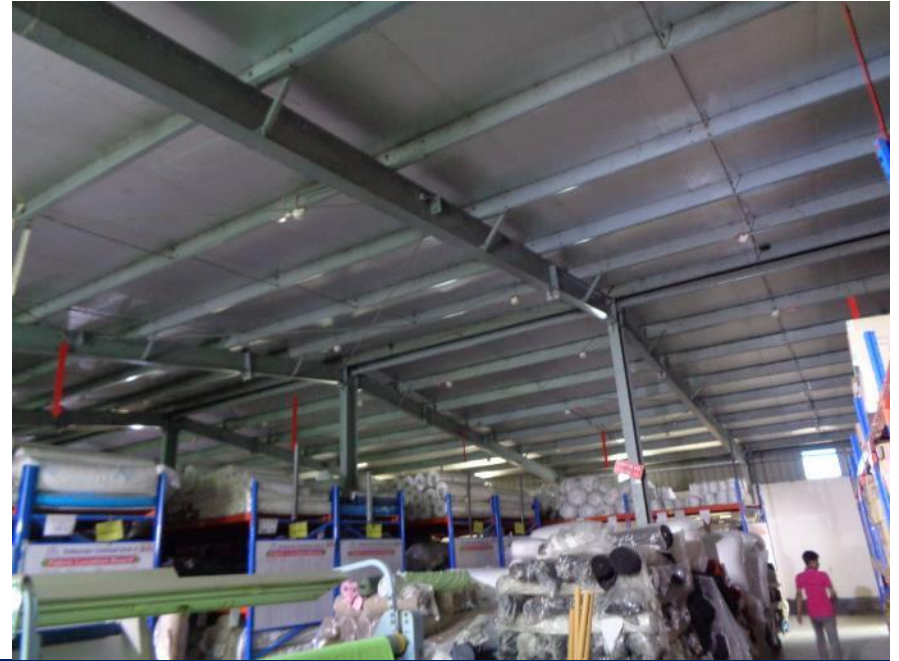
Loose cable bracing at wall and roof

Building engineer is required to identify the loose bracing and tighten the bracing accordingly.

| Item No. | Observation | Recommended Action Plan | Recommended Timeline |
|---|---|---|---|
| 11 | Loose cable bracing. (Fabric Warehouse Shed) | Building engineer is required to identify the loose bracing and tighten the bracing accordingly. | 6-months |

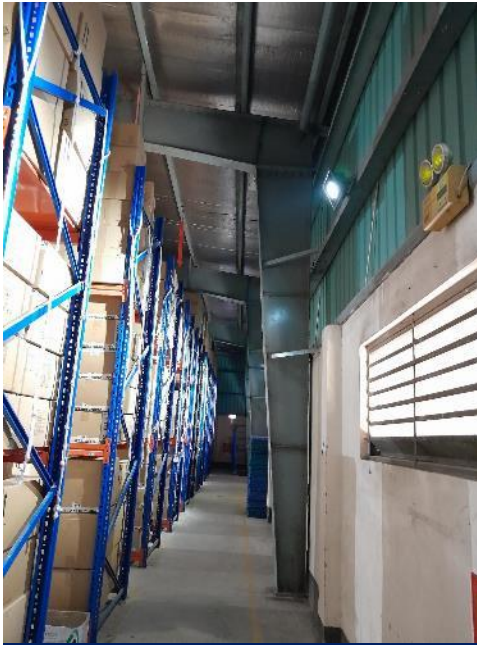
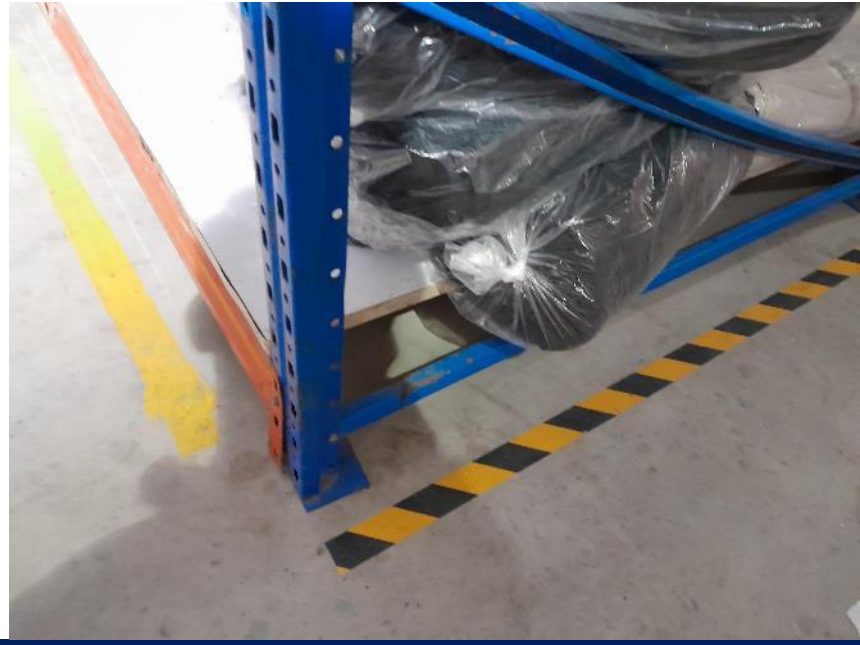
Steel racks without anchored/braced.

Building engineer is required to be provide adequate anchor/braced all non-structural elements to avoid falling hazard due to any kind of lateral force.

| Item No. | Observation | Recommended Action Plan | Recommended Timeline |
|---|---|---|---|
| 12 | Lack of anchorage of nonstructural elements. (Fabric Warehouse Shed) | Building engineer is required to be provide adequate anchor/braced all non-structural elements to avoid falling hazard due to any kind of lateral force. | 6-months |

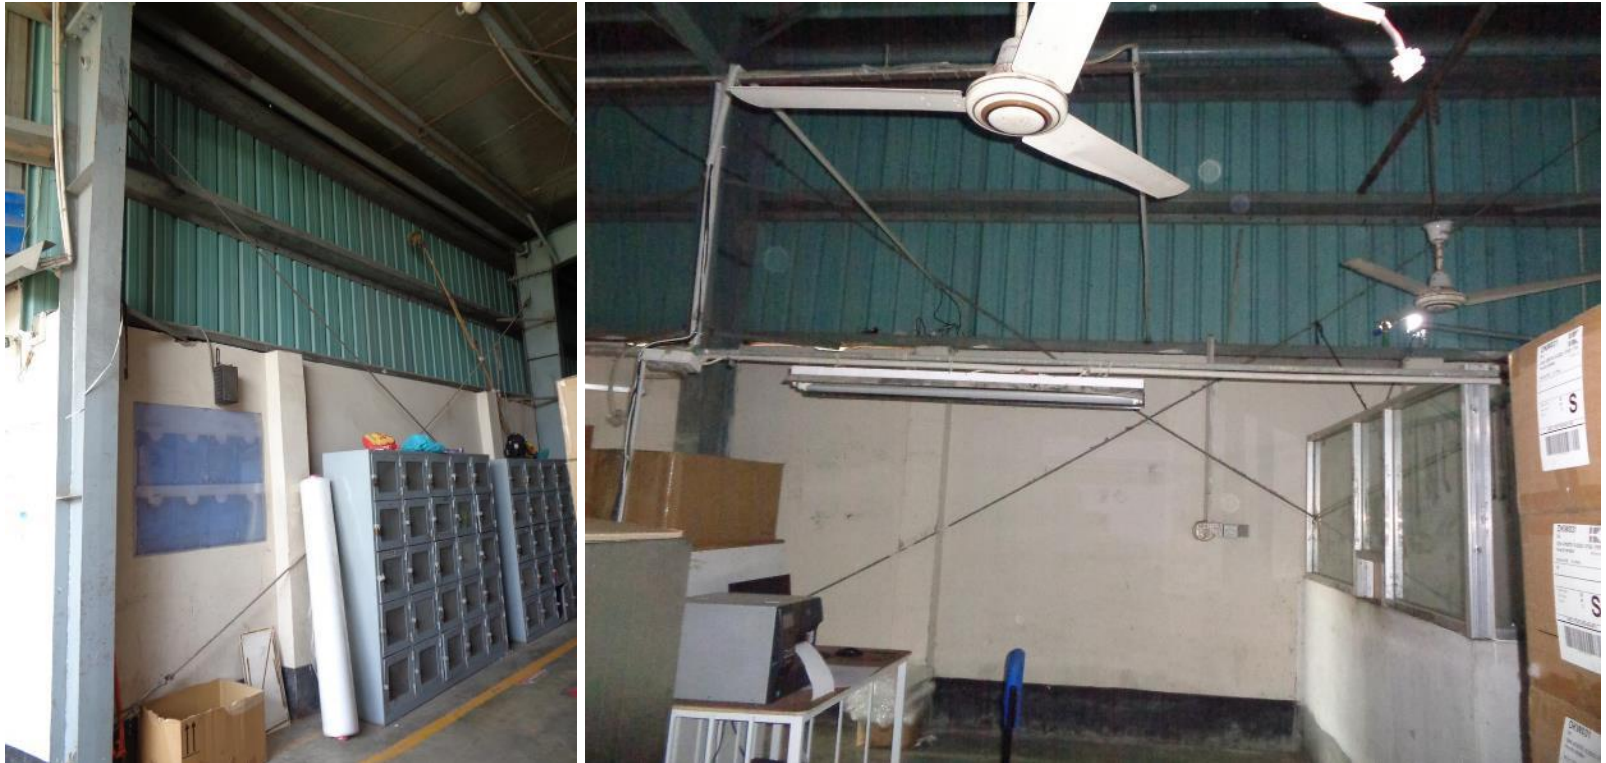
Loose cable bracing at wall and roof

Building engineer is required to identify the loose bracing and tighten the bracing accordingly.

| Item No. | Observation | Recommended Action Plan | Recommended Timeline |
|---|---|---|---|
| 15 | Loose cable bracing. (Finished Goods Warehouse Shed) | Building engineer is required to identify the loose bracing and tighten the bracing accordingly. | 6-months |

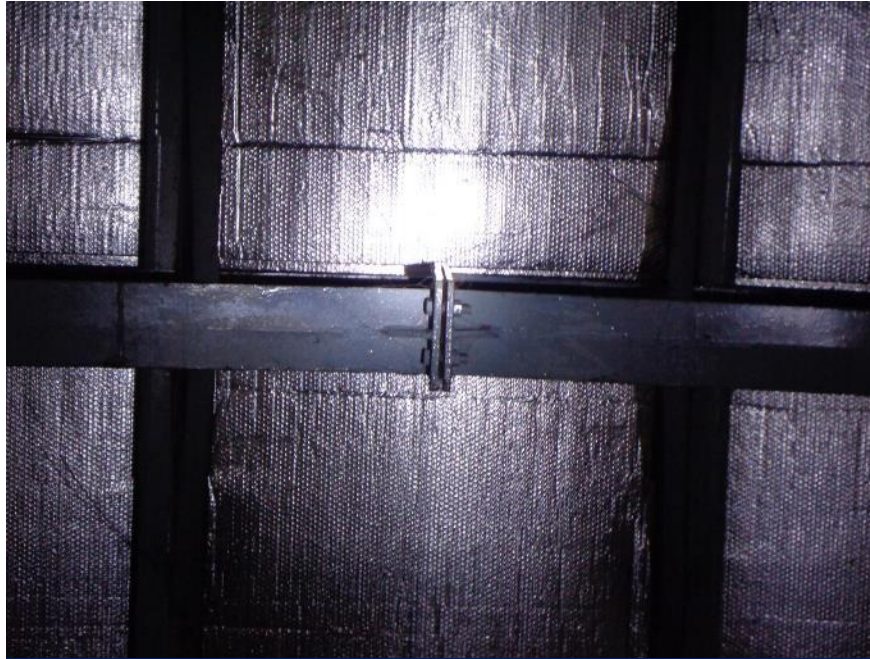
Onsite connection gap (Finished goods Warehouse)

Connection gap found between steel connection plates of rafter. Building engineer is required to fill all the steel connection gap with suitable method.

| Item No. | Observation | Recommended Action Plan | Recommended Timeline |
|---|---|---|---|
| 16 | Gap between connection plates.<br>(Finished Goods Warehouse Shed) | Building engineer is required to fill all the steel connection gap with suitable method. | 6-weeks |
