# Al-Muslim Apparels Ltd. (Extension)

East Narsingdipur, Ashulia, Savar, Dhaka.  
(23.9245265889, 90.308980602)  
13 June 2023

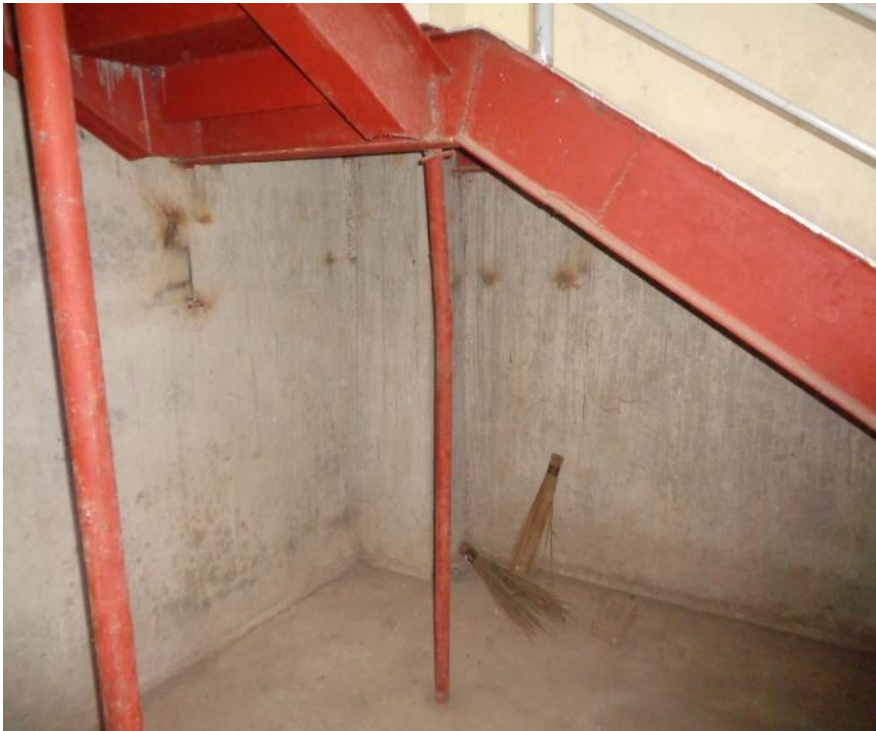
Twisted column observed under stair at basement

Twisted column observed under stair at basement and connection gap found between steel joints. Building engineer is required to check the adequacy of the steel stair and incorporate in DEA report. Also, repair the twisted column and connection gap with a suitable method.

| Item No. | Observation | Recommended Action Plan | Recommended Timeline |
|---|---|---|---|
| 03 | Twisted steel stair column and connection gap (Utility Building) | Building engineer is required to check the adequacy of the steel stair and incorporate in DEA report. | 6-weeks |
| 04 | Twisted steel stair column and connection gap (Utility Building) | Repair the twisted column and connection gap with a suitable method. | 6-months |

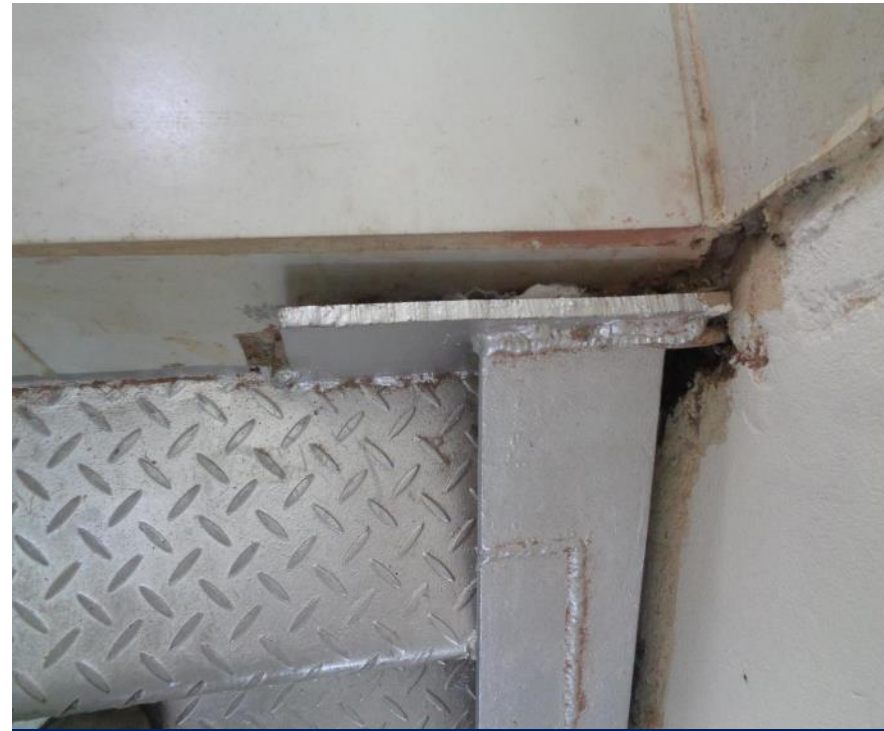
Connection gap found between steel joints

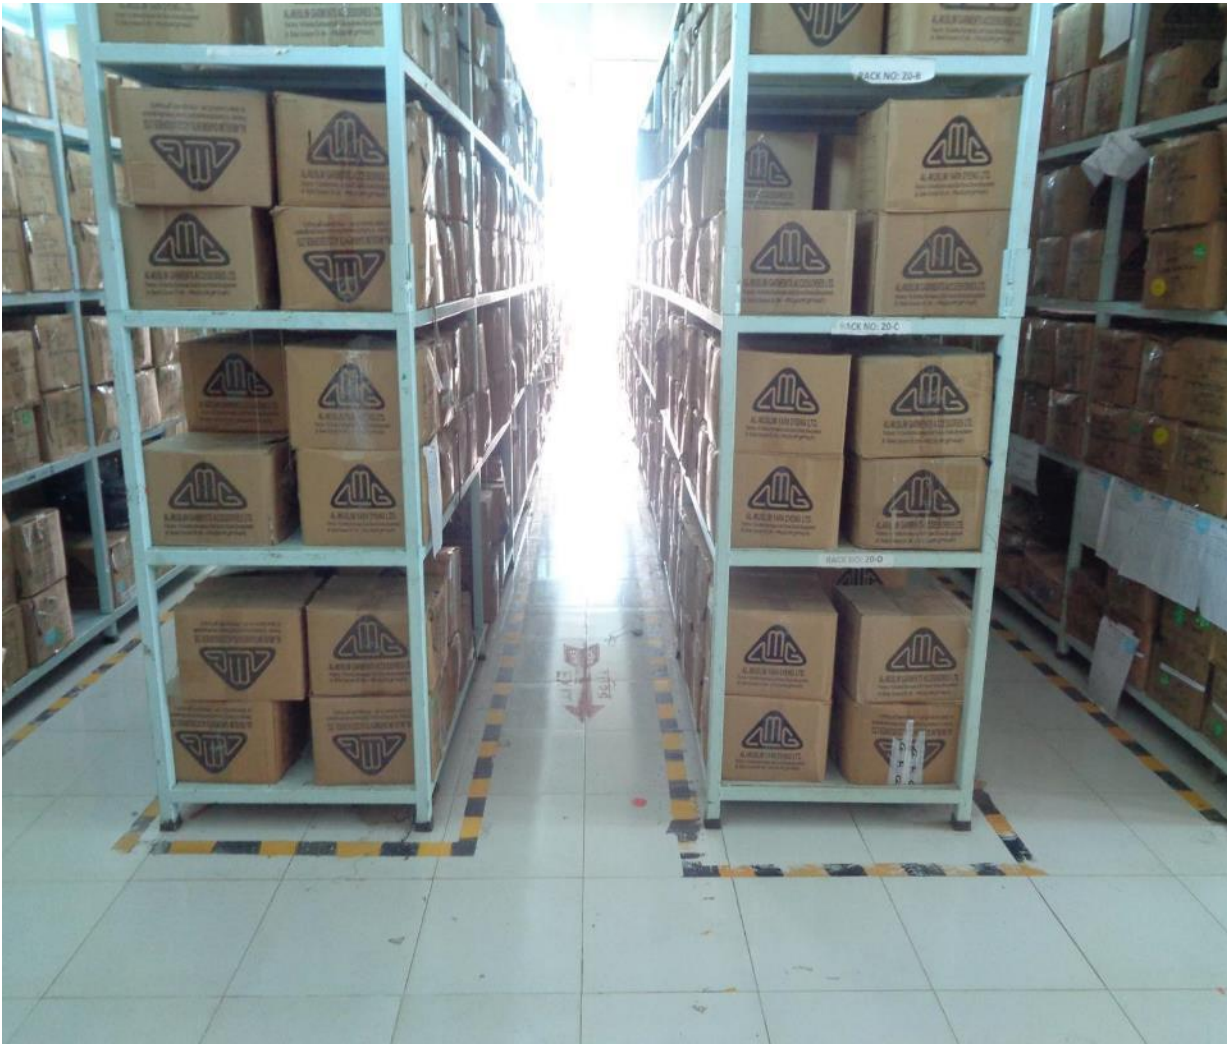
Storage rack found within the building without braced/anchored

Building engineer is required to brace/anchor all non structural elements.

| Item No. | Observation | Recommended Action Plan | Recommended Timeline |
|---|---|---|---|
| 05 | Non-structural elements found unbraced/not anchored (Utility Building) | Building engineer is required to brace/anchor all non-structural elements. | 6-weeks |

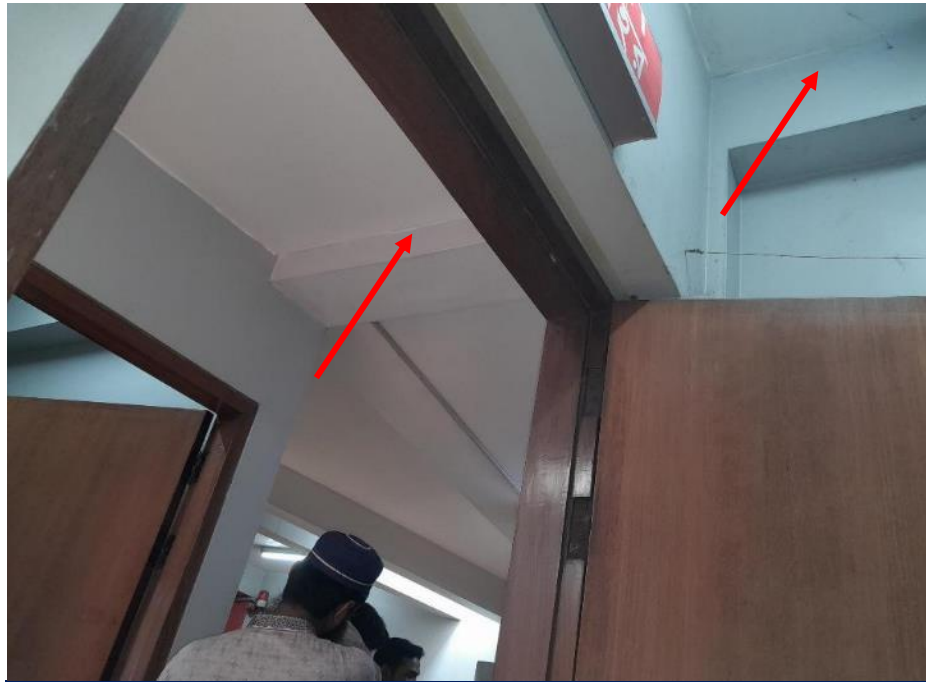
Level difference in roof slab

Level difference in roof slab which was not shown in slab layout. Building engineer is required to update the as-built drawing.

| Item No. | Observation | Recommended Action Plan | Recommended Timeline |
|---|---|---|---|
| 08 | Discrepancy in as-built drawing (Dormitory Office Building) | Building engineer is required to update the as-built drawing. | 6-weeks |

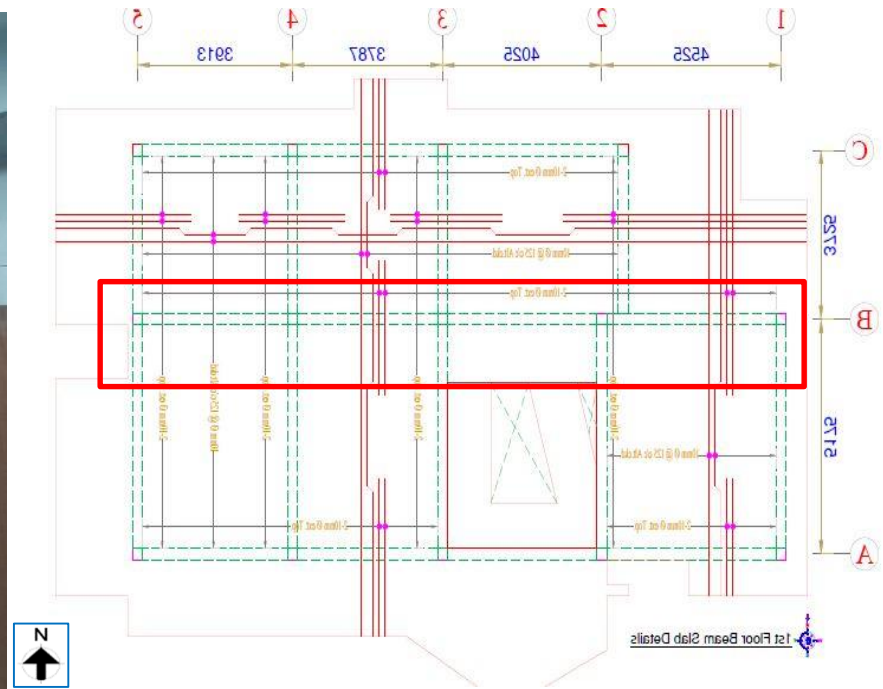
Level difference not shown in slab layout

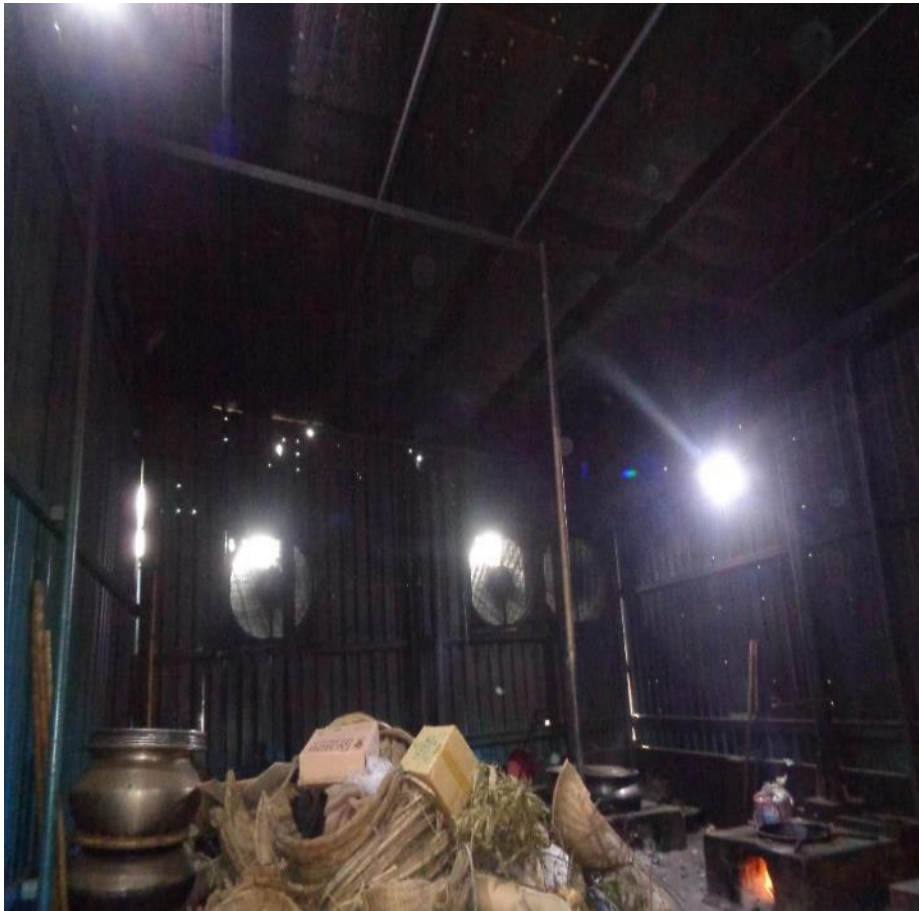
Both Kitchen shed and Jhute Store Shed were appeared to be non engineered due to lack of apparent load path, poor connection and apparently inadequate member size. Building engineer is required to check the connection adequacy for uplift forces as part of EA and prepare a remediation plan.

| Item No. | Observation | Recommended Action Plan | Recommended Timeline |
|---|---|---|---|
| 09 | Apparently non engineered shed (Kitchen shed, Jhute Store Shed) | Building engineer is required to check the connection adequacy for uplift forces as part of EA and prepare a remediation plan. | 6-weeks |
| 10 | Apparently non engineered shed (Kitchen shed, Jhute Store Shed) | Carry out the remedial works if required. | 6-months |
