Union Label & Accessories Ltd.

Baniarchala, Bhabanipur, Gazipur Sadar, Gazipur.

10 April 2023, 14 May 2023 & 06 June 2023

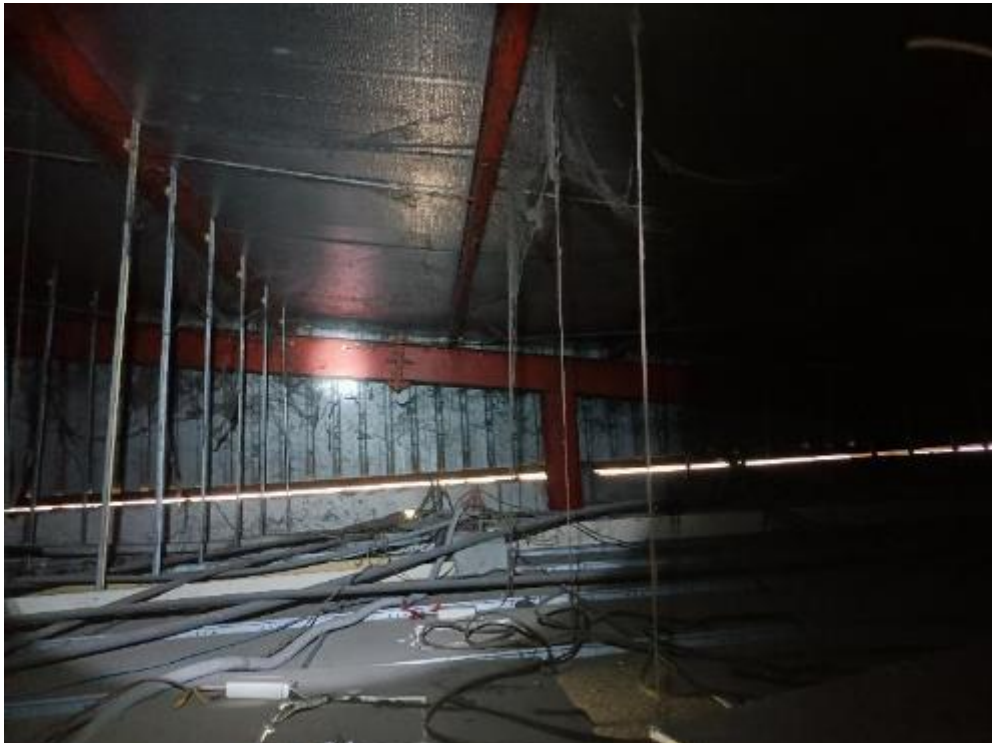
In the provided as-built drawing no details were found for the jack beam, tie beam and strut member. On the other hand, flange bracing were found missing on grid 11, 12, 13. The building engineer is required to update the drawings providing the details of all structural member.

Rafter without flange bracing

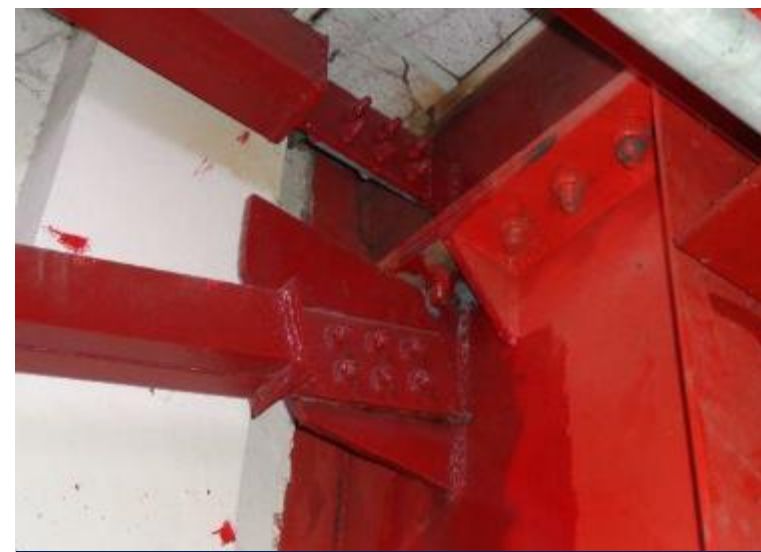
Strut and bracing

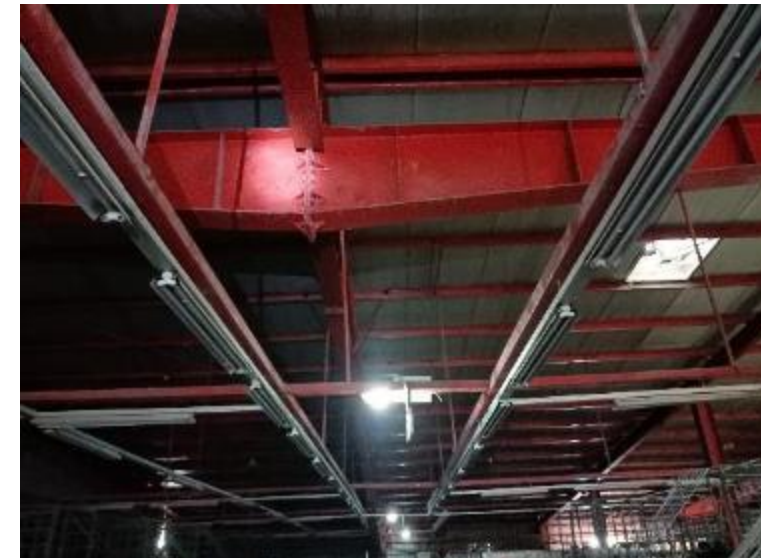
Jack Beam

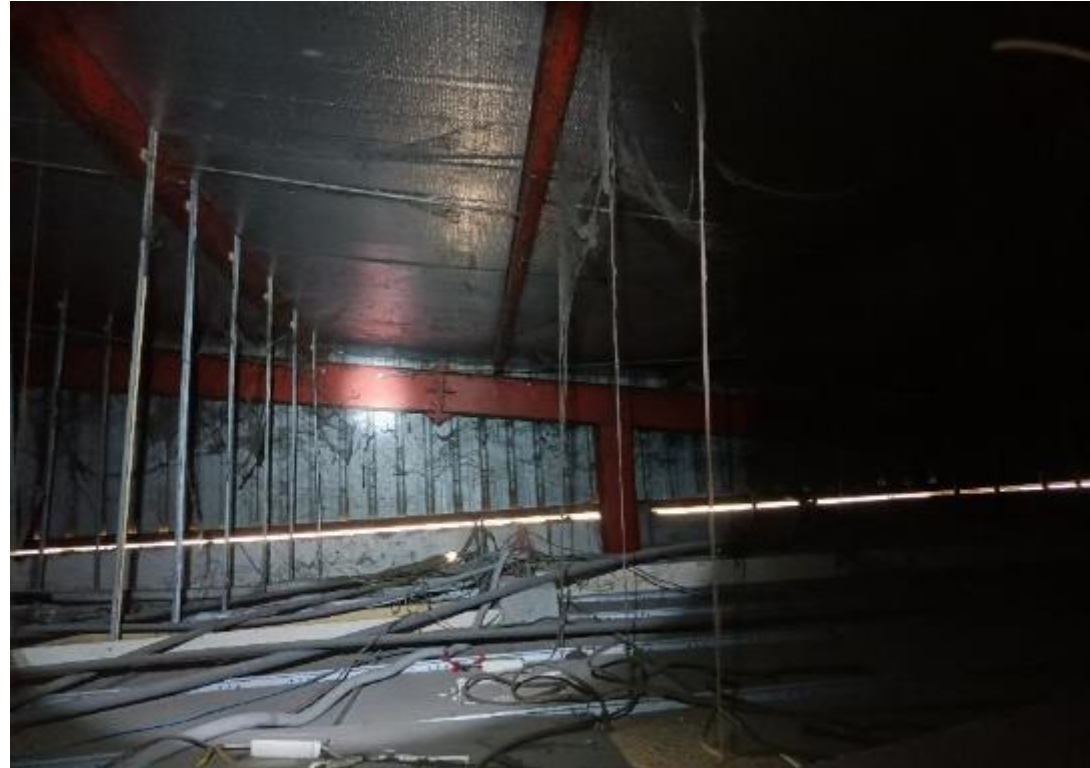
As per the recommendation of prepared EA the factory carried out the retrofitting work except the grid 11, 12 and 13. Additional flanges were not fully added to the rafter of grid 11, 12 and 13.

Rafter of grid 13

Prepared EA required to revise as per updated drawings and submit along with retrofitting drawings to RSC. Remedial works must be carried after getting acceptance of EA from RSC.

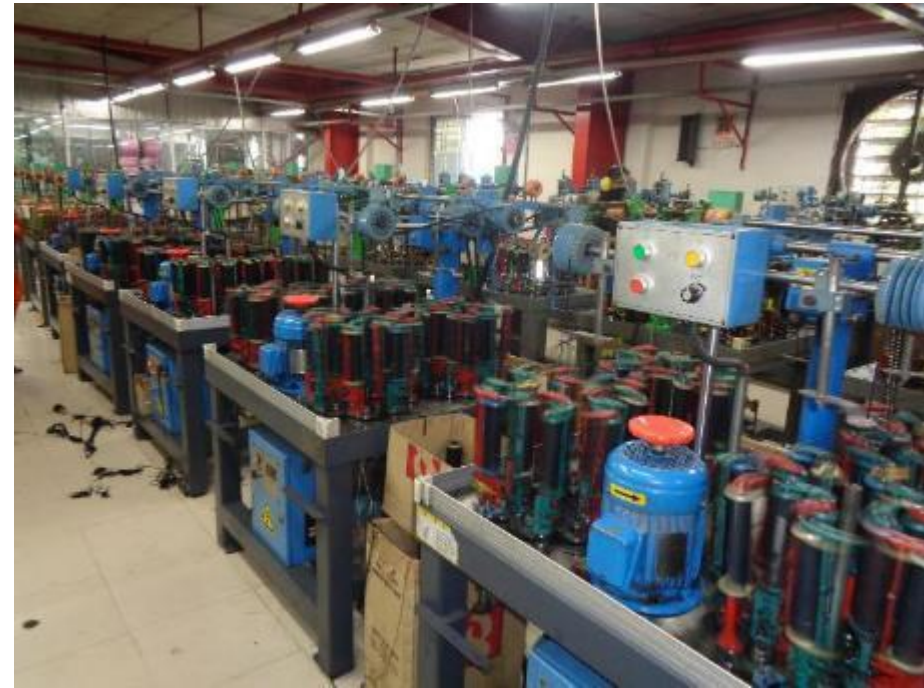
Vibration observed at the first floor

During inspection, significant vibration was observed at the first floor of the Main Shed due to the spinning machine's operation. Building engineer is required to measure the vibration and to investigate whether the vibration is impacting the structure or not and to take proper measure accordingly.

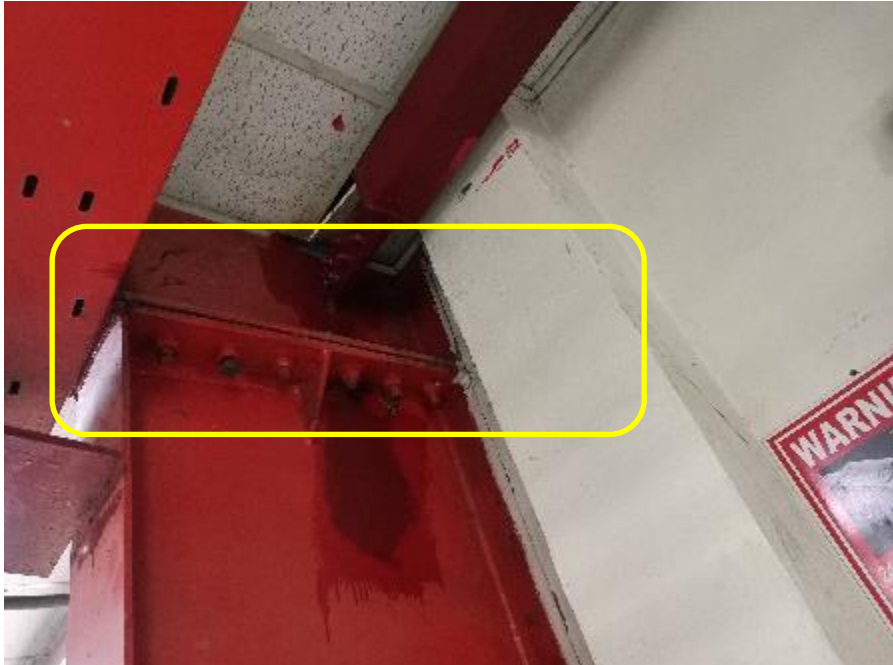
Significant gaps were observed in Rafter-column joint at several locations. Also, loose cable bracings were found. Building engineer is required to carry out suitable remedial works for the gap and tighten the loose bracing where necessary.

Gap observed in connections

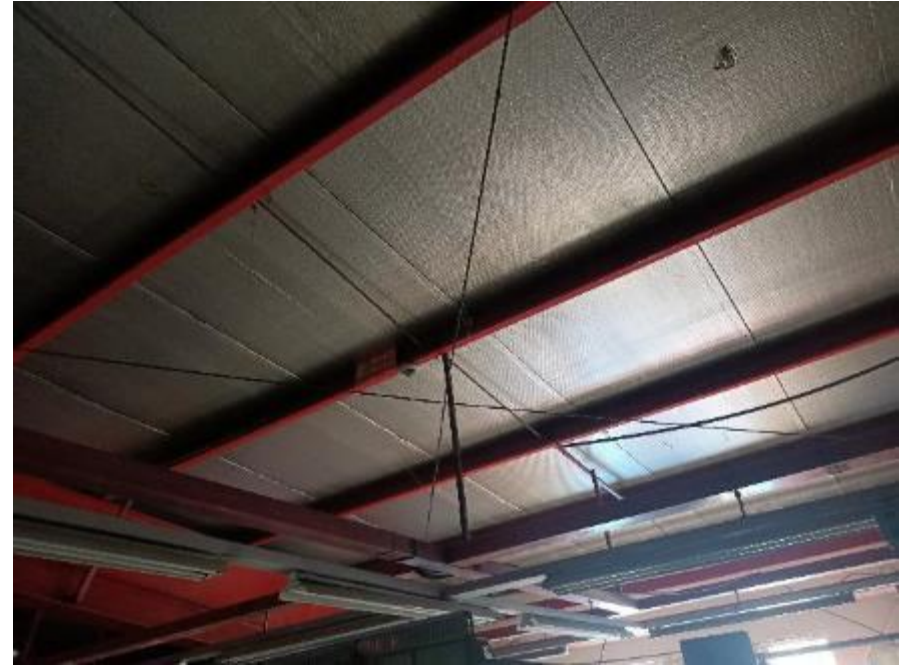
Loose cable bracing

07	Significant connection gap and loose bracing. (Main Shed)	Tighten the loose bracing where necessary.	6-weeks

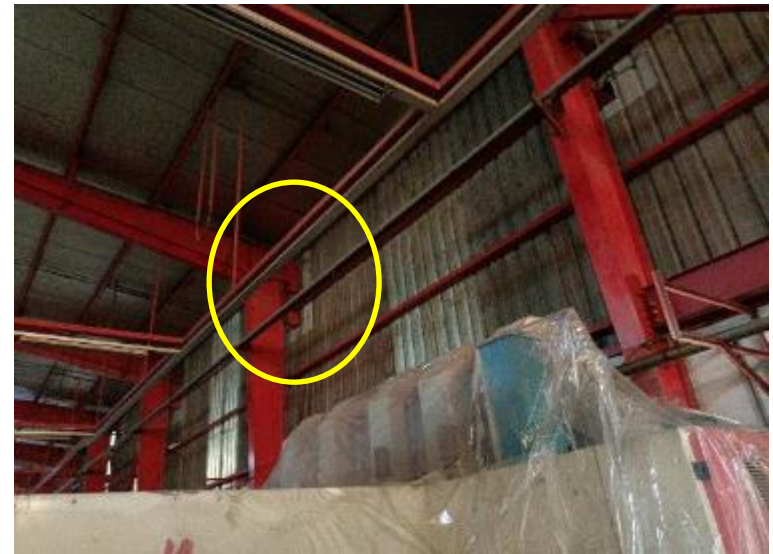
Sectional details of Grid D, E, F & G and corbel beam details were found missing in the provided as-built drawings. On the other hand, bracing layout were not matched with the as-built condition. The building engineer is required to update the drawings providing the details of all structural member.

Corbel beam

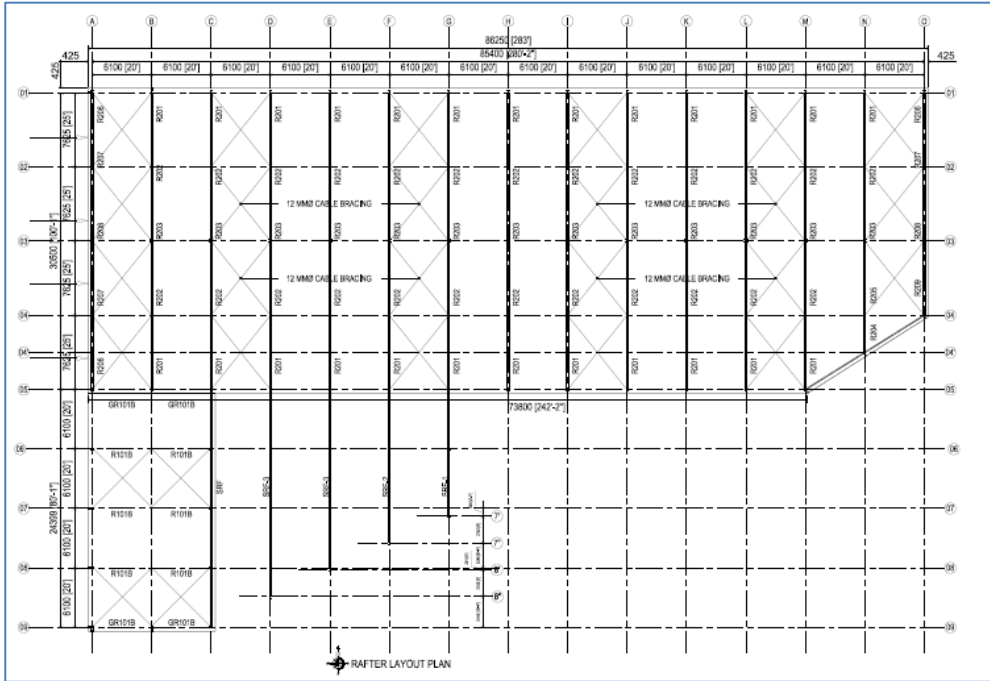
Rafter without flange bracing

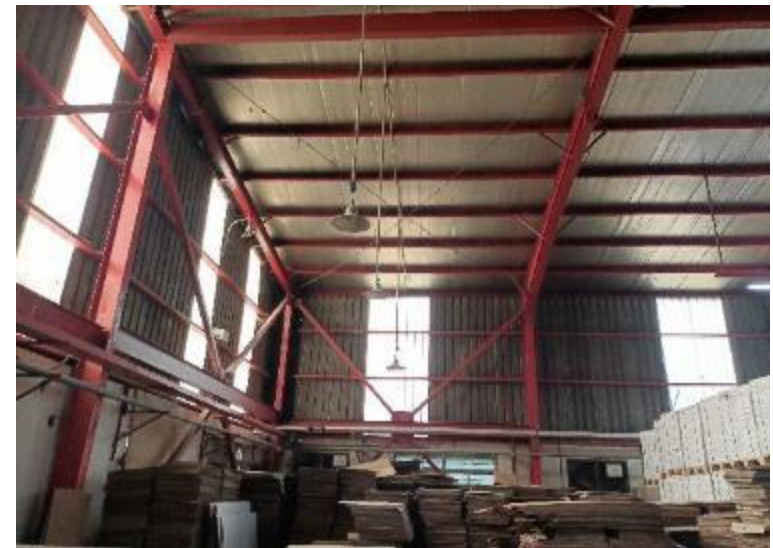
Bracings

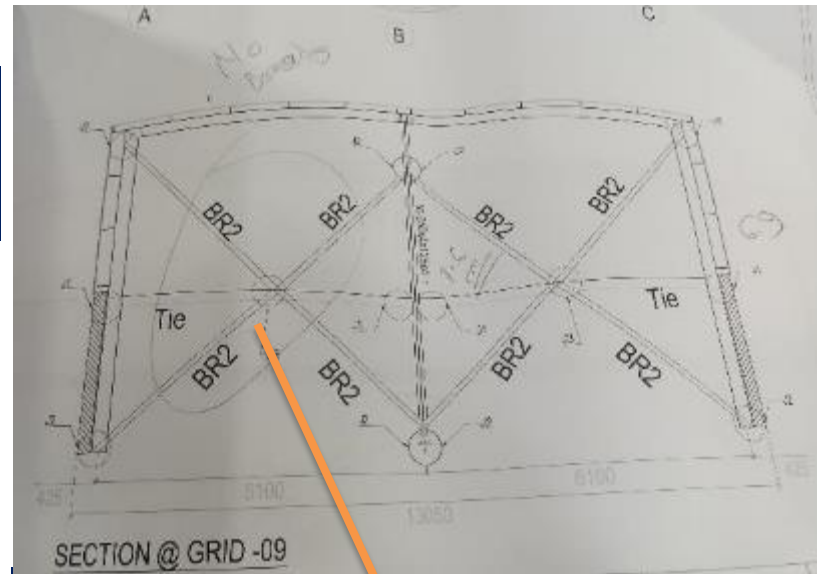
Vertical bracings were found missing at southside of the shed. On the other hand, compression strut were not observed at south part of the shed.

Bracing details

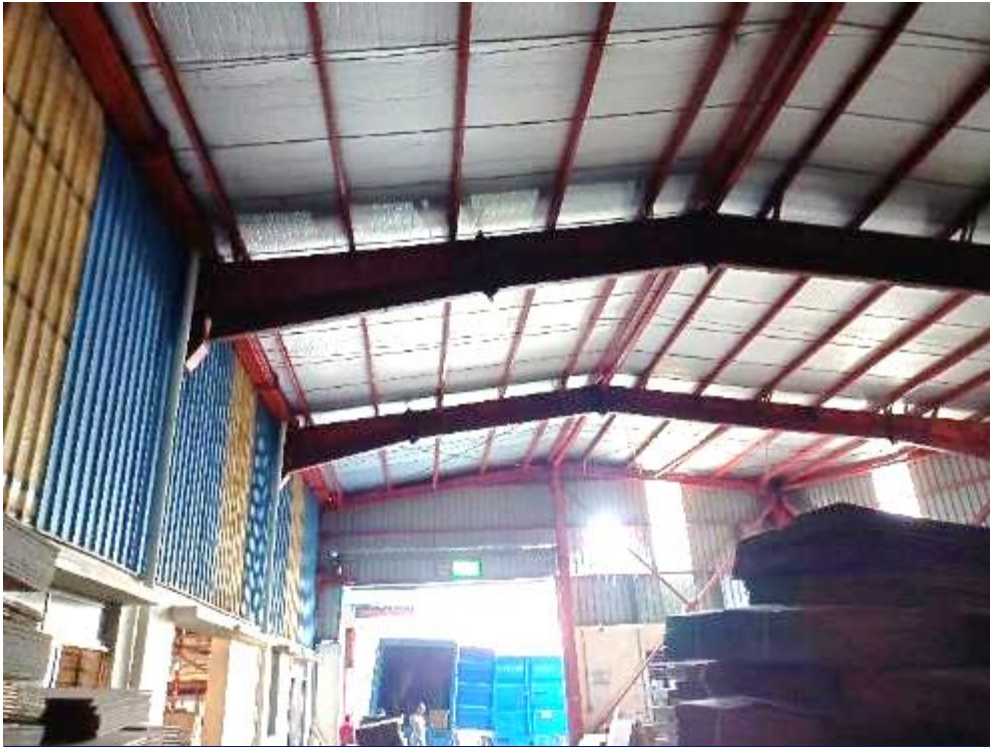
No-compression strut

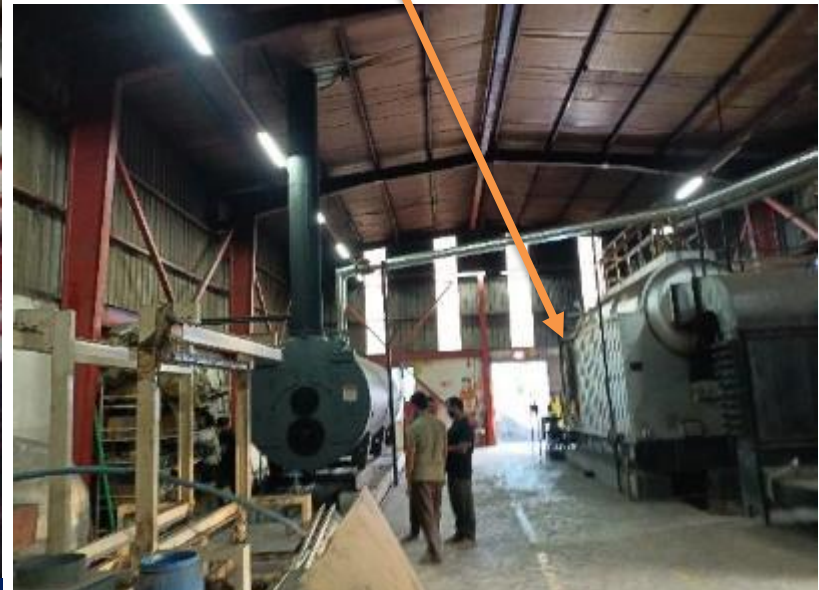
Missing bracings

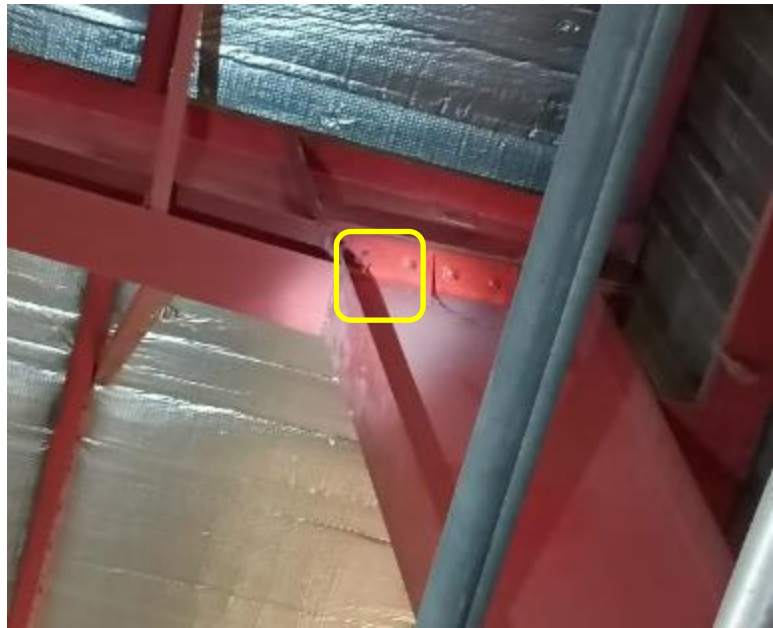
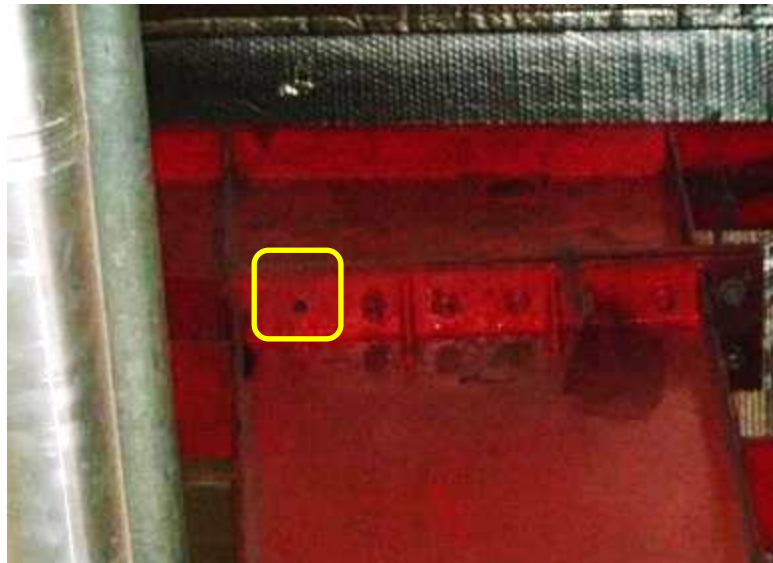
Significant gaps observed in column-bracing joint at several locations. Also, bolt missing found in rafter-column joint. Building engineer is required to carry out suitable remedial works for the connection gap and install the missing bolt.

Gap observed in connections

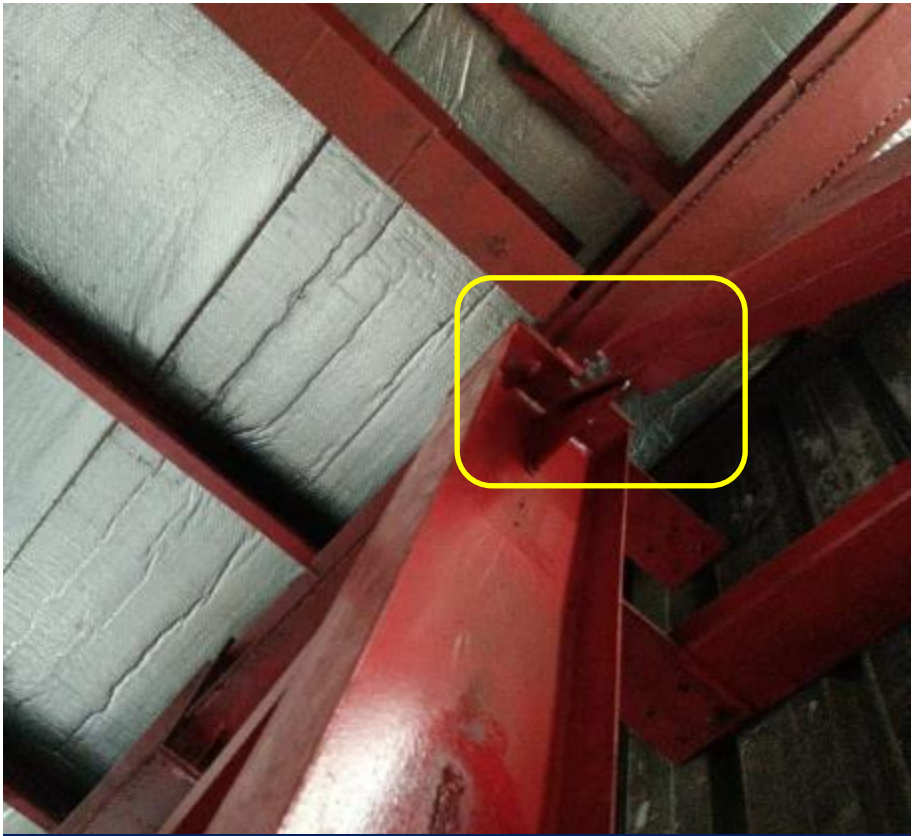
Bolt missing

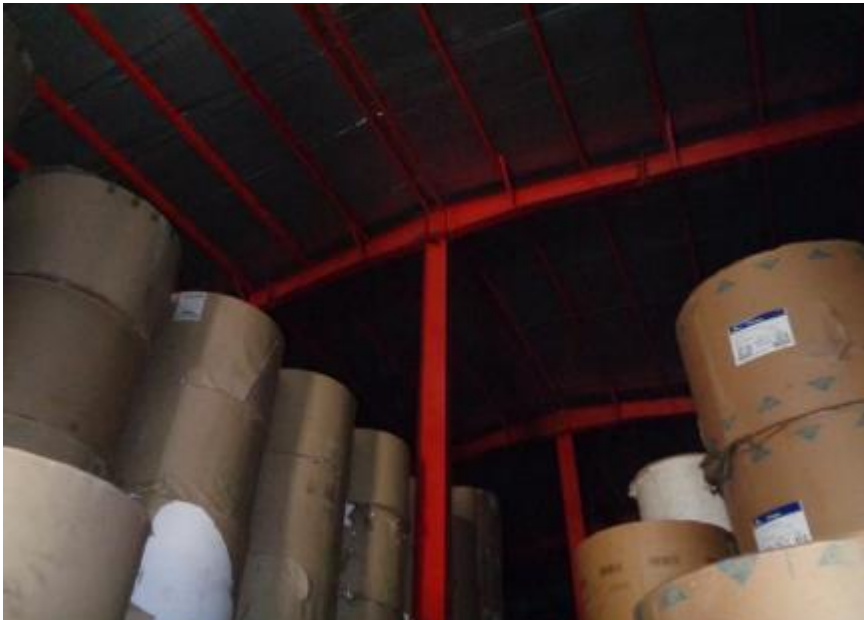
Bonded Warehouse-2

Roof and wall bracing are provided but load transfer media is not provided along long direction for this shed. Therefore, lateral stability system of the shed is apparently incomplete. Building engineer is required to check the lateral stability of the structure.

No load transfer media is provided along long direction
Bonded Warehouse 1 & 2

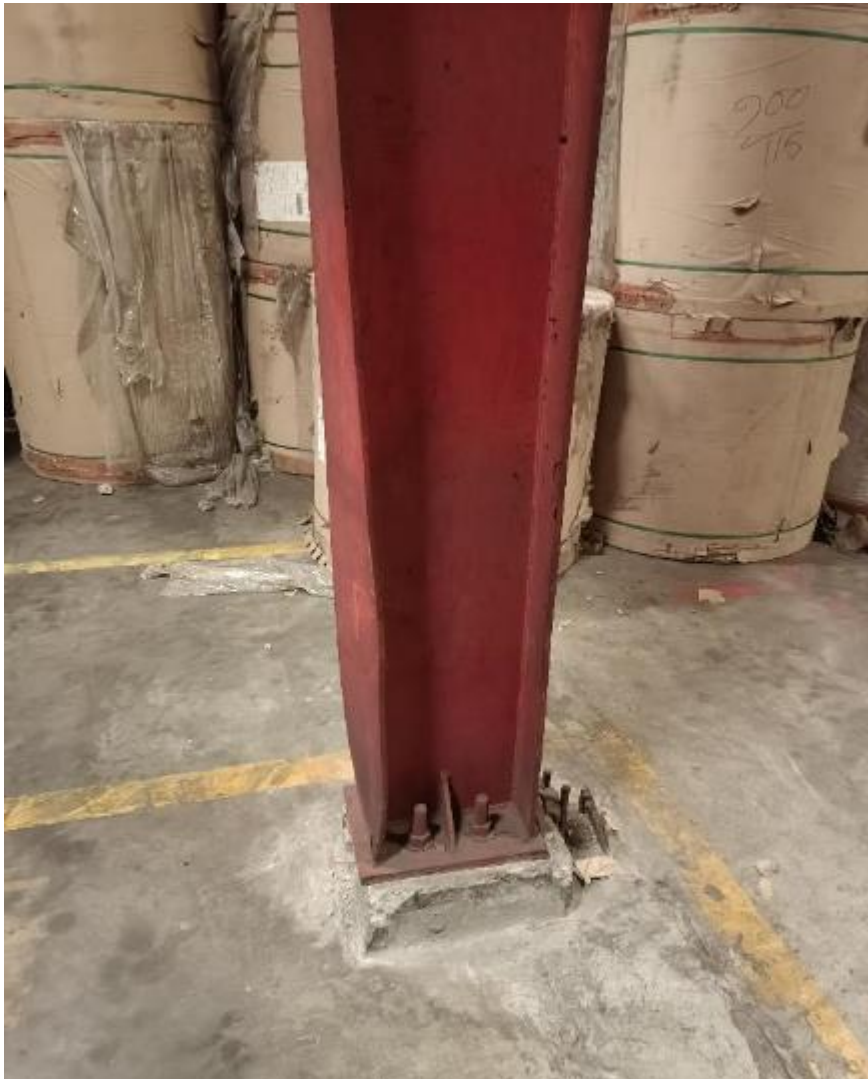
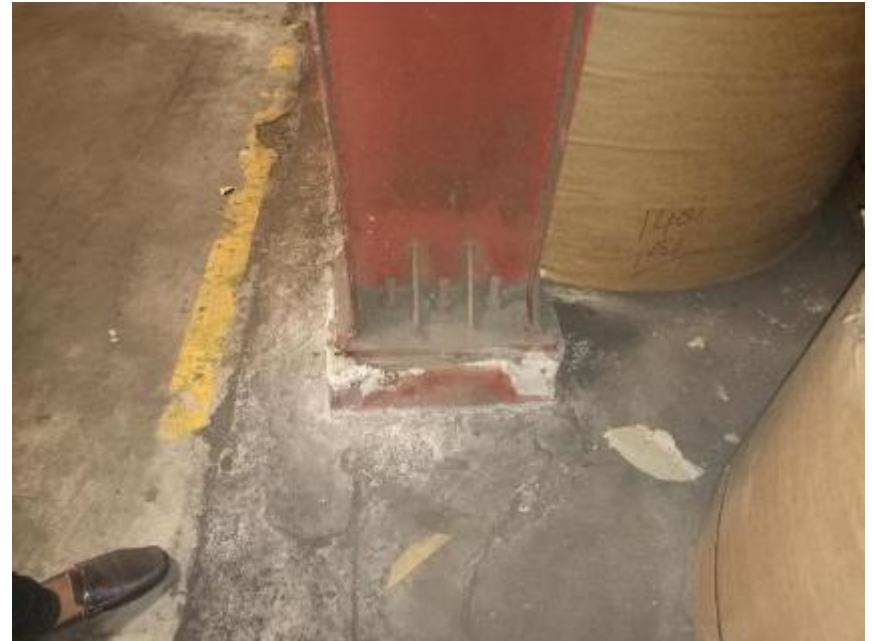
Effected Column

Sign of damage due to vehicle impact on steel column. Impact protection not provided to columns at floor area of Bonded Warehouse-1. Columns are susceptible to impact loading from vehicles.

Item No.	Observation	Recommended Action Plan	Recommended Timeline
14	Incomplete lateral stability system. (Bonded Warehouse Shed 1 & 2)	Implement remediation work if required.	6-months
15	Columns susceptible to vehicle impact. (Bonded Warehouse Shed 1)	Install a barrier to prevent vehicle impact in column.	6-weeks
16	Columns susceptible to vehicle impact. (Bonded Warehouse Shed 1)	Repair the damaged column as per recommendation by factory engineer.	6-weeks
17	Connection gap at joint. (Bonded Warehouse Shed 1 & 2)	Building engineer is required to repair the gap in connections with a suitable method.	6-weeks
18	Retrofitting design requires detail review. (Manual Carton Shed)	The factory is required to submit the Engineering Assessment (EA) to the RSC for detail review.	6-weeks
19	Retrofitting design requires detail review. (Manual Carton Shed)	Carry out remedial action if required.	6-months
20	Tie beam missing. (Manual Carton Shed)	Install the missing tie beam as per drawing after getting acceptance from RSC.	6-weeks

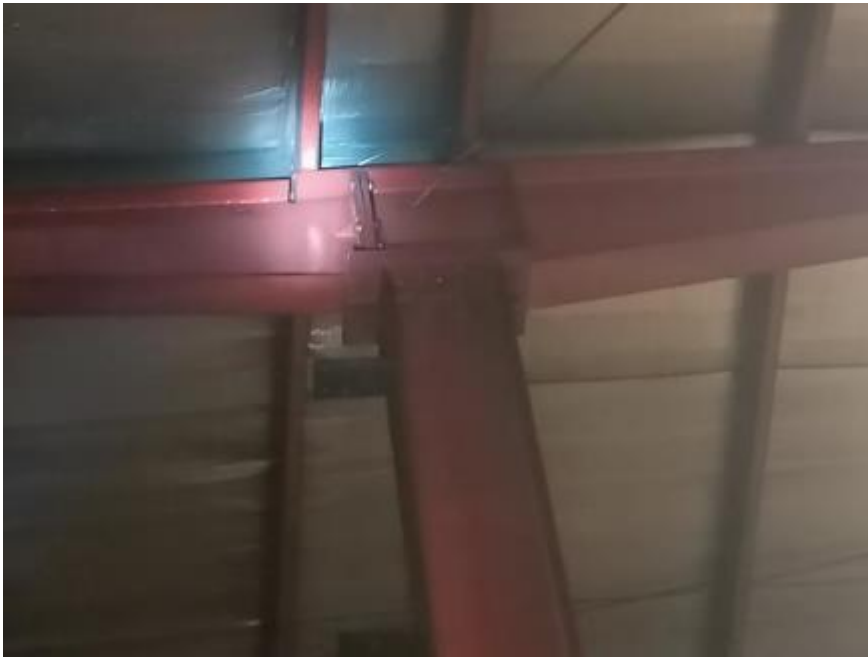
Significant gaps observed in Rafter-column joint at several locations. Building engineer is required to carry out suitable remedial works.

Gap observed in connections
Bonded Warehouse -1

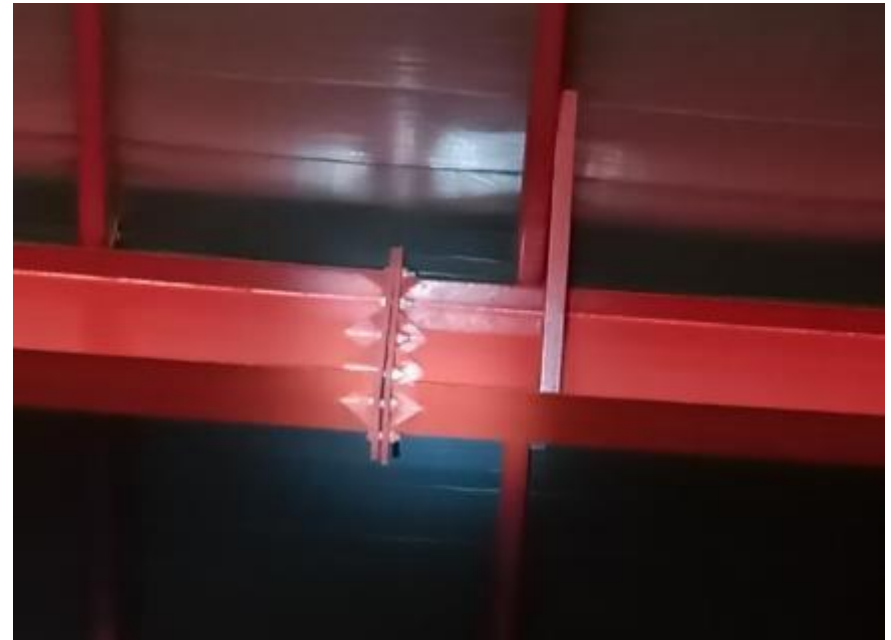
Gap observed in connections
Bonded Warehouse -2

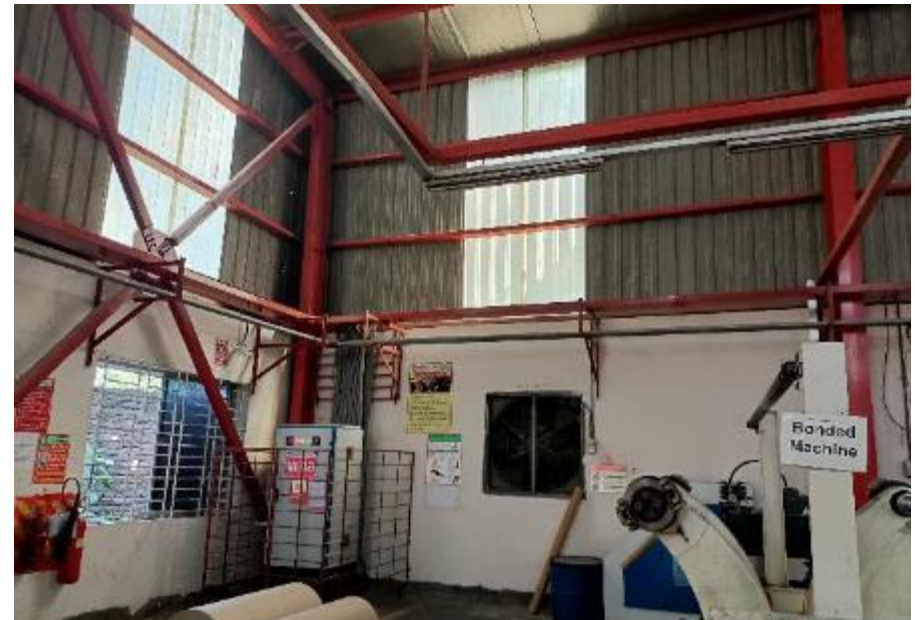
Steel tie beams were found missing at east side of Shed as per the retrofitting drawing. Building engineer is required to install the missing bracing as per the accepted drawings.

Missing tie beam

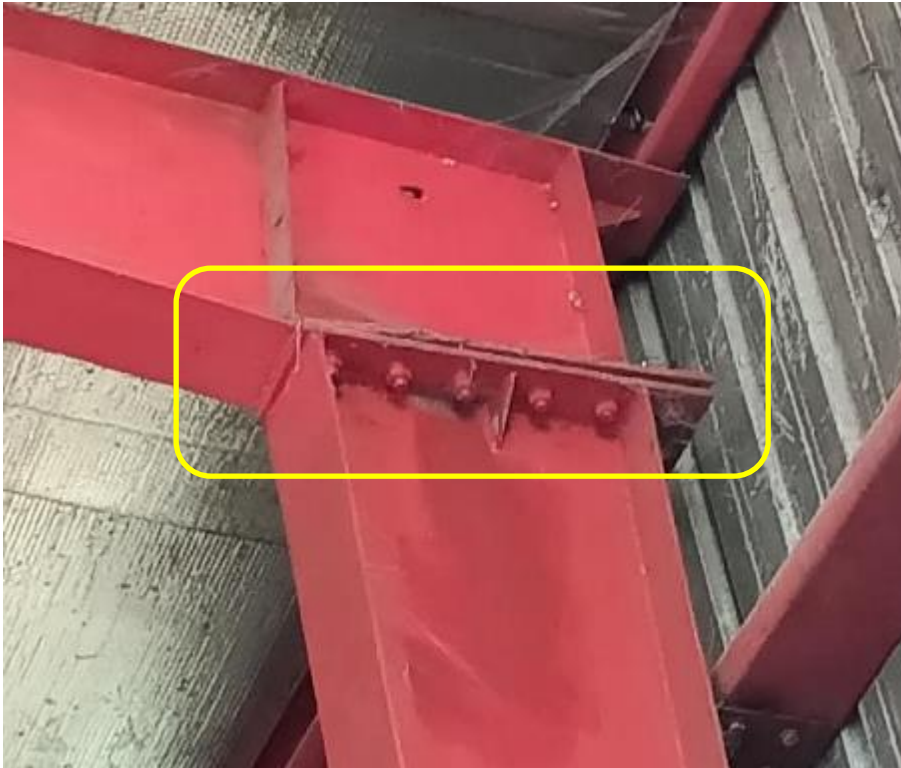
Significant gaps observed in Rafter-column joint at several locations. Building engineer is required to carry out suitable remedial works.

Gap observed in connections

Item No.	Observation	Recommended Action Plan	Recommended Timeline
21	Significant connection gap. (Manual Carton Shed)	Building engineer is required to repair the gap in connections with a suitable method.	6-weeks
22	Absence of design documents. (Utility Building)	Building engineer is required to prepare the design documents including a design report, and a set of structural drawings in compliance with section 1.9.1.1 and section 1.9.1.2, part-6 of BNBC and submit it to RSC for review.	6-weeks
23	Absence of design documents. (Utility Building)	Carry out remedial works (if any) after reviewed by the RSC.	6-months
24	Lack of design documents. (Bonded Warehouse Shed-3)	Building engineer is required to prepare the design documents including a design report, and a set of structural drawings in compliance with section 1.9.1.1 and section 1.9.1.2, part-6 of BNBC and submit it to RSC for review.	6-weeks

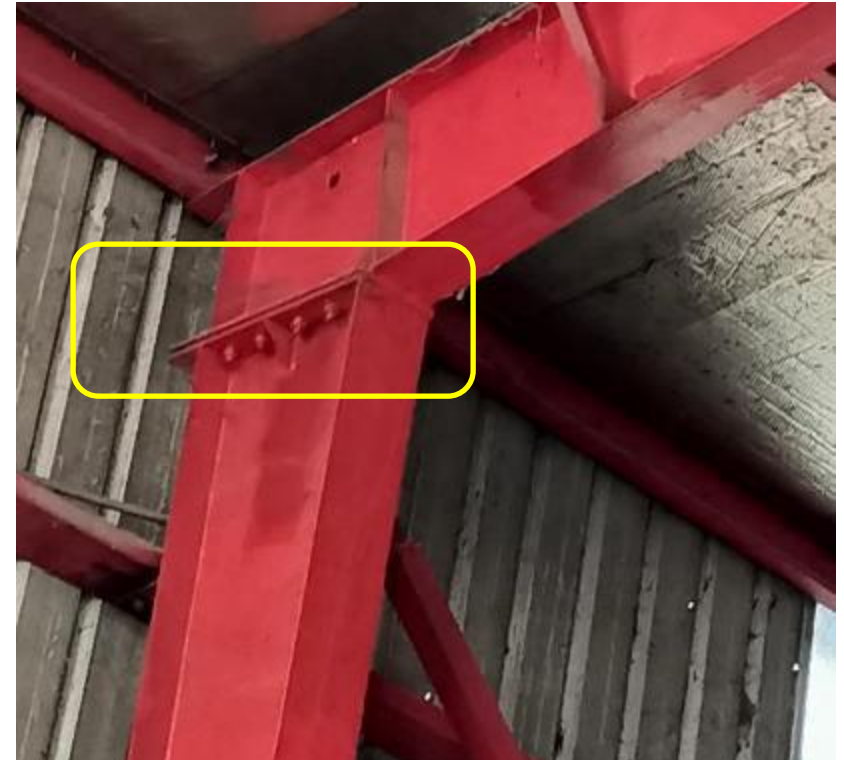
Gap observed in connections

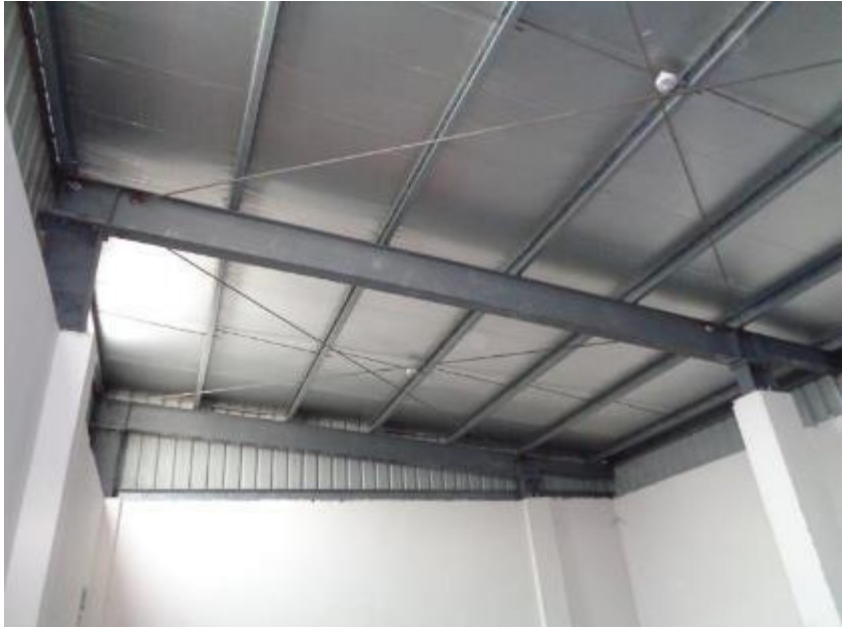
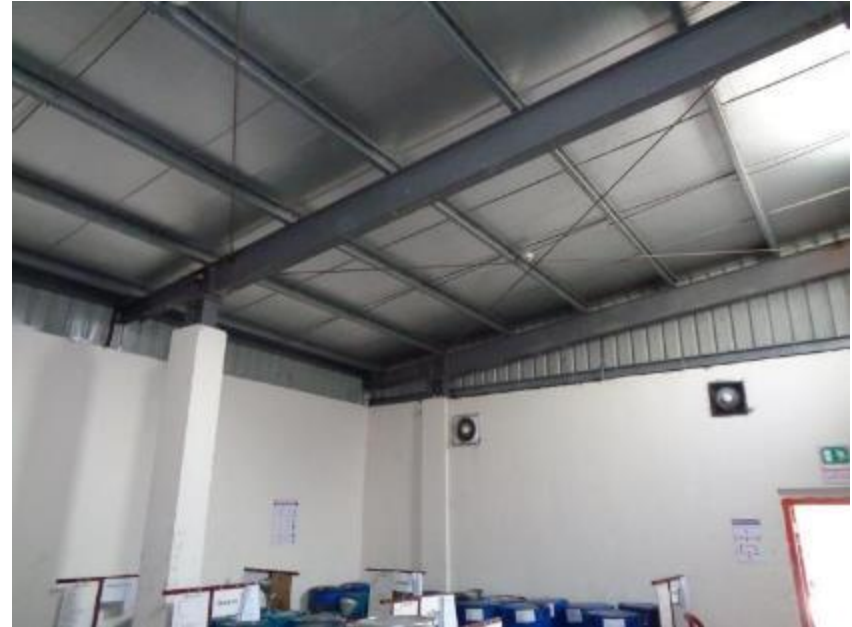
No load transfer media is provided along long direction

Only roof bracings are provided but load transfer media is not provided along long direction for this shed. Therefore, lateral stability system of the shed is apparently incomplete. Building engineer is required to check the lateral stability of the structure.

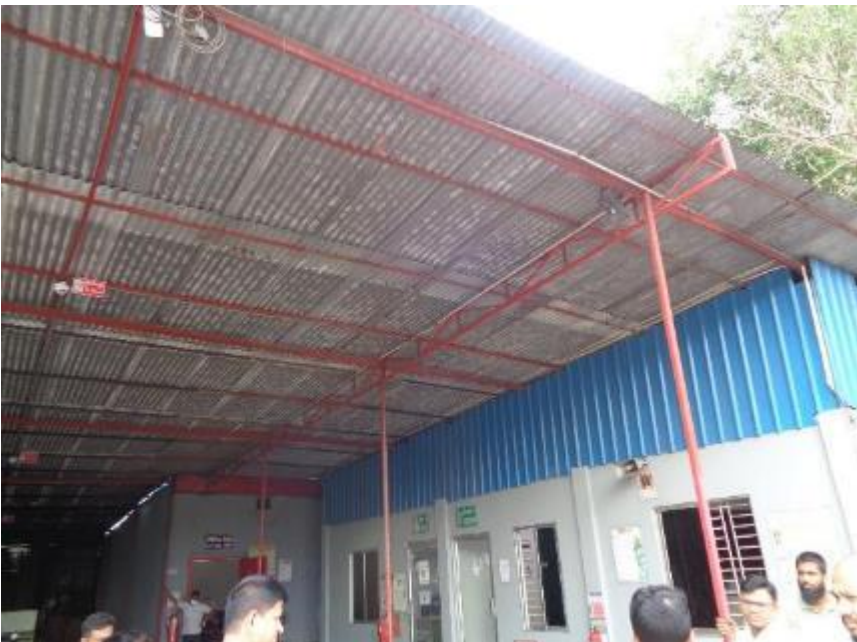
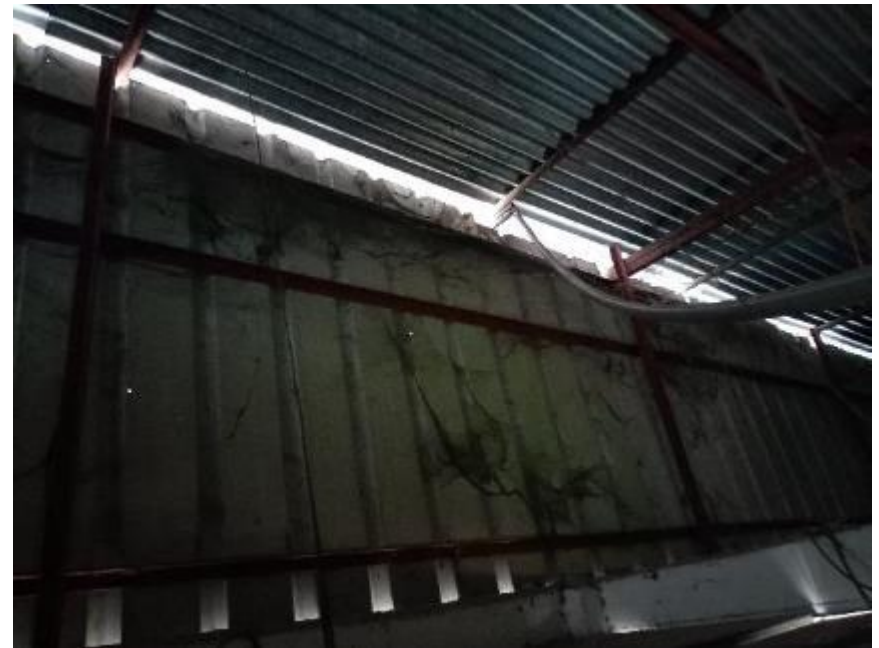
Apparently Inadequate structural member, poor connection details were found. Building engineer is required to check the adequacy of the steel members & connection for uplift and lateral forces otherwise replace with engineered structure.

Apparently inadequate connection

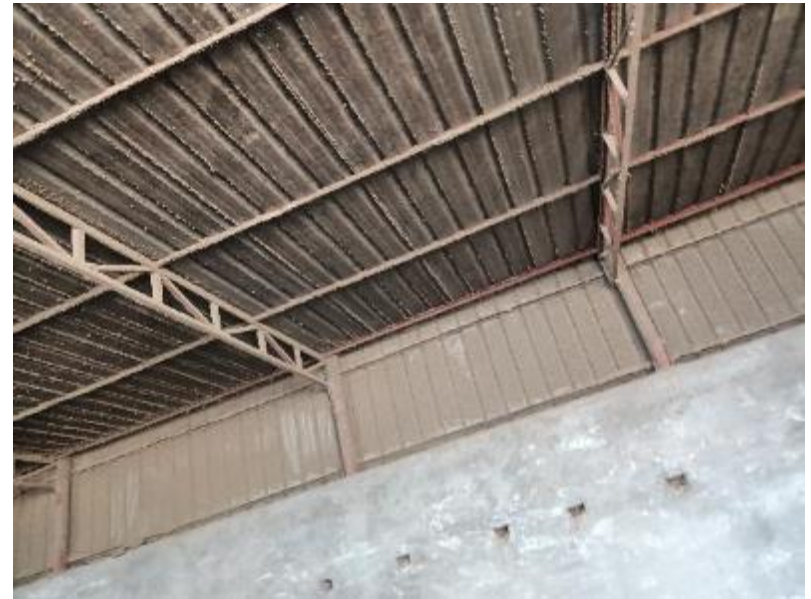
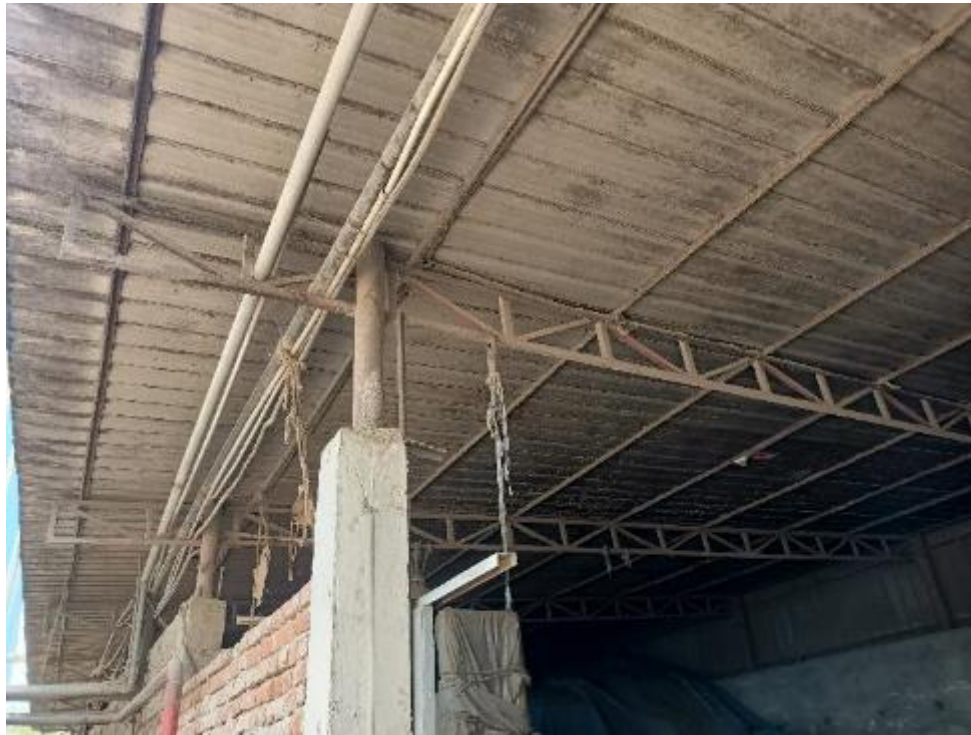
Type of truss, member details and support conditions were not matched with as-built condition. The factory engineer is required to survey the whole structure and prepare full set of as-built drawing in compliance in compliance with section 1.9.1.2, part-6 of BNBC.

Truss section

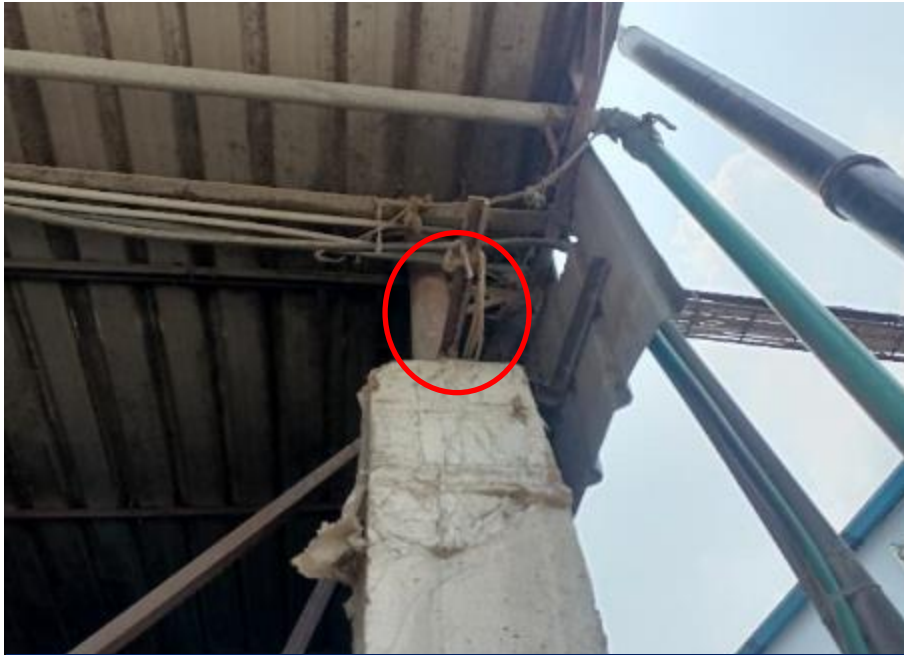
Truss connection with Steel column

Apparently inadequate connection between truss and Steel pipe column was observed. On other hand connection details or proper drawings were not found on site. The building engineer is required to check the connection adequacy of the truss against uplift force of wind.

Item No.	Observation	Recommended Action Plan	Recommended Timeline
32	Apparently inadequate connection on truss. (Wastage Shed)	Building engineer is required to check the connection adequacy for uplift forces as part of EA otherwise replace with well designed structure.	6-weeks
33	Apparently inadequate connection on truss. (Wastage Shed)	Implement remediation work where required.	6-months
34	Lack of drawing for steel part. (Poly Recycle Shed)	Building engineer is required to prepare a full set of structural drawings in compliance with section 1.9.1.2, part-6 of BNBC and submit it to RSC for review.	6-weeks
35	Apparently inadequate connection. (Poly Recycle Shed)	Factory is required to carry out the Engineering Assessment (EA) to check connection adequacy against the uplift force.	6-weeks
36	Apparently inadequate connection. (Poly Recycle Shed)	Carryout remedial work if required.	6-months
37	Lack of drawing. (Security & Fire Pannel Room 2)	Building engineer is required to prepare a full set of structural drawings in compliance with section 1.9.1.2, part-6 of BNBC and submit it to RSC for review.	6-weeks

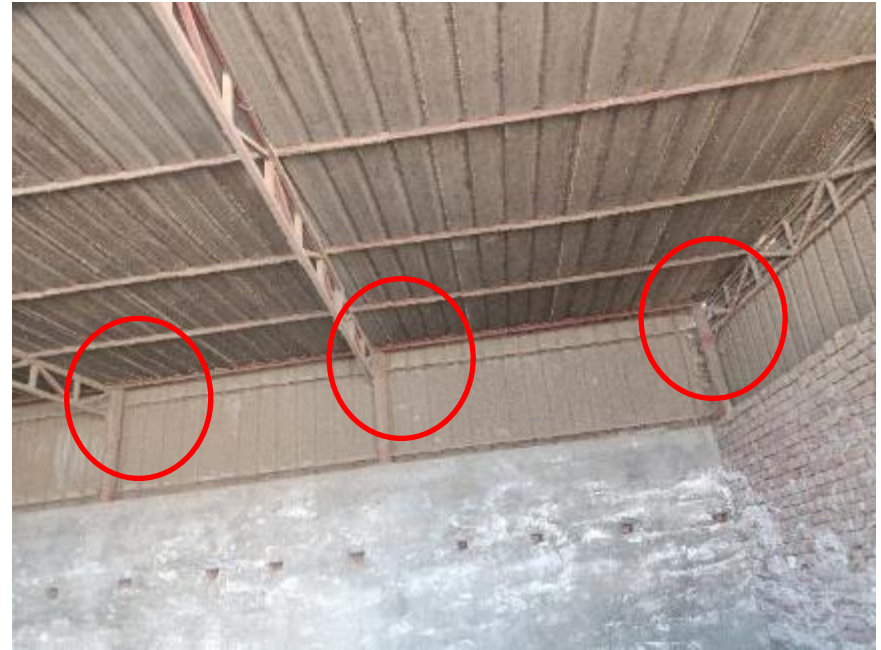
Truss connection with steel column

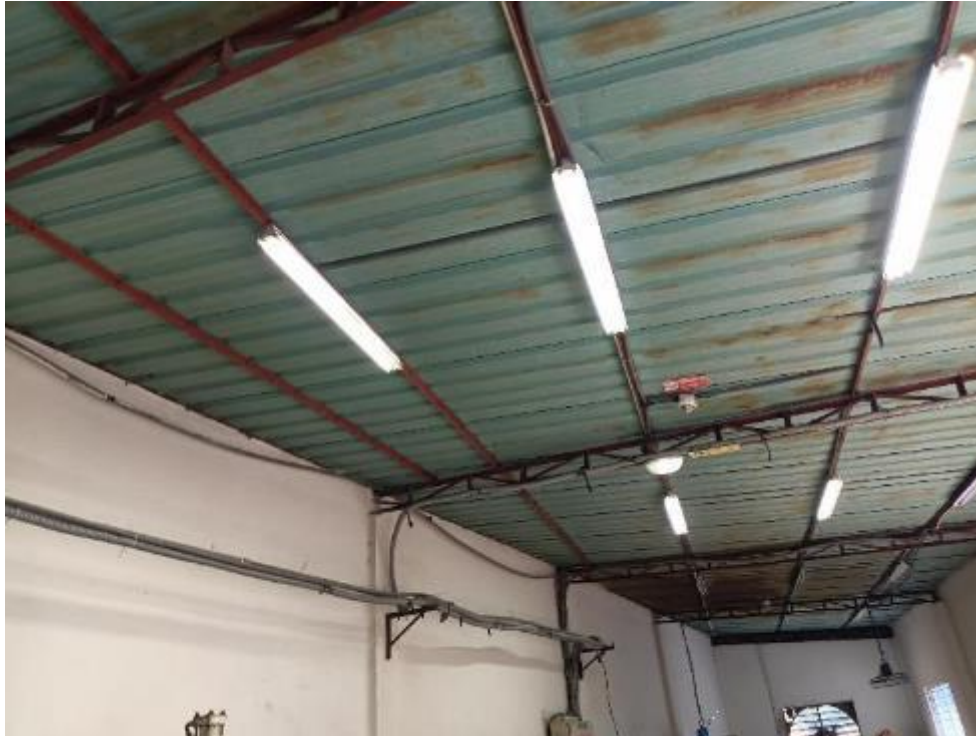
Inside of Poly Recycle Room

Proper as-built drawing was not available for the Poly Recycle Room. Only a section and elevation was provided for the shed but not matched with the onsite condition.

The building engineer is required to survey the whole structure and prepare full set of as-built drawing in compliance in compliance with section 1.9.1.2, part-6 of BNBC.

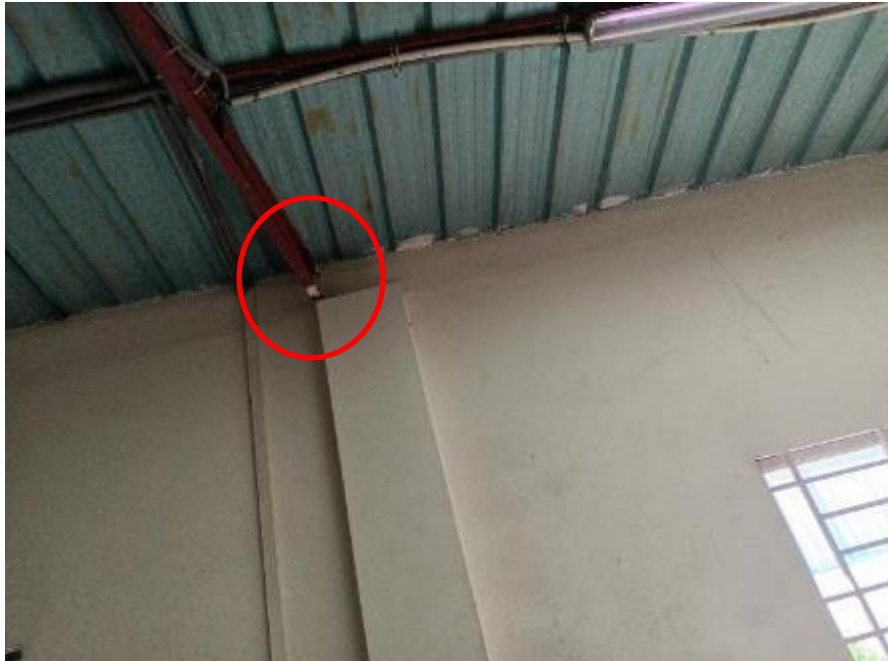
Truss connection with RC column

Apparently inadequate connection between truss and RC column was observed. On other hand connection details or proper drawings were not found on site. The building engineer is required to check the connection adequacy of the truss against uplift force of wind.

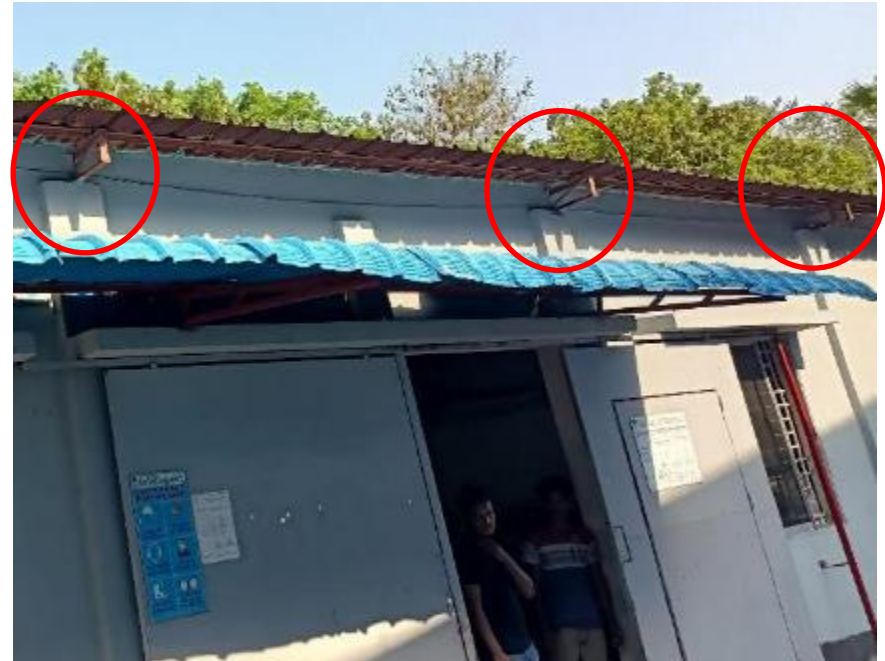
Truss connection with RC column
