Union Label & Accessories Ltd.

Baniarchala, Bhabanipur, Gazipur Sadar, Gazipur.

10 April 2023, 14 May 2023 & 06 June 2023

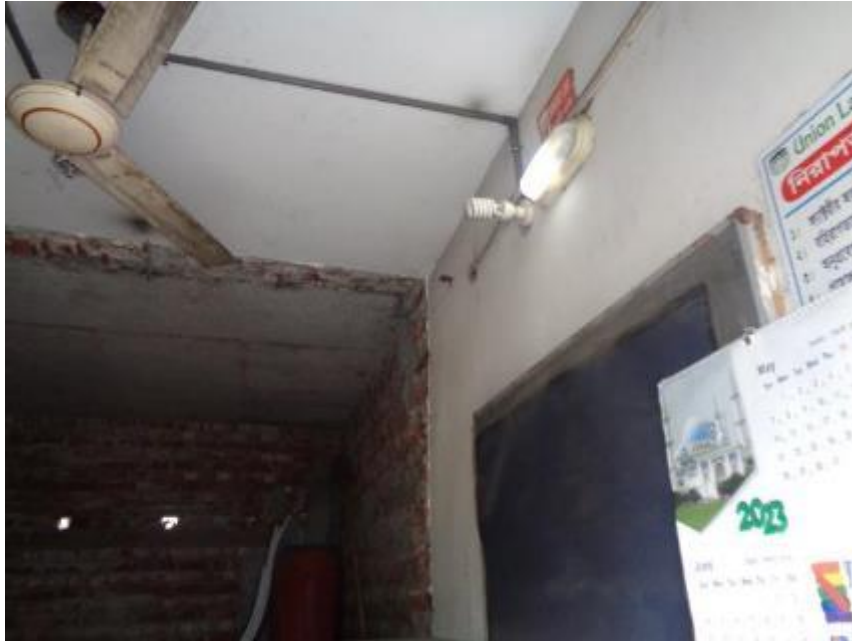
No drawings were found for the Security & Fire Pannel Room 2. The factory engineer is required to survey the whole structure and prepare full set of as-built drawing in compliance in compliance with section 1.9.1.2, part-6 of BNBC.

Inside of Security and Fire Pannel Room 2

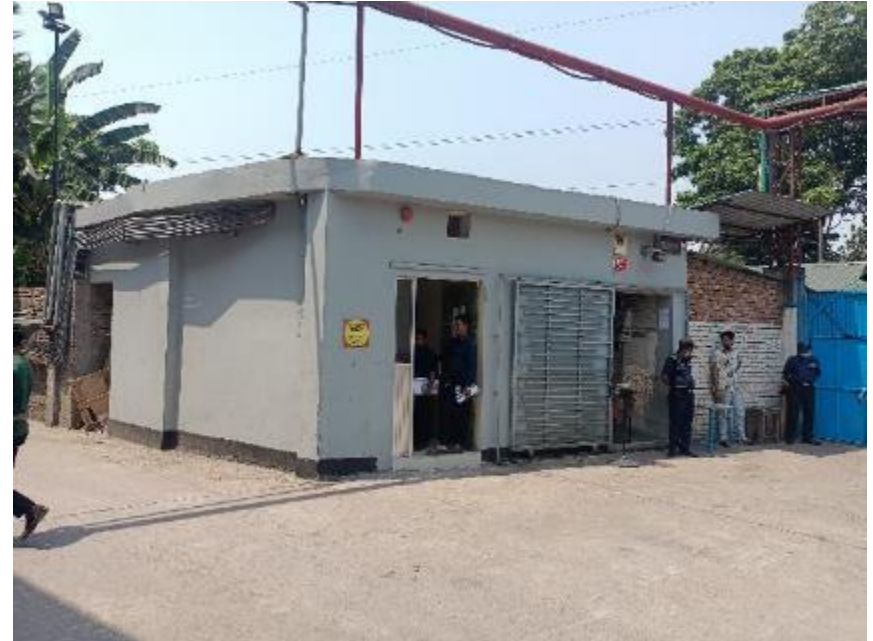
Security and Fire Pannel Room 2
