Hannan Knitwears Limited

555, Rahan Ali Road, North Khaikur Road, National University, Gazipur
(23,945026N, 90,390026E)

17 October 2015

Observations

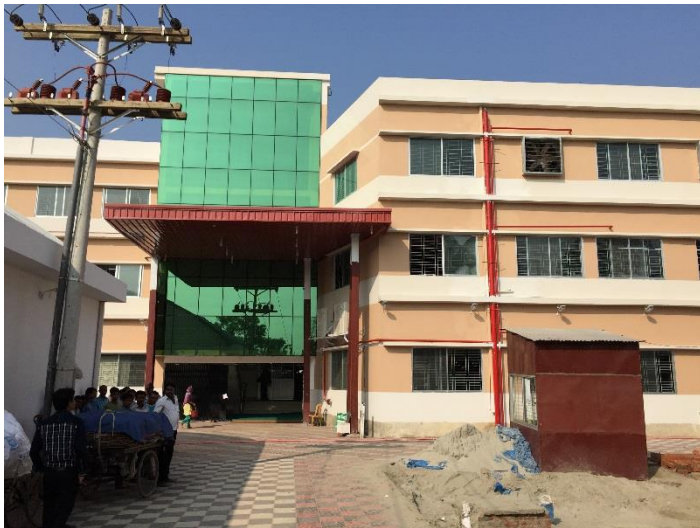
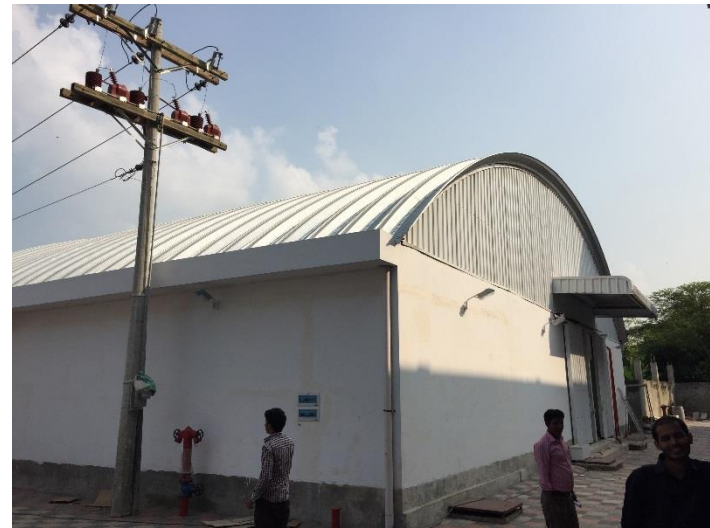
No tie in the arches (21m)

No evidence of calculations of the roof structure

0.8mm metal trapezoidal sheet

ITEM 1: Non engineered Curved Roof to shed Building (B4)

Item No.	Observation	Recommended Action Plan	Recommended Timeline
1	Non engineered Curved Roof to Building (B4)	A Detail Engineering Assessment (DEA) of B4 to be commenced immediately.	Immediate - Now
2	Non engineered Curved Roof to Building (B4)	Building to be evacuated temporarily if high winds are forecast within the 6 week period of carrying out the DEA	Immediate - Now
3	Non engineered Curved Roof to Building (B4)	Detail Engineering Assessment to be completed.	6-weeks
4	Non engineered Curved Roof to Building (B4)	Upgrades as required plus monitoring	6-months
5	Thickness of the flanges and webs appear light (B1)	Building Engineer to verify beam/column sizes for critical sections.	6-weeks
6	Thickness of the flanges and webs appear light (B1)	Carry out any remedial actions required	6-months

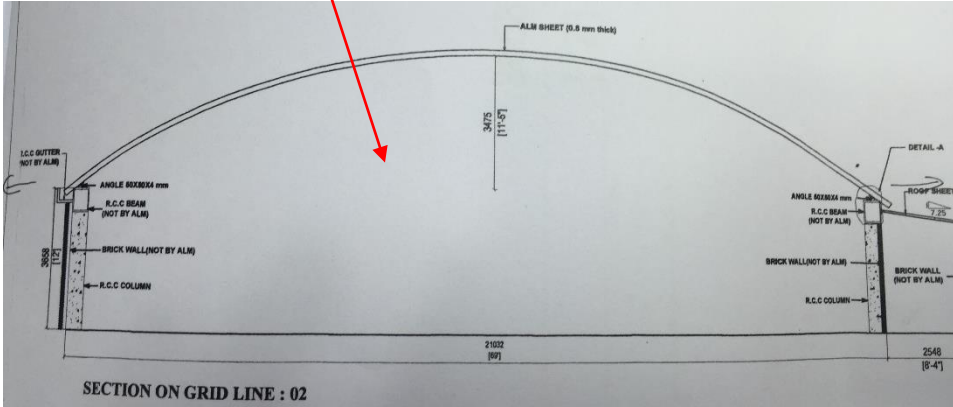
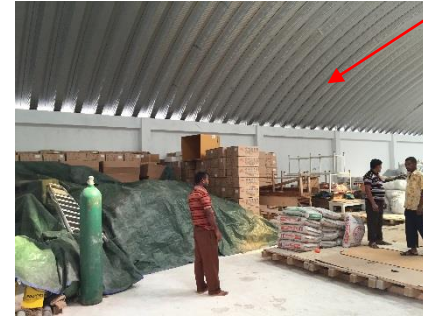
Vertical partition that seems to be touching the roof

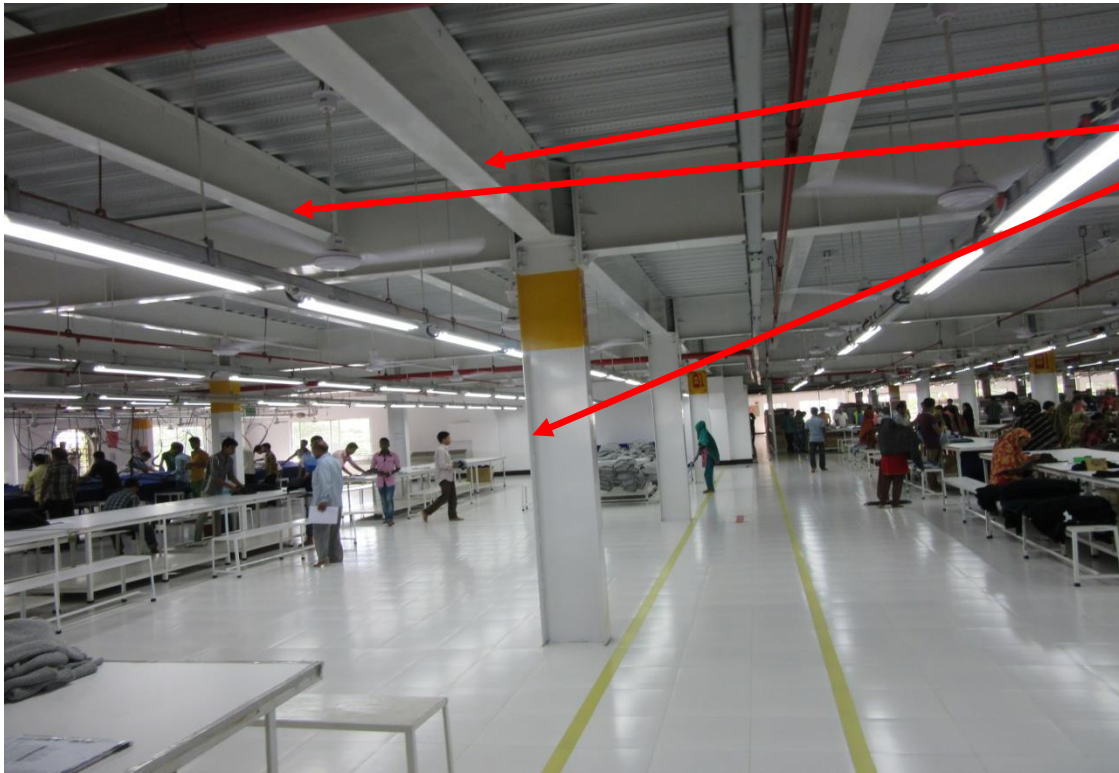
Thickness (flanges and webs):
Main Beam (each floor) - 5mm
Secondary Beams (each floor) - 3mm
Columns (2nd and 3rd floor) - 5mm

ITEM 2: Thickness of the flanges and webs appear light (B1)

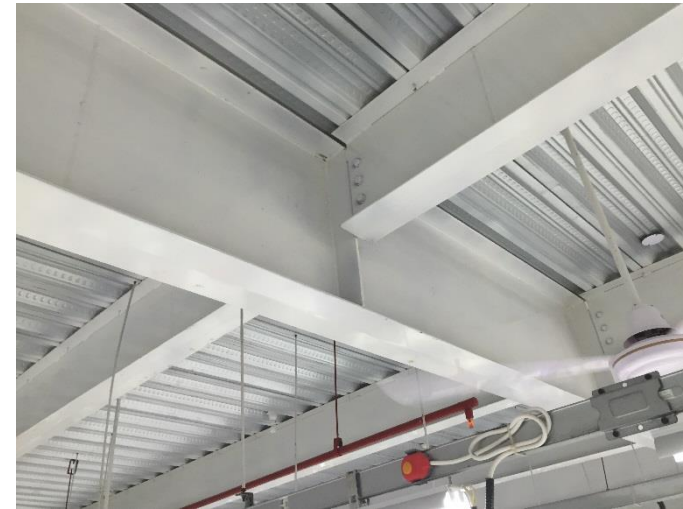
It appears that the steel sections could be affected by lateral torsional buckling effects

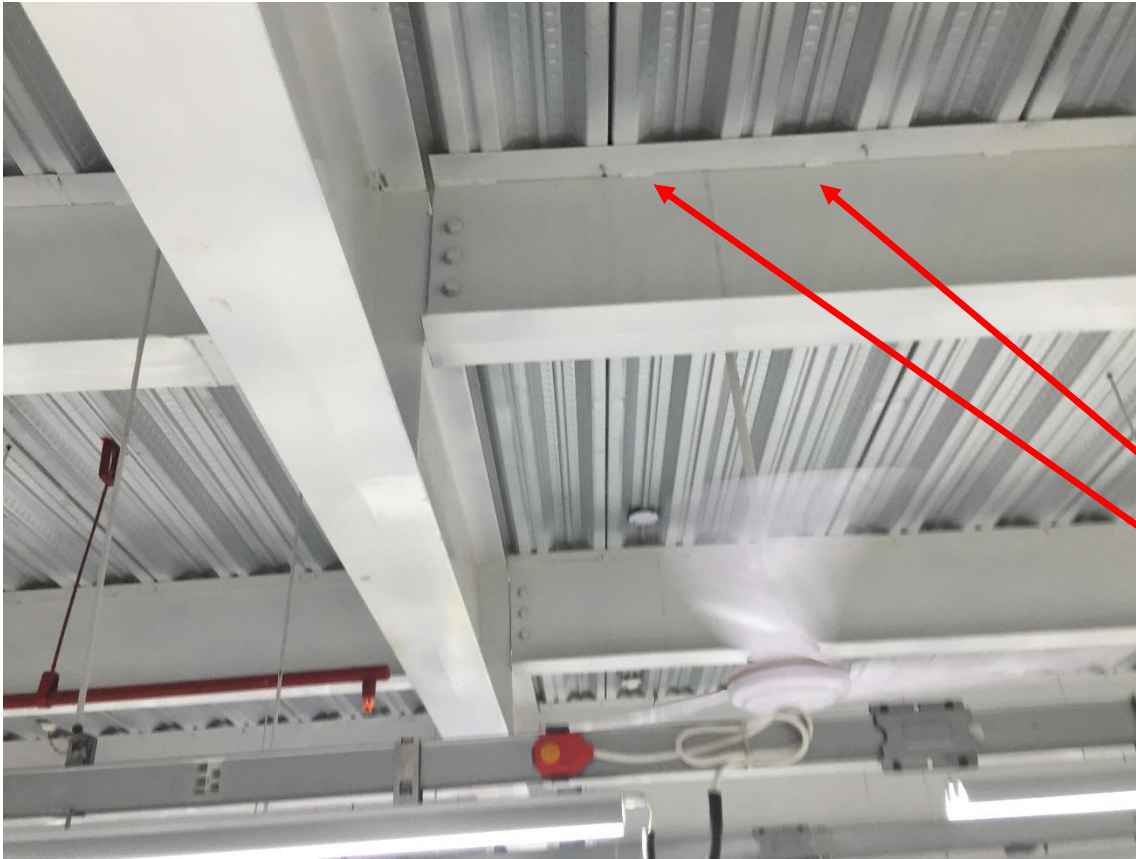
Discontinuous welds in one side (continuous on the other side)

ITEM 3: Welds Non continuous in some beams and columns (B1)

Item No.	Observation	Recommended Action Plan	Recommended Timeline
7	Welds Non continuous in some beams and columns (B1)	Building Engineer to verify beam/column sizes for critical sections and to check the weld details for the plate girders	6-weeks
8	Welds Non continuous in some beams and columns (B1)	Carry out any remedial actions required	6-months
9	Bracing missing	Building Engineer to review requirement for bracing and design for installation if necessary	6-weeks
10	Bracing missing	Carry out any remedial actions required	6-months
11	Poorly constructed canopy	Building engineer to review details at canopy (incomplete baseplate, column constructed out of tolerance) and justify existing by calculation or propose upgrades	6-weeks
12	Poorly constructed canopy	Carry out any remedial actions required	6-months

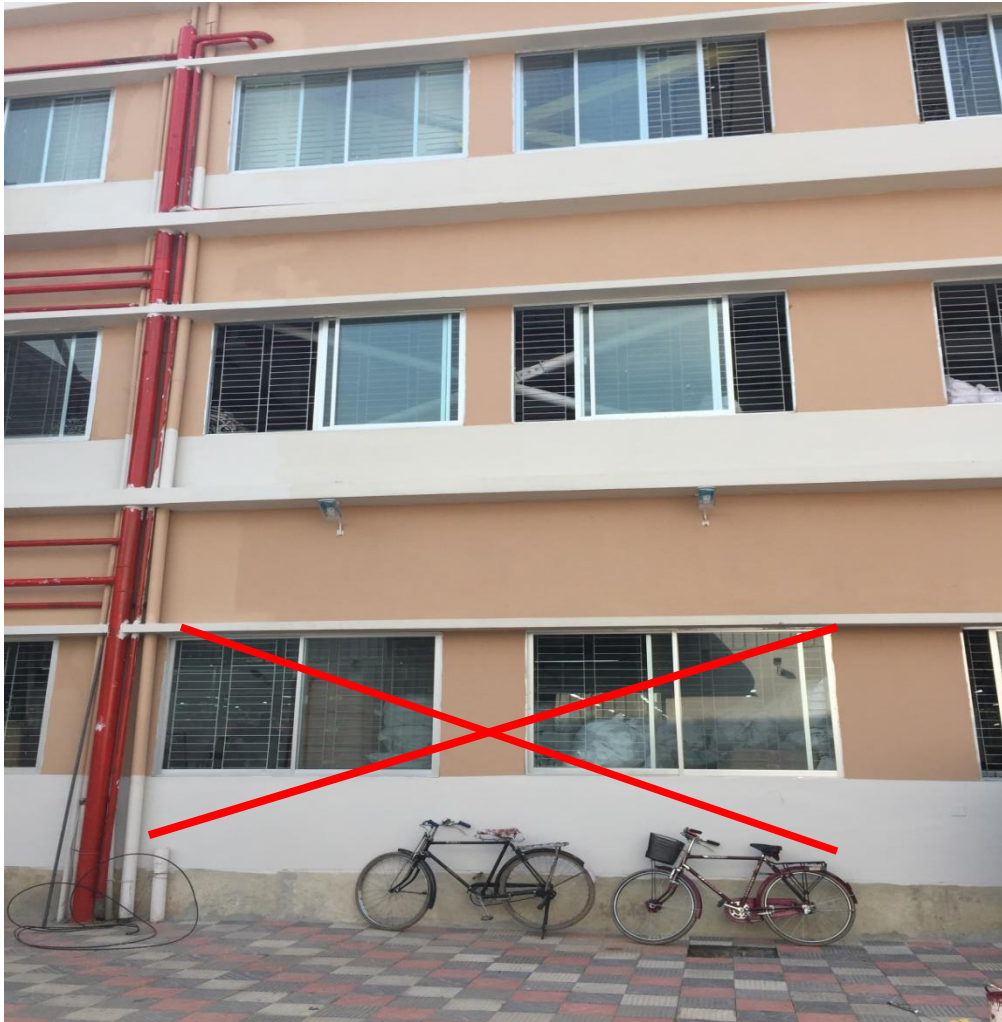
No Cross Bracing at Ground Floor

ITEM 4: Bracing missing (B1)

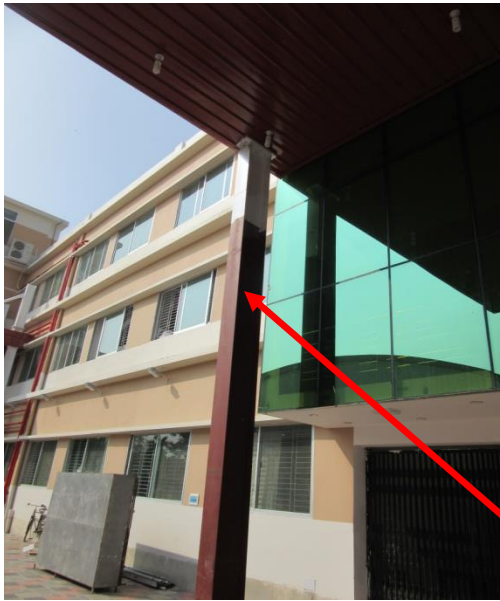
Lack of verticality of one of the Steel Columns

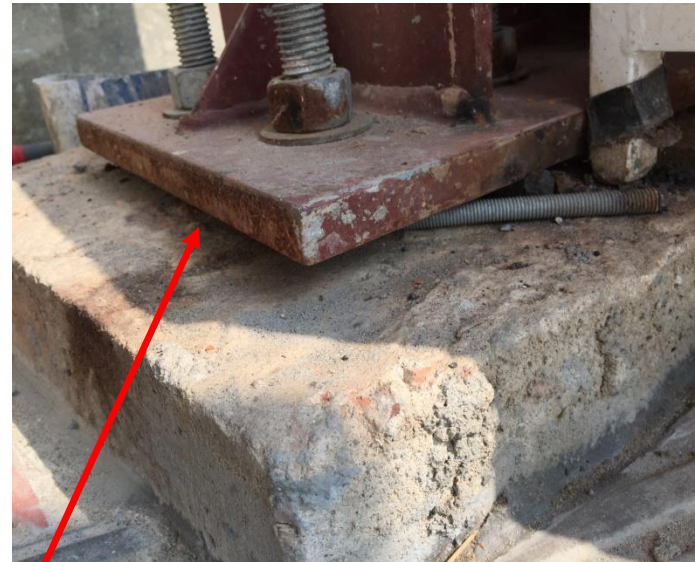
Base connection not well completed

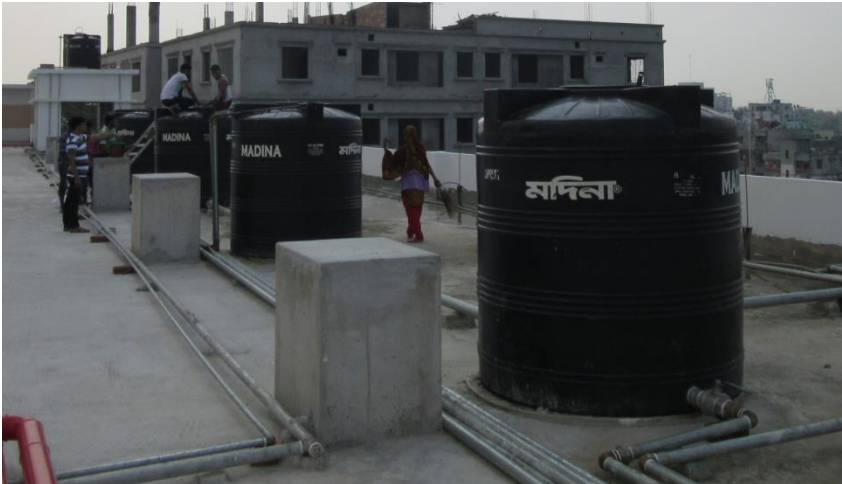
4 no. 3000 Ltr Tank

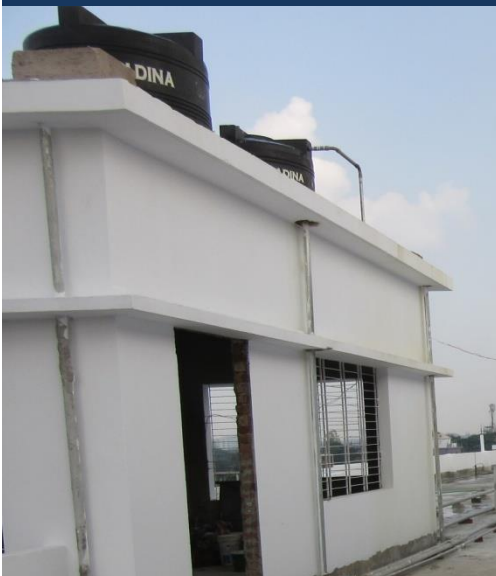
2 no. 2000 Ltr Tank
