# AKH ECO APPARELS LTD.

495-Balithia, Shah-Belishwer, Dhamrai, Dhaka  
(23.9166 N, 90.1136 E)  
18<sup>th</sup> October 2015

# Observations

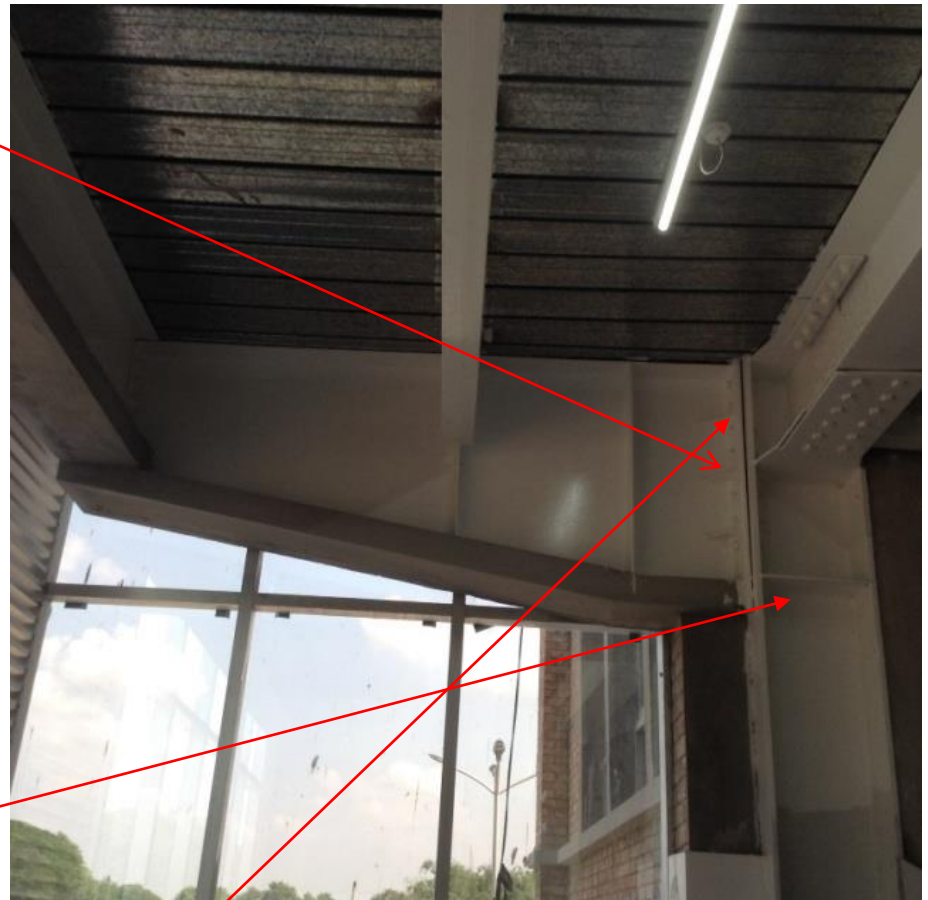
Connection of cantilevers at stair appear light

5 mm stiffener

Top of connection is open

**ITEM 1** Connection of cantilever beams at stair appear light

Item No.	Observation	Recommended Action Plan	Recommended Timeline
1	Connection of cantilever beams at stair appear light, particularly the stiffener	Building Engineer to review design of the cantilever beam/column connection. It is also noted that the top of the cantilever connection is not fully tightened	6-weeks
2	Connection of cantilever beams at stair appear light, particularly the stiffener	Building Engineer to review design of the cantilever beam/column connection. It is also noted that the top of the cantilever connection is not fully tightened	6-months
3	Connections of cantilevers on floor plate at level 4 appear light. Note lack of deep back span beam	Building Engineer to review design of the cantilever beam/column connection. There is a lighter beam forming the back span It is also noted that the top of the cantilever connection is not fully tightened	6-weeks
4	Connections of cantilevers on floor plate at level 4 appear light. Note lack of deep back span beam	Carry out any remedial action as a result of the connection review. Alter connection to avoid gap between end plate and column flange	6-months

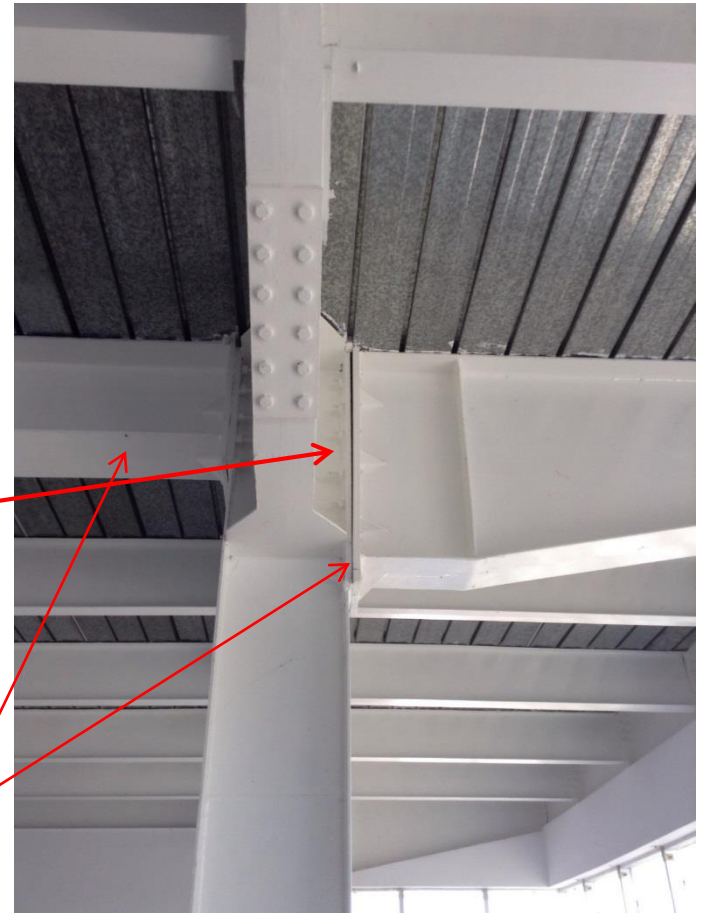
Various depth of beam on each side of column

Connections between cantilevers on floor plate at level 2 appear light

**ITEM 2** Connections of cantilevers on floor plate at level 4 appear light

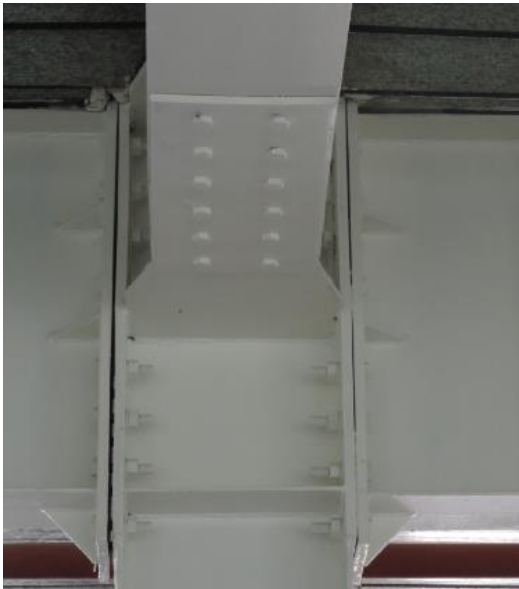
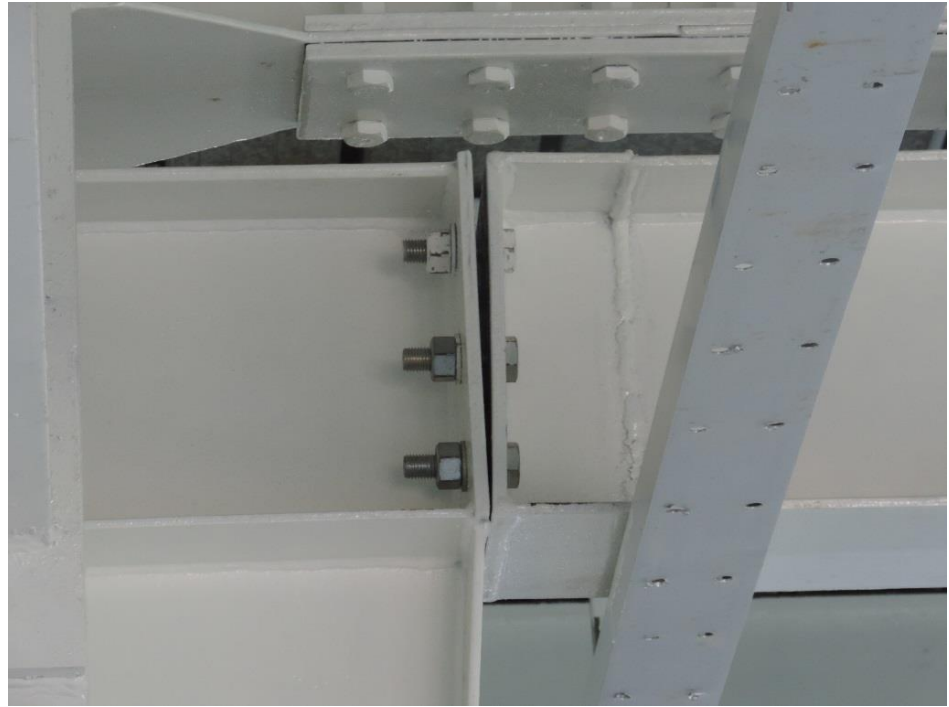
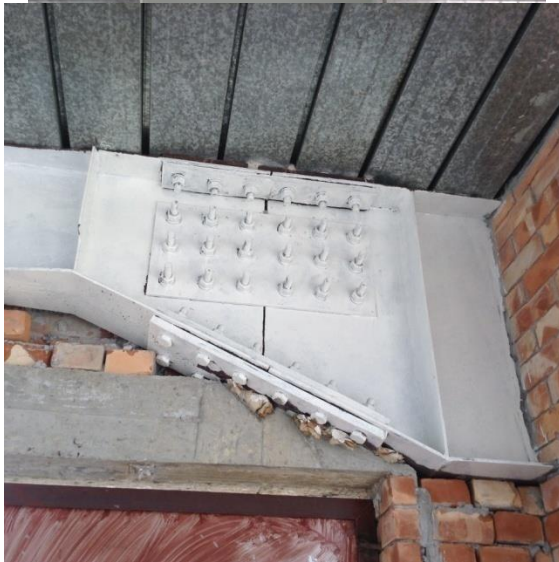
Open connections noted throughout the building

**ITEM 3** Open connections noted throughout the building

<b>Item No.</b>	<b>Observation</b>	<b>Recommended Action Plan</b>	<b>Recommended Timeline</b>
5	Open connections noted throughout the building	Building Engineer inspect and snag all connections and agree remedial actions.	<b>6-weeks</b>
6	Open connections noted throughout the building	Carry out remedial actions to open connections.	<b>6-months</b>
7	Column stubs noted on roof at southern end	Any proposed additions to the existing building structure, including additional storeys, should be reviewed by the Building Engineer.	<b>6-weeks</b>
8	Loading bay column not protected from traffic collision	Building engineer to review column in loading bay and its vulnerability to a collision by a truck.	<b>6-weeks</b>
9	Loading bay column not protected from traffic collision	Install protective measures following from above review	<b>6-months</b>
10	Rubble and water tanks temporary noted on roof.	Building engineer to review loading from 5000litres tanks on roof. (advised tanks were temporary as pumps were yet to be installed for underground tank)	<b>6-weeks</b>

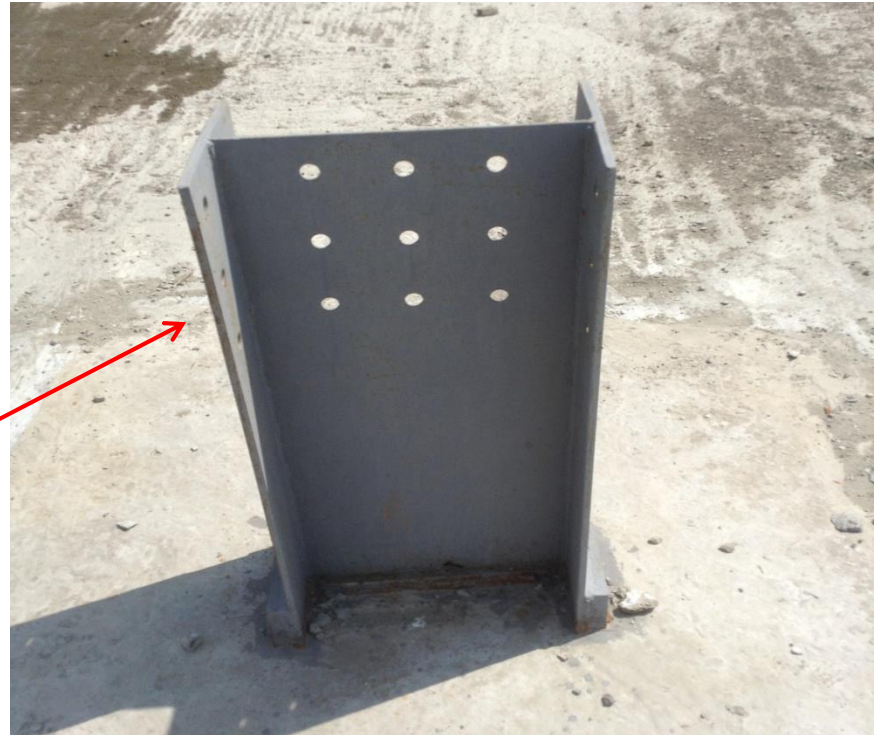
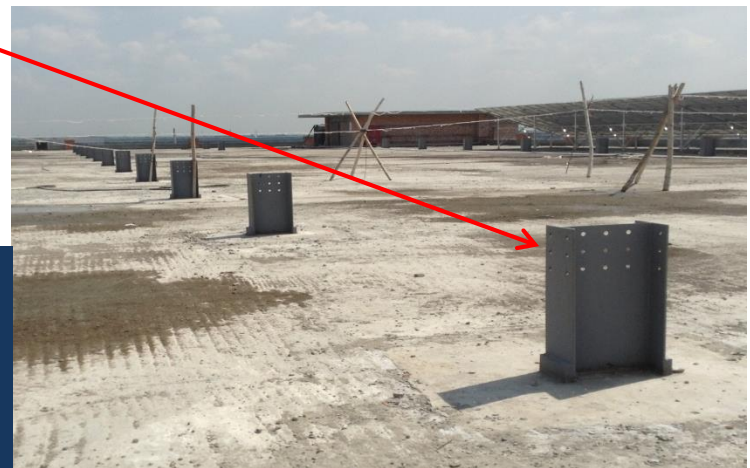
**Column stubs noted on roof at southern end. Any proposed additions to the existing building structure, including additional storeys, should be reviewed by the Building Engineer**

**ITEM 4** Column stubs noted on roof at southern end.

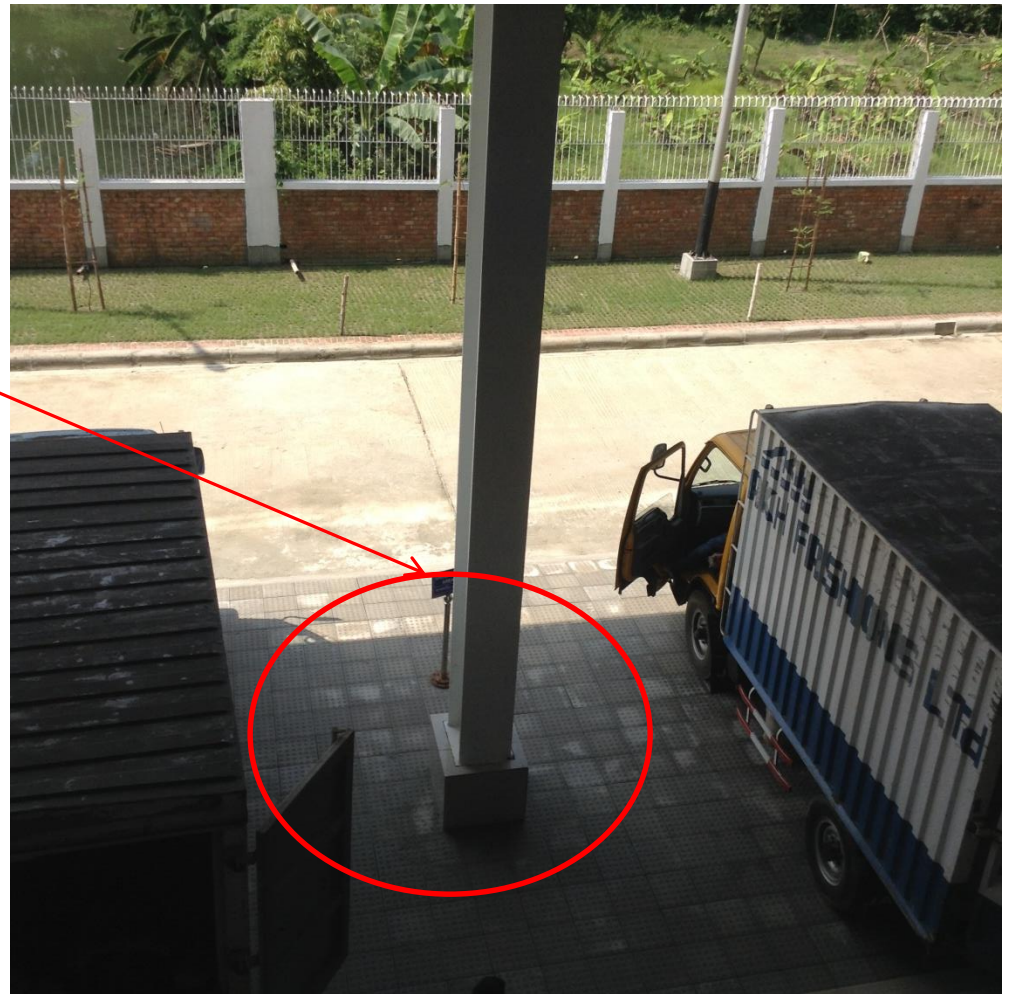
Loading bay column not protected from traffic collision

**ITEM 5** Loading bay column not protected from traffic collision

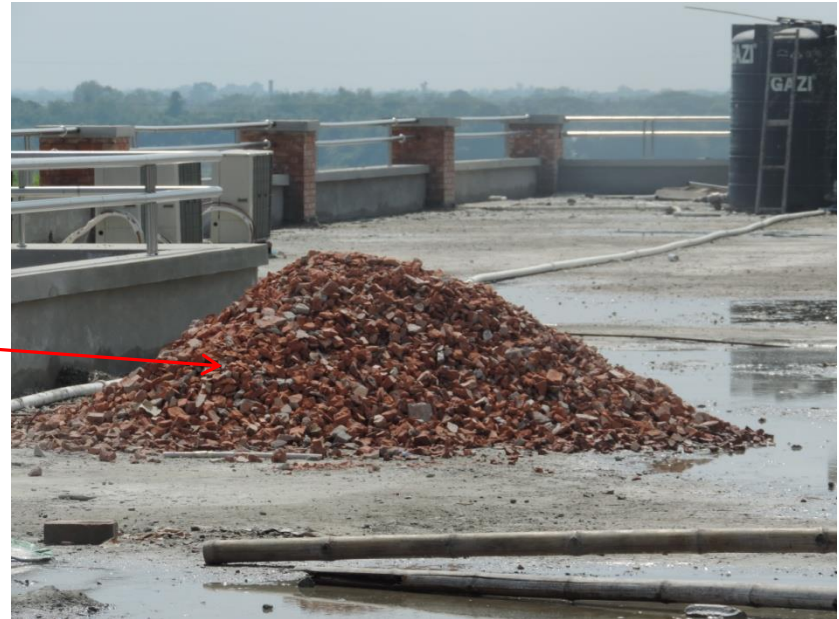
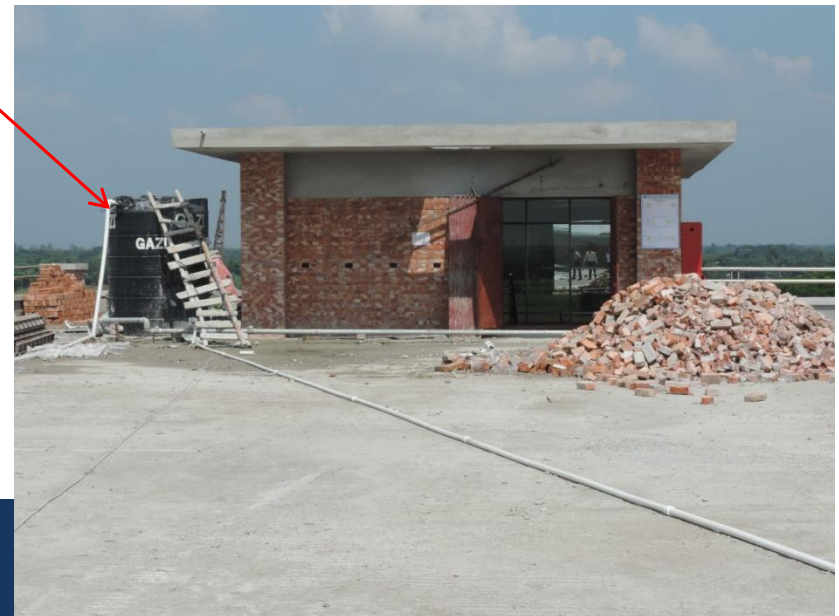
Rubble and water tanks noted on roof.

**ITEM 6** Rubble and water tanks temporary noted on roof.

11	Rubble and water tanks temporary noted on roof.	Rubble to be removed from roof. Remove temporary tanks if required by above review	<b>6-months</b>
