# Magpie Composite Textile Ltd. (Extension)

832/833, Dewan Idris Road, Amtoli, Ashulia, Savar, Dhaka.

28 May 2023

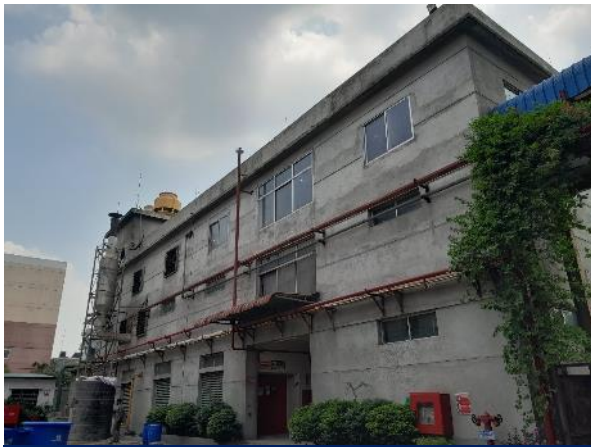
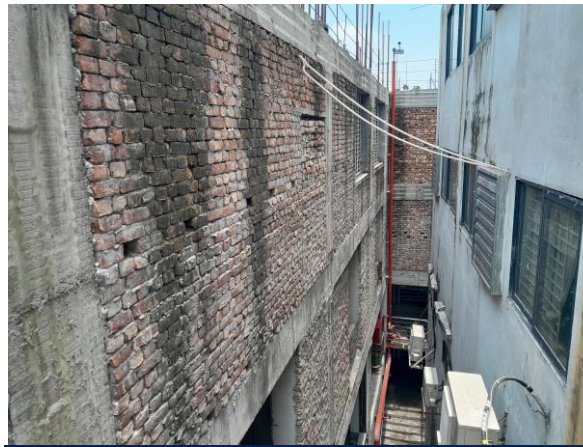
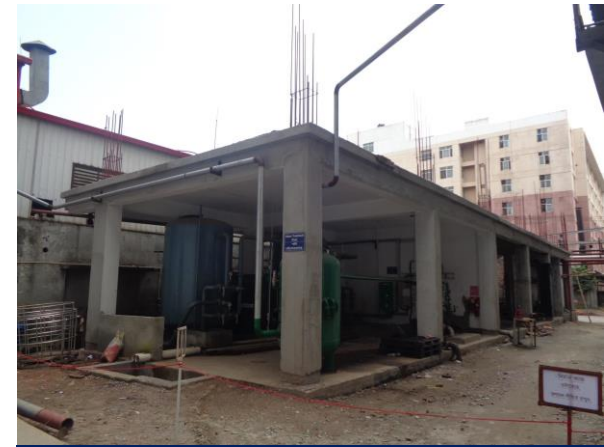
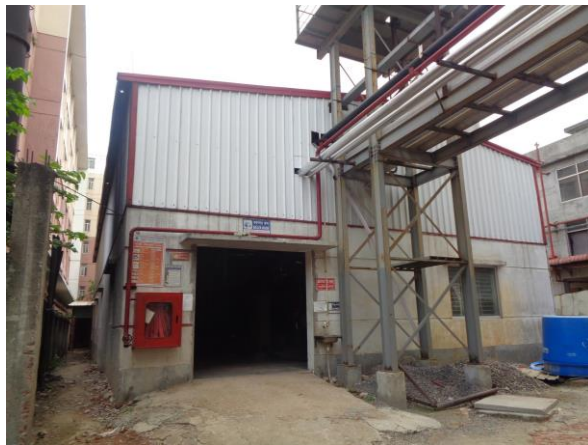
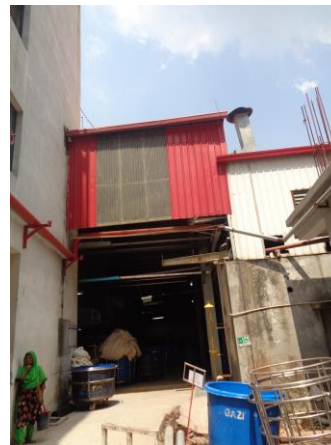
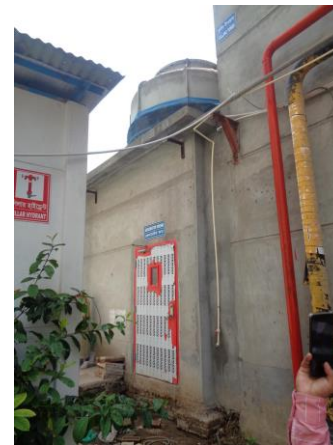
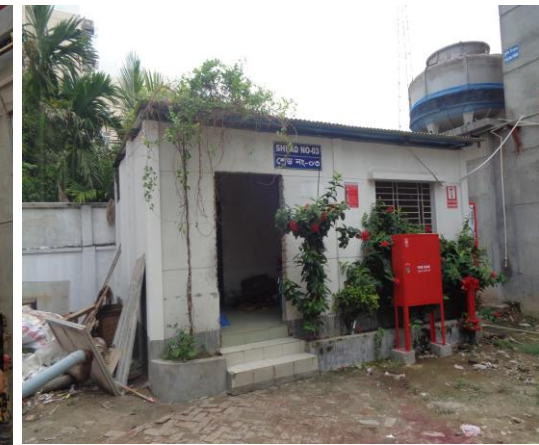
**Absence of building permit drawings for all  
building except Building-2**

Permit drawing was not available for the structures. The factory is required to collect building permit drawing from local authority.

| Item No. | Observation | Recommended Action Plan | Recommended Timeline |
|---|---|---|---|
| 01 | Absence of building permit drawings for all building except Building-2. | The factory is required to collect building permit drawing for the structures from the government authorized institutions. | 6-months |

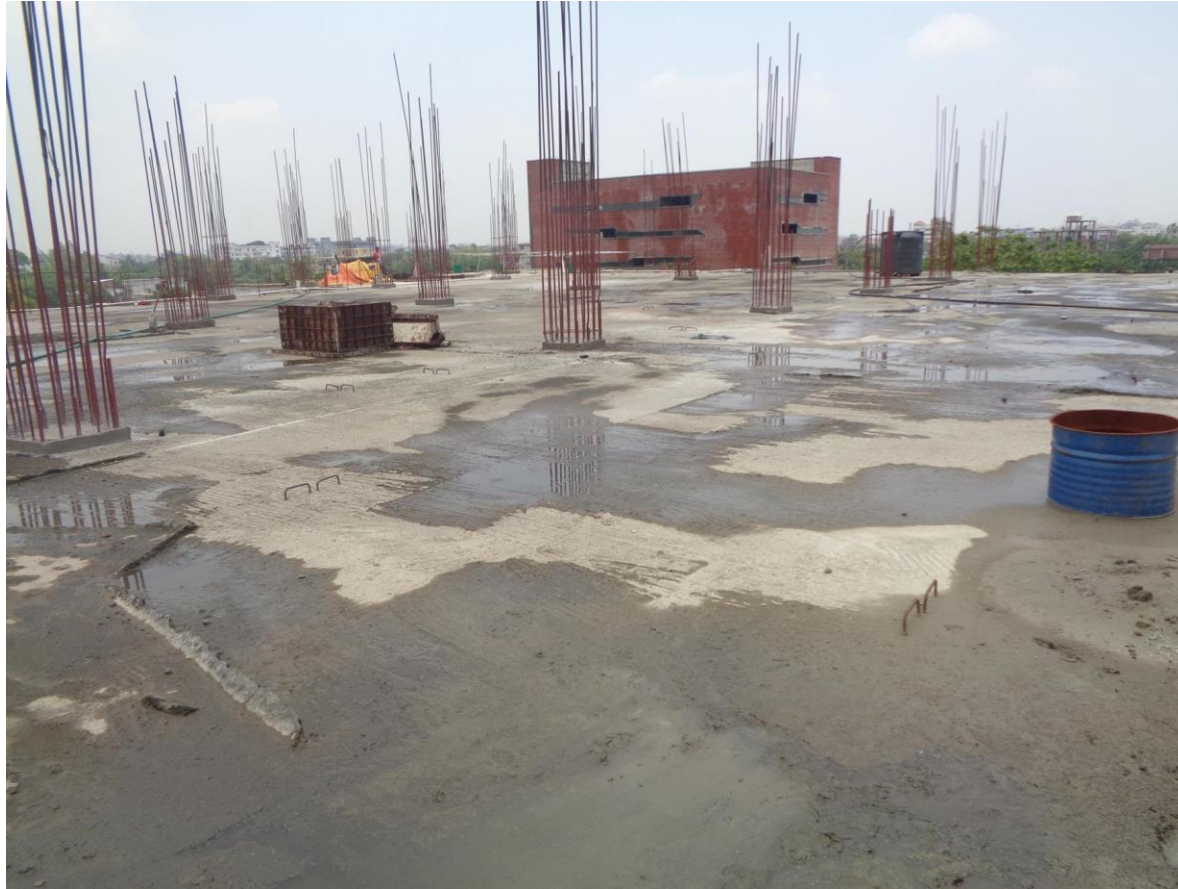
Water ponding on the roof

The building engineer is required to provide adequate slope and outlet.

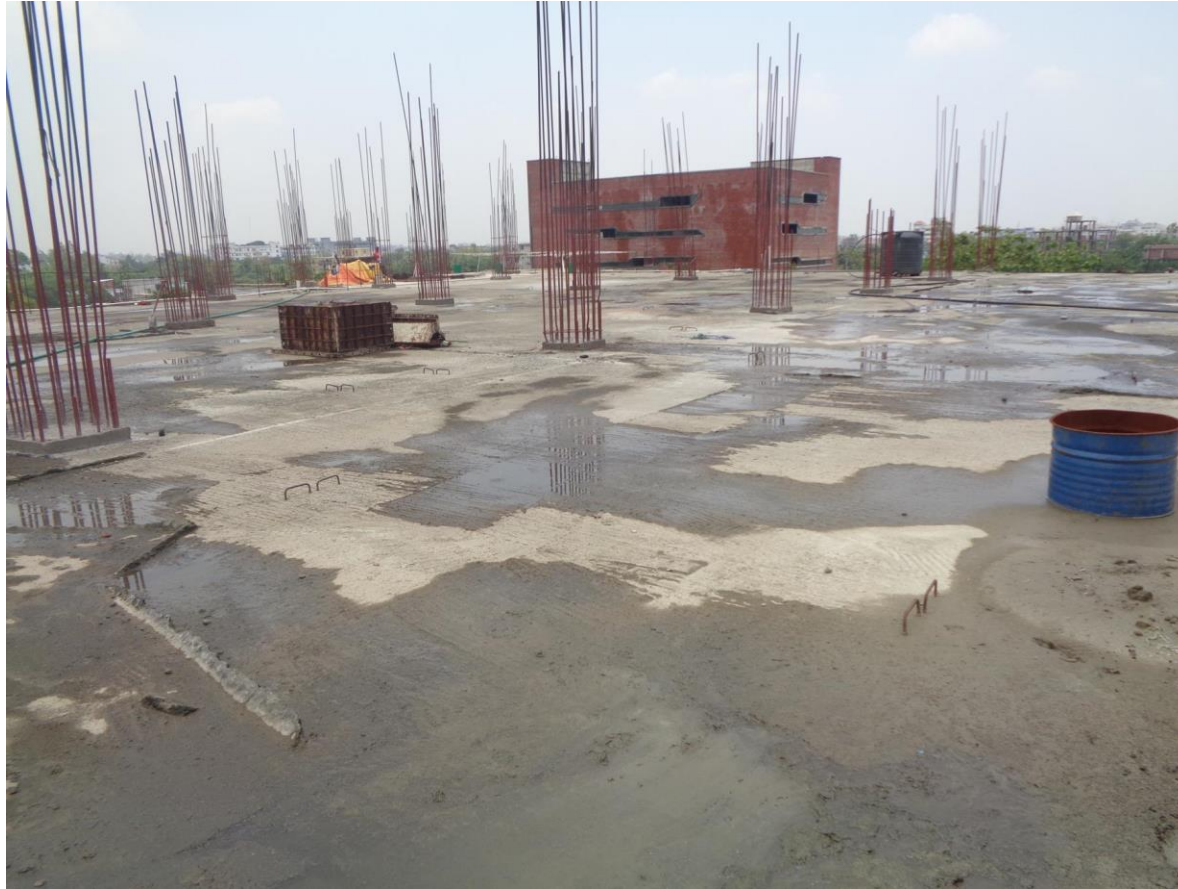
Water ponding on the roof

The building engineer is required to provide adequate slope and outlet.

| Item No. | Observation | Recommended Action Plan | Recommended Timeline |
|---|---|---|---|
| 02 | Water ponding on the roof. Building-2 | The Building engineer is required to develop proper drainage system on the roof with adequate slope and outlets. | 6-months |

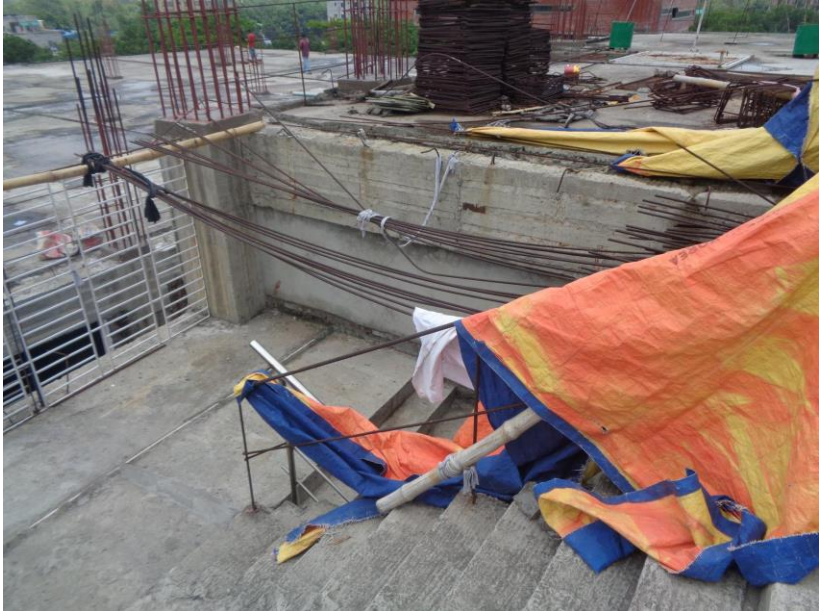
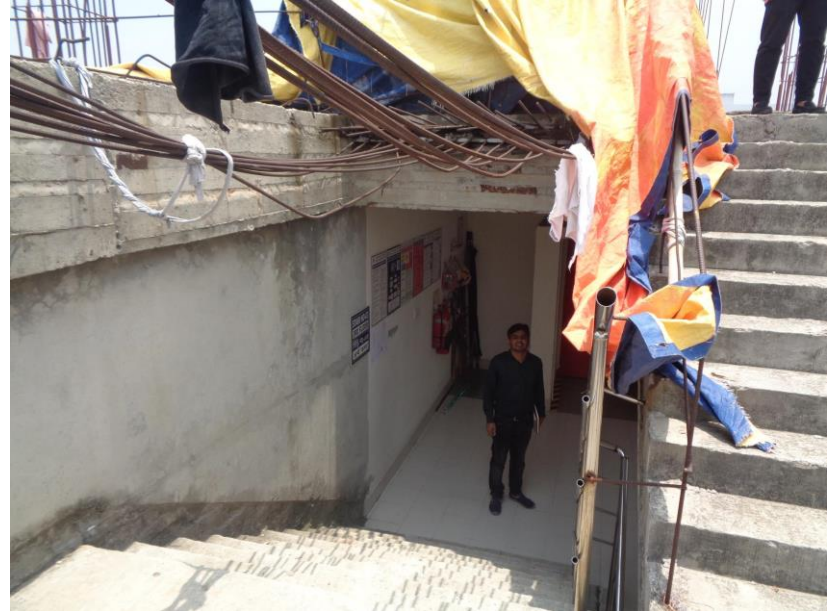
Exposed rebar and very low clear height to stair which may cause accident

The building engineer is required to provide fall protection (barrier/railing) to avoid falling hazard from roof and stair.

| Item No. | Observation | Recommended Action Plan | Recommended Timeline |
|---|---|---|---|
| 03 | Exposed rebar prone to accident. Building-2 | The factory is required to provide fall protection barrier at roof to avoid falling hazard. | 6-weeks |
| 04 | Exposed rebar prone to accident. Building-2 | The factory is required to provide fall protection railing at stair to avoid falling hazard. | 6-weeks |

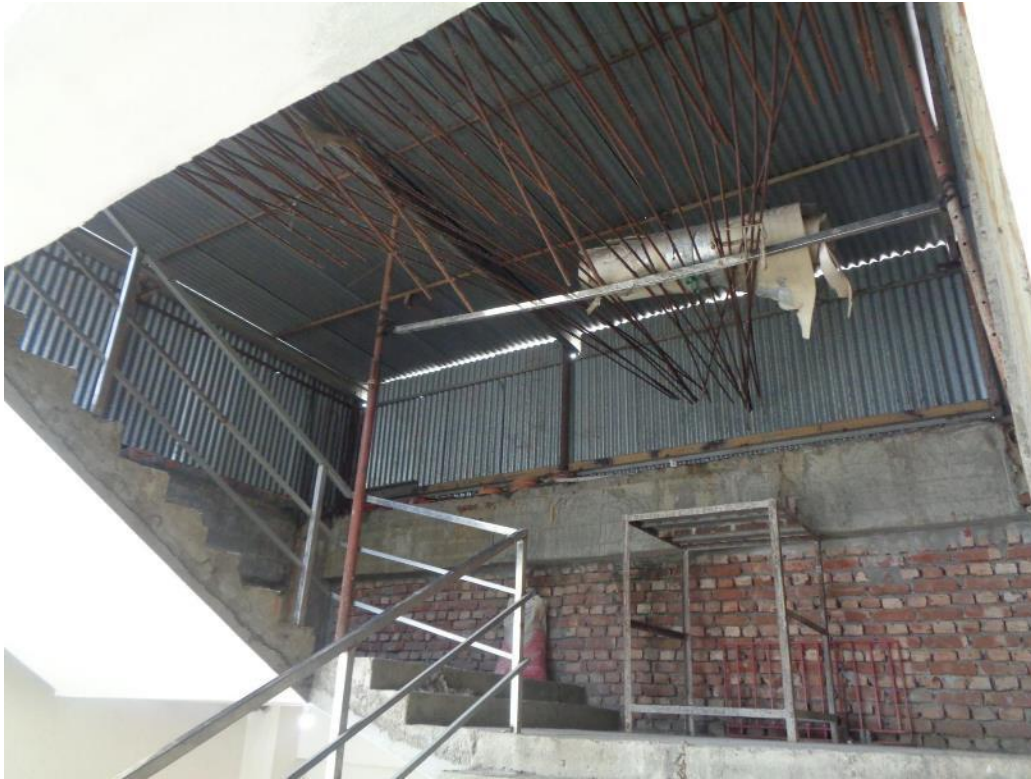
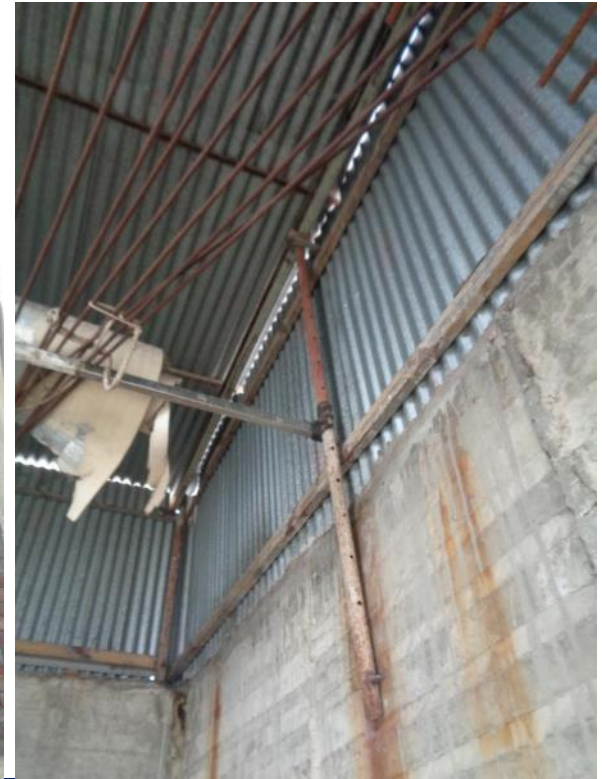
Non-engineered steel roof on the stair

The building engineer is required to check the connection and stability of the stair and suggest proper remedial actions.

| Item No. | Observation | Recommended Action Plan | Recommended Timeline |
|---|---|---|---|
| 05 | Non-engineered steel roof on the stair. Building-2 | The building engineer is required to check the adequacy of the steel roofing and suggest necessary remedial actions. | 6-weeks |

| Item No. | Observation | Recommended Action Plan | Recommended Timeline |
|---|---|---|---|
| 06 | Non-engineered steel roof on the stair. Building-2 | Carry out suggested remedial works. | 6-months |

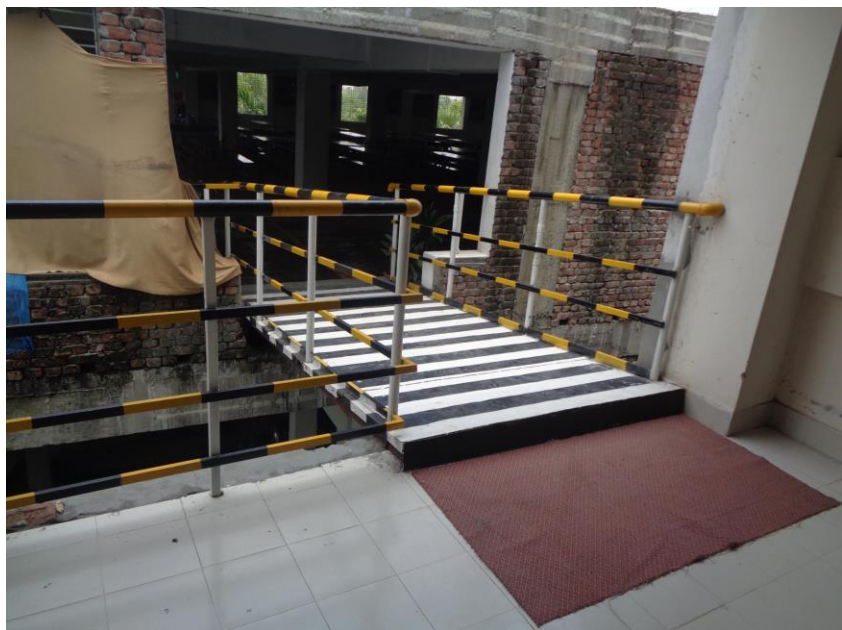
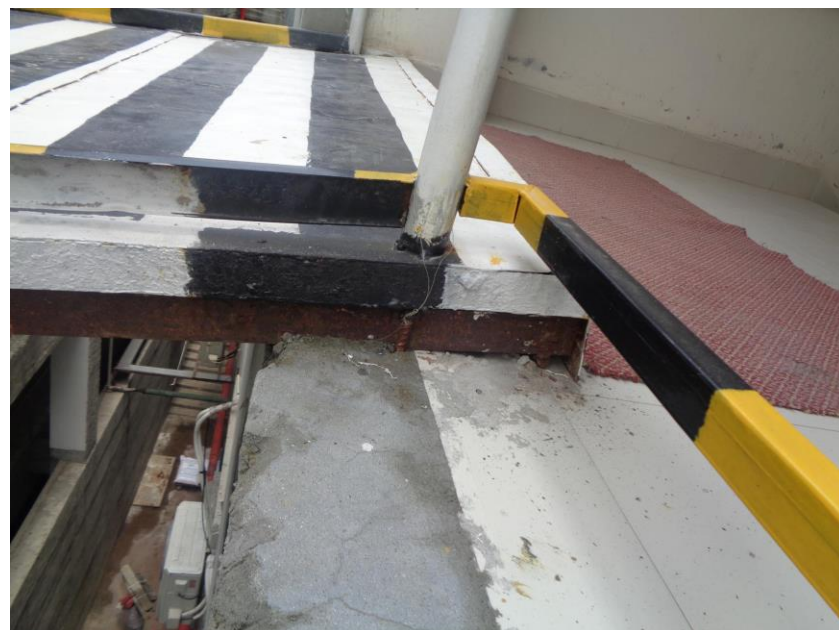
Anchorage of undocumented connecting bridge between building 2 & building 4 has not flexibility for movement of the buildings.

The building engineer is required to provide adequacy of the connection for lateral forces and suggest proper remedial measures.

| Item No. | Observation | Recommended Action Plan | Recommended Timeline |
|---|---|---|---|
| 07 | Improper connection of connecting bridge. Building-2 | The building engineer is required to provide adequacy of the connection for lateral forces and suggest proper remedial measures. | 6-weeks |
| 08 | Improper connection of connecting bridge. Building-2 | Carry out suggested remedial works. | 6-months |

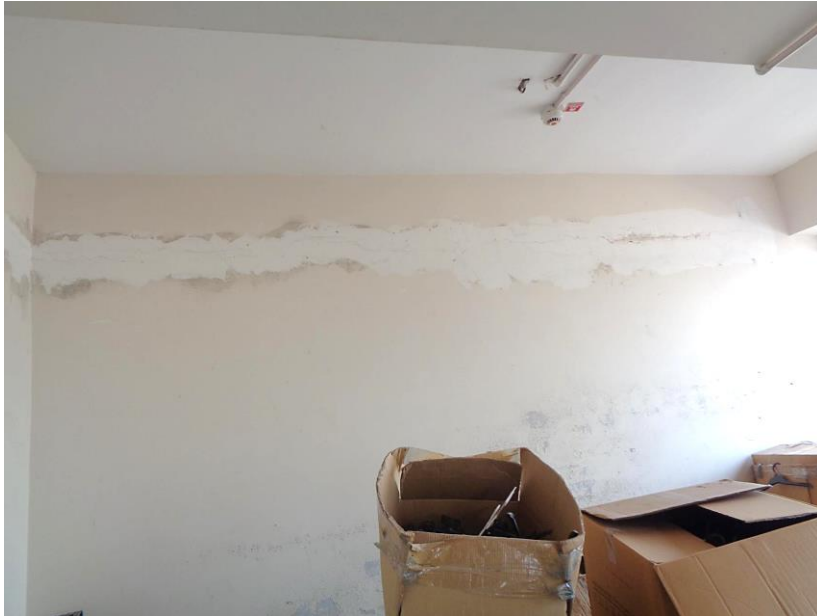
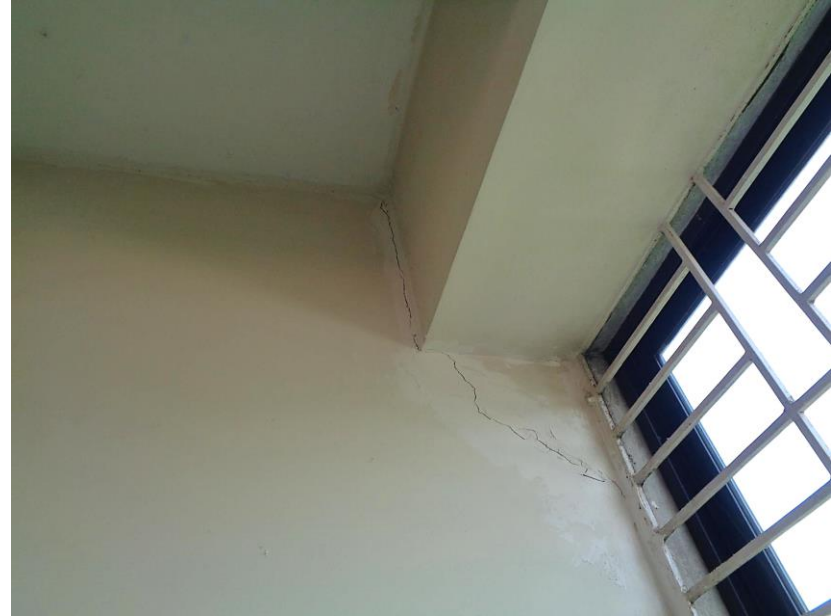
Crack on walls

The building engineer is required to investigate the reason of crack and carry out proper remedial works accordingly.

| Item No. | Observation | Recommended Action Plan | Recommended Timeline |
|---|---|---|---|
| 09 | Crack on brick walls. Building-2 | The building engineer is required to investigate the reason of crack and carry out proper remedial works accordingly. | 6-weeks |

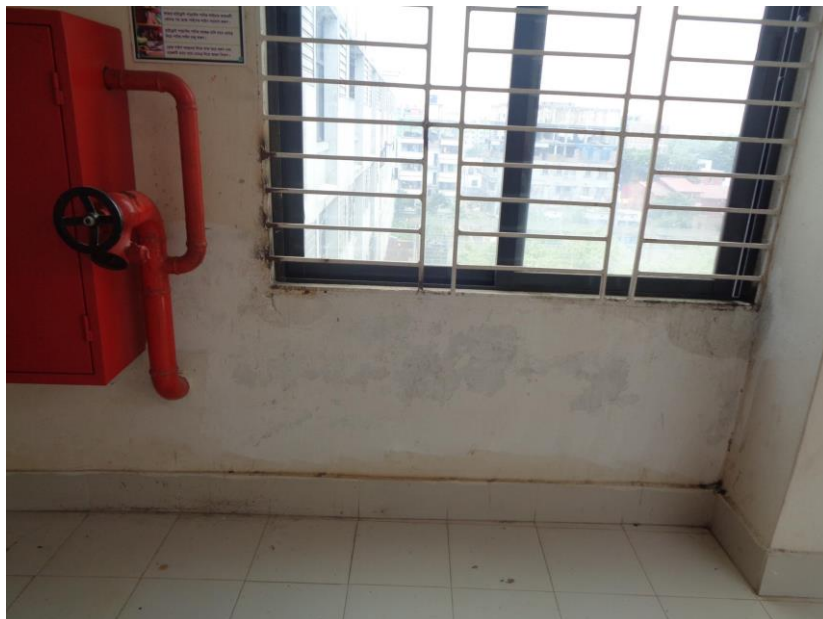
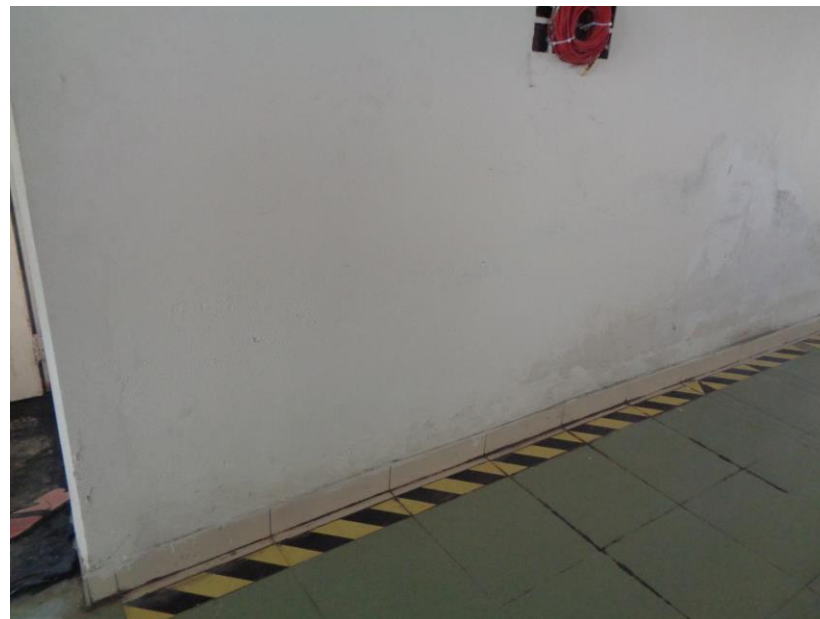
Dampness on walls

The building engineer is required to investigate the reason of dampness and carry out proper remedial works accordingly.

| Item No. | Observation | Recommended Action Plan | Recommended Timeline |
|---|---|---|---|
| 10 | Dampness on brick walls. Building-2 | The building engineer is required to investigate the reason of dampness and carry out proper remedial works accordingly. | 6-weeks |

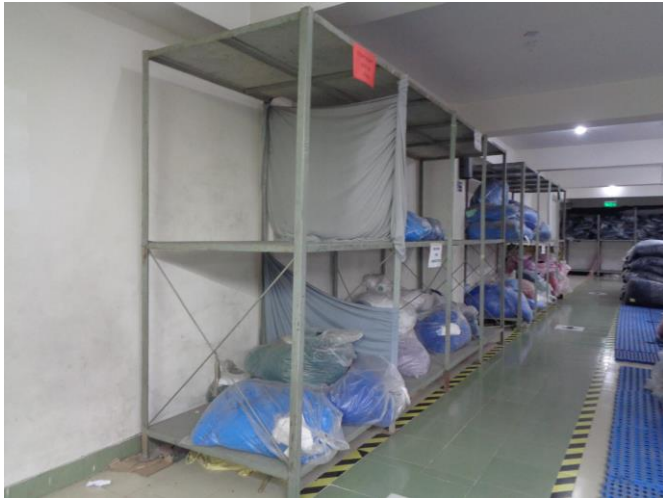
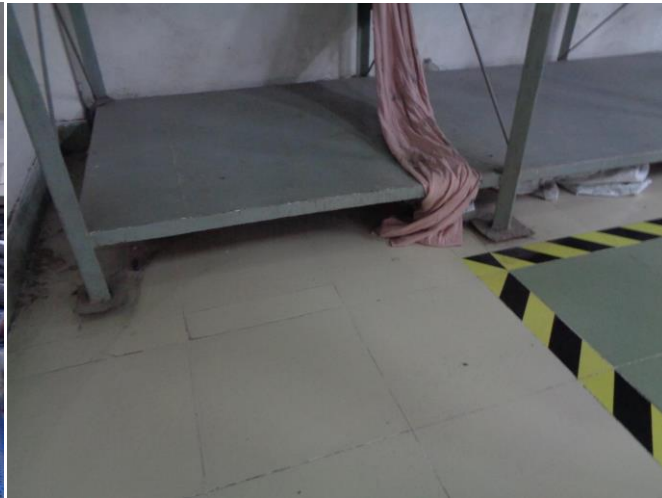
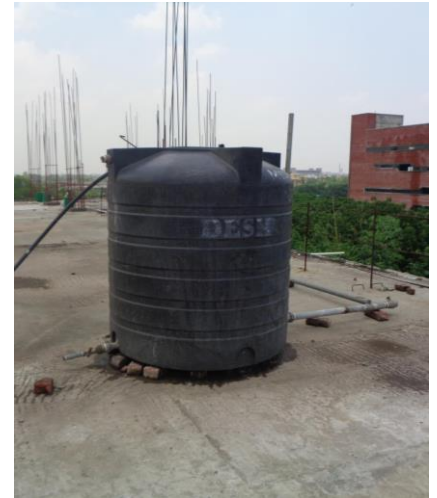
Lack of anchorage of storage racks and water tank

The building engineer is required to anchor all non-structural elements within the factory.

| Item No. | Observation | Recommended Action Plan | Recommended Timeline |
|---|---|---|---|
| 11 | Lack of anchorage of non-structural elements (storage racks, water tank). Building-2 | Provide anchorage/bracing for all non-structural elements including storage tanks & water tanks within the factory to resist effect of seismic forces. | 6-weeks |

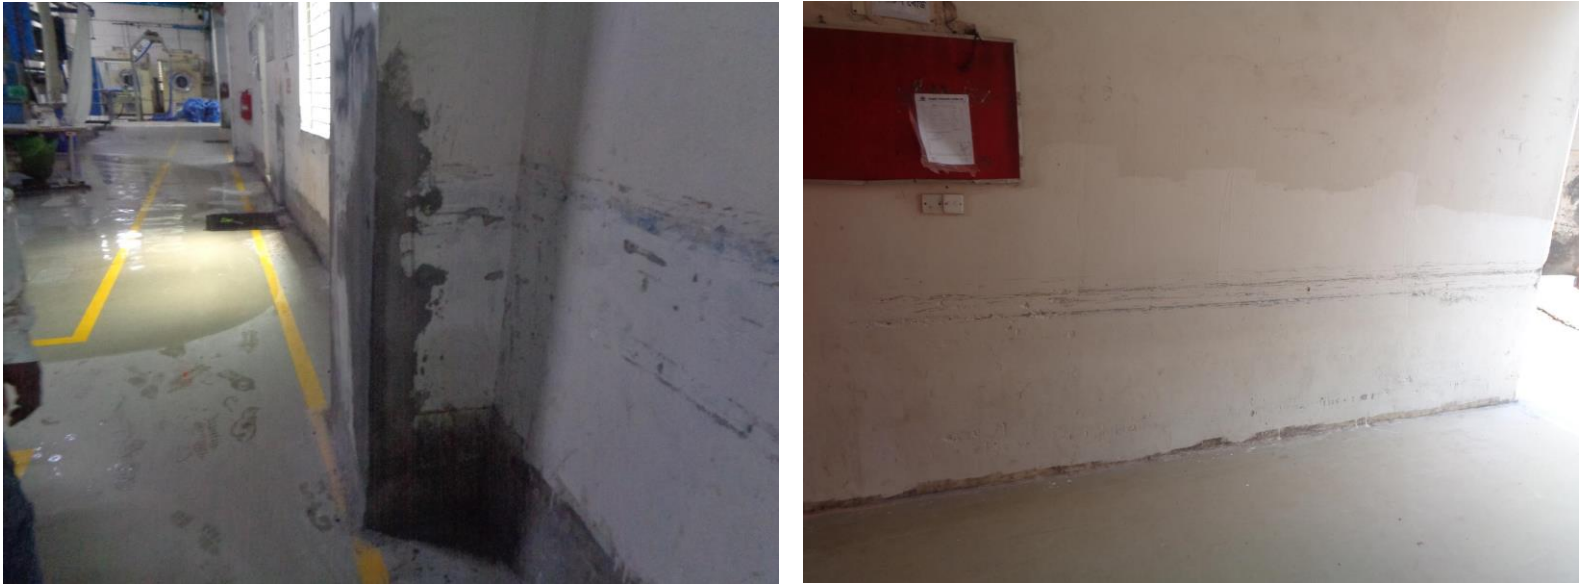
Sign of trolley impact on column and wall

The building engineer is required to provide adequate protection/barrier for the columns & walls.

| Item No. | Observation | Recommended Action Plan | Recommended Timeline |
|---|---|---|---|
| 12 | Trolley impact on columns and walls. Building-2 | The building engineer is required provide adequate barrier/protection to the columns & walls. | 6-weeks |

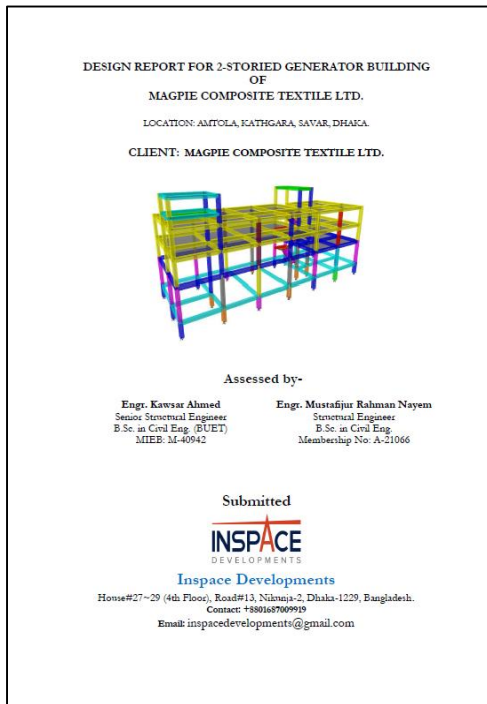
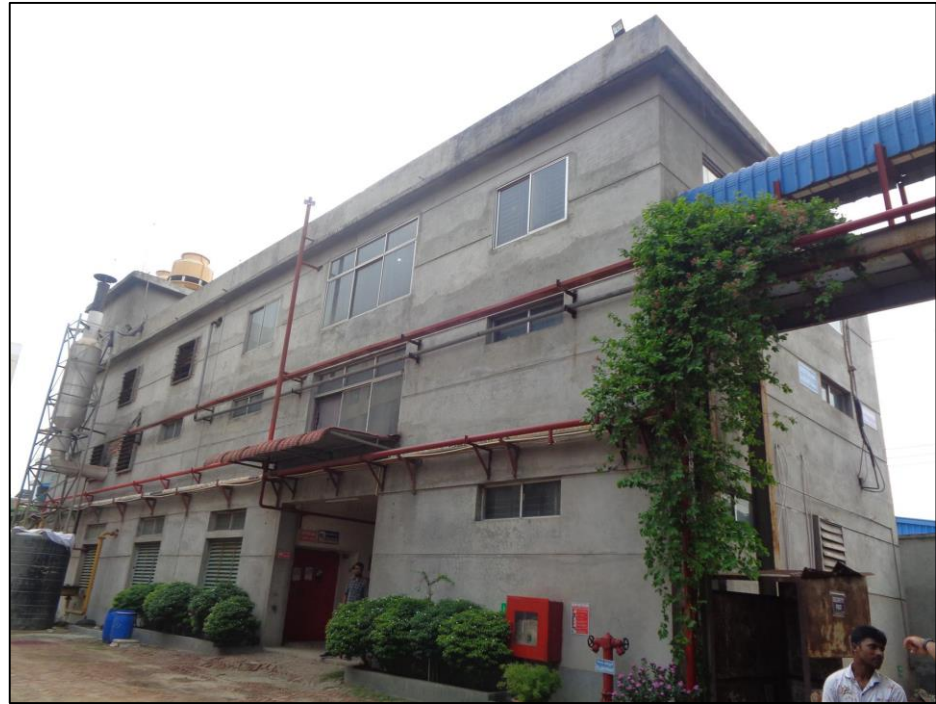
Irregularity check has not incorporated in the design report of Building-3

The building engineer is required to incorporate the irregularity in the design report.

| Item No. | Observation | Recommended Action Plan | Recommended Timeline |
|---|---|---|---|
| 13 | Design report to be revised for irregularity check. Building-3 | The building engineer is required to incorporate the irregularity in the design report and suggest remedial works if required. | 6-weeks |
| 14 | Design report to be revised for irregularity check. Building-3 | Carry out suggested remedial works. | 6-months |

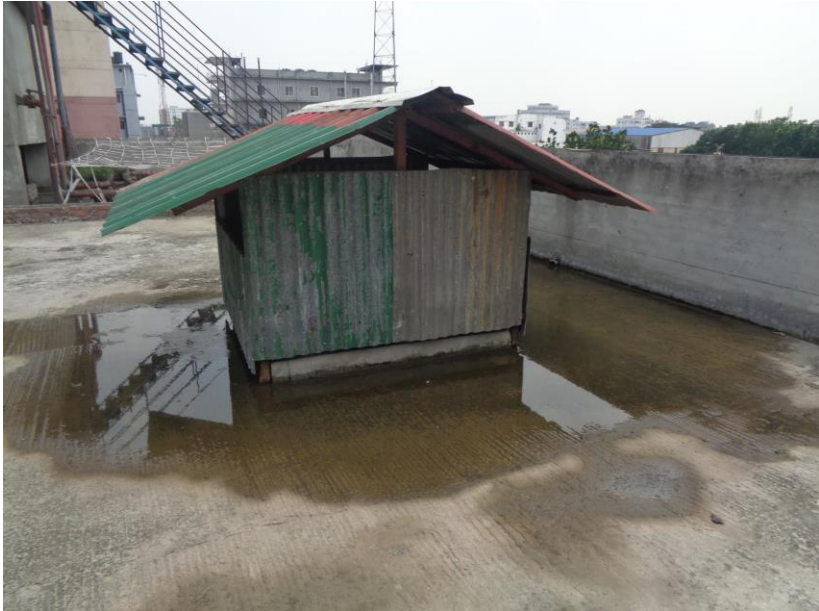
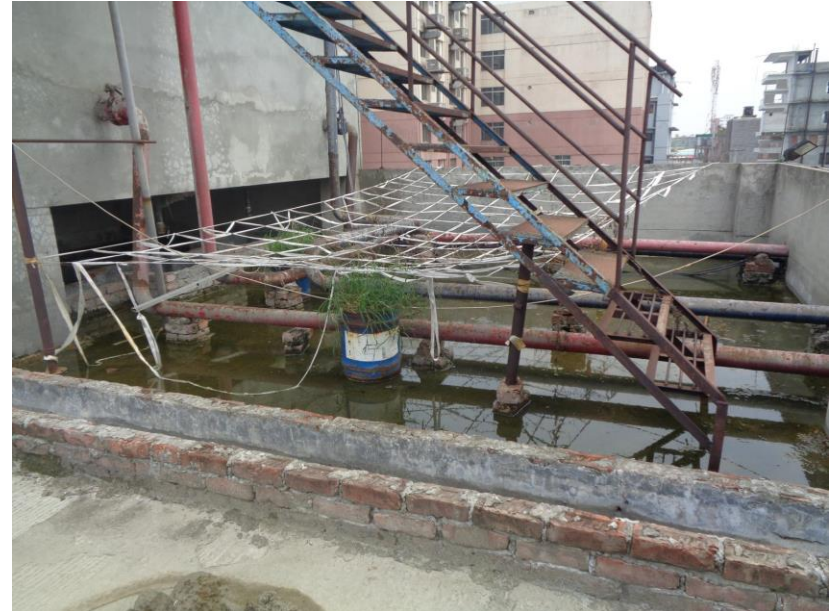
Water ponding on the roof

The building engineer is required to provide adequate slope and outlet on the roof.

| Item No. | Observation | Recommended Action Plan | Recommended Timeline |
|---|---|---|---|
| 15 | Water ponding on the roof. Building-3 | The building engineer is required to develop proper drainage system on the roof with adequate slope and outlets. | 6-months |

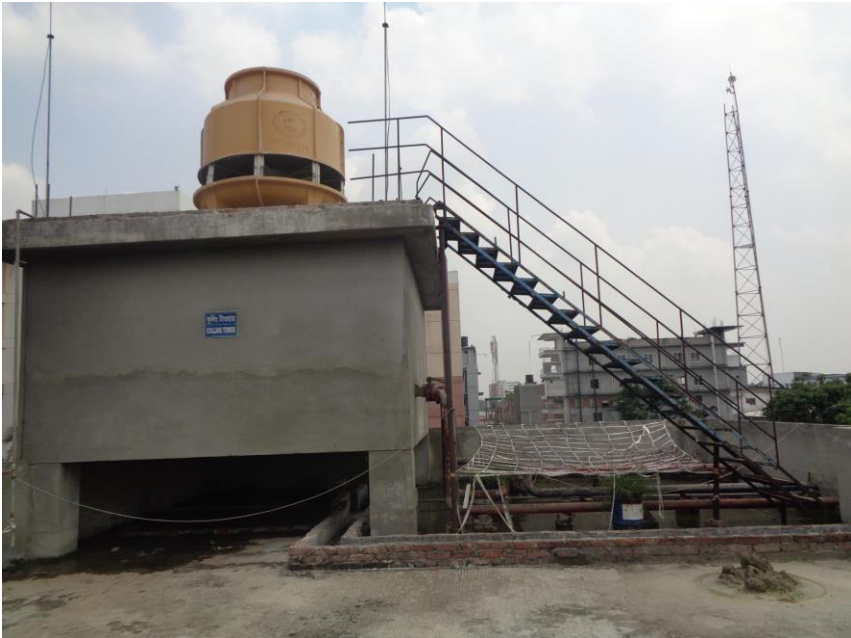
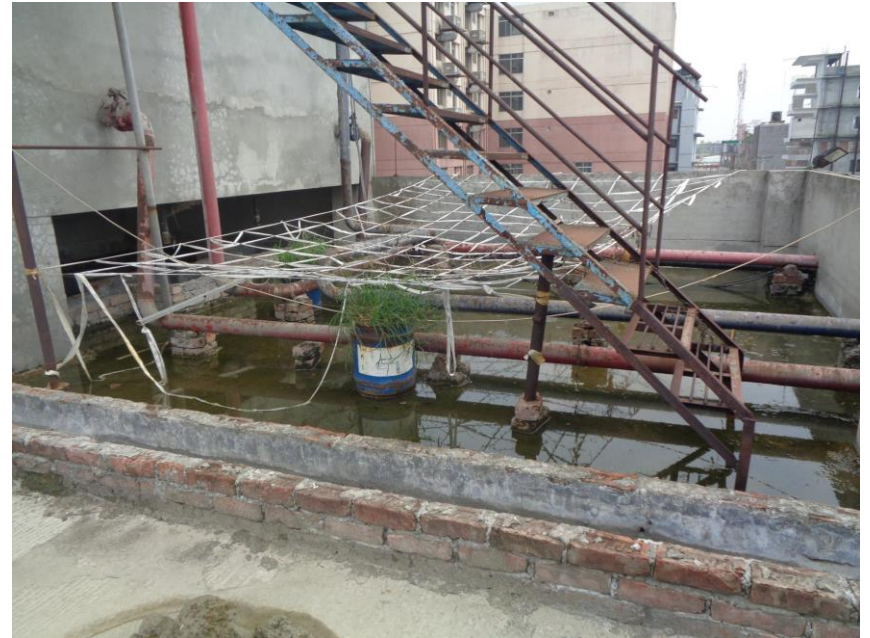
Inadequate and corroded steel ladder

The building engineer is required to repair or replace the ladder

| Item No. | Observation | Recommended Action Plan | Recommended Timeline |
|---|---|---|---|
| 16 | Inadequate and corroded steel ladder. Building-3 | The building engineer is required to replace the corroded ladder with a new one. | 6-months |

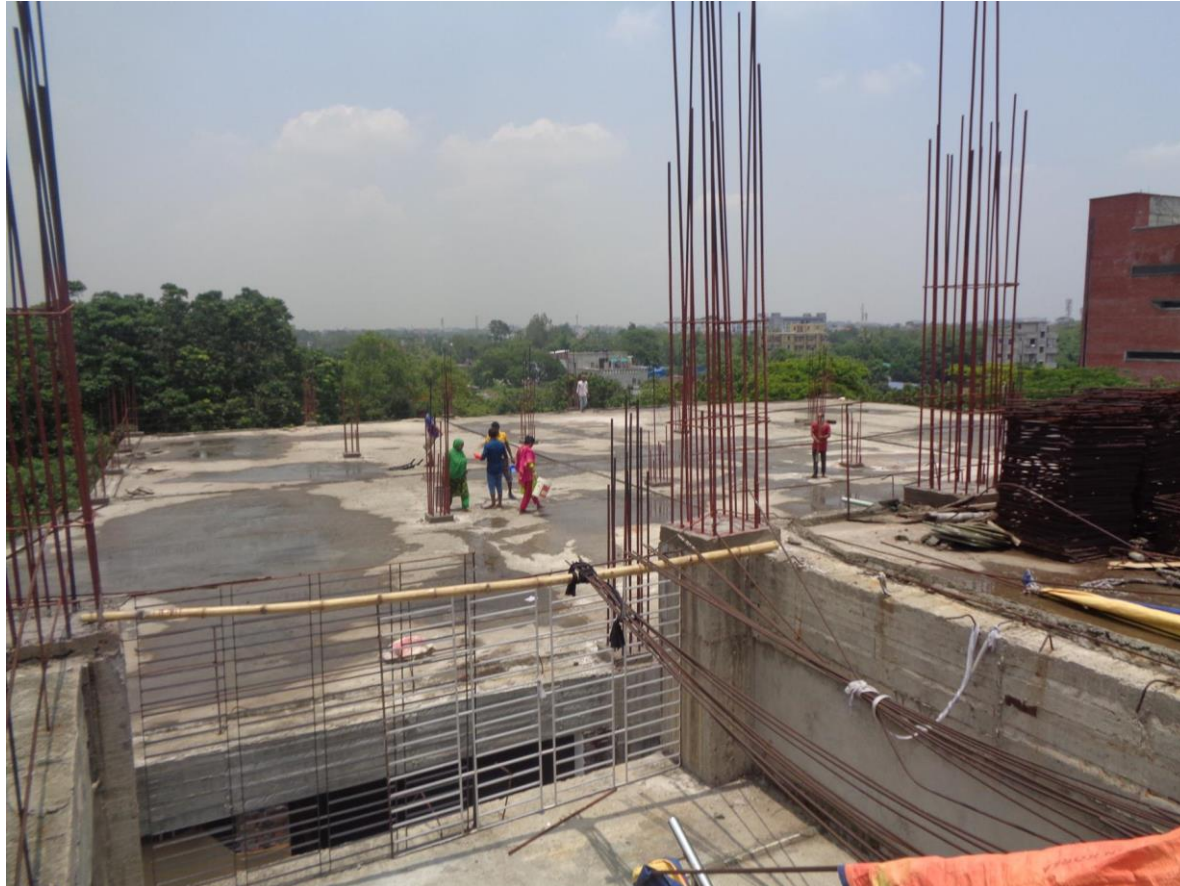
Water ponding on the roof

The factory is required to provide adequate slope and outlet.

| Item No. | Observation | Recommended Action Plan | Recommended Timeline |
|---|---|---|---|
| 17 | Water ponding on the roof. Building-4 | The building engineer is required to develop proper drainage system on the roof with adequate slope and outlets. | 6-months |

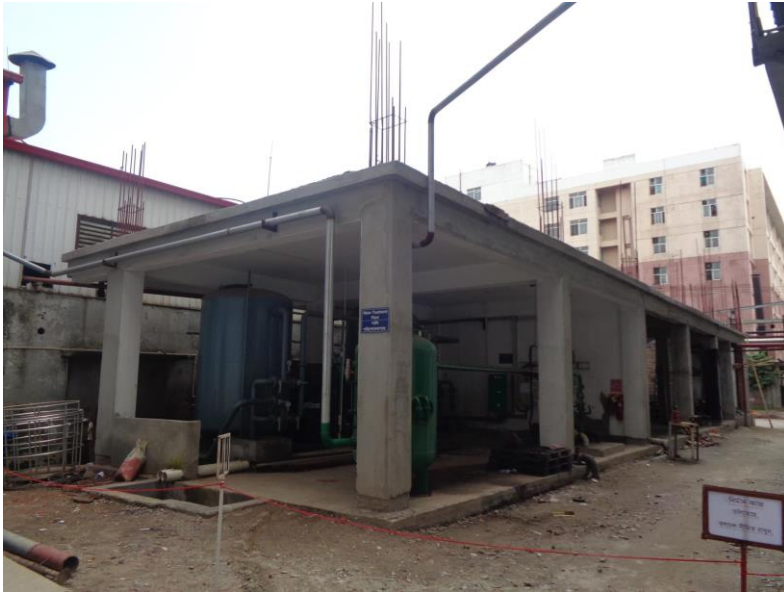
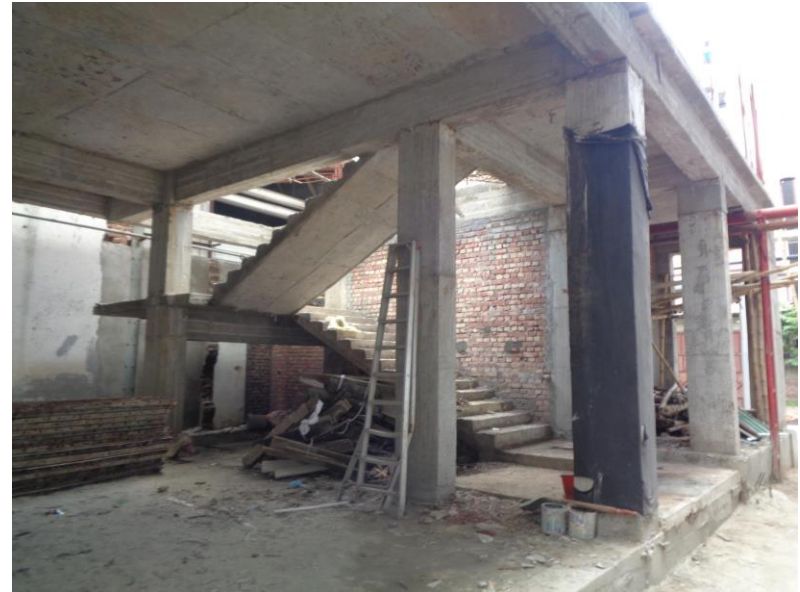
Lack of fall protection in the roof and open stair

The factory is required to provide fall protection barrier/railing to avoid falling hazard.

| Item No. | Observation | Recommended Action Plan | Recommended Timeline |
|---|---|---|---|
| 20 | Falling Hazard. (Lab Building) | The building engineer is required to provide fall protection (barrier/railing) to avoid falling hazard from roof and stair. | 6-weeks |

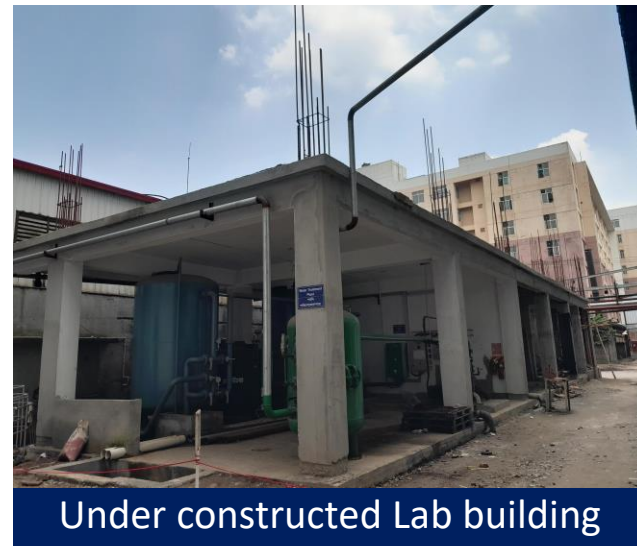
Provided Cylinder test  
report(1set)

Concrete strength considered 3,500 psi in the design report. Only one set test report dated 26-Sep-2022 was available onsite which doesn't satisfy frequency of testing requirement of BNBC. The building is under construction. The factory has no permit drawing for the building. But the design report is prepared following BNBC-2006 building code. The building engineer is required to check the applicable building code and revise the design documents based on in-situ material strength.

| Item No. | Observation | Recommended Action Plan | Recommended Timeline |
|---|---|---|---|
| 18 | Design report to be revised for in-situ material strength. (Lab Building) | The building engineer is required to check the applicable building code and revise the design documents based on in-situ material strength. | 6-weeks |
| 19 | Design report to be revised for in-situ material strength. (Lab Building) | Carry out suggested remedial works as per design report if required. | 6-months |

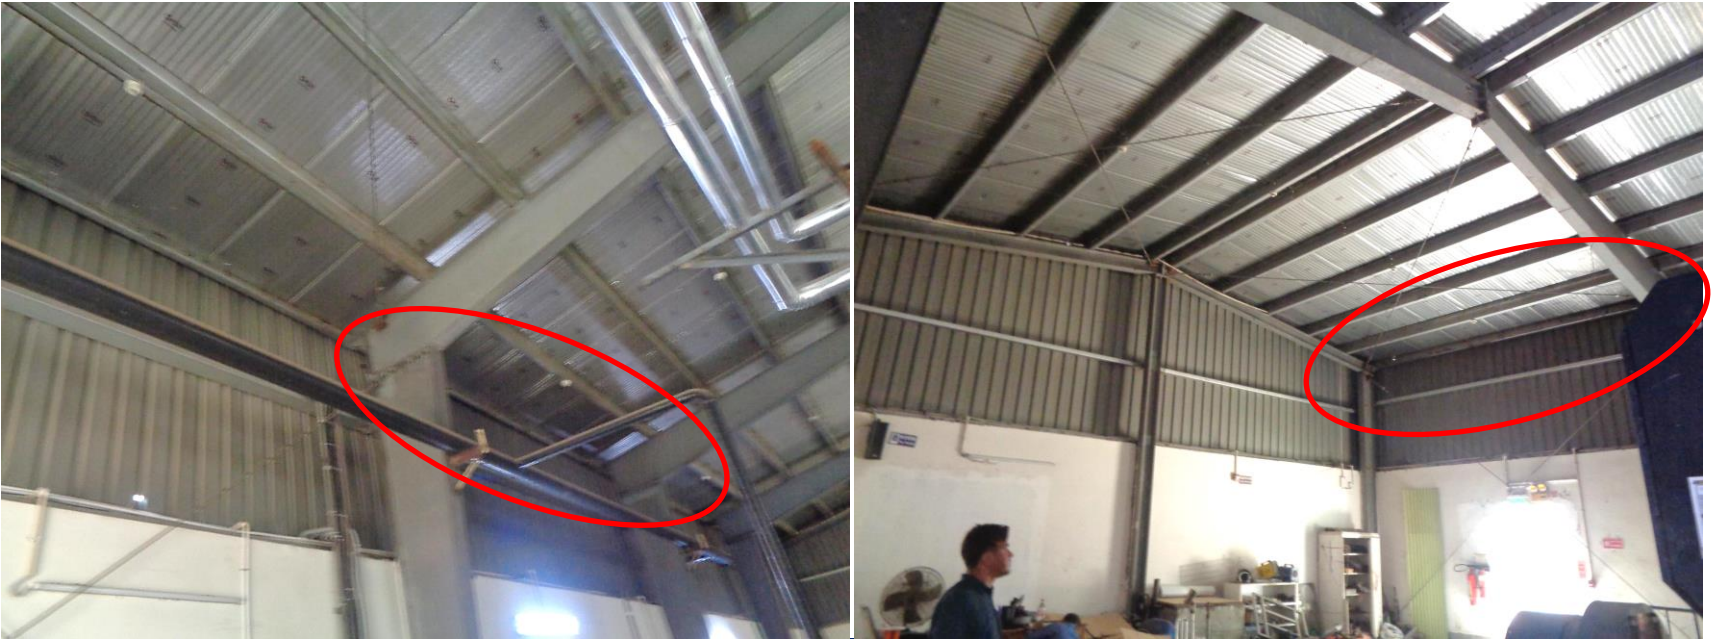
Absence of load transfer media along long direction of the shed

The building engineer is required to check the stability system and suggest proper remedial actions.

| Item No. | Observation | Recommended Action Plan | Recommended Timeline |
|---|---|---|---|
| 21 | Incomplete lateral stability system. Boiler Shed | The building engineer is required to check the stability of structure and suggest necessary remedial actions. | 6-weeks |
| 22 | Incomplete lateral stability system. Boiler Shed | Carry out suggested remedial works. | 6-months |

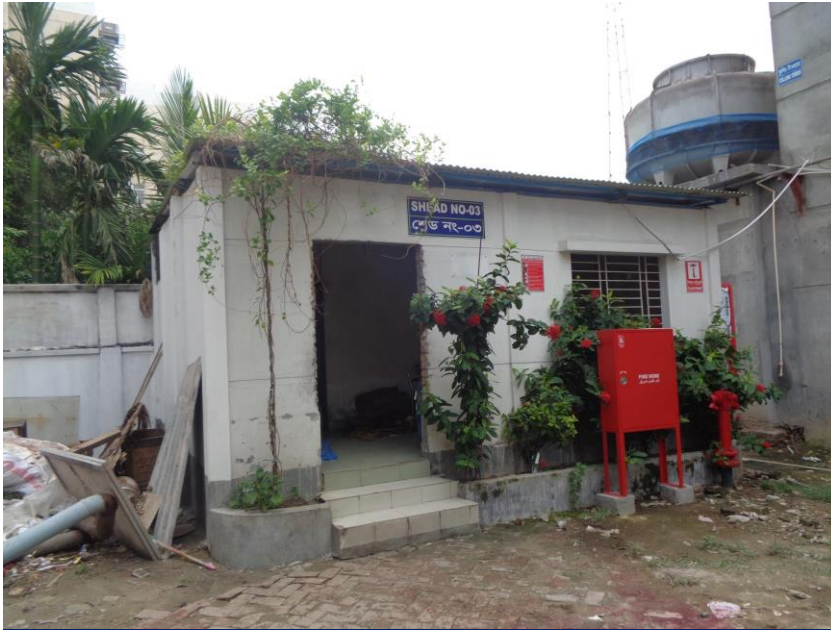
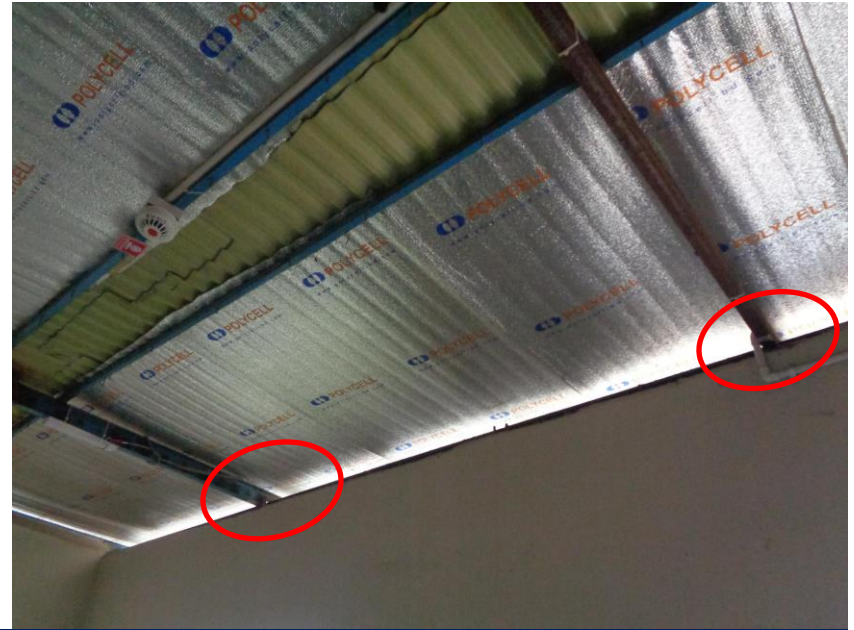
Lack of anchorage of steel roof

Building engineer is required to produce as built drawing and upgrade the roof connections for uplift force.

| Item No. | Observation | Recommended Action Plan | Recommended Timeline |
|---|---|---|---|
| 23 | Lack of anchorage of steel roof for uplift forces. Tea Room | Building engineer is required to produce as built drawing and upgrade the roof connections for uplift force. | 6-weeks |

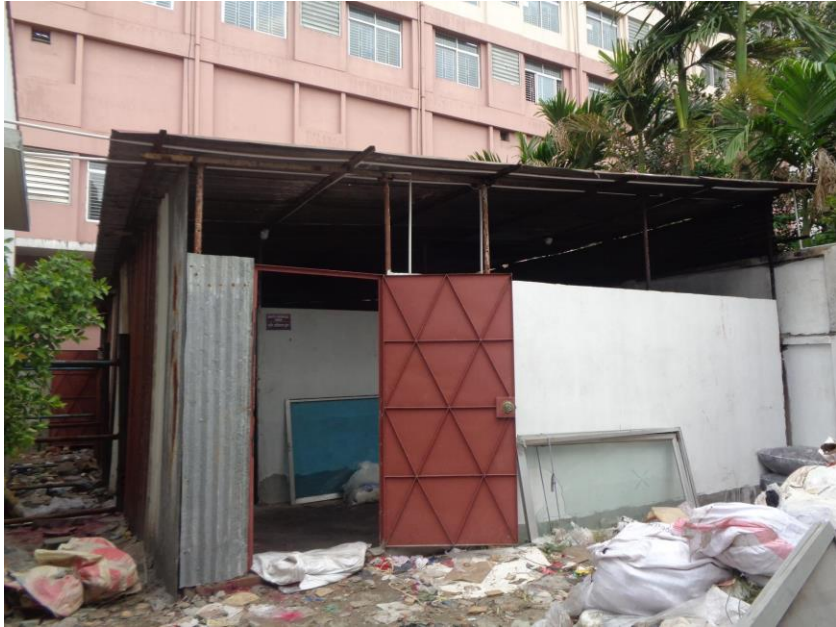
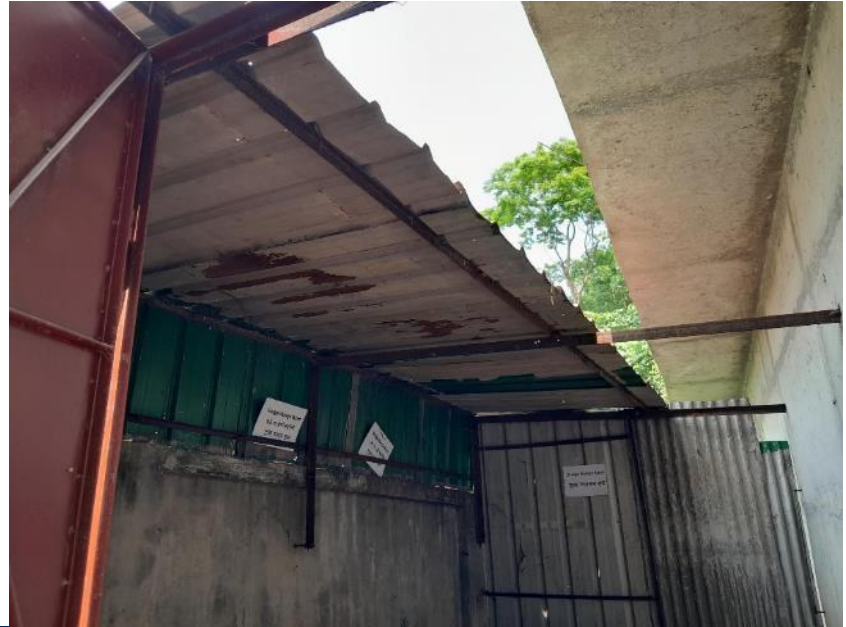
Non-engineered structures

Building engineer is required to replace the non-engineered sheds with engineered structures.

| Item No. | Observation | Recommended Action Plan | Recommended Timeline |
|---|---|---|---|
| 24 | Non-engineered structure. (Wastage Shed & ETP Shed) | The factory is required to replace the non-engineered sheds with engineered structures. | 6-months |
