# Fancy Fashion Sweaters Ltd. (Extension)

1153-54, Shahid Siddique Road, Khaikur, Board Bazar, Gazipur.

4 June 2023

# Observations

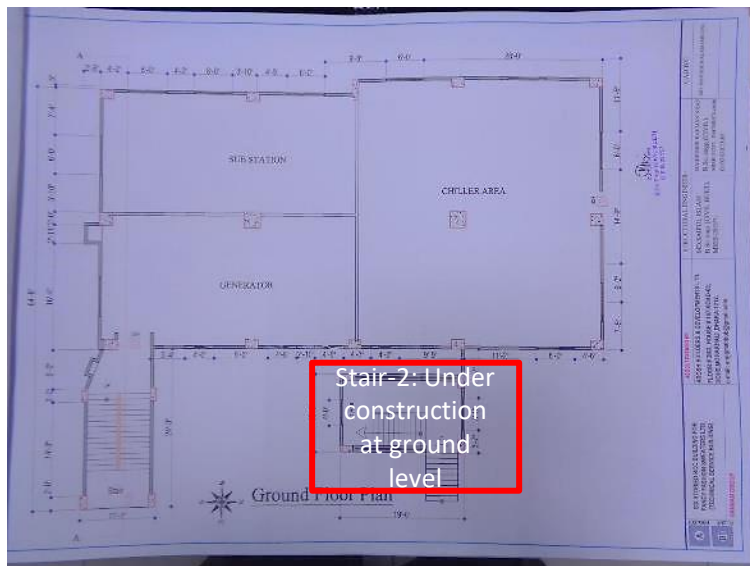
Ground floor plan

As-built drawings doesn't match with as-built condition. The building engineer is required to survey the structures and prepare accurate as-built drawings. Submit the drawing to the RSC for review.

| Item No. | Observation | Recommended Action Plan | Recommended Timeline |
|---|---|---|---|
| 03 | Incomplete as-built structural drawings. Building-2 (Service Building) | The building engineer is required to survey the structure and produce accurate as-built architectural & structural drawings. | 6-weeks |

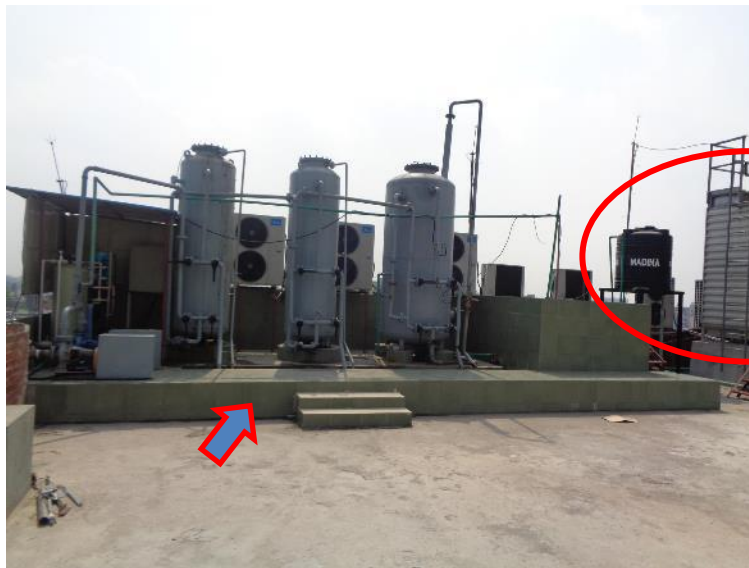
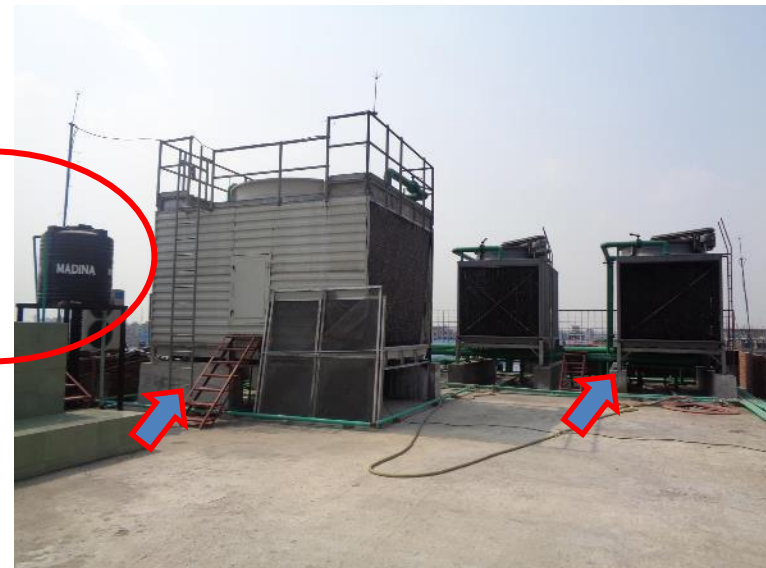
Floor built-ups and water tanks on the roof

Two plastic water tanks and floor raises are not shown in the as-built drawings. The building engineer is required to survey the structures and prepare accurate as-built drawings.

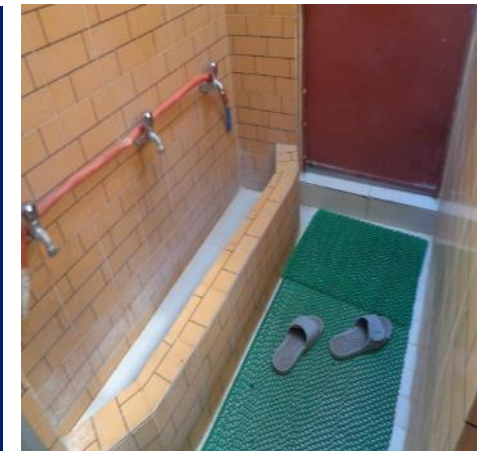
Floor built-ups of toilet zone not shown in drawing.

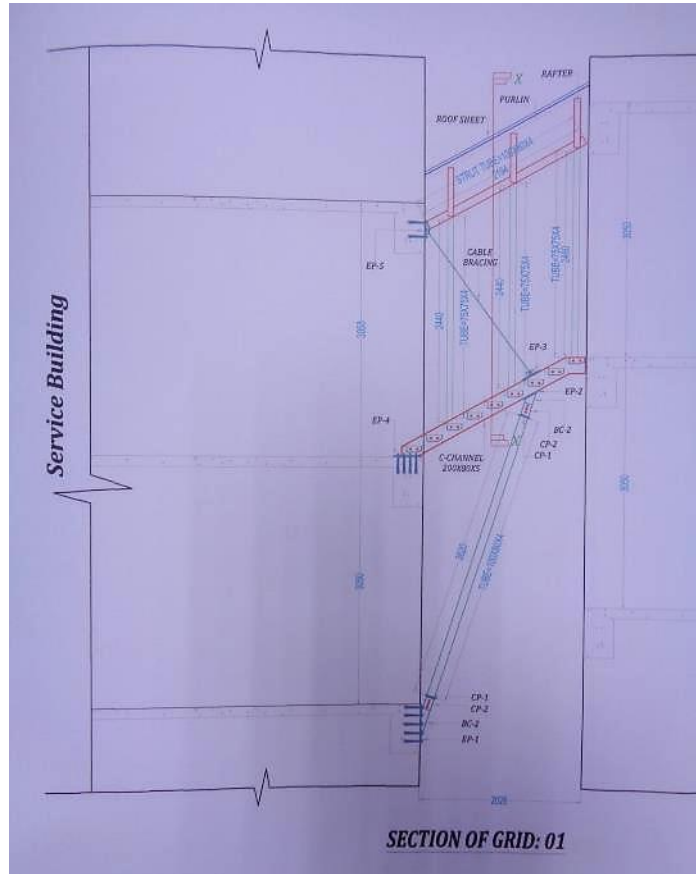
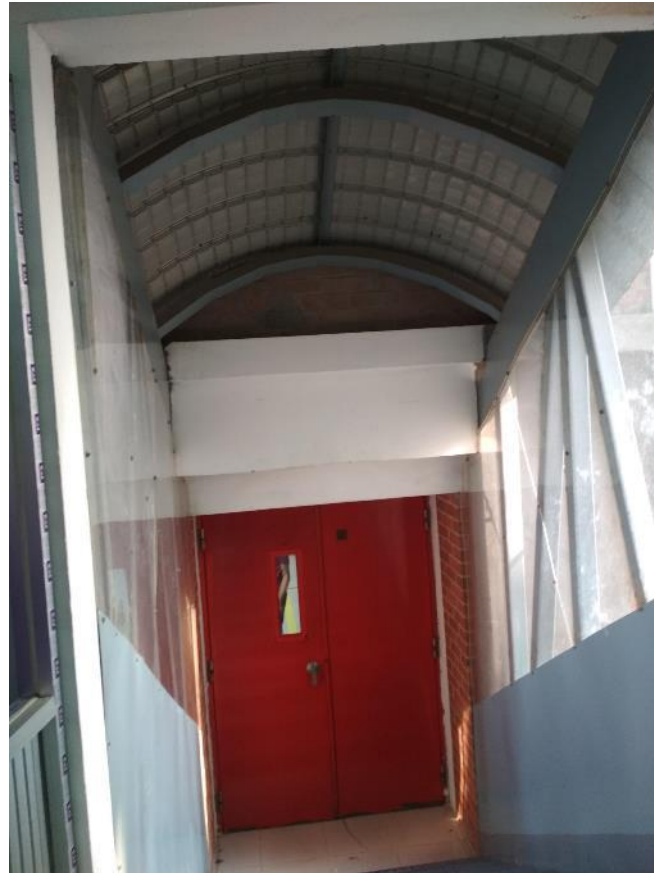
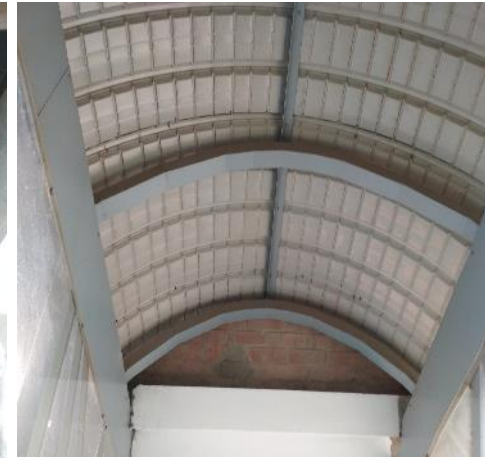
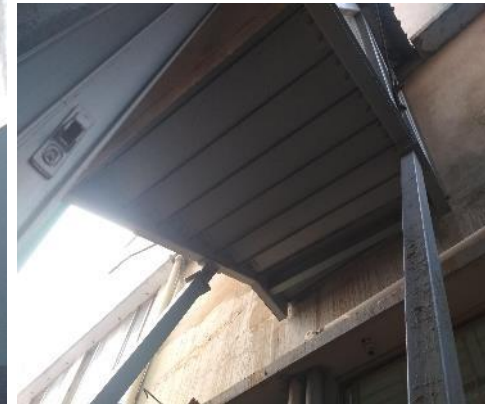
Steel connecting bridge between Building-1 and Building-2

Only a set of drawing was available for the connecting bridge. The building engineer is required to check the adequacy of the steel connecting bridge and suggest necessary remedial actions if required.

| Item No. | Observation | Recommended Action Plan | Recommended Timeline |
|---|---|---|---|
| 04 | Absence of adequacy check of steel connecting bridge. Building-2 (Service Building) | The building engineer is required to check the adequacy of the steel connecting bridge and suggest necessary remedial actions. | 6-weeks |
| 05 | Absence of adequacy check of steel connecting bridge. Building-2 (Service Building) | Carry out suggested remedial works. | 6-months |

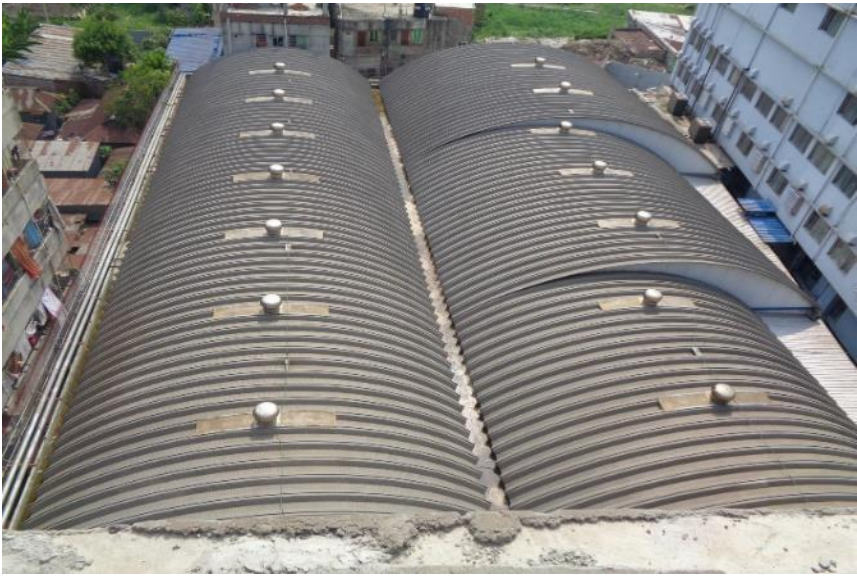
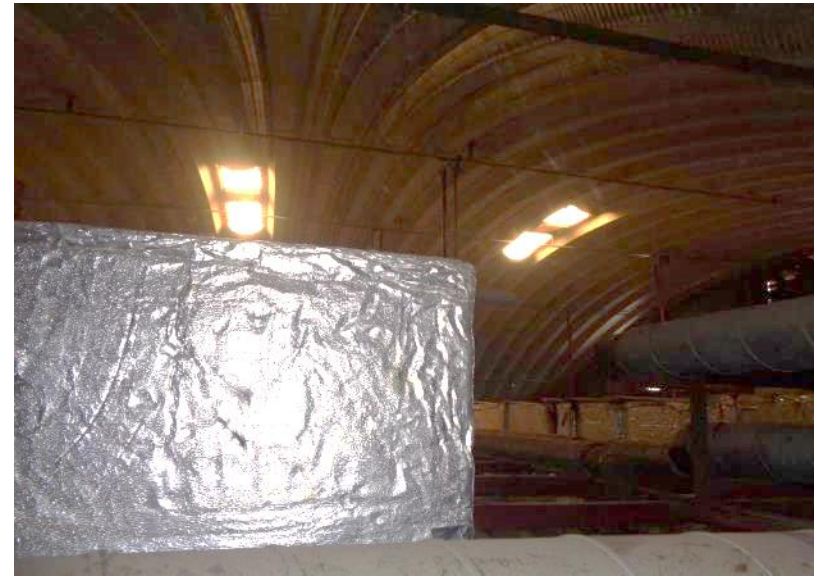
Metal curved roof decking system: No lateral support perpendicular to the deck rib

There is no framing along perpendicular direction of deck rib of steel curved roof. Therefore, the lateral stability of the steel decking roof is questionable. Also, there was no concrete test report onsite to confirm the design strength. So, the building engineer is required to check the lateral stability of the roof system and prepare a complete set of design report for the structure based on in-situ material strength.

| Item No. | Observation | Recommended Action Plan | Recommended Timeline |
|---|---|---|---|
| 06 | Stability of curved roof decking system.<br>(Jacquard Shed) | The building engineer is required to check the lateral stability of the roof system and prepare a complete set of design report for the structure based on in-situ material strength. | 6-weeks |
| 07 | Stability of curved roof decking system.<br>(Jacquard Shed) | Suggest necessary remedial work where required. | 6-weeks |
| 08 | Stability of curved roof decking system.<br>(Jacquard Shed) | Carry out suggested remedial works if required. | 6-months |

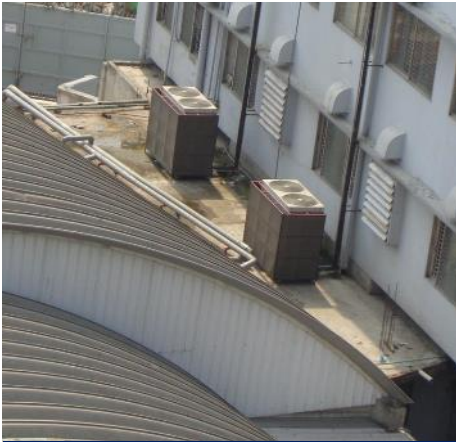
RC portion adjacent to the shed

The RC portion, steel roof extension at north and individual truss-column framings are not shown in the drawing. The building engineer is required to survey the structure and produce a complete set of as-built drawing with necessary connection details.

| Item No. | Observation | Recommended Action Plan | Recommended Timeline |
|---|---|---|---|
| 09 | Incomplete as-built drawings.<br>(Jacquard Shed) | The building engineer is required to survey the structure and produce a complete set of as-built drawing with necessary connection details. | 6-weeks |

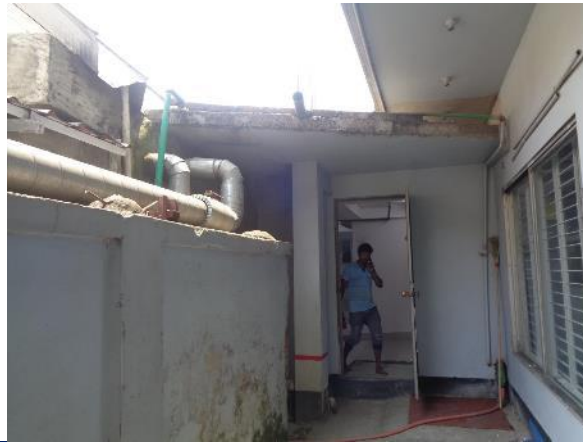
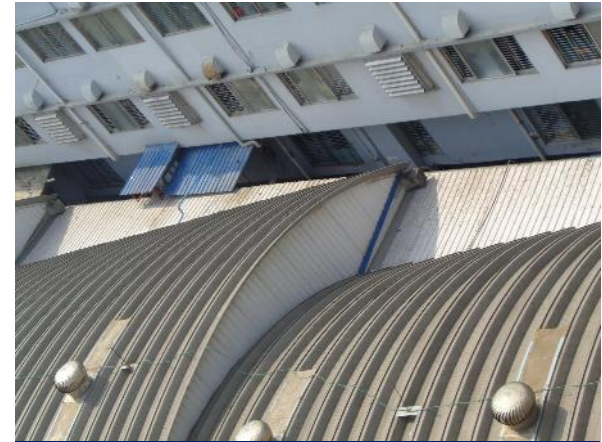
Roof extension on north

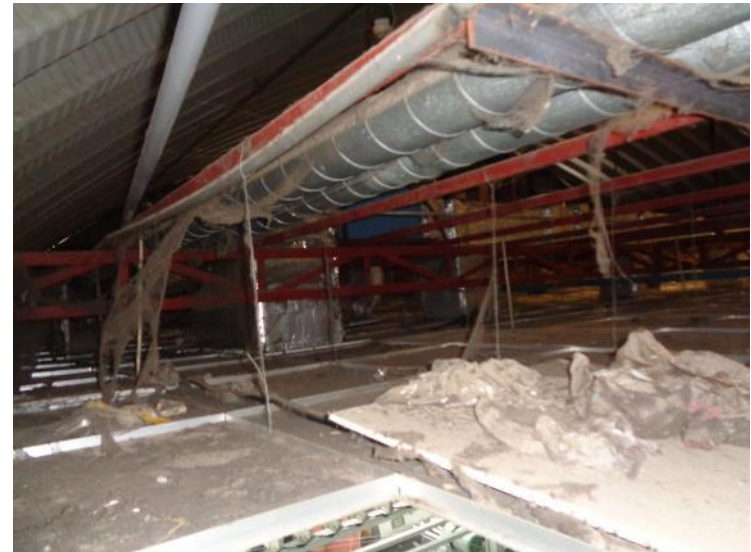
Individual truss-column frame for MEP

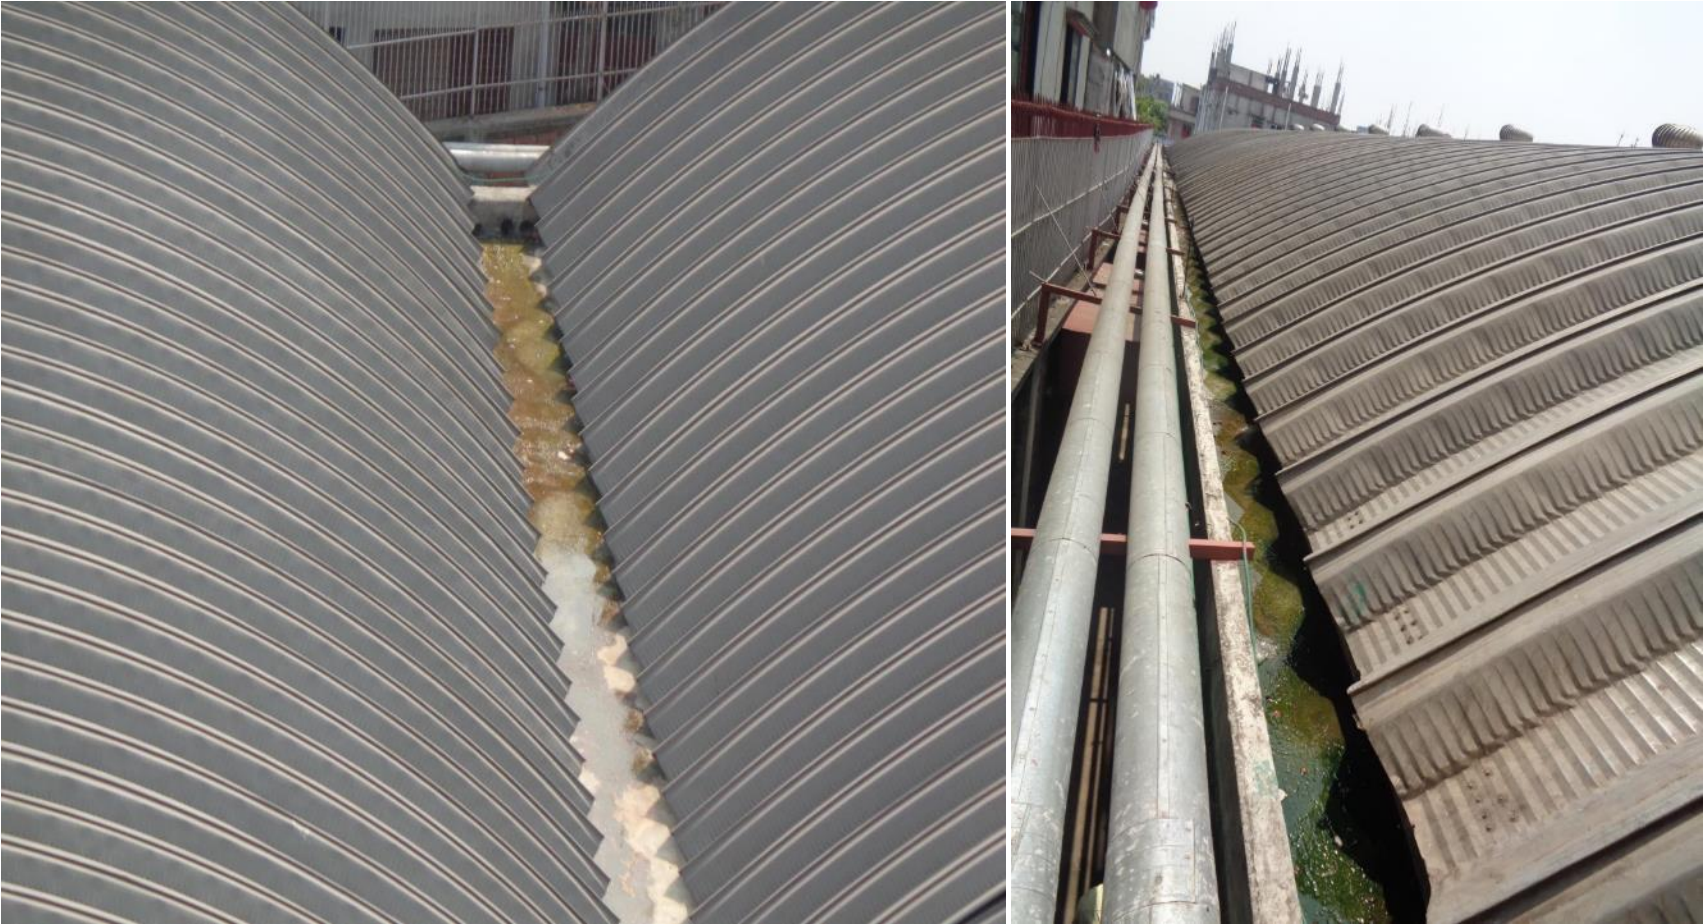
Water ponding on the concrete valley gutters of roof

Building engineer is required to provide adequate slope and outlet for the drainage system.
