# Yester Jeans Ltd (Extension Building)

Plot # 115-116, Adamjee EPZ, Siddhirganj, Narayanganj-1431.

19 June 2023

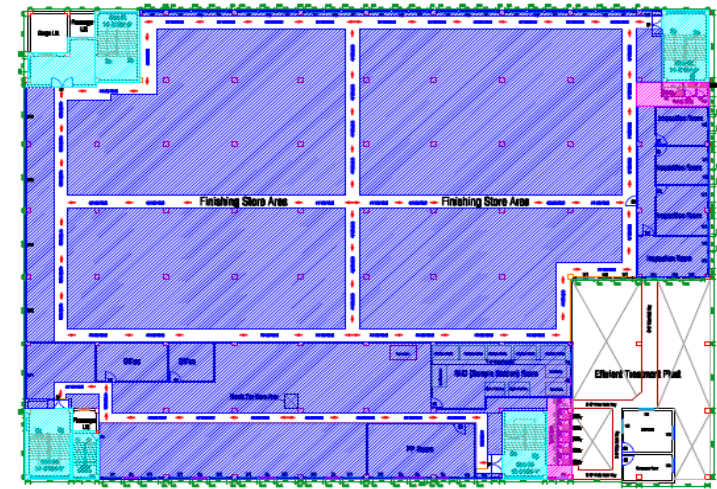
Live load chart of BNBC

The 1<sup>st</sup> floor of the building is being allotted for fabric store. As per BNBC, the minimum floor live load for light storage is 6 kN/m<sup>2</sup> (125 psf). But the storage area of the building is designed for 5 kN/m<sup>2</sup> live loads.

Building engineer is required to revise the storage live load limit and related design documents based on BNBC requirement.

| Item No. | Observation | Recommended Action Plan | Recommended Timeline |
|---|---|---|---|
| 02 | Load plan & design report not comply with BNBC requirements.<br>(Production Building-2) | Building engineer is required to revise the storage live load and related design documents based on BNBC requirement. | 6-weeks |

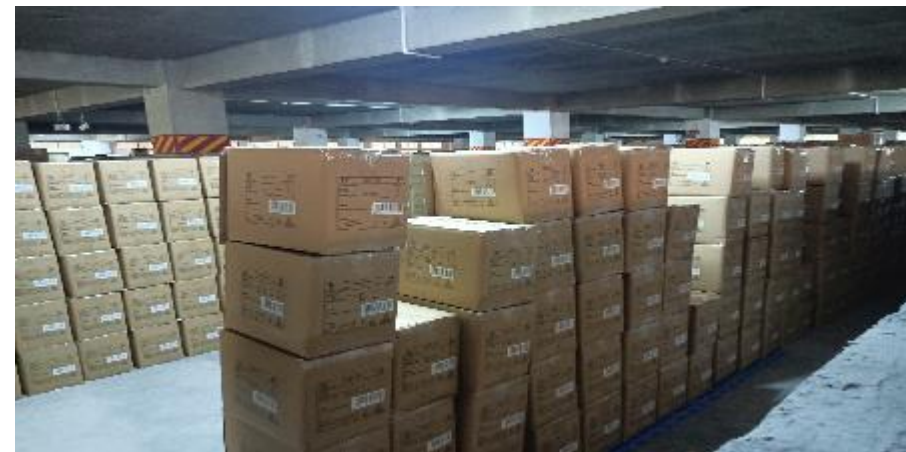
Floor live load

5 kPa live load for fabric store

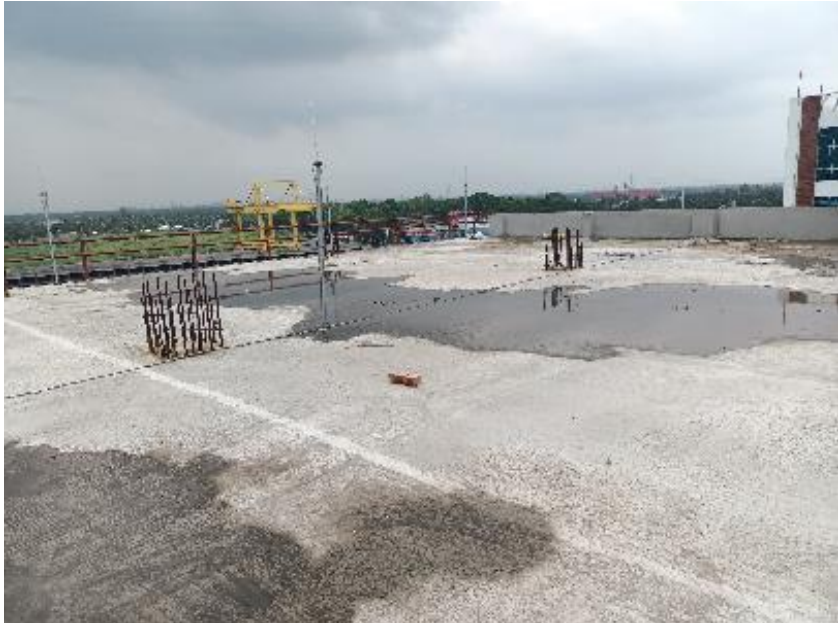
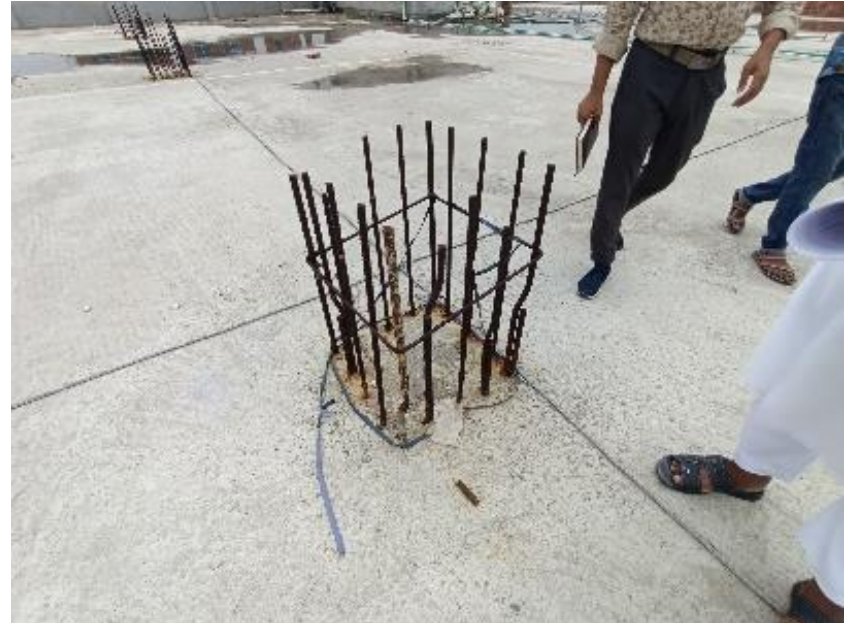
Exposed rebar at column on roof

Exposed reinforcement was found extended from column on roof. All exposed reinforcement is to be protected from corrosion which may cause degradation of the concrete. Factory engineer is required to take necessary measures to prevent the corrosion in exposed rebar.

| Item No. | Observation | Recommended Action Plan | Recommended Timeline |
|---|---|---|---|
| 06 | Expose rebar on roof. (Production Building-2) | All exposed reinforcement is to be protected from corrosion which may cause degradation of the concrete. | 6-weeks |

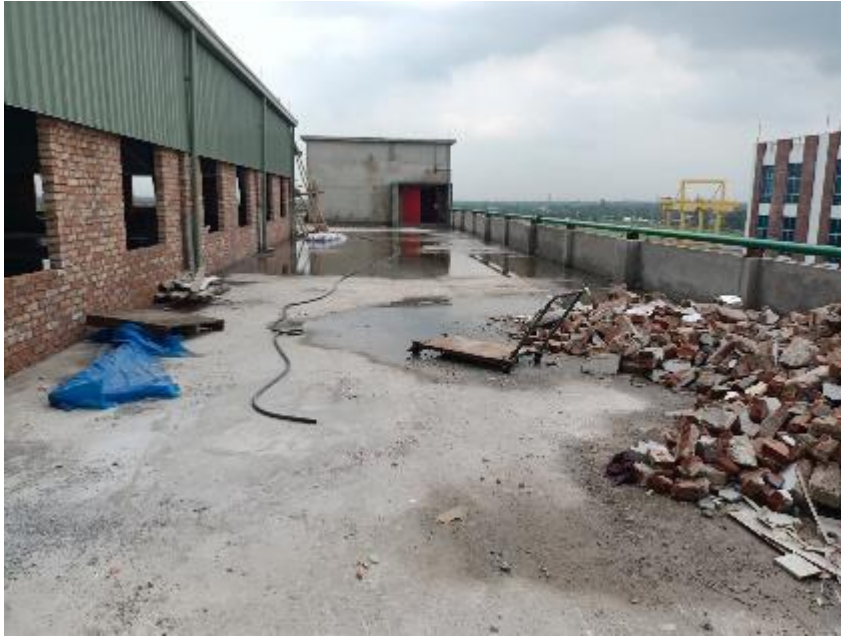
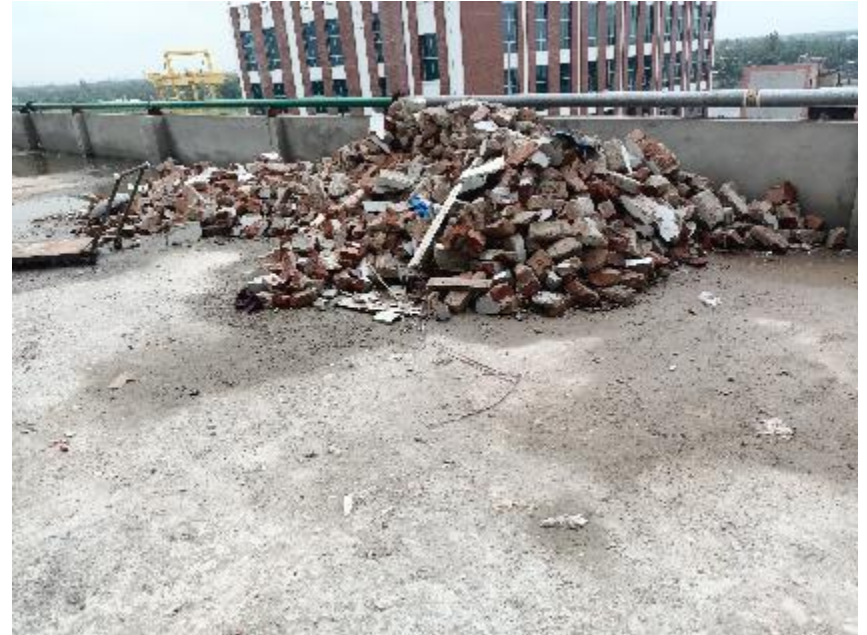
Construction debris was found on the roof. The factory is required to remove wastage from roof and keep the roof clean.

| Item No. | Observation | Recommended Action Plan | Recommended Timeline |
|---|---|---|---|
| 07 | Construction debris on the roof. (Production Building-2) | Remove construction materials from the roof. | 6-weeks |

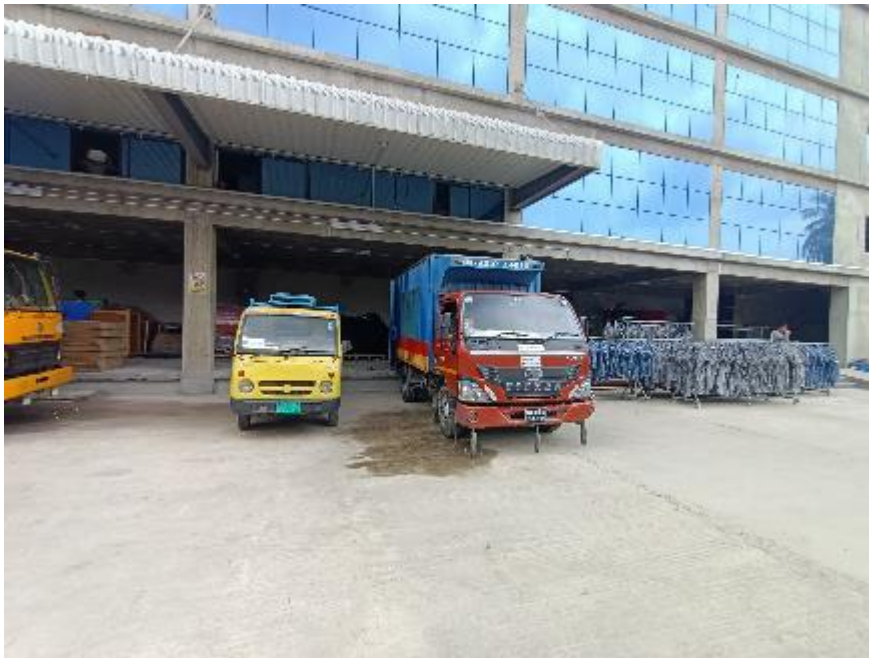
Columns are susceptible to vehicle impact in the loading-unloading areas on ground floor. Building engineer is required to install a barrier to prevent vehicle impact in column.

Susceptible column

| Item No. | Observation | Recommended Action Plan | Recommended Timeline |
|---|---|---|---|
| 08 | Columns susceptible to vehicle impact. (Production Building-2) | Install a barrier to prevent vehicle impact in column. | 6-weeks |

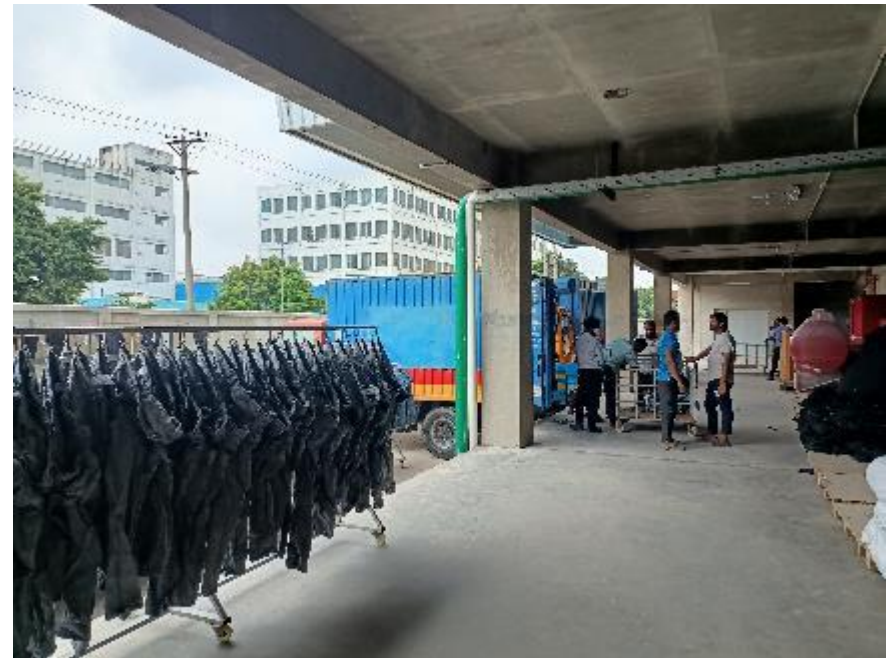
Susceptible column

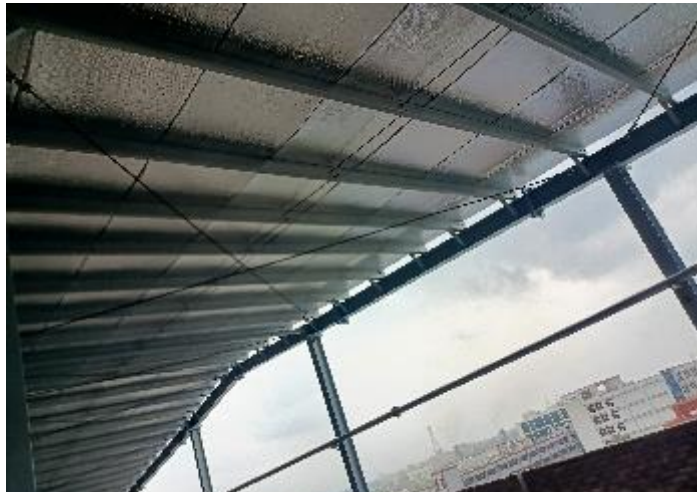
Lateral load transfer media (compression strut) was found offset along grid 2 at point C. Also, number of joint of rafter did not match with provided drawings. Building engineer is required to revise the drawings as per as-built condition and submit to RSC.

Rafter section

| Item No. | Observation | Recommended Action Plan | Recommended Timeline |
|---|---|---|---|
| 09 | Discrepancies in as built drawings. (Production Building-2 Roof Shed) | Building engineer is to survey the whole structure and update as-built drawings representing accurate site condition. | 6-weeks |

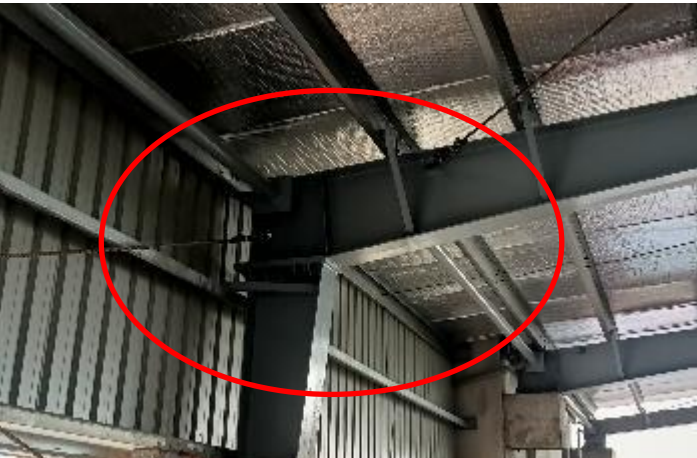
Offset strut

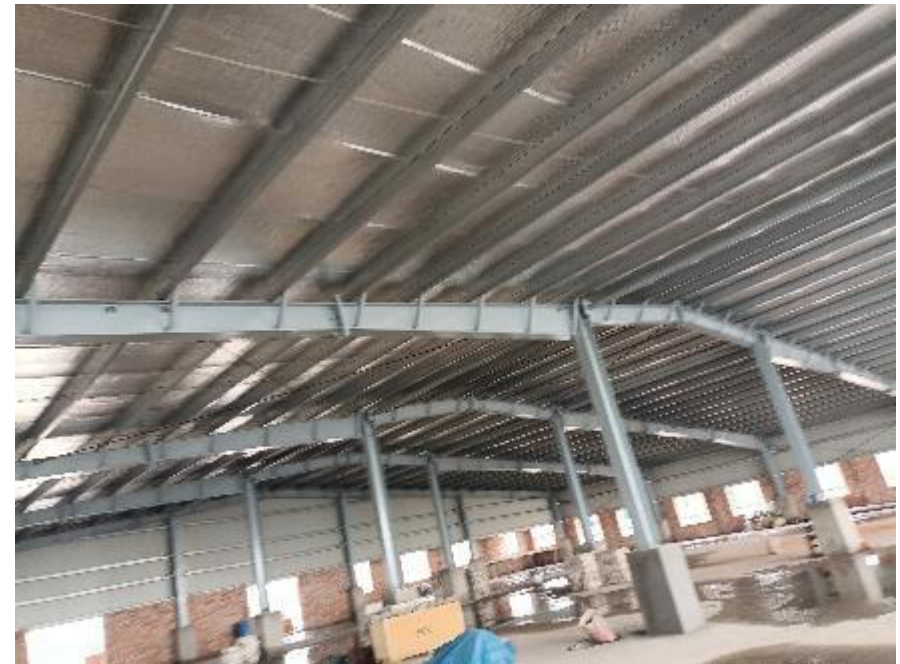
Roof Shed

In the design report, wind load calculation for roof shed and rafter deflection check was not found. Building engineer is required revised the design report incorporating all the missing information.

| Item No. | Observation | Recommended Action Plan | Recommended Timeline |
|---|---|---|---|
| 10 | Incomplete design report. (Production Building-2 Roof Shed) | Building engineer is required revise the design report providing all the necessary calculation and checks. | 6-weeks |
| 11 | Incomplete design report. (Production Building-2 Roof Shed) | Carry out remedial works (if any) after review by RSC. | 6-months |

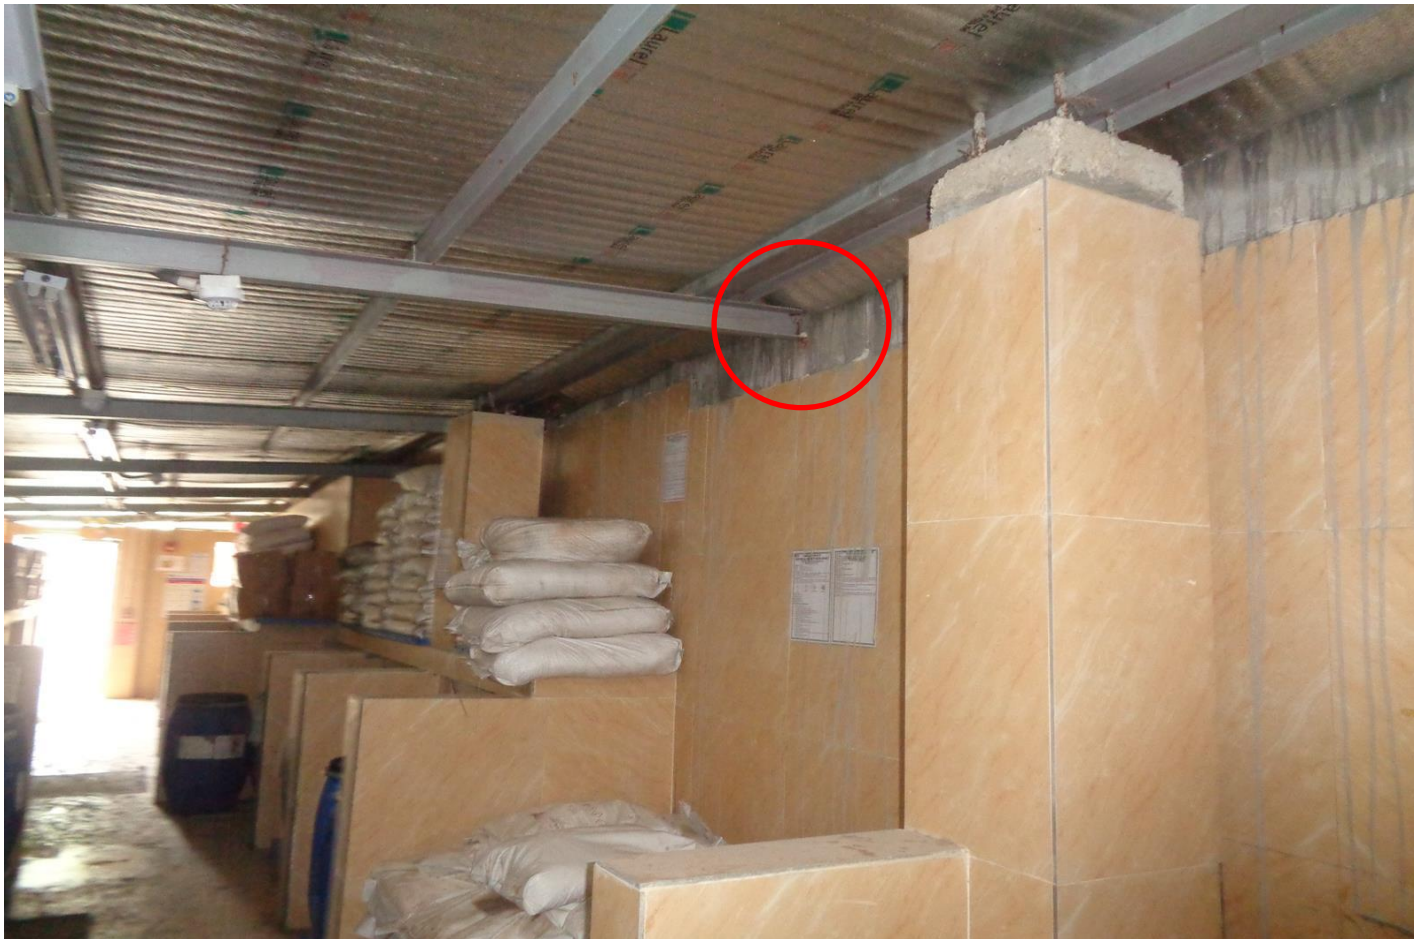
Rafter inserted to brick wall

Rafter were inserted to brick wall. The connection between rafter & brick wall was appeared to be inadequate. Building engineer is required to check the connection adequacy for uplift forces as part of EA.

| Item No. | Observation | Recommended Action Plan | Recommended Timeline |
|---|---|---|---|
| 12 | Apparently inadequate connection. (Chemical Store Shed) | Building engineer is required to check the connection adequacy for uplift forces and propose a remediation plan. | 6-weeks |
| 13 | Apparently inadequate connection. (Chemical Store Shed) | Carry out remedial works where required. | 6-months |
