# SOUTHERN CLOTHINGS LIMITED

## (Extension)

Bottola, Zirabo, Ashulia, Dhaka  
(23.907989, 90.321843)

12 June 2023

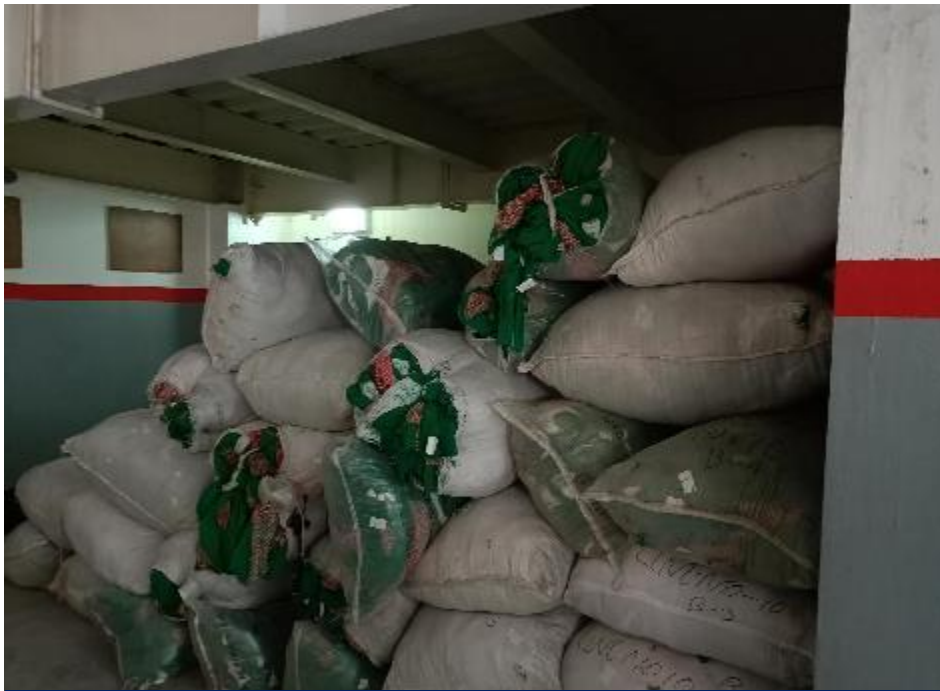
Storage on suspended floors

Currently, the typical floor of the building is being allotted for fabric store. As per BNBC, the minimum floor live load for light storage is 6 kN/m<sup>2</sup> (125 psf). But the storage (typical floors) area of the building is designed for 5 kN/m<sup>2</sup> live loads. The building engineer is required to revise the storage live load limit and related design documents based on BNBC requirement.

| Item No. | Observation | Recommended Action Plan | Recommended Timeline |
|---|---|---|---|
| 01 | Load plan & design report not comply with BNBC requirements. (Building 3) | Building engineer is required to revise the storage live load and related design documents based on BNBC requirement. | 6-weeks |

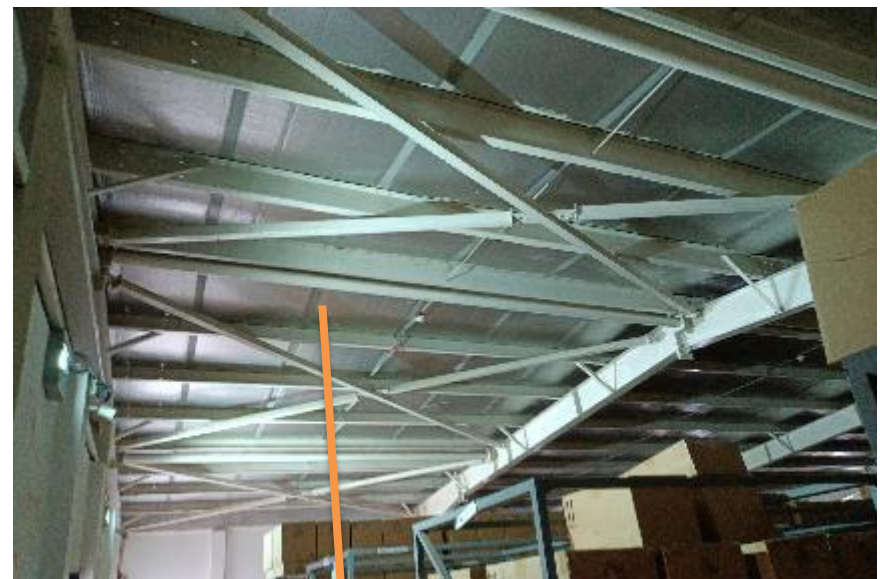
Roof bracing and compression strut layout are not matched with as-built condition. Building engineer is required to revise the structural drawings as per on site condition and submit to RSC.

Strut and bracing

| Item No. | Observation | Recommended Action Plan | Recommended Timeline |
|---|---|---|---|
| 04 | Mismatch in drawings. (Building 3) | Building engineer is to survey the whole structure and update as-built drawings representing accurate site condition. | 6-weeks |

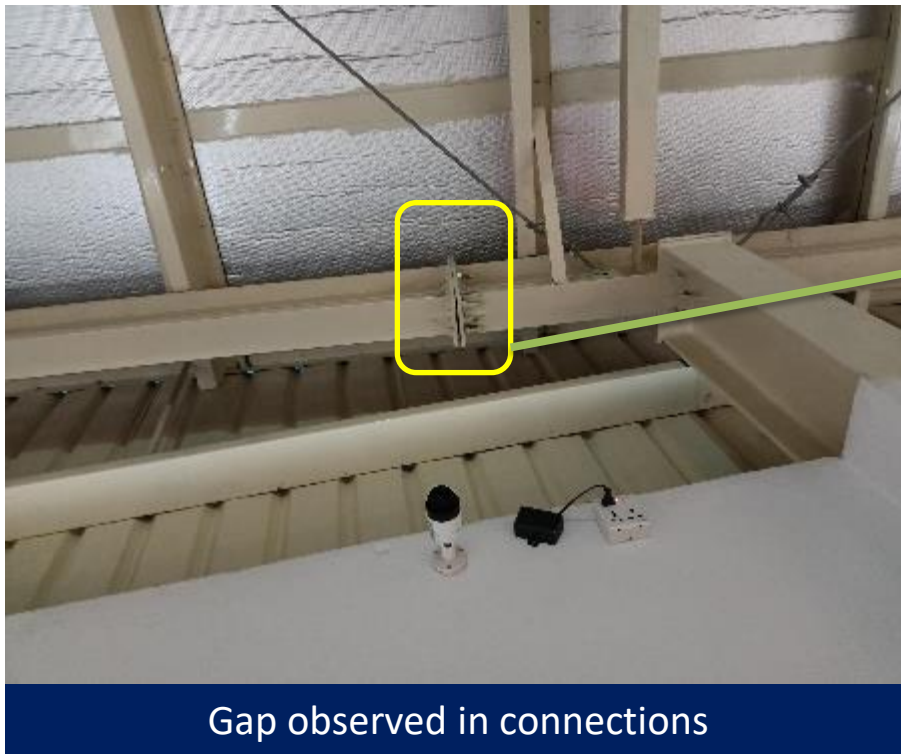
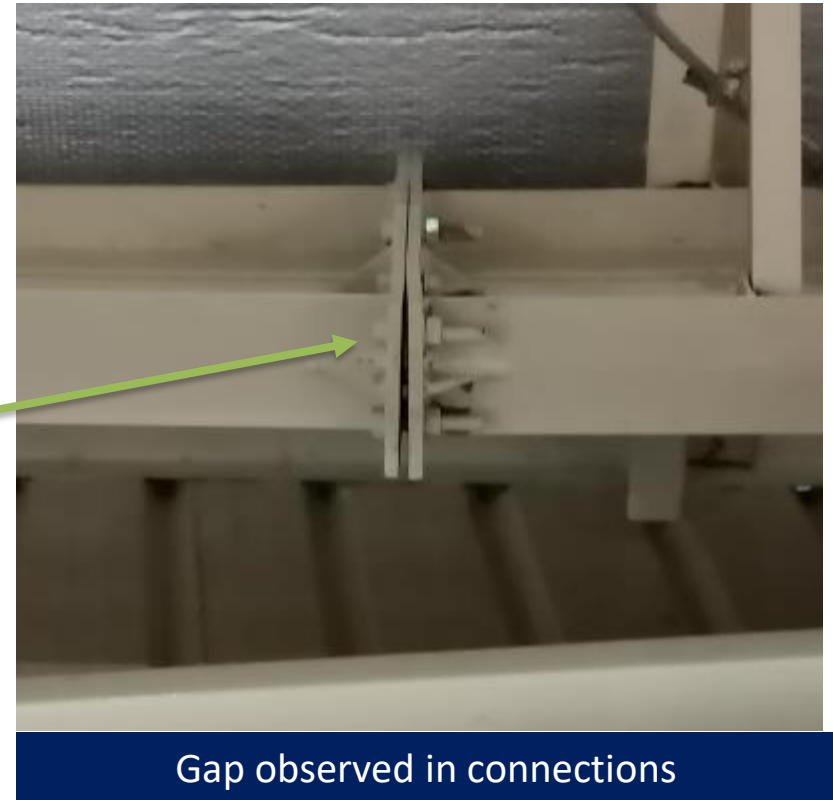
Significant gaps observed in Rafter-column joint at several locations. Building engineer is required to carry out suitable remedial works.

| Item No. | Observation | Recommended Action Plan | Recommended Timeline |
|---|---|---|---|
| 05 | Significant connection gap. (Building 3) | Building engineer is required to repair the gap in connections with a suitable method. | 6-weeks |

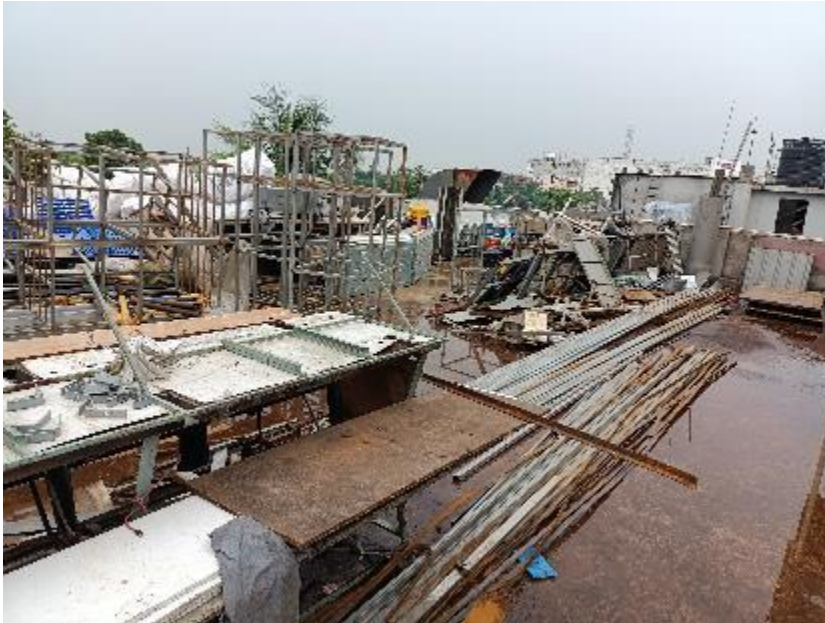
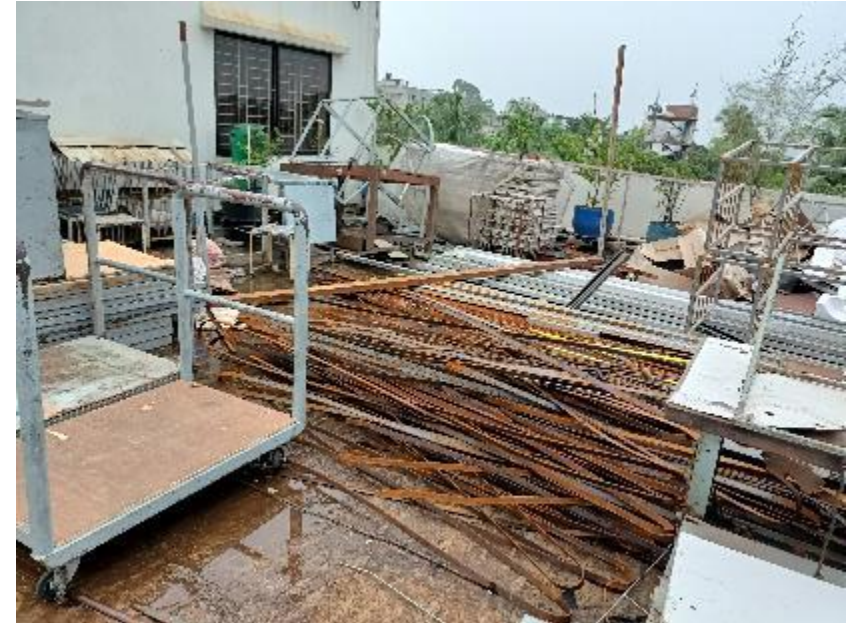
Stacking of construction materials and wastage found almost everywhere on the roof.

| Item No. | Observation | Recommended Action Plan | Recommended Timeline |
|---|---|---|---|
| 06 | Staking of construction material on the roof. (Building 3) | Remove construction materials and wastage from roof. | 6-weeks |

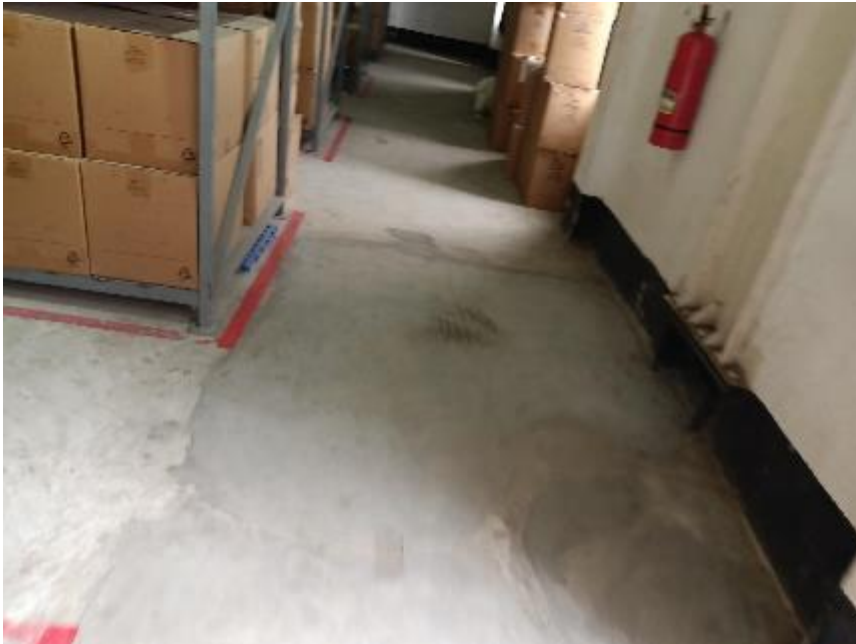
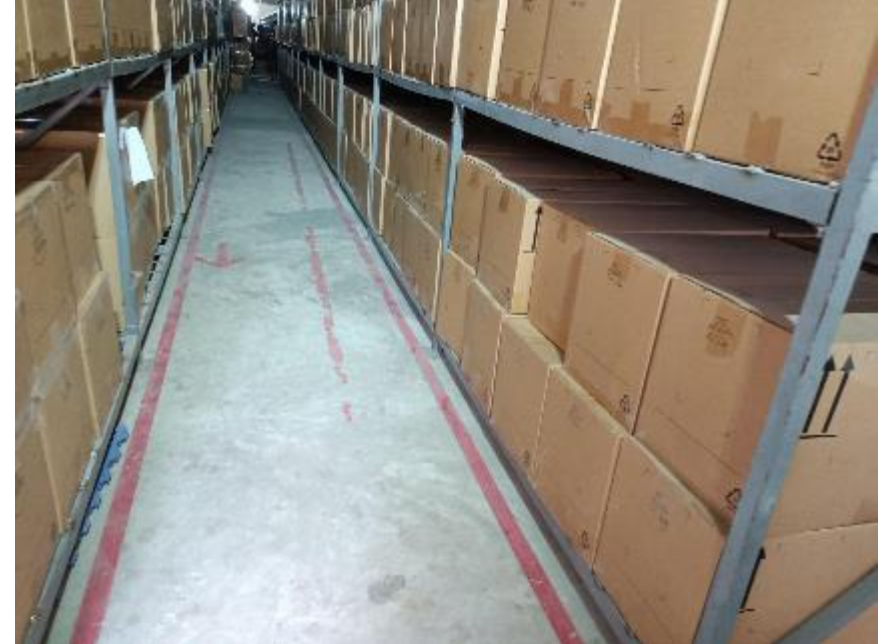
Non-anchored storage rack at several floors

Some racks on different floors are not anchored or braced to resist lateral (earthquake) forces. The factory is required to anchor/brace all non-structural elements adequately to resist earthquake forces.

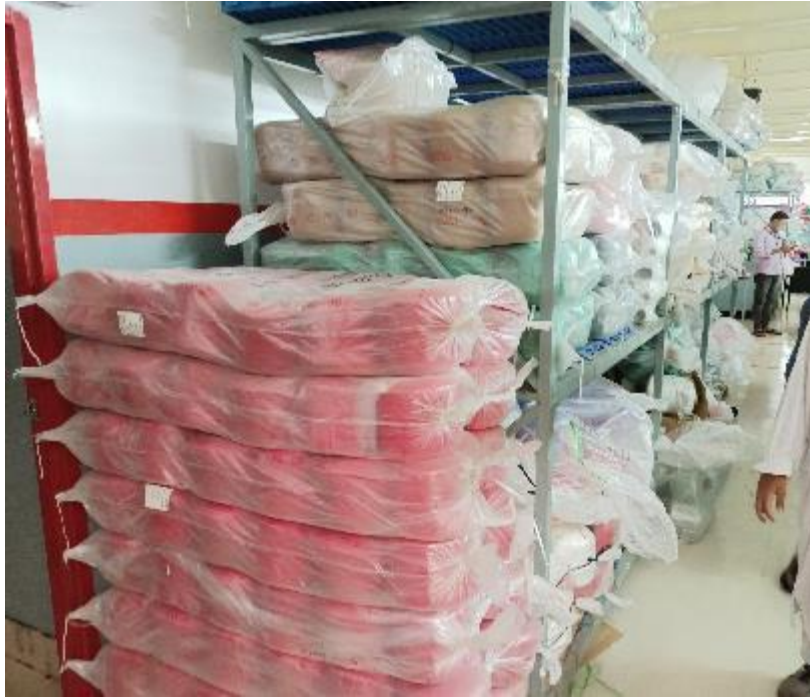
Floor loading

On the other hand, load plan was not found for the building. Building engineer is required to revised the design report updating the above-mentioned issues and submit to RSC.

Tensile strength of MS plate was considered 345 Mpa (50 Ksi) but no plate test report was found during the inspection. Building engineer is required to confirm the tensile strength of MS plate from existing building.

| Item No. | Observation | Recommended Action Plan | Recommended Timeline |
|---|---|---|---|
| 07 | Design report required to be revised. (Building 4) | Building engineer is required revise the design report considering actual size and strength of concrete & steel materials. | 6-weeks |

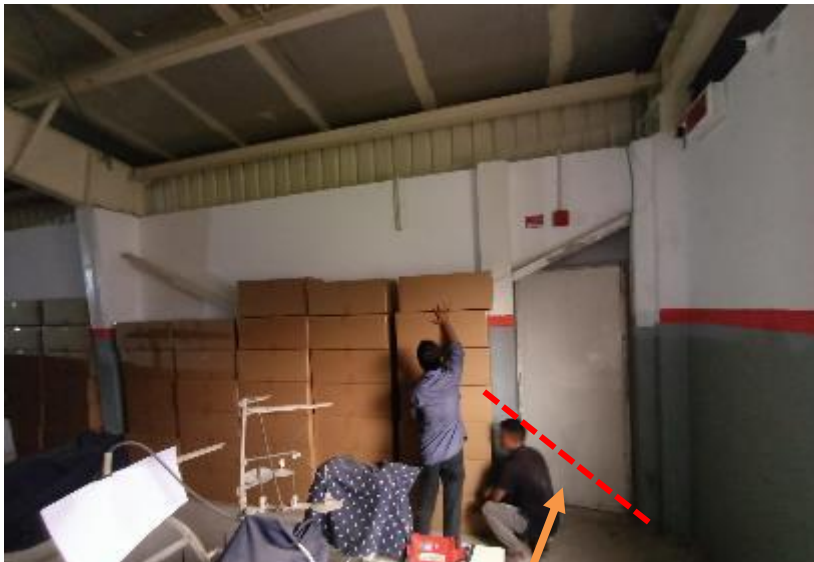
Missing bracing

Vertical bracings were found missing at Northwest corner of the shed due to door opening. Building engineer is required to install the missing bracing where necessary.

| Item No. | Observation | Recommended Action Plan | Recommended Timeline |
|---|---|---|---|
| 11 | Vertical bracing missing. (Building 4) | Install the vertical bracings where necessary. | 6-weeks |

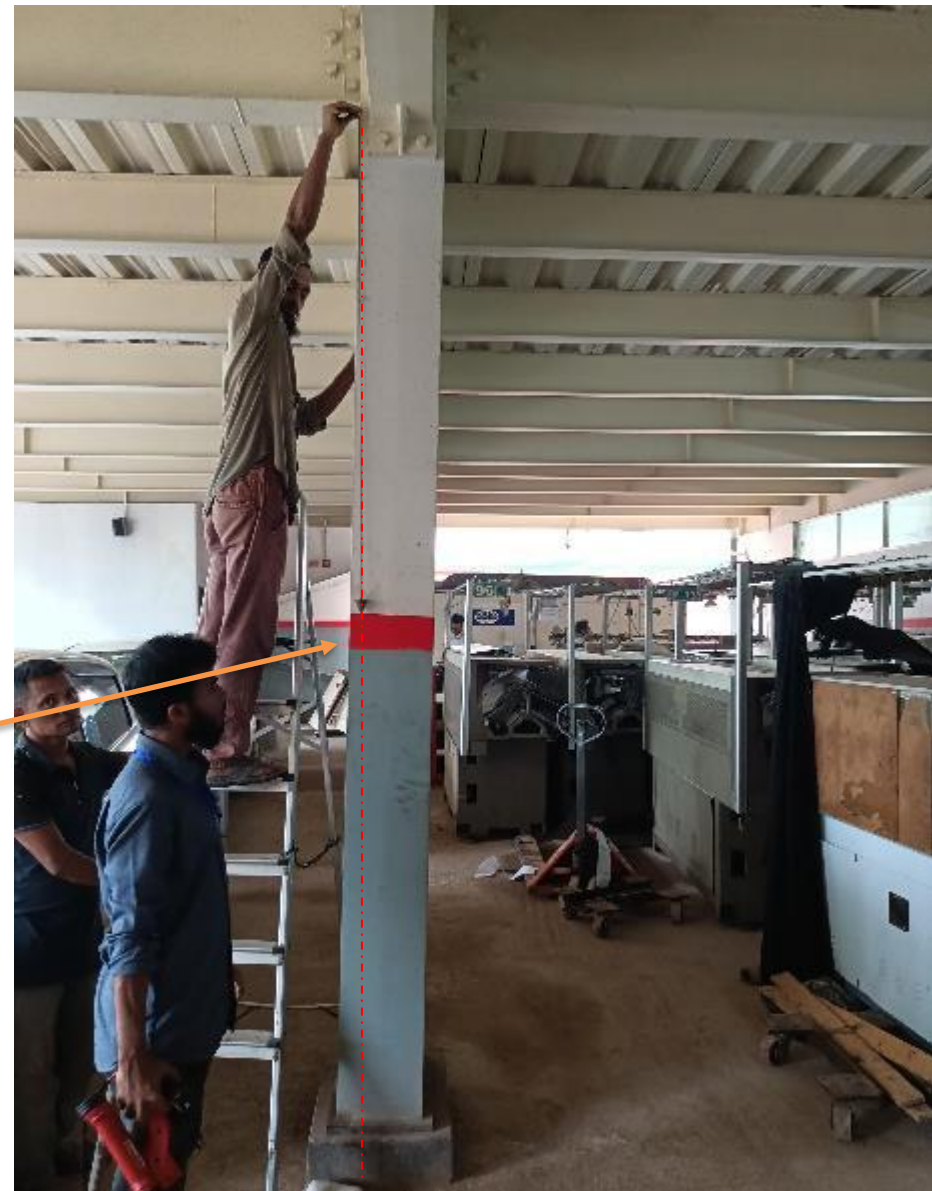
A distorted steel column found on ground floor in parking areas. Stability for the distorted columns and related elements need to be checked. Factory Engineer to review design, loads and column stress in the area identified above.

Distorted steel column

| Item No. | Observation | Recommended Action Plan | Recommended Timeline |
|---|---|---|---|
| 12 | Distorted steel column. (Building 4) | Building engineer to review design of distorted steel column considering the as-built condition of the column. | 6-weeks |
| 13 | Distorted steel column. (Building 4) | Carry out remedial works (if any) after review by RSC. | 6-months |

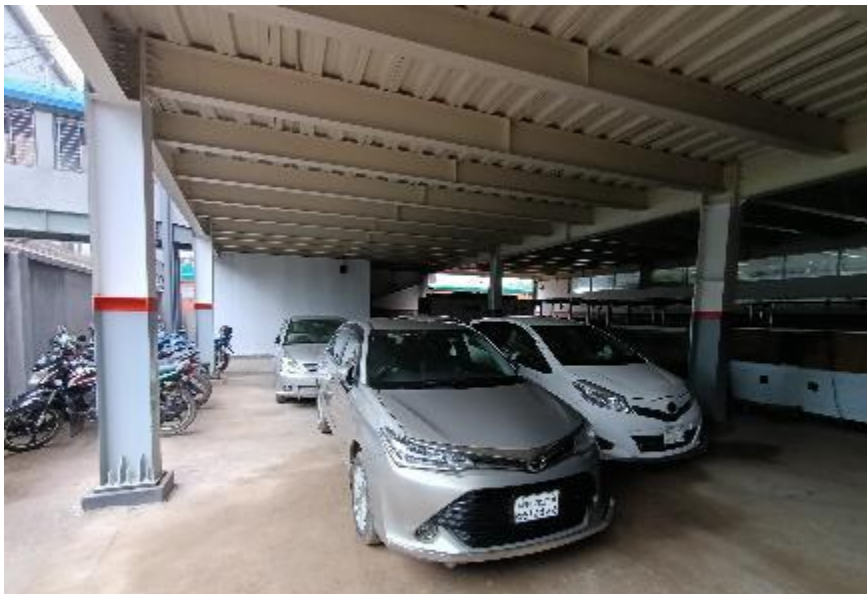
Columns are susceptible to vehicle impact in the parking areas on ground floor. Building engineer is required to install a barrier to prevent vehicle impact in column.

Susceptible column

| Item No. | Observation | Recommended Action Plan | Recommended Timeline |
|---|---|---|---|
| 14 | Columns susceptible to vehicle impact. (Building 4) | Install a barrier to prevent vehicle impact in column. | 6-weeks |

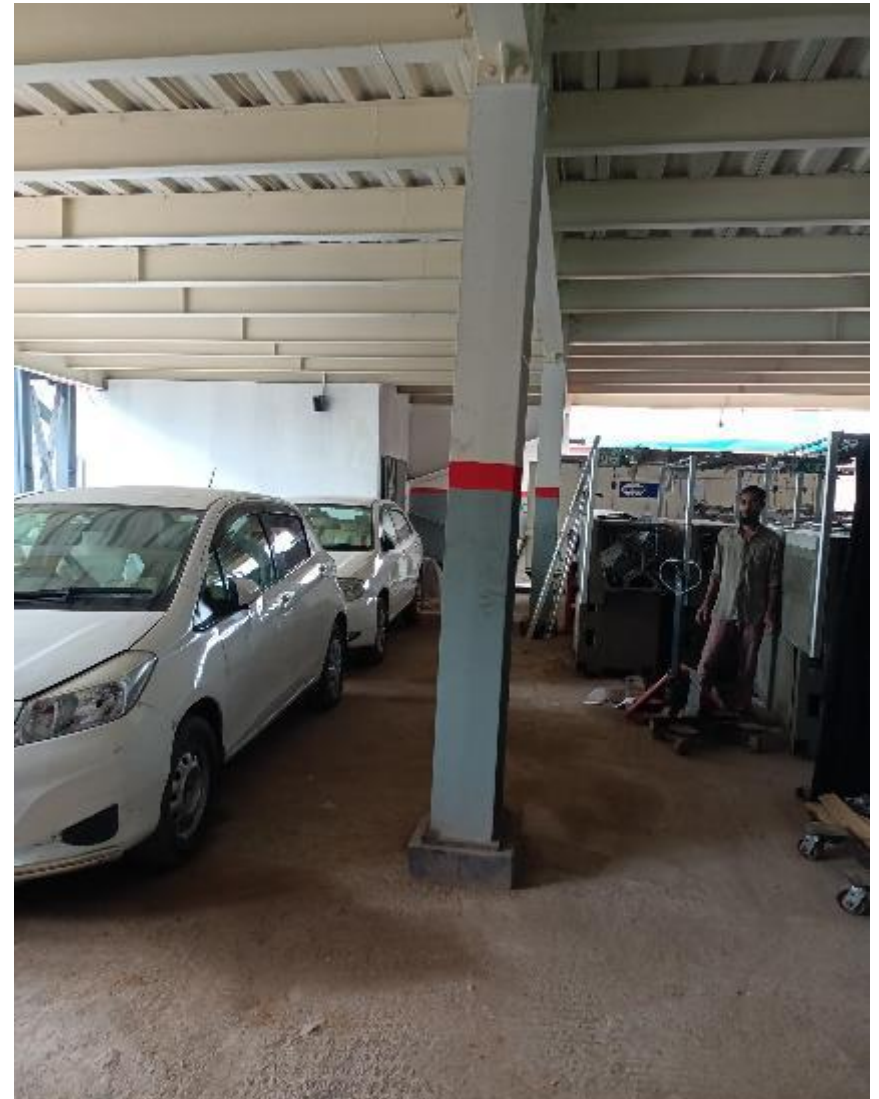
Susceptible column

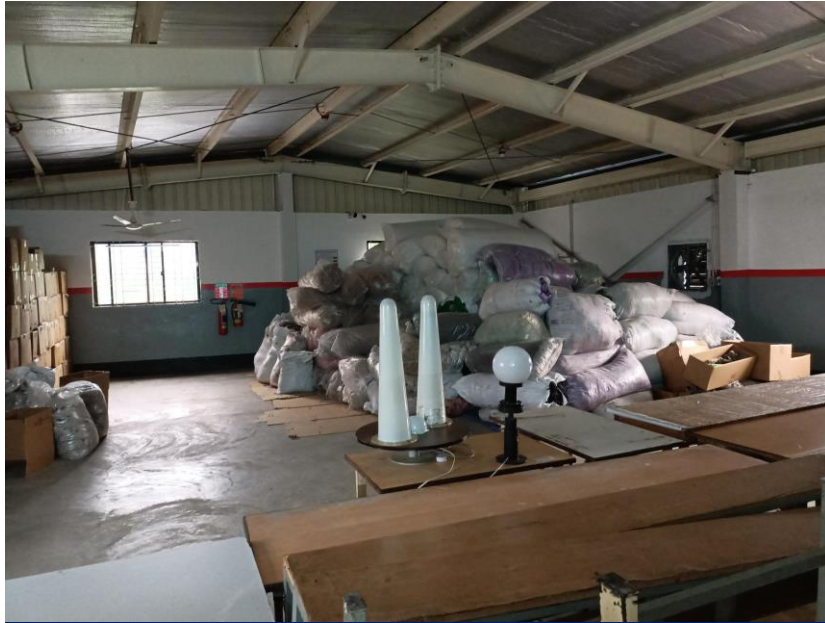
Floor loading

On the other hand, load plan was not found for the building. Building engineer is required to revised the design report updating the above-mentioned issues and submit to RSC.

Tensile strength of MS plate was considered 290 Mpa (42 Ksi) but no plate test report was found during the inspection. Building engineer is required to confirm the tensile strength of MS from existing building.

| Item No. | Observation | Recommended Action Plan | Recommended Timeline |
|---|---|---|---|
| 15 | Design report required to be revised. (Building 5) | Building engineer is required revise the design report considering actual size and strength of concrete & steel materials. | 6-weeks |

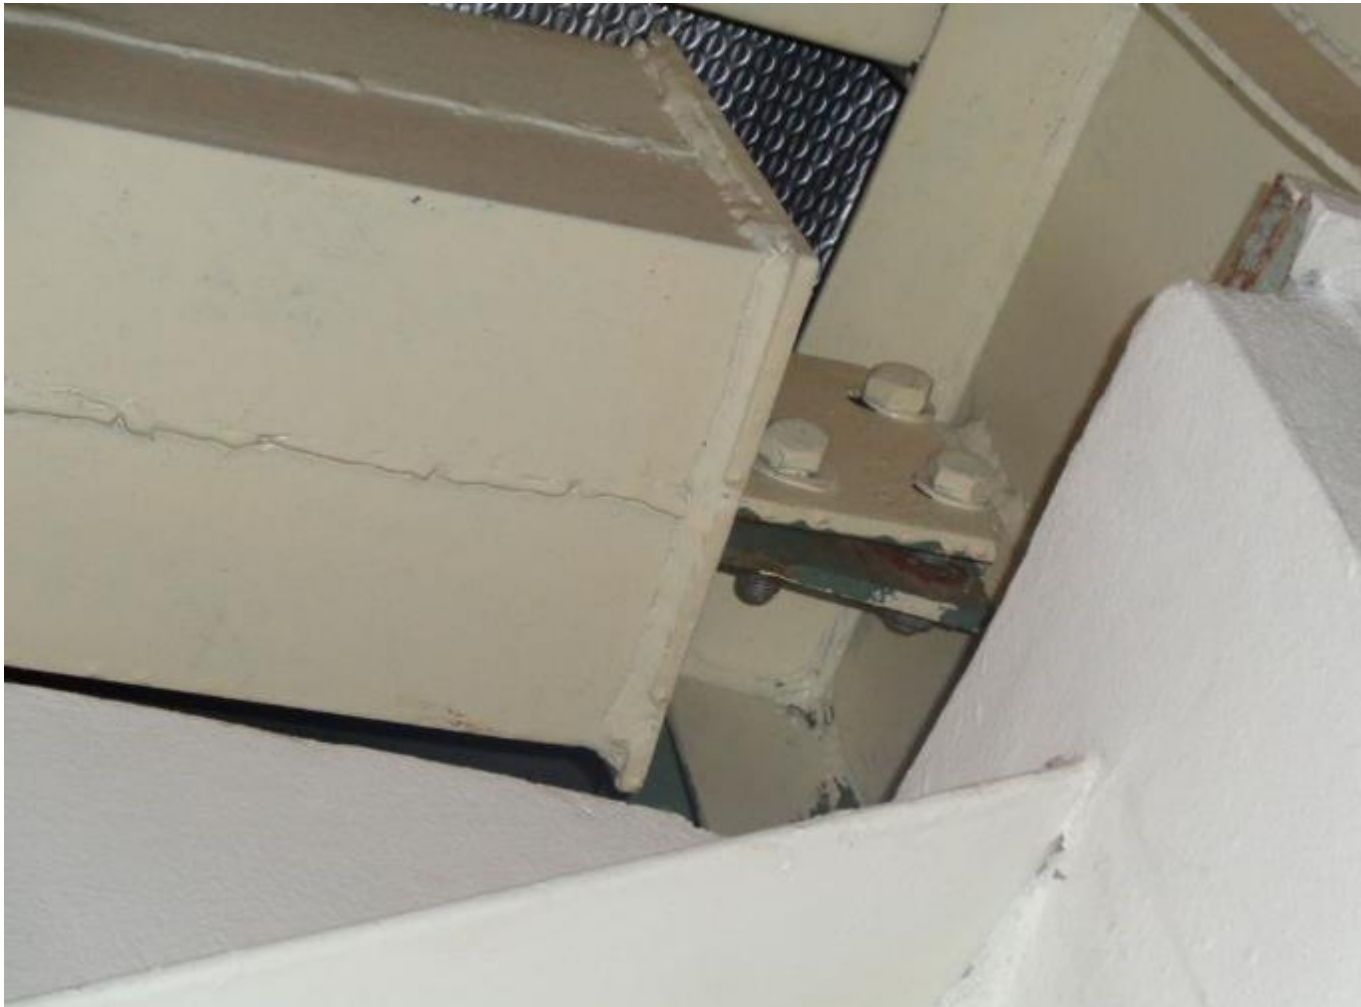
Significant gaps observed in strut joint at several locations. Building engineer is required to carry out suitable remedial works.

Gap observed in connections

| Item No. | Observation | Recommended Action Plan | Recommended Timeline |
|---|---|---|---|
| 19 | Connection gap in joint. (Building 5) | Building engineer is required to repair the gap in connections with a suitable method. | 6-weeks |

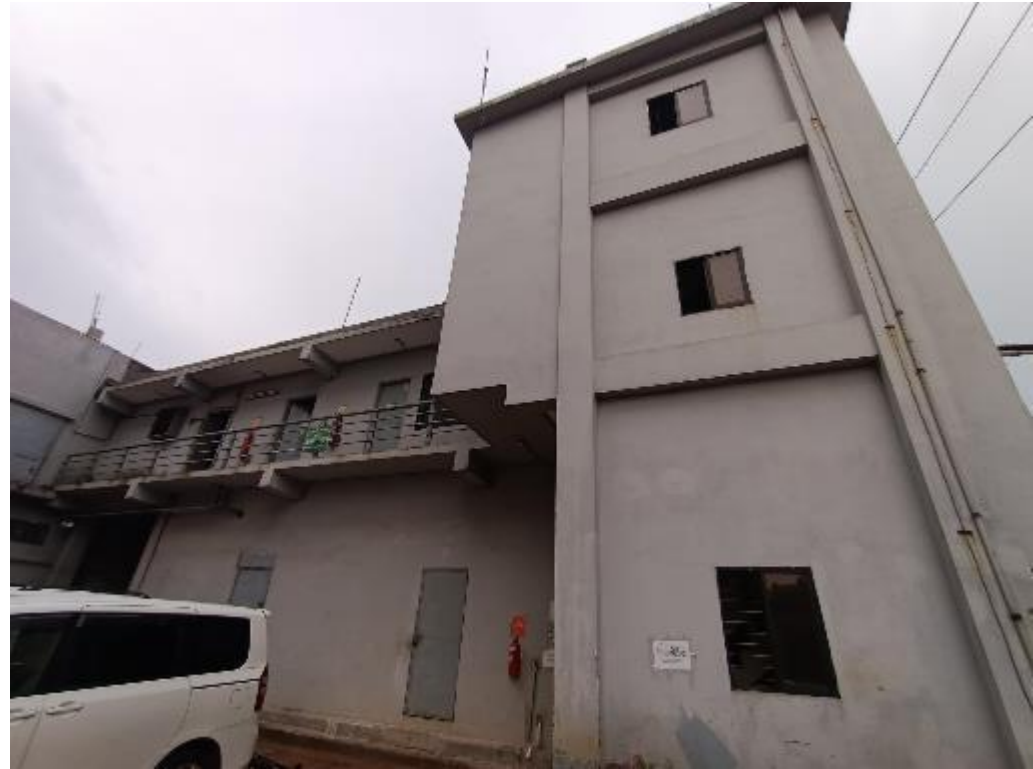
As per BNBC, every building or structure designed shall have its design documents prepared in accordance with the provision of Section 1.9.1. The design document shall include a design report, and a set of structural drawings, which shall be prepared in compliance with section 1.9.1.1 and section 1.9.1.2, part-6 of BNBC. At the time of inspection, only as-built drawing and geotechnical report were available, but no design report & load plan were available which are required to be prepared in compliance with section 1.9.1.1 (part-6, BNBC).

No design report was available for Utility Building

| Item No. | Observation | Recommended Action Plan | Recommended Timeline |
|---|---|---|---|
| 20 | Absence of design documents. (Building 6) | Building engineer is required to prepare the design documents including a design report, and a set of structural drawings in compliance with section 1.9.1.1 and section 1.9.1.2, part-6 of BNBC and submit it to RSC for review. | 6-weeks |

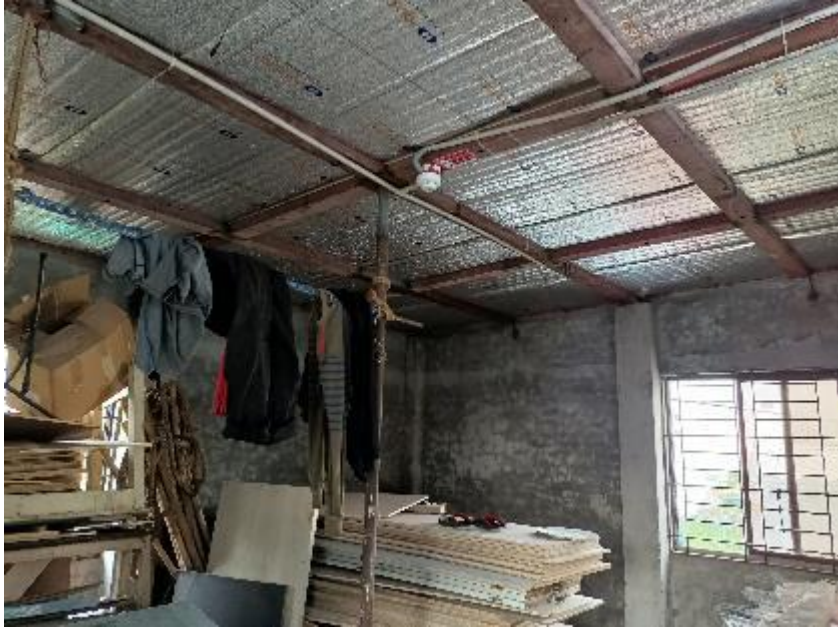
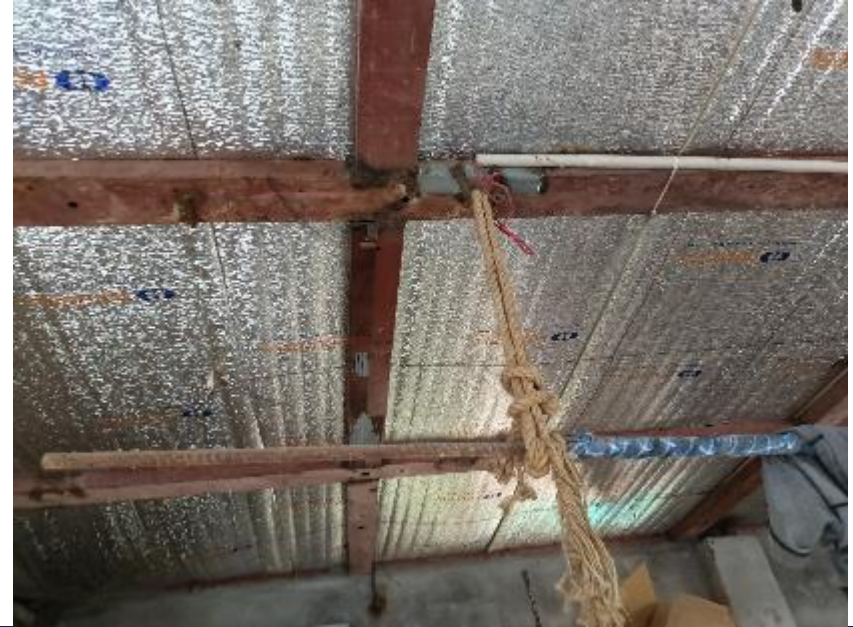
Roof shed

The structure was appeared to be non engineered due to lack of apparent load path, poor connection and apparently inadequate member size. Building engineer is required to carry out member adequacy & lateral stability check of the wastage shed.

| Item No. | Observation | Recommended Action Plan | Recommended Timeline |
|---|---|---|---|
| 24 | Apparently non-engineered Shed. (Building 6-roof shed) | Building engineer is required to carry out member adequacy & lateral stability check of the shed. | 6-weeks |
| 25 | Apparently non-engineered Shed. (Building 6-roof shed) | Implement remediation work where necessary. | 6-months |

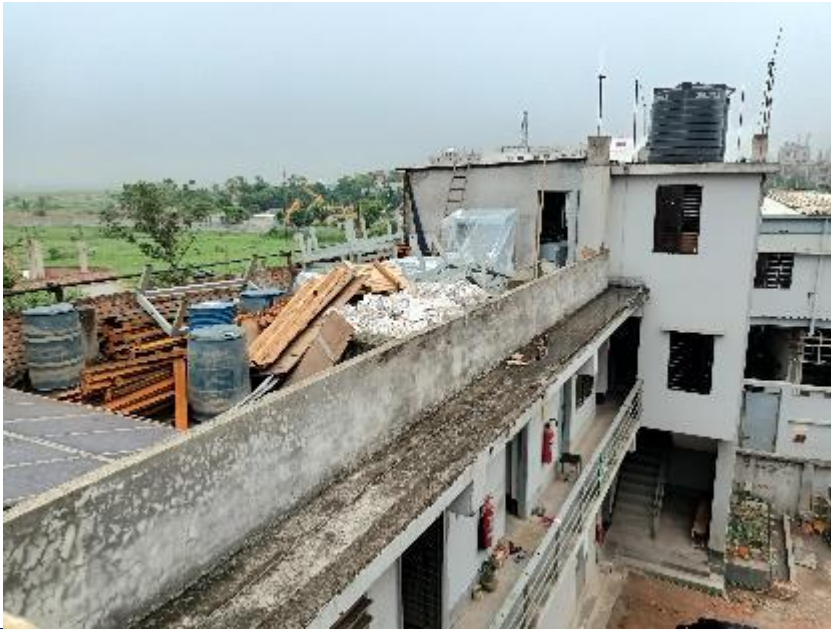
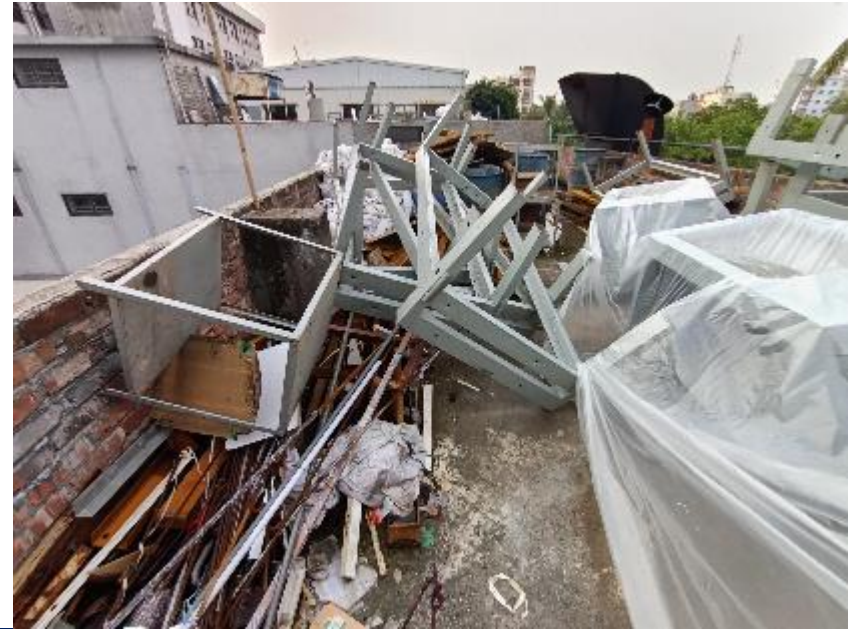
Stacking of construction materials and wastage found almost everywhere on the roof.

| Item No. | Observation | Recommended Action Plan | Recommended Timeline |
|---|---|---|---|
| 26 | Stacking of construction material on roof. (Building 6) | Remove construction materials and wastage from roof. | 6-weeks |

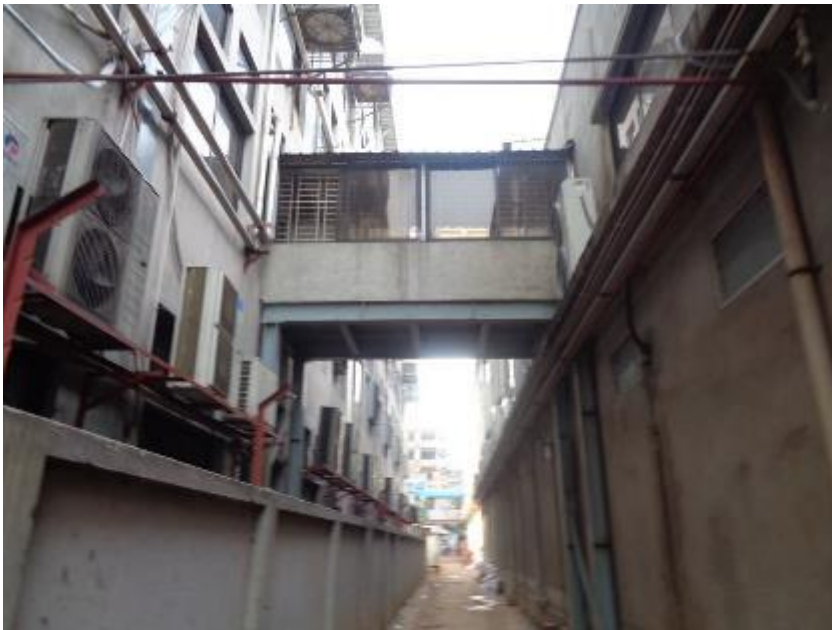
Connection Bridge-1

No drawing documents were available for the connection bridge-1. On the other hand, sectional details were found missing in the provided as-built of connection bridge-2. Factory is required prepared full set of as-built drawings and design documents for the structure.

| Item No. | Observation | Recommended Action Plan | Recommended Timeline |
|---|---|---|---|
| 27 | Lack of information and drawings. (Connection bridge 1 & 2) | Building engineer is to survey the whole structure and update as-built drawings representing accurate site condition. | 6-weeks |

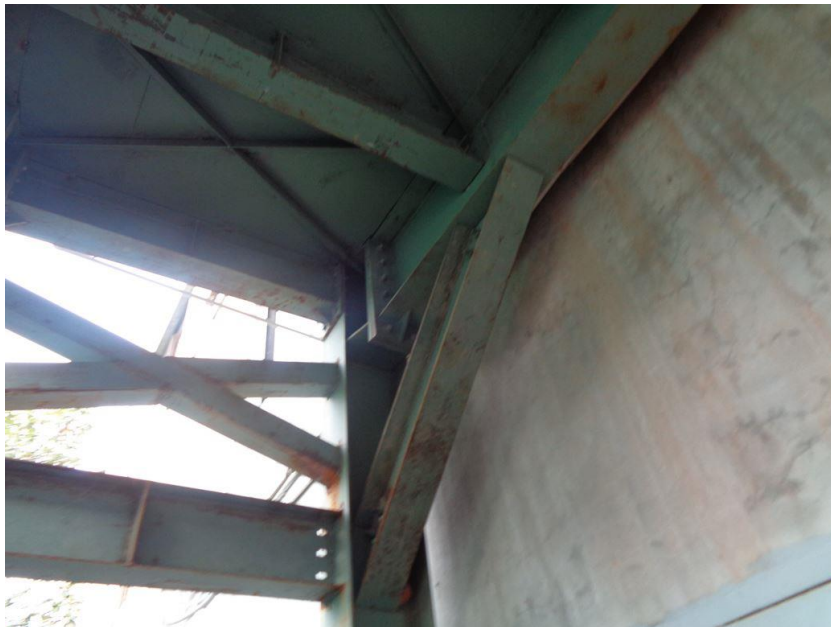
Corrosion in steel member of connection bridge were observed in the several locations. The building engineer is required to suggest proper remedial measure accordingly

Corrosion

| Item No. | Observation | Recommended Action Plan | Recommended Timeline |
|---|---|---|---|
| 28 | Corrosion in steel member (Connection bridge 1 & 2) | Building engineer to remove the corrosion and apply suitable corrosion resistance coating. | 6-weeks |

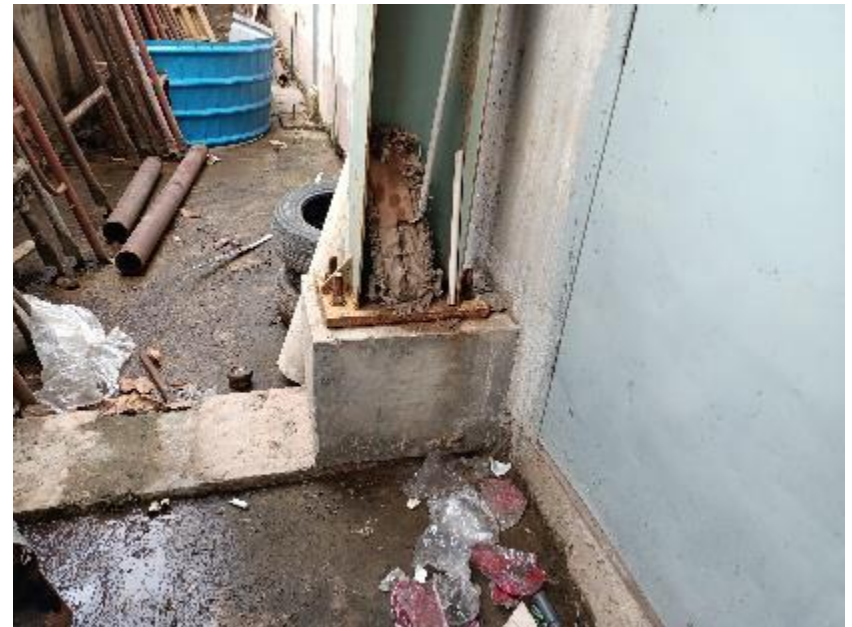
Corrosion
