Green Textile Limited (Unit-3)_Expansion

Nejhuri, Baraid Bazar, Bhaluka, Mymensingh
(24.446123, 90.338425)

24 May 2023

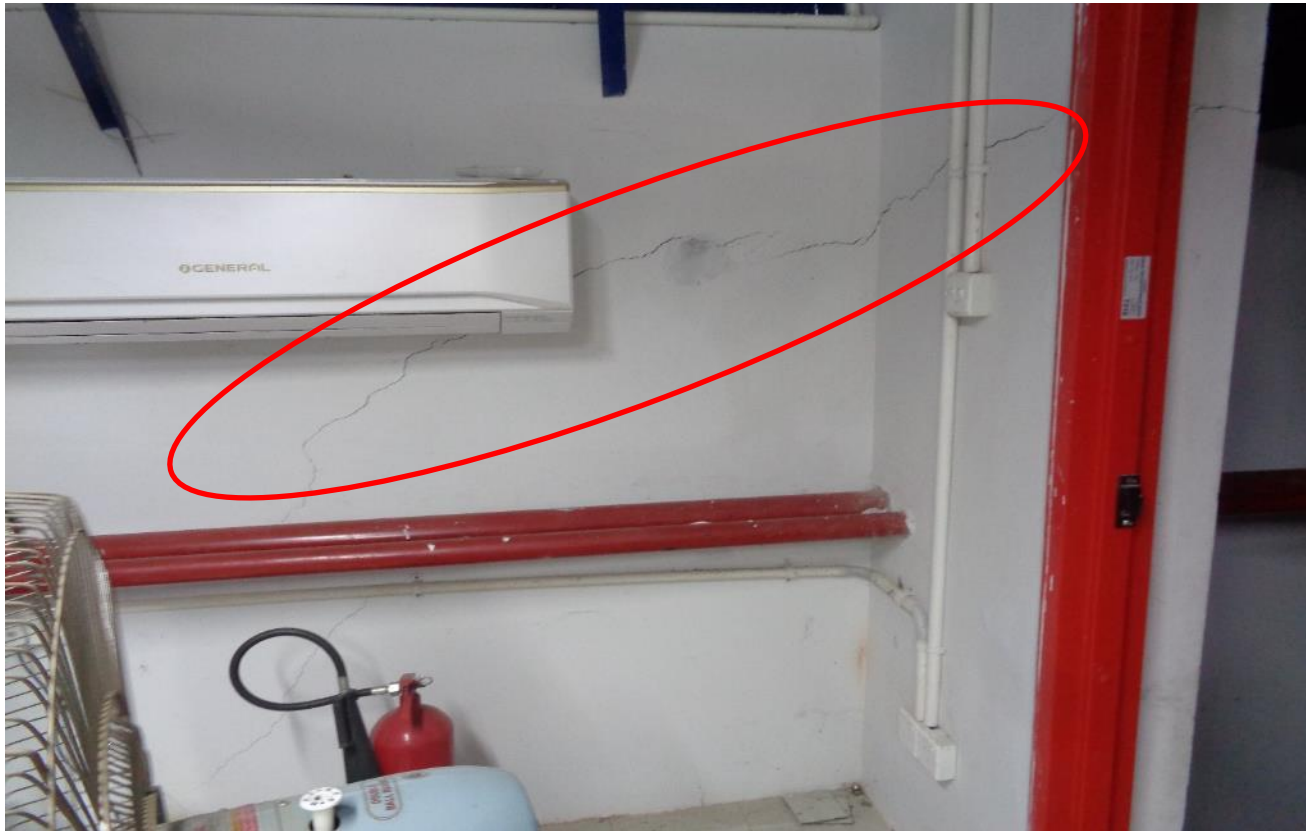
Crack on brick wall

Diagonal crack was found on brick wall of mezzanine floor

Building engineer is required to investigate the cause of wall cracks and prepare an investigation report with necessary remedial measure. Repair the cracked area as per the suggestion of investigation report.

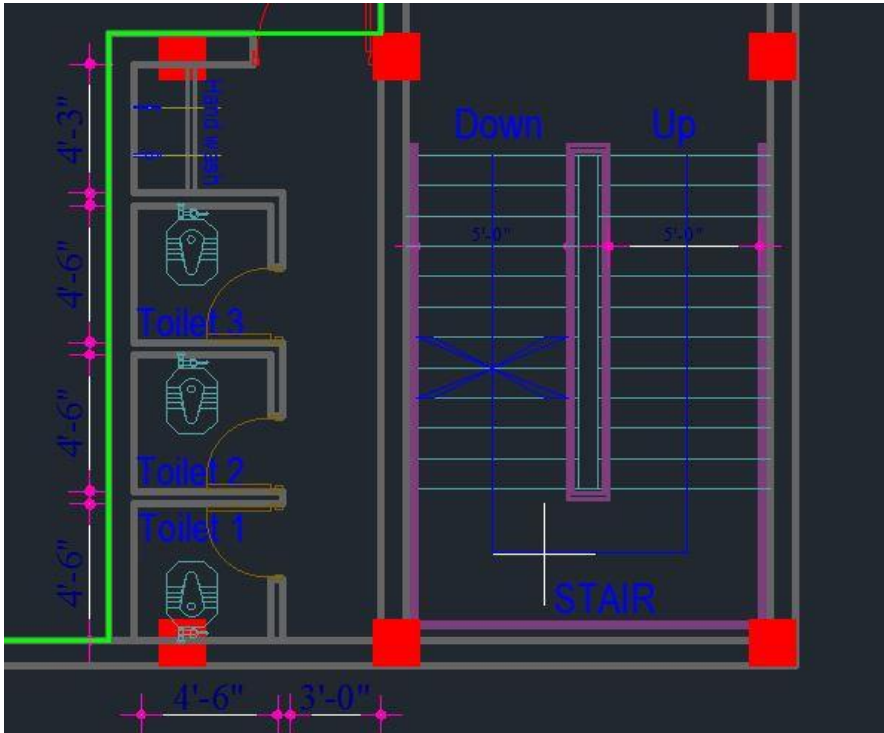
Discrepancy in as-built drawing

Floor build-up not shown in as-built drawing

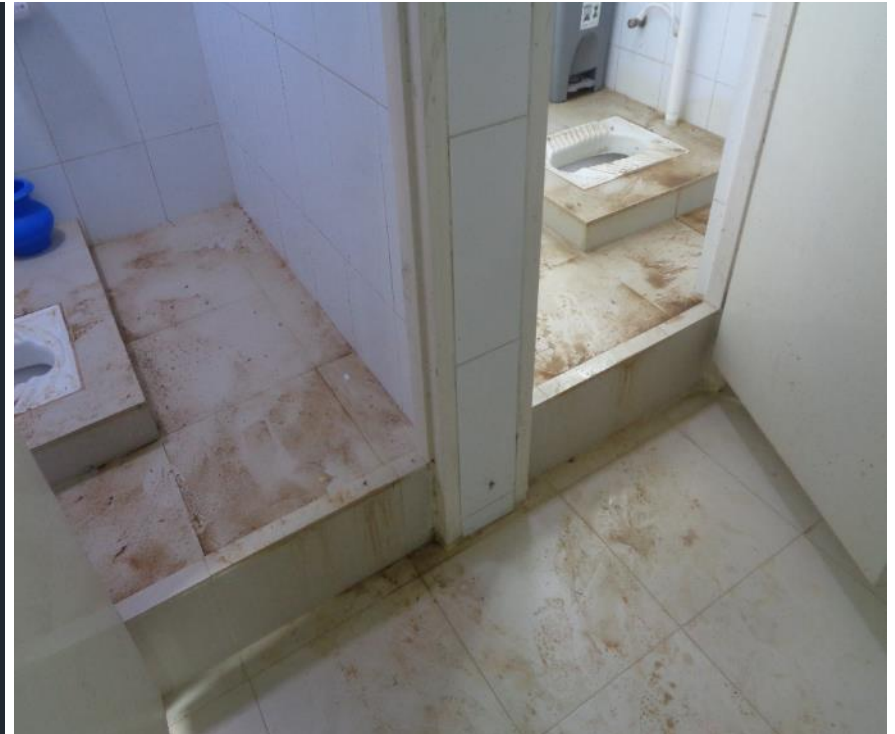
200mm build up found at toilet area

200mm build up found at toilet area which was not shown in as-built drawing. Building engineer is required to survey the whole structure and update as-built drawing as per onsite condition.

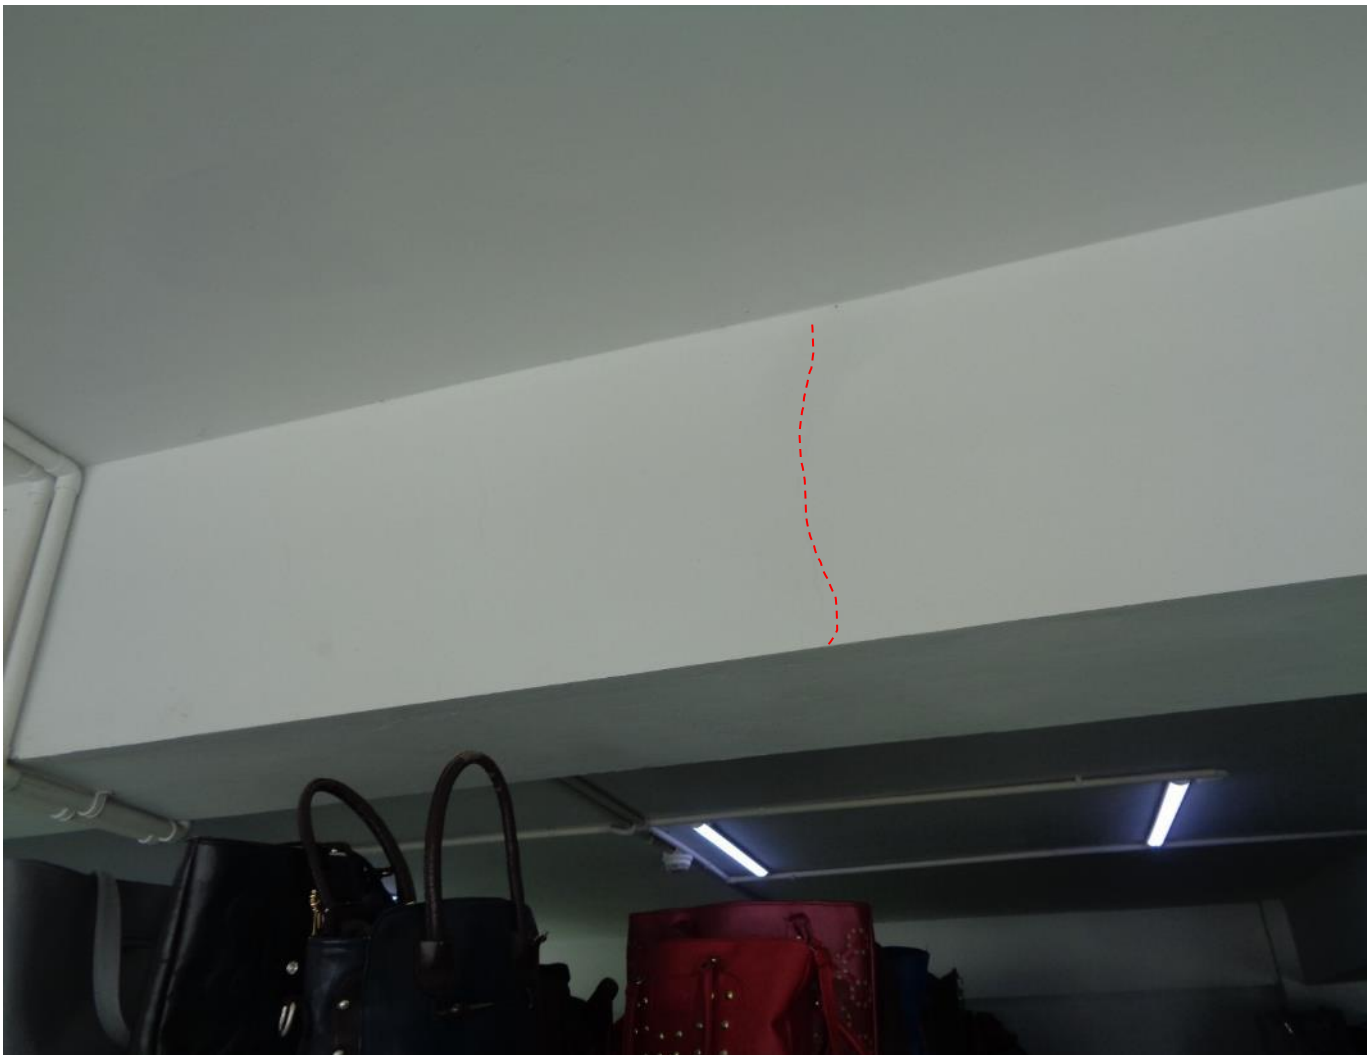
Crack on floor beams

Hairline crack was found on beam at several locations

Building engineer is required to investigate the cause of cracks and repair the cracked area accordingly.

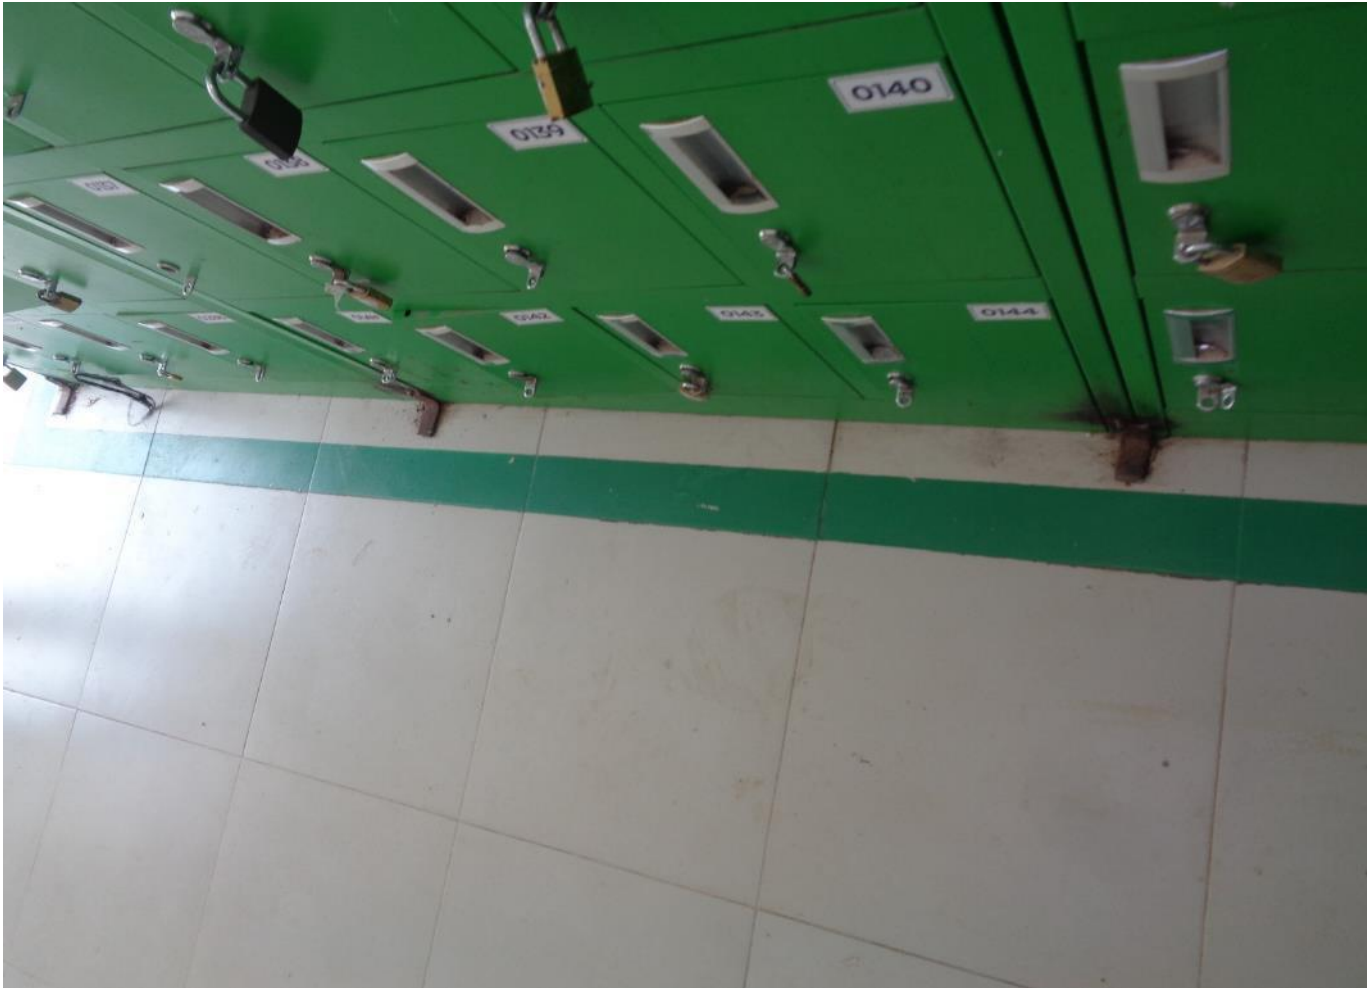
Non-structural elements not anchored properly

Slender lockers were found not anchored

Some steel lockers were not found anchored with the floor. Factory is required to anchor all non- structural elements within the factory.
