# FIRE SAFETY INSPECTION REPORT

## Comfit Composite Knit Ltd. (Extensions 2)

Factory ID: 24544

Date: 8 May 2023

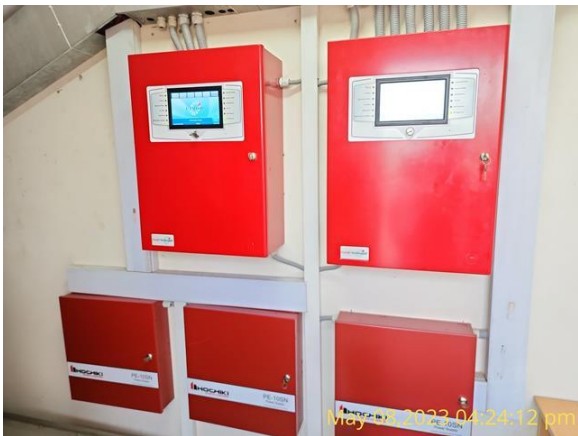
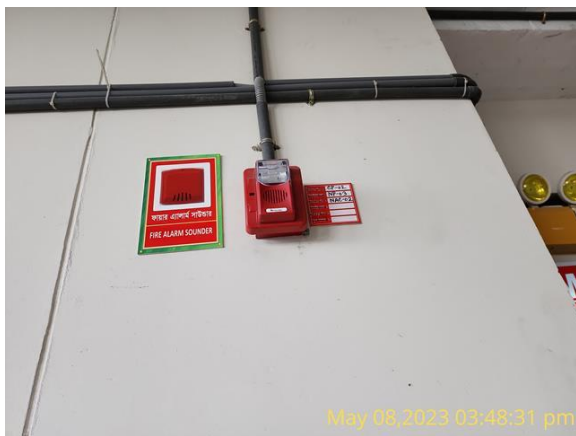
| No. | Category | Finding | Recommendation | Remediation<br>Timeframe |
|---|---|---|---|---|
| F-1 | Fire Protection | The fire alarm and detection system installation requires detailed review to confirm compliance with NFPA 72 and RSC Technical Guidelines (Standard).<br>(All buildings) | Submit as-built drawings, testing records, equipment certification and other relevant documentation to the RSC for review and then approval/acceptance test. | Drawing<br>Within 3 months<br>Install<br>Within 3 months |

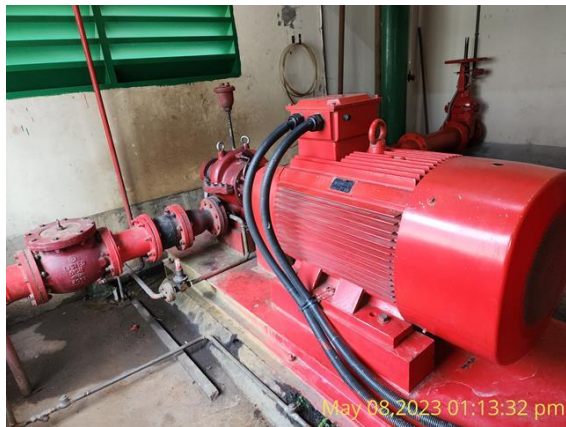
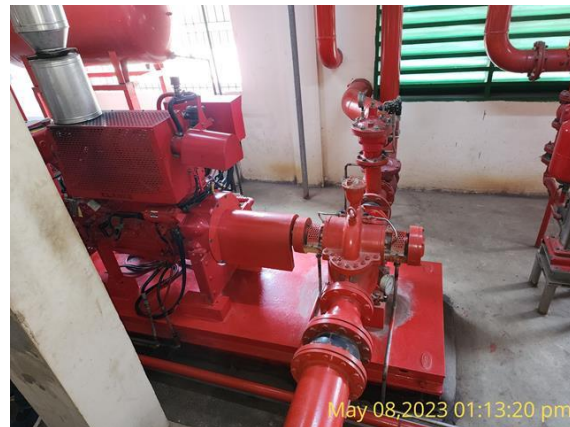
| No. | Category | Finding | Recommendation | Remediation<br>Timeframe |
|---|---|---|---|---|
| F-2 | Fire Protection | The fire pump set installation requires detailed review to confirm compliance with NFPA 20 and RSC Technical Guidelines (Standard). | Submit as-built drawings, testing records, equipment certification and other relevant documentation to the RSC for review and then approval/acceptance test. | Drawing<br>Within 3 months<br>Install<br>Within 3 months |

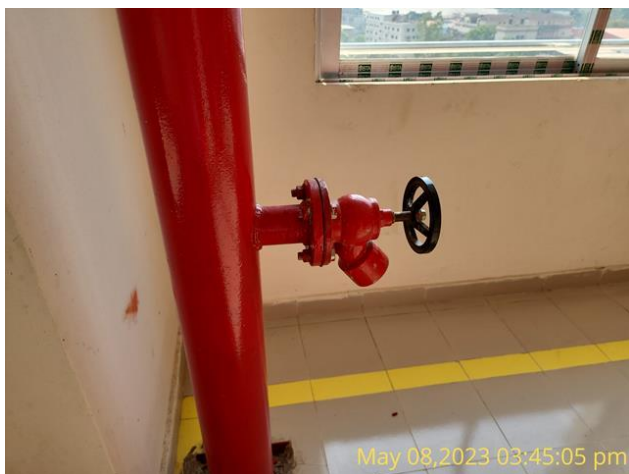
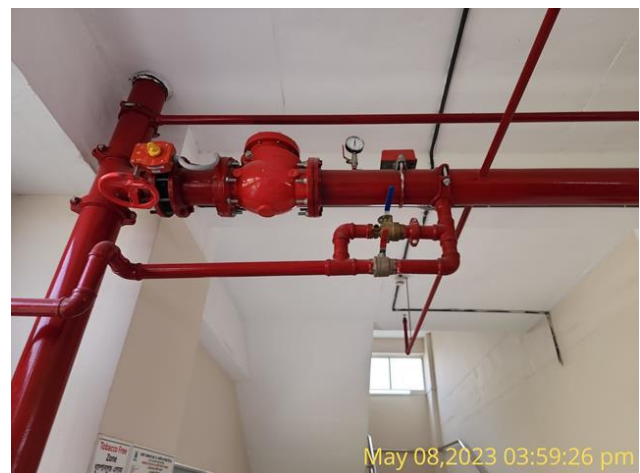
| F-3 | Fire Protection | The firefighting system (sprinkler & standpipe) installation requires detailed review to conform compliance with NFPA 13, NFPA 14. (Eco Ville and Banana Leaf Building) | Submit as built drawing, testing records, equipment certification and all relevant documents to the RSC for review, approval and acceptance test. | Drawing Within 3 months<br>Install Within 3 months |

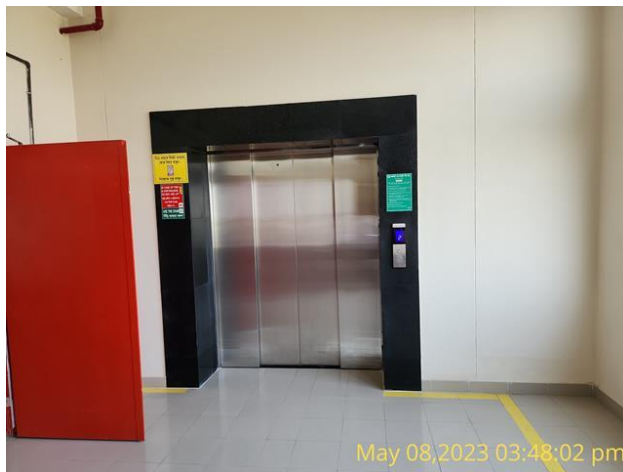
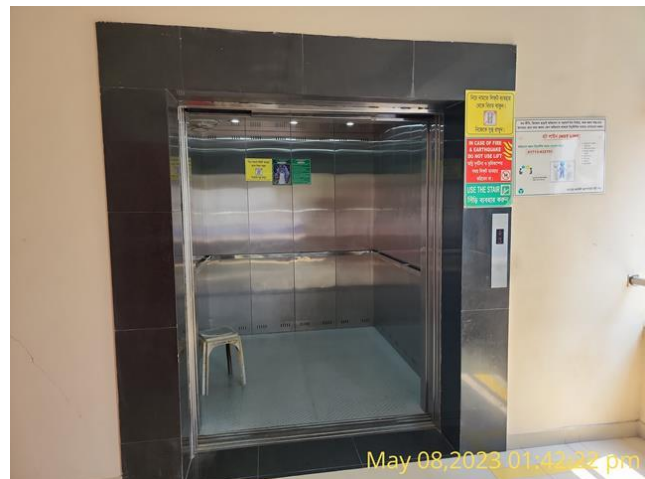
| F-4 | Egress | Elevator shaft is provided in the exit stair enclosures and directly open to exit stair enclosure. (Eco Ville and Banana Leaf Building). | Modify the elevator and stair enclosure arrangement in a way to satisfy RSC standard 6.14.3.<br>Or<br>Separate the elevator by 1.5-hr fire rated opening protection from factory floors and exit stairs.<br>There is a variety of opening protective types i.e., fire rated lift landing doors, fire doors with vestibules, fire rated curtain combination for both heat & smoke control with integration with fire alarm control panel. | Within 3 months |

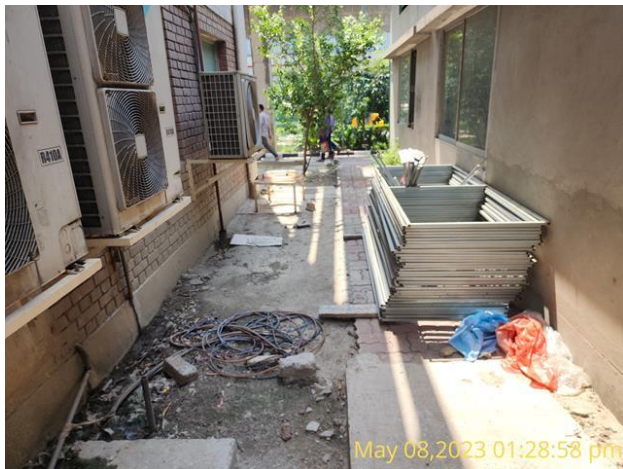
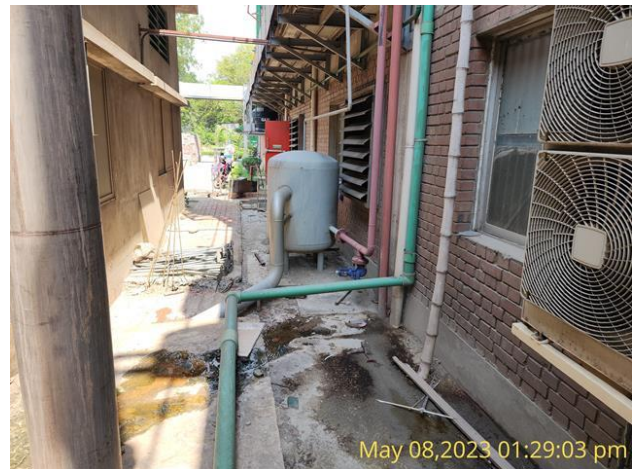
| F-5 | Egress | Exit discharge path not leveled surface (New Utility Building). | Level the exit discharge path to ensure smooth and safe evacuation and ensure that the path is slip resistant. | Within 1 month |

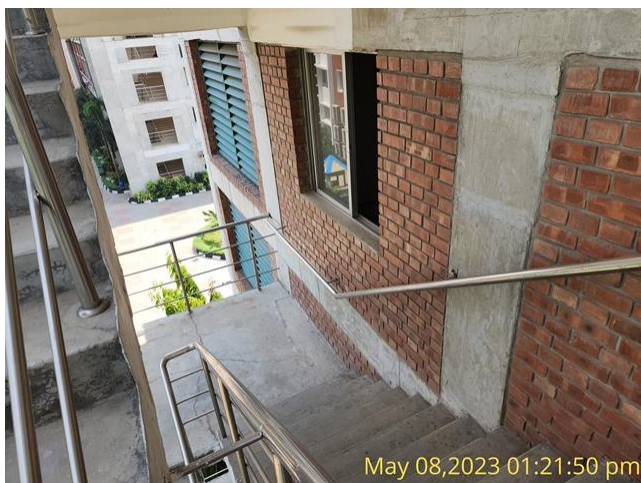
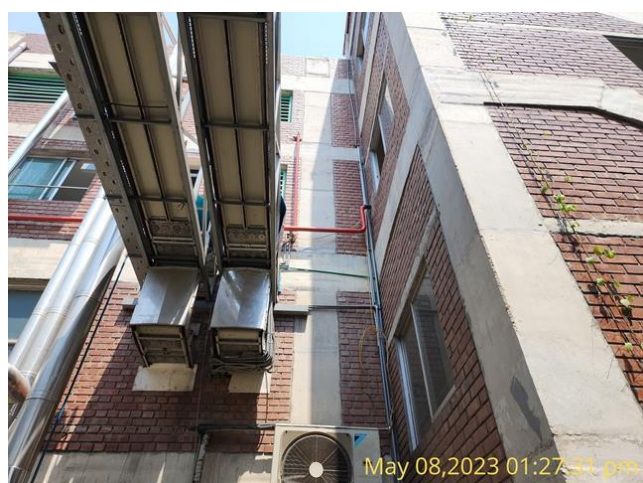
F-6 Fire Rated Construction

Exterior exit stairs are not properly separated from the building.  
(New Utility Building)

Exterior exit stairs shall be separated from the building with a rating requirement of 1-hr. fire rating for 3 or few store building. The rating of the exterior wall shall extend 3.05 m (10 ft) beyond the ends of the stair structures.

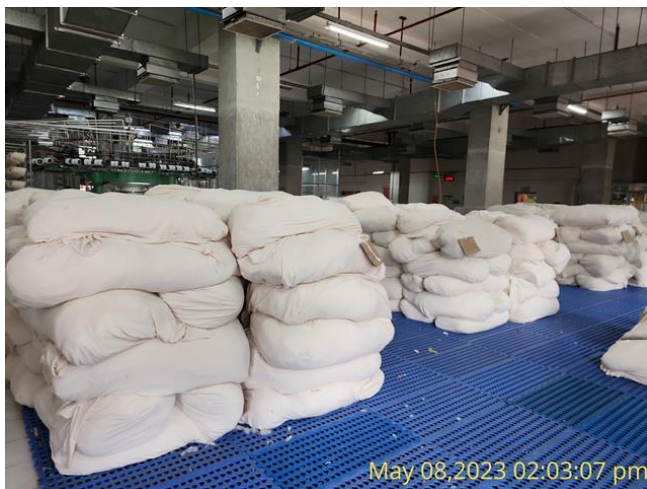
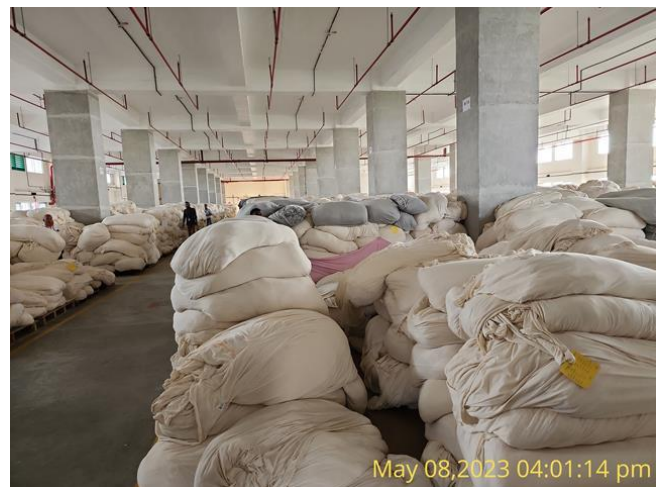
| F-7 | Fire Rated Construction | Areas used for combustible storage open to the factory are not properly defined and/or not within limits. (Banana Leaf –1 <sup>st</sup> floor Eco ville – Mezzanine) | <p>Provide defined storage areas and limit the storage arrangement as follows:</p> <p>Maximum height of 2.45m (8 ft) and maximum area of 23 m<sup>2</sup> (250 ft<sup>2</sup>).</p> <p>If sprinkler protected: maximum height of 3.66m (12 ft) and maximum area of 93m<sup>2</sup> (1000 ft<sup>2</sup>).</p> <p>Separate the areas of unenclosed combustible storage by a minimum clear distance of 3 m (10 ft).</p> <p>Areas shall limit within 10% of entire floor area.</p> | Within 2 months |

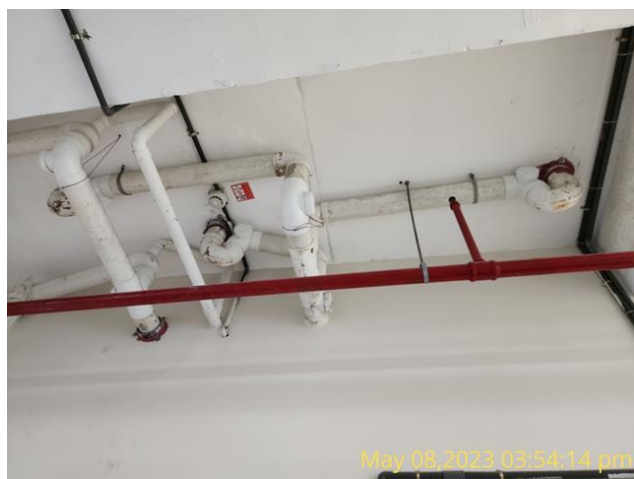
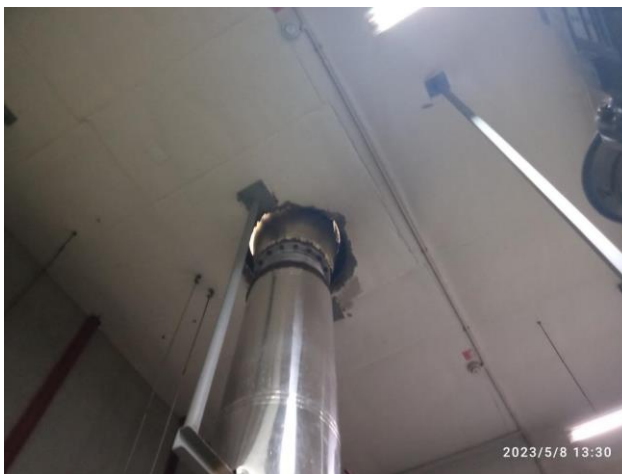
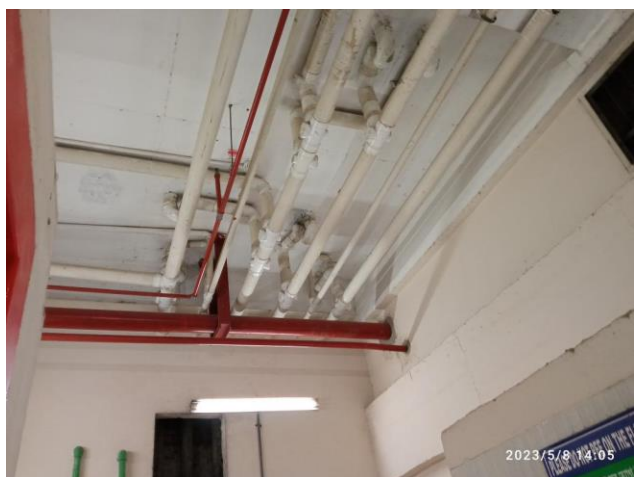
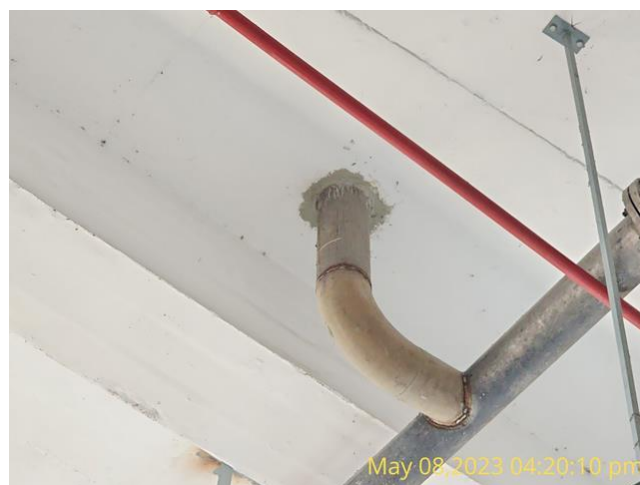
| F-8 | Fire Rated Construction | Unsealed utility pipes, electric riser penetration located in the fire-rated floor/ceiling assemblies (All buildings) | Penetrations of fire resistive rated assemblies shall be protected with listed through penetration fire stop system tested in Accordance with ASTM E814 in Accordance with RSC standard 4.7. | Within 3 months |

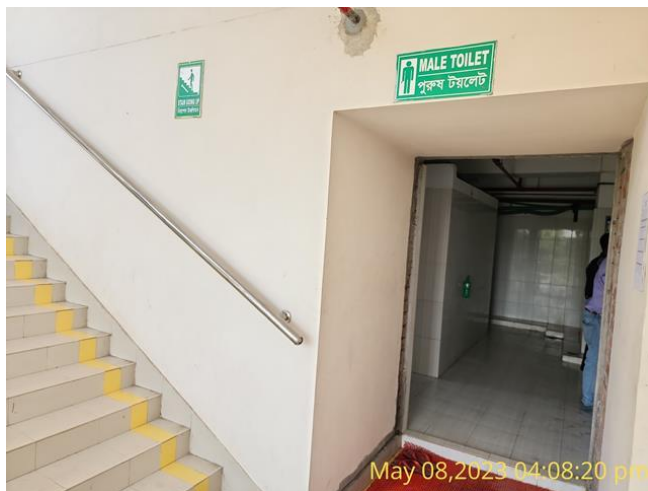
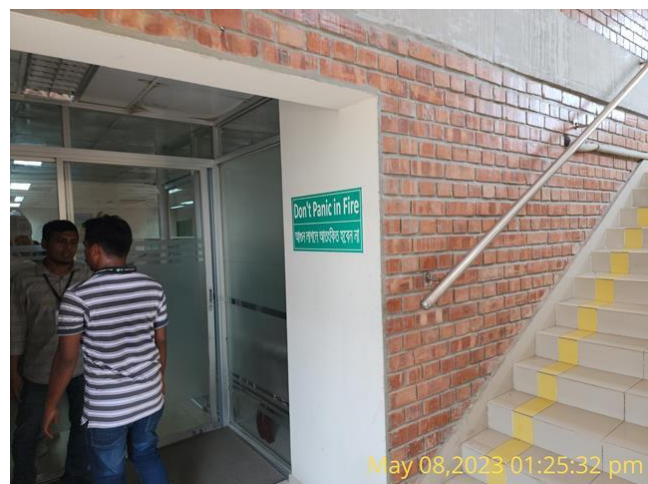
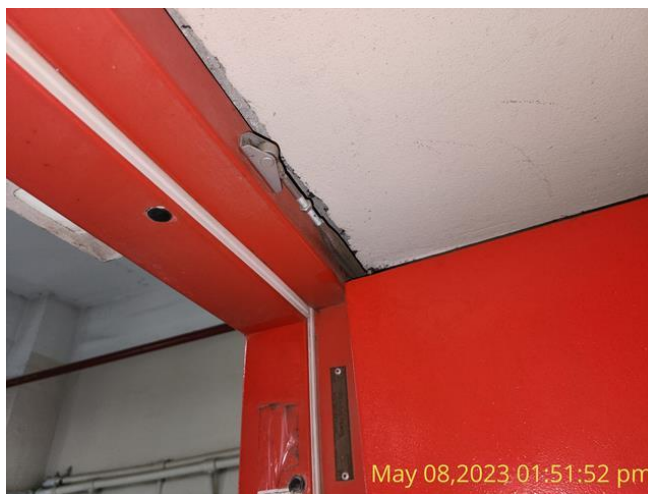
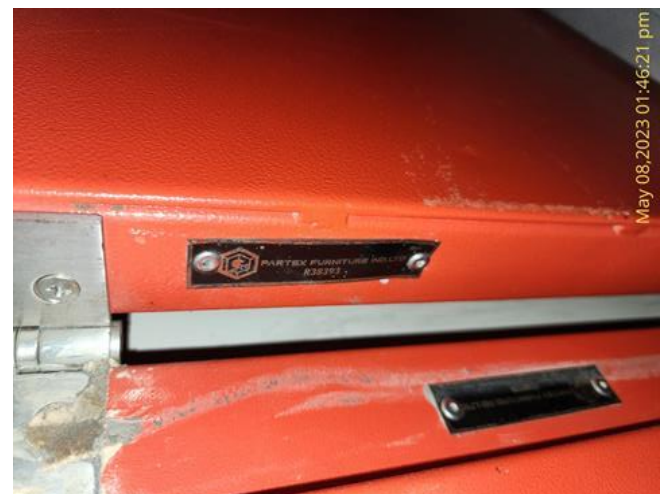
| F-9 | Fire Rated Construction | Exit doors are provided with 2 hr fire rated doors however fire door accessories are not working as required. Also several door has no credible listing mark. (All buildings) | <p>Separate the exit stairs from work areas and other building spaces on all floor levels by minimum 2- hr fire-rated construction. Provide minimum 1.5- hr fire rated doors and seal all unprotected openings and penetrations to maintain the fire separation (10" wall).</p> <p>Ensure that all fire doors are self-closing and positive latching, and are provided with fire exit (panic) hardware where serving production floors or assembly occupancies.</p> <p>If fire doors are required to be held open for functional reasons, provide automatic-closing devices tied to the fire alarm system.</p> <p>Once fire doors are installed, every door in a stair enclosure serving more than 5 stories shall be provided with re-entry unless it meets RSC 6.8.3.1.</p> | Within 1 month |

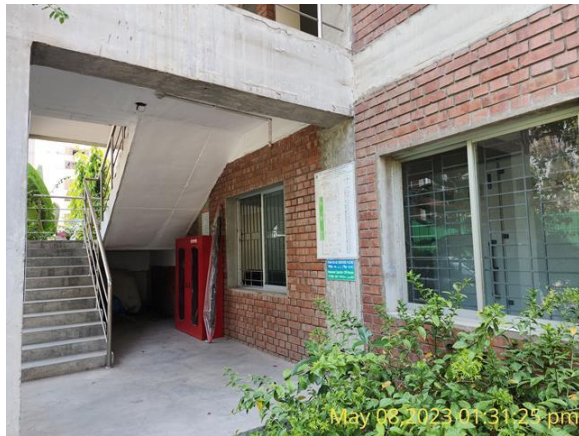
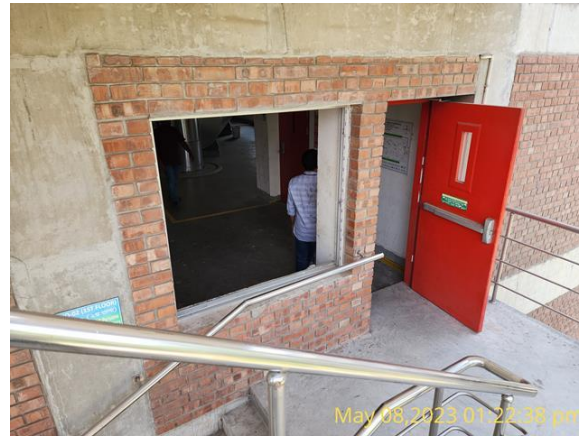
| F-13 | Fire Rated Construction | Unsealed penetrations and openings are located in exit stair enclosures. and separation walls. (New Utility Building) | Seal all penetrations and openings in exit stair enclosure and separation walls to maintain the required fire separation. Penetration is prohibited into and through an exit enclosure. | Within 2 months |

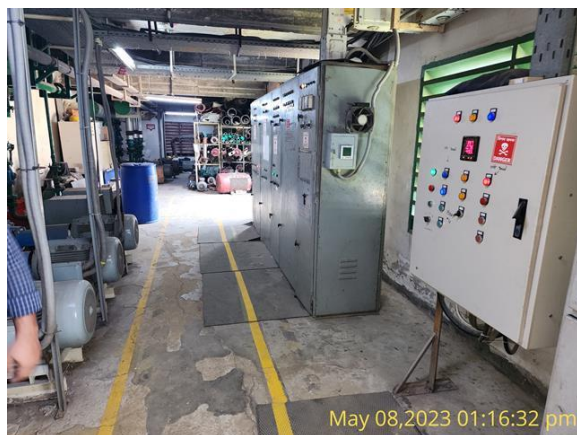
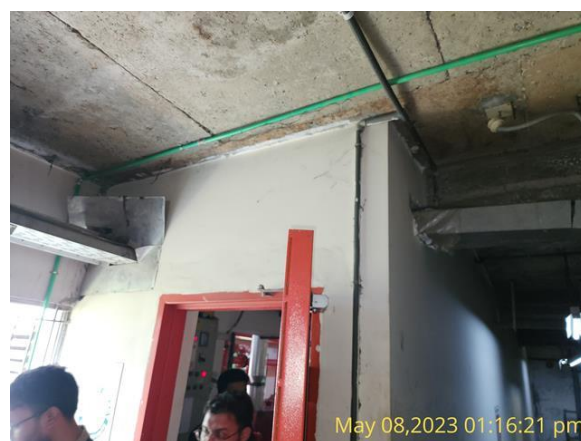
| F-15 | Fire Rated Construction | The fire pump room is not provided with adequate fire separation. (Unprotected opening and penetration) | Provide fire pump room with 2 hr rated fire separation when not sprinklered and 1 hr rated fire separation when provided with automatic sprinklers, in accordance with NFPA 20. | Within 3 months |

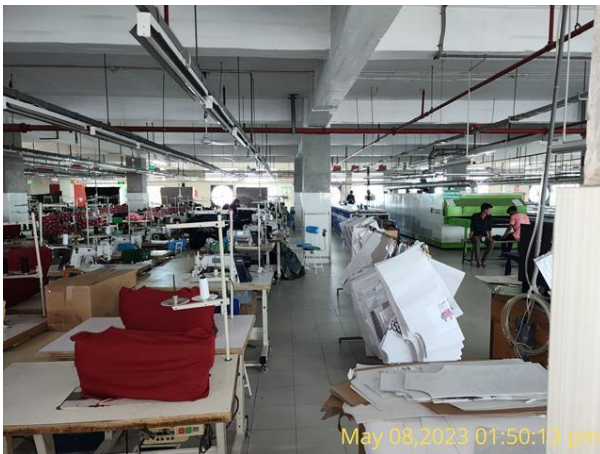
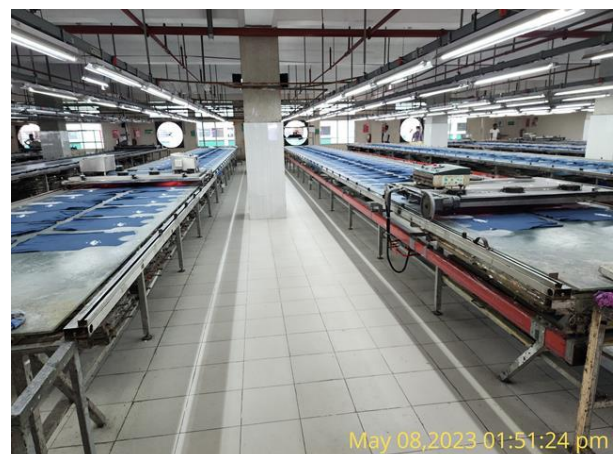
| F-17 | Egress | Adequate and unobstructed aisles were not provided at Banana Leaf Building. | Provide minimum and clear aisle widths of 36-in where applicable and required. | Within 3 months |

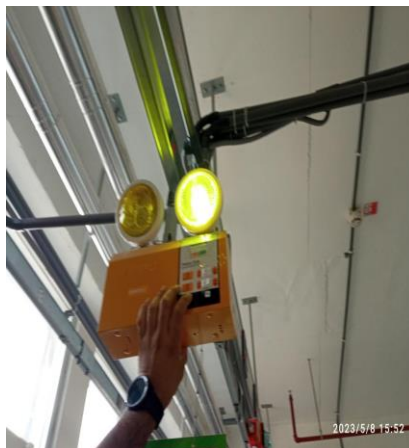
| F-19 | Egress Lighting | Manual on-off switch is provided for emergency lighting / exit signage units.<br><br>All buildings. | Remove manual on/off switches from emergency lighting / exit signage units to prevent them from being switched off. | Within 1 month |

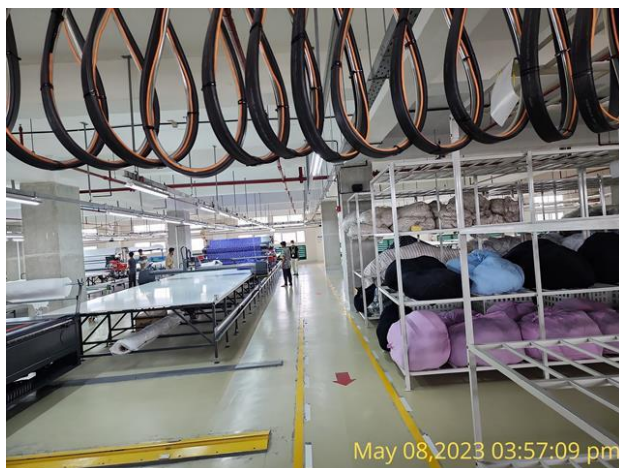
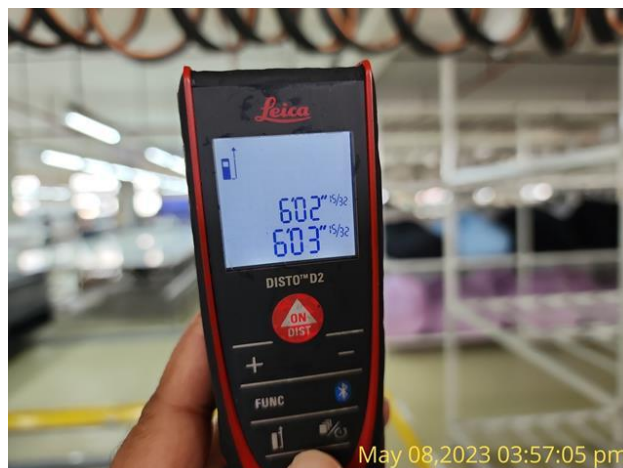
| F-21 | Egress | Headroom on the means of egress does not meet the RSC 6.3.3. (Eco Ville building 3rd floor) | All means of egress shall have a minimum ceiling height of 2.3m (7 ft 6 in.) with projections from the ceiling not less than 2.03 m (6 ft 8 in.). | Within 2 months |
