Issue 1  
16 July 2023

# Sterling Denims Ltd. Unit-2

Dhania, Nayerhat, Ashulia, Savar, Dhaka- 1350.

5 June 2023

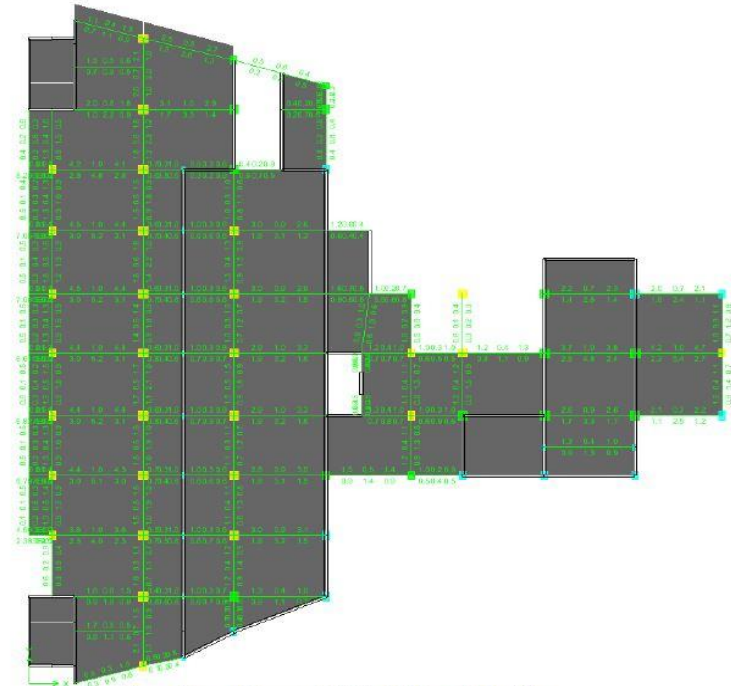
Figure: Beam reinforcement (in<sup>2</sup>) in GF Floor of the building

Plan irregularity/diaphragm irregularity/weak storey check/slab design not provided in design report

Plan irregularity/weak storey check not provided in design report. Also, only a brief description for slab is provided rather than providing a detail design of slab. Building engineer is required to update the design report including all requirements of BNBC 1.9.1.

| Item No. | Observation | Recommended Action Plan | Recommended Timeline |
|---|---|---|---|
| 01 | Design report needs to be updated and reviewed (Main Production Building Unit-2) | Building engineer is required to update the design report including all requirements of BNBC 1.9.1. | 6-weeks |

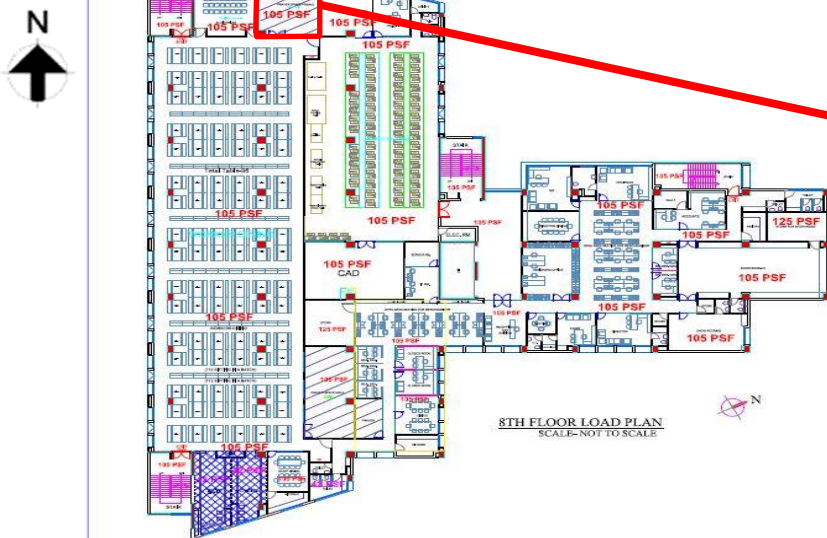
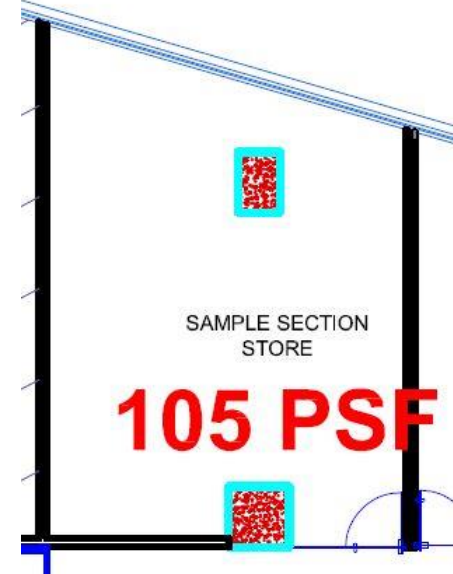
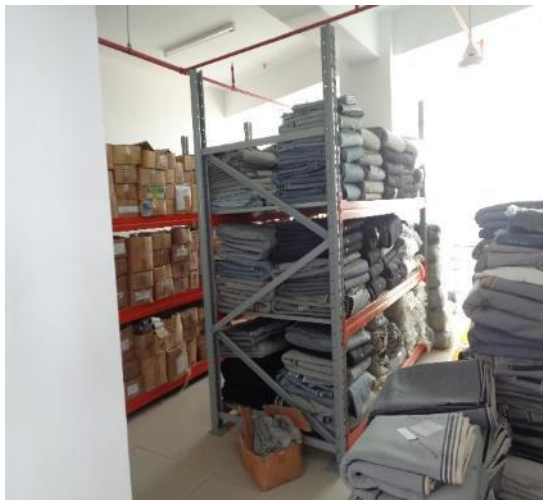
Live load on highlighted area is considered as 5 kPa in prepared load plan. As per BNBC- Part 6, live load for light storage areas is required to be considered minimum 6 kPa. Building engineer is required to revise the load plan as per BNBC requirement and check the design accordingly.

| Item No. | Observation | Recommended Action Plan | Recommended Timeline |
|---|---|---|---|
| 03 | Prepared load plan to be revised (Main Production Building Unit-2) | Building engineer is required to revise the load plan as per BNBC requirement and check the design accordingly. | 6-weeks |

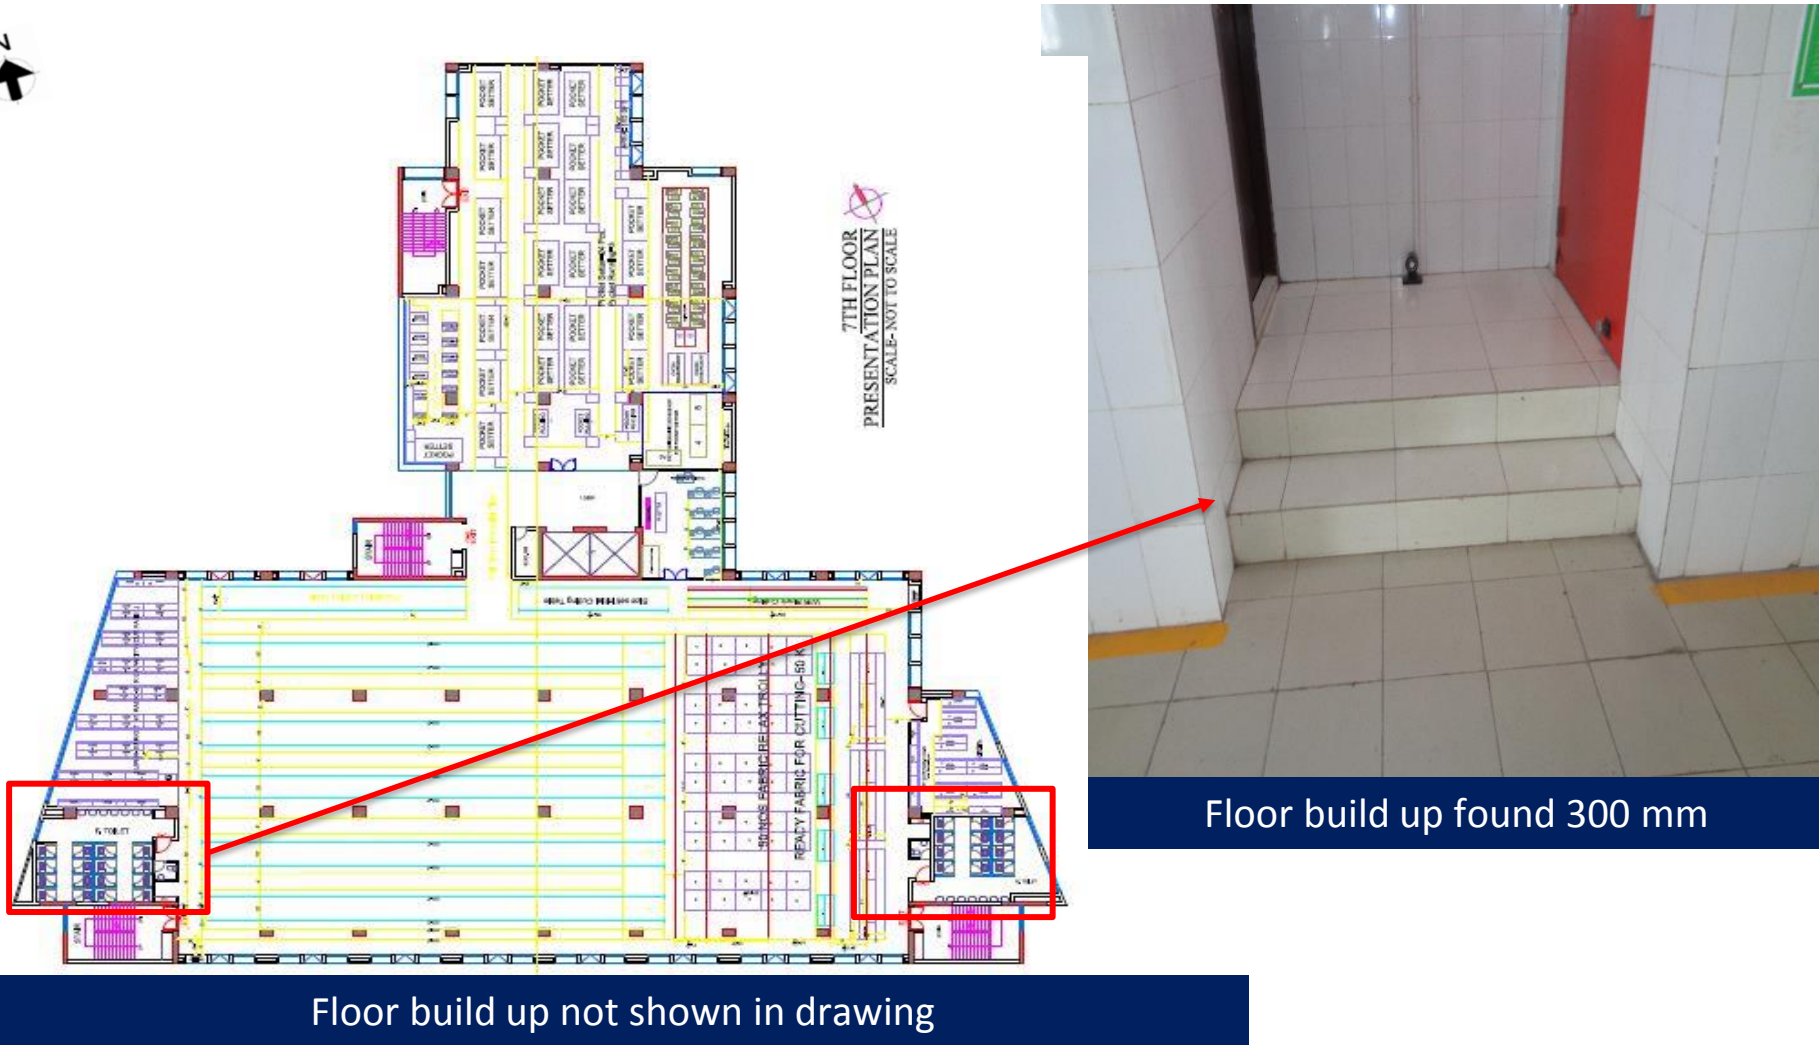
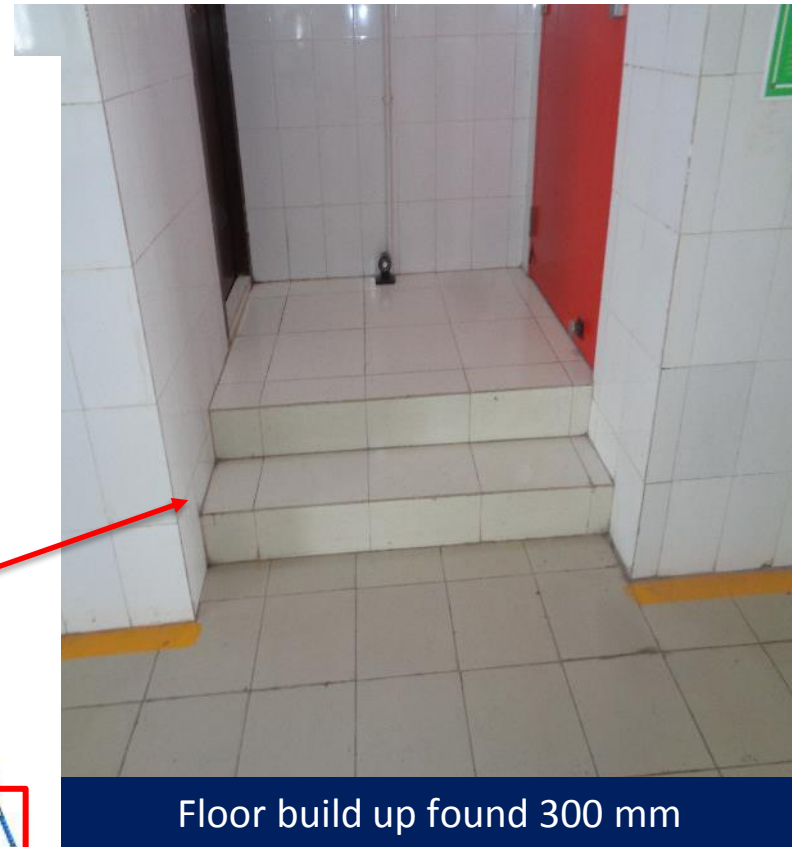
300 mm floor build up was found at toilet areas which was not shown in drawing. Building engineer is required to update the as-built drawing.

| Item No. | Observation | Recommended Action Plan | Recommended Timeline |
|---|---|---|---|
| 05 | Discrepancies in as-built drawing (Main Production Building Unit-2) | Building engineer is required to update the as built drawing. | 6-weeks |

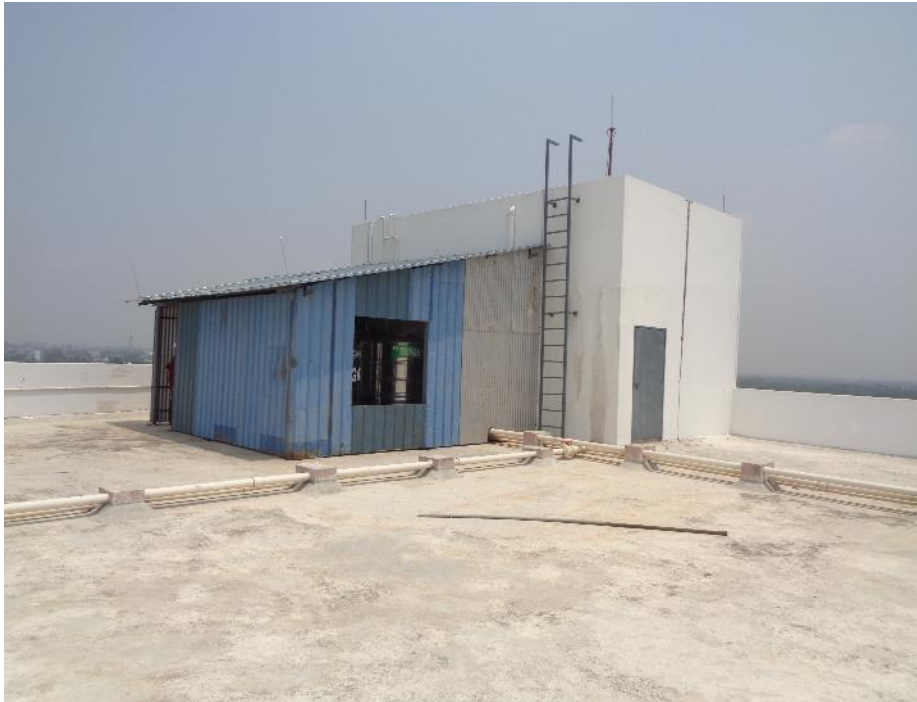
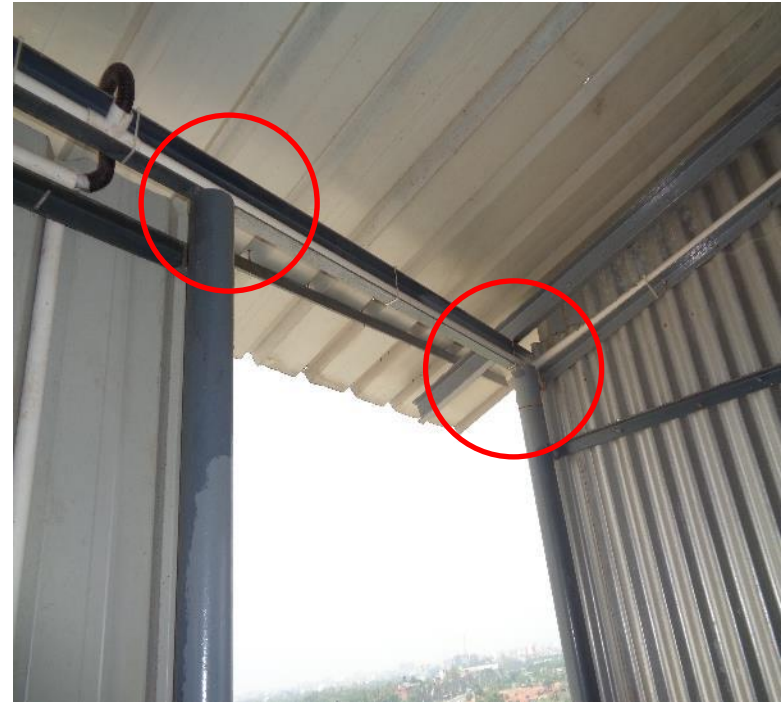
Roof Shed

Poor connection

Rooftop shed was appeared to be non-engineered due to lack of apparent load path, poor connection and inadequate member size. Building engineer is required to check the connection adequacy for uplift forces as part of EA and implement remediation work where required.

| Item No. | Observation | Recommended Action Plan | Recommended Timeline |
|---|---|---|---|
| 06 | Apparently non engineered shed (Main Production Building Unit-2) | Building engineer is required to check the connection adequacy for uplift forces as part of EA. | 6-weeks |

| Item No. | Observation | Recommended Action Plan | Recommended Timeline |
|---|---|---|---|
| 07 | Apparently non engineered shed (Main Production Building Unit-2) | Implement remediation work where required. | 6-months |

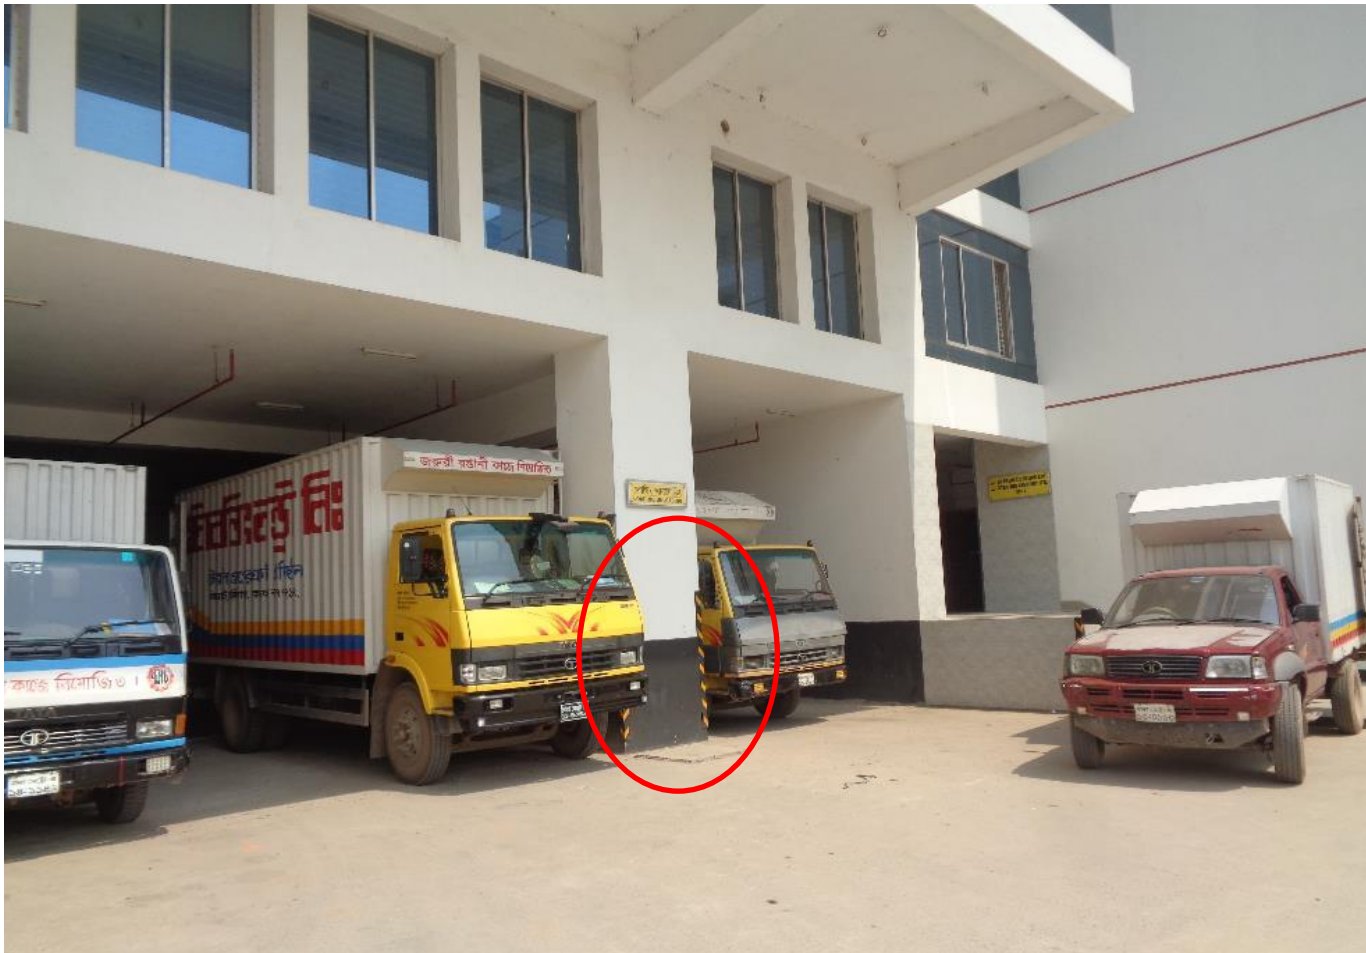
Inadequate safety barrier provided for the exposed columns at ground floor

Columns at ground floor are prone to possible vehicle impact. Building engineer is required to provide barrier for all exposed column at ground floor to prevent from possible vehicle impact.

| Item No. | Observation | Recommended Action Plan | Recommended Timeline |
|---|---|---|---|
| 08 | Possible vehicle impact for column (Main Production Building Unit-2) | Building engineer is required to provide adequate safety barrier for all exposed column at ground floor to prevent from possible vehicle impact. | 6-weeks |

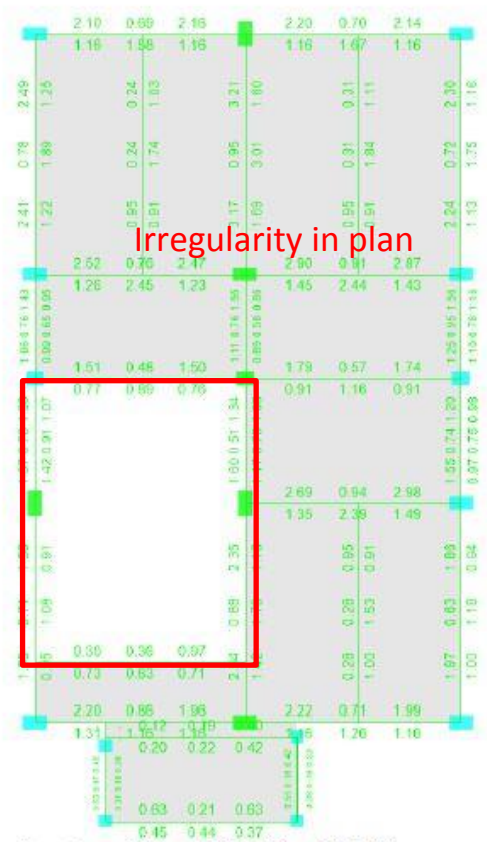
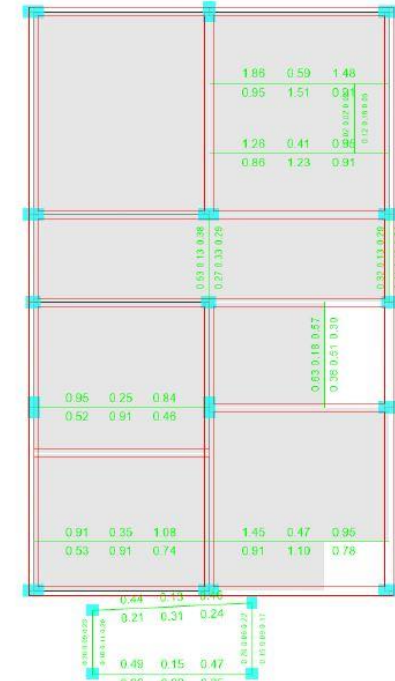
Weak storey/diaphragm irregularity check/slab design not provided in design report

Weak storey check not provided in design report. Also, only a brief description for slab is provided rather than providing a detail design of slab. Building engineer is required to update the design report including all requirements of BNBC 1.9.1.

| Item No. | Observation | Recommended Action Plan | Recommended Timeline |
|---|---|---|---|
| 09 | Design report needs to be updated and reviewed (Utility Building -2) | Building engineer is required to update the design report including all requirements of BNBC 1.9.1. | 6-weeks |

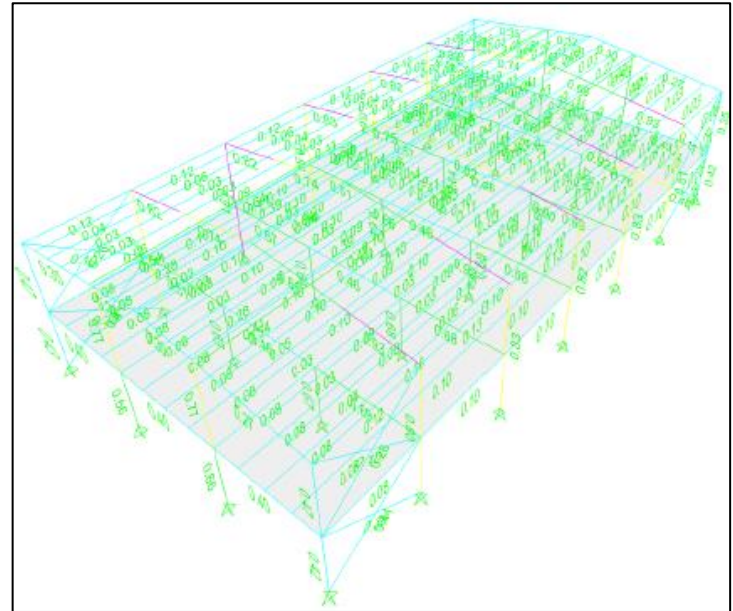
FEA model for super structure

Material strength specification in design report

In design report, concrete design strength 3500 psi and steel MS plate design strength 50 ksi has been considered. However, no material test report was available to confirm these considered material strength. In addition, no adequacy check for pedestal column was also provided. Building engineer is required to update the design report including all requirements of BNBC 1.9.1.

| Item No. | Observation | Recommended Action Plan | Recommended Timeline |
|---|---|---|---|
| 11 | Design report needs to be updated and reviewed. (PP Spray Shed) | Building engineer is required to prepare the design report including all requirements of BNBC. | 6-weeks |

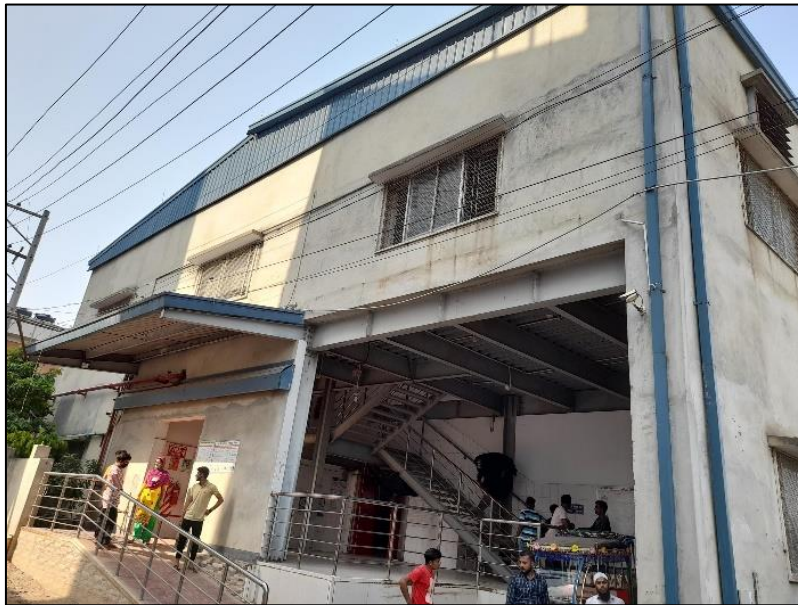
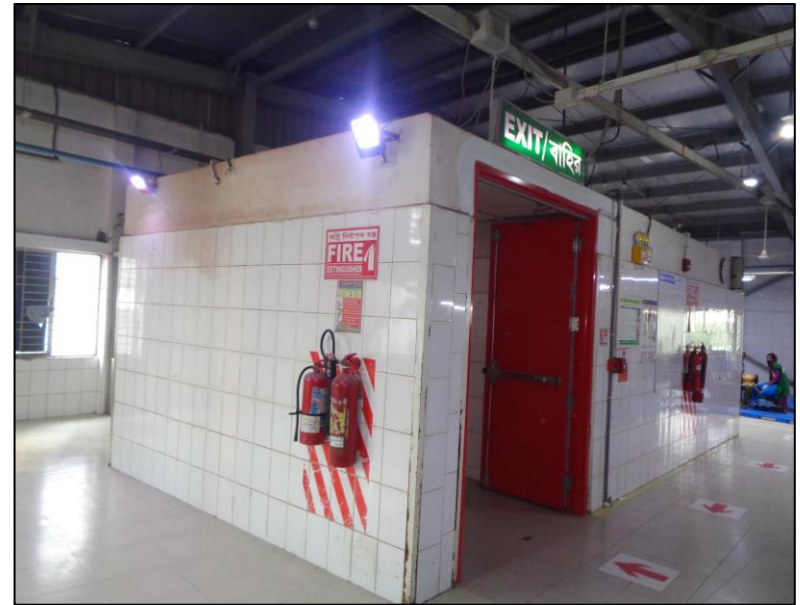
PP Spray Shed

Undocumented 250mm masonry wall

During inspection, an undocumented 250mm masonry wall area was observed on 1<sup>st</sup> floor which was not incorporated in as-built architectural drawing. The building engineer is required to survey the whole structure and update the as-built drawing as per on-site condition in accordance with BNBC.

| Item No. | Observation | Recommended Action Plan | Recommended Timeline |
|---|---|---|---|
| 13 | Discrepancies in as-built drawing. (PP Spray Shed) | Building engineer is required to update the as built drawing as per BNBC. | 6-weeks |

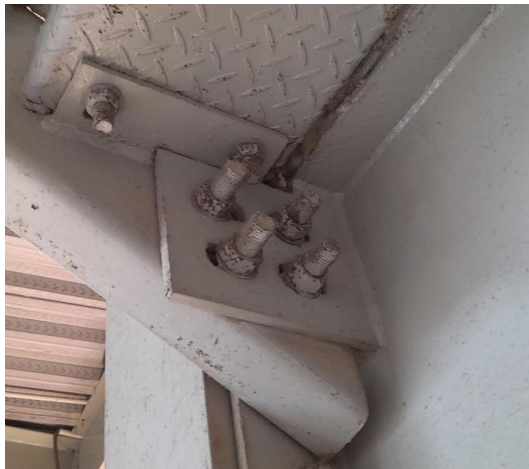
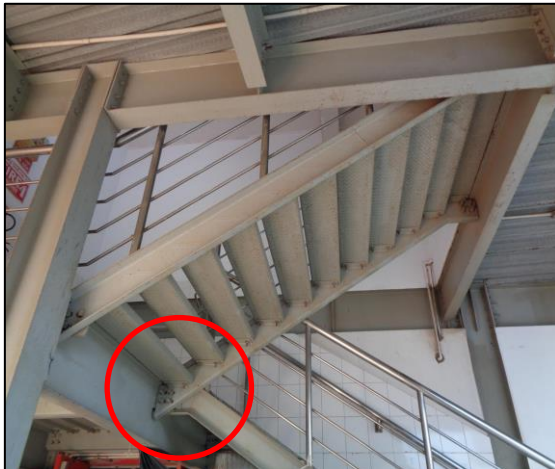
Oversized hole in bolted connection

Oversized hole, loose bolt and gap between connection plates observed in bolted connection. Also, the steel bracing connections and the gusset size appeared to be inadequate. The building engineer is required to check the connections adequacy as part of EA and fill up all the connection gaps & tighten the bolt with proper engineered way.

| Item No. | Observation | Recommended Action Plan | Recommended Timeline |
|---|---|---|---|
| 14 | Apparently inadequate connection. (PP Spray Shed) | The building engineer is required to check the connections adequacy as part of EA and fill up all the connection gaps & tighten the loose bolt with proper engineered way. | 6-weeks |

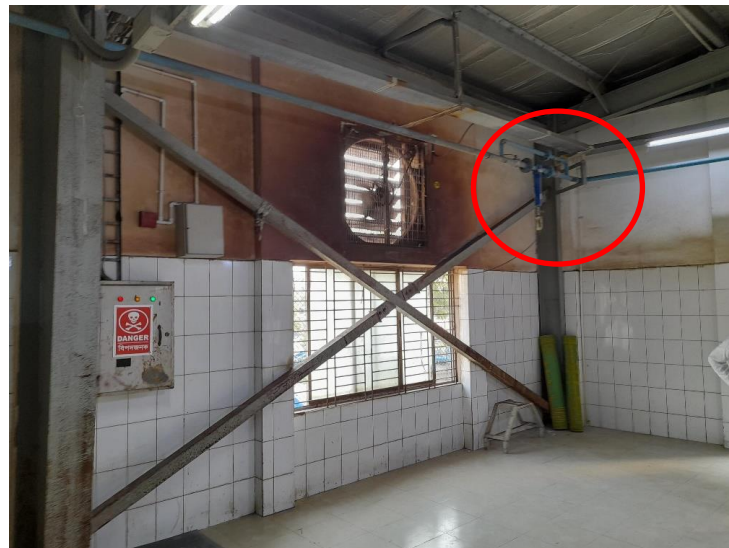
Apparently inadequate bracing gusset plate and eccentricity in joint

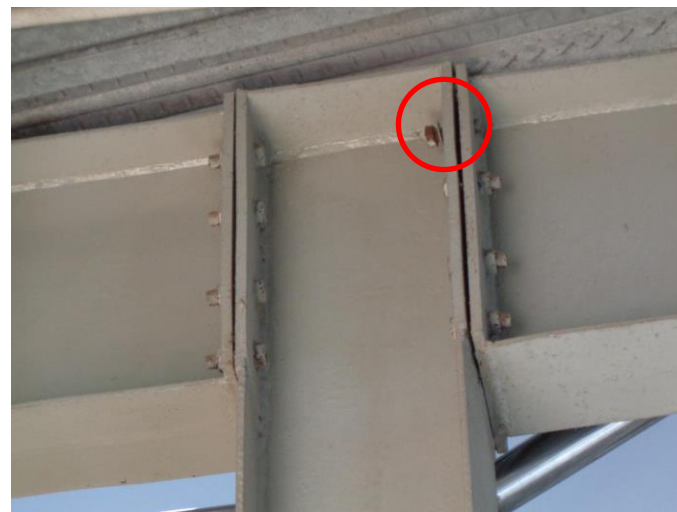
Gap between connection plates & loose bolt

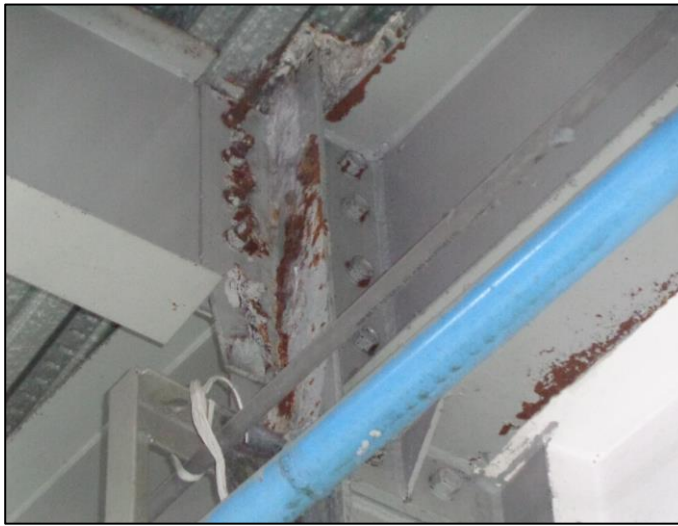
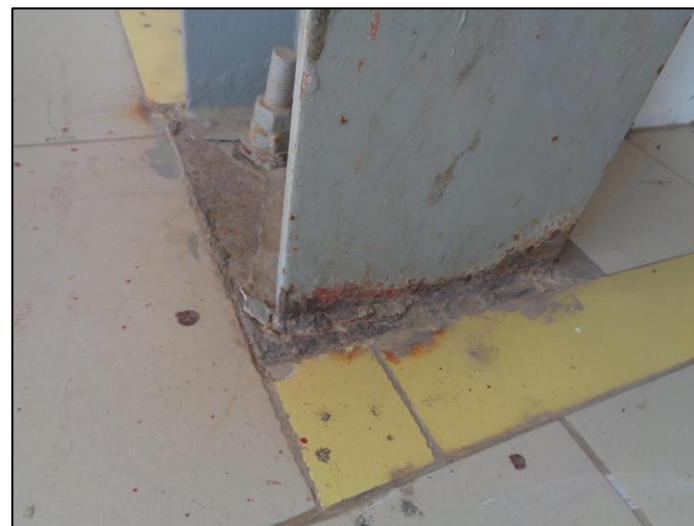
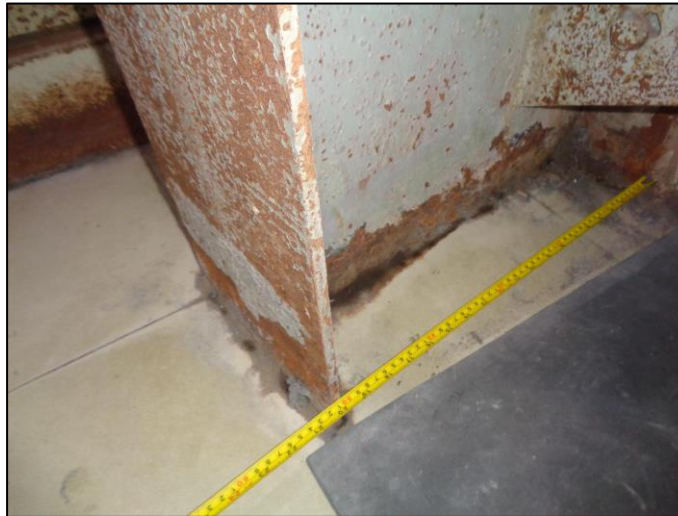
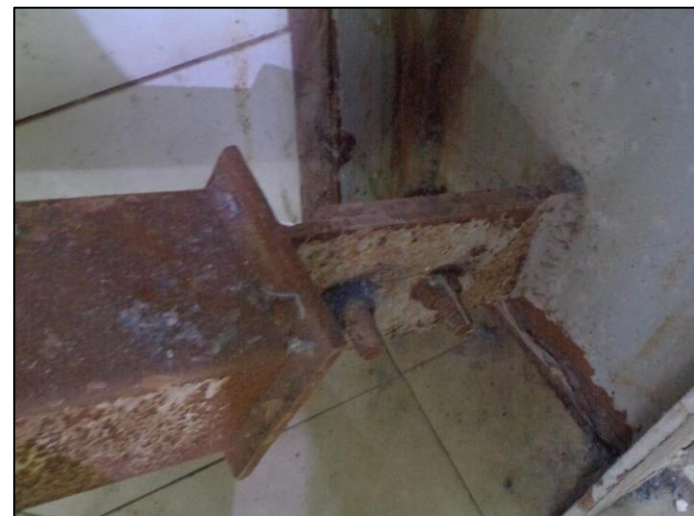
Corrosion in steel members

Corrosion was observed in steel columns and bracings of PP Spray Shed. Factory is required to remove the corrosion & provide rust proof paint on all steel members to protect from corrosion.

| Item No. | Observation | Recommended Action Plan | Recommended Timeline |
|---|---|---|---|
| 17 | Corrosion in steel members. (PP Spray Shed) | Building engineer is required to remove the corrosion and provide rust proof paint on all steel members to protect from corrosion. | 6-weeks |

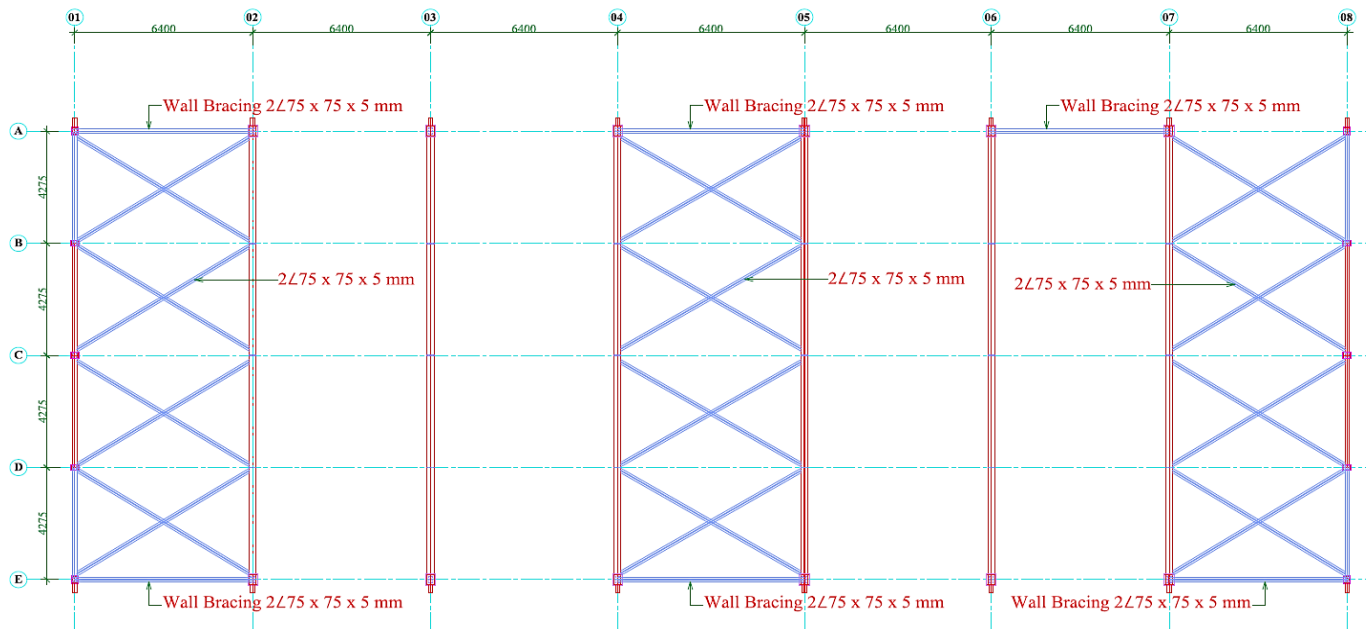
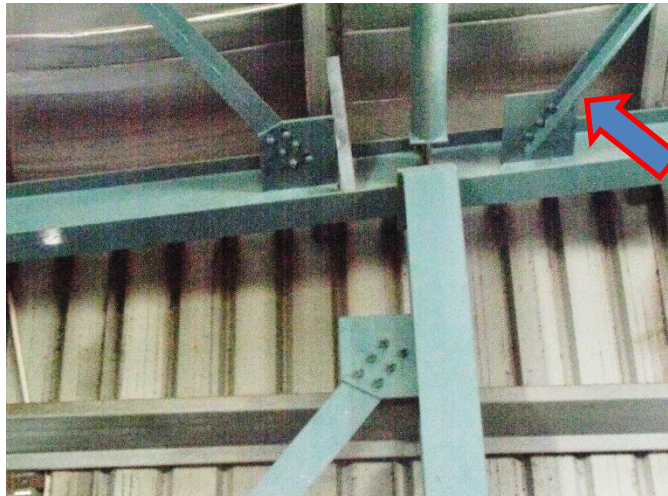
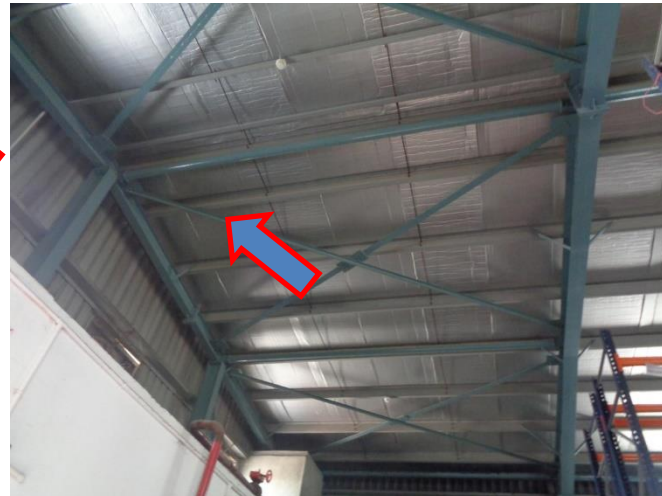
Bracing layout drawing: 2L-75x75 mm bracing at roof

2L-50x50 mm bracing measured at roof

50x50 mm bracing was found instead of 75x75 mm bracing at roof. The building engineer is required to survey the structures and prepare accurate as-built drawings with connection details. Also, check the adequacy of the shed for the actual size of bracing members.

| Item No. | Observation | Recommended Action Plan | Recommended Timeline |
|---|---|---|---|
| 18 | Mismatch between structural drawing and on-site condition. (Chemical Store Shed) | The building engineer is required to survey the structures and prepare accurate as-built drawings with connection details. | 6-weeks |

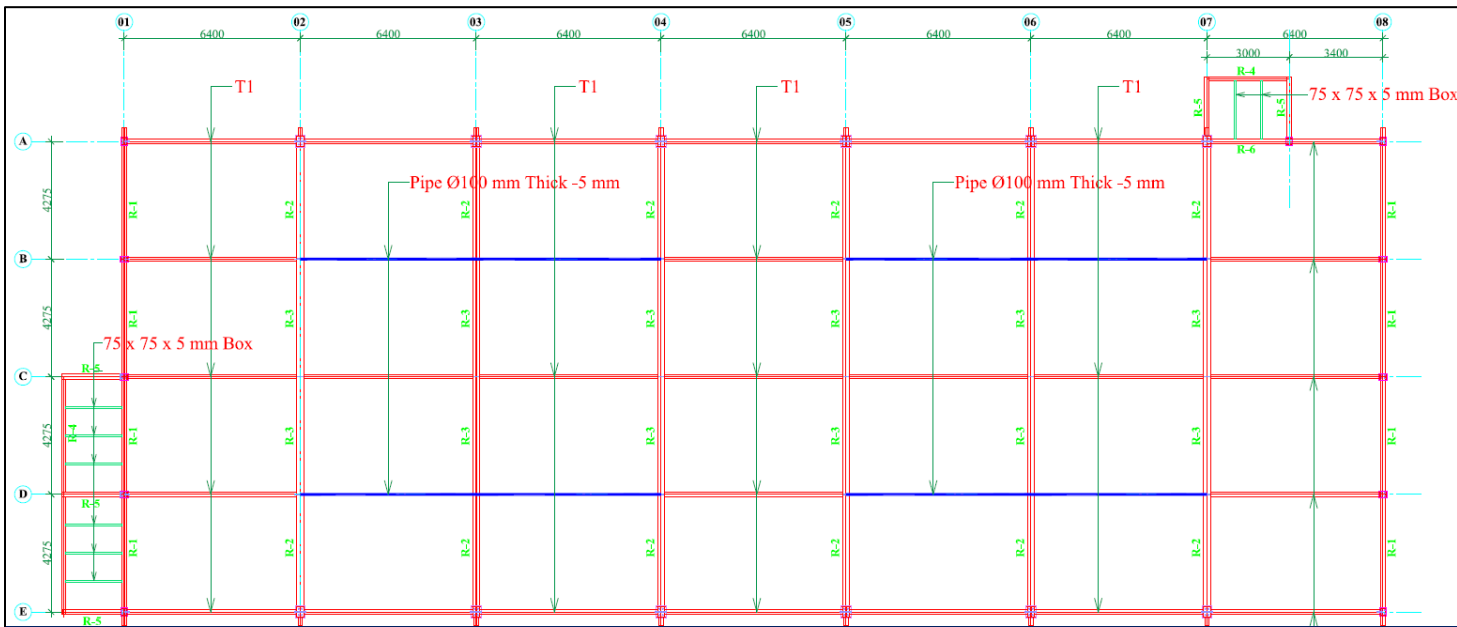
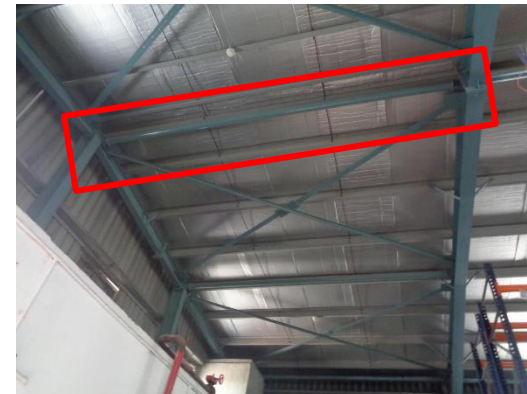
Compression strut layout drawing: I shaped strut (T1) at eave, ridge and end & central bays

Pipe compression strut was found instead of I-shaped strut at roof. The building engineer is required to survey the structures and prepare accurate as-built drawings with connection details. Also, check the adequacy of the shed for the actual size of strut members.

MS pipe compression member found onsite

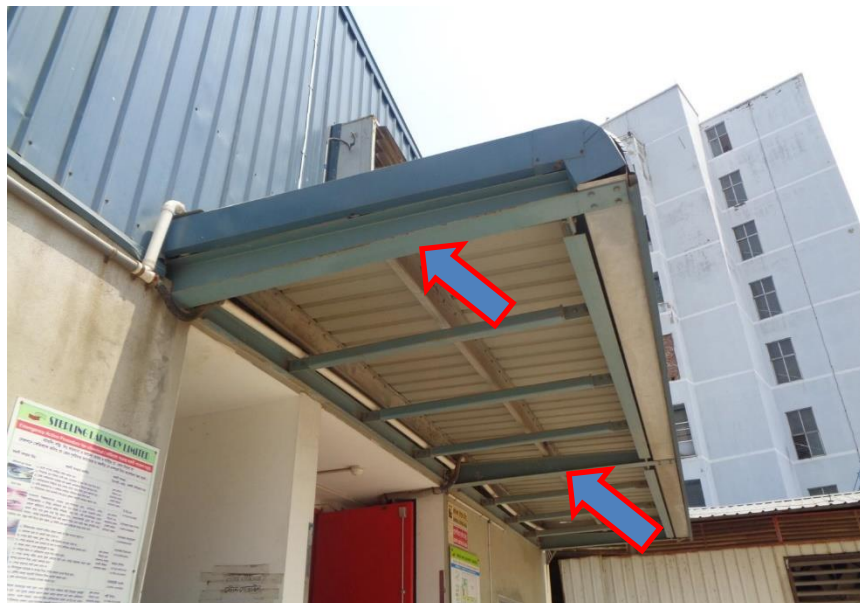
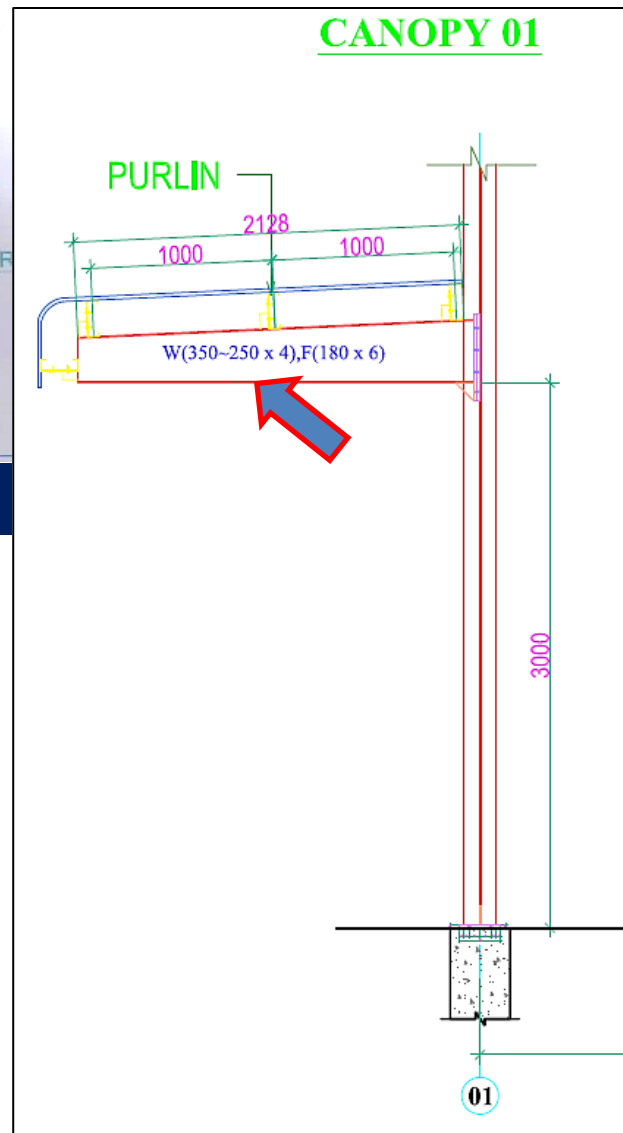
Cantilever rafter of Canopy-01

Cantilever size- W250~125x4,F150x6  
measured onsite

Mismatch found between cantilever rafter sizes. The building engineer is required to survey the structures and prepare accurate as-built drawings with connection details. Also, check the adequacy of the shed for the actual size of rafter members.

| Item No. | Observation | Recommended Action Plan | Recommended Timeline |
|---|---|---|---|
| 19 | Mismatch between structural drawing and on-site condition. (Chemical Store Shed) | Check the adequacy of the shed for the actual size of steel members. | 6-weeks |

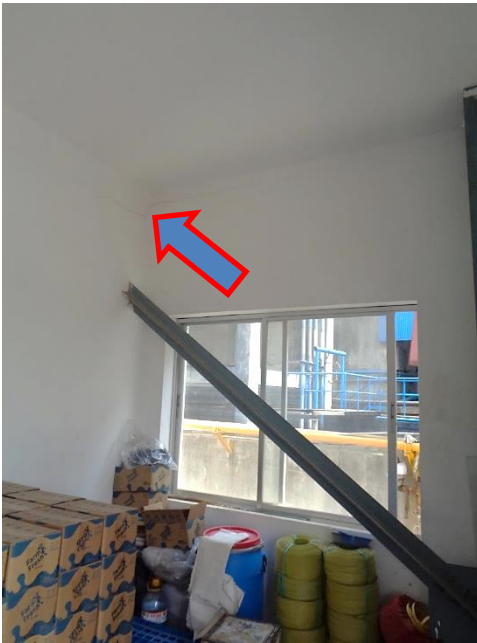
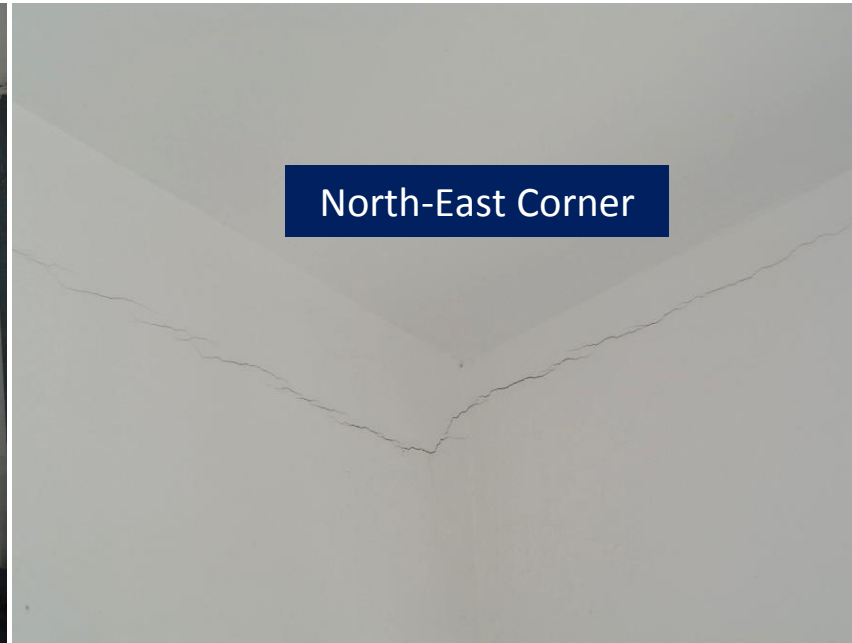
North-East Corner

Crack in brick walls

Crack observed in brick walls. The building engineer is required to identify the reason of crack and carry out suitable remedial works.

| Item No. | Observation | Recommended Action Plan | Recommended Timeline |
|---|---|---|---|
| 21 | Crack in brick walls. (Chemical Store Shed) | The building engineer is required to identify the reason of crack and carry out suitable remedial works. | 6-weeks |

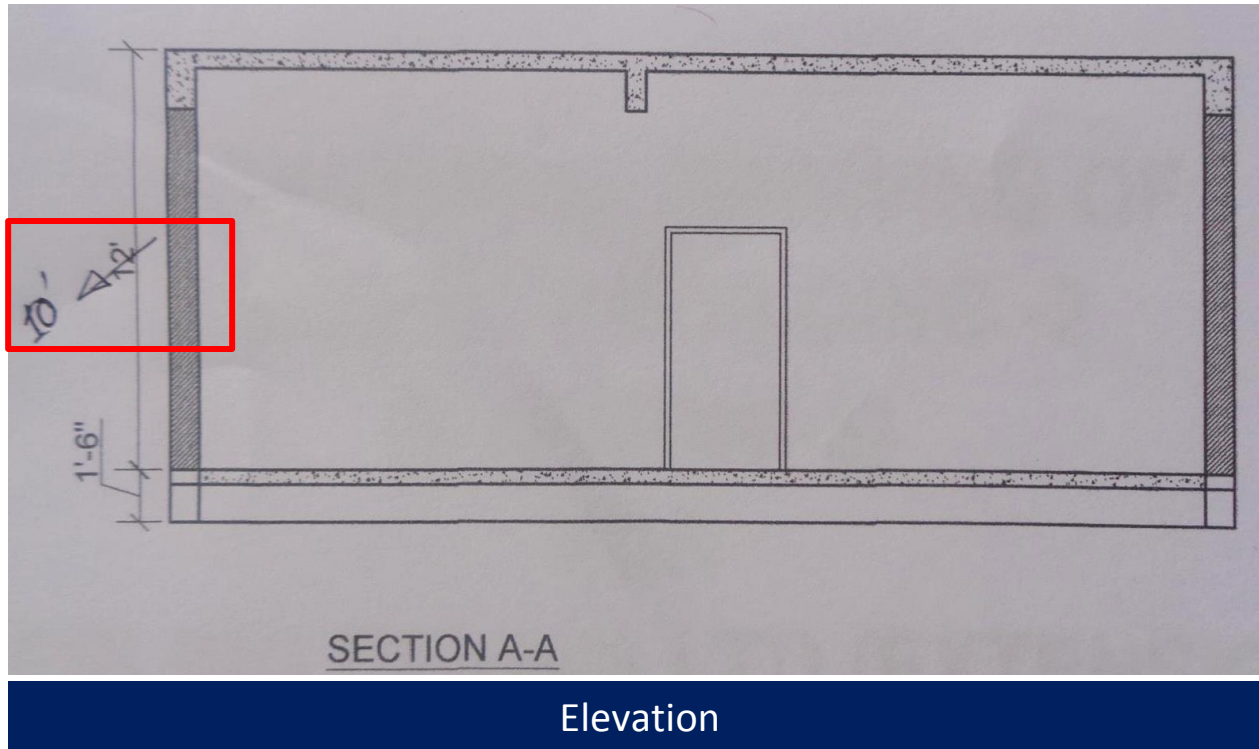
Floor height was measured 3 m instead of 3.6 m. The building engineer is required to survey the structures and prepare accurate as-built drawings.

| Item No. | Observation | Recommended Action Plan | Recommended Timeline |
|---|---|---|---|
| 22 | Discrepancy in as-built drawing. (Security Building) | The building engineer is required to survey the structures and prepare accurate as-built drawings. | 6-weeks |

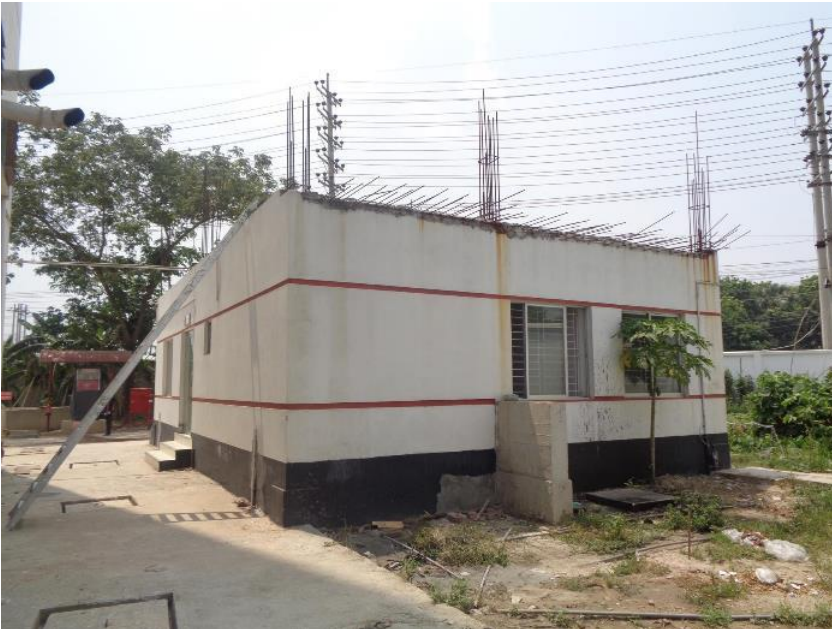
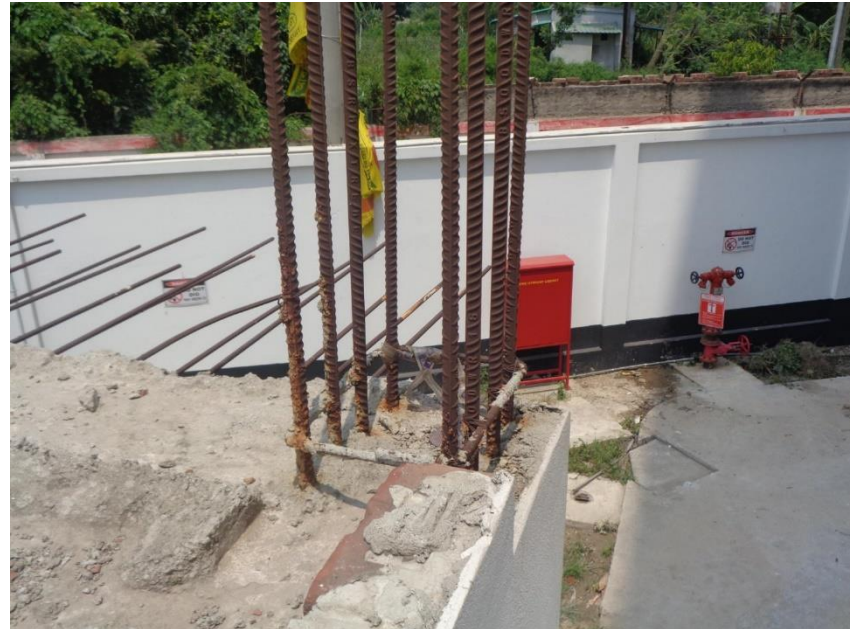
Exposed rebar on the roof which is prone to corrosion

The building engineer is required to provide protective coating to the exposed rebar.
