Max Sweater (BD) Ltd (Extension)

24,26 DIGHI BORABO,TARABO, Rupgonj, Narayangonj

22 May 2023

Building Information

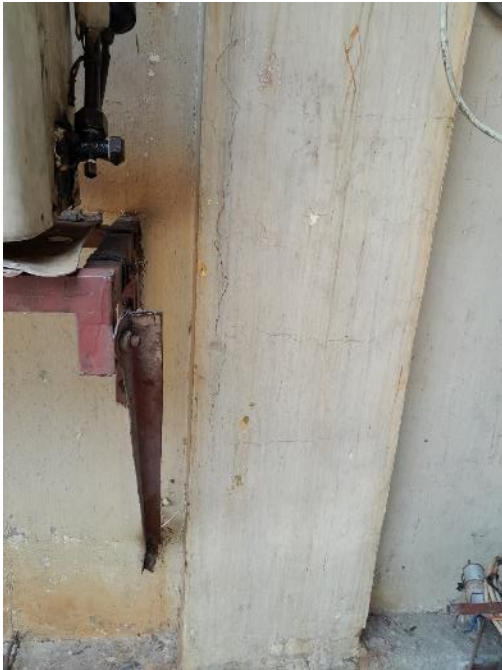
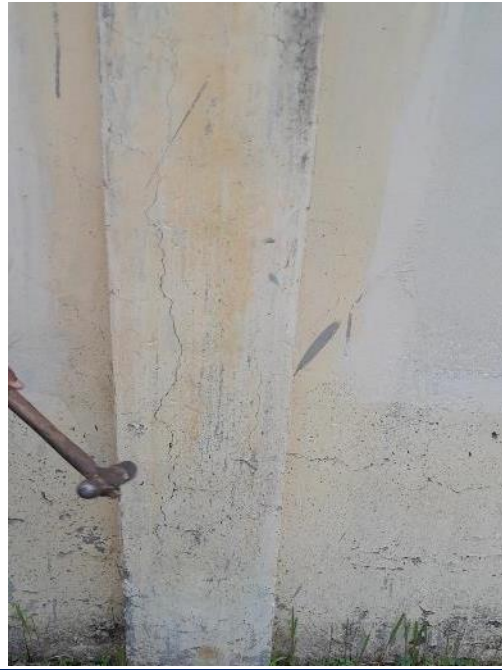
Crack on periphery columns

Corrosion crack observed in periphery columns

Corrosion crack was observed in the periphery columns of the marked zone in north and east grid. Building engineer is required to investigate the crack and determine column capacity.

| Item No. | Observation | Recommended Action Plan | Recommended Timeline |
|---|--|---|---|
| 04 | Crack on periphery columns. (Shed 4) | Building engineer is required to investigate the crack and determine column capacity. | 6-weeks |
| 05 | Crack on periphery columns. (Shed 4) | Carry out remedial works where necessary. | 6-weeks |

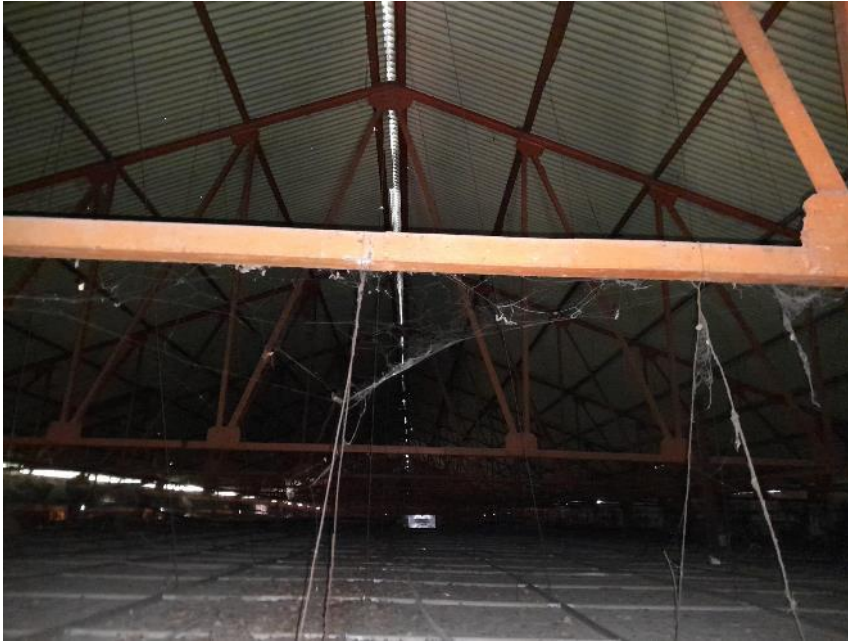
Lack of lateral stability system

Truss tie in long direction L 50X50X6 is appeared to slender considering the length 3.66 m.

Lateral stability member in long direction appeared to be inadequate. Building engineer is required to check the lateral stability of the shed in long direction.

| Item No. | Observation | Recommended Action Plan | Recommended Timeline |
|---|--|--|---|
| 06 | Lack of lateral stability system. (Shed 4) | Building engineer is required to check the lateral stability of the shed in long direction. | 6-weeks |
| 07 | Lack of lateral stability system. (Shed 4) | Carry out remedial works where necessary. | 6-months |

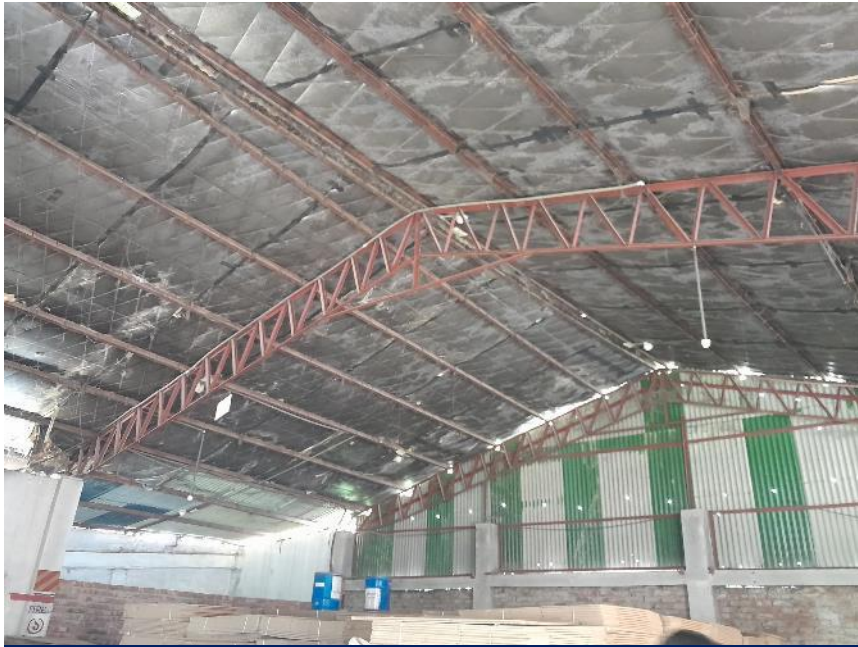
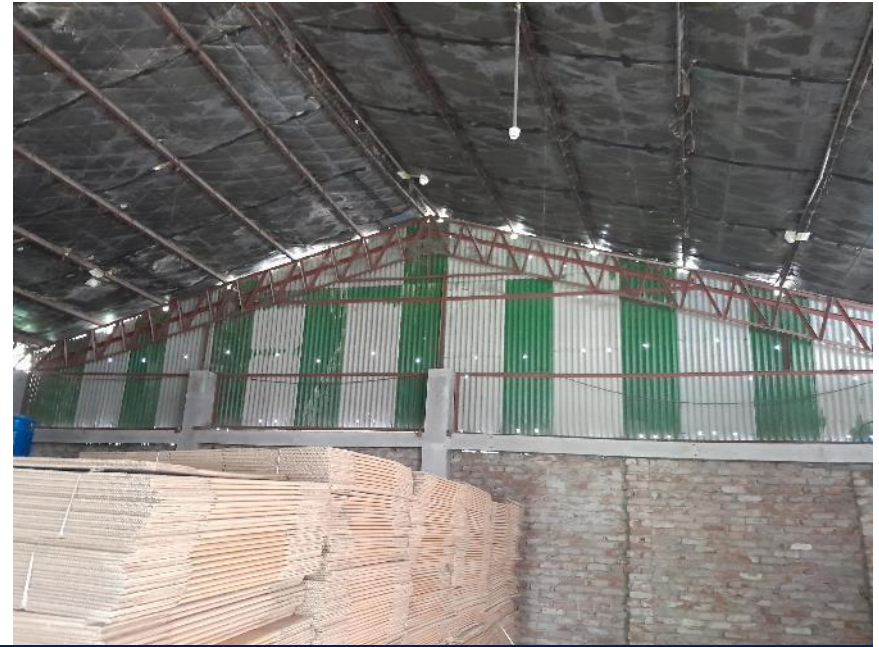
Lack of lateral stability system

Roof truss system appeared in adequate for lateral stability. Also, no stability member observed for long direction. Furthermore, poor connection details observed. Building engineer is required to check the connection and lateral stability of the shed.

| Item No. | Observation | Recommended Action Plan | Recommended Timeline |
|---|--|--|---|
| 08 | Lack of lateral stability system. (Shed 9) | Building engineer is required to check the lateral stability of the shed. | 6-weeks |
| 09 | Lack of lateral stability system. (Shed 9) | Carry out remedial works where necessary. | 6-months |

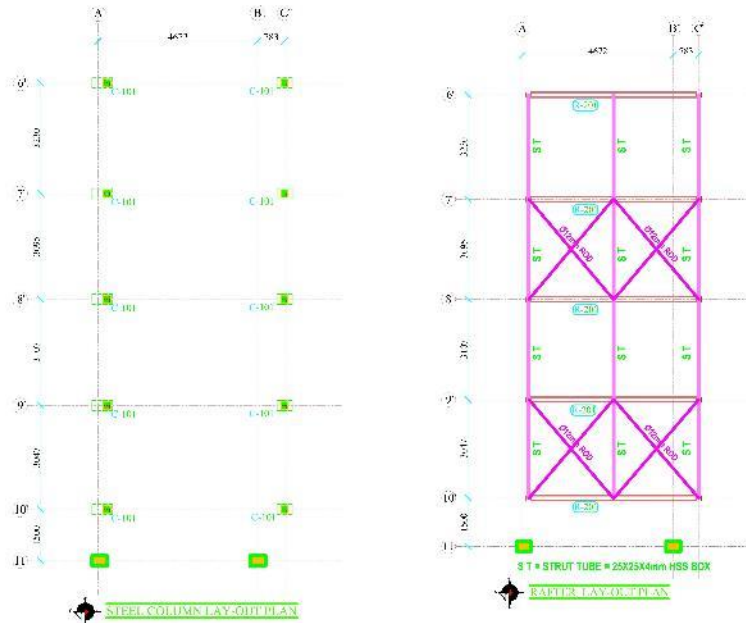
Compression strut of 25X25X4 mm size apparently inadequate for taking compression load. Building engineer is required to check the capacity of compression strut.

| Item No. | Observation | Recommended Action Plan | Recommended Timeline |
|---|--|--|---|
| 10 | Apparently inadequate compression strut for long direction (Shed 10) | Building engineer is required to check the capacity of compression strut and suggest necessary remedial actions. | 6-weeks |

| Item No. | Observation | Recommended Action Plan | Recommended Timeline |
|---|--|--|---|
| 11 | Apparently inadequate compression strut for long direction (Shed 10) | Carry out remedial works where necessary. | 6-months |

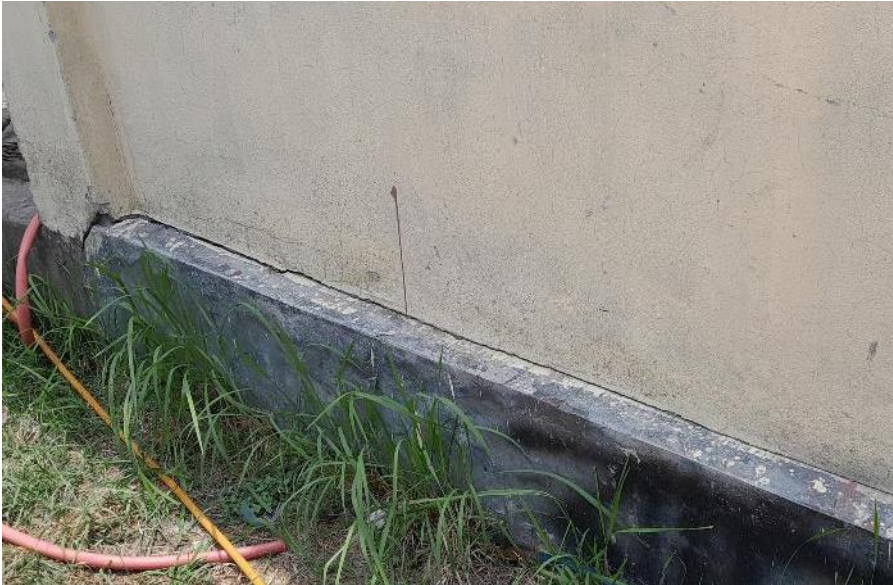
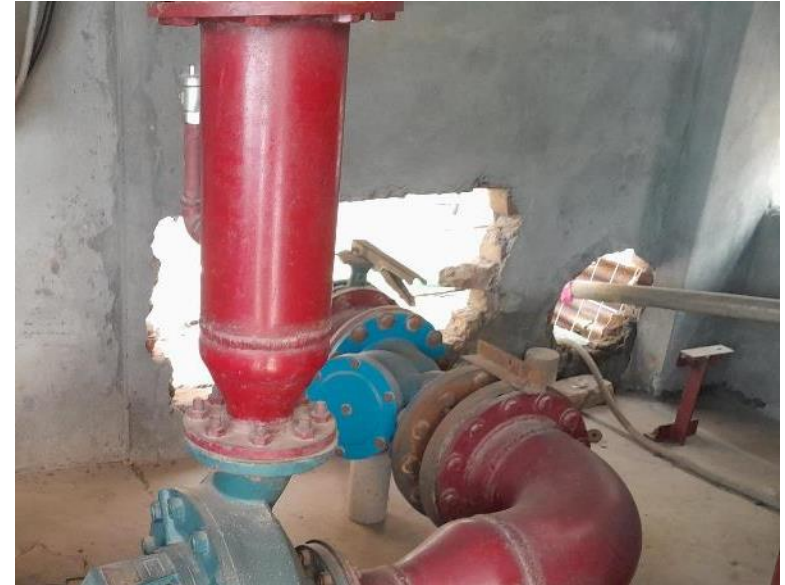
Crack in roof supported brick wall

During inspection, brick wall crack and broken wall found at shed 13 (pump room). Building engineer is required to investigate the reason of the crack and provide remedial measure accordingly.

| Item No. | Observation | Recommended Action Plan | Recommended Timeline |
|---|--|--|---|
| 12 | Crack in roof supported brick wall. (Shed 13) | Building engineer is required to investigate the reason of the crack and provide remedial measure accordingly. | 6-weeks |
| 13 | Crack in roof supported brick wall. (Shed 13) | Carry out remedial works where necessary. | 6-months |

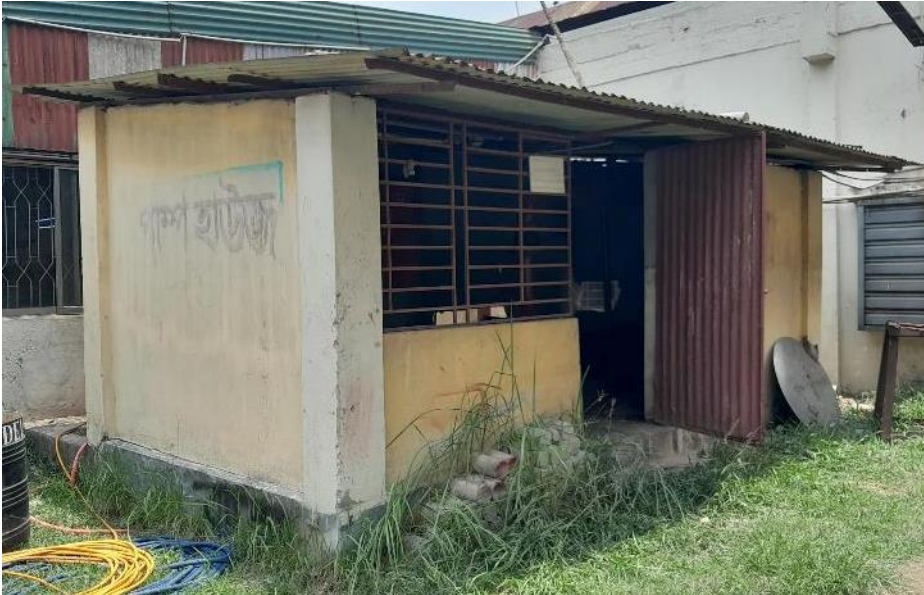
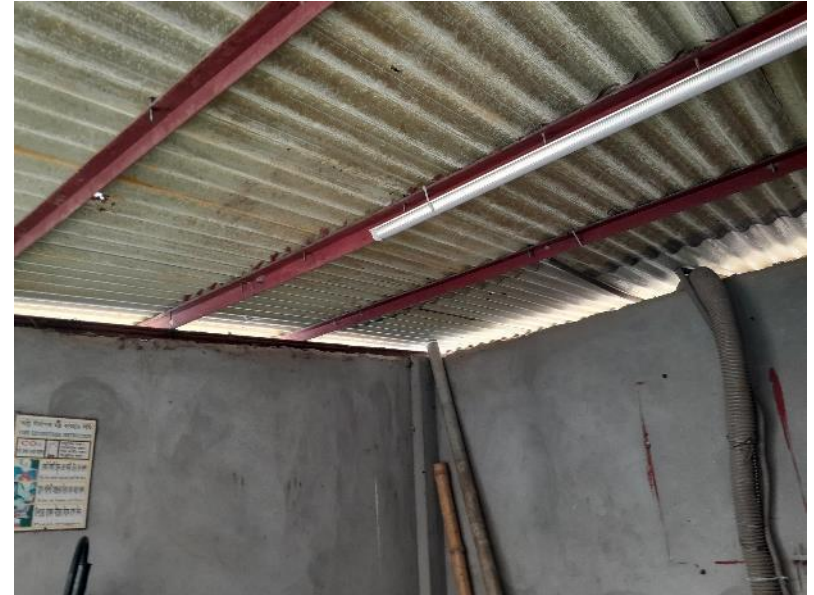
Non-engineered shed

The shed has no other lateral stability system rather than 125 mm peripheral brick walls. Horizontal crack in the brick wall was observed which makes the wall unstable to resist lateral loads. The building engineer is required to check the lateral stability of the structure and suggest proper alternatives.

| Item No. | Observation | Recommended Action Plan | Recommended Timeline |
|---|--|--|---|
| 14 | Non-engineered sheds. (Shed 13) | The building engineer is required to check the lateral stability of the structure and suggest proper alternatives. | 6-weeks |
| 15 | Non-engineered sheds. (Shed 13) | Carry out remedial works where necessary. | 6-months |

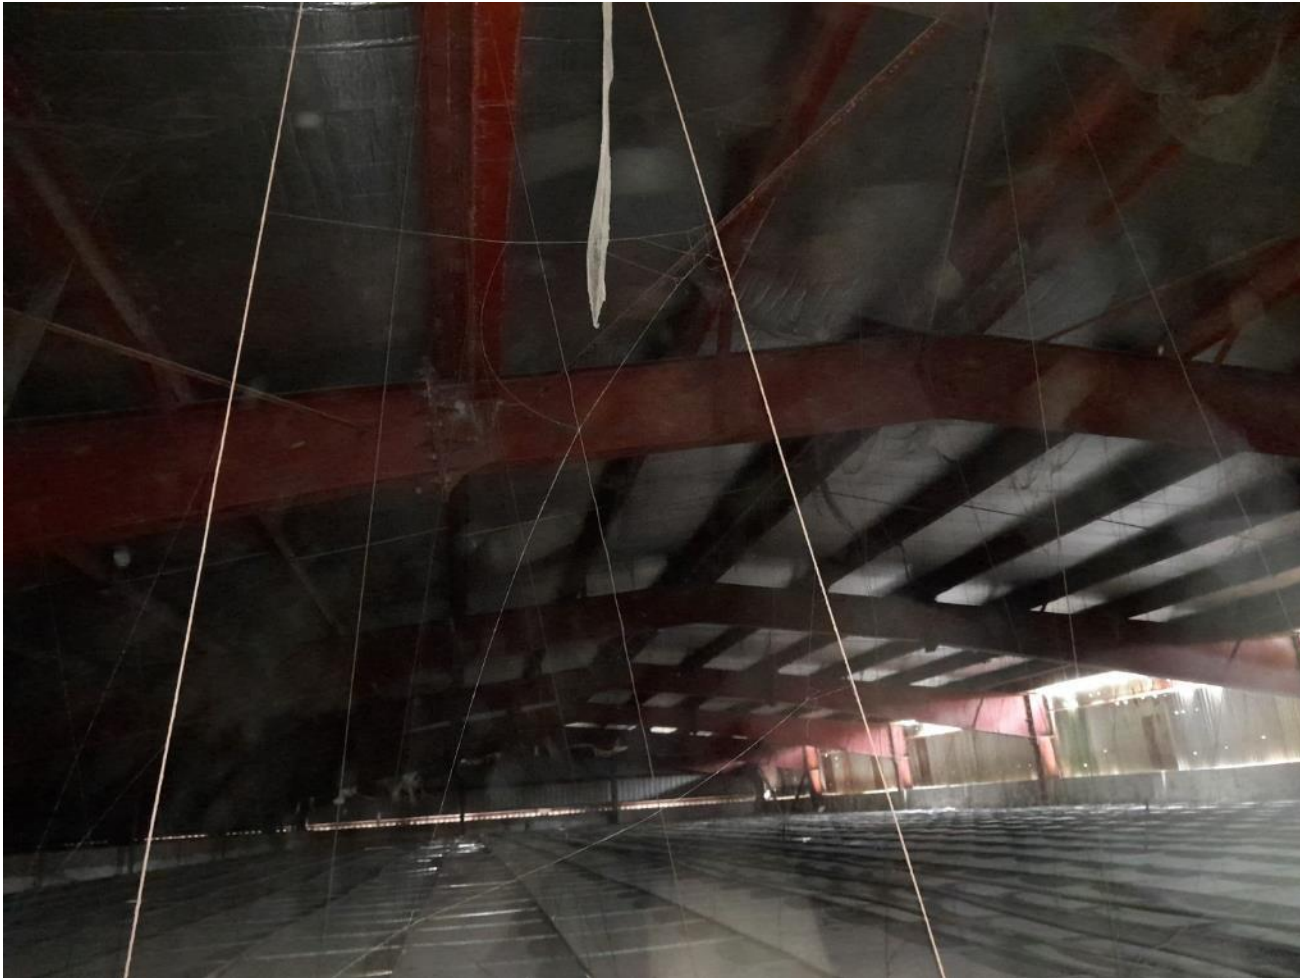
**Apparently lack of lateral stability of portal frame
along long direction**

Apparently lack of lateral stability observed in the N-S direction of the shed as frame provided in the long direction. Only end bays are braced and load transfer media not provided in the short direction. Building engineer is required to check the lateral stability of the shed.

| Item No. | Observation | Recommended Action Plan | Recommended Timeline |
|---|---|---|---|
| 16 | Apparently lack of lateral stability system in long direction. (Shed 14~18) | Building engineer is required to check the lateral stability of the shed and suggest necessary remedial actions. | 6-weeks |
| 17 | Apparently lack of lateral stability system in long direction. (Shed 14~18) | Carry out remedial works where necessary. | 6-months |

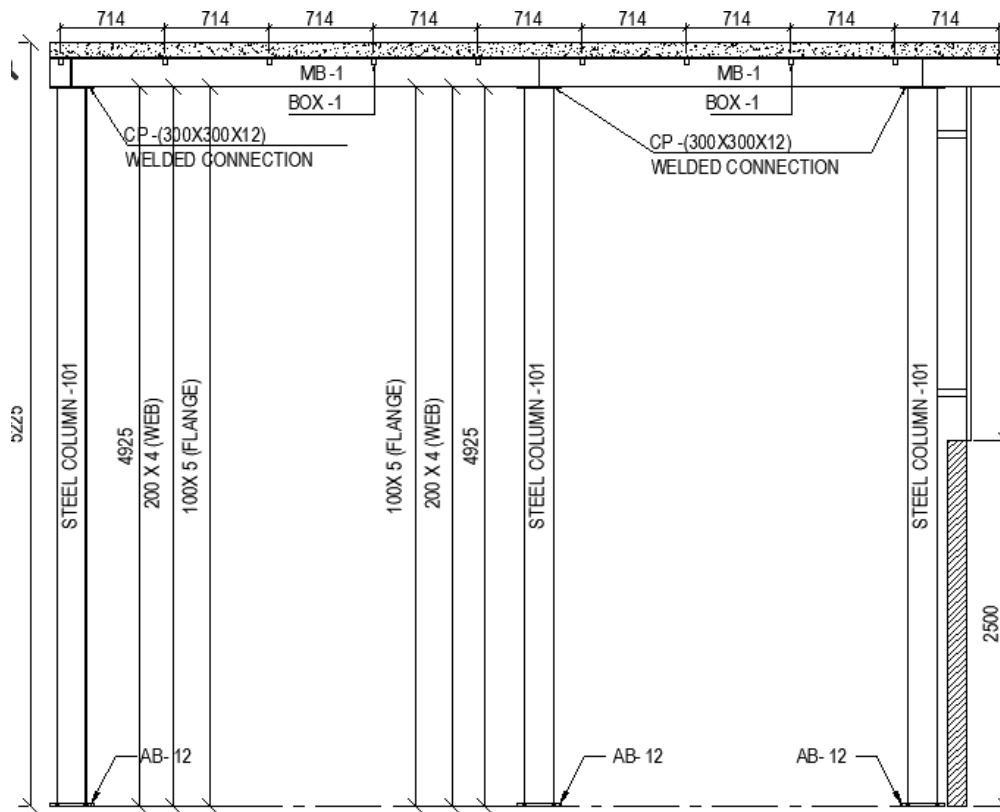
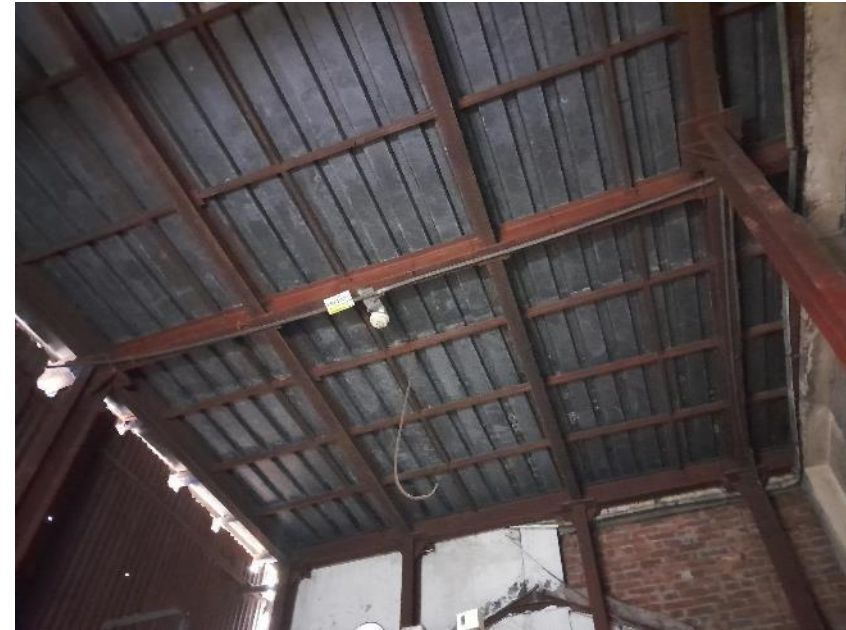
Lack of lateral stability system

The connections were not fully moment resisting and bracing system was not observed in the 5m high shed. Building engineer is required to check the connection and lateral stability of the shed.

| Item No. | Observation | Recommended Action Plan | Recommended Timeline |
|---|---|---|---|
| 18 | Lack of lateral stability system. (Shed 20) | Building engineer is required to check the connections & lateral stability of the shed and suggest necessary remedial action accordingly. | 6-weeks |
| 19 | Lack of lateral stability system. (Shed 20) | Carry out remedial works where necessary. | 6-months |
