# Dewan Fashion Wears Ltd. (Relocated)

Mamun Nagor, Sarabo, Kashimpur, Gazipur.

09 July 2023

# Building Information

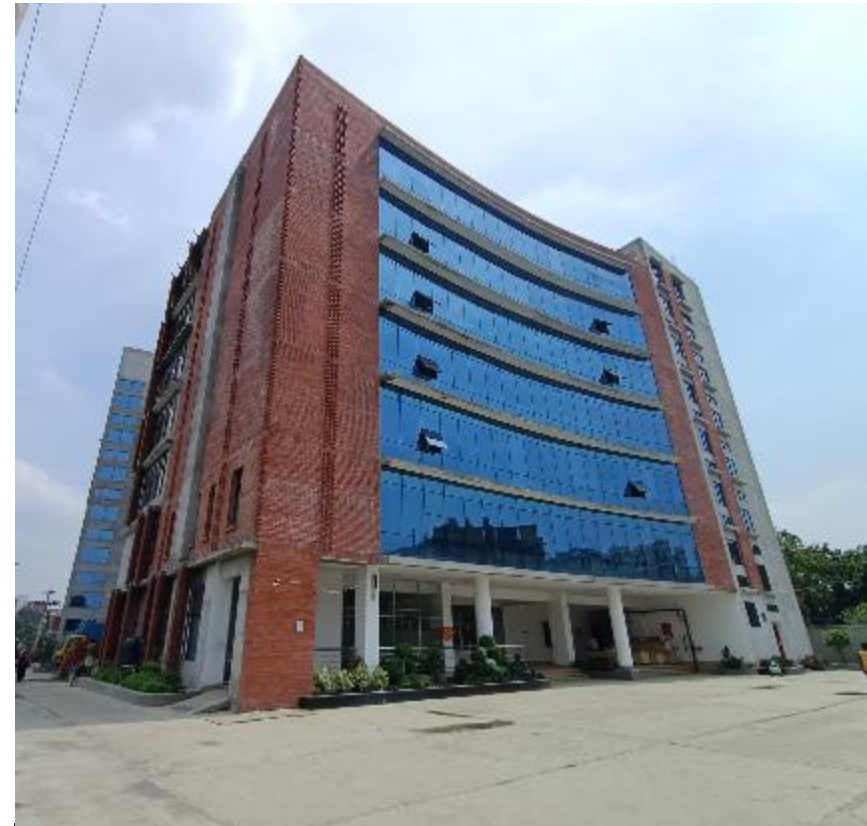
Design report (wind speed 239.4 KmPH)

A set of design report was available for the Main Building following BNBC 2020. But site classification and seismic design category not determined in the design report. Also, plan & vertical irregularity check not provided in the design report.

| Item No. | Observation | Recommended Action Plan | Recommended Timeline |
|---|---|---|---|
| 01 | Design report required to be revised. (Main Building) | Building engineer is required to update the design report & analysis model for applicable seismic design category and all other requirements as per section 1.9.1 of BNBC (part-6). Submit the design documents to the RSC for review. | 6-weeks |

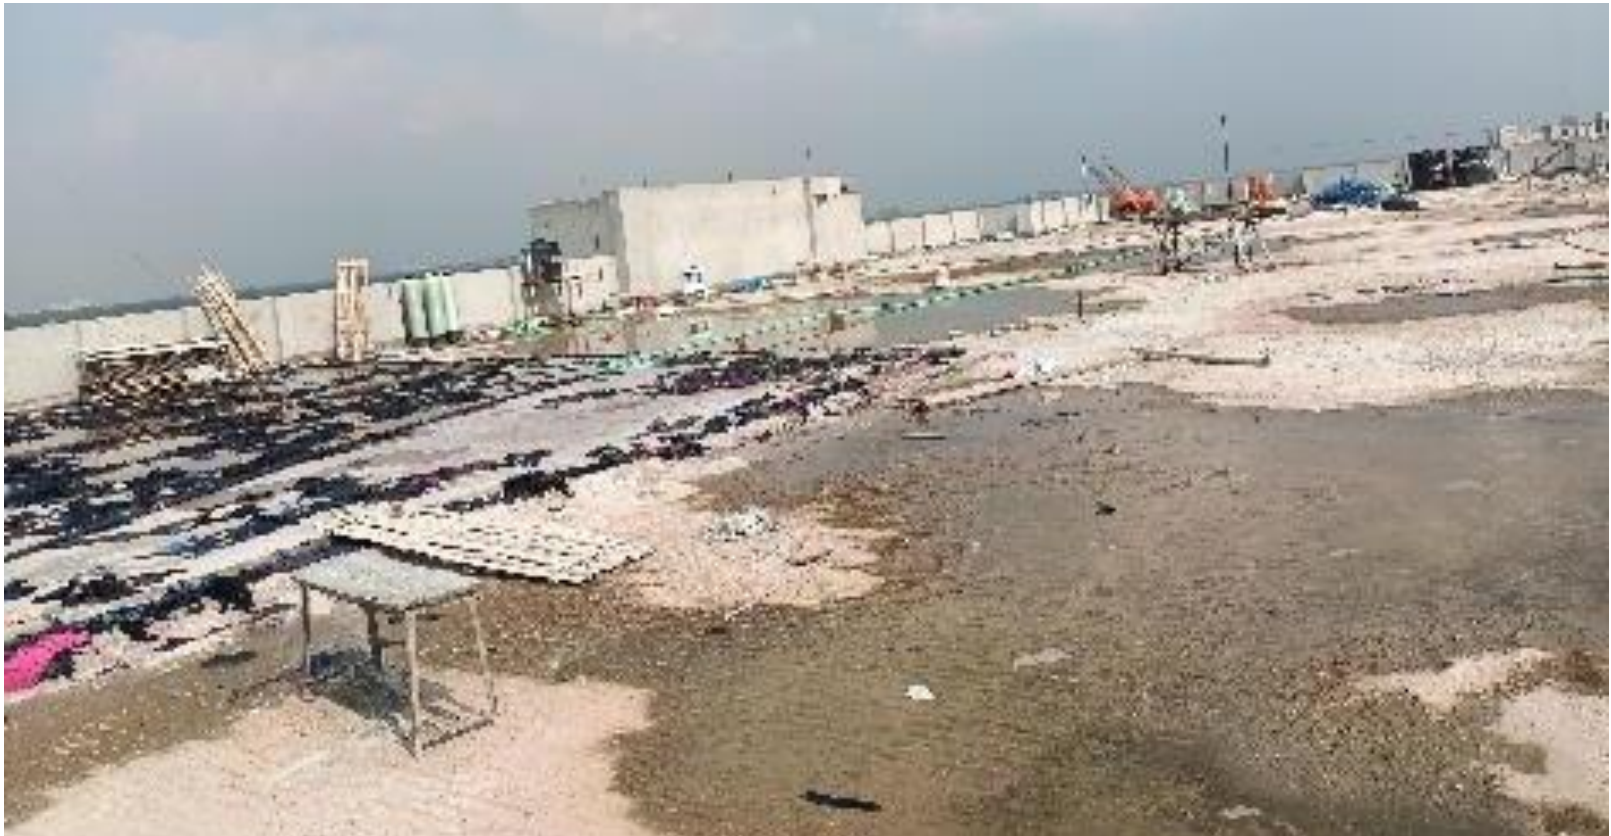
Wastage on the roof

Wastage and construction material were found on the current roof. Building engineer is required to remove all kind of wastage from the roof.

| Item No. | Observation | Recommended Action Plan | Recommended Timeline |
|---|---|---|---|
| 04 | Construction debris on the roof. (Main Building) | Remove the Construction debris from the roof. | 6-weeks |

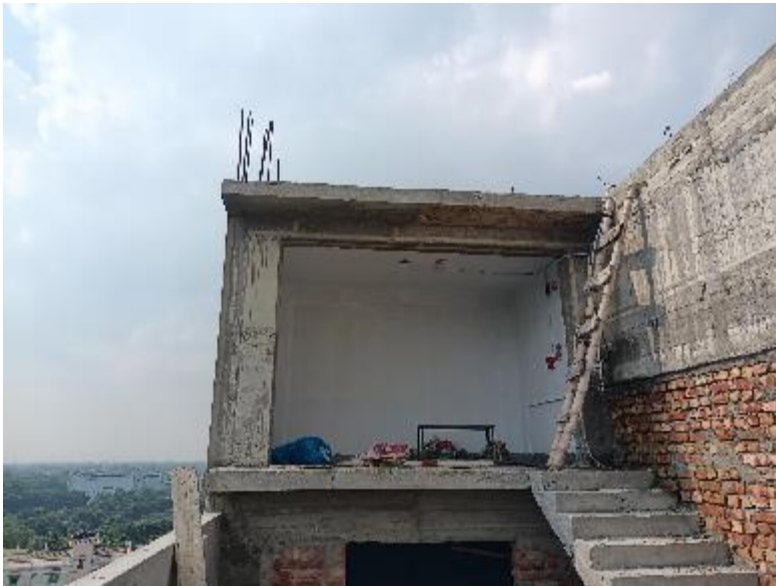
Exposed rebar at roof top column

Exposed rebars were found at roof top column. Building engineer is required to take proper measure to protect the rebar. Also, complete the casting of waterproofing work.

| Item No. | Observation | Recommended Action Plan | Recommended Timeline |
|---|---|---|---|
| 05 | Expose rebar and incomplete water proofing on the roof. (Main Building) | Apply corrosion resistance coating to the exposed rebar to protect from corrosion. | 6-weeks |

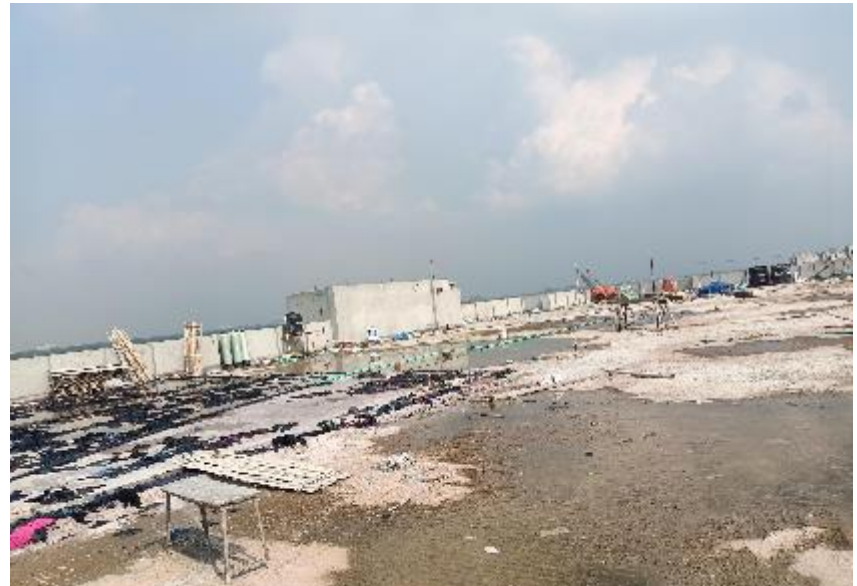
Incomplete water proofing work

| Item No. | Observation | Recommended Action Plan | Recommended Timeline |
|---|---|---|---|
| 06 | Expose rebar and incomplete water proofing on the roof. (Main Building) | Develop proper water drainage system on the roof with adequate slope and water outlets. | 6-months |

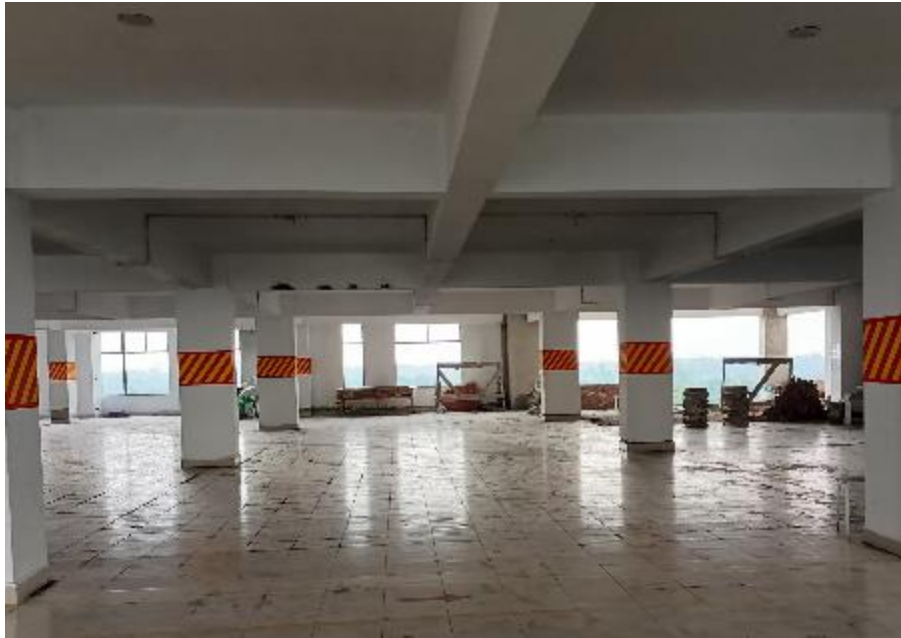
Falling hazard risk at East side windows

No protection was found at East side windows and inadequate railing was found at stair. Building engineer is required to provide necessary step to mitigate the falling hazard risk. Also increase the height of the railing of stair.

| Item No. | Observation | Recommended Action Plan | Recommended Timeline |
|---|---|---|---|
| 08 | Falling hazard risk at east side windows & stair railing | Install railing or grills to the open windows. | 6-weeks |

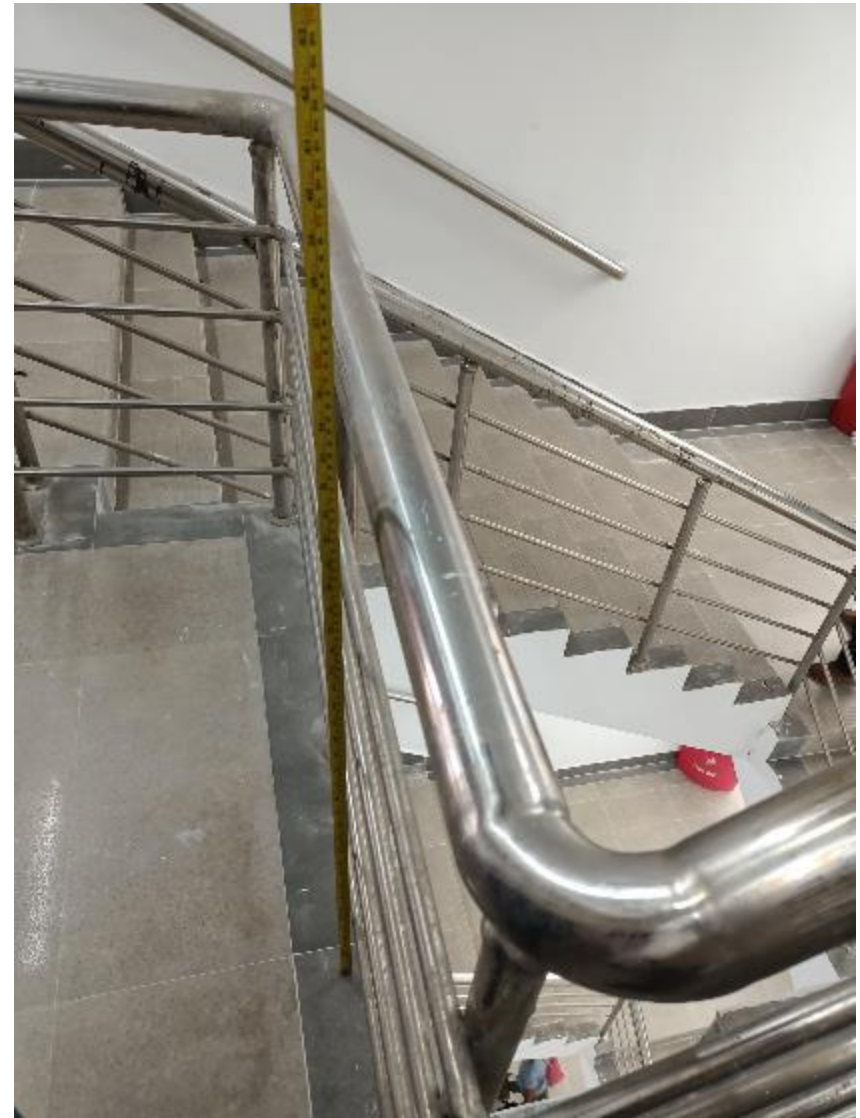
Unsafe railing

| Item No. | Observation | Recommended Action Plan | Recommended Timeline |
|---|---|---|---|
| 07 | Falling hazard risk at east side windows & stair railing | Building engineer is required to increase the height of the handrail to avoid possible falling hazard from stair. | 6-weeks |

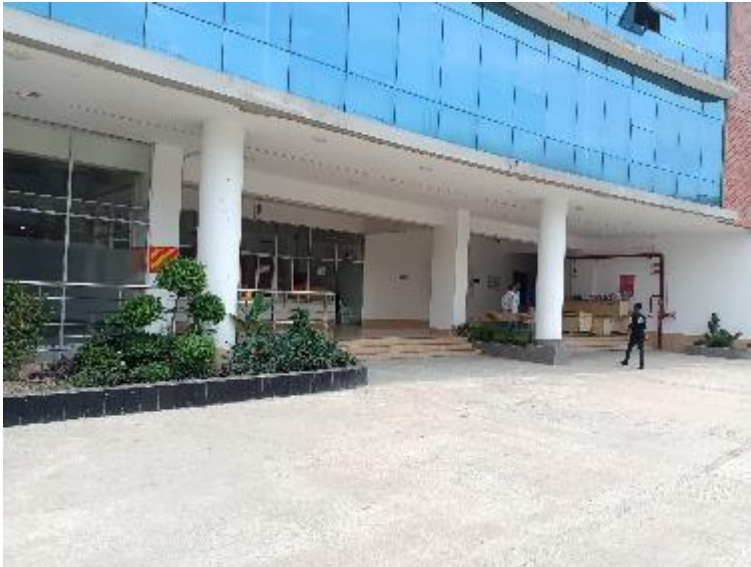
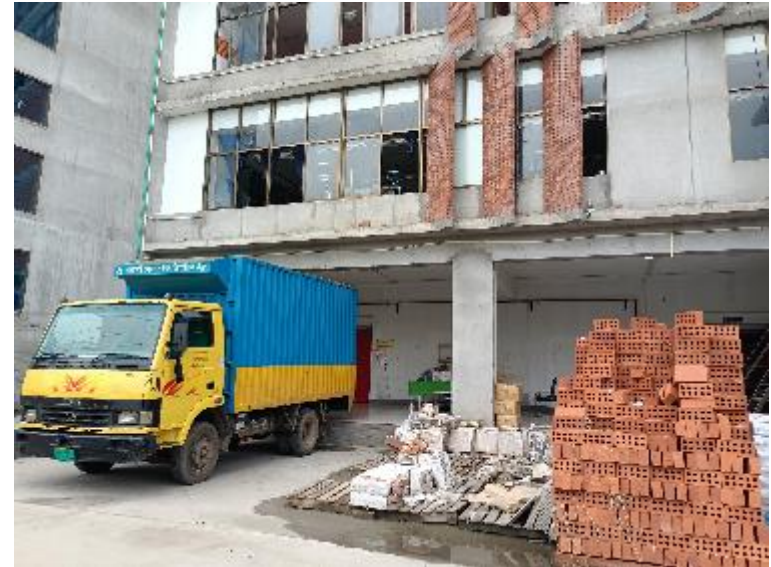
Column susceptible to vehicle impact

Some of the columns & beams were found adjacent to the driveway of parking & loading unloading platform. These column are susceptible to vehicle impact. The factory engineer is required to take necessary measures to prevent the vehicle impact by providing the barrier around the columns.

| Item No. | Observation | Recommended Action Plan | Recommended Timeline |
|---|---|---|---|
| 09 | Column and beam susceptible to vehicle impact | The factory is required to provide barrier around the column and take necessary measures for the beams to protect from possible vehicle impact. | 6-months |

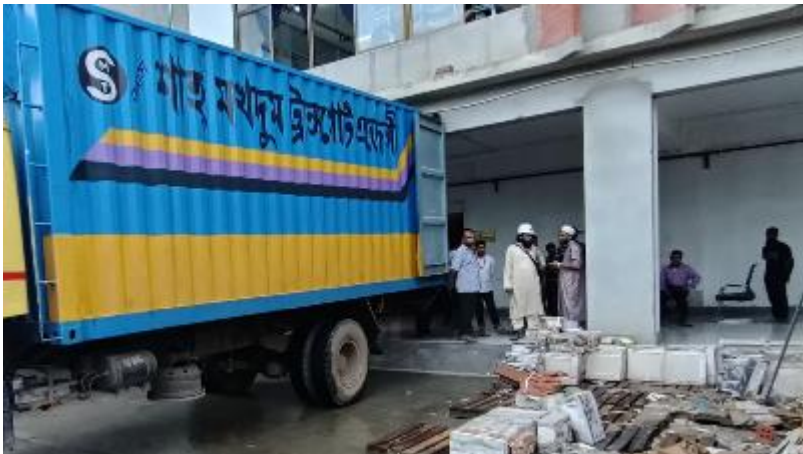
Beams adjacent to the driveway of loading unloading zone

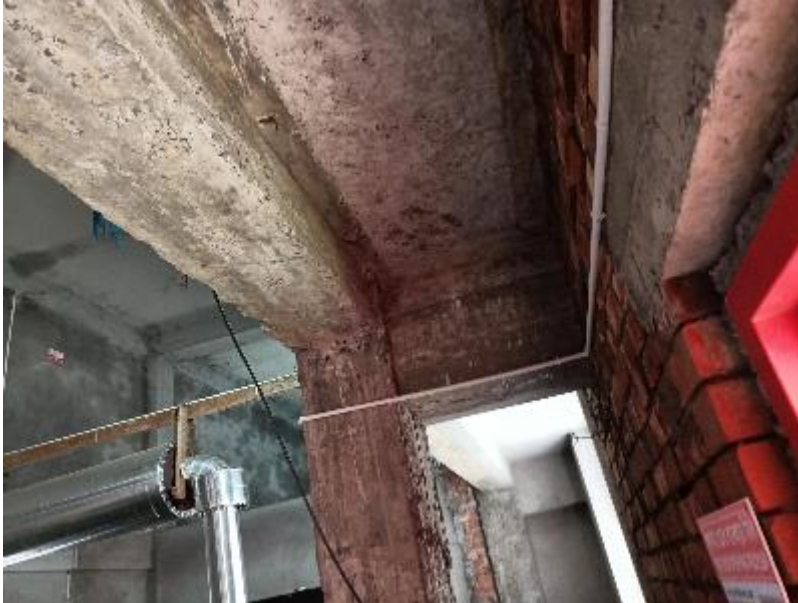
Additional slab at front

Additional slab at front was not shown in the slab details. Also, tie beam layout and details were not available in the provided structural drawings. Building engineer is required to revised the structural drawings providing all structural details.

| Item No. | Observation | Recommended Action Plan | Recommended Timeline |
|---|---|---|---|
| 10 | Lack of information in the structural drawings. (Utility Building) | Building engineer is required to prepare the full set of as-built drawing in compliance with section 1.9.1.2 (part-6, BNBC). | 6-weeks |

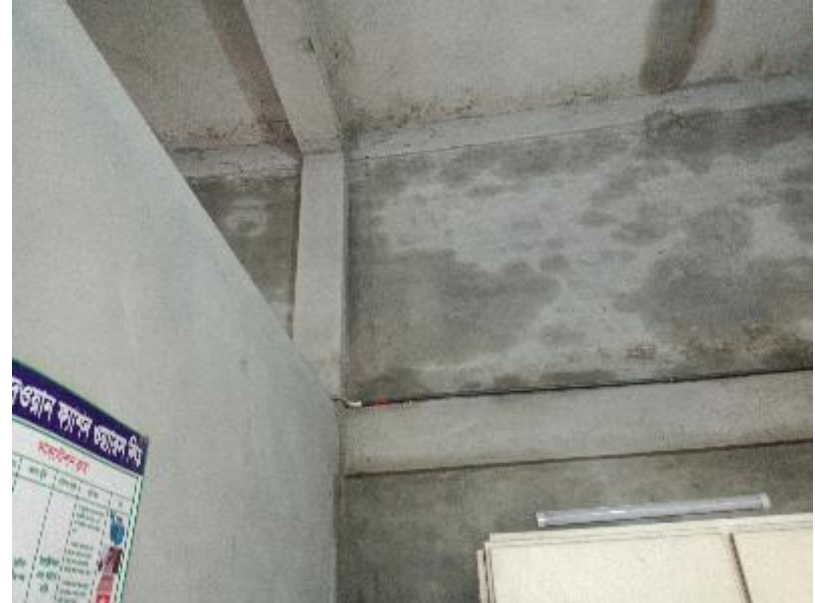
Tie & floor beam

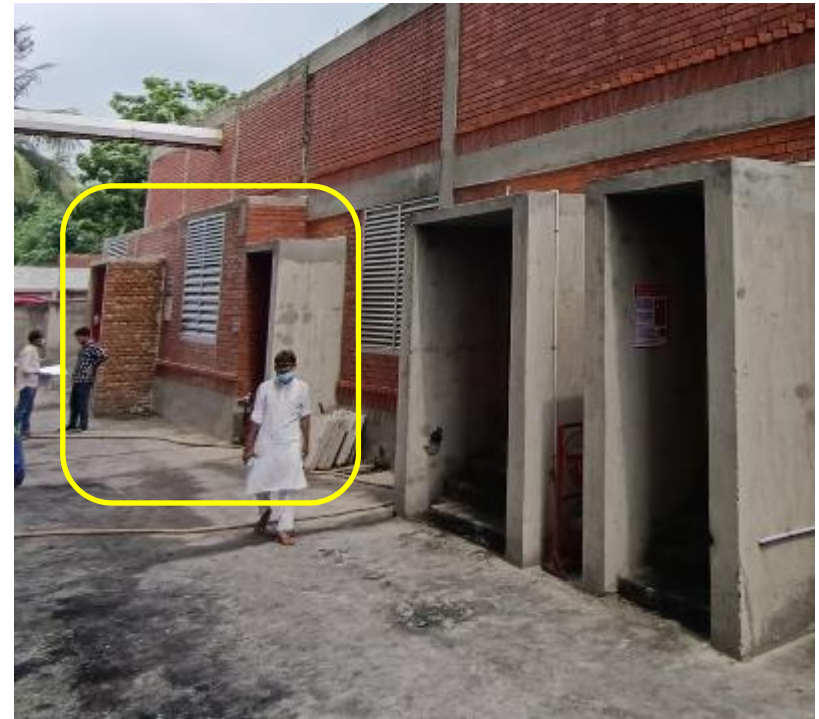
additional slab at front

Additional slab at front was not considered in the design report. Building engineer is required to revise the design report considering figure of the structure.

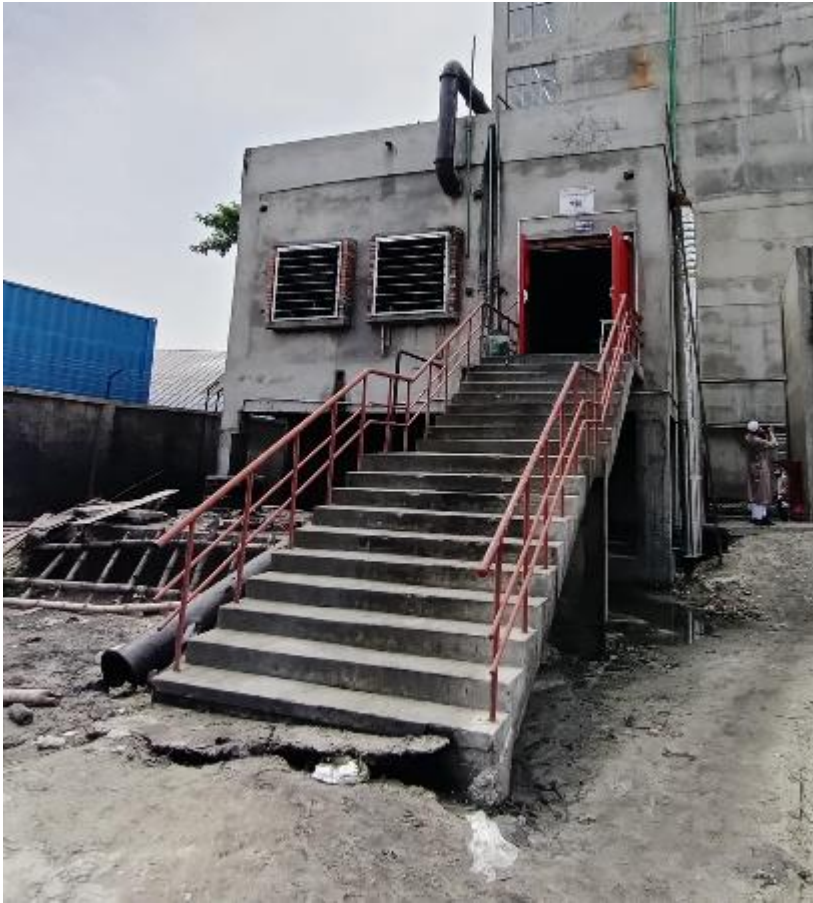
RC Stair

Architectural drawings were not found for the Fire Pump and Boiler Room. Also, the structural details were not available for the RC stair of the building.

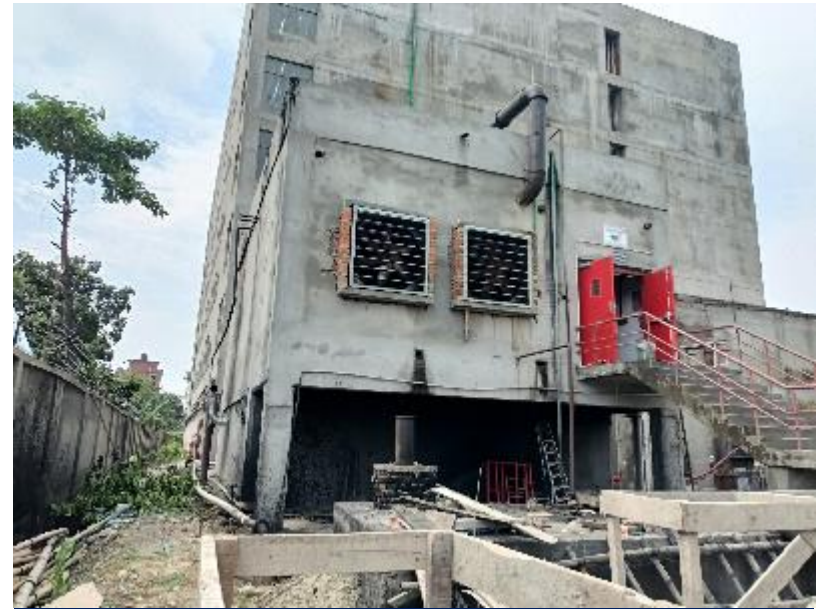
Fire Pump and Boiler Room
