# Arcorp Denim Ltd.

Holding#332 Road#2 Ward#5 Block#B  
Kumkumari, Gazipur, Ashulia, Savar, Dhaka  
23.8827N, 90.3269E

20 October 2015

# Observations

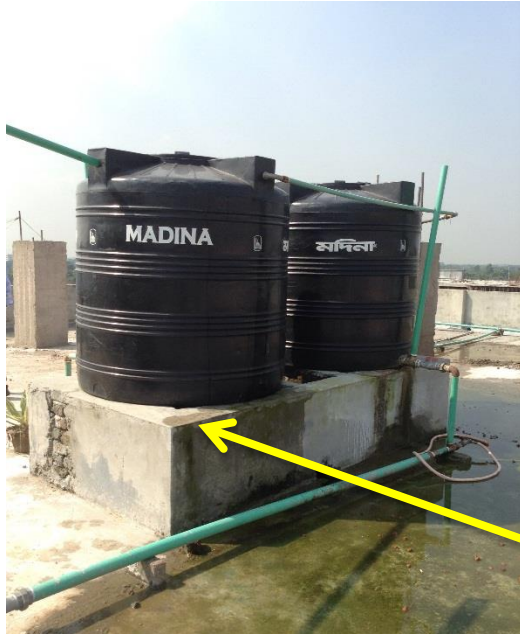
Water tank on roof.  
Capacity 2 x 2000L

Item No.	Observation	Recommended Action Plan	Recommended Timeline
1	Water tanks on roof	Empty 5000 ltr. tank on the roof to be removed. The engineer to check the roof slab under the two full tanks. (2-2000ltr tanks.)	6-weeks
2	Water tanks on roof	Remove tanks if required.	6-months
3	Minor cracks on walls perpendicular to cantilever on 5th floor and cantilevers appear to have deflected	Building Engineer to check cantilever design for the wall loading and live load. Engineer to confirm likely deflection and its impact on the external wall.	6-weeks
4	Minor cracks on walls perpendicular to cantilever on 5th floor and cantilevers appear to have deflected	Restrict loading on the cantilevers to the design capacity from the engineering check.	6-months
5	Non Engineered steel roof to stair core	Engineer to review the steel roof structure to both stair cores and design a stable roof structure.	6-weeks
6	Non Engineered steel roof to stair core	Construct engineered roof to stair core	6-months

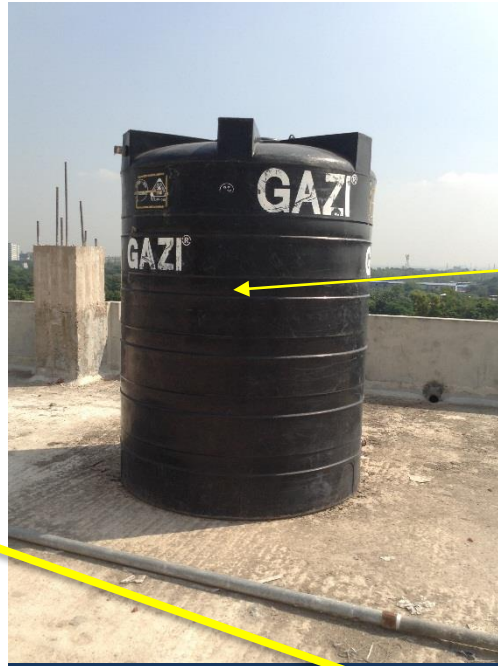
Empty water tank –  
5000L

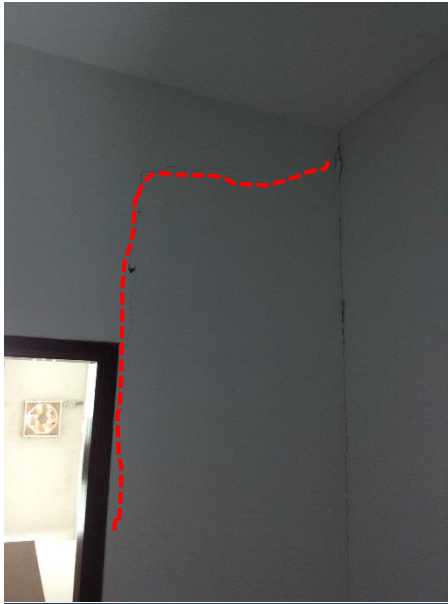
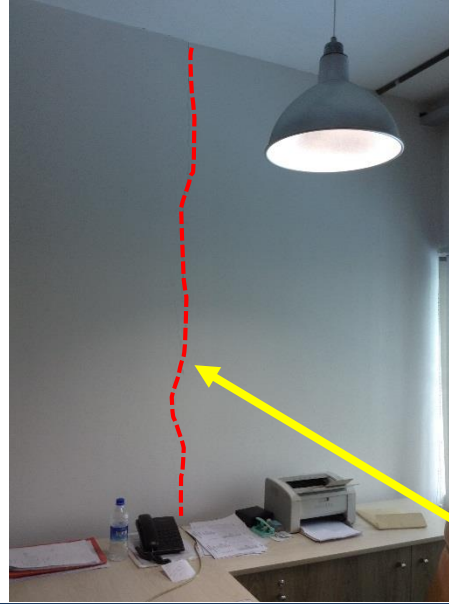
Minor cracks on walls perpendicular to cantilever on 5th floor

Building engineer to verify reason for cracking.

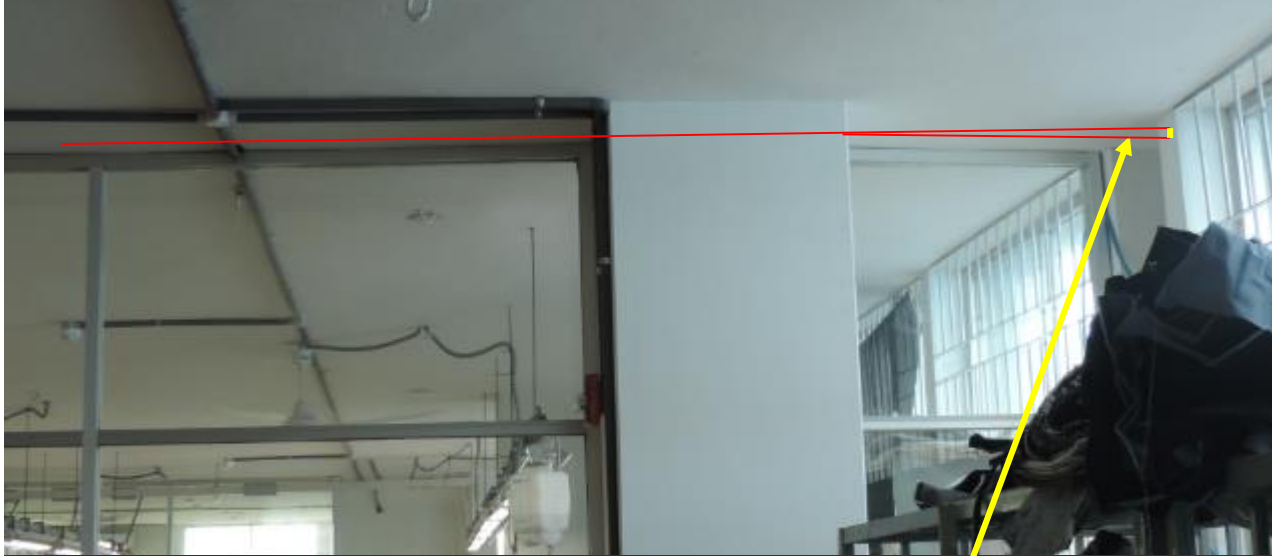
Cantilevers appear to have deflected

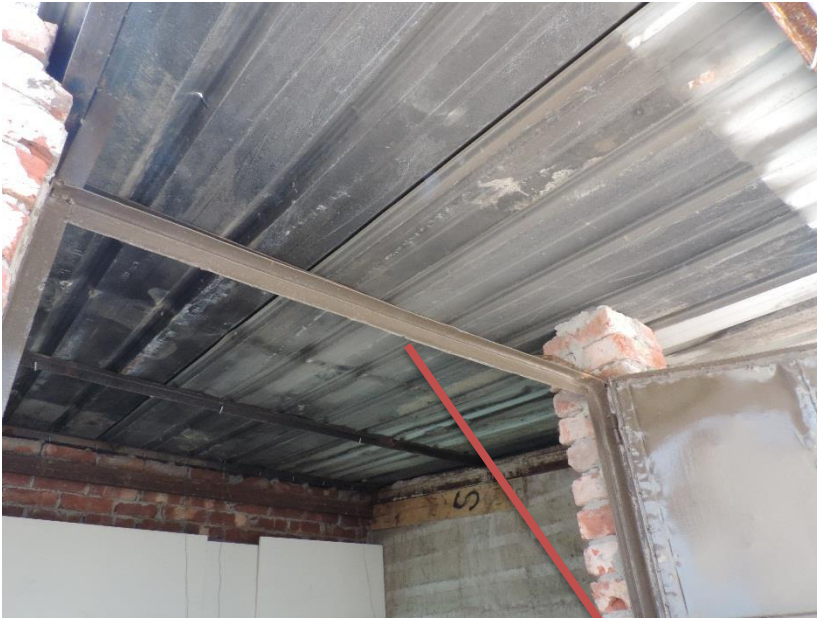
Non Engineered steel roof to stair core

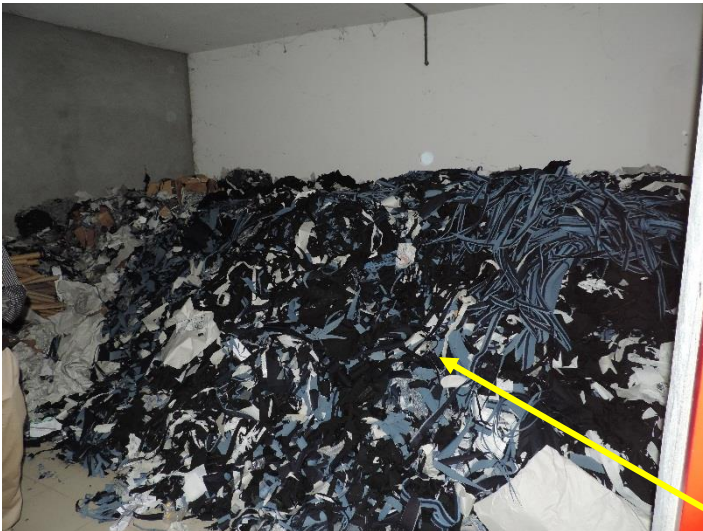
Waste storage

Item No.	Observation	Recommended Action Plan	Recommended Timeline
7	Uncontrolled loading on the floor	Limit loading on the floor plate to 2kPa	6-weeks
8	Uncontrolled loading on the floor	Produce and actively manage a loading plan for all floor plates within the factory giving consideration to floor capacity and column capacity	6-months
9	Uncontrolled loading on the floor	Continue to implement load plan.	6-months
10	Columns on loading bay unprotected from traffic impact	Engineer to review loading bay columns and their vulnerability to impact from truck. Design column protection.	6-weeks
11	Columns on loading bay unprotected from traffic impact	Implement design	6-months

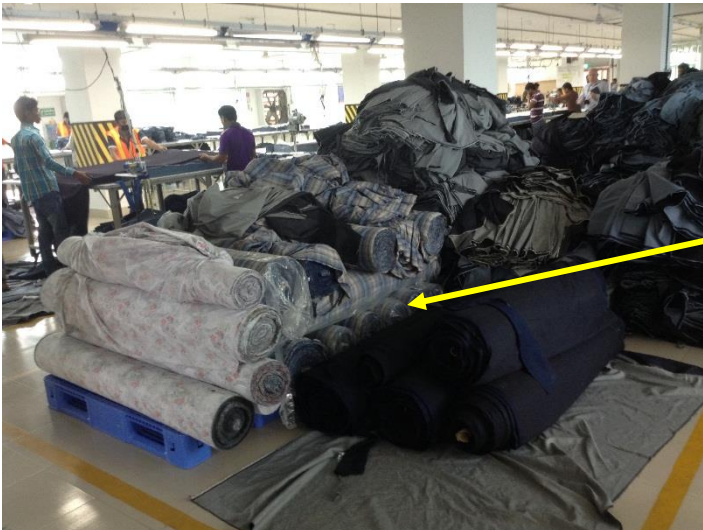
Fabric roll and loose garments

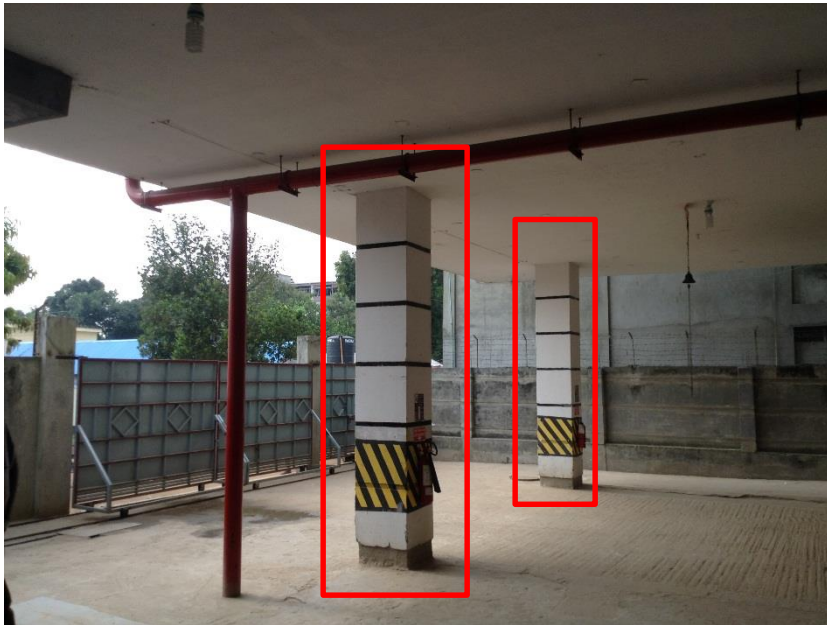
Columns in loading bay unprotected from traffic impact.

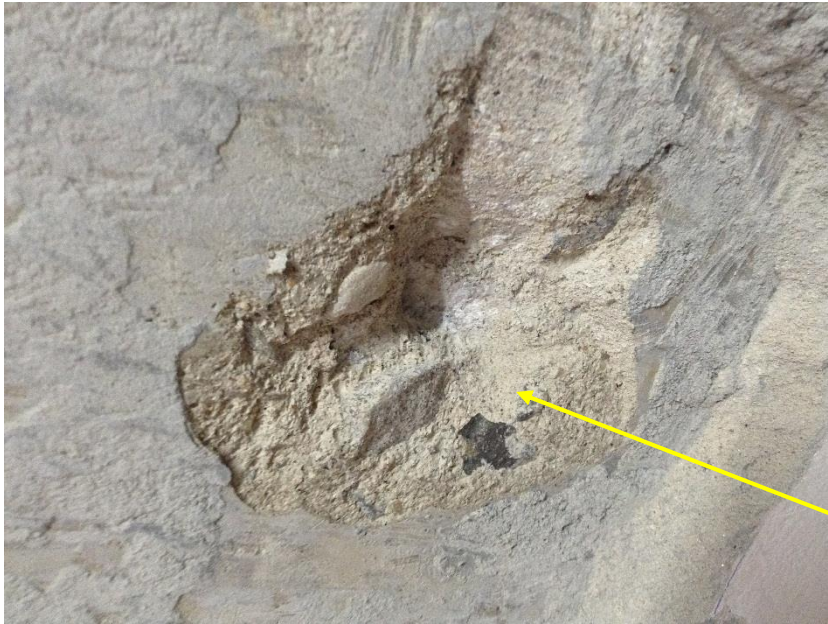
**Stone Aggregate noted in ground floor columns**
