# Mohsin Knitwear Ltd.

B 361-364 BSCIC I/A  
Enayetnagar, Fatullah, Narayanganj  
(23.624188N, 90.481758E )  
21 October 2015

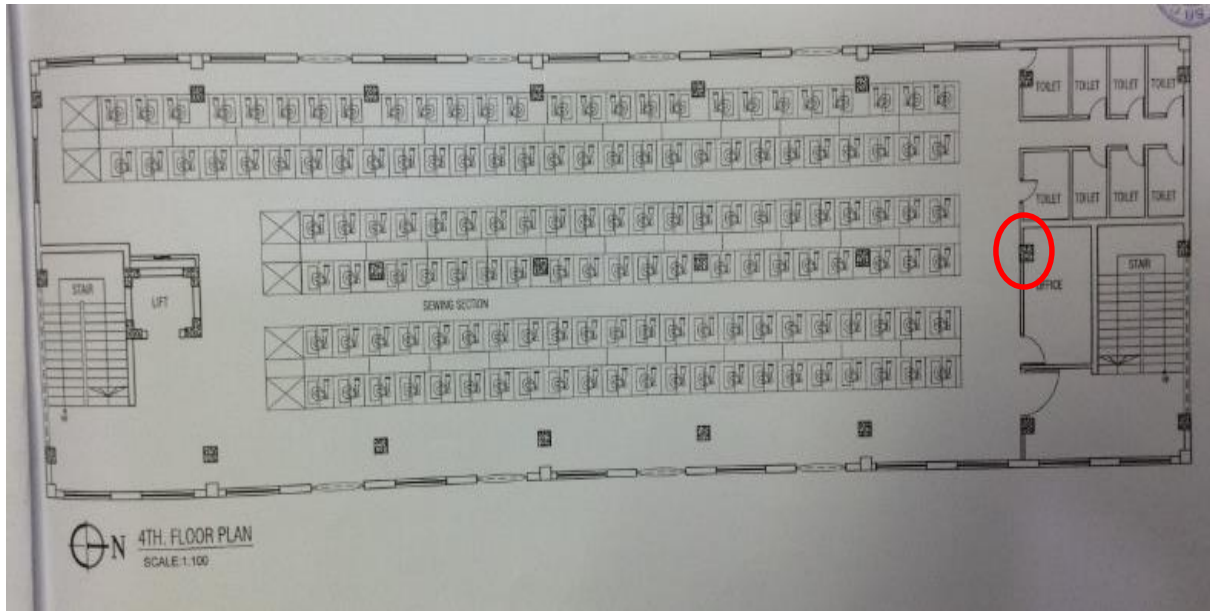
**Column under toilet area would appear to be stressed in excess of normal design limits**

| Item No. | Observation | Recommended Action Plan | Recommended Timeline |
|---|---|---|---|
| 1 | Columns, in the highlighted area which support the toilet area appear to be stressed in excess of normal design limits | Building Engineer to review design, loads and column stresses in area identified above. | 6-weeks |
| 2 | Columns, in the highlighted area which support the toilet area appear to be stressed in excess of normal design limits | Verify insitu concrete strength either by 100mm diameter cores or existing cylinder strength data for cores from 4 columns | 6-weeks |
| 3 | Columns, in the highlighted area which support the toilet area appear to be stressed in excess of normal design limits | Produce and actively manage a loading plan for all floor plates within the factory giving consideration to floor capacity and column capacity. | 6-months |

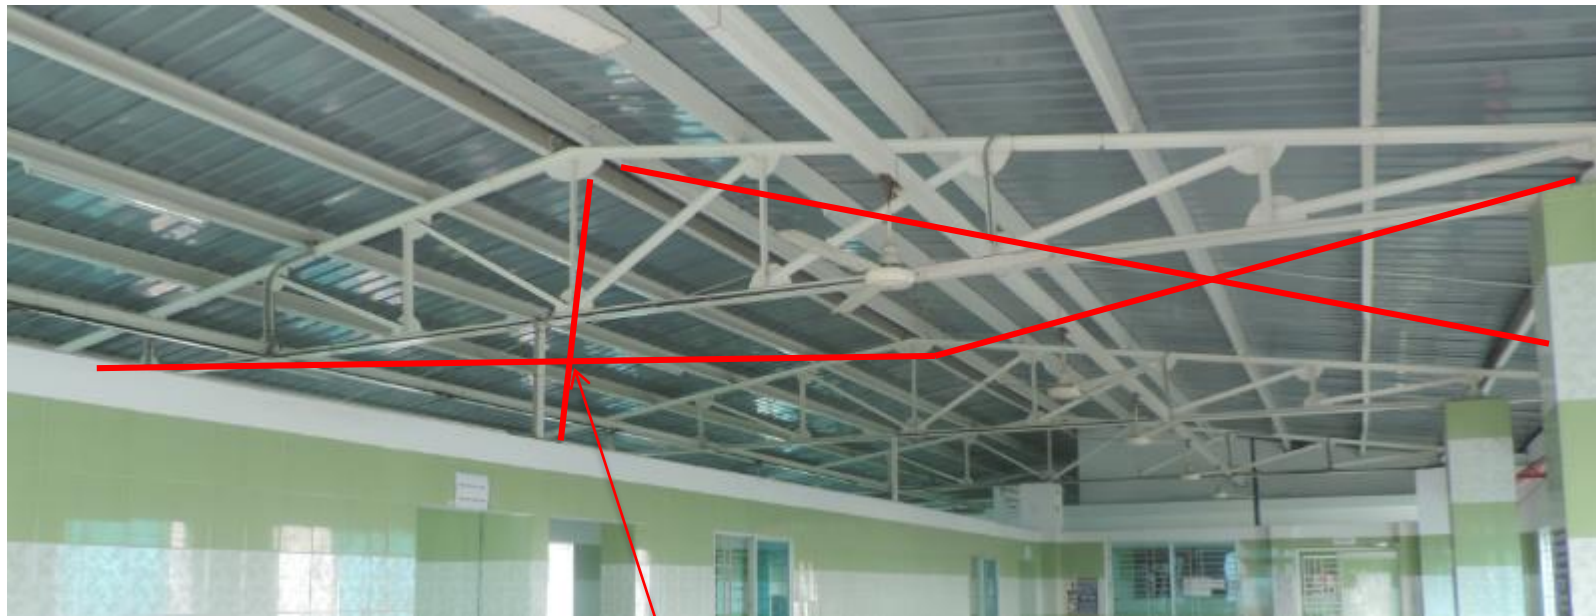
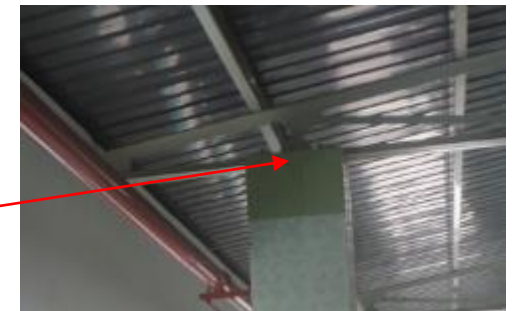
**Prayer roof**

**Steel roof to Prayer/Dining room has no diaphragm bracing and the truss column connection is not apparent**

**There is no apparent lateral bracing in the roof structure**

**No obvious connection  
between the truss and the  
RC column**

| Item No. | Observation | Recommended Action Plan | Recommended Timeline |
|---|---|---|---|
| 4 | Steel roof to Prayer/Dining room has no diaphragm bracing and the truss column connection is not apparent | Building Engineer to review design, of the Prayer / Dining room roof and how its tied to the RC columns | 6-weeks |
| 5 | Steel roof to Prayer/Dining room has no diaphragm bracing and the truss column connection is not apparent | Carry out any remedial works as a result of the above review | 6-months |

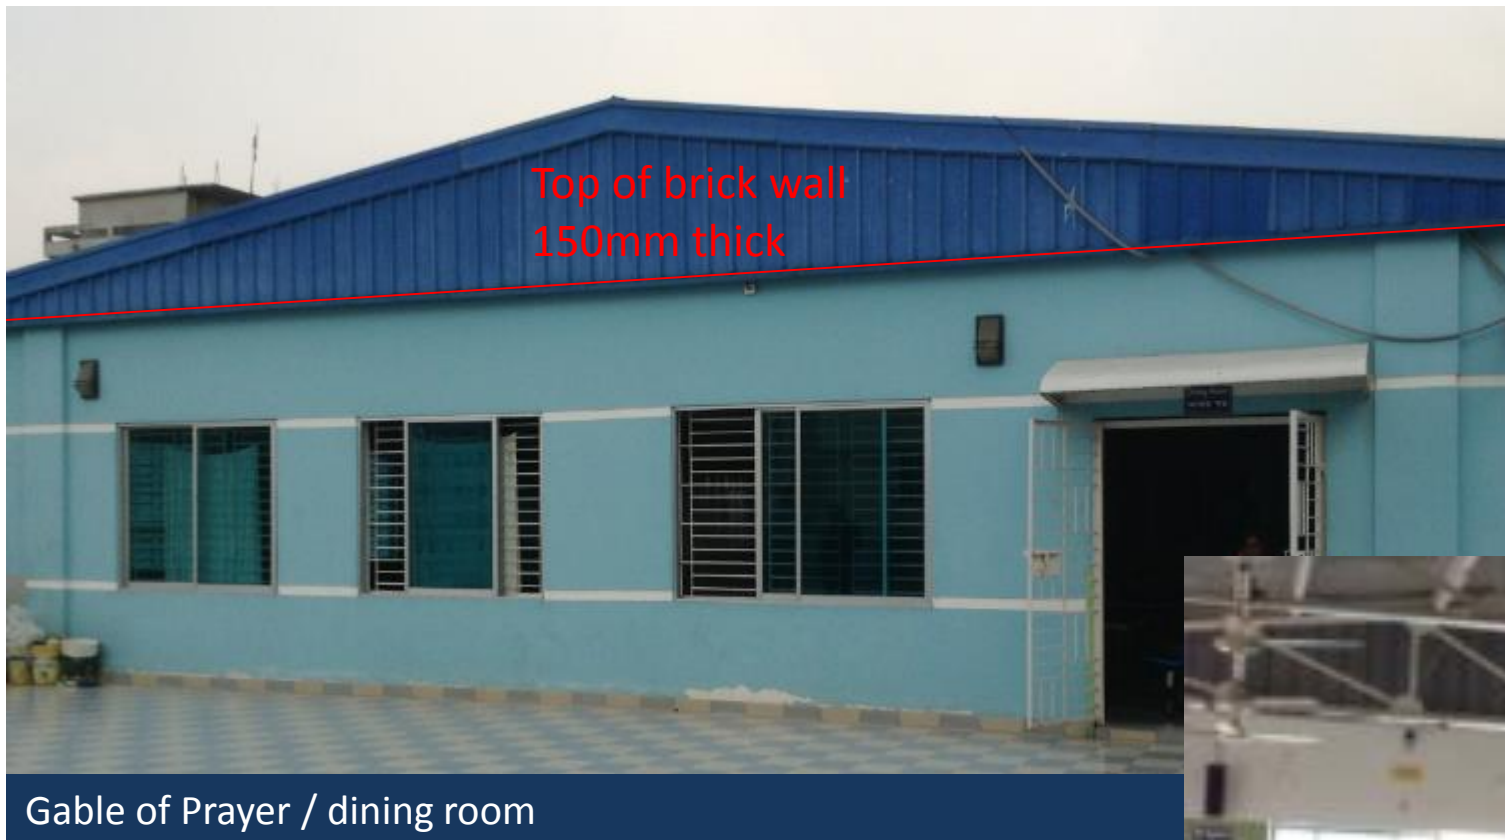
**Gable wall to Prayer room has no head restraint**

Top of brick wall  
150mm thick

| Item No. | Observation | Recommended Action Plan | Recommended Timeline |
|---|---|---|---|
| 6 | Gable wall to Prayer room has no head restraint | Engineer to review the stability of the gable wall of the Prayer / dining room on the top floor. | 6-weeks |
| 7 | Gable wall to Prayer room has no head restraint | Carry out such works following the Engineers recommendations | 6-months |

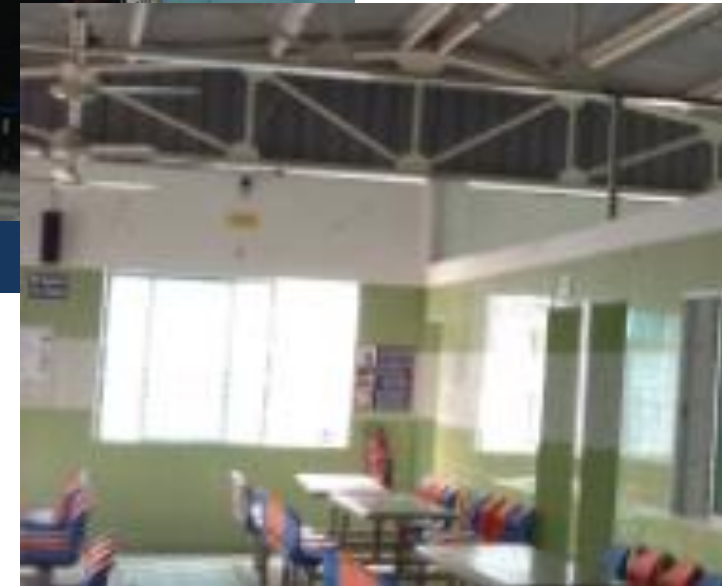
No Head restraint to top of wall

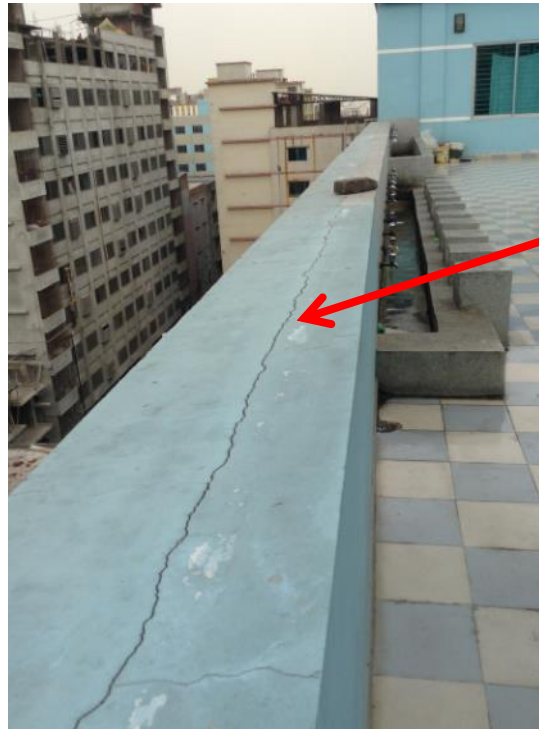
**Parapet wall on west side  
(rear of building)**

**Capping on parapet appears to be loose**

| Item No. | Observation | Recommended Action Plan | Recommended Timeline |
|---|---|---|---|
| 8 | Capping on parapet appears to be loose | Engineer to survey the capping and investigate the obvious movement | 6-weeks |
| 9 | Capping on parapet appears to be loose | Carry out remedial works following the inspections and review by the Engineer. | 6-months |
| 10 | Capping on parapet appears to be loose | Monitor for cracking on an ongoing basis. | 6-months |

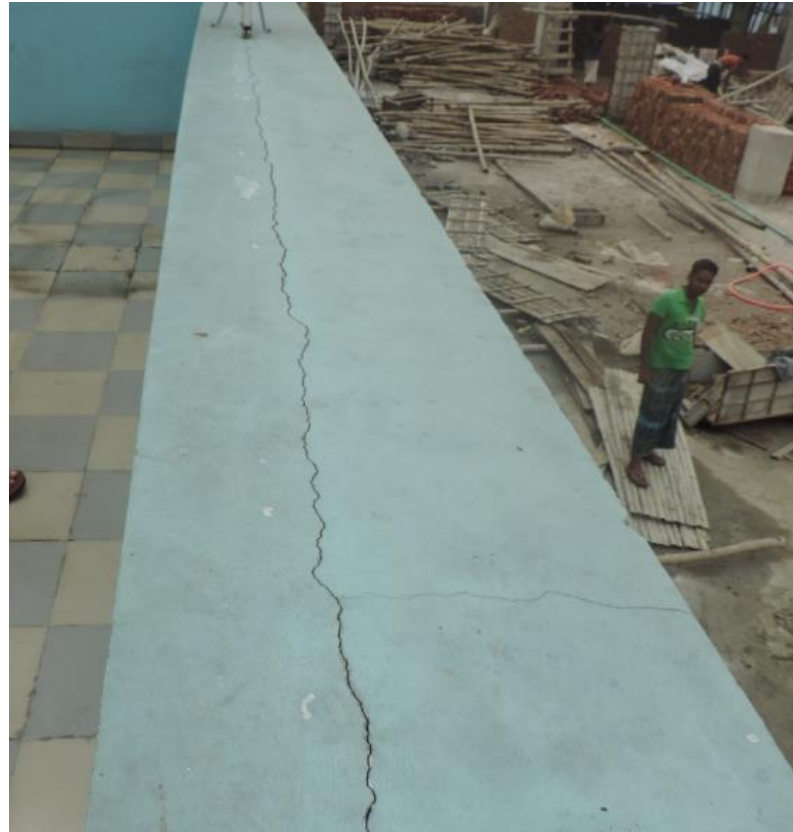
**Crack along capping to  
parapet wall**

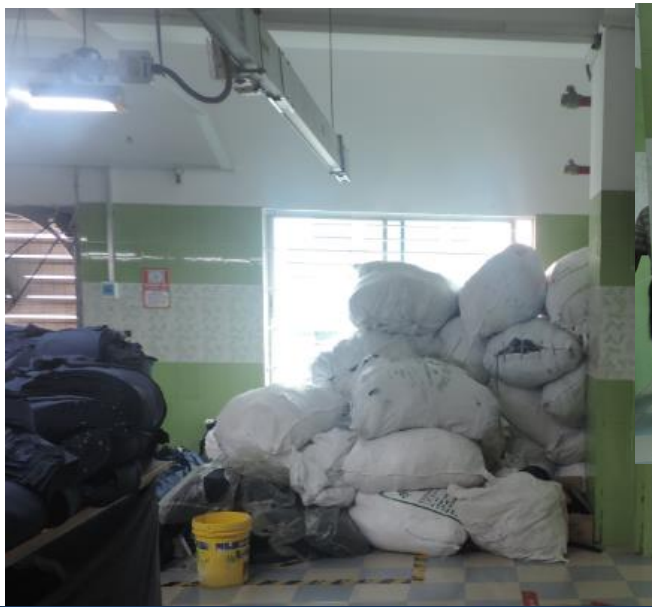
**6<sup>th</sup> Floor cotton bags in cantilever section of the floor**

| Item No. | Observation | Recommended Action Plan | Recommended Timeline |
|---|---|---|---|
| 11 | Floor loading uncontrolled | Produce and actively manage a loading plan for all floor plates within the factory giving consideration to floor capacity and column capacity | 6-weeks |
| 12 | Floor loading uncontrolled | Continue to implement load plan. | 6-months |

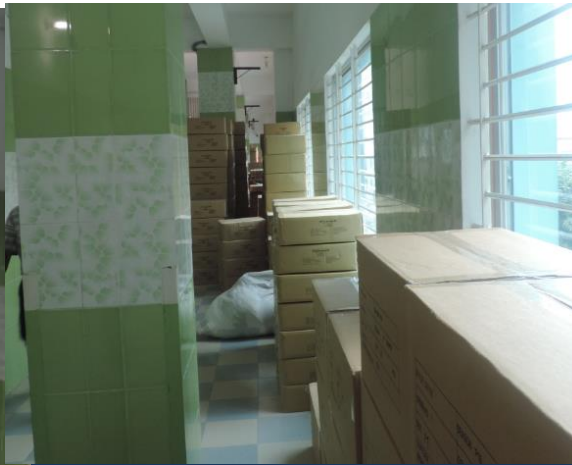
**1<sup>st</sup> Floor storage in cantilever areas**

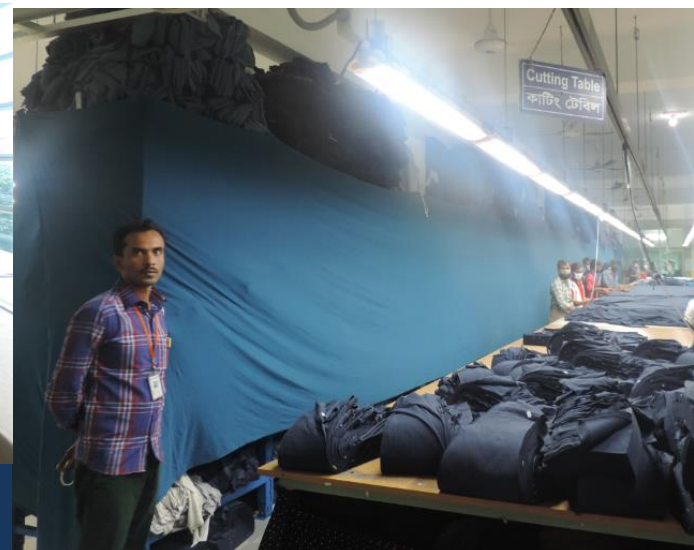
**6<sup>th</sup> Floor storage in centre of floor full height**

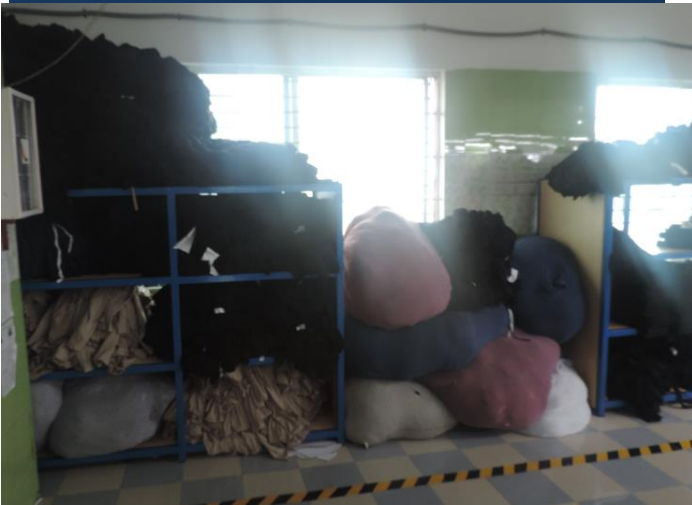
**4<sup>th</sup> Floor, storage in cantilever section of the floor**

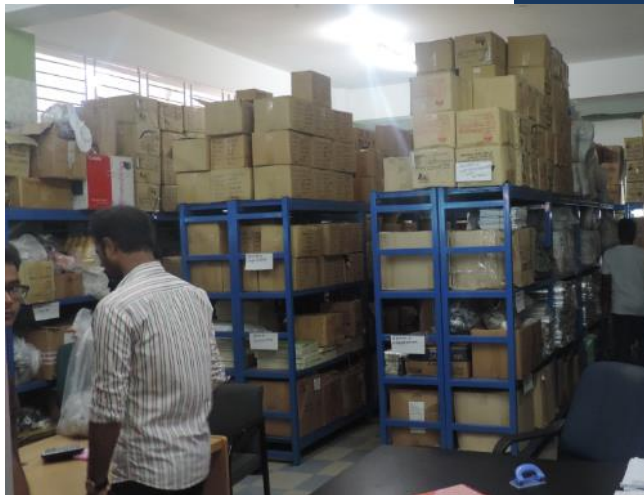
**1<sup>st</sup> Floor storage in centre of floor full height**

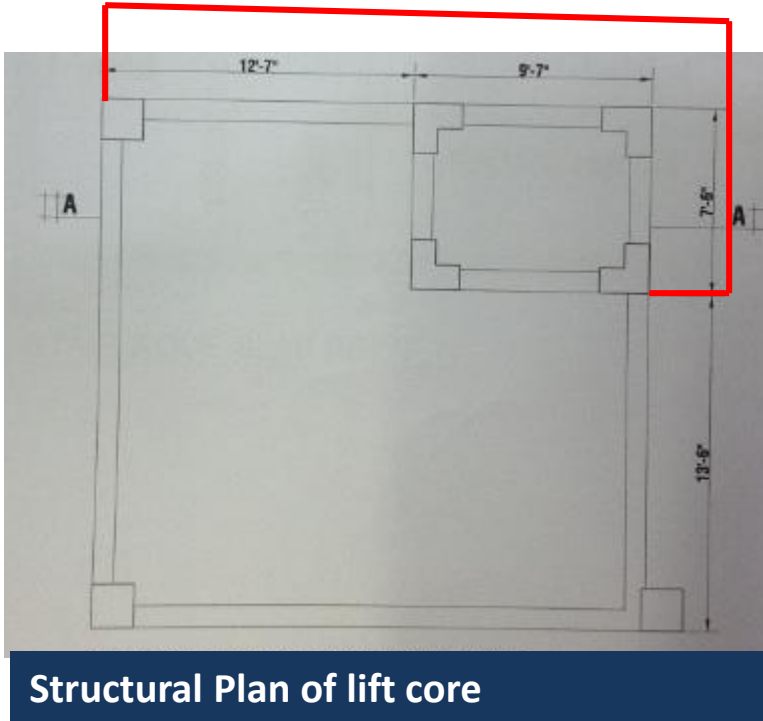
**Machine room on roof not shown correctly  
on drawings**

Extend of machine  
room

| Item No. | Observation | Recommended Action Plan | Recommended Timeline |
|---|---|---|---|
| 13 | Water tank on roof not shown correctly on the structural drawings | Building Engineer to survey as constructed machine room. Updated drawings to be prepared showing the correct as constructed layout. | 6-weeks |
| 14 | Water tank on roof not shown correctly on the structural drawings | Prepare/update calculations showing the structural adequacy of the building structure taking into account the increased size and geometry of the Machine room | 6-weeks |
| 15 | Water tank on roof not shown correctly on the structural drawings | Make any alterations if required from above study | 6-months |
