# Aman Graphics & Designs Ltd. (Extension)

Najimnagar, Hemayetpur, Savar, Dhaka.  
Geographic Coordinates: (23.793061, 90.264437)  
16 July 2023

# Building Information

# Observations

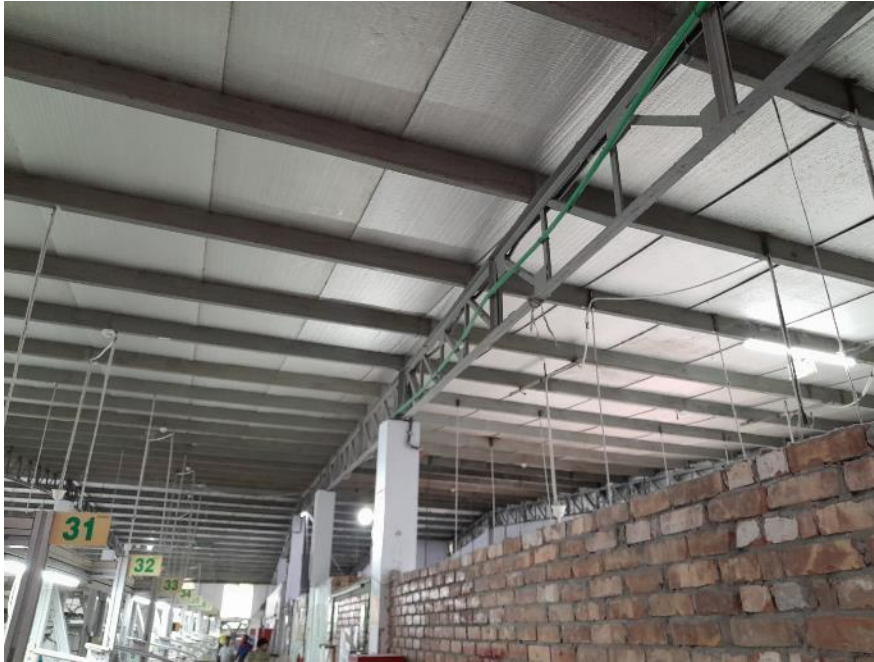
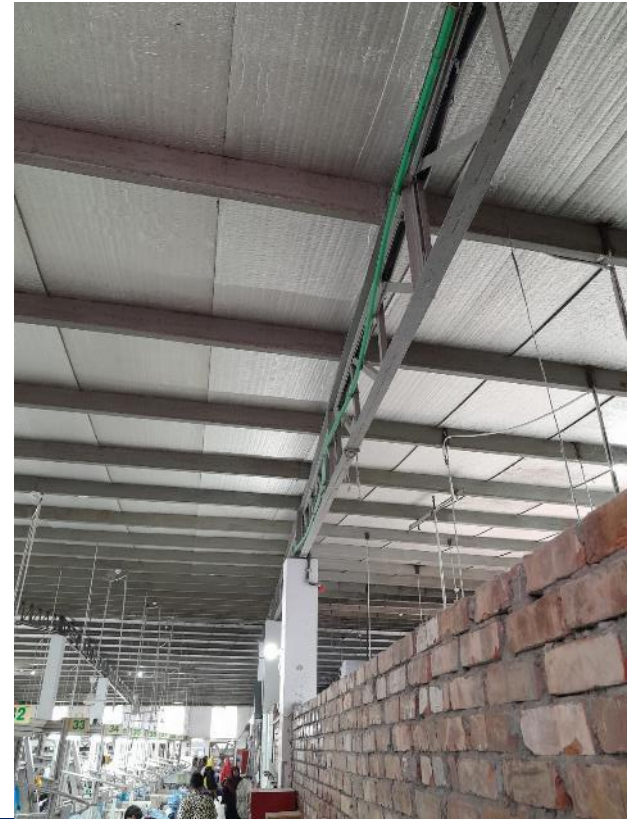
**Lack of stability system**

Load transfer media along the long direction and roof bracing system not observed in the shed. Building engineer is required to check the lateral stability of the shed and adequacy of connection between truss and RC column.

| Item No. | Observation | Recommended Action Plan | Recommended Timeline |
|---|---|---|---|
| 01 | Lack of stability system. (Shed-4) | Building engineer is required to check the lateral stability of the shed and adequacy of connection between truss and RC column. | 6-weeks |
| 02 | Lack of stability system. (Shed-4) | Complete remedial works where necessary. | 6-months |

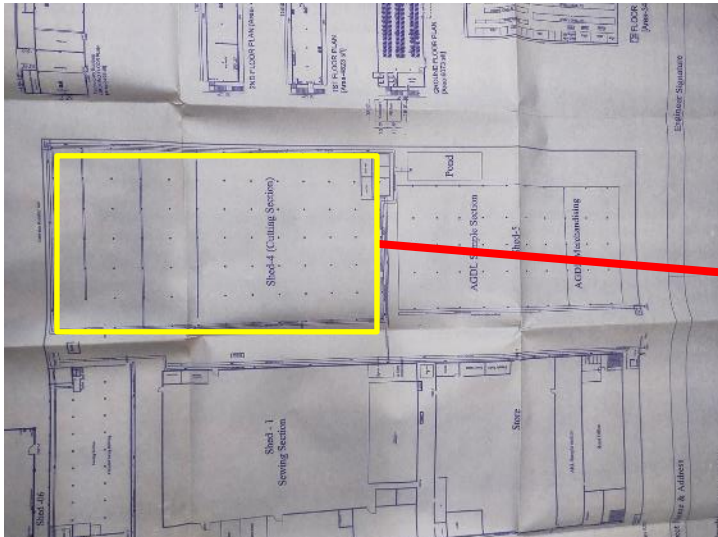
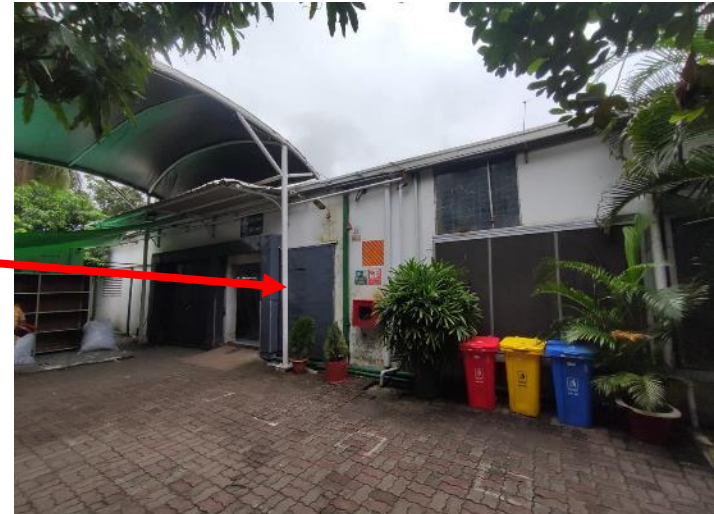
Shed 4

# Absence of design Report

As per BNBC every building or structure designed shall have its design documents prepared in accordance with the provision of Section 1.9.1. The design document shall include a design report, and a set of structural drawings, which shall be prepared in compliance with section 1.9.1.1 and section 1.9.1.2 as per BNBC. Design report was not found which is required to be prepared in compliance with section 1.9.1.1 (part-6, BNBC).

| Item No. | Observation | Recommended Action Plan | Recommended Timeline |
|---|---|---|---|
| 03 | Absence of design Report (Shed-4) | Building engineer is required to prepare design report as per BNBC. | 6-weeks |
| 04 | Absence of design Report (Shed-4) | Complete implementation of any remedial works deemed necessary by design report. | 6-months |

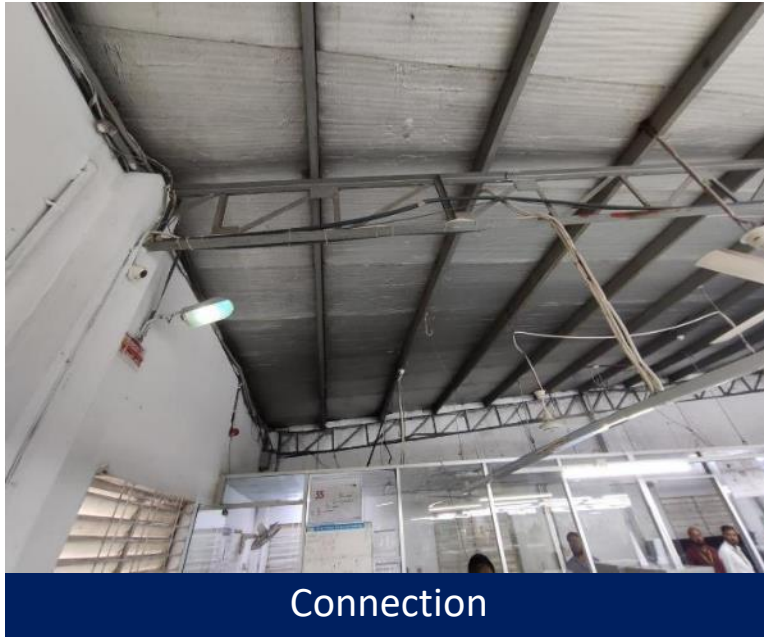
Connection details and tie beam layout was not shown in drawing.

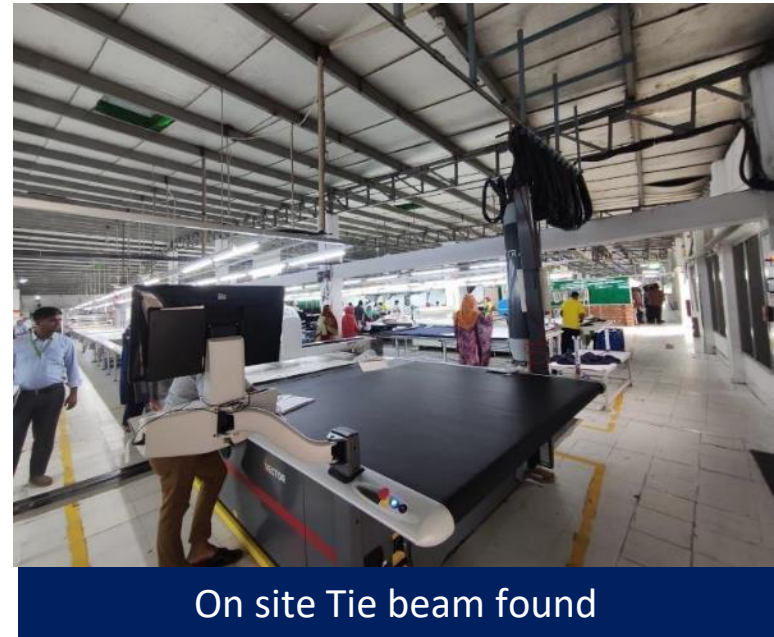
On site Tie beam found

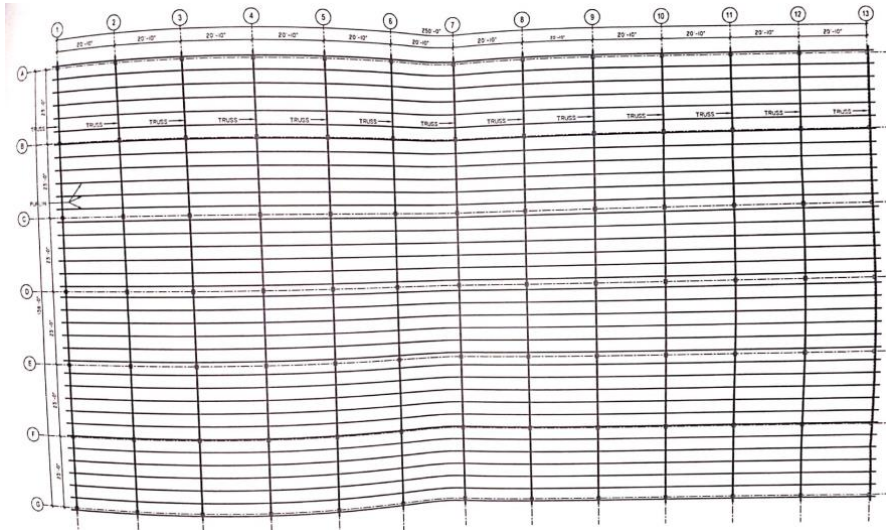
Truss Layout plan

During inspection, mismatch found in truss layout plan. In shed 4 there were 14 number of truss found but in as built drawing only 13 number of truss shown. Building engineer is required to survey the full structure and update the as-built drawing accordingly.

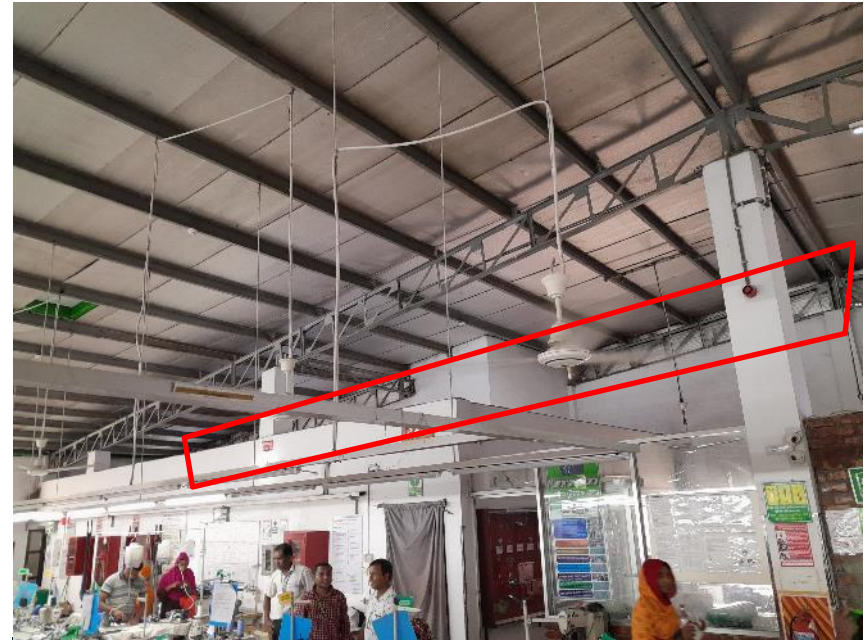
Onsite condition.

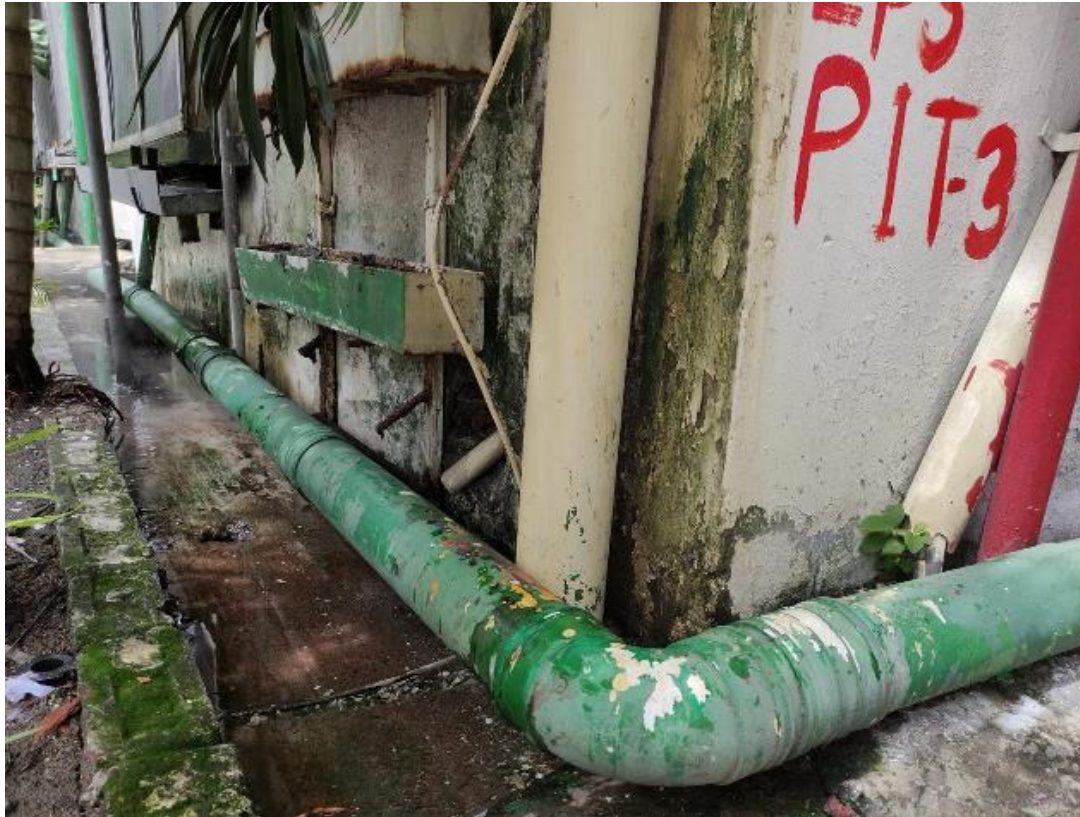
Dampness was found on periphery wall

Dampness was found on periphery brick wall of shed 4.  
Factory is required to repair all damp areas as per  
suggestion of building engineer.

| Item No. | Observation | Recommended Action Plan | Recommended Timeline |
|---|---|---|---|
| 06 | Dampness Observed. (Shed-4) | Building engineer is required to repair all damp areas with suitable method. | 6-months |

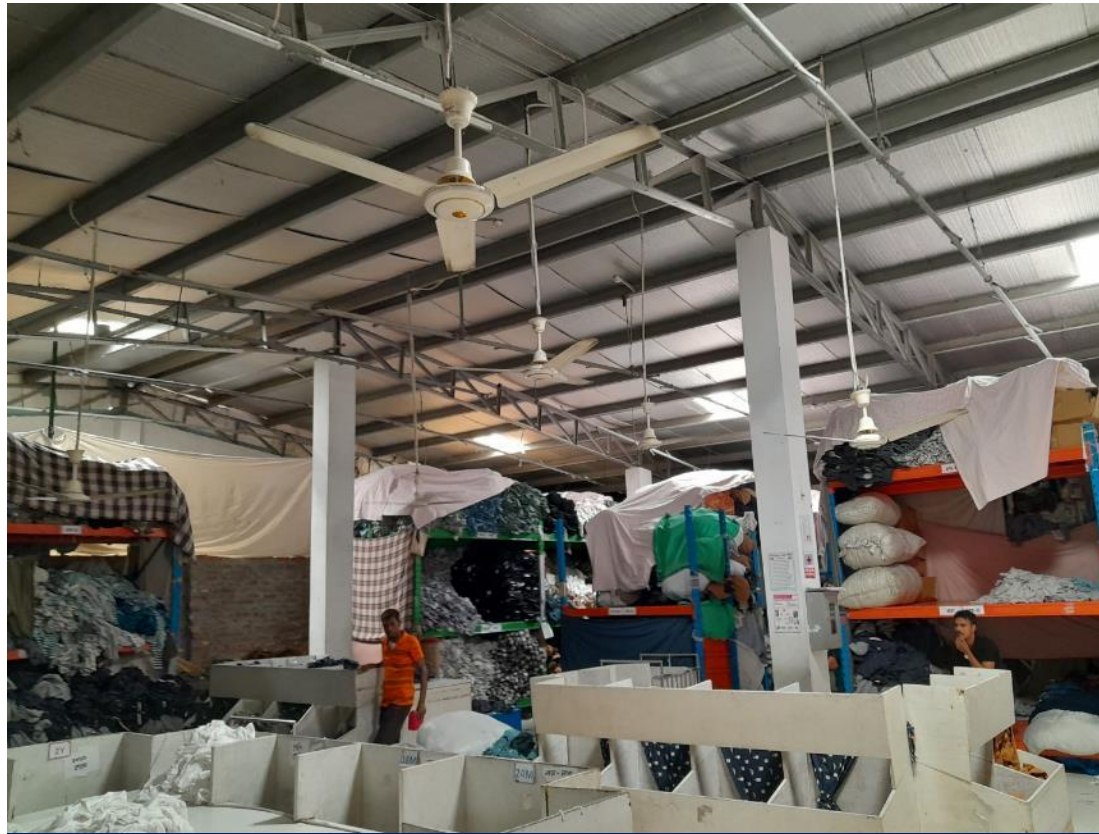
# **Lack of stability system**

Load transfer media along the long direction and roof bracing system not observed in the shed. Building engineer is required to check the lateral stability of the shed and adequacy of connection between truss and RC column.

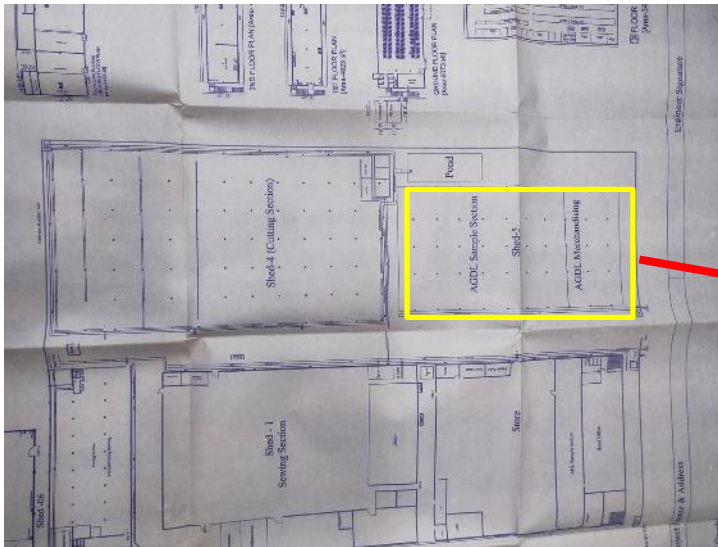
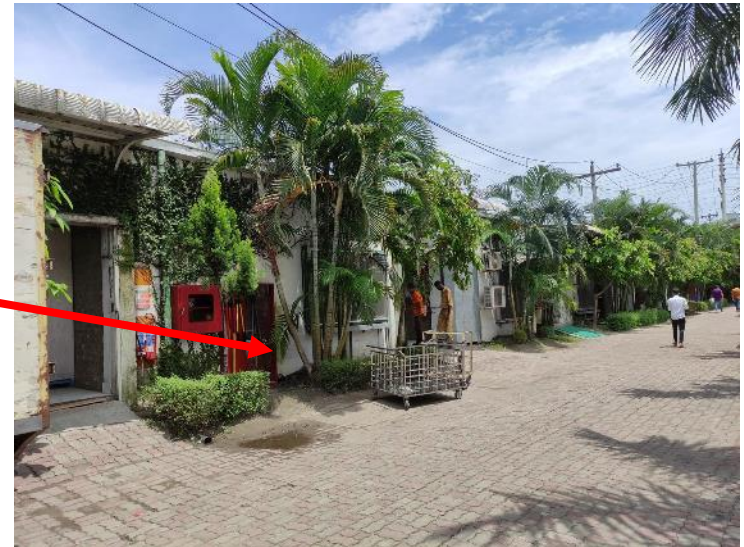
Shed 5

As per BNBC every building or structure designed shall have its design documents prepared in accordance with the provision of Section 1.9.1. The design document shall include a design report, and a set of structural drawings, which shall be prepared in compliance with section 1.9.1.1 and section 1.9.1.2 as per BNBC.

Design report was not found which is required to be prepared in compliance with section 1.9.1.1 (part-6, BNBC).

| Item No. | Observation | Recommended Action Plan | Recommended Timeline |
|---|---|---|---|
| 09 | Absence of design Report. (Shed-5) | Building engineer is required to prepare design report as per BNBC. | 6-weeks |
| 10 | Absence of design Report. (Shed-5) | Complete implementation of any remedial works deemed necessary by design report. | 6-months |

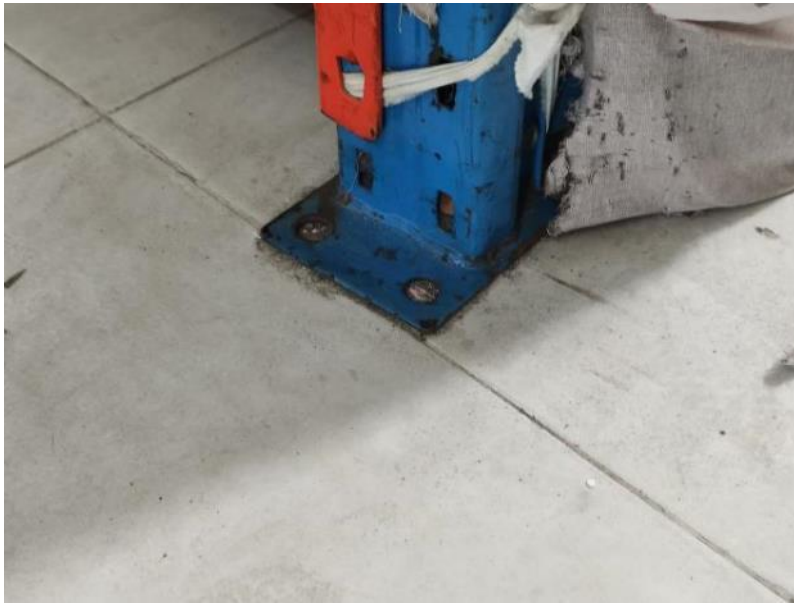
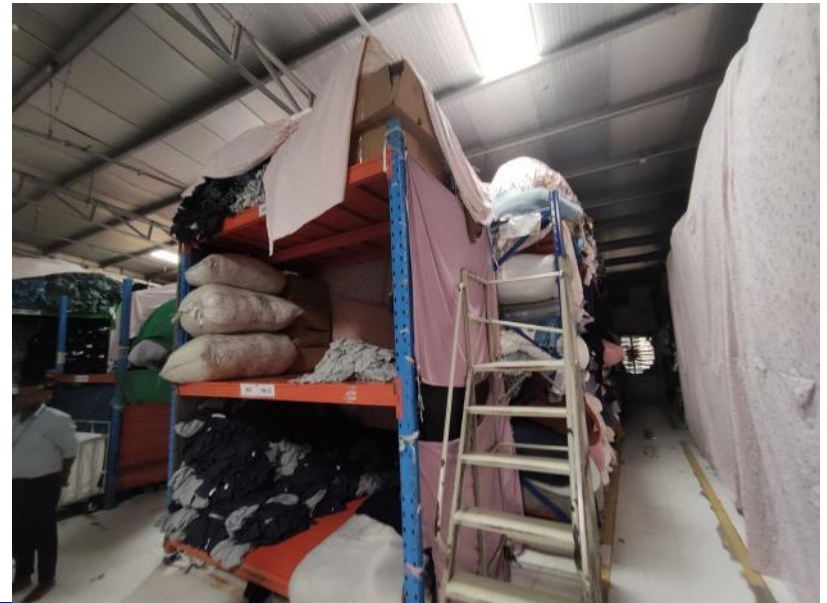
Lack of anchorage of storage rack

During inspection Lack of anchorage of storage found on shed 5. Building engineer required to brace/anchor all the non-structural elements.

| Item No. | Observation | Recommended Action Plan | Recommended Timeline |
|---|---|---|---|
| 11 | Lack of anchorage of storage rack (Shed-5) | Building engineer required to brace/anchor all the unbraced non-structural elements. | 6-months |

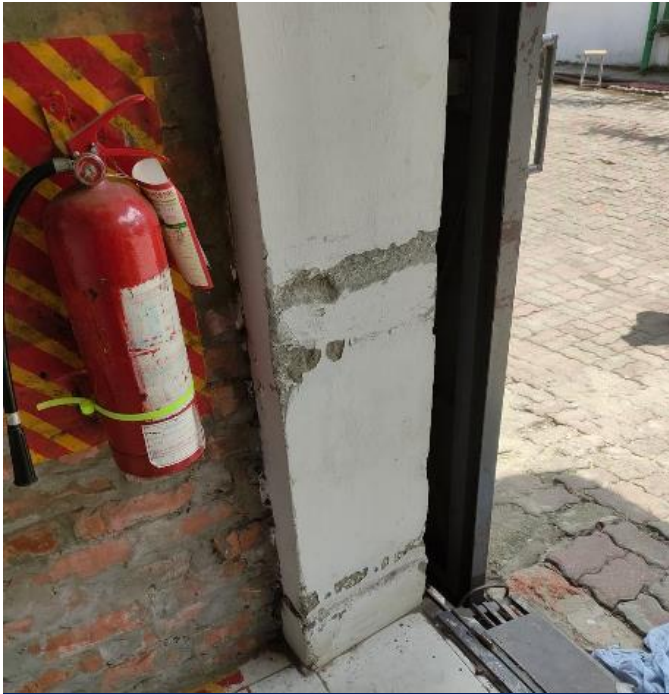
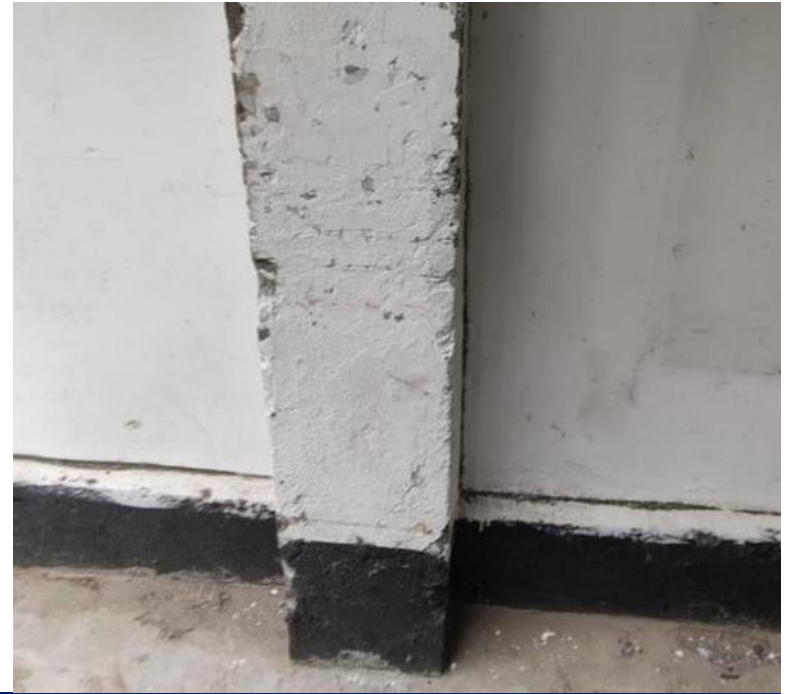
Damage RC Column due to trolley Impact

During inspection, Damage RC Column due to trolley Impact. Building engineer required to provide barrier around the RC column to protect from possible trolley impact.

| Item No. | Observation | Recommended Action Plan | Recommended Timeline |
|---|---|---|---|
| 12 | RCC Column susceptible for trolley Impact. (Shed-5) | Building engineer required to provide barrier around the RC column to protect from possible trolley impact. | 6-weeks |

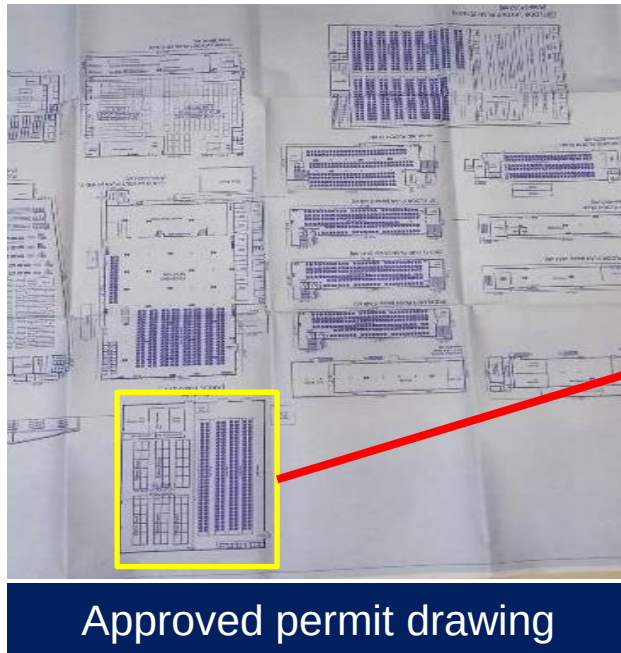
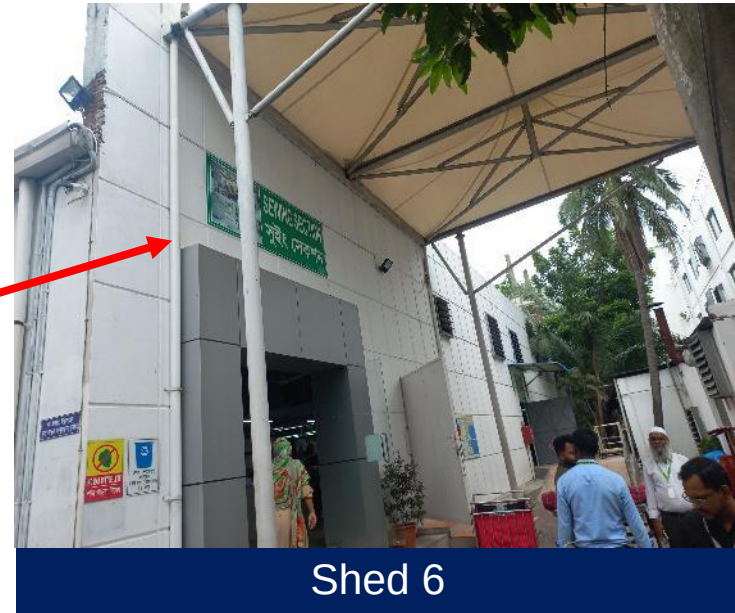
Shed 6

# Absence of design Report

As per BNBC every building or structure designed shall have its design documents prepared in accordance with the provision of Section 1.9.1. The design document shall include a design report, and a set of structural drawings, which shall be prepared in compliance with section 1.9.1.1 and section 1.9.1.2 as per BNBC. Design report was not found which is required to be prepared in compliance with section 1.9.1.1 (part-6, BNBC).

| Item No. | Observation | Recommended Action Plan | Recommended Timeline |
|---|---|---|---|
| 13 | Absence of design Report. (Shed-6) | Building engineer is required to prepare design report as per BNBC. | 6-weeks |
| 14 | Absence of design Report. (Shed-6) | Complete implementation of any remedial works deemed necessary by design report. | 6-months |

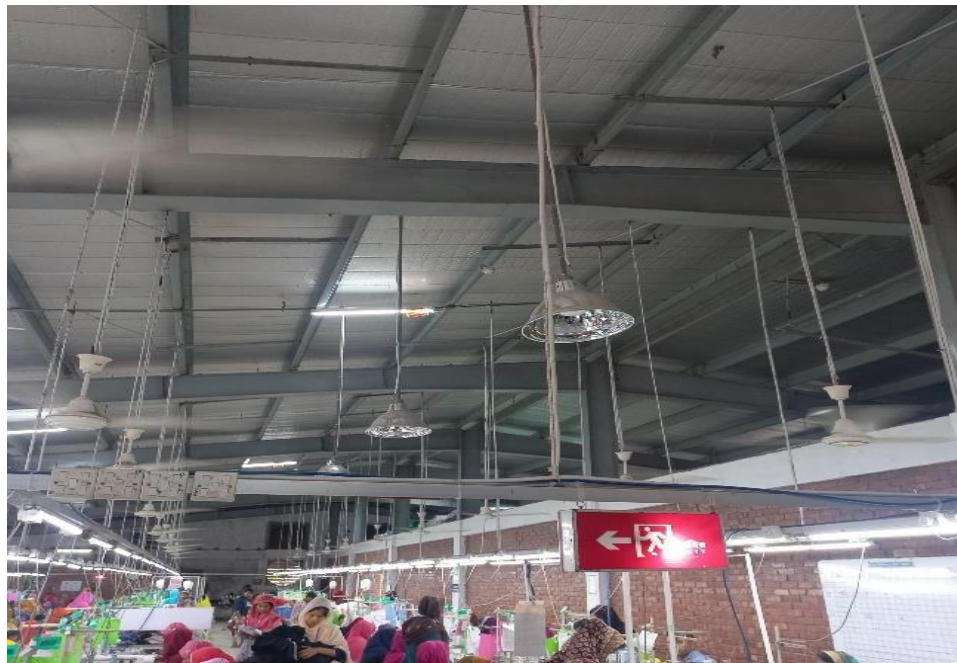
Portal/Moment resisting frame is only provided along short direction. Lateral Stability.

Portal/Moment resisting frame is only provided along short direction. No bracing was provided along long direction at roof structure. Building engineer is required to check the lateral stability of the structure.

| Item No. | Observation | Recommended Action Plan | Recommended Timeline |
|---|---|---|---|
| 15 | Lack of Lateral Stability. (Shed-6) | Building engineer is required to check the lateral stability of the structure. | 6-weeks |
| 16 | Lack of Lateral Stability. (Shed-6) | Complete remedial works where necessary. | 6-months |

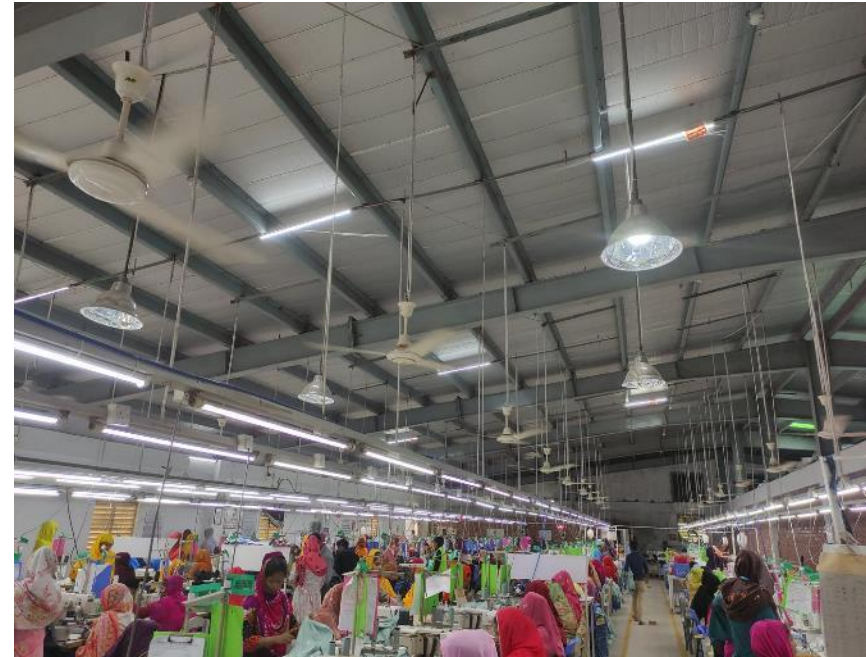
No bracing was provided along long direction.

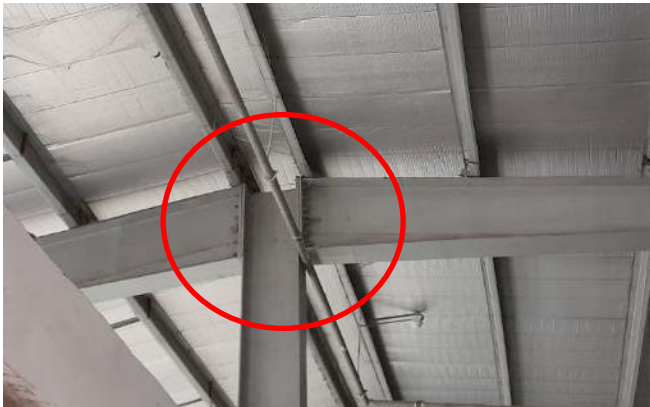
Partial rigid connection at ridge

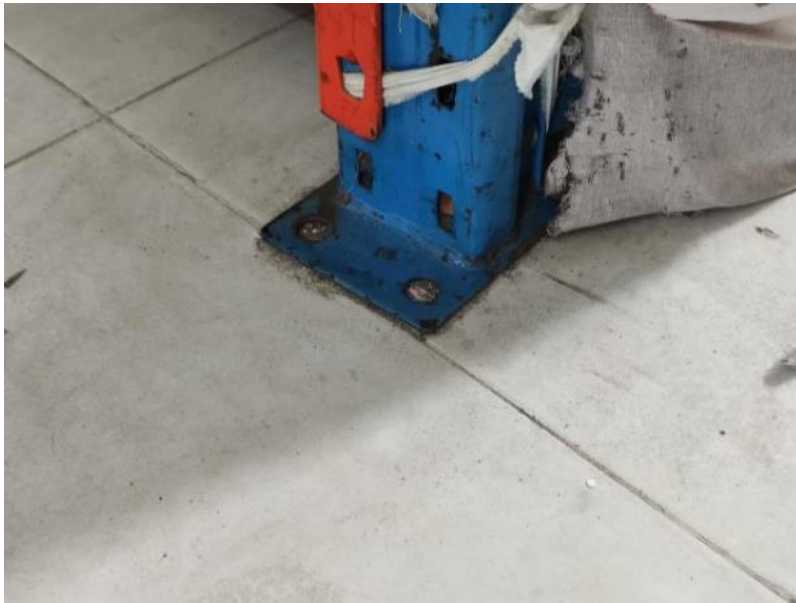
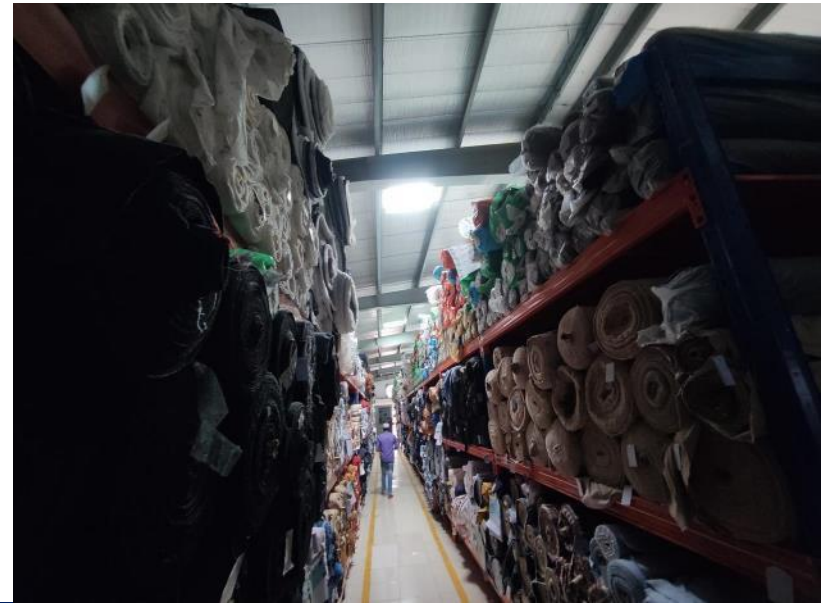
Lack of anchorage of storage rack

During inspection Lack of anchorage of storage rack was found on shed 6. Building Engineer required to brace/anchor all the unbraced non-structural elements (rack/plastic water tank).

| Item No. | Observation | Recommended Action Plan | Recommended Timeline |
|---|---|---|---|
| 17 | Lack of anchorage of storage rack (Shed-6) | Building engineer required to brace/anchor all the unbraced non-structural elements. | 6-months |

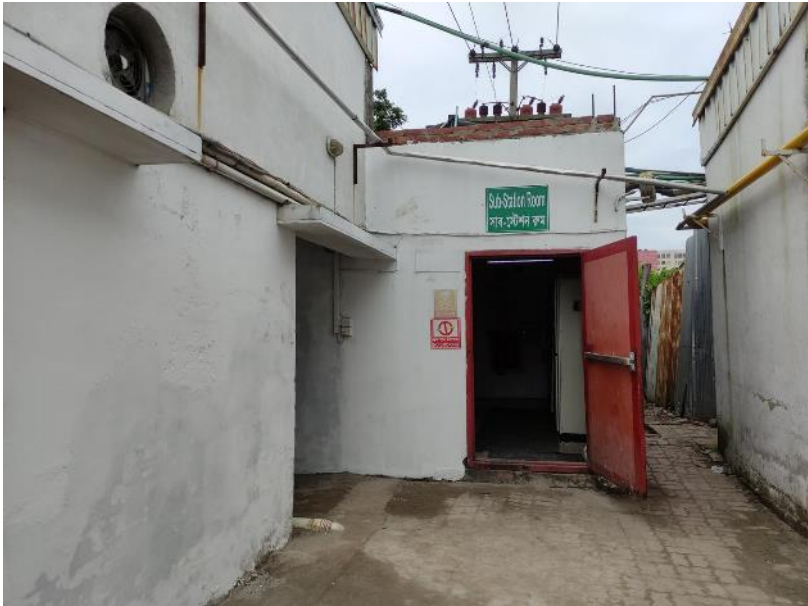
Sub Station 1

During inspection, no as-built drawing was found for sub-station 1 & 2. Building engineer is required to produce as-built drawing for sub-station 1 & 2.

| Item No. | Observation | Recommended Action Plan | Recommended Timeline |
|---|---|---|---|
| 18 | Absence of As-built drawing. (Sub Station 1 & 2) | Building engineer is required to produce as-built drawing for sub-station 1 & 2. | 6-weeks |

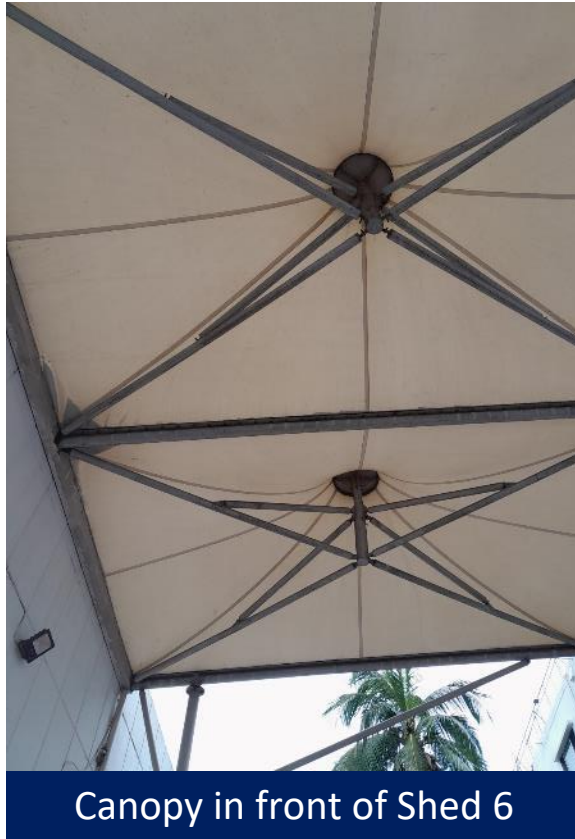
Canopy in front of Shed 6

# **Absence of drawing and design report**

Building engineer is required to prepare as-built drawings and design report as per BNBC. In design report building engineer is required to check the stability for uplift forces.

| Item No. | Observation | Recommended Action Plan | Recommended Timeline |
|---|---|---|---|
| 19 | Absence of drawing and design report. (Canopies) | Building engineer is required to prepare as-built drawings and design report as per BNBC. | 6-weeks |
| 20 | Absence of drawing and design report. (Canopies) | Carry out necessary remedial works where required. | 6-months |
