# M.I.M. FASHION WEAR LTD.

226/1 Tilargati, Singhbari Road, Tongi, Gazipur.  
(23.9083 N, 90.3753 E)

17<sup>th</sup> October 2015

# Non Structural Observation

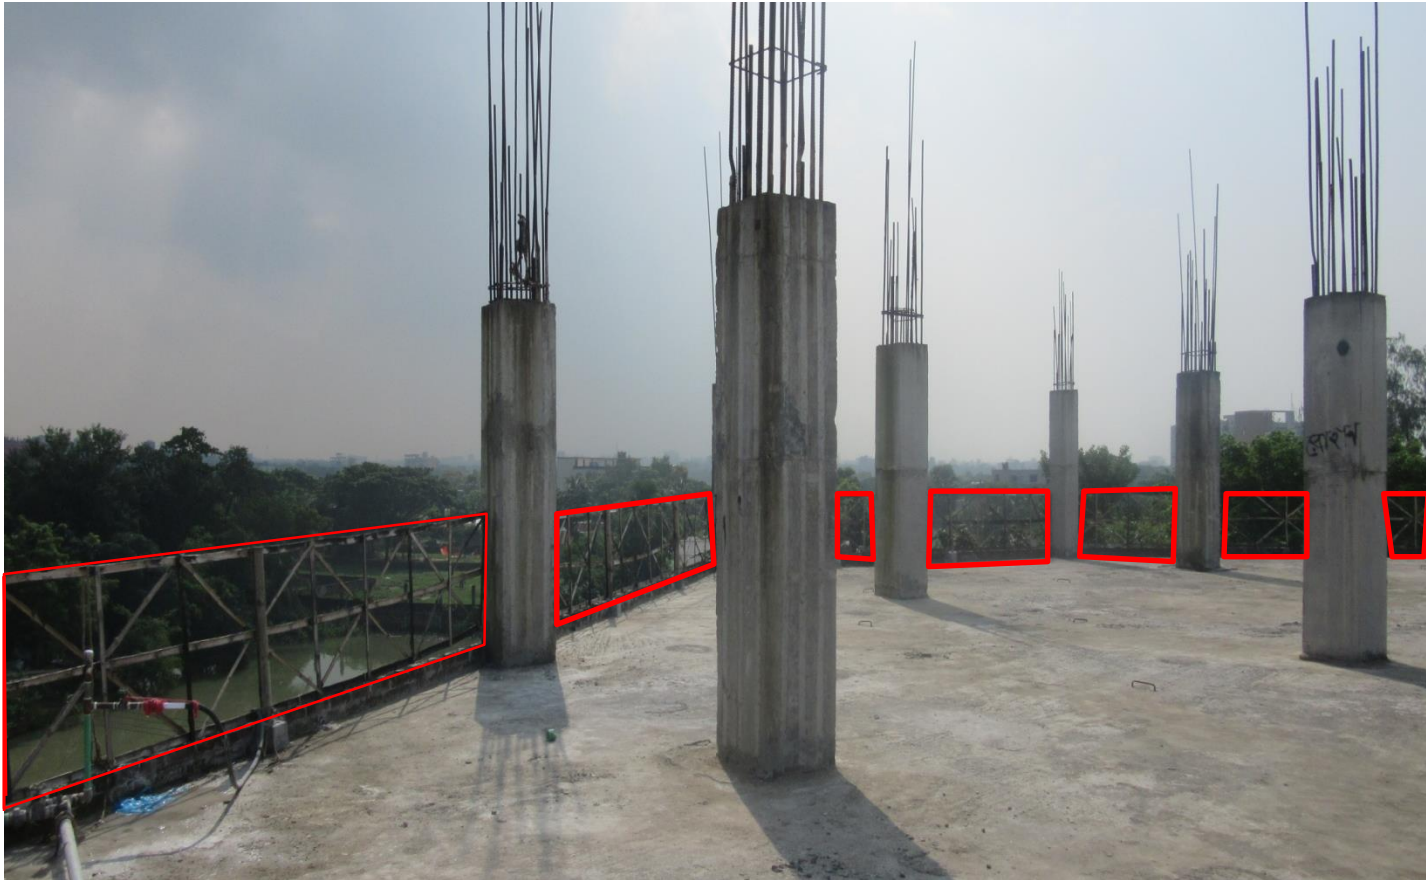
# Poor edge protection on roof (H&S issue)

Poor edge protection on roof slab creating a safety issue

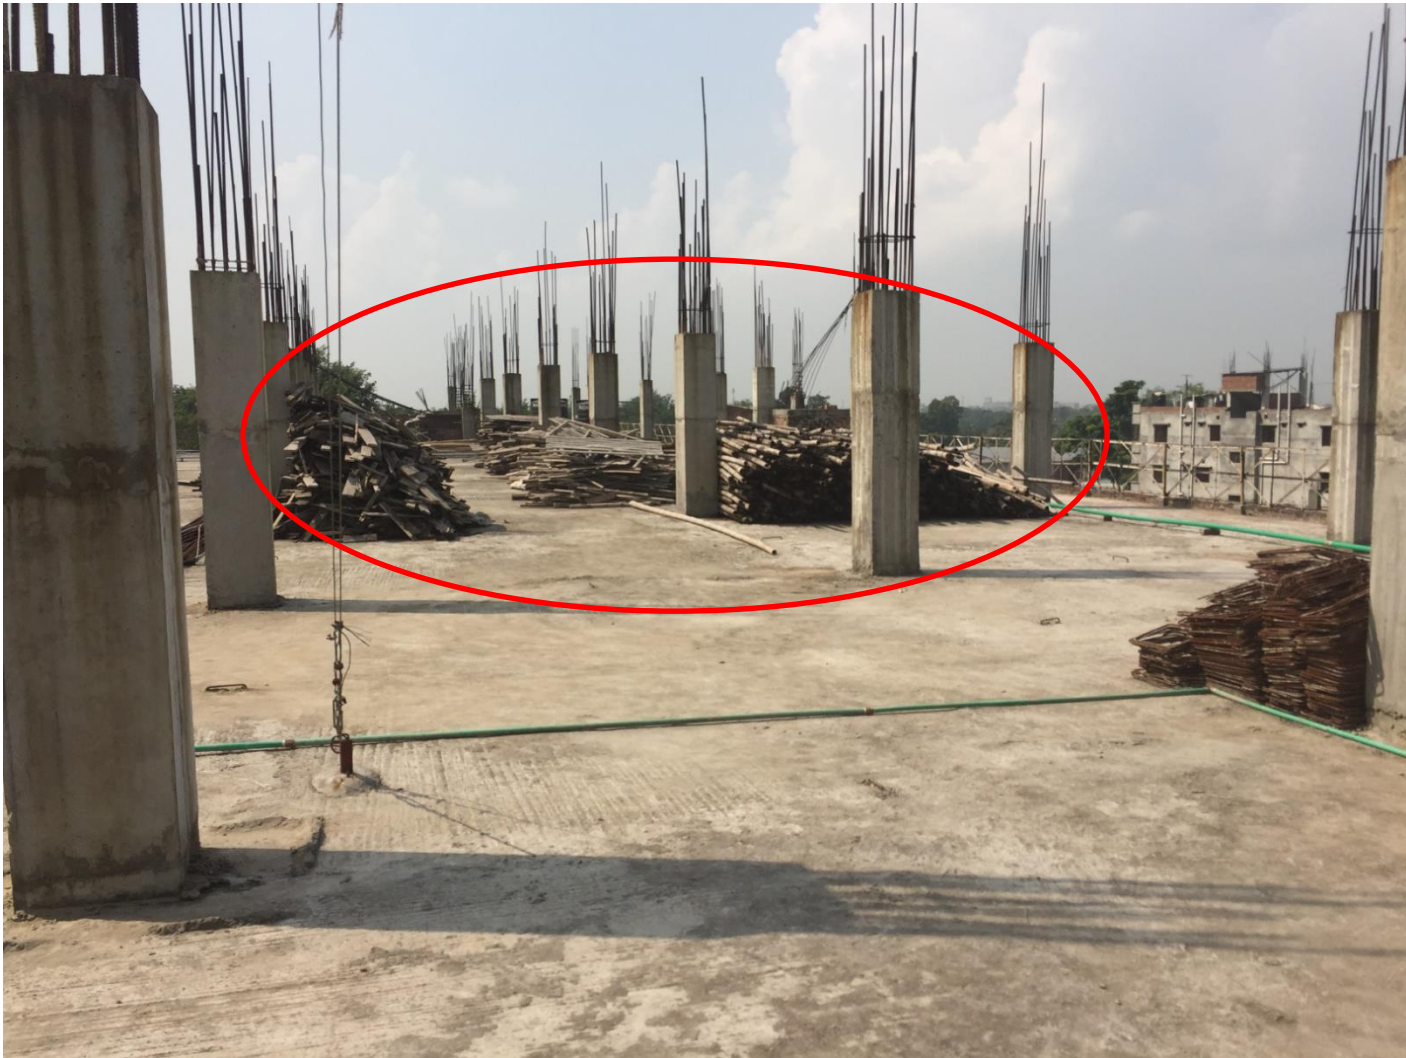
# **Uncontrolled construction material storage on the roof**

Uncontrolled material storage

| Item No. | Observation | Recommended Action Plan | Recommended Timeline |
|---|---|---|---|
| 1 | Uncontrolled storage of construction materials | Remove construction materials from the roof | 6-months |

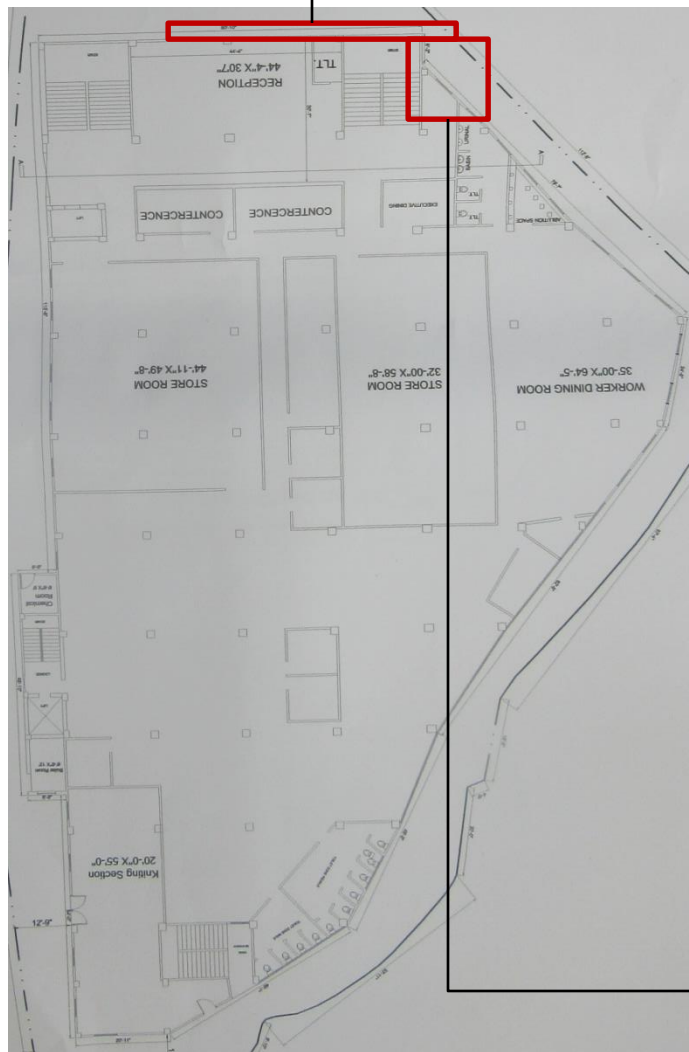
Horizontal crack on north side wall

| Item No. | Observation | Recommended Action Plan | Recommended Timeline |
|---|---|---|---|
| 2 | Cracks on outer wall of North and East side | Remove the plaster and engage an Building Engineer to investigate the cracks on the outer brick wall | 6-months |

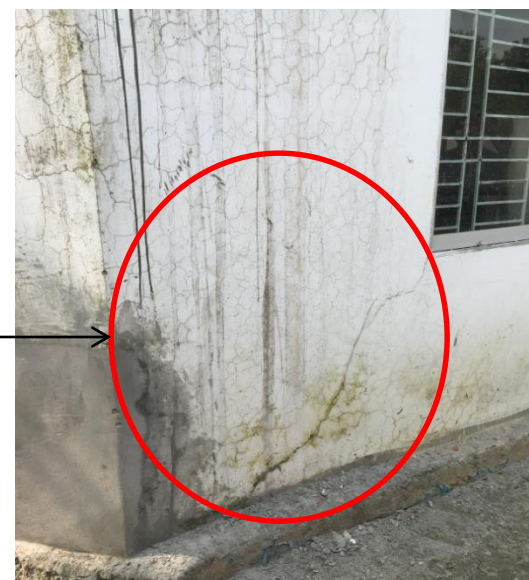
Horizontal & diagonal crack on outside of brick wall

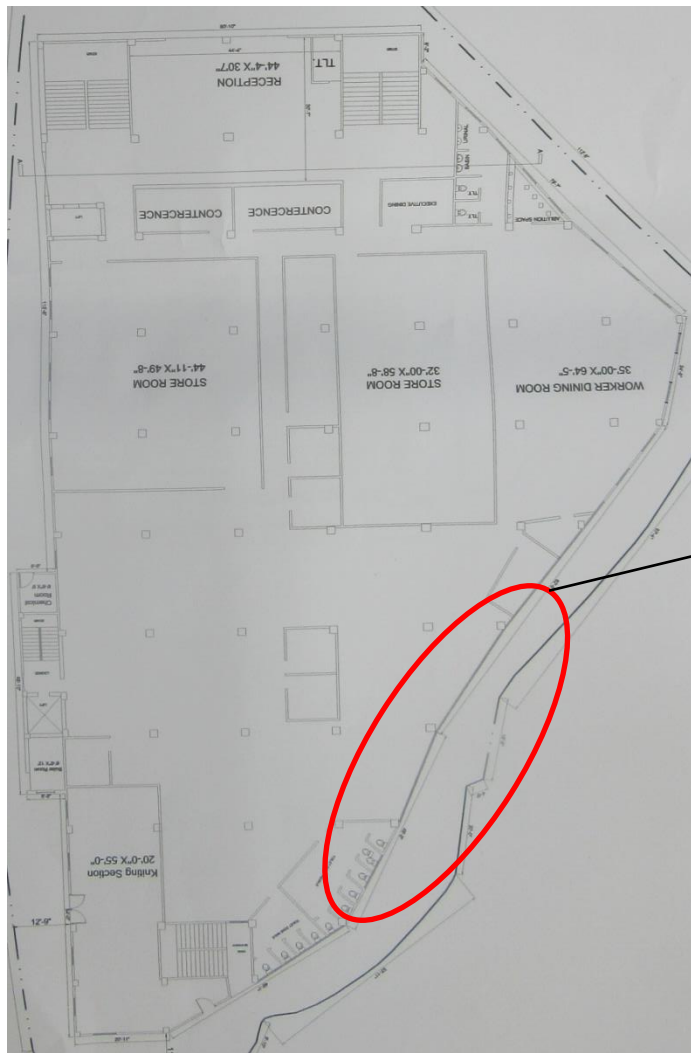
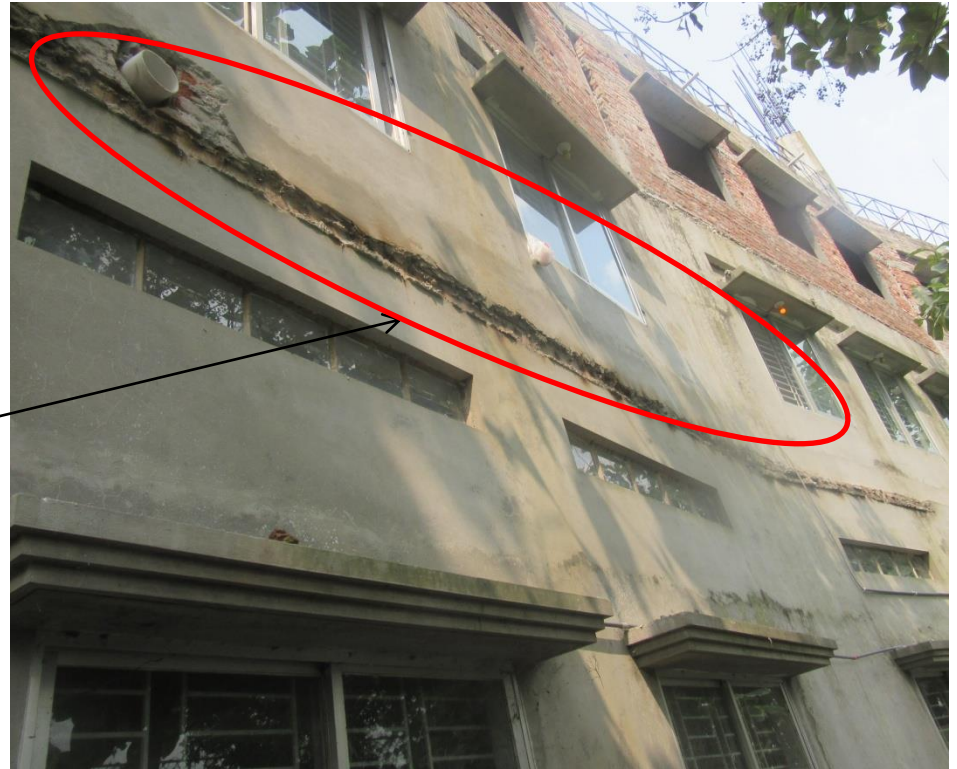
**Reinforcing bars are exposed in the slab on  
East Façade**

Cut bars are exposed, which could cause corrosion due to environmental effects on East side

| Item No. | Observation | Recommended Action Plan | Recommended Timeline |
|---|---|---|---|
| 3 | Reinforcing bars are exposed in the slab on East Façade | Protect the cutting edge of bars against corrosion | 6-months |

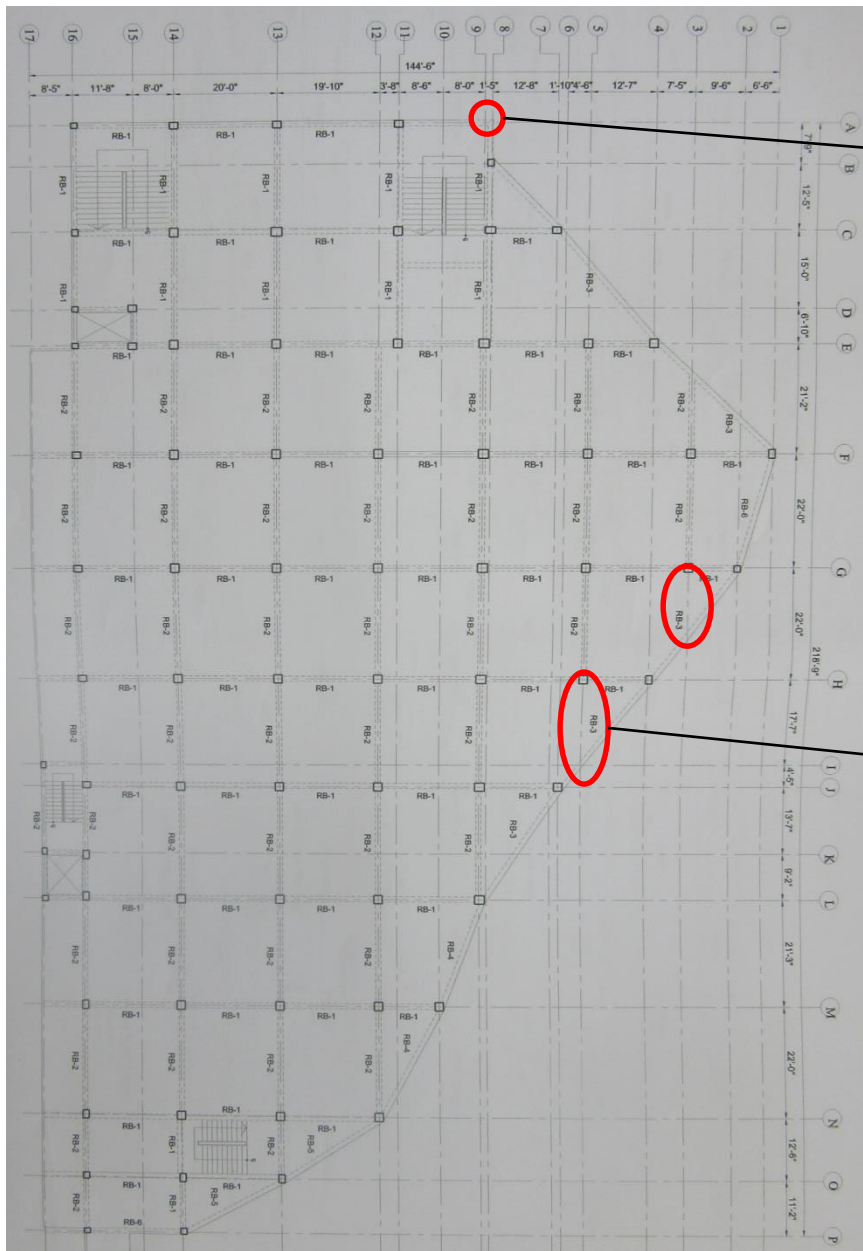
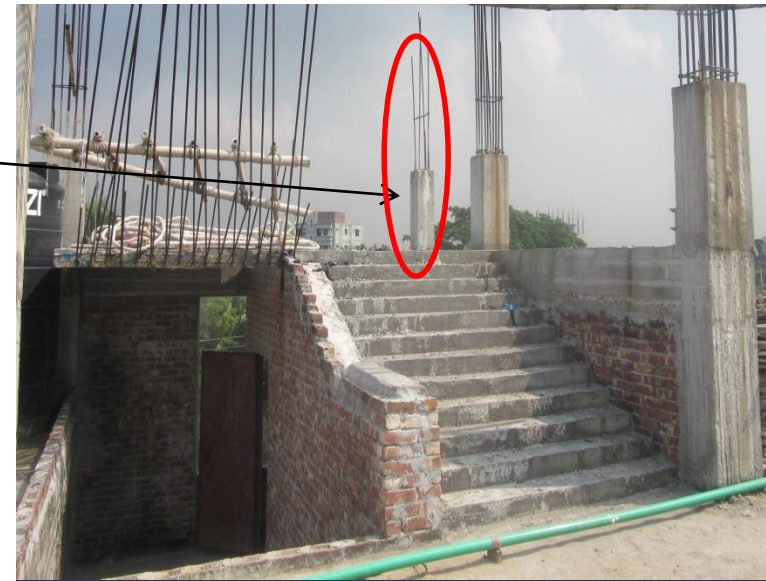
The observed column was not present in structural drawing

| Item No. | Observation | Recommended Action Plan | Recommended Timeline |
|---|---|---|---|
| 4 | Discrepancy between Structural drawings and Site observations | Engage an Engineer to update “as built” structural drawings | 6-months |

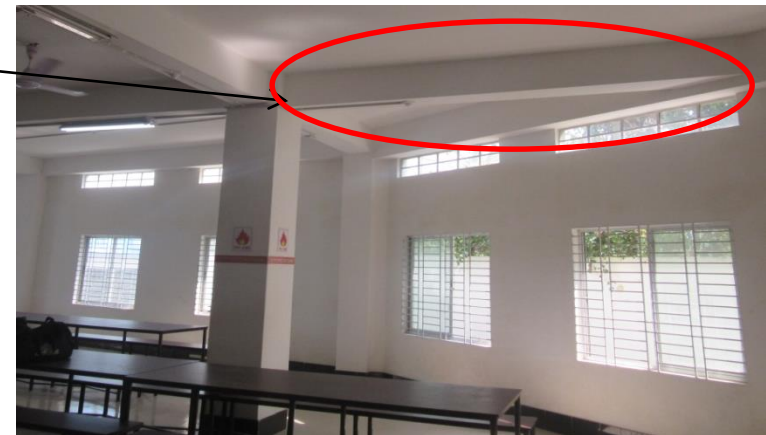
The observed beam was not present in structural drawing
