# Crystal Vestiti Ltd.

31 July 2023

# Observations

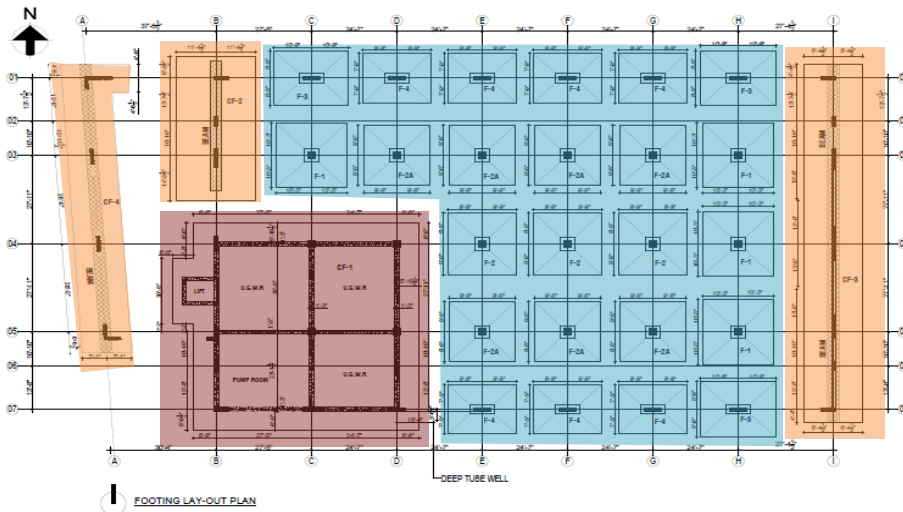
The building is standing on three different types of shallow foundations.

Foundation rest on fat clay (CH) and Liquid Limit is greater than 50 which indicates possibility of expansive behavior of the soil. There are some low land water bodies nearby the building.

The building engineer is required to carry out further investigation for the expansive soil and incorporate the result in the design report. Suggest remedial measure accordingly.

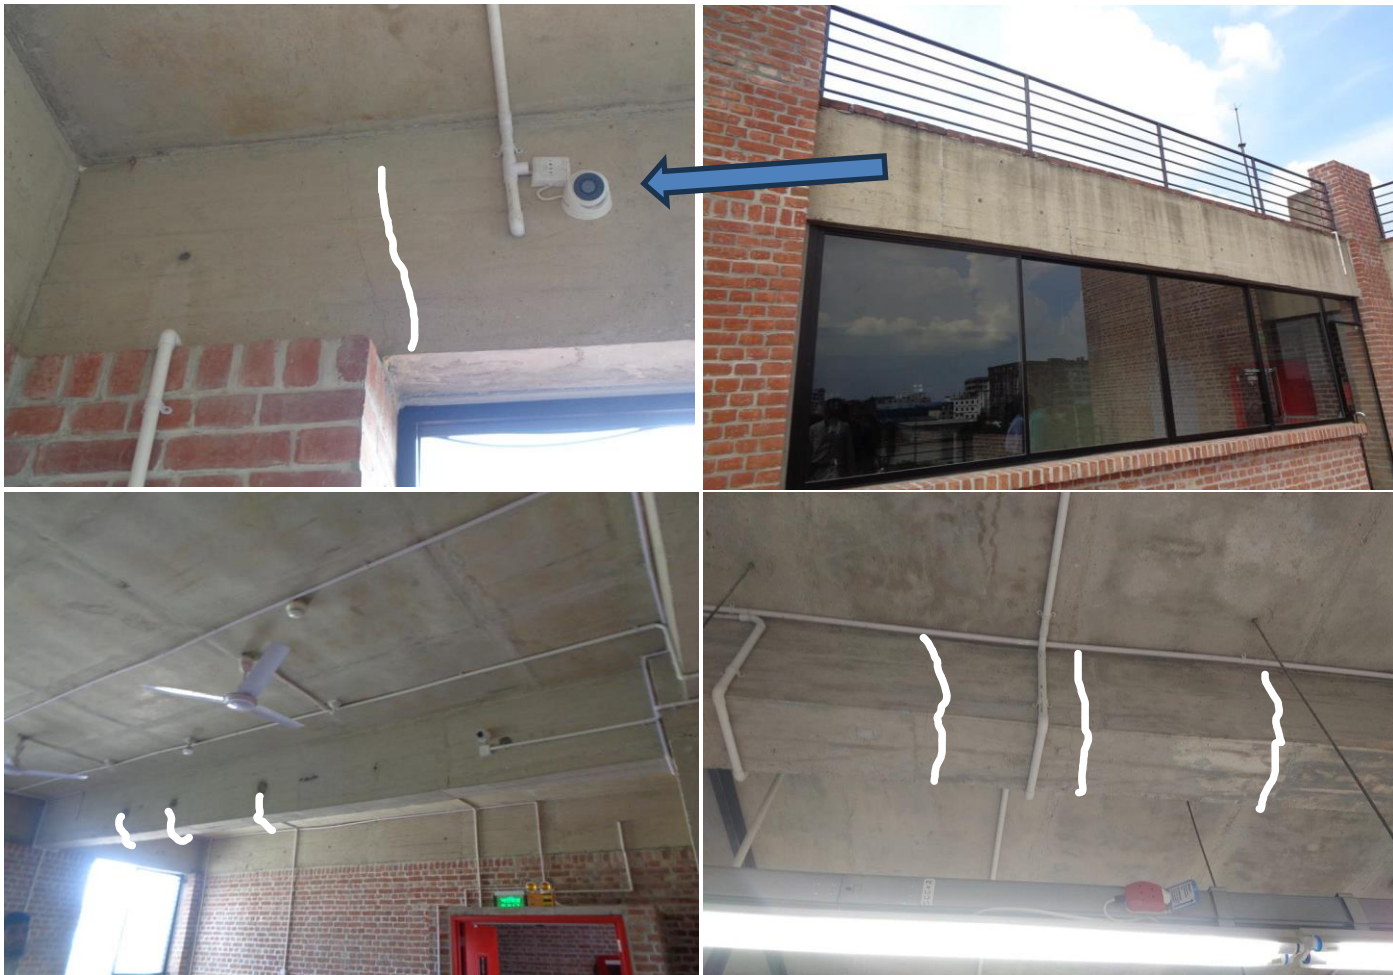
Cracks on beam in several location of all floors

The building engineer is required to check the intensity of crack , investigate the reason of crack considering both structural and geotechnical concern and prepare an investigation report with proper remedial actions .

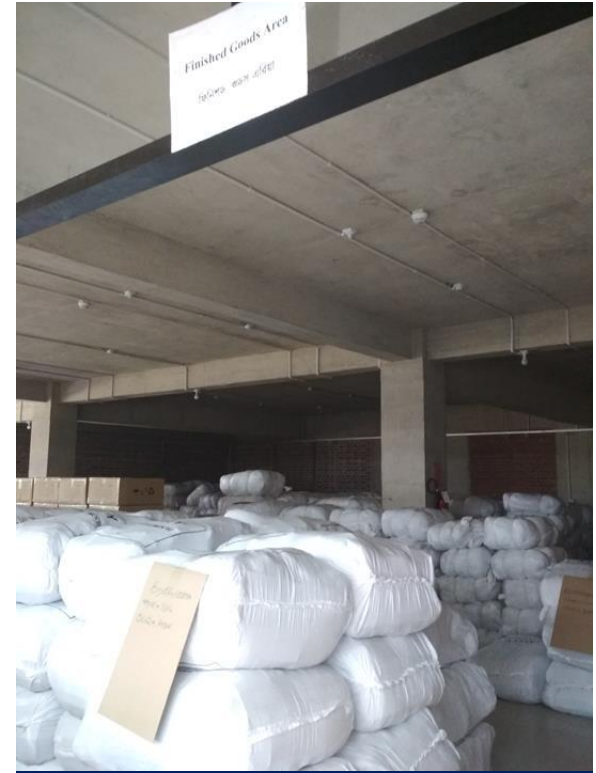
Heavy storage on suspended ground floor

There was no floor live load plan for the suspended ground floor. The building engineer is required to prepare floor load plan for the suspended ground floor.

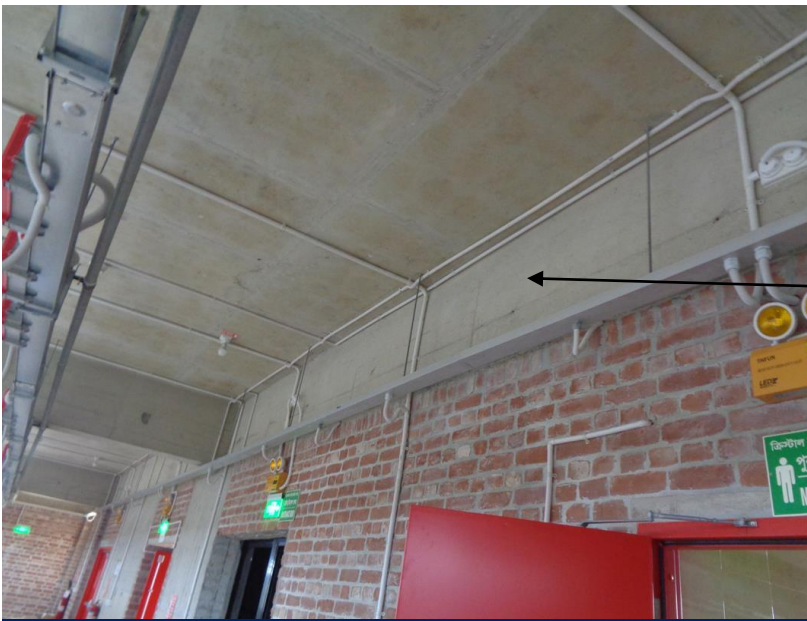
Beam on site: 900 mm depth

The building engineer is required to update as-built structural drawing as per site condition.

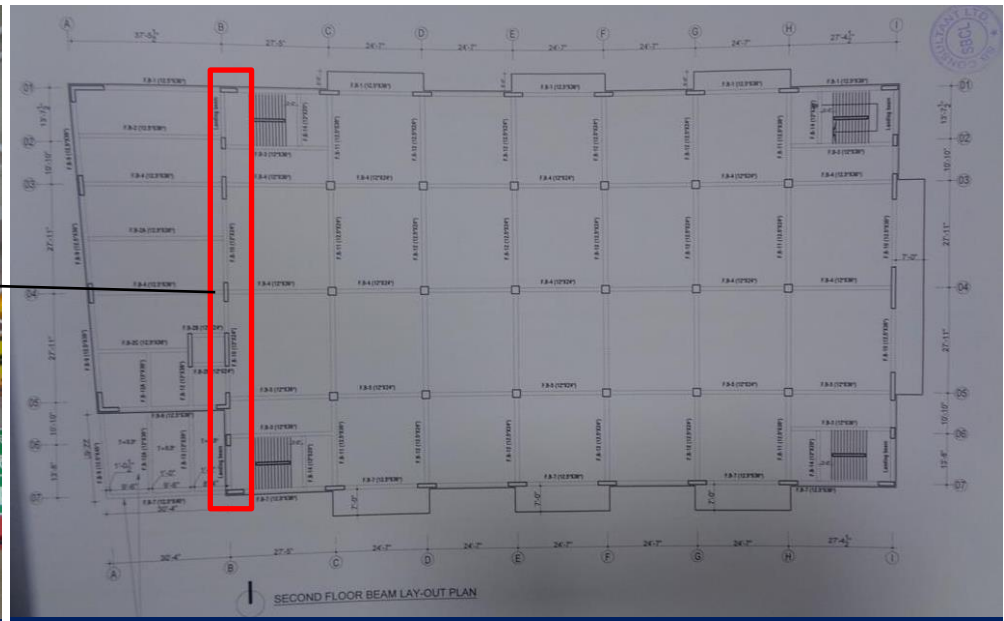
As built drawing: beam depth 600 mm

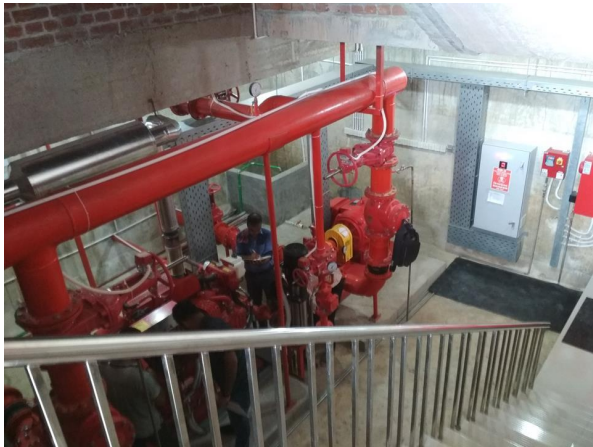
Underground fire pump room not shown in as-built architectural drawing and mismatch found in 1st & 2nd floor beam. The building engineer is required to survey the structure and prepare accurate as-built architectural and structural drawing.

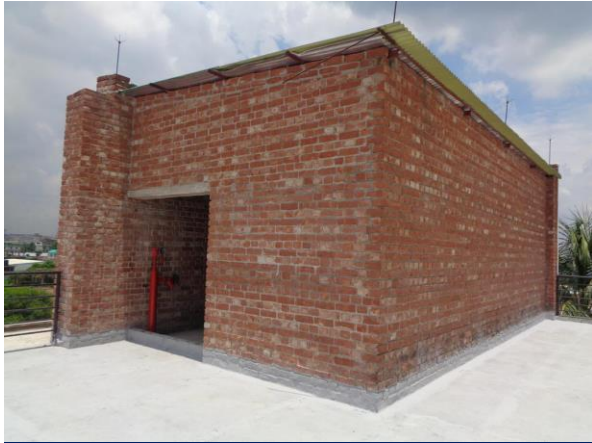
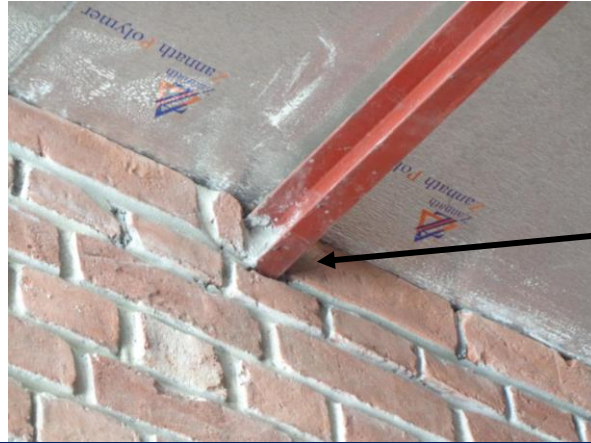
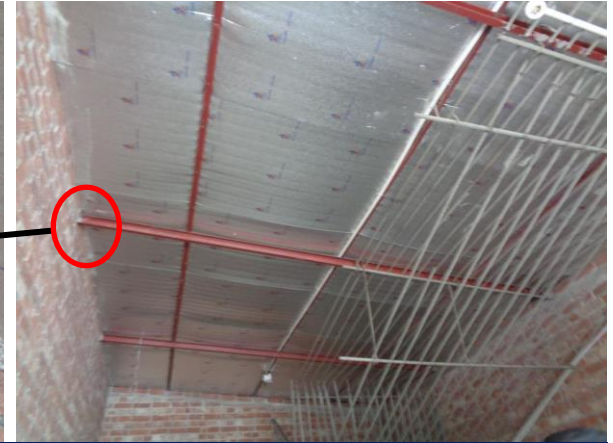
Lack of anchorage between rafter and wall connection of staircase roof.

The building engineer is required to provide adequate anchorage to resist uplift forces.

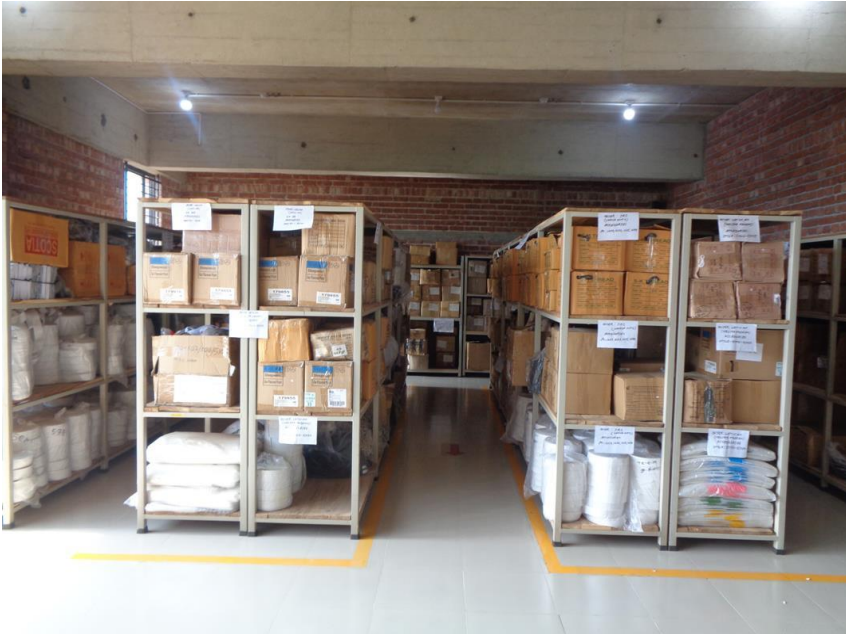
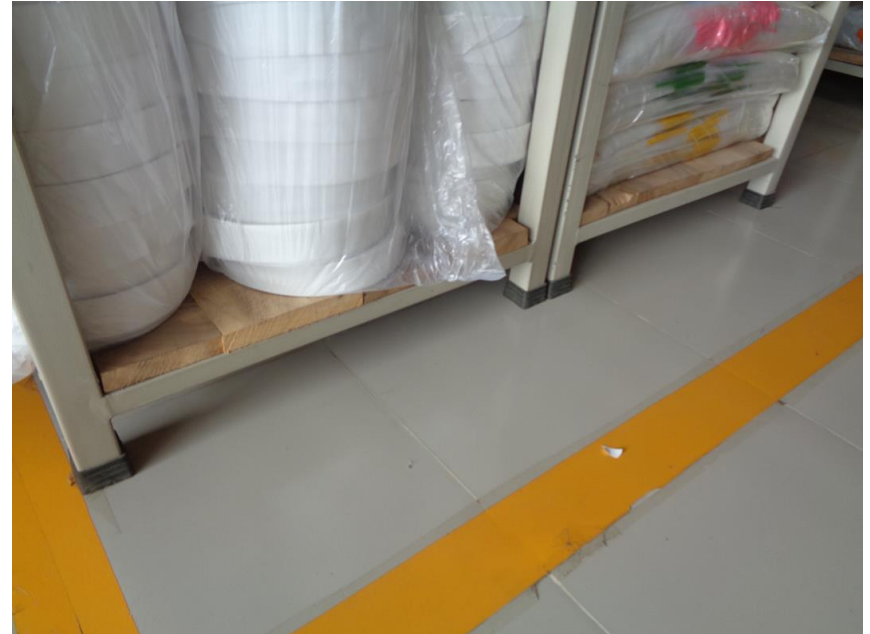
Lack of anchorage for storage rack

The factory is required to anchor/brace all the non-structural element including storage racks.

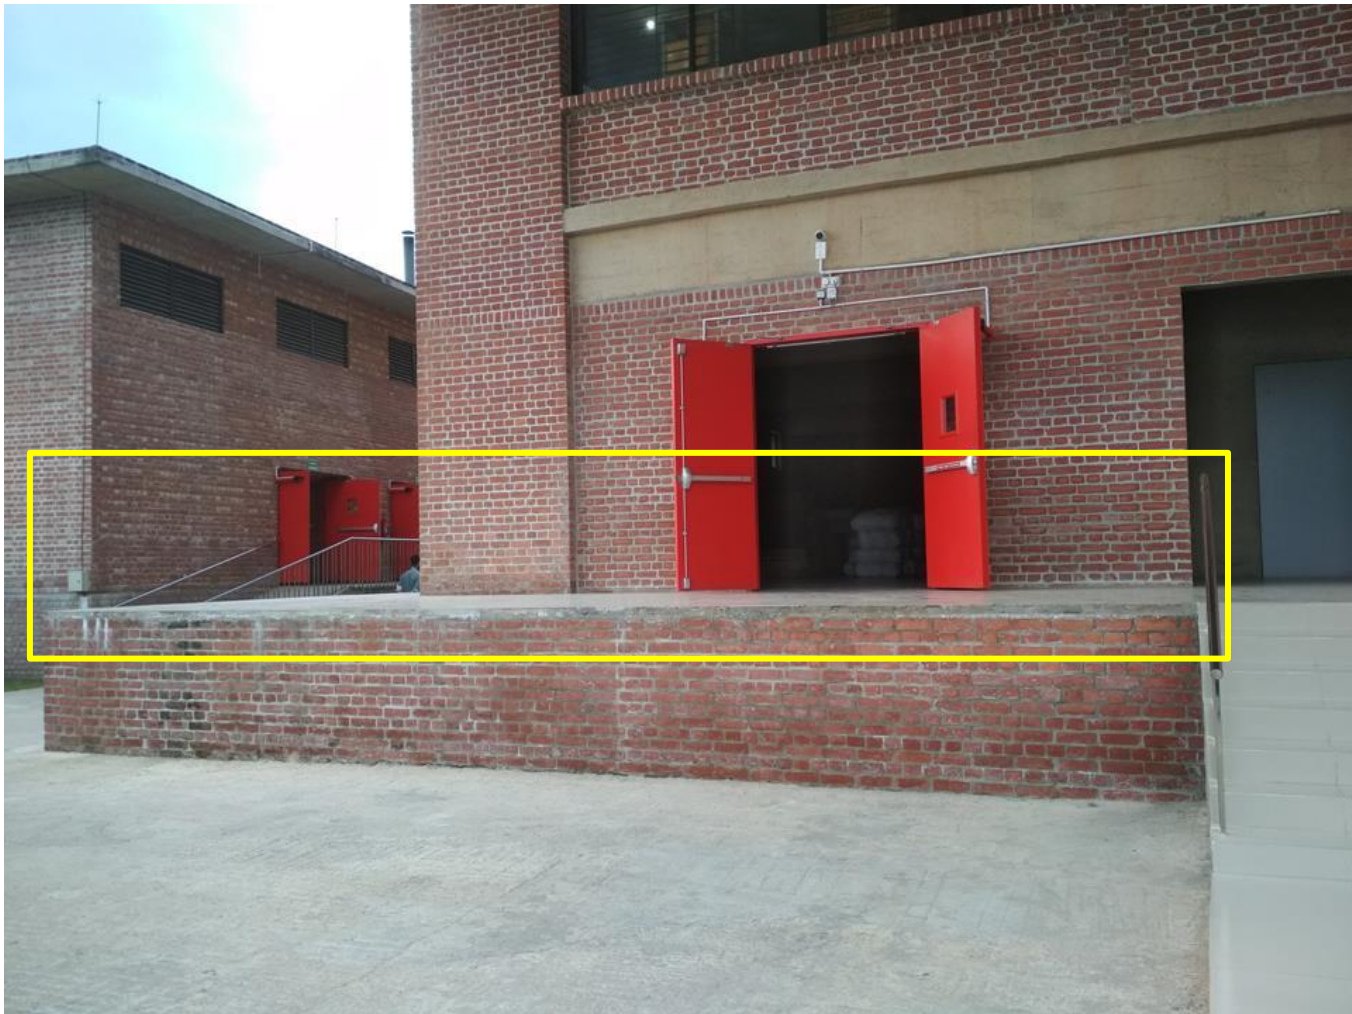
Falling hazard at loading-unloading area

The factory is required to provide suitable fall protection system to avoid falling hazard.

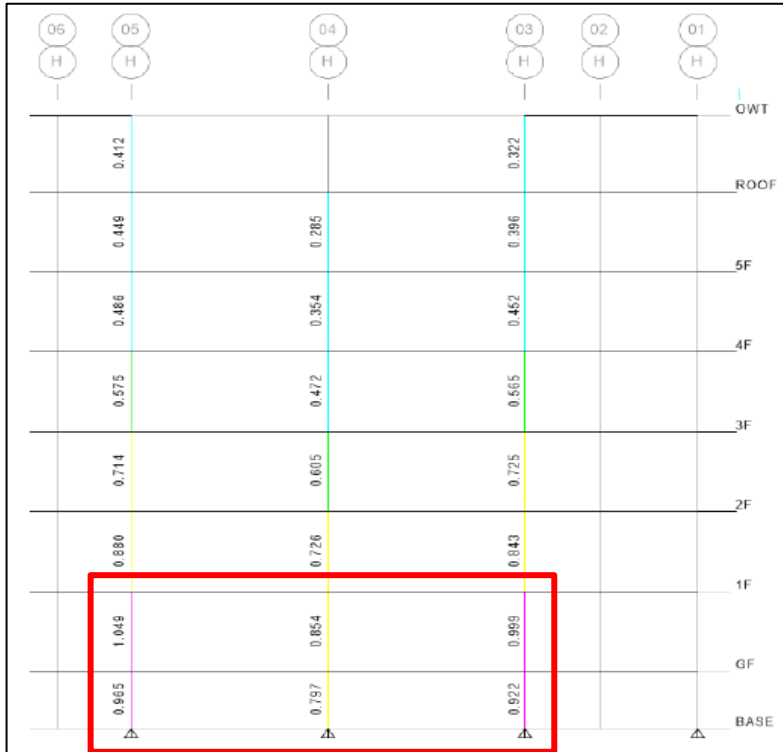
Figure 3.1.8: PMM ratio of Column in Grid H'

COMMENTS: From the above PMM ratio we can say that all the columns are adequate with respect to provided re-bar & concrete strength.

Over stress column in design report:  
PMM>1.0

For proposed 6 storied building, considering design strength of concrete, some of the columns were found over-stressed. Prior to vertical extension, the building engineer is required to revise Detail Engineering Assessment (DEA) for the proposed building.

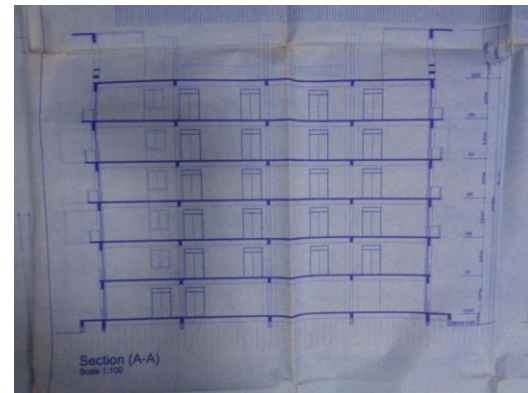
Building-1 was permitted for proposed 6 storey

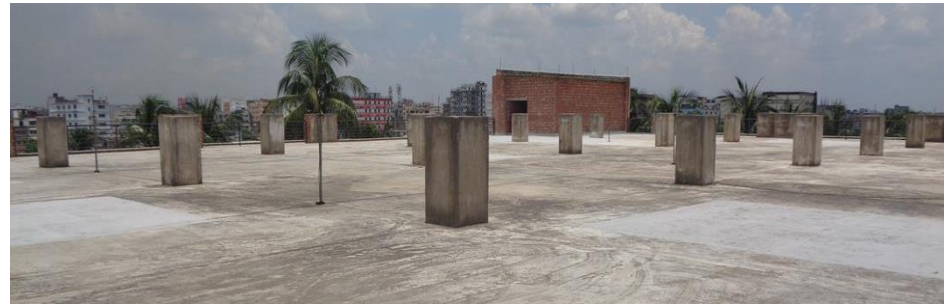
Extended column on roof indicates future vertical extension of the building.

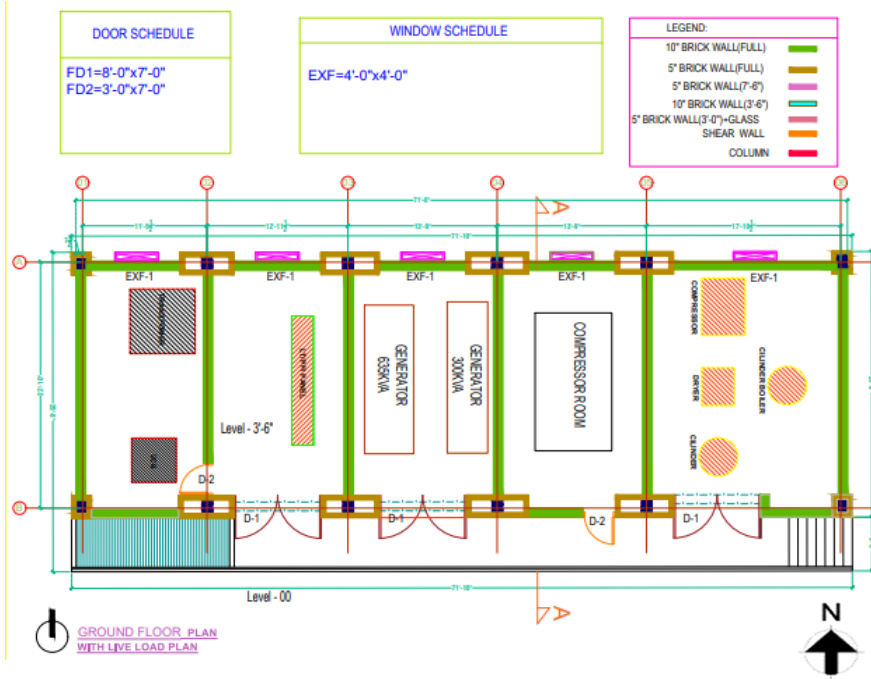
Brick wall layout: 250 mm brick walls

There were 6m high 250mm brick walls on the beams which was not considered in the finite element analysis (FEA) model. The column height was 6m and size was 300mm x 375mm. The building engineer is required to consider wall loads & slenderness effect of column in the analysis and update the FEA model & design report accordingly.

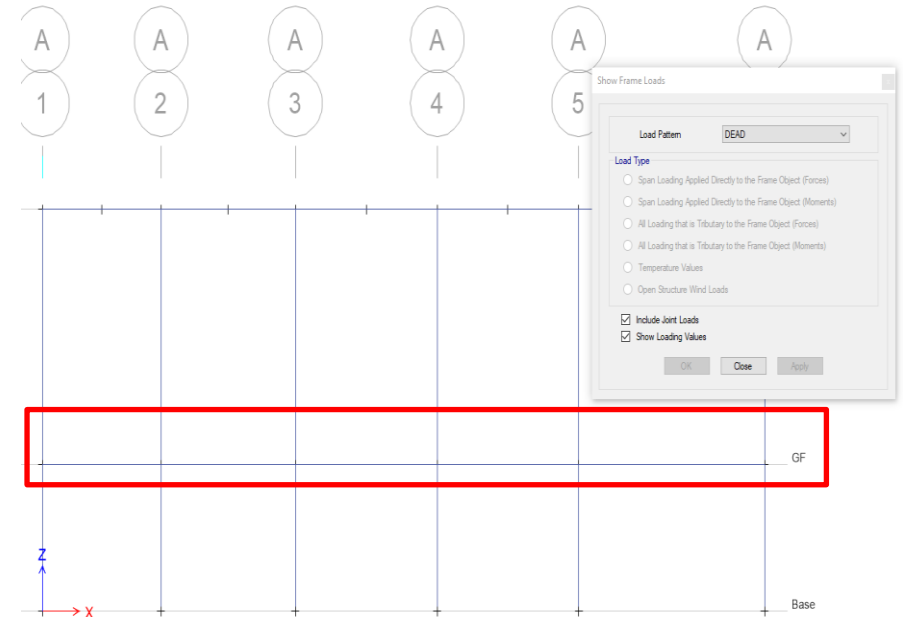
FEA Model: Wall load missing on frame

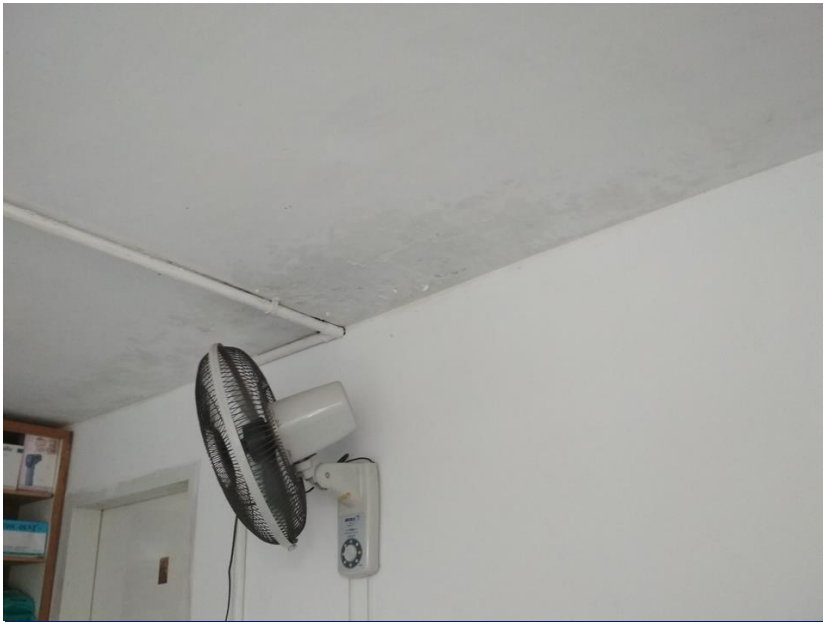
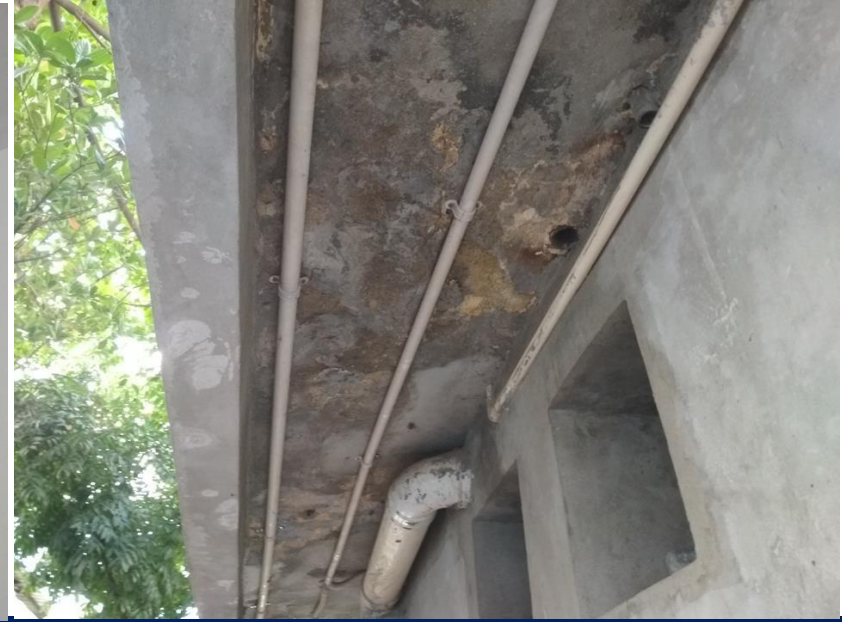
Dampness on roof slab

The factory is required to identify the reason of dampness and take necessary remedial measures.

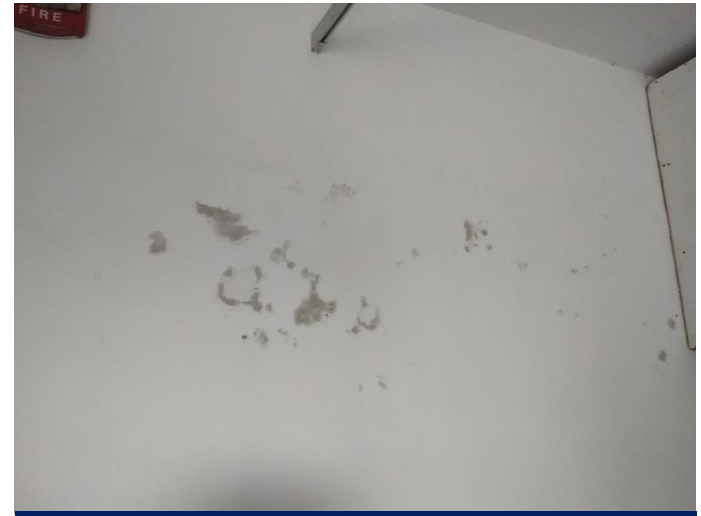
Dampness on brick wall
