SM Sourcing

Baimail, Konabari, Joydevpur , Gazipur

23 July 2023

Observations

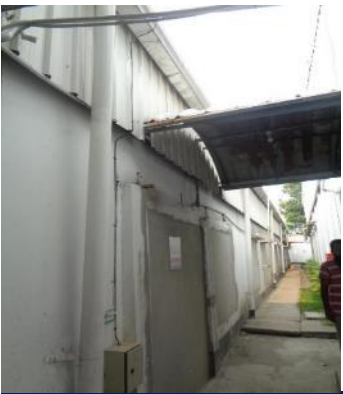
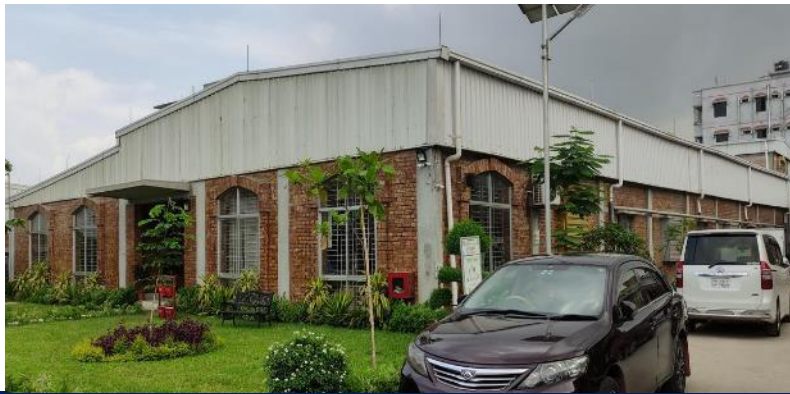
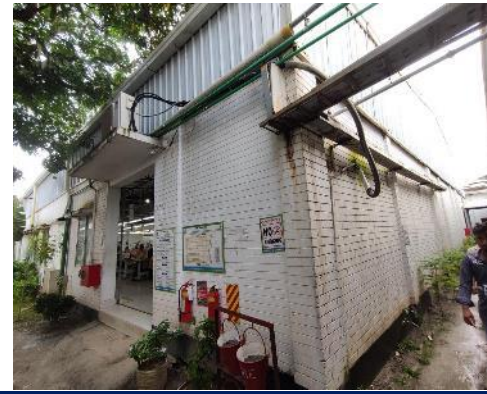
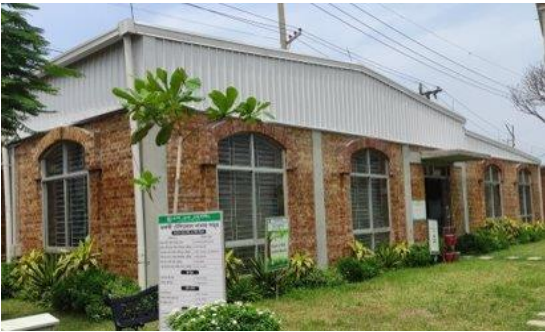
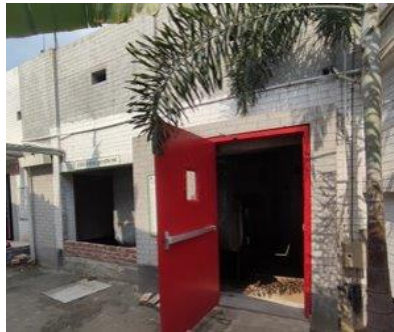
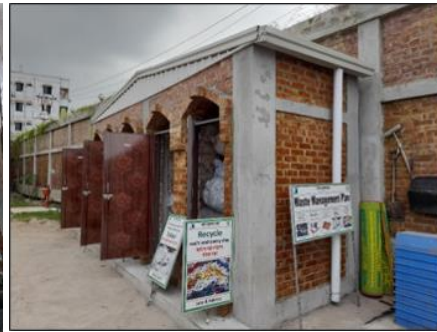
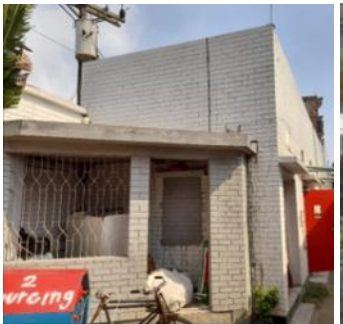
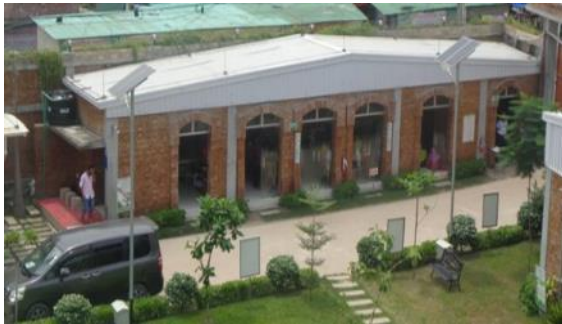
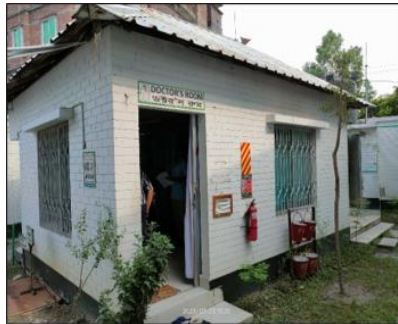
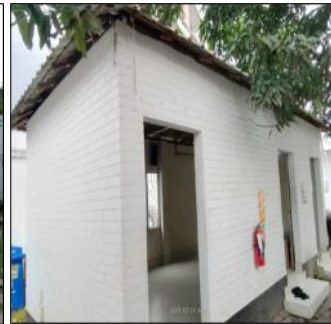
Lack of building permit

Building permit drawing was not available for the mentioned structure. The factory is required to collect building permit from BNBC prescribed local building permit authority.

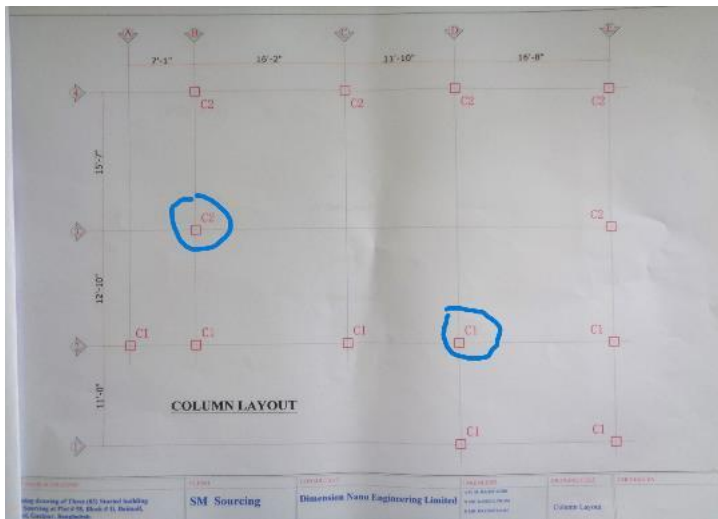
Column layout

High stressed column & foundation

Cursory calculation indicates that the Stresses in the columns and foundations of the building are above the design limit, and the factor of safety is below 1.5 considering 2 kPa floor live load and equivalent material strength 13.1 MPa from concrete core test reports and ultimate bearing capacity 3.24 ksf from soil test report. The columns and foundations are highly loaded from peripheral brick walls and rooftop water tanks. Also, the concrete strength and soil bearing capacities are very low. The factory is required to reduce floor live load to 1 kPa and maintain until completion of Detail Engineering Assessment (DEA) as well as suggested remedial works. Verify in-situ soil bearing capacity by further testing and incorporate the test result in DEA.

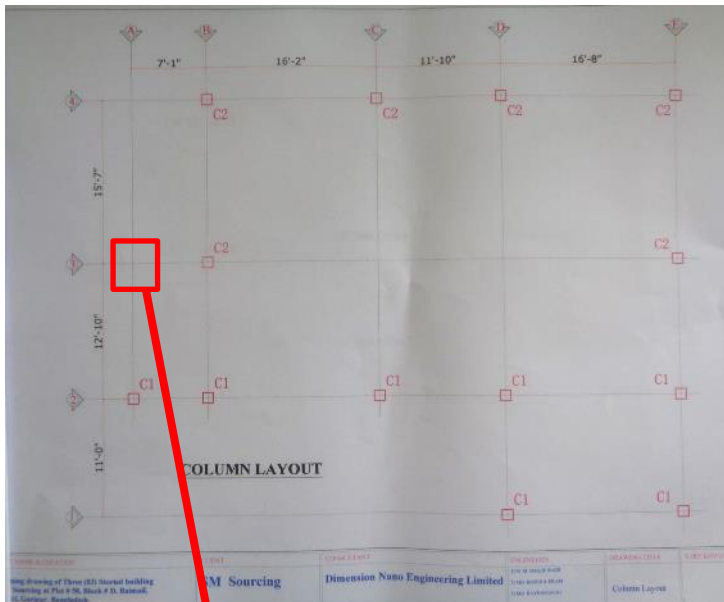
Column layout: Marked column not shown in drawing

Column of porch not align with main building column grid. But drawing shown along the same column grid of main building.

Column layout, size and rebar number didn't match between provided drawing and as-built condition. The marked column built up-to ground floor roof which was not shown in column layout; all the column sizes were found 250x250 mm instead of 375x375 mm; and only 4 rebars were found in column by scanning where drawings shown 6 & 8 rebars. Also, mismatch was found in column grid dimension.

Building engineer is required to survey the structure and prepare accurate as-built drawings and submit to the RSC for review.

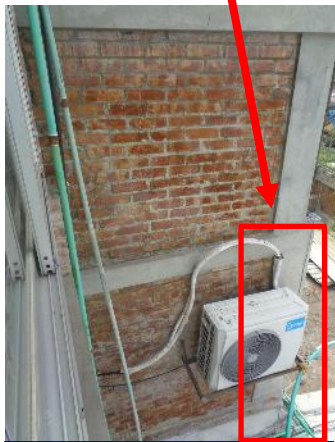
Column built up-to ground floor roof

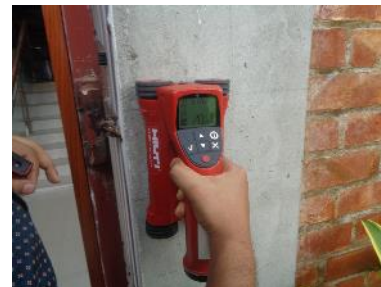
Column rebar: 4 numbers instead of 8

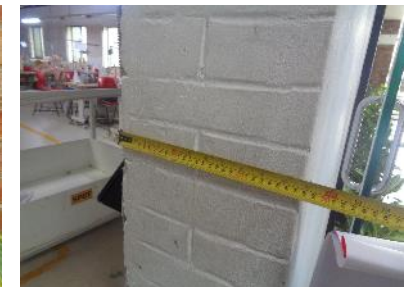
Column size: 250 mm instead of 375 mm

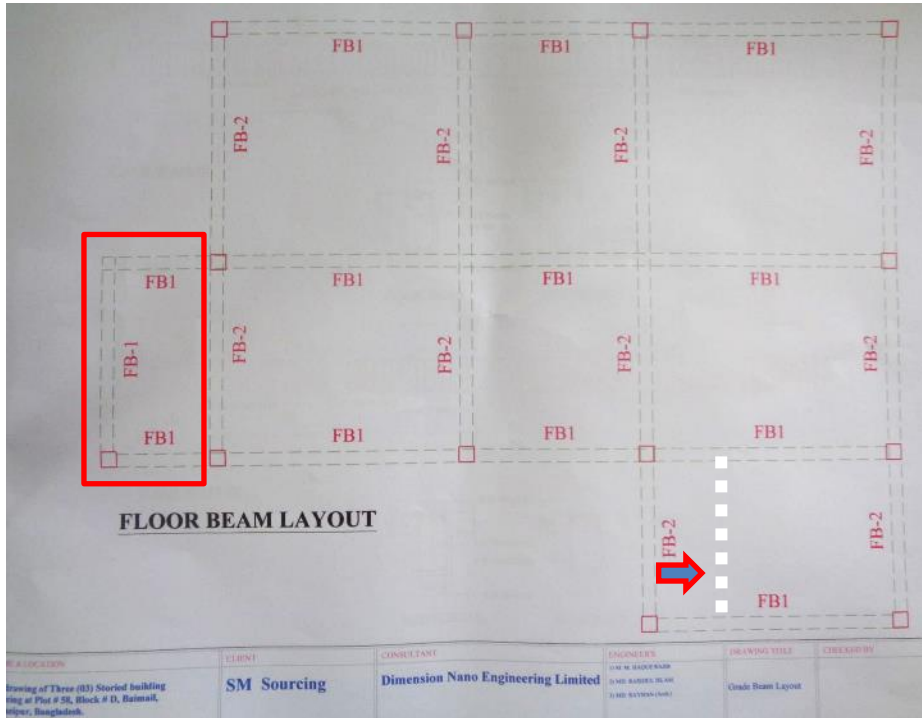
Beam layout: Red marked beams were not found onsite. And white marked beam was found shifted.

The beam layout and beam sizes were not matched with the provided drawings.

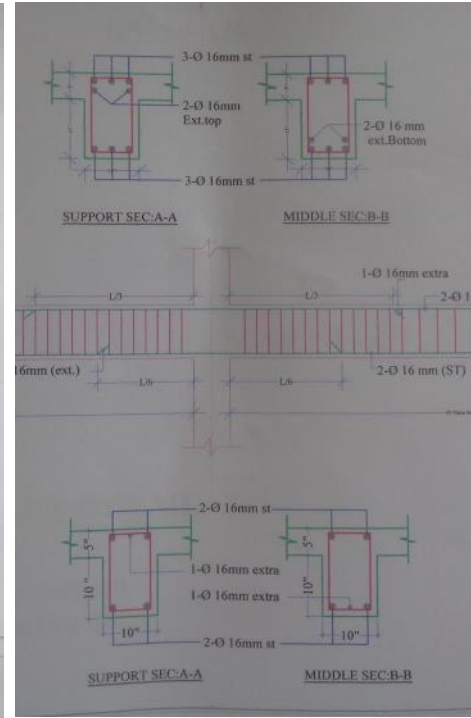
Beam depth in drawing:
 FB-1 = 500 mm
 FB-2 = 375 mm

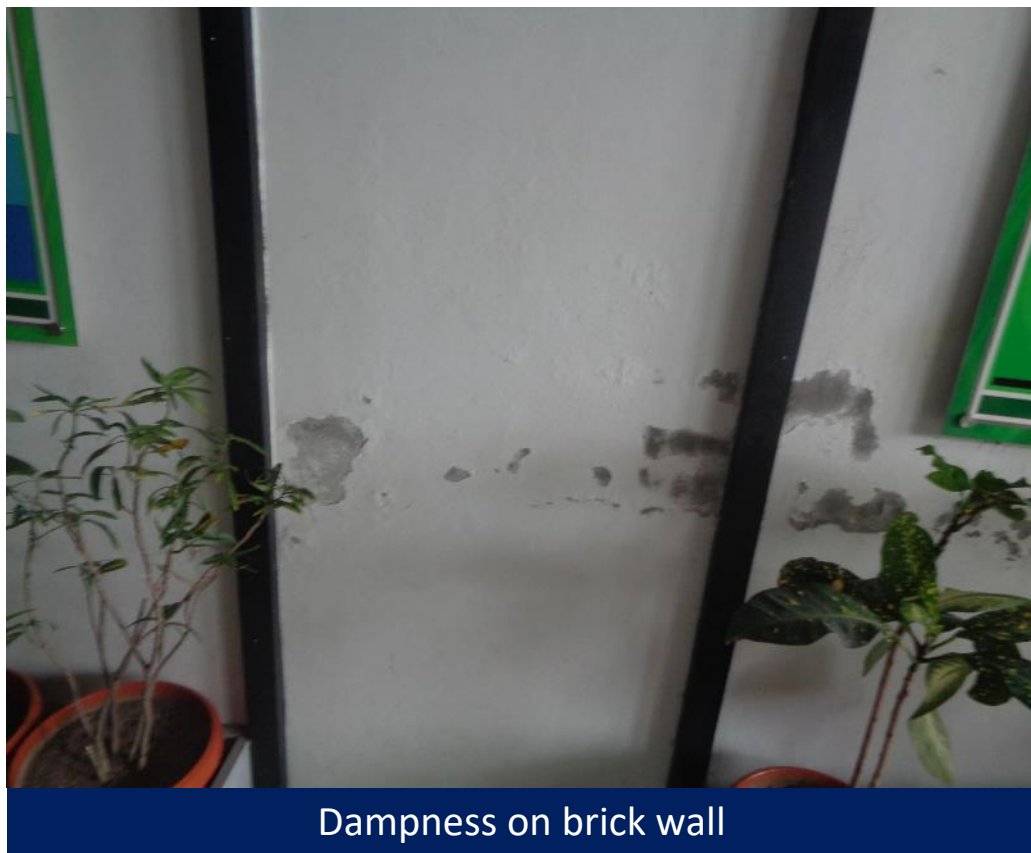
Dampness on exterior walls

Dampness on brick wall

The factory is required to seal the source of water and repair the damped area with suitable method.

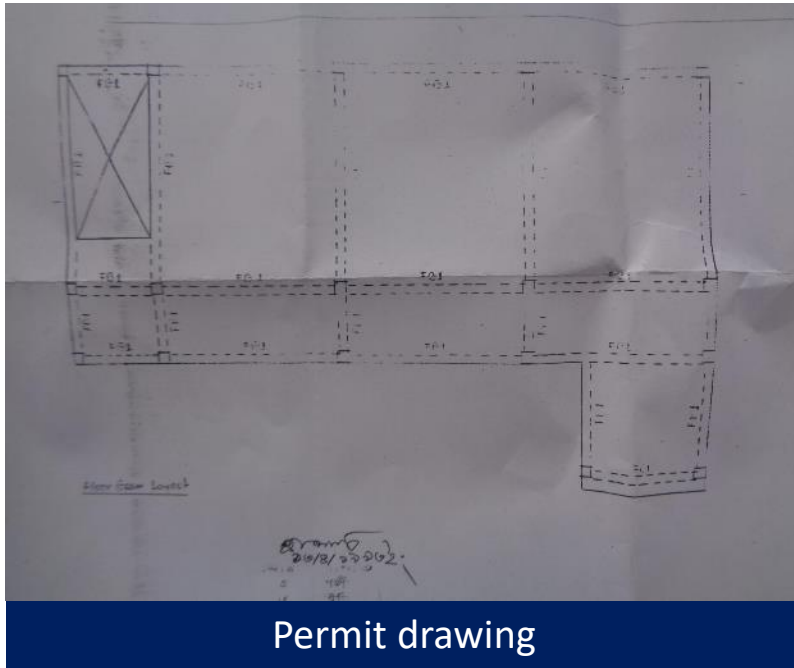
Permit drawing

The as-built construction did not reflect the permit drawing. The number of beam & column and the floor layout was not matched with permit drawing. The factory is required to collect building permit from BNBC prescribed local building permit authority.

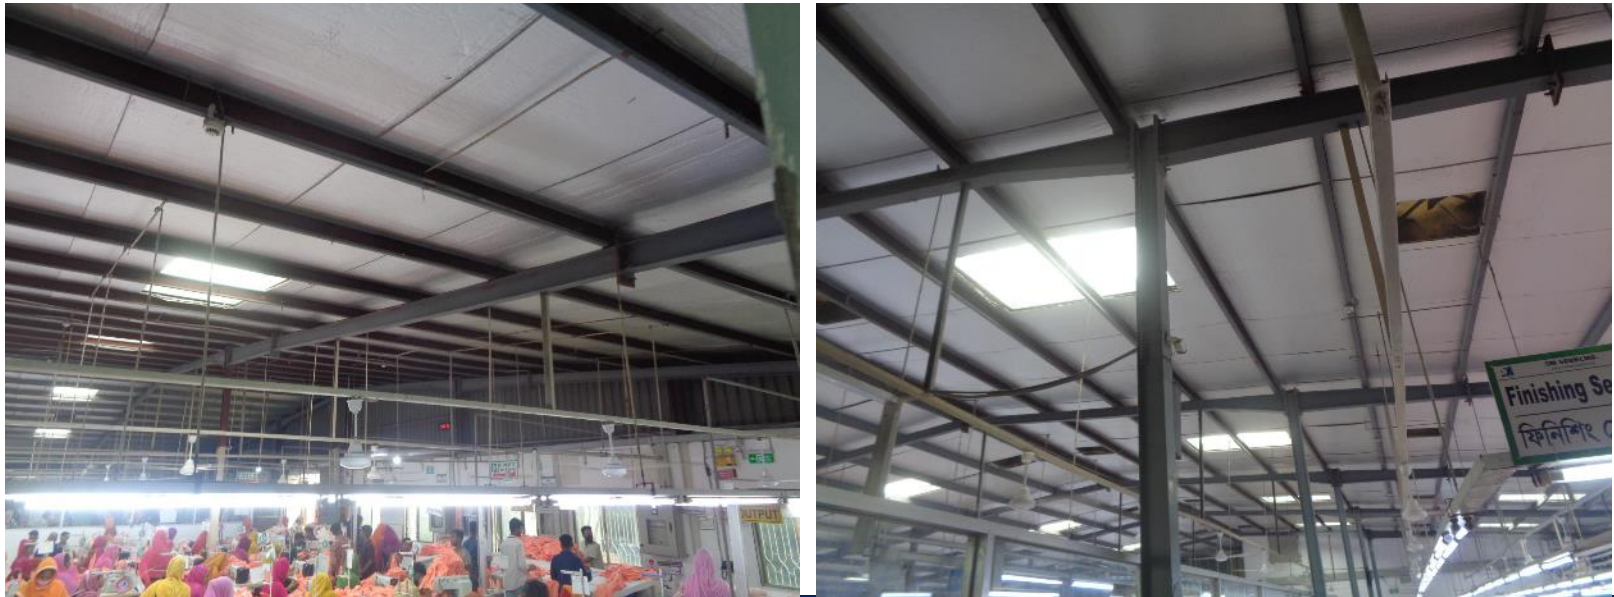
Absence of load transfer media along transverse direction of rafter and absence of bracing

Lack of lateral stability system (bracing & compression strut) was observed in the structure. Also, the column and rafter size seems to be inadequate. The building engineer is required carryout Engineering Assessment (EA) to check the lateral stability of the structure and suggest proper remedial actions accordingly.

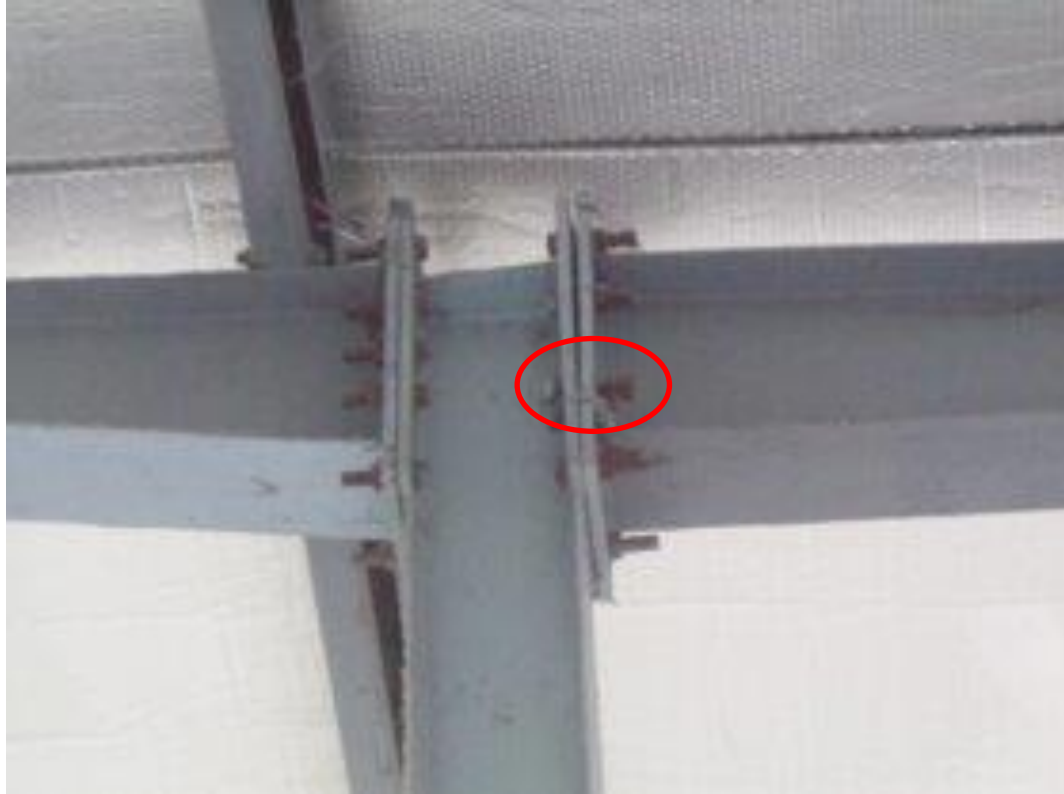
Gap between connection plates and loose bolt

The factory is required to check the connections and repair the gap with suitable method. Also, tight the loose bolts.

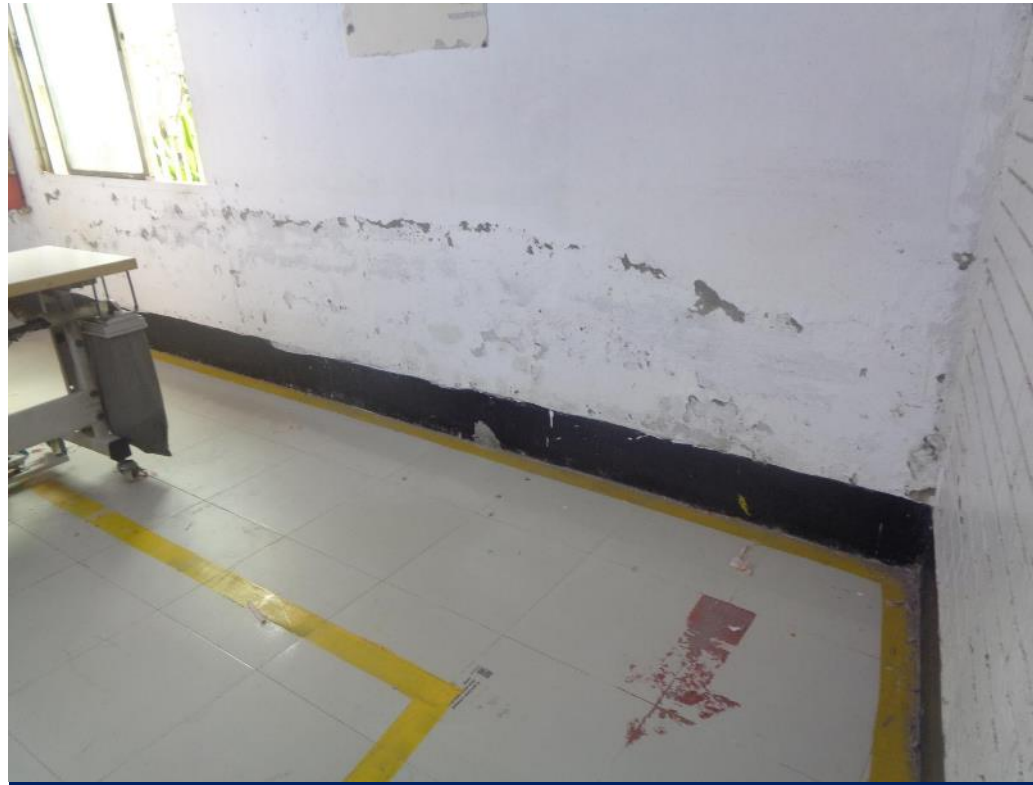
Dampness on exterior brick walls at west

Dampness on brick wall

The factory is required to seal the source of water and repair the damped area with suitable method.

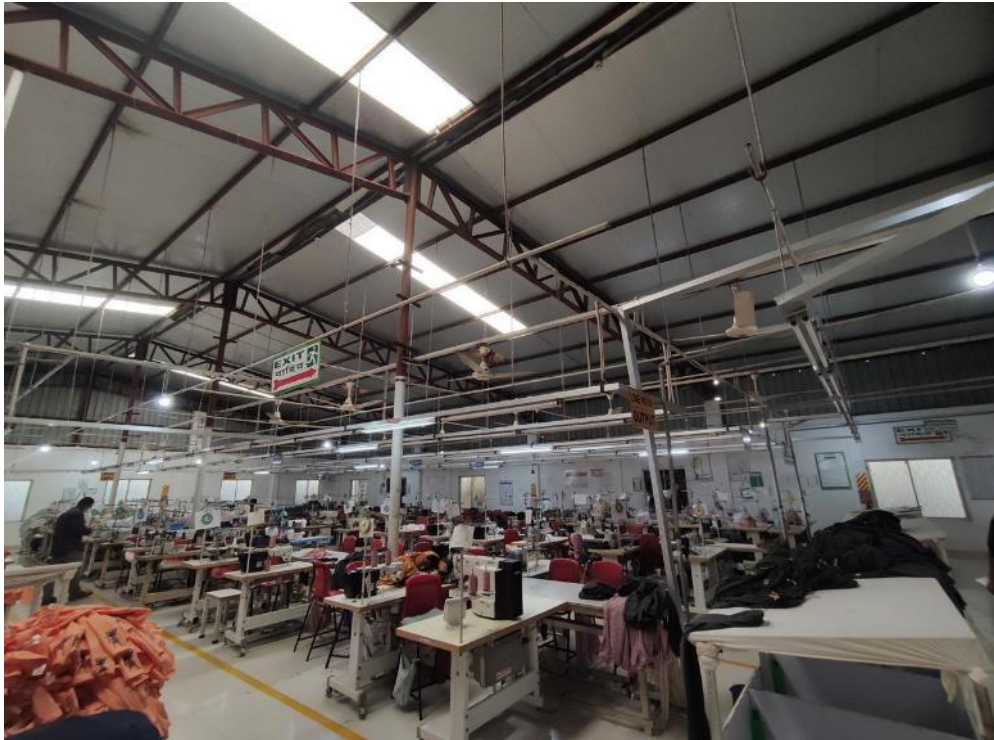
No load transfer media & bracings at roof

No bracing system was observed along transverse direction of roof truss. Also, the connection between RC column and steel roof truss was improper. The building engineer is required carry out Engineering Assessment (EA) to check the connection & lateral stability of the structure and suggest proper remedial actions accordingly. Submit the EA documents to the RSC for review.

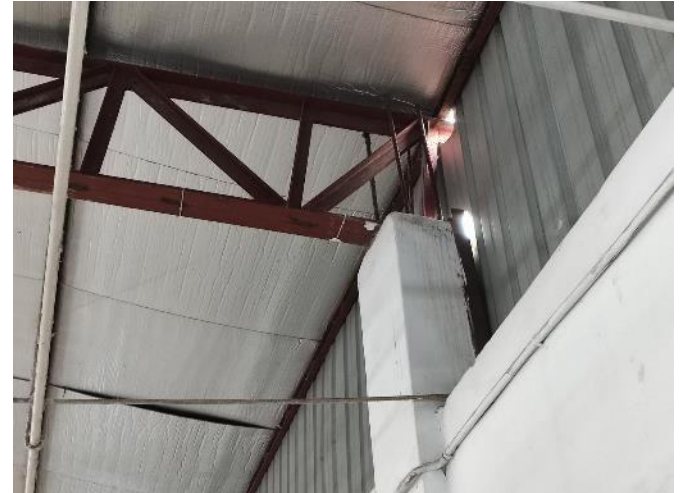
Improper connection between RC column and steel roof truss

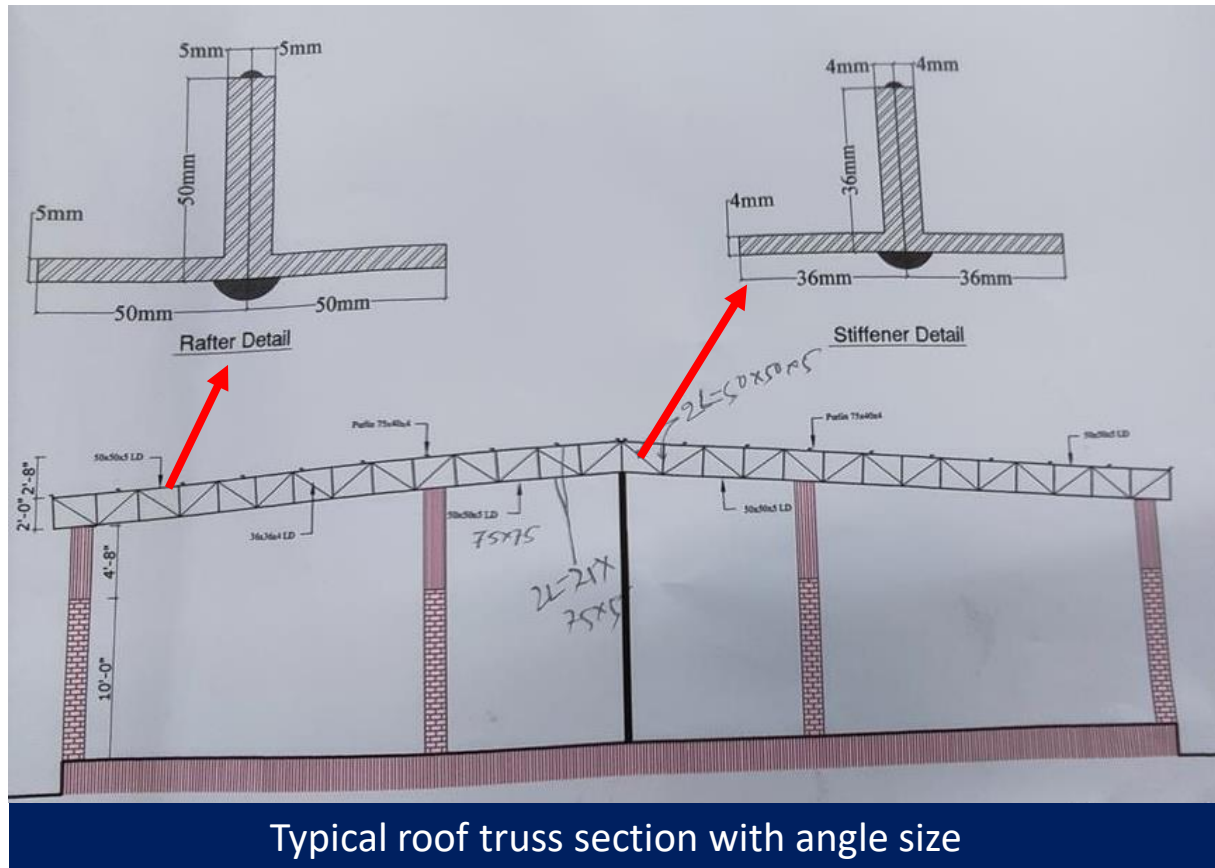
Typical roof truss section with angle size

Some discrepancies were observed between provided drawing & on-site condition. Bottom chord angle size was found 2L-75X75X5 onsite where drawing shows 2L-50X50X5. The building engineer is required to check the as-built condition and prepare accurate as-built drawings structural connection details.

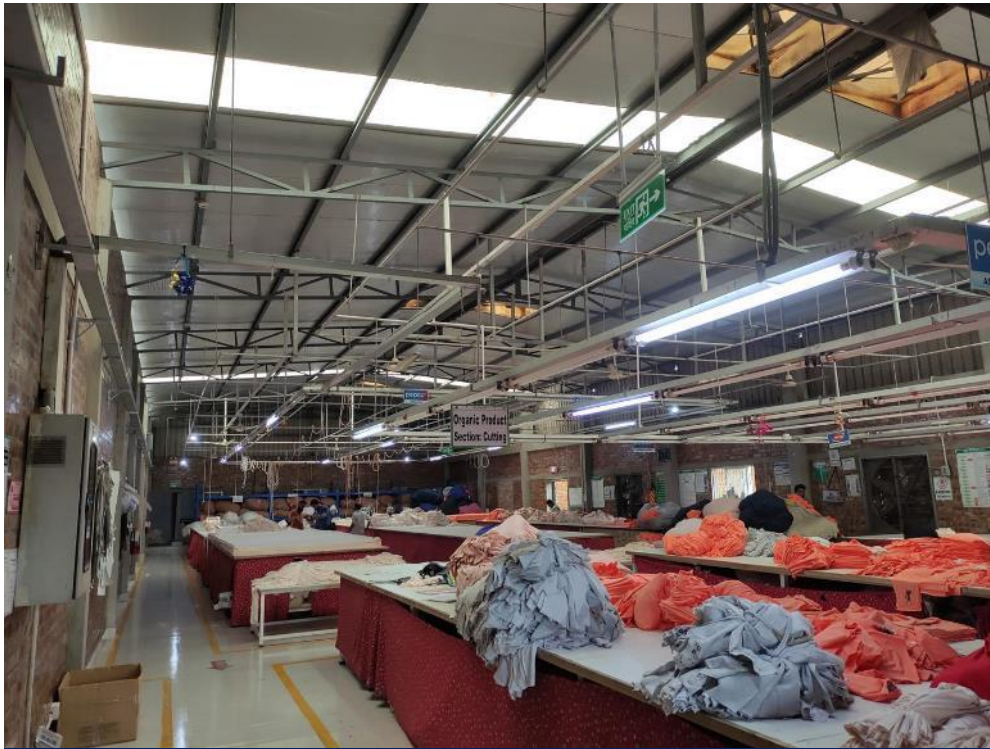
No load transfer media & bracings at roof

No bracing system was observed along transverse direction of roof truss. Also, the connection between RC column and steel roof truss was improper. The building engineer is required carry out Engineering Assessment (EA) to check the connection & lateral stability of the structure and suggest proper remedial actions accordingly.

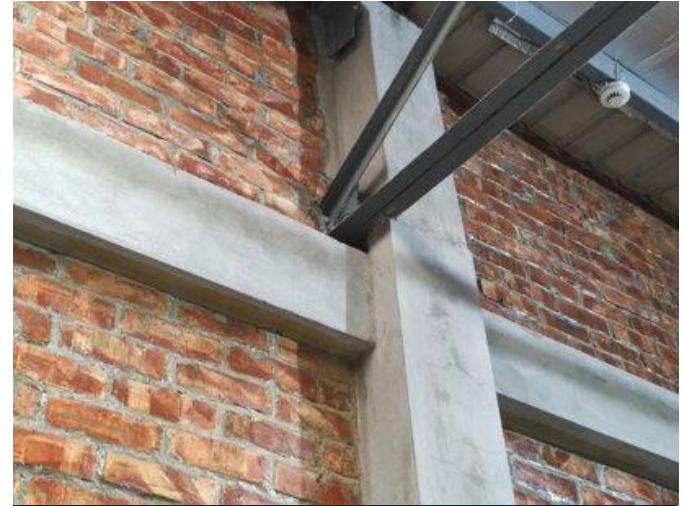
Improper connection between RC column and steel roof truss

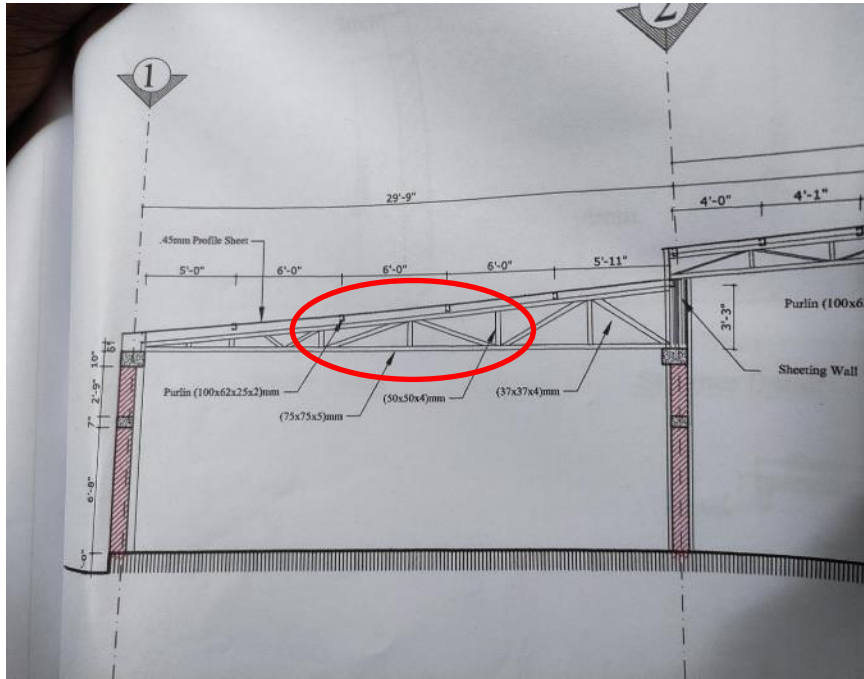
Truss angle direction (as-built drawing)

Some discrepancies were observed between provided drawing & on-site condition. The direction of diagonal chord of roof truss doesn't match with drawing. The building engineer is required to check the as-built condition and prepare accurate as-built drawings with structural connection details.

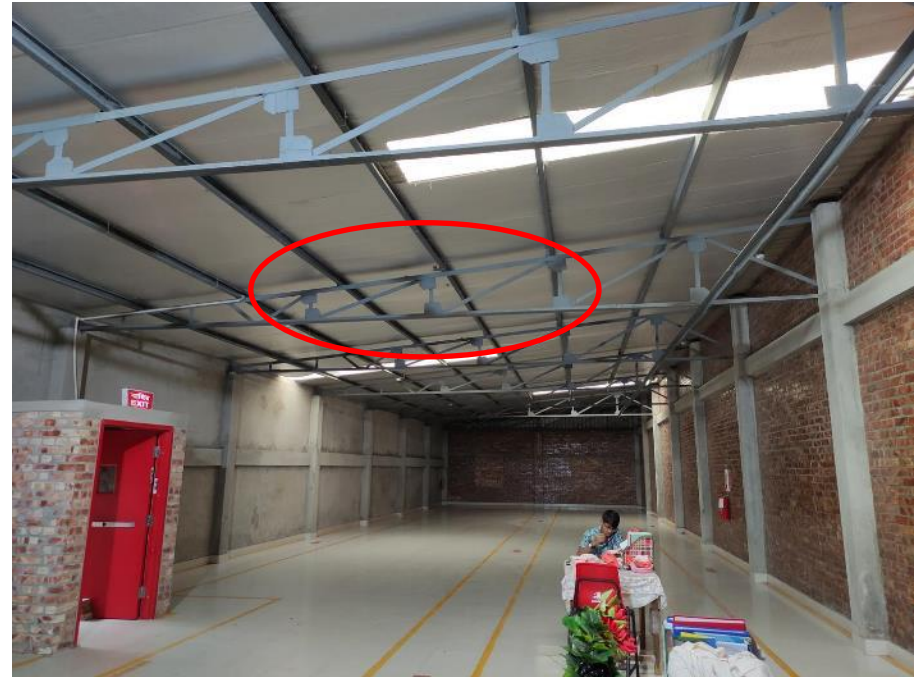
Truss angle direction (on-site condition)

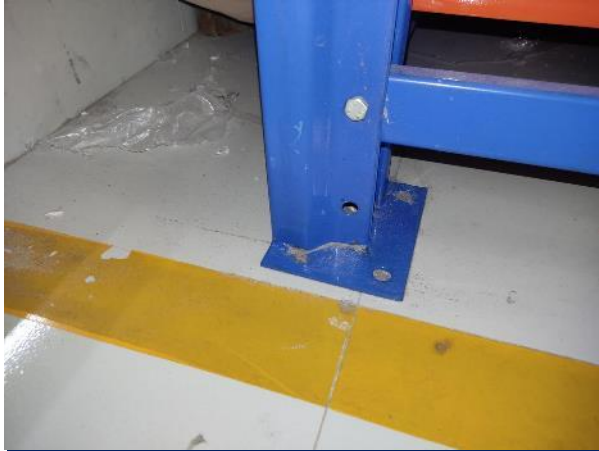
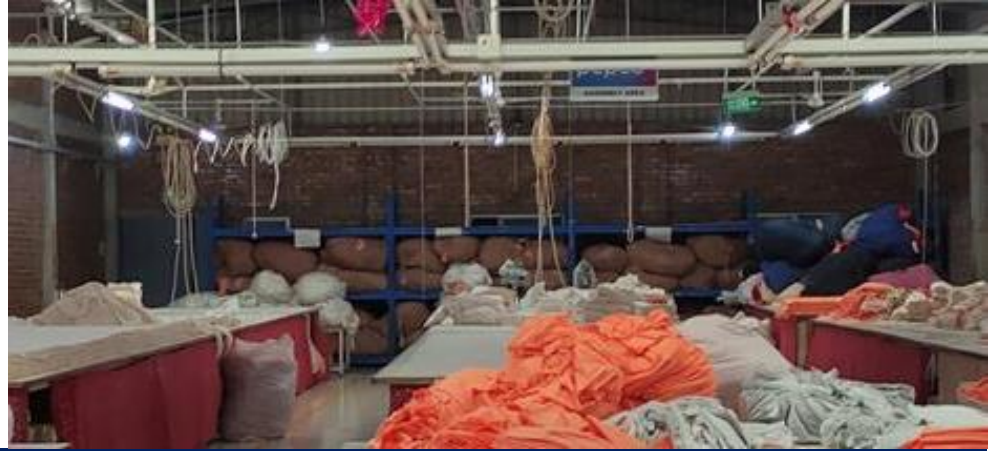
Unbraced storage rack

During inspection unbraced storage rack was found. Building Engineer is required to brace/anchor all the unbraced storage rack.

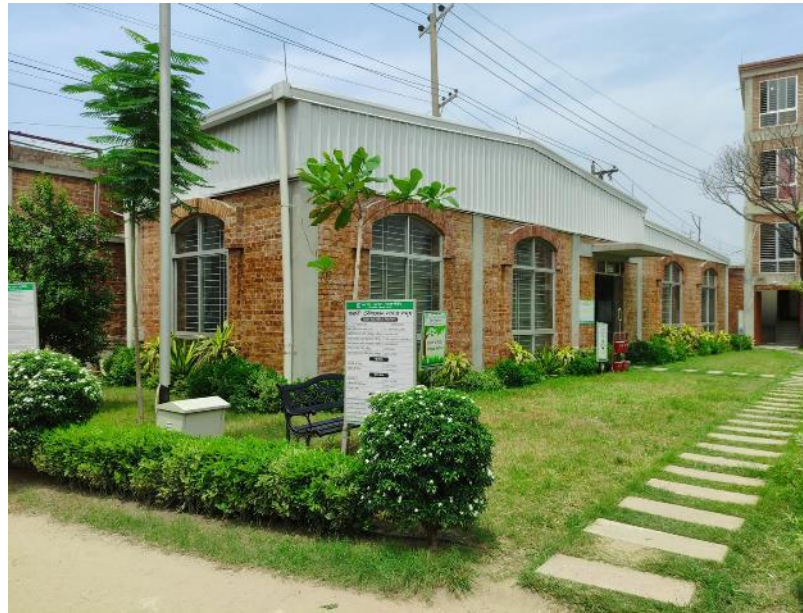
Shed 4

During inspection design report was not found which is required to be prepared in compliance with section 1.9.1.1 (part-6, BNBC).

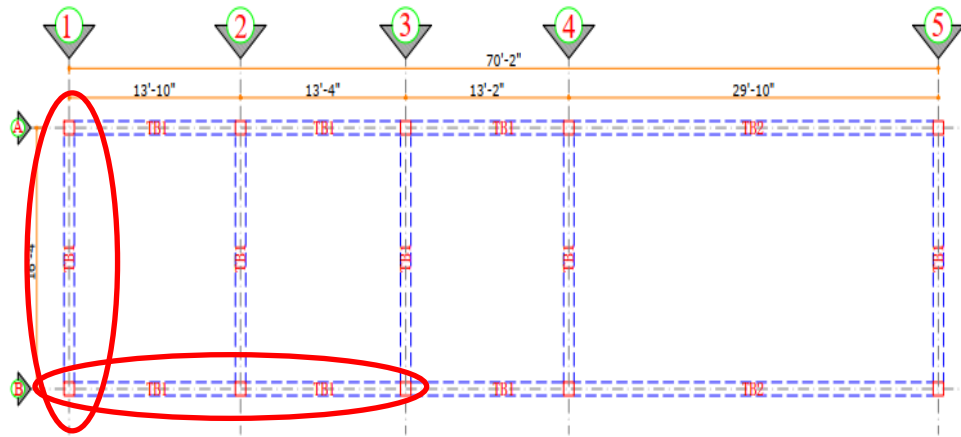
Tie Beam Layout Plan

Tie Beam Layout (as-built drawing)

Some tie-beams were found missing on-site. The building engineer is required to survey the structure and prepare accurate as-built drawings.

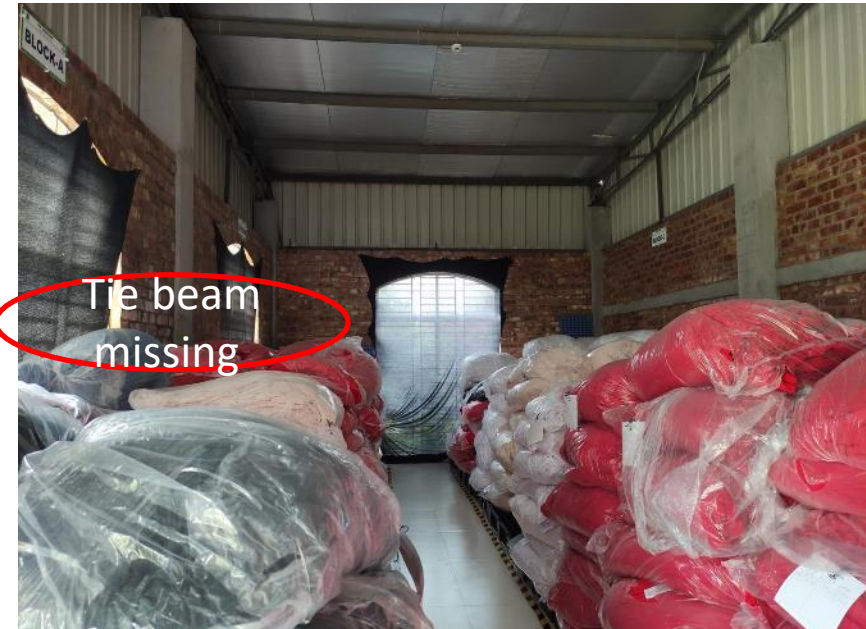
Tie Beam missing (on-site condition)

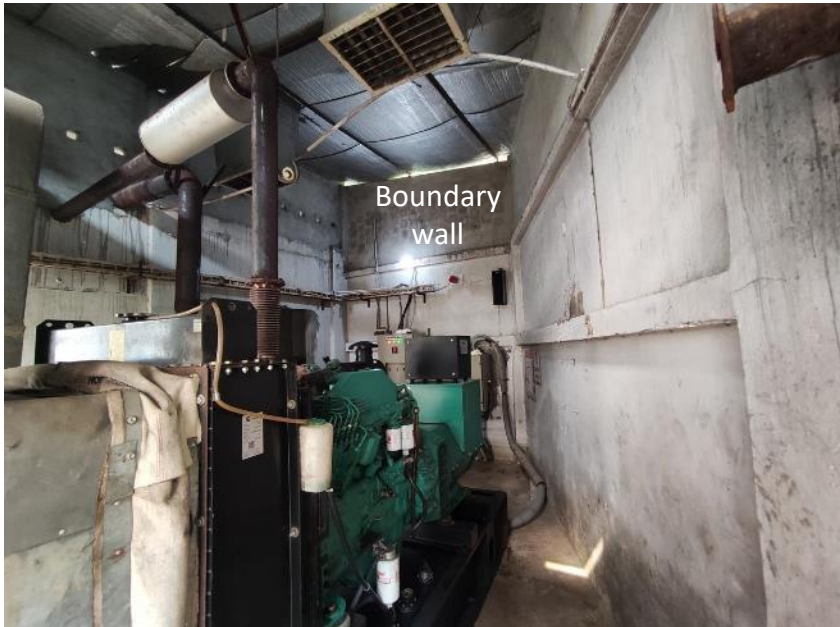
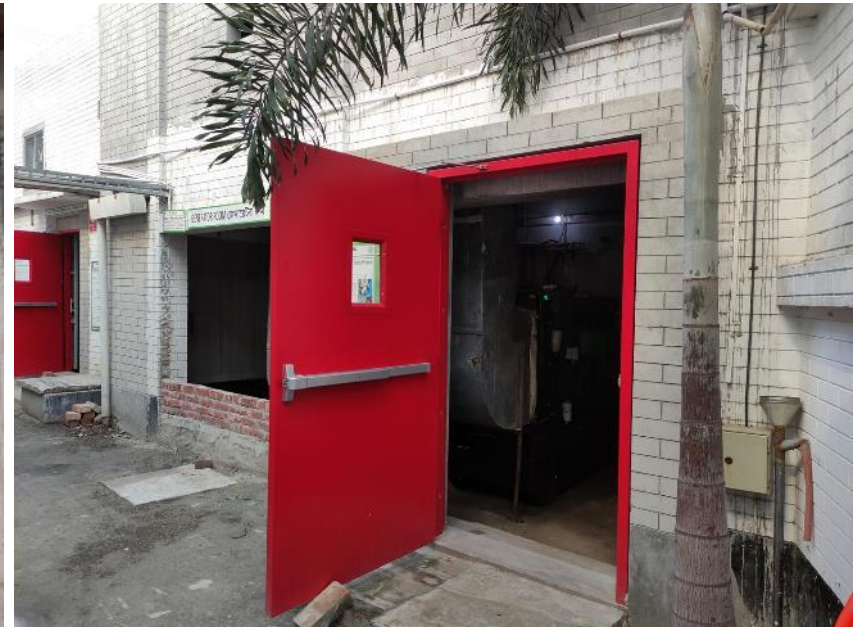
Apparently non-engineered structure with inadequate member and connection

The stability system of steel roof & peripheral walls and their connections are apparently non-engineered. Also, the member size of lightweight steel roof seems to be inadequate. The building engineer is required to suggest proper alternatives to make the structure adequate and prepare necessary design documents accordingly. Otherwise, the factory is required to replace the shed with well-designed structure.

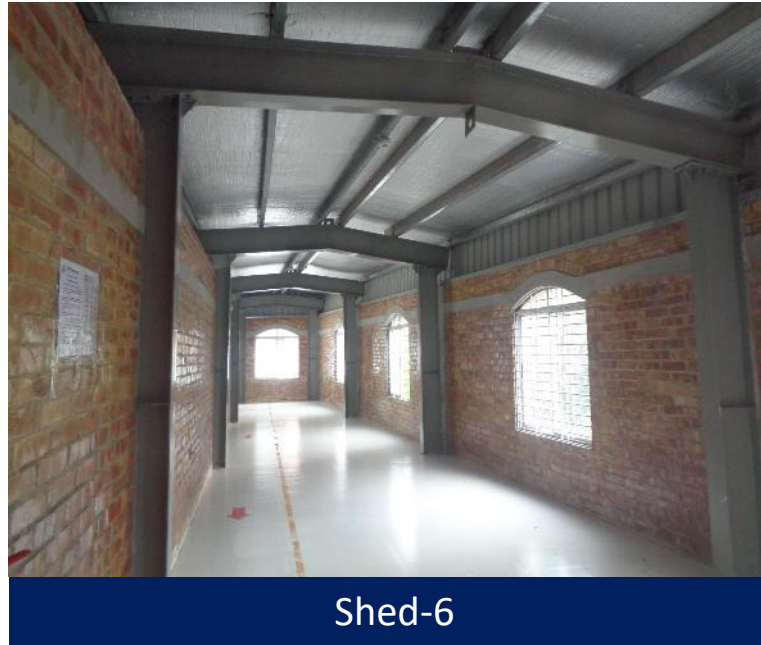
Shed-6

As per BNBC, every building or structure designed shall have its design documents prepared in accordance with the provision of Section 1.9.1, part-6 of BNBC. The design document shall include a design report, and a set of structural drawings, which shall be prepared in compliance with section 1.9.1.1 and section 1.9.1.2 as per BNBC. During inspection, design report including floor load plan was not found which is required to be prepared in compliance with section 1.9.1.1 (part-6, BNBC).

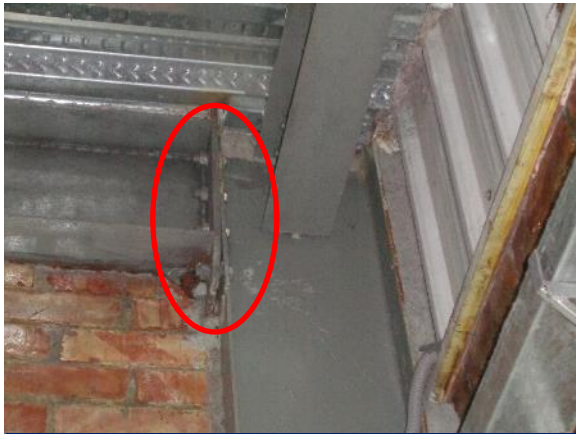
Large gap between end plates

Several improper connections were observed in the steel structure. The building engineer is required to check the connections and suggest proper remedial actions to make the connection active & adequate.

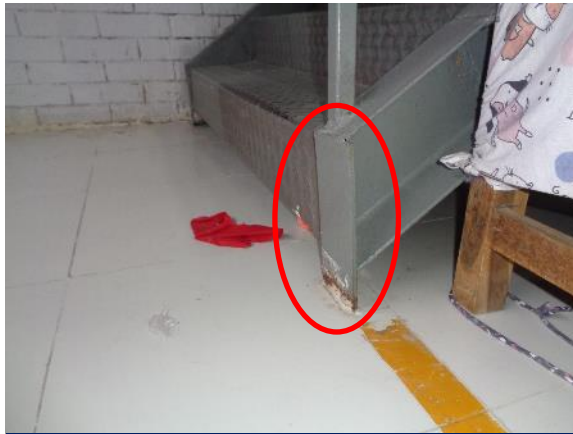
Stair rested on a thin plate leg

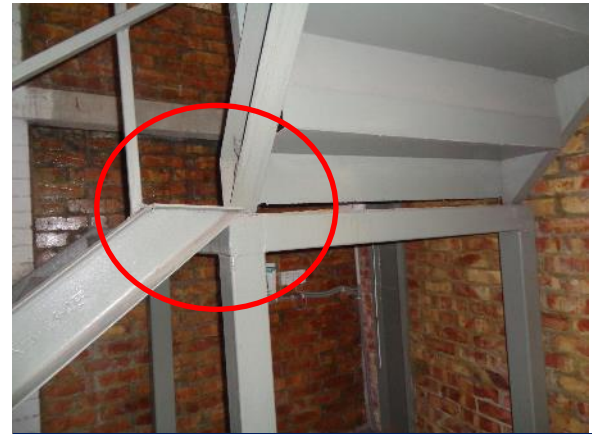
Less contact surface of connection

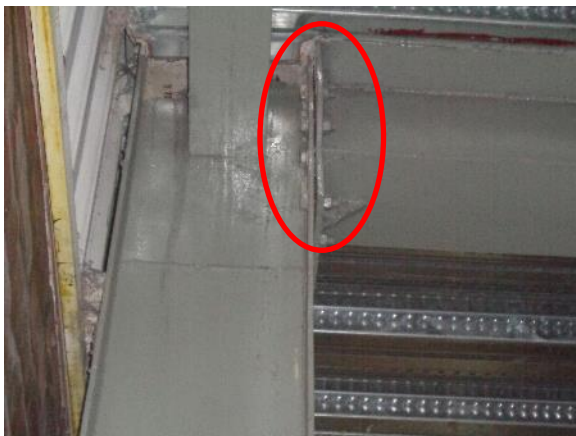
Large gap between end plates

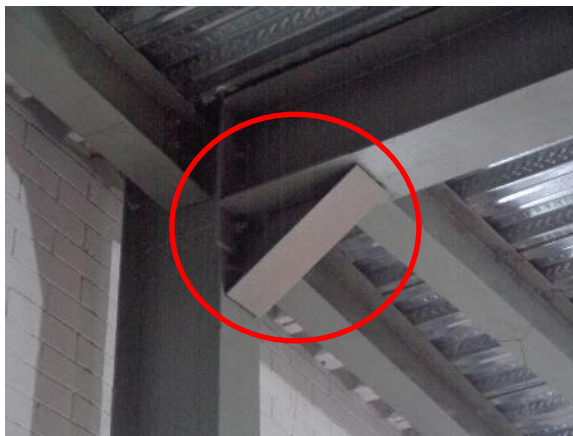
Haunch ends not connected to beam & column flanges

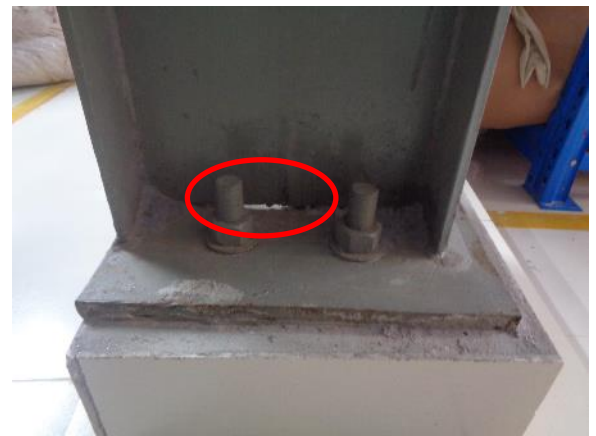
Gap between web & baseplate

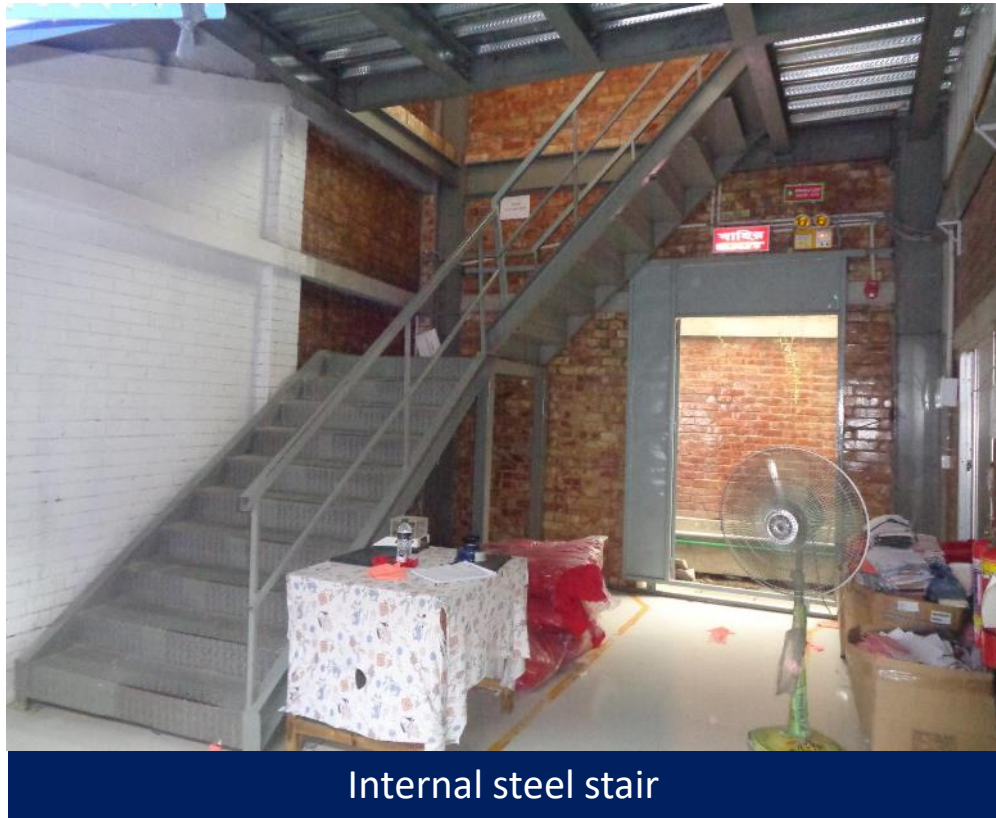
Internal steel stair

Proper documentation was not available for the steel stair. The building engineer is required to prepare as-built documents of the steel stair with necessary connection details.

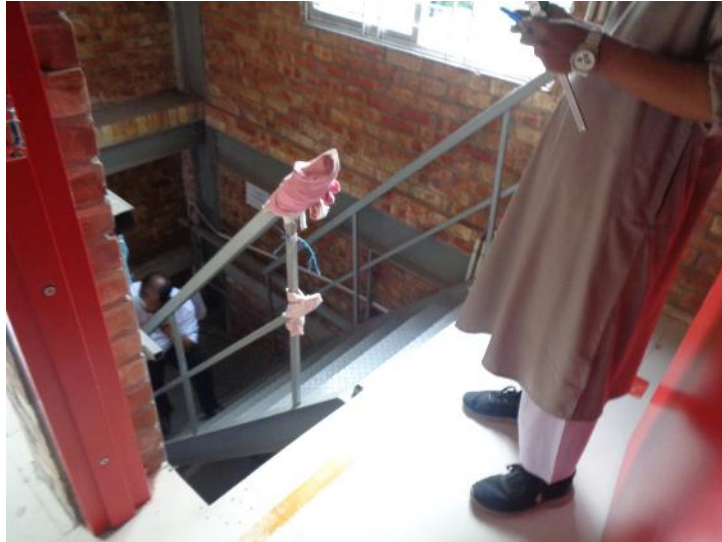
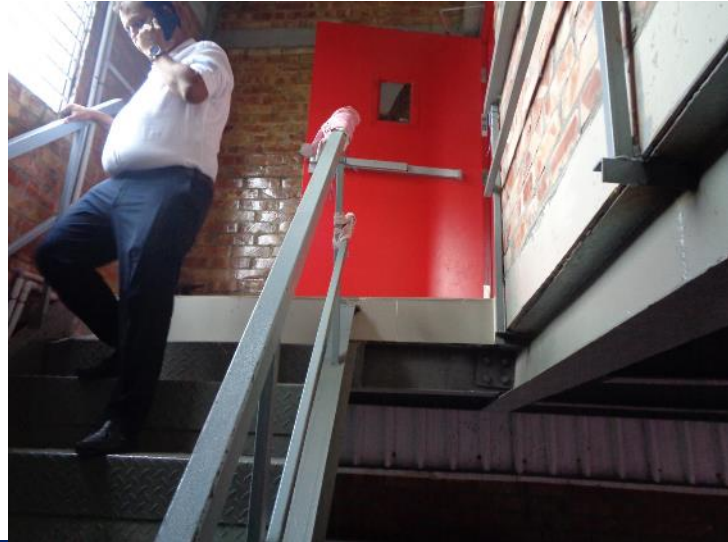
Falling hazard from stair landing

Falling hazard observed in the stair due incomplete railing. The factory is required to complete the railing to avoid possible falling hazard.

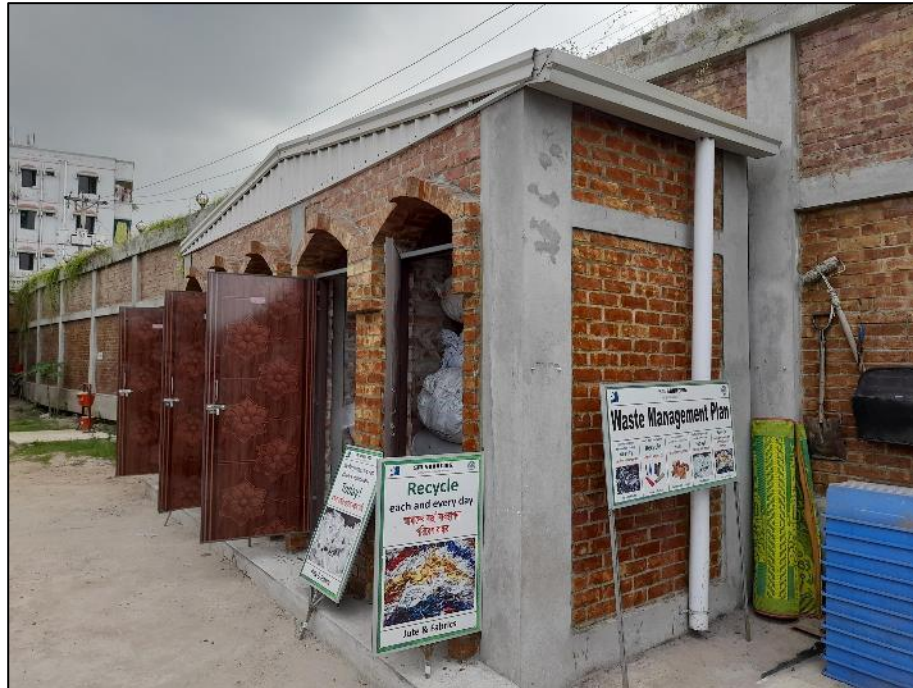
Shed 7

Absence of as-built drawings

The building engineer is required to survey the structure and prepare accurate as-built drawings.

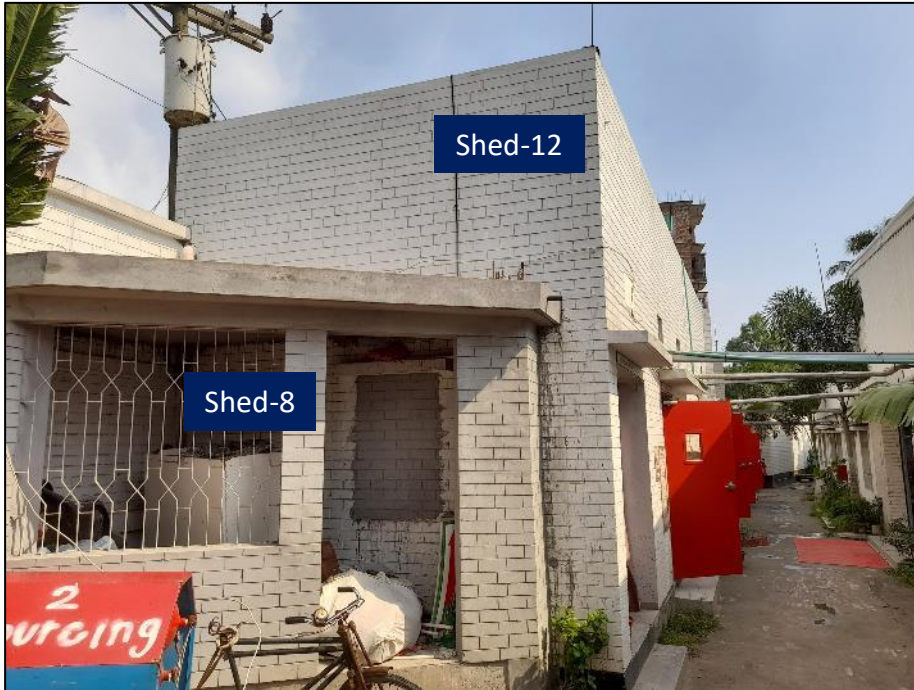
Apparently non-engineered structure with inadequate member and connection

The stability system of steel roof & peripheral walls and their connections are apparently non-engineered. The building engineer is required to suggest proper alternatives to make the structure adequate and prepare necessary design documents accordingly. Otherwise, the factory is required to replace the shed with well-designed structure.
