SM Sourcing

Baimail, Konabari, Joydevpur , Gazipur

23 July 2023

Observations

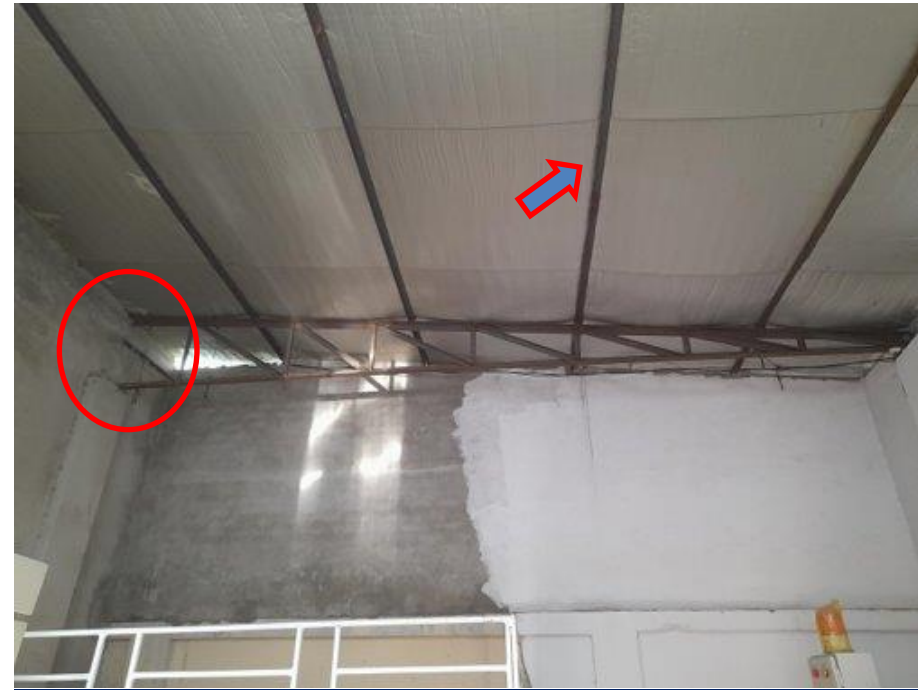
Apparently inadequate member and connection

The stability system of steel roof & peripheral walls and their connections are apparently non-engineered. The building engineer is required to suggest proper alternatives to make the structure adequate and prepare necessary design documents accordingly. Otherwise, the factory is required to replace the shed with well-designed structure.

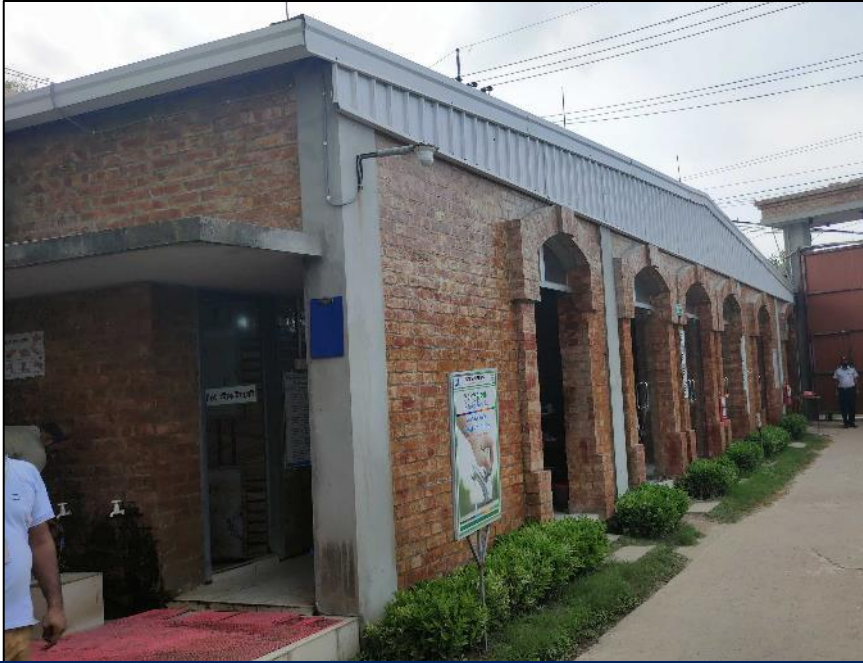
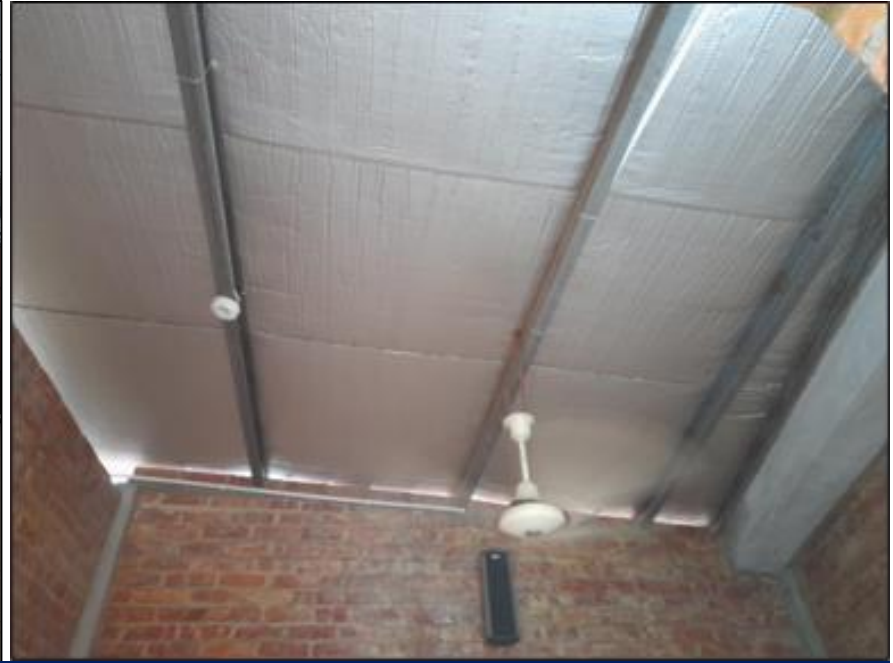
Shed 9

During inspection design documents was not found which is required to be prepared in compliance with section 1.9.1.1 (part-6, BNBC).

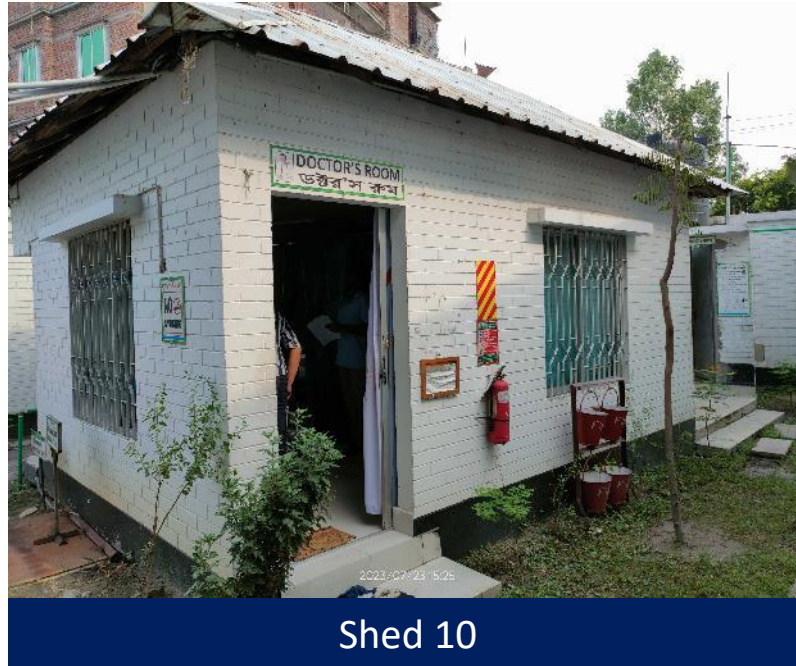
Shed 10

Absence of as-built drawings

The building engineer is required to survey the whole structures and prepare accurate as-built drawings with connection details.

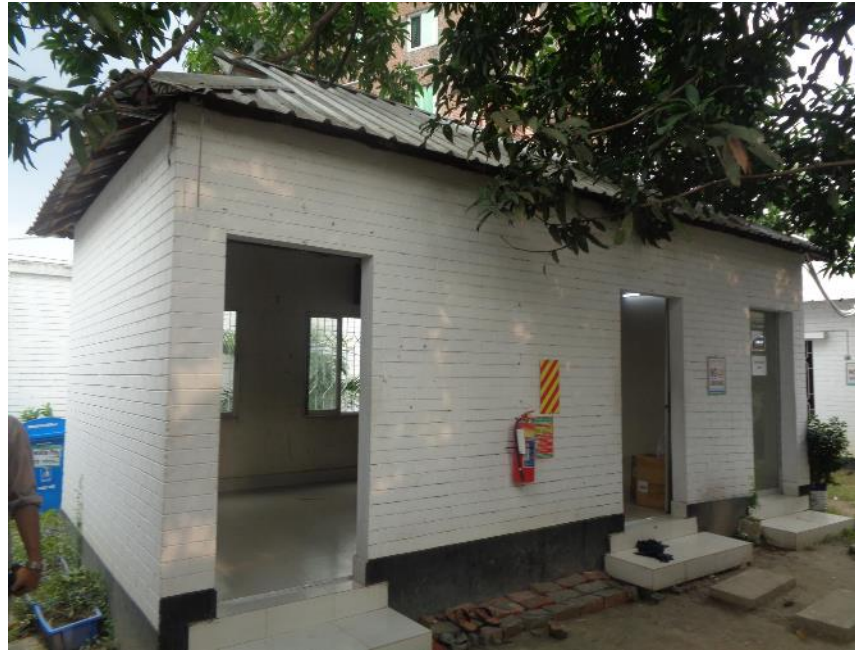
Shed 11

Absence of as-built drawings

The building engineer is required to survey the whole structures and prepare accurate as-built drawings with connection details.
