# Baridhi Garments Ltd. (Extension)

SFB#8, Cumilla EPZ, Cumilla-3500, Cumilla  
(23.443694, 91.183057)  
25 July 2023

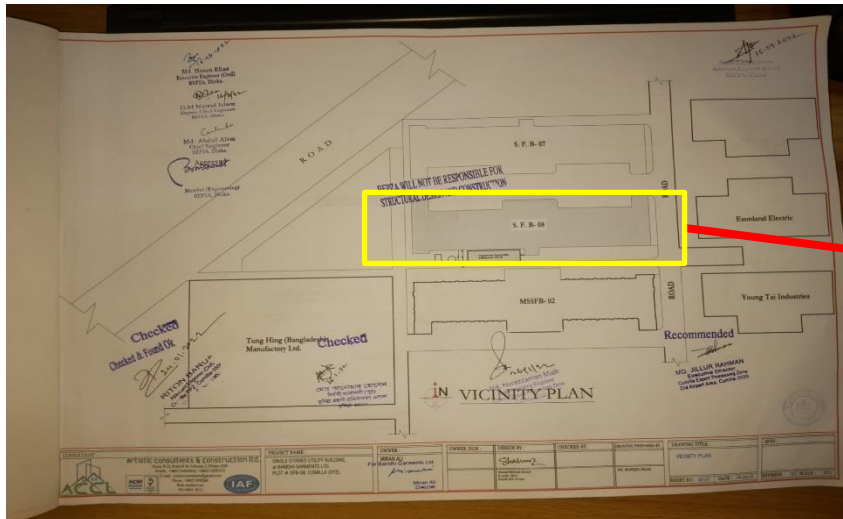
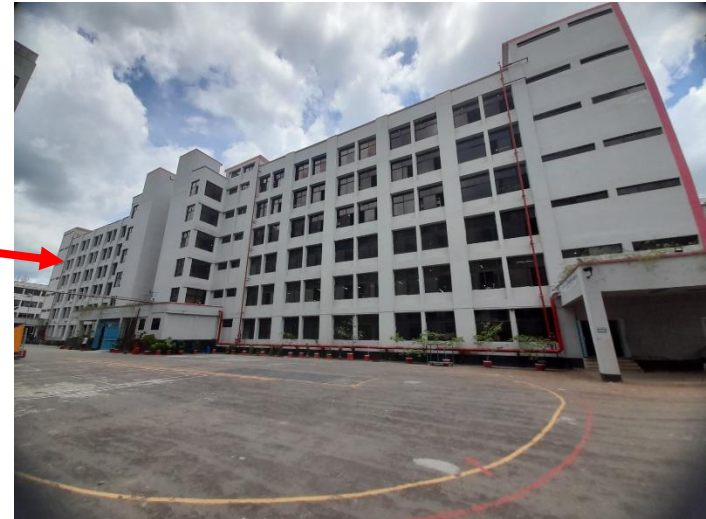
SFB 08 (Extension Building)

As per BNBC every building or structure designed shall have its design documents prepared in accordance with the provision of Section 1.9.1. The design document shall include a design report, and a set of structural drawings, which shall be prepared in compliance with section 1.9.1.1 and section 1.9.1.2 as per BNBC. Design report was not found which is required to be prepared in compliance with section 1.9.1.1 (part-6, BNBC).

| Item No. | Observation | Recommended Action Plan | Recommended Timeline |
|---|---|---|---|
| 01 | Absence of design Report (Extension Building) | Building engineer is required to prepare design report as per BNBC. | 6-weeks |

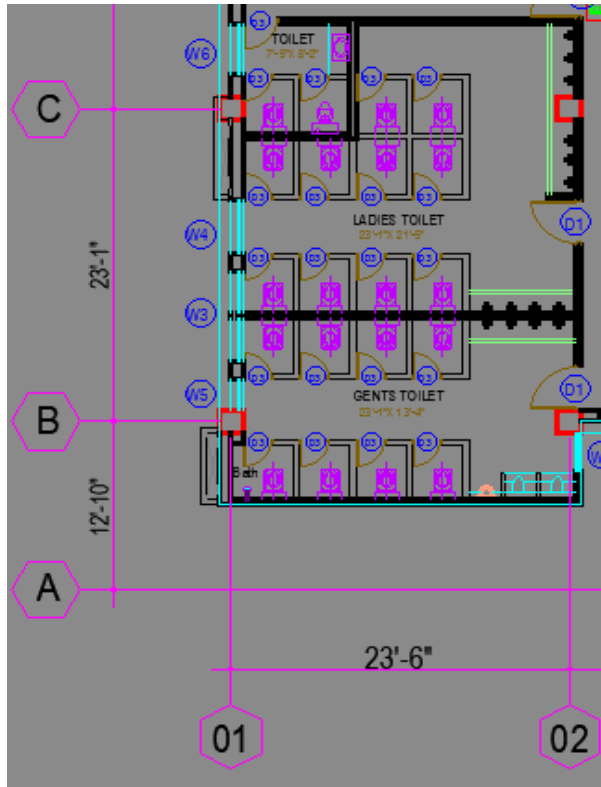
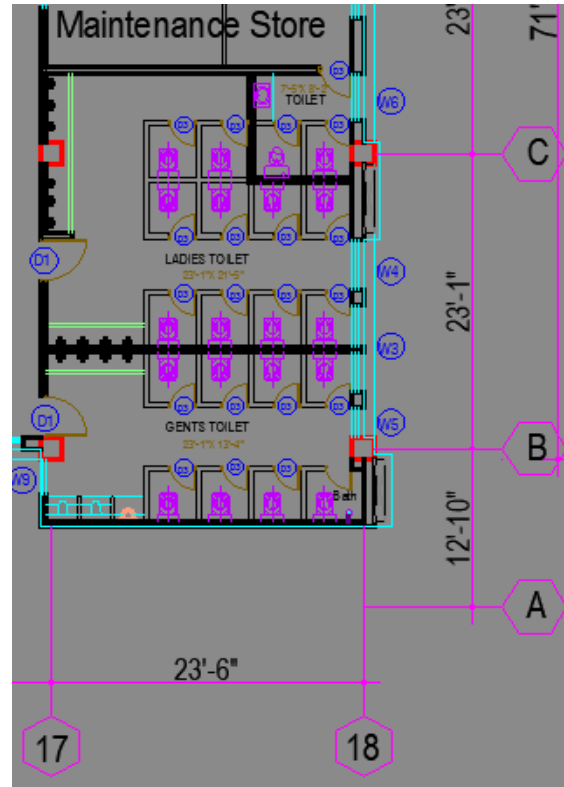
Architectural layout for toilets

The location and numbers of toilet shown in the drawing are not matching with the site condition. As well as built up and some other occupancies are required to be updated in the drawing. Building engineer is required to survey the whole structure and update the as-built drawing.

| Item No. | Observation | Recommended Action Plan | Recommended Timeline |
|---|---|---|---|
| 05 | Discrepancies in as-built drawing (Extension Building) | Building engineer is required to survey the full structure and update the as-built drawing accordingly. | 6-weeks |

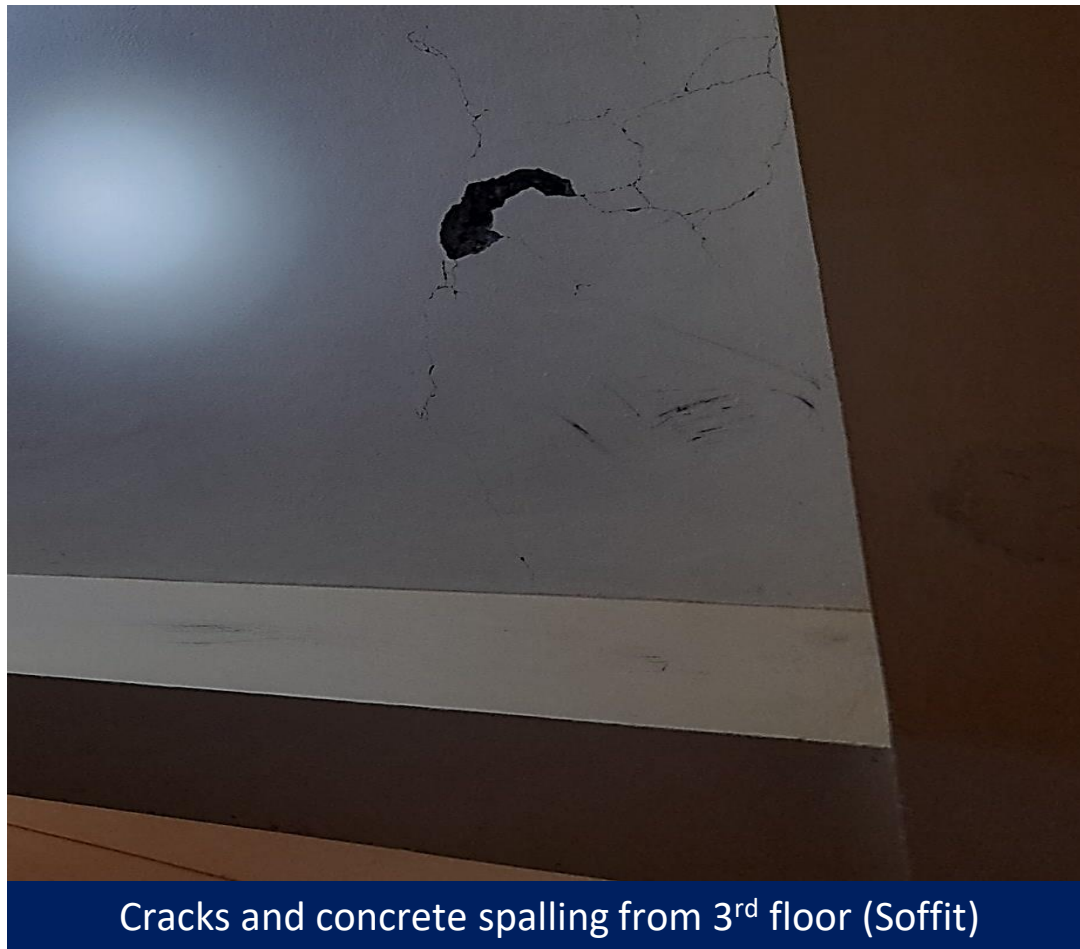
Cracks and concrete spalling from 3<sup>rd</sup> floor (Soffit)

Cracks and concrete spalling were observed on floor slab ( Soffit ). Building engineer is required to investigate the cracks and carry out suitable repair work as per recommendation of investigation report.

| Item No. | Observation | Recommended Action Plan | Recommended Timeline |
|---|---|---|---|
| 06 | Crack and spalling of concrete on third floor ceiling (Extension Building) | The building engineer is required to investigate the causes of crack and repair with a suitable method immediately. | 6-weeks |

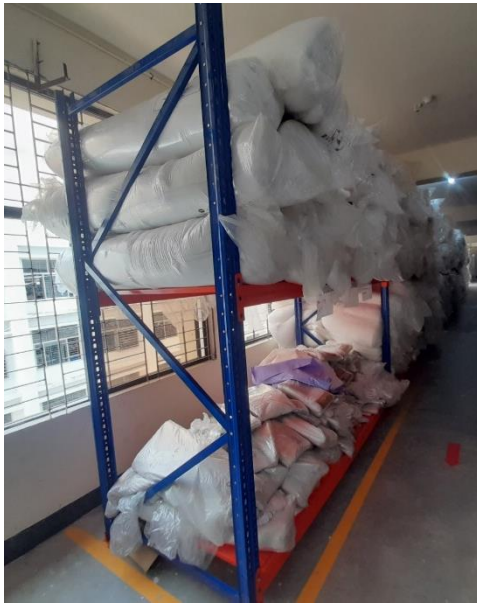
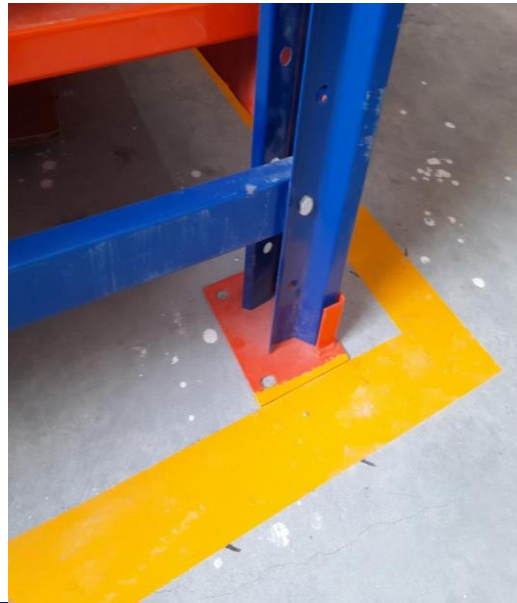
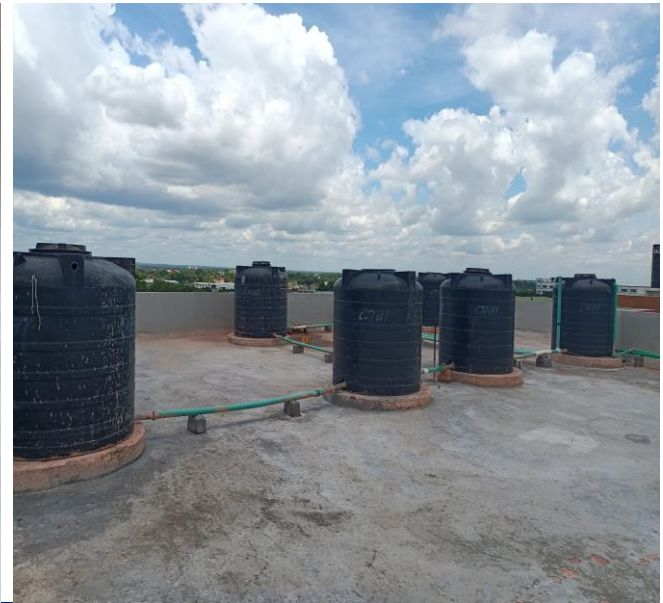
Racks and plastic water tanks not anchored or braced

During inspection lack of anchorage of storage rack and water tank found. Non-structural elements suspended from, attached to, or resting atop the structure shall be adequately anchored and braced to resist earthquake forces.

| Item No. | Observation | Recommended Action Plan | Recommended Timeline |
|---|---|---|---|
| 07 | Racks and plastic water tanks not anchored or braced (Extension Building) | Building engineer is required to take proper measure to provide adequate anchorage and bracing. | 6-weeks |

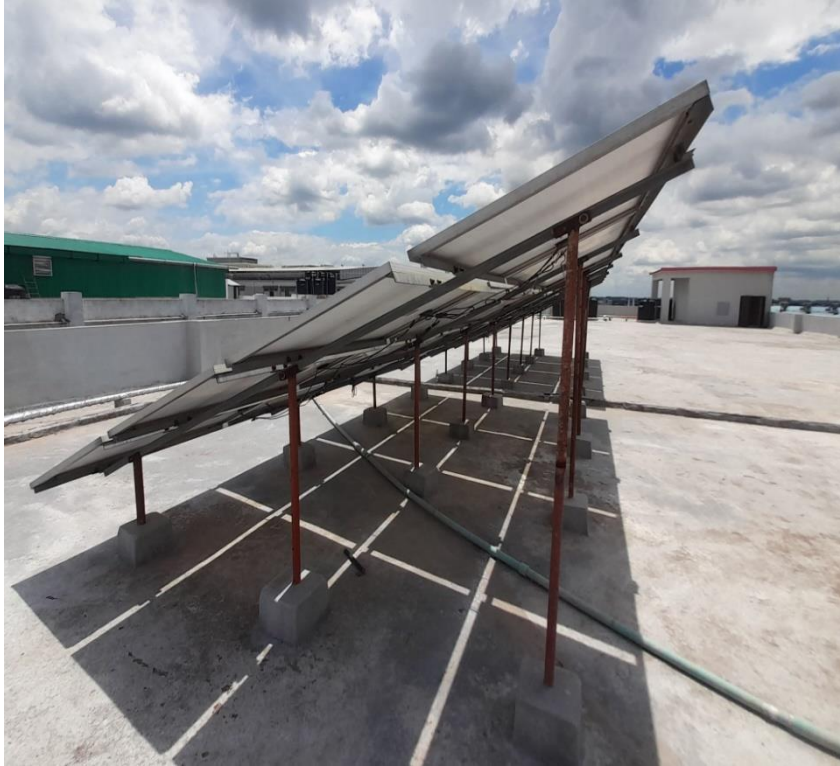
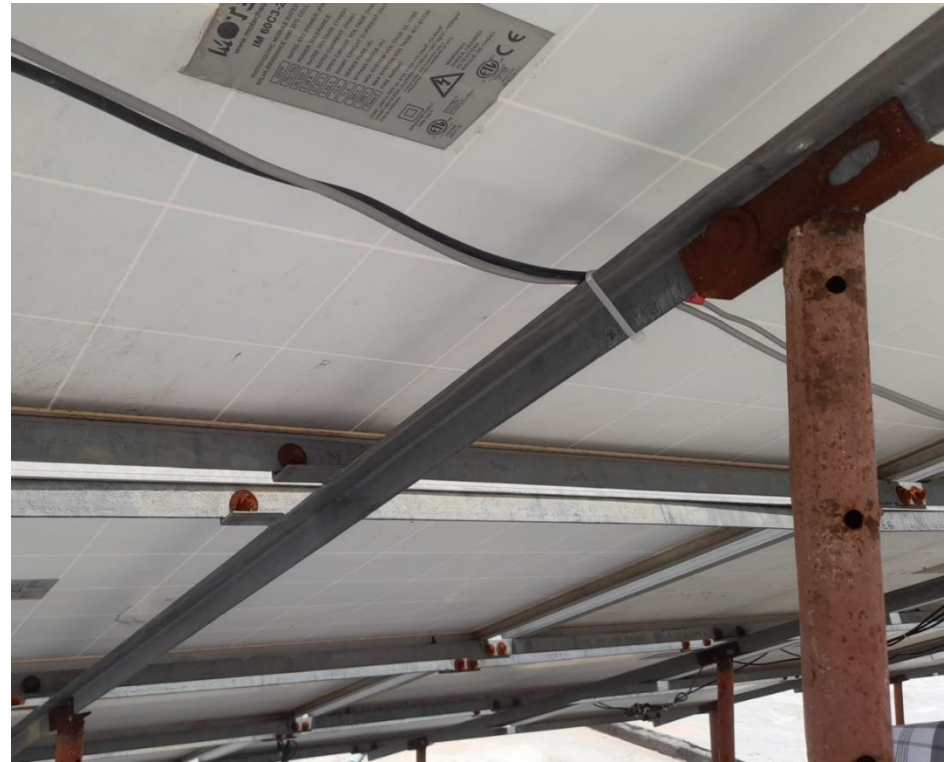
Corrosion was observed on steel members of solar panel support's structure. As well as double bolts were missing in some places.

Building engineer is required to replace the damaged steel members and provide rust proof paint on all steel members to protect from corrosion.

| Item No. | Observation | Recommended Action Plan | Recommended Timeline |
|---|---|---|---|
| 08 | Corrosion on solar panel support's structure (Extension Building) | Building engineer is required to remove the rust and provide anti corrosive paint. | 6-weeks |

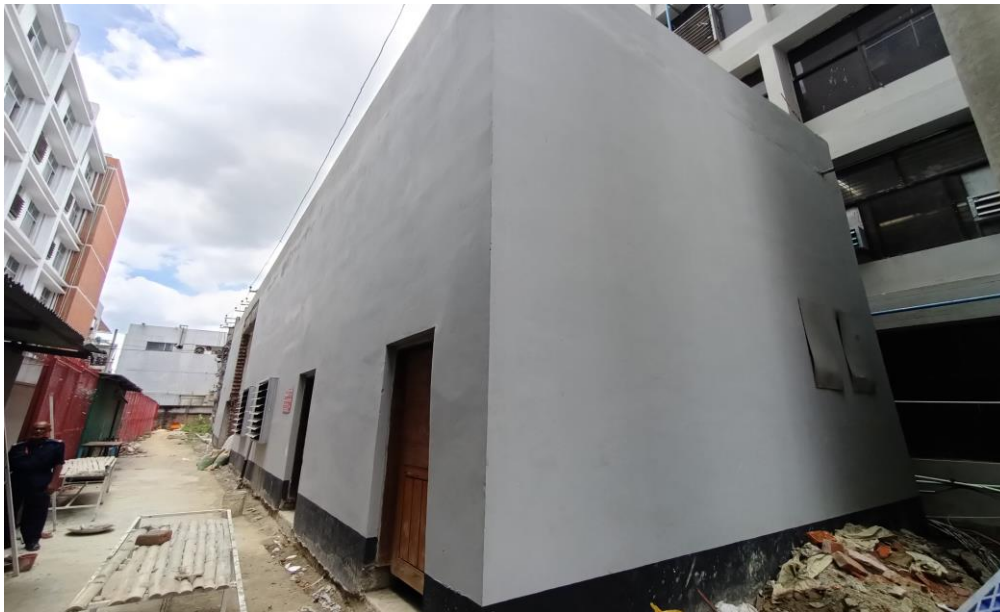
Strength of concrete and rebar considered in design report as 3500 psi and 60000 psi. But no test report was provided in this regards. Moreover, software-based analysis file were not found. Building engineer is required to revised the design report providing all required documents and test reports.

| Item No. | Observation | Recommended Action Plan | Recommended Timeline |
|---|---|---|---|
| 09 | Design report required to be revised (Utility Building) | Building engineer is required revise the design report considering actual size and strength of concrete & steel materials. | 6-weeks |

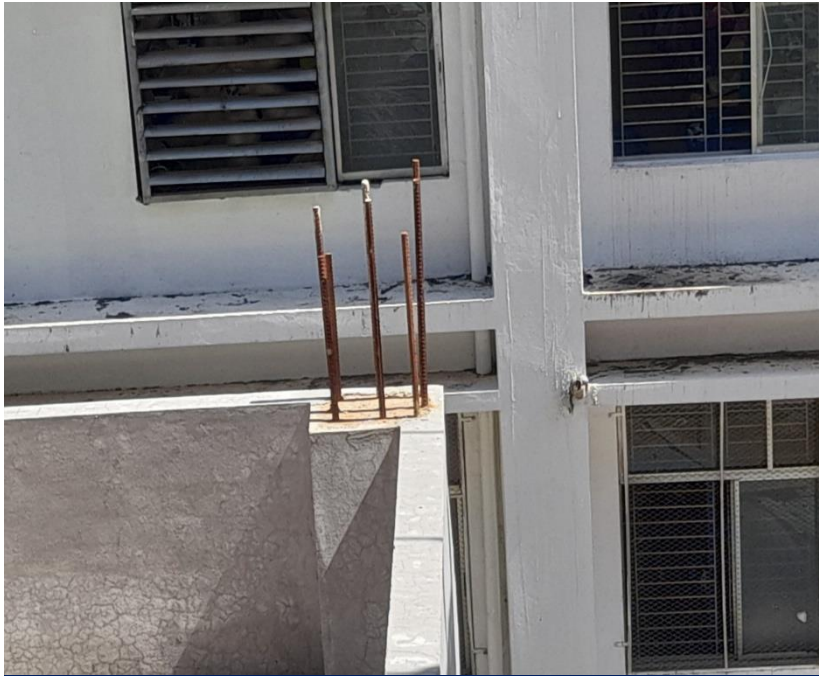
Column exposed reinforcement got rusty

Exposed reinforcement is left which was prone to corrosion. Building engineer is required to provide rust proof paint on exposed reinforcement to protect from corrosion.

| Item No. | Observation | Recommended Action Plan | Recommended Timeline |
|---|---|---|---|
| 11 | Exposed corroded rebar (Utility Building) | Building engineer is required to remove the rust and provide anti corrosive paint. | 6-weeks |

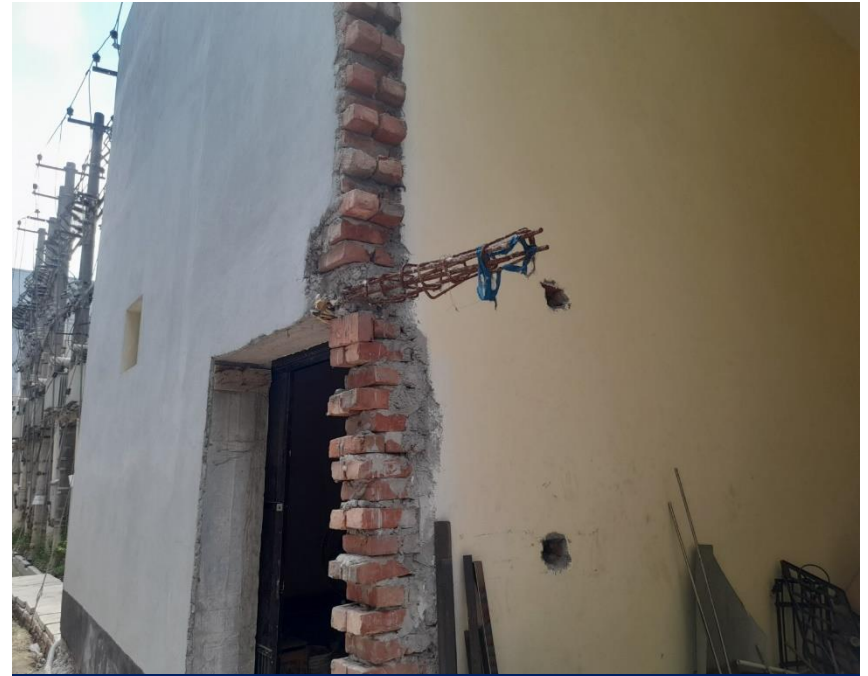
Lintel exposed reinforcement got corroded
