Hydroxide Knitwear Ltd. (Extension)

Mouchak, Kaliakoir, Gazipur, Dhaka
(24.022136, 90.296435)

23 May & 24 July 2023

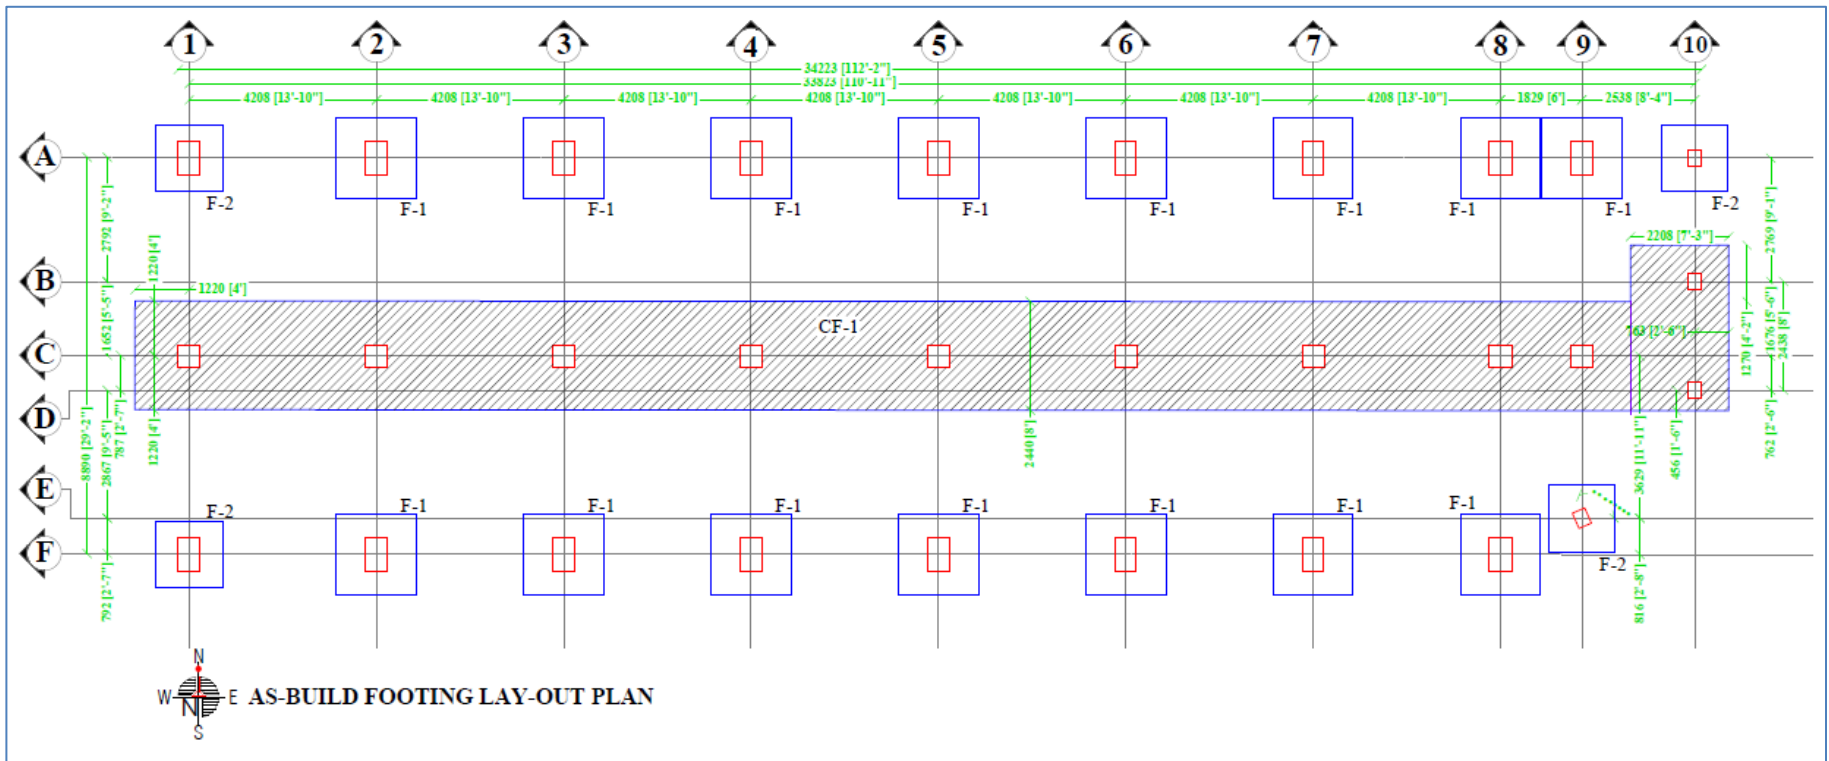
Foundation layout

High stressed footing

Cursory calculation indicates that stress exceeds the normal design limit for edge and corner foundation, considering the floor live load 3kPa, minimum concrete strength based on aggregate type and allowable soil bearing capacity 5.33 T/m². Building engineer is required to review the design, loads and foundation stresses.

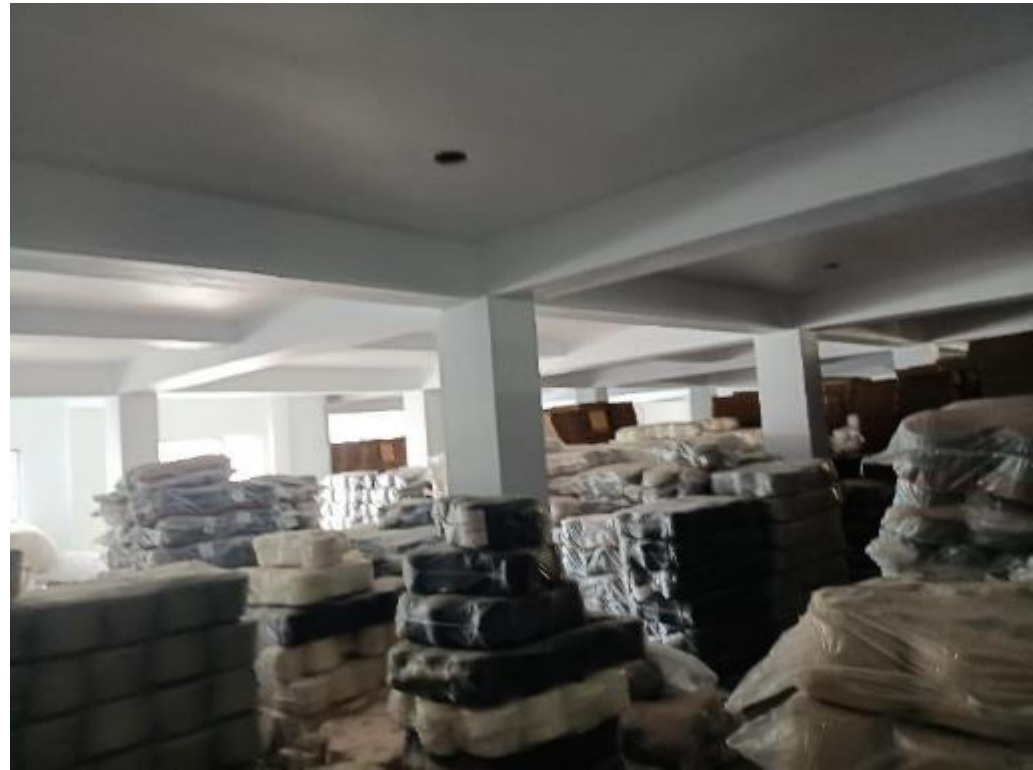
Absence of design documents

As per BNBC, every building or structure designed shall have its design documents prepared in accordance with the provision of Section 1.9.1. The design document shall include a design report, and a set of structural drawings, which shall be prepared in compliance with section 1.9.1.1 and section 1.9.1.2, part-6 of BNBC. At the time of inspection, only as-built drawing found on site, but design report & load plan were not available which are required to be prepared in compliance with section 1.9.1.1 (part-6, BNBC).

No design report was available for Building 5

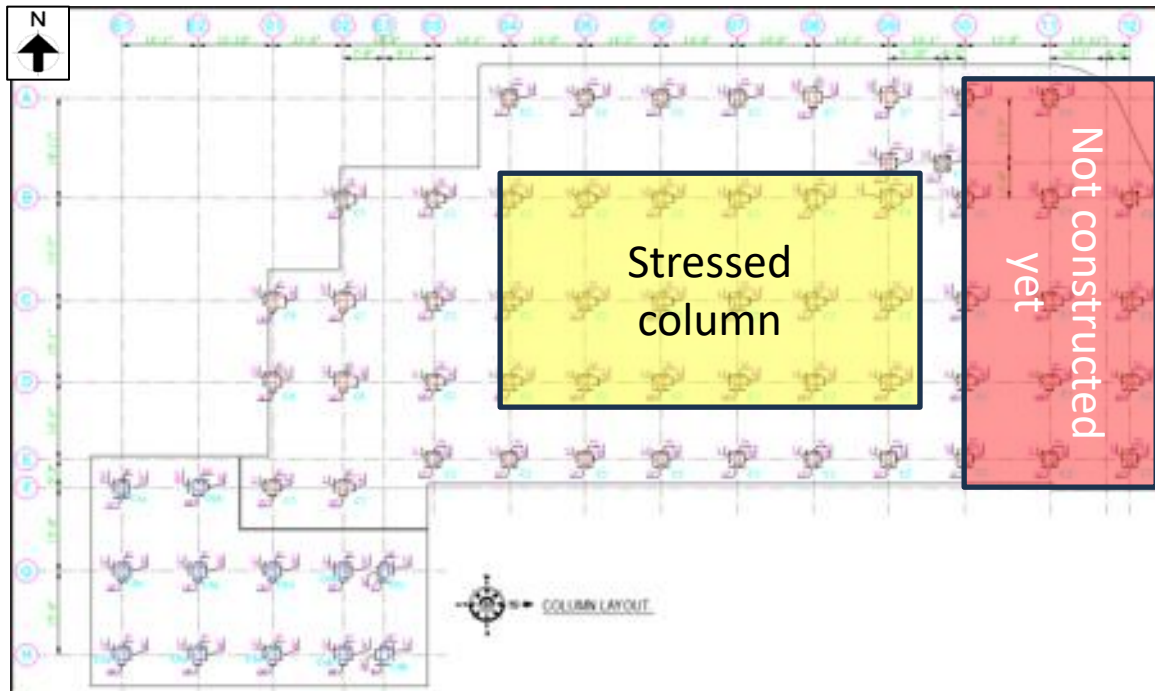
Stressed column/foundation in layout

Possible vertical extension

Cursory calculation indicates the stress in highlighted column in layout will exceed normal design limit for above of 5 storied. Building engineer is required to review, design of column stress in-case of conducting any vertical extension above 5 storied.

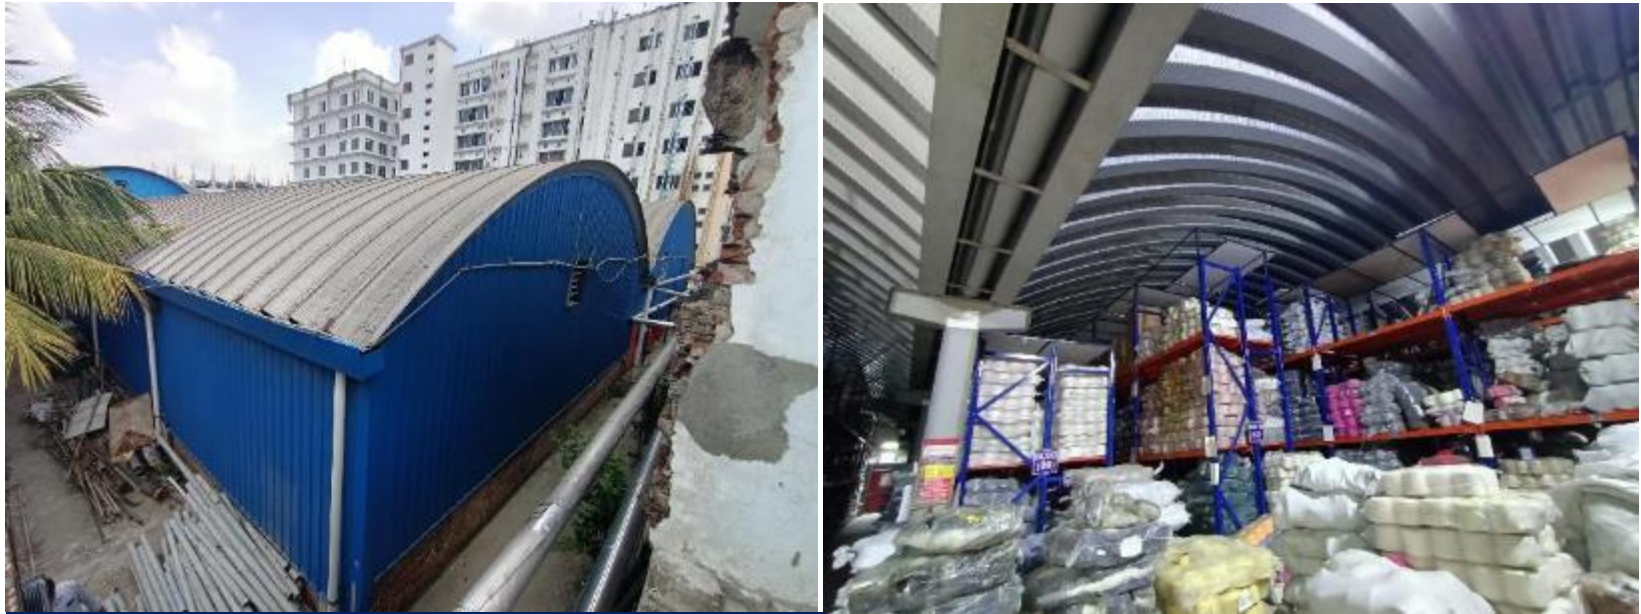
Warehouse Shed

Lack of design report and as-built drawing

As per BNBC, every building or structure designed shall have its design documents prepared in accordance with the provision of Section 1.9.1. The design document shall include a design report, and a set of structural drawings, which shall be prepared in compliance with section 1.9.1.1 and section 1.9.1.2, part-6 of BNBC. At the time of inspection, no design report and as-built drawing was available which are required to be prepared in compliance with section 1.9.1.1 (part-6, BNBC).

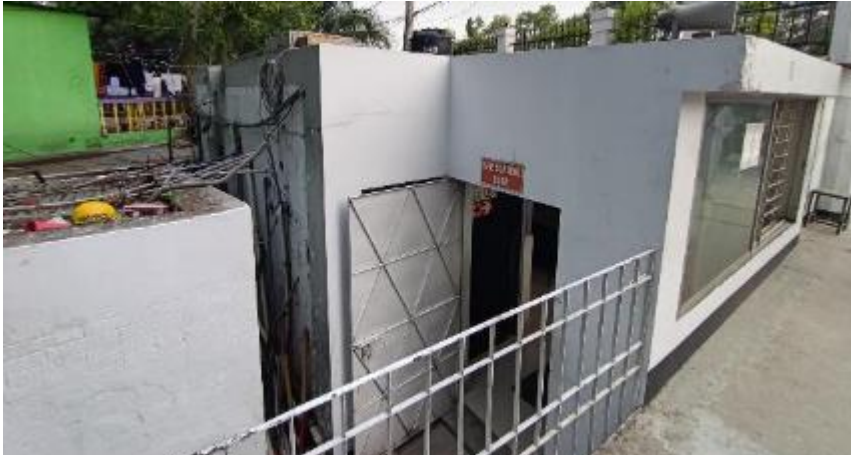
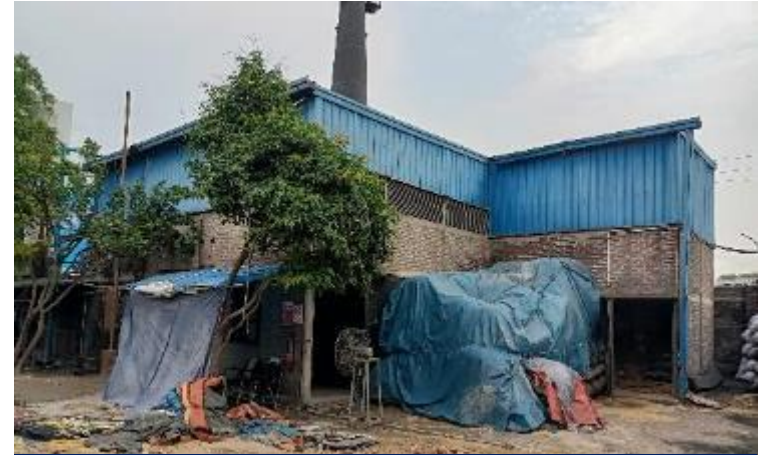
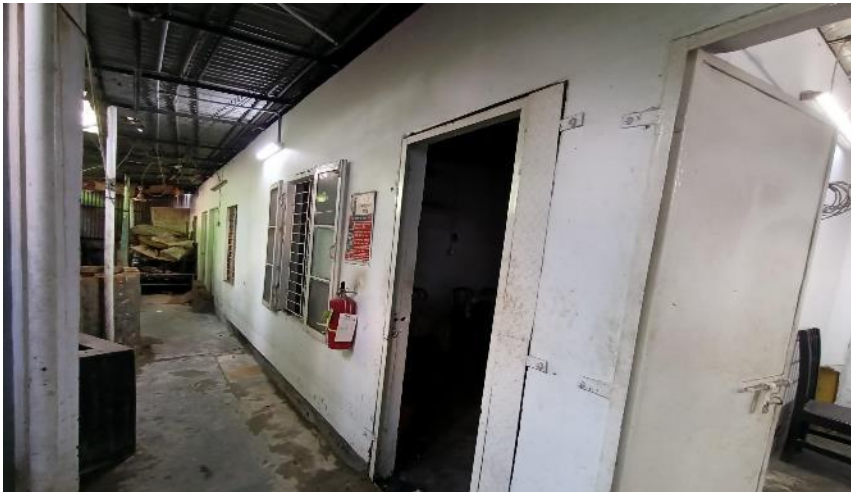
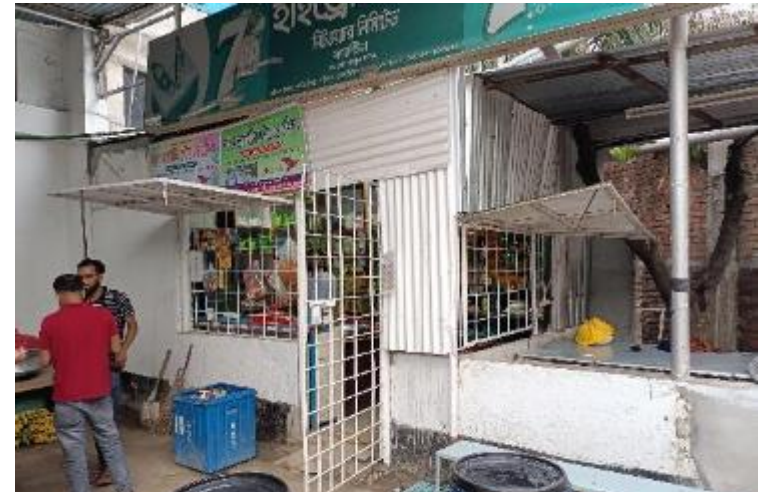
Lack of drawings-Structural & Architectural

As-built drawings were not found for the mentioned structures (Building-6, Shed-4, Shed-9 & Shed-10). The building engineer to survey the structure and prepare as-built structural drawings with clear connection details.

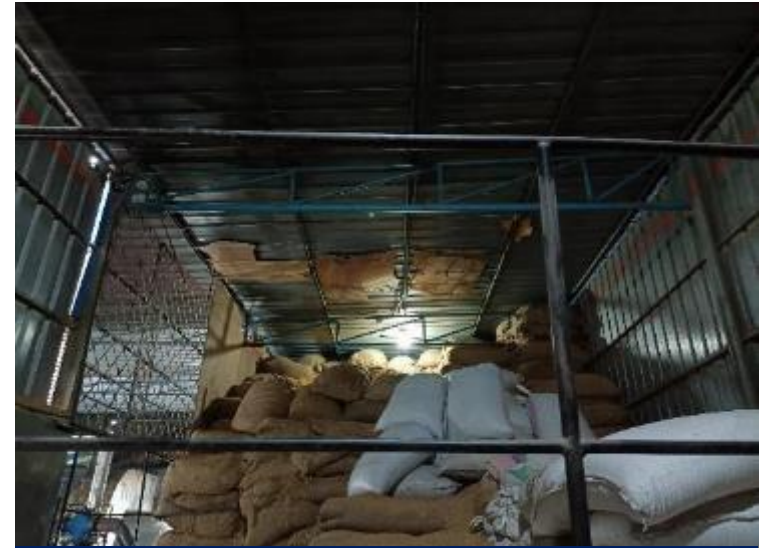
Shed-04 (Husk Boiler)

Apparently inadequate connection

Apparently inadequate connection was observed at the lightweight roof of these Shed. The building engineer to check the connection adequacy of the lightweight roof against the uplift pressure of wind.

Item No.	Observation	Recommended Action Plan	Recommended Timeline
14	Apparently inadequate connection. (Shed 04, 09 & 10)	Building engineer is required to check the connection of the steel shed for the uplift pressure of wind.	6-weeks
15	Apparently inadequate connection. (Shed 04, 09 & 10)	Complete implementation of remedial works if required.	6-months
16	Absence of permit drawing from local authority. (Building-5, Building-6, Shed-1, Shed-4, ETP, Shed-9 and Shed-10)	Building engineer is required to seek and collect approval from the local authority.	6-months

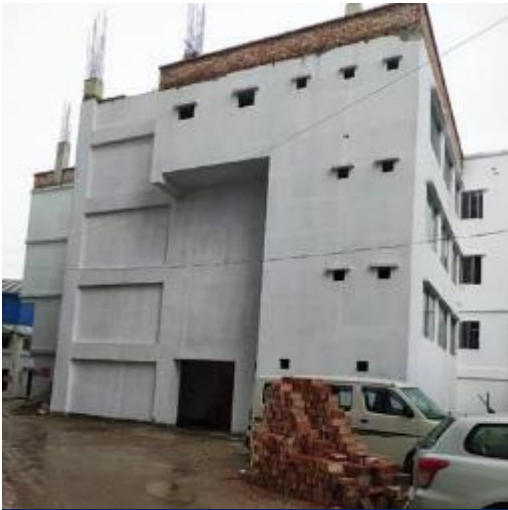
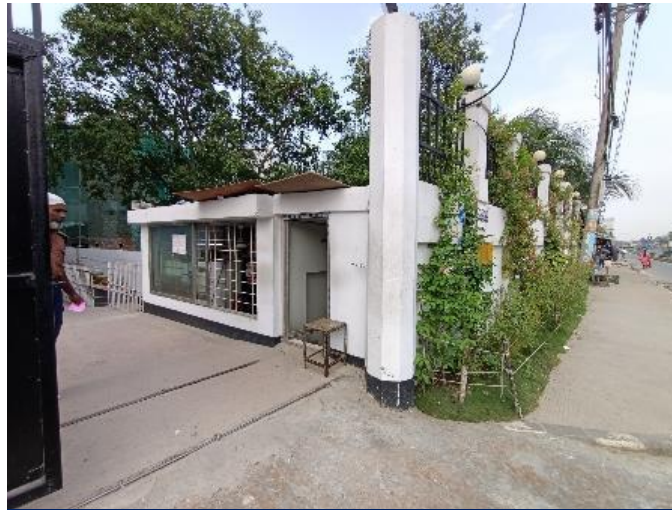
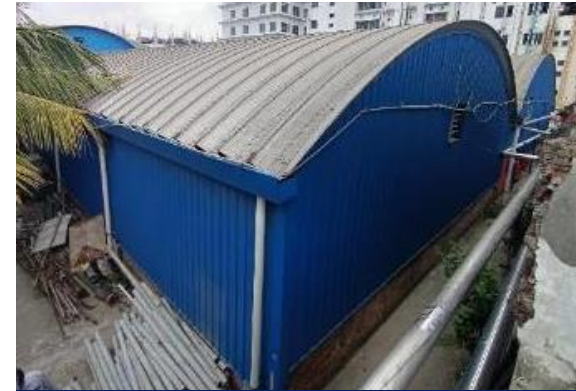
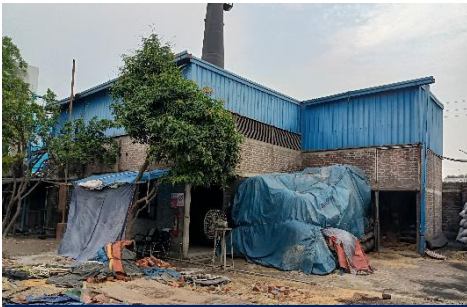
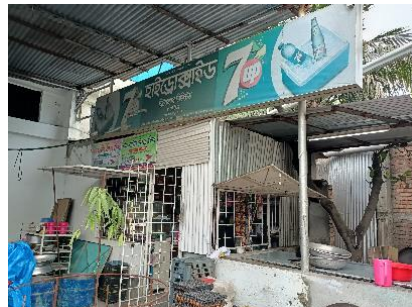
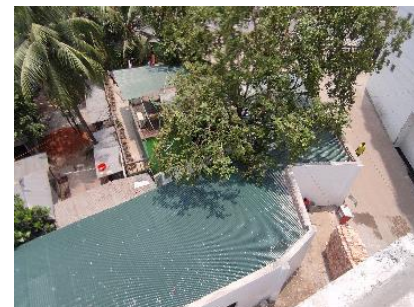
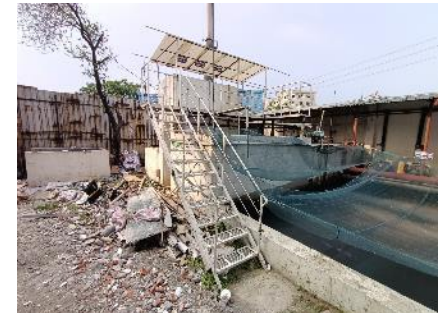
Absence of permit drawing local authority

At the time of inspection, no approval drawing from local authority was available for the above-mentioned structures. Building engineer is required to seek approval from the local authority.
