# EUROTEX KNITWEAR LTD. (Extension)

Nayamati, Kutubpur, Fatullah, Narayanganj-1400  
(23.649037, 90.501637)  
13 August 2023

# Building Information

1. Building-4 (Storage Building) is a six storied (G+5) reinforced concrete (RC) structure.
2. Building-5 (Dyeing Finishing 2) is a five storied (G+4) RC structure.

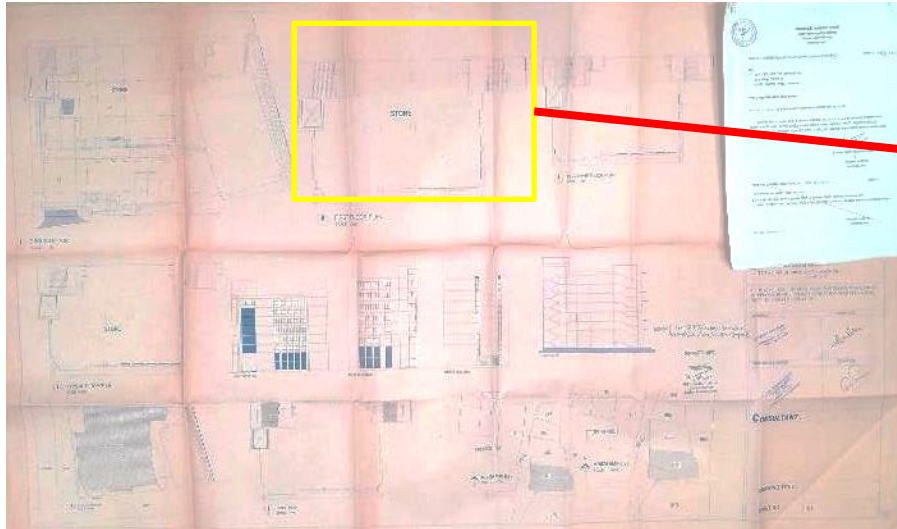
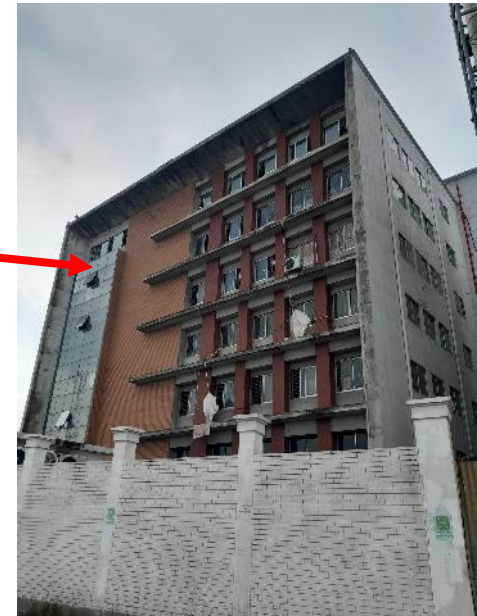
Building 4

As per BNBC, every building or structure designed shall have its design documents prepared in accordance with the provision of Section 1.9.1. The design document shall include a design report and a set of structural drawings which shall be prepared in compliance with section 1.9.1.1 and section 1.9.1.2, part-6 of BNBC. During inspection, design report was not found which is required to be prepared in compliance with section 1.9.1.1, part-6 of BNBC.

| Item No. | Observation | Recommended Action Plan | Recommended Timeline |
|---|---|---|---|
| 01 | Absence of design documents (Building 4) | Building engineer is required to prepare design report as per BNBC, part-6, Section-1.9.1. | 6-weeks |
| 02 | Absence of design documents (Building 4) | Produce and actively manage a loading plan for all floor plates within the factory consideration to floor capacity and column capacity. | 6-weeks |
| 03 | Absence of design documents (Building 4) | Complete implementation of any remedial works deemed necessary by design report (if required). | 6-months |

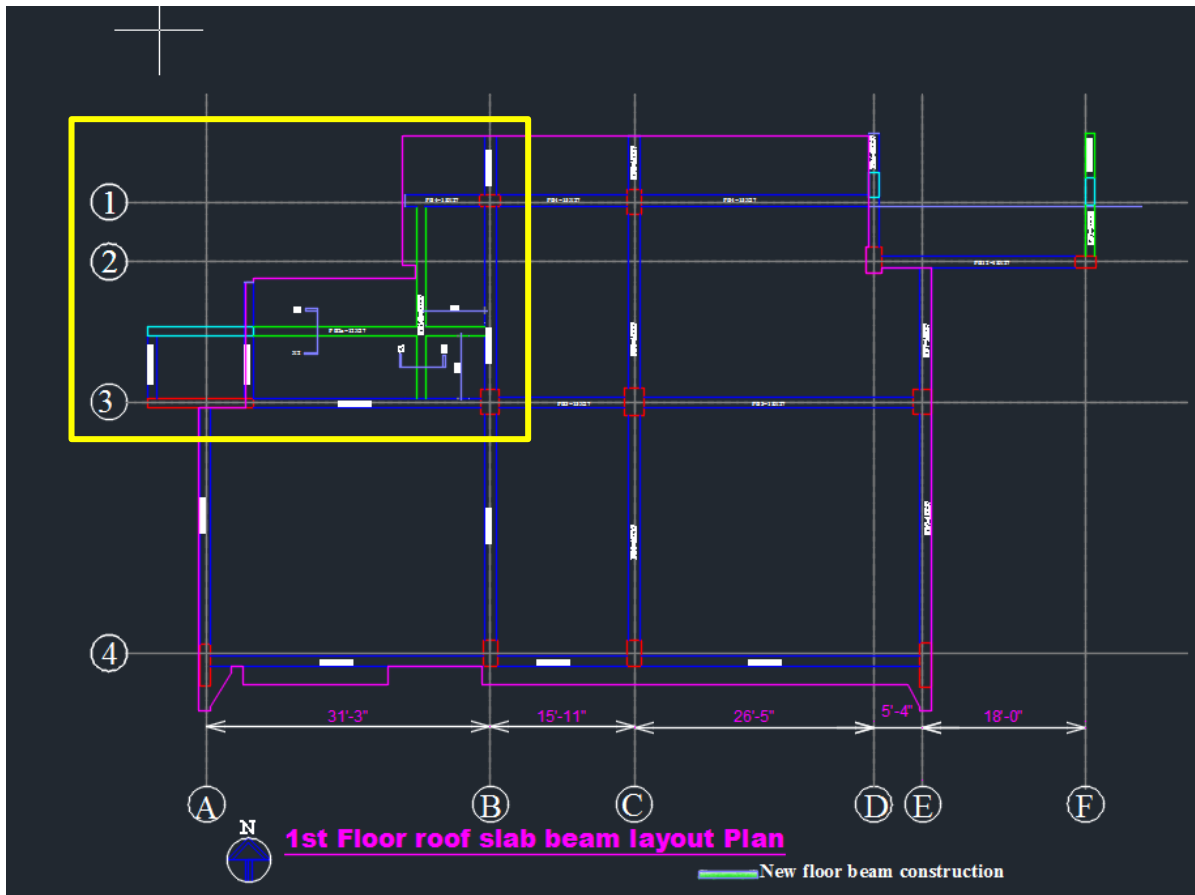
The marked beam cut to separate the buildings and the beams became cantilever beam. The building engineer is required to check the reinforcement of the beam & review the design.

| Item No. | Observation | Recommended Action Plan | Recommended Timeline |
|---|---|---|---|
| 04 | Design review of cantilever beam (Building 4) | Building engineer is required to review the design of cantilever beams and suggest necessary remedial measures. | 6-weeks |

| Item No. | Observation | Recommended Action Plan | Recommended Timeline |
|---|---|---|---|
| 05 | Design review of cantilever beam (Building 4) | Carry out suggested remedial works if required. | 6-months |

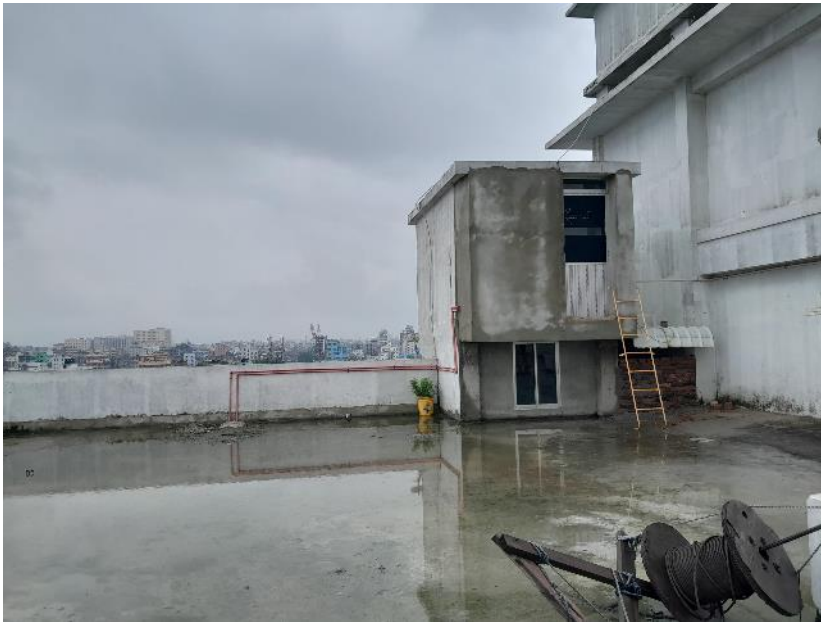
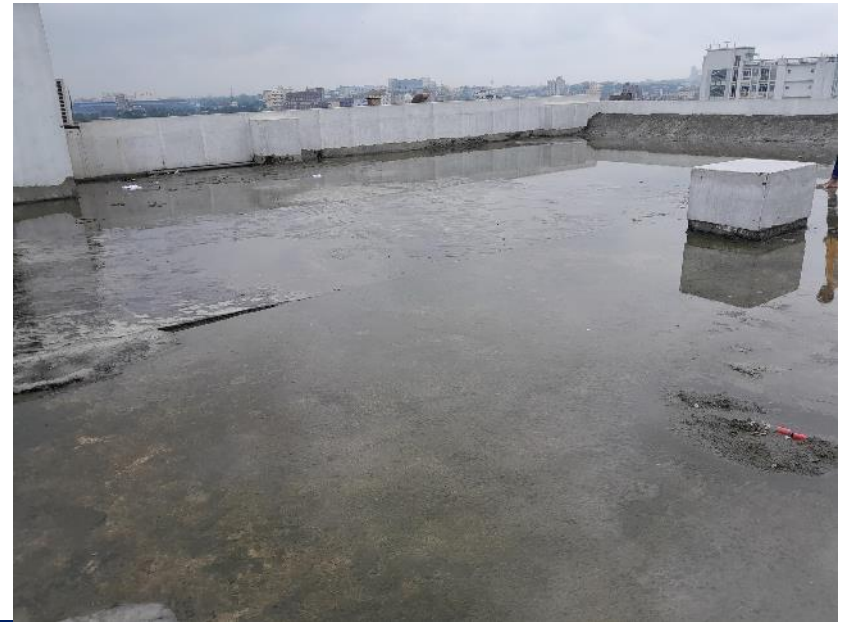
**Observation: Building 4**

Water ponding was found at roof floor due to rainwater.

Building engineer is required to provide adequate drainage system to avoid water ponding on the roof.

| Item No. | Observation | Recommended Action Plan | Recommended Timeline |
|---|---|---|---|
| 06 | Poor roof drainage system. (Building 4) | Building engineer is required to develop adequate drainage system to avoid water ponding on the roof. | 6-months |

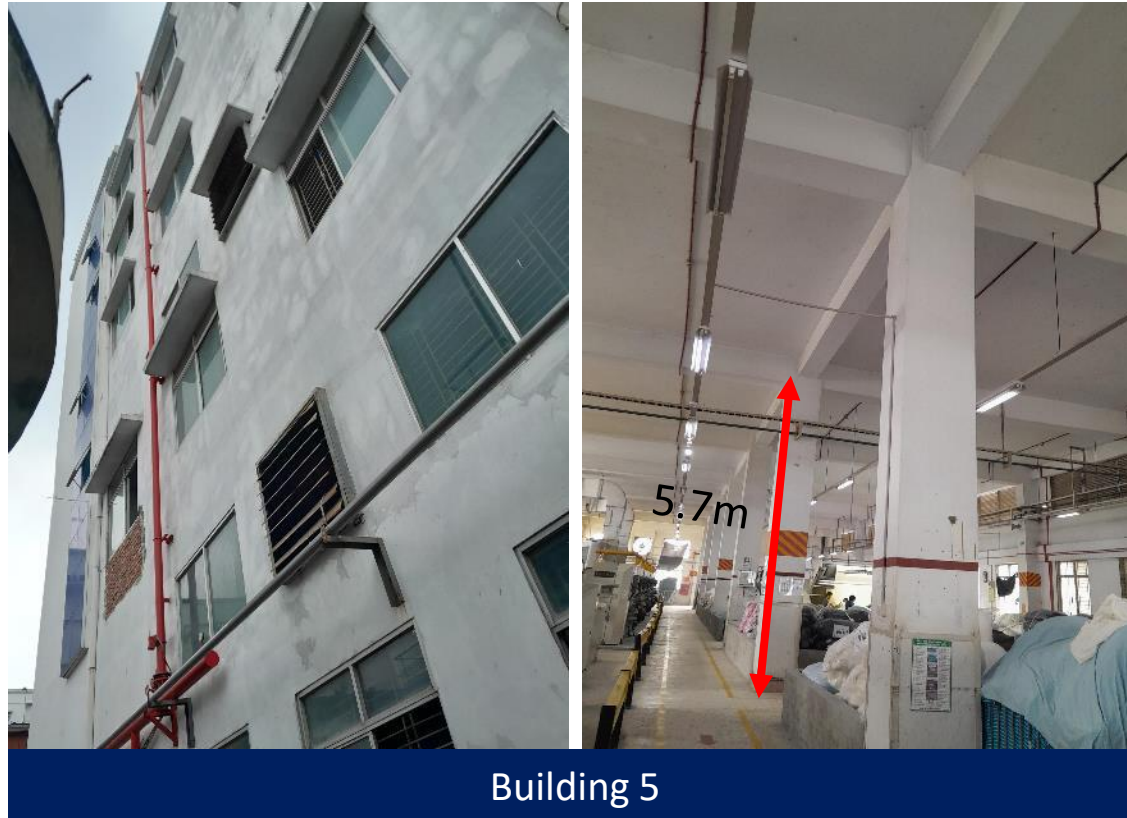
As per BNBC, every building or structure designed shall have its design documents prepared in accordance with the provision of Section 1.9.1. The design document shall include a design report and a set of structural drawings which shall be prepared in compliance with section 1.9.1.1 and section 1.9.1.2, part-6 of BNBC.

During inspection design report was not found which is required to be prepared in compliance with section 1.9.1.1, part-6 of BNBC. The lateral stability check must be included in the design report.

| Item No. | Observation | Recommended Action Plan | Recommended Timeline |
|---|---|---|---|
| 07 | Absence of design documents (Building 5) | Building engineer is required to prepare design report as per BNBC, part-6, Section-1.9.1. | 6-months |
| 08 | Absence of design documents (Building 5) | Produce and actively manage a loading plan for all floor plates within the factory consideration to floor capacity and column capacity. | 6-weeks |
| 09 | Absence of design documents (Building 5) | Complete implementation of any remedial works deemed necessary by design report (If required). | 6-months |

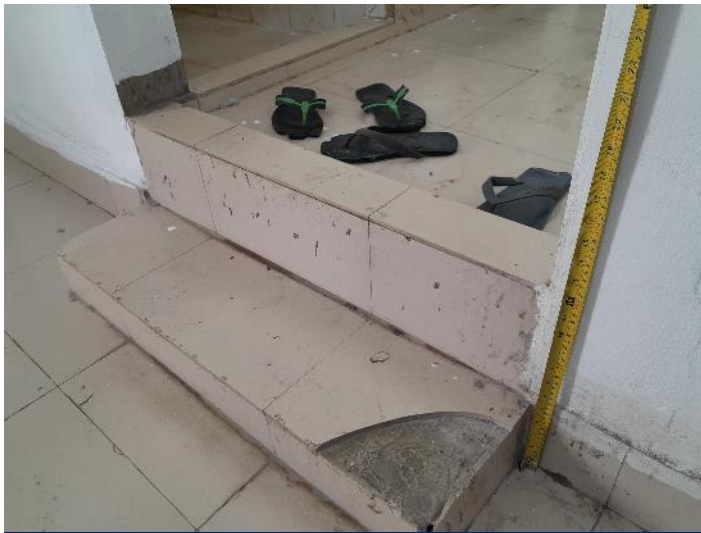
Onsite toilet build-up

During inspection, difference found between architectural layout drawing and onsite floor use. Also, 250 mm build-up at toilet area was not shown in as-built drawing. Building engineer is required to survey the full building and update the as-built drawing accurately.

| Item No. | Observation | Recommended Action Plan | Recommended Timeline |
|---|---|---|---|
| 10 | Inconsistency in as-built drawing. (Building 5) | Building engineer is required to survey the structure and prepare accurate as-built drawing. | 6-weeks |

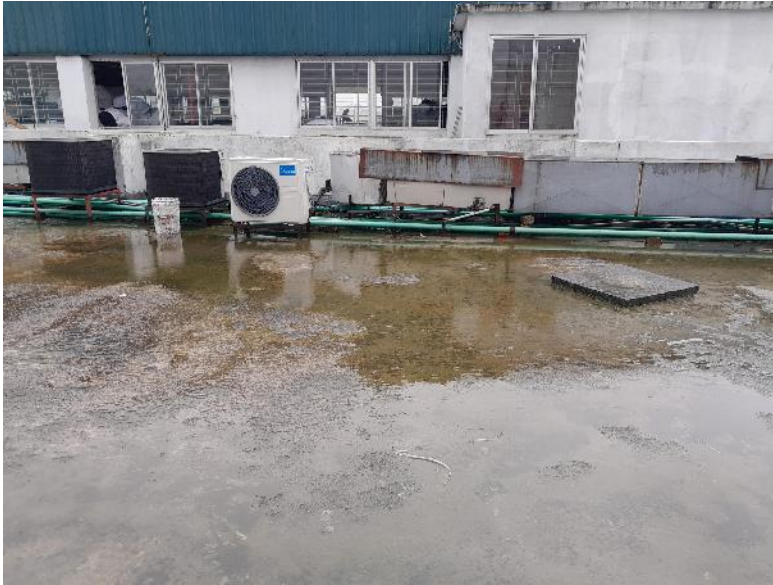
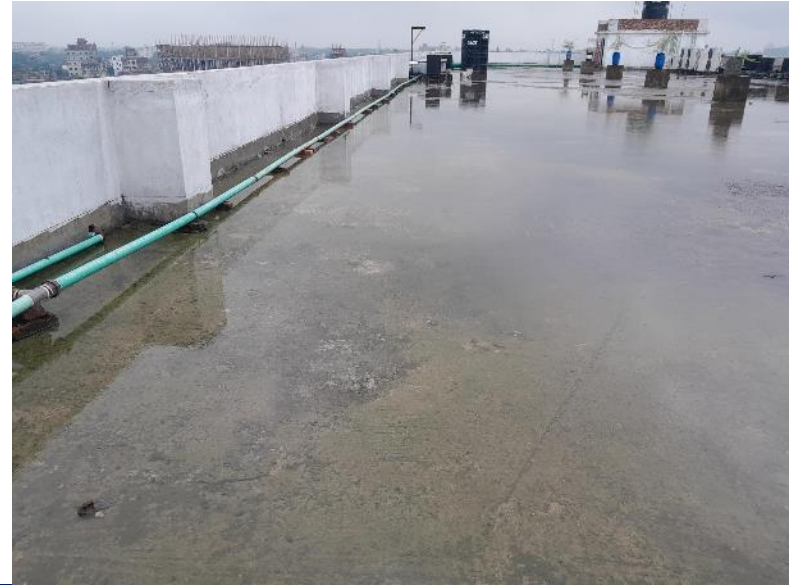
**Observation: Building 5**

Water ponding was found at roof floor due to rainwater.

Building engineer is required to provide adequate drainage system to avoid water ponding on the roof.

| Item No. | Observation | Recommended Action Plan | Recommended Timeline |
|---|---|---|---|
| 11 | Poor roof drainage system. (Building 5) | Building engineer is required to develop adequate drainage system to avoid water ponding on the roof. | 6-months |

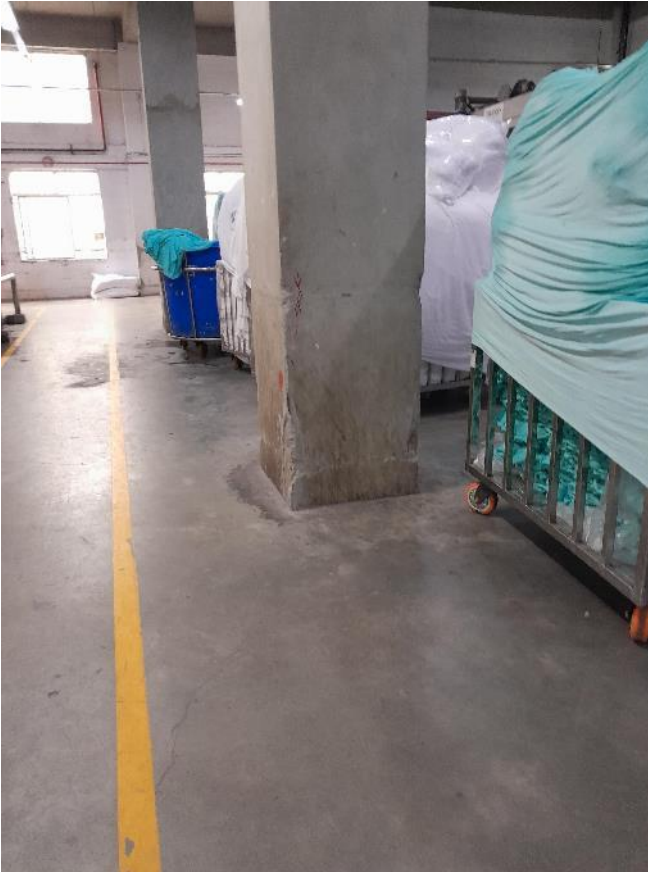
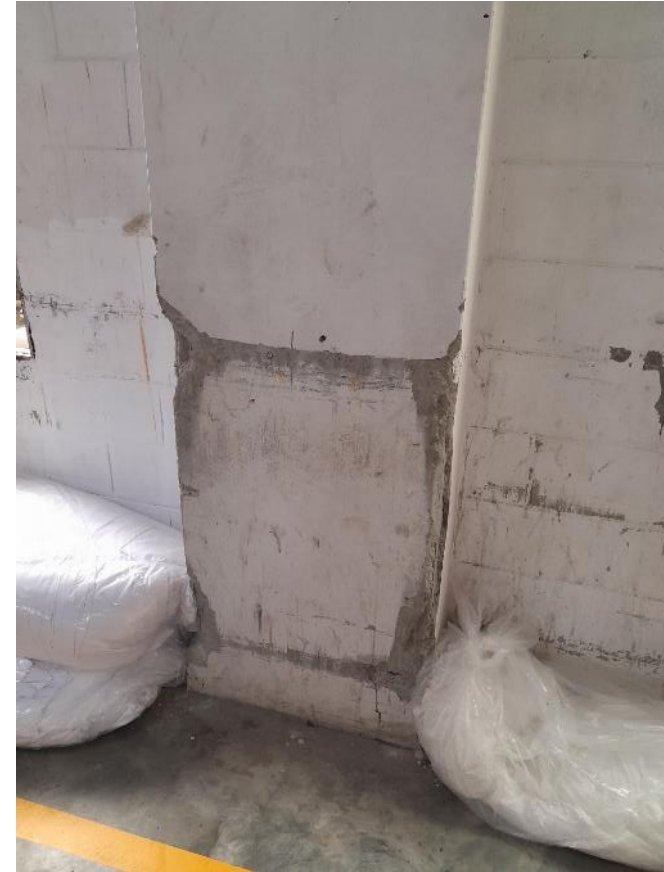
**Observation: Building 4 & 5**

Damage RC column due to trolley Impact

During inspection, damage RC column observed due to trolley Impact. The factory is required to repair the column surface and provide barrier around the RC column to avoid possible trolley impact.

| Item No. | Observation | Recommended Action Plan | Recommended Timeline |
|---|---|---|---|
| 12 | RC Column susceptible for trolley Impact. (Building 4 & 5) | The factory is required to repair damage column surface and provide barrier around the RC column to avoid possible trolley impact. | 6-months |

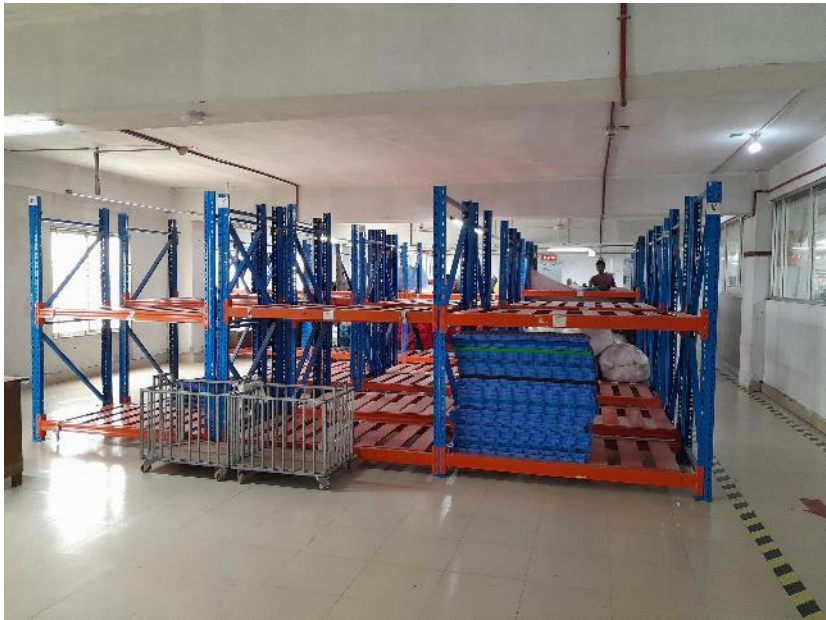
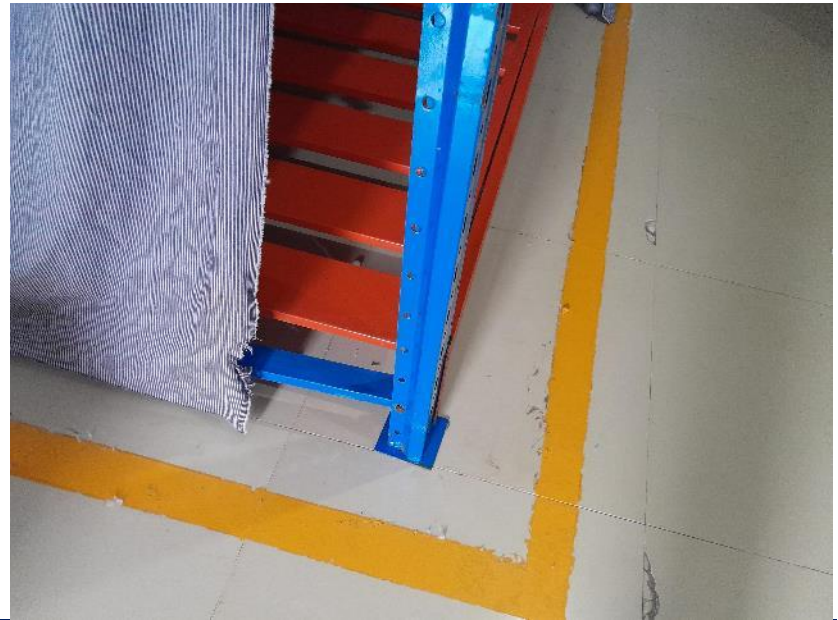
Lack of anchorage/brace of storage racks

During inspection lack of anchorage/brace of storage racks found on Building 4 & 5. The factory is required to brace/anchor all the non-structural elements including storage racks.

| Item No. | Observation | Recommended Action Plan | Recommended Timeline |
|---|---|---|---|
| 13 | Lack of anchorage of storage racks (Building 4 & 5) | The factory is required to brace/anchor all the unbraced non-structural elements including storage racks. | 6-months |
