Ayesha Clothing Company Ltd.

(Printing Unit -2)

14 August 2023

Observations

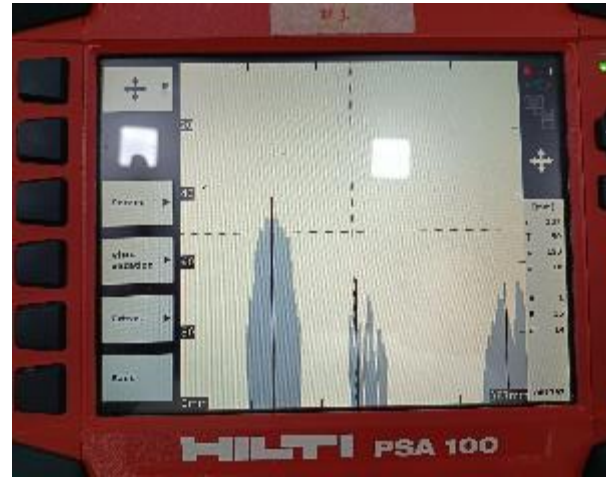
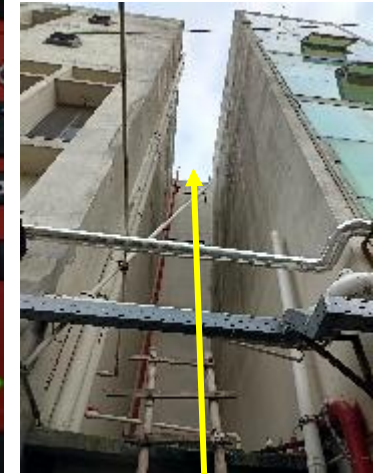
COLUMN SCHEDULE OF NEW COLUMN

Number of rebar at C-7 column found less than the drawings. At shorter face 3 nos of rebar was found whereas drawings shows 4 nos. Also, beam Layouts are not fully matched with site condition. Mismatches are shown in red on the beam layout.

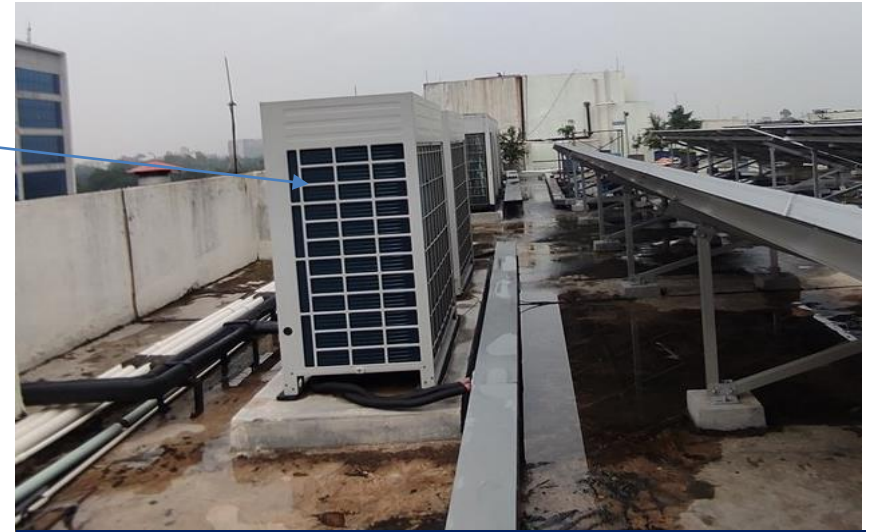
BTS room and AC outdoors were not shown in the roof layout and load plan. Building engineer is required to revise the survey the as-built condition and prepare full set of as-built drawings. Also, update the design report addressing the mismatches and applying the additional load of BTS room & AC outdoors.

AC outdoors

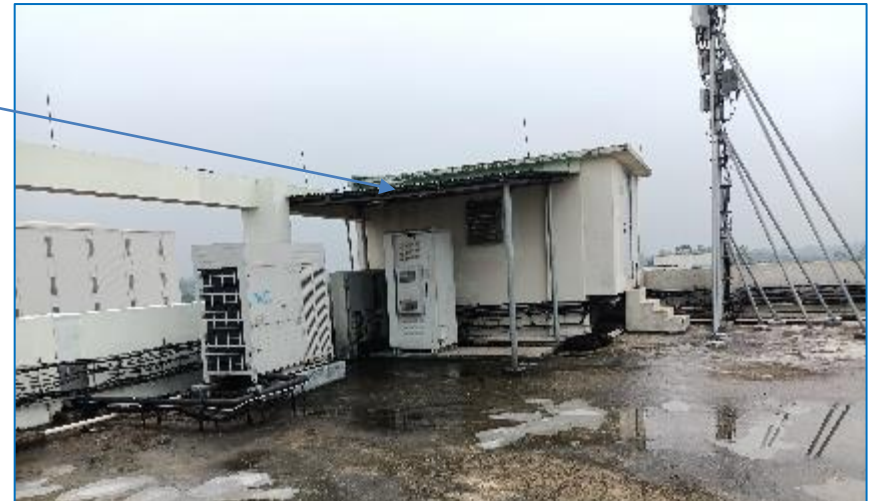
BTS room

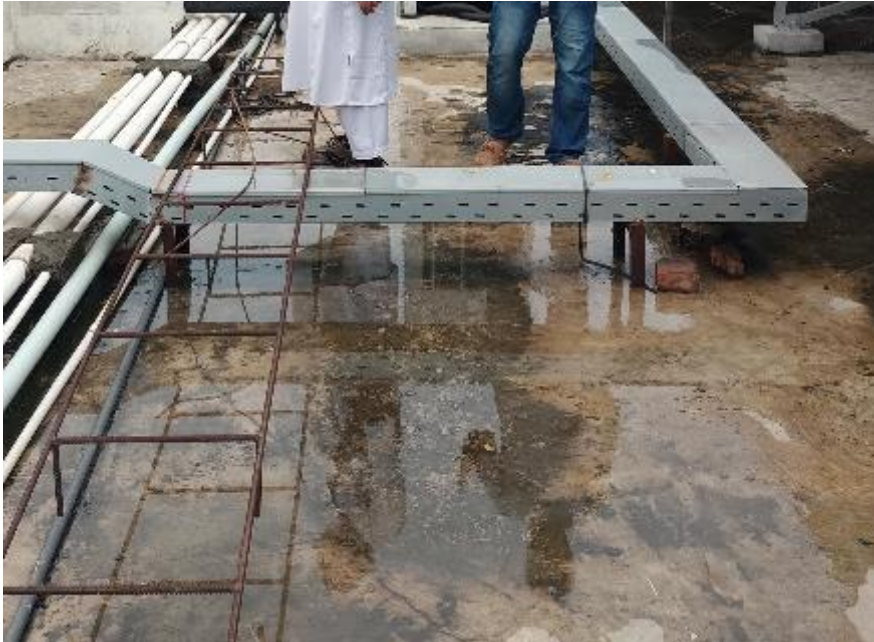
Water ponding at roof

Dampness at ceiling and water ponding at roof was observed during inspection at Building L.

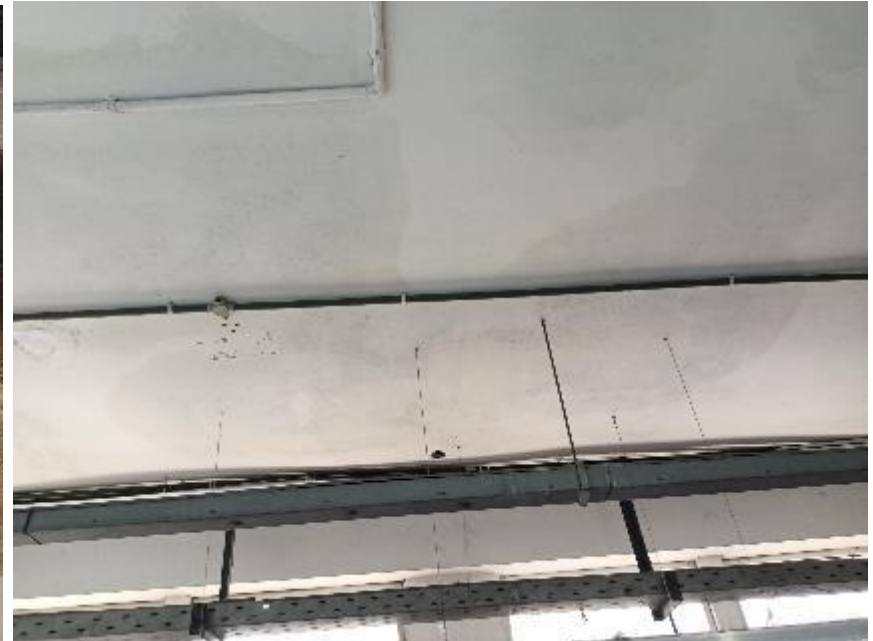
Dampness on slab soffit

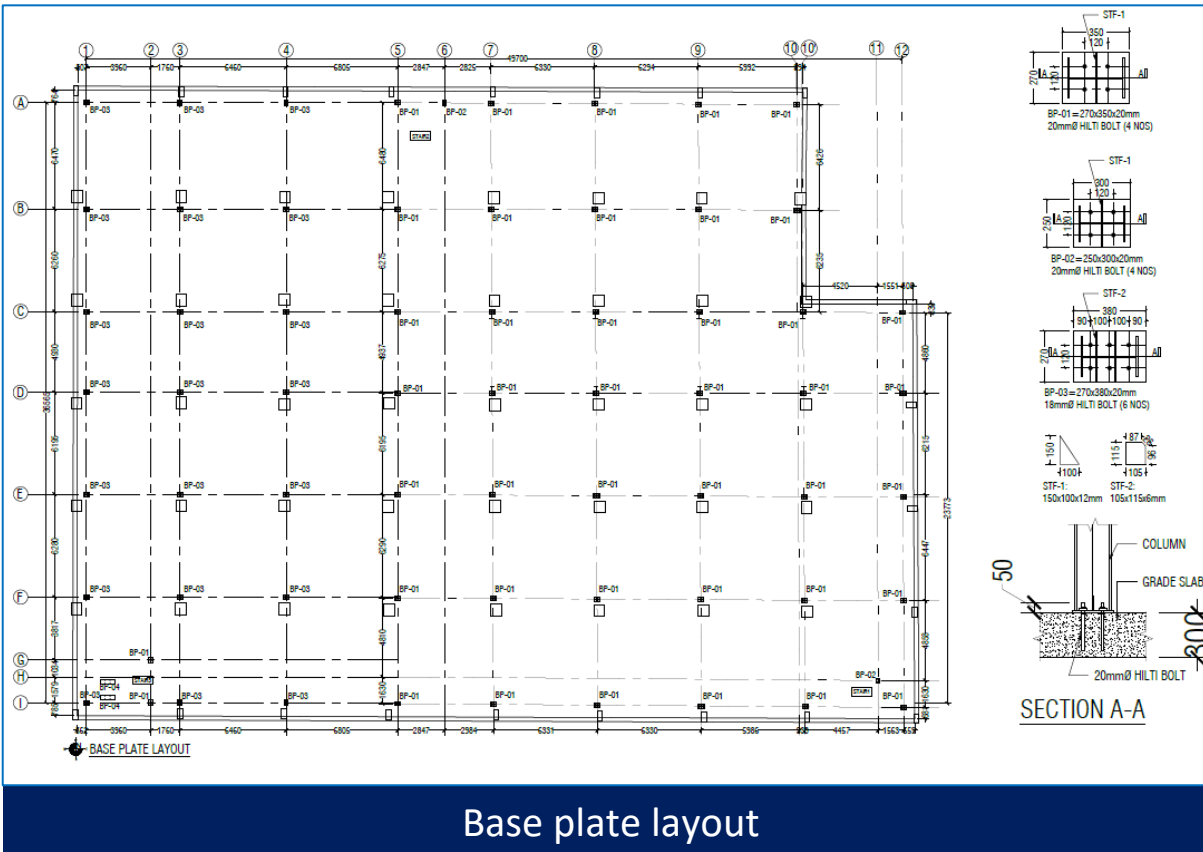
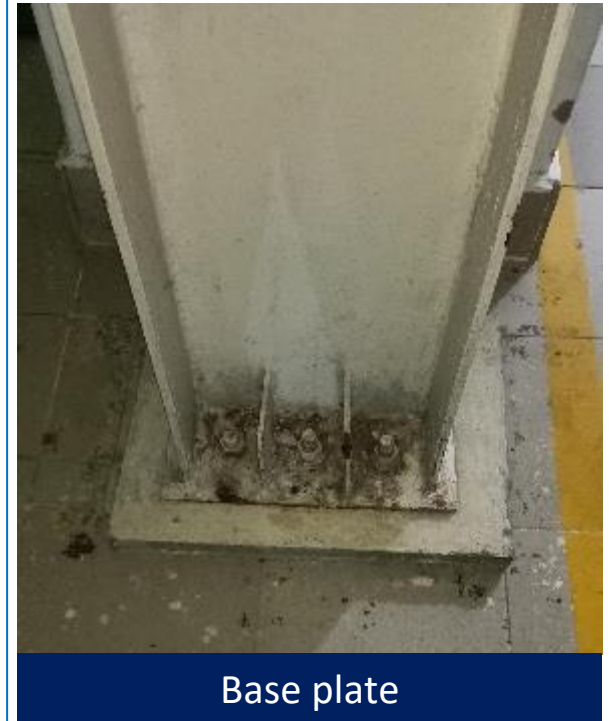
Foundation details of the steel structure not mentioned in the drawings. Building engineer is required to check the foundation system and bearing/punching capacity of foundation of the steel structure.

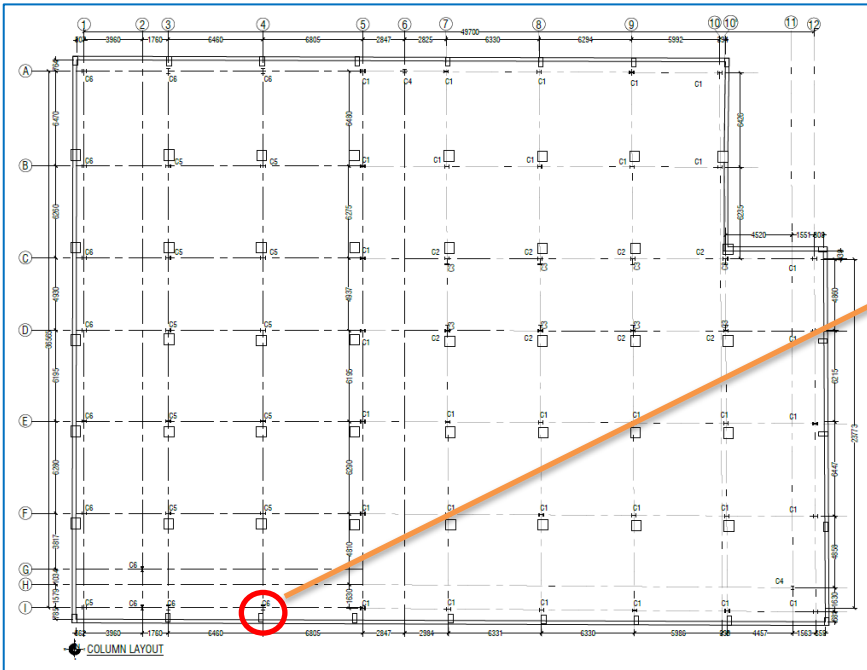
Column Layout

A distorted steel column found on ground floor at steel mezzanine. Stability for the distorted columns and related elements need to be checked. Factory Engineer to review design, loads and column stress in the area identified above.

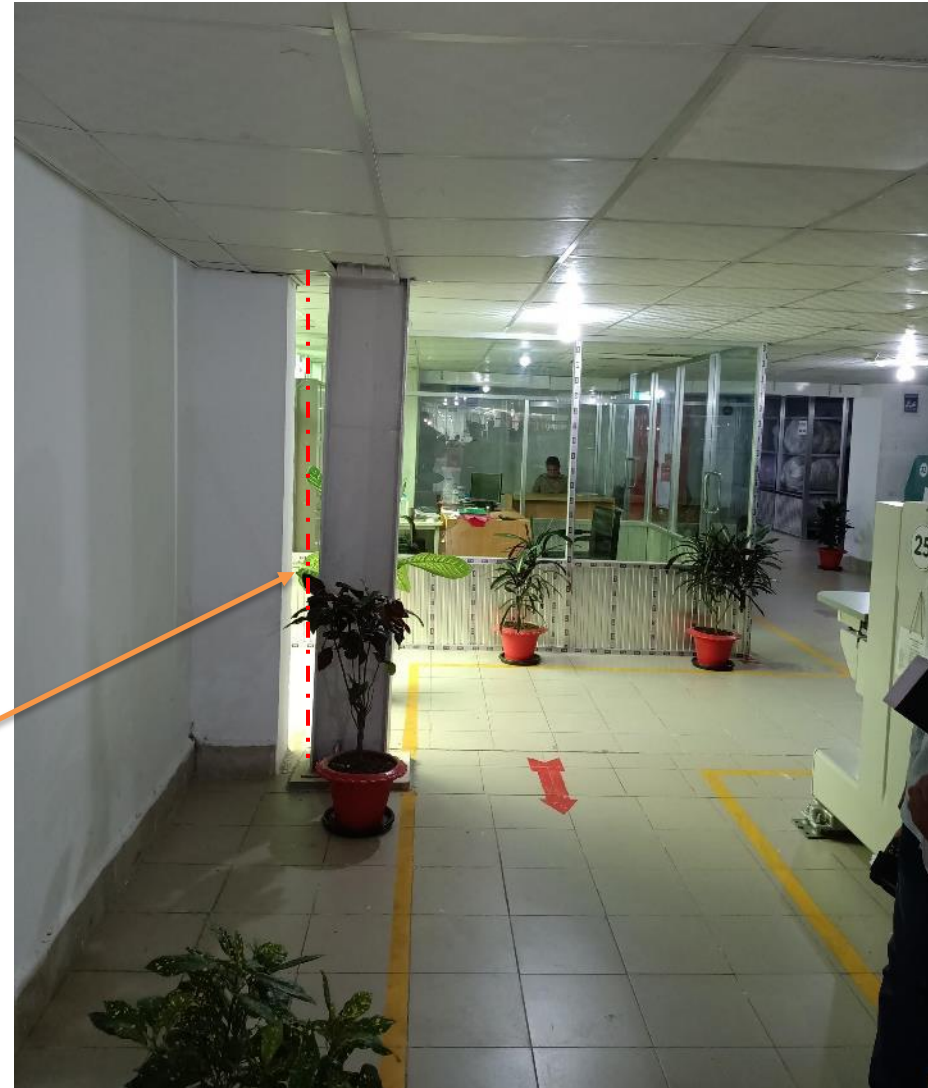
Distorted steel column

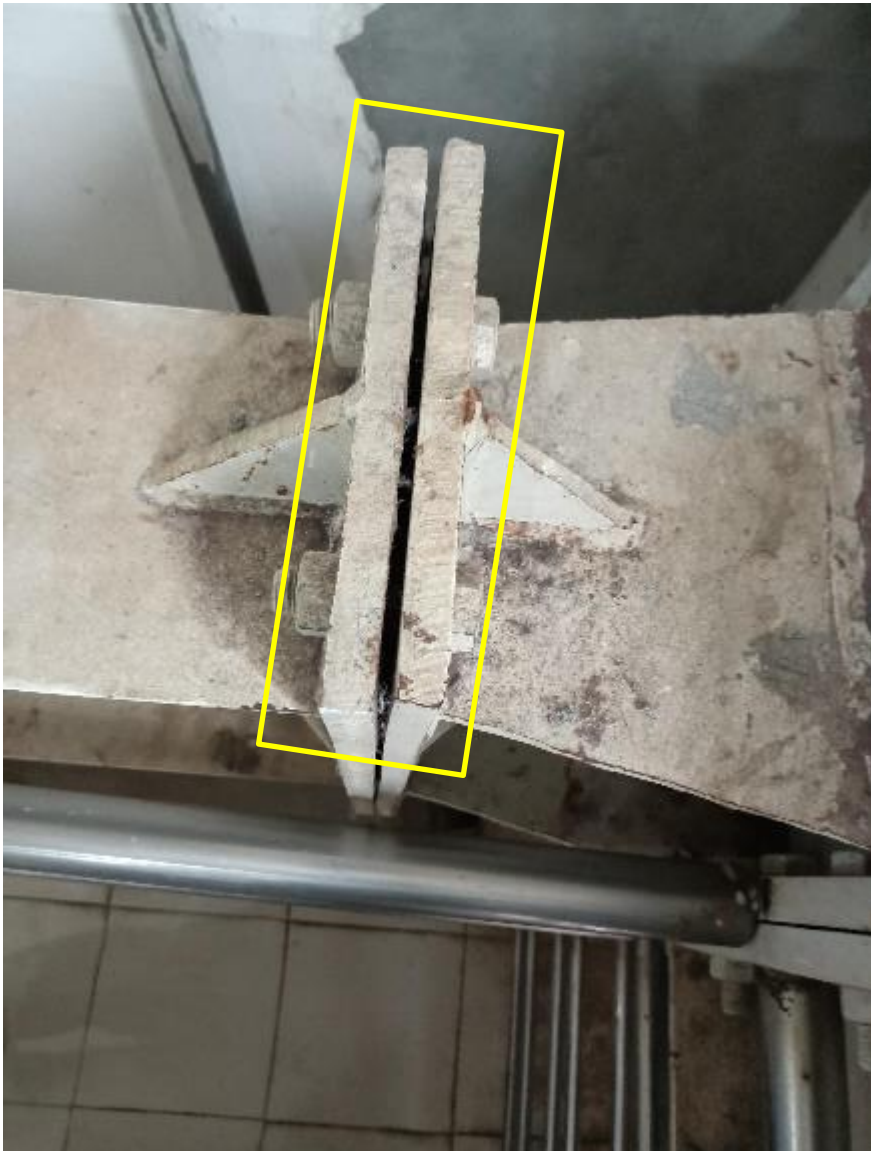
Gap observed in connections

Nut missing and significant gaps observed in beam joint at several locations. Building engineer is required to carry out suitable remedial works.

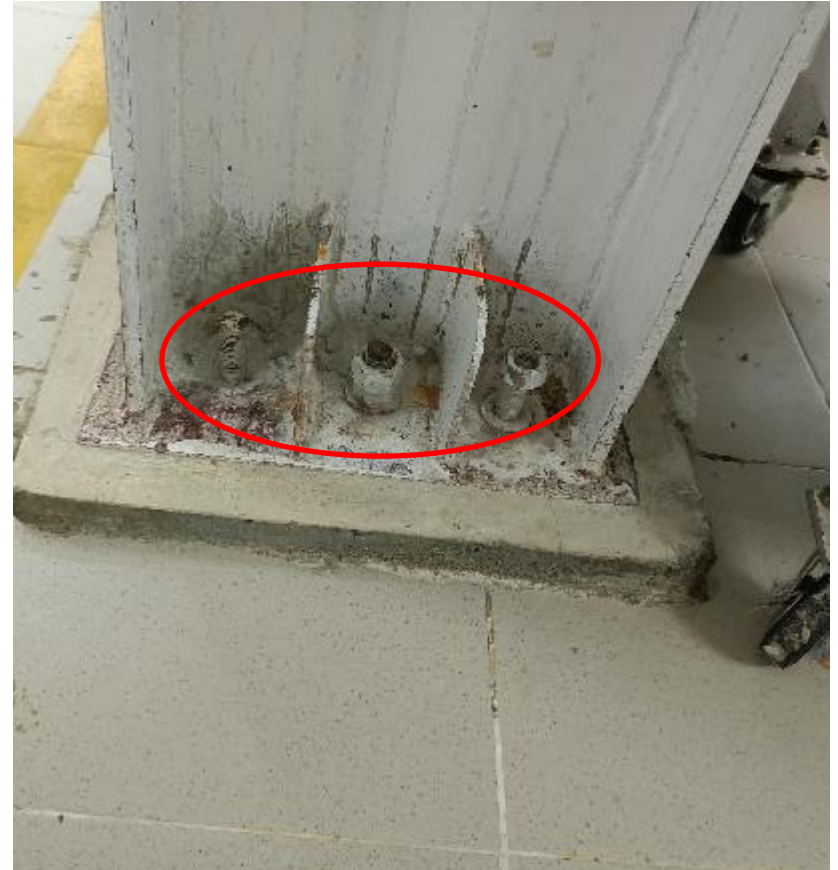
Nut missing at base plate

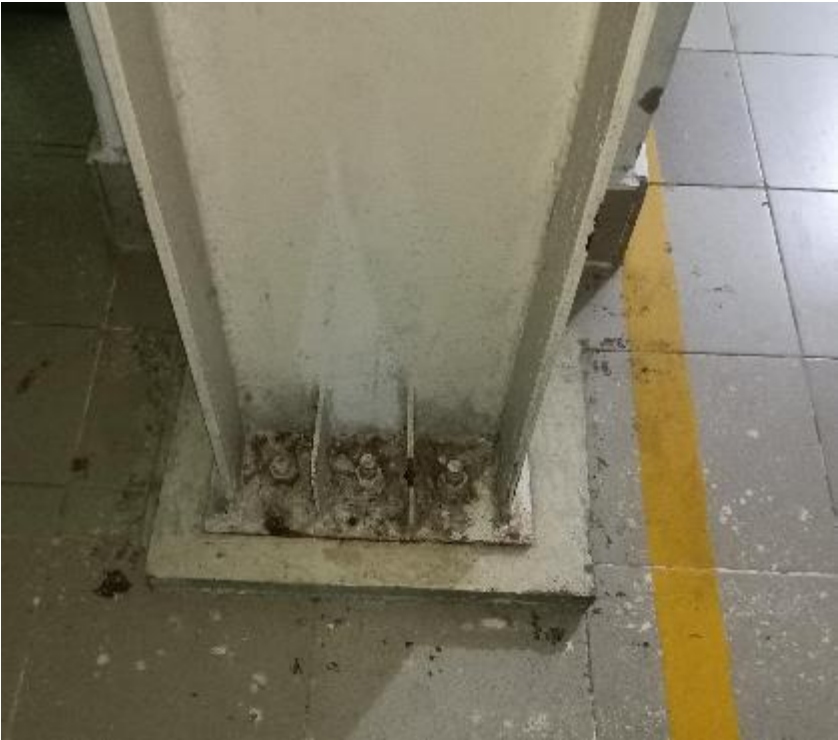
Corrosion in steel column base plate were observed in the several locations. The building engineer is required to take proper remedial measure.

Corrosion

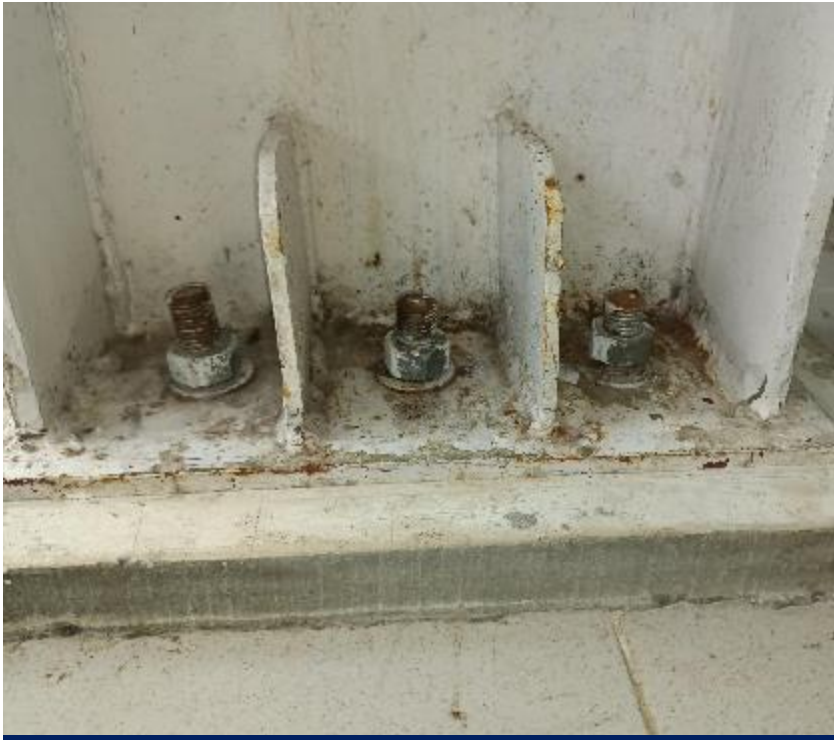
Corrosion

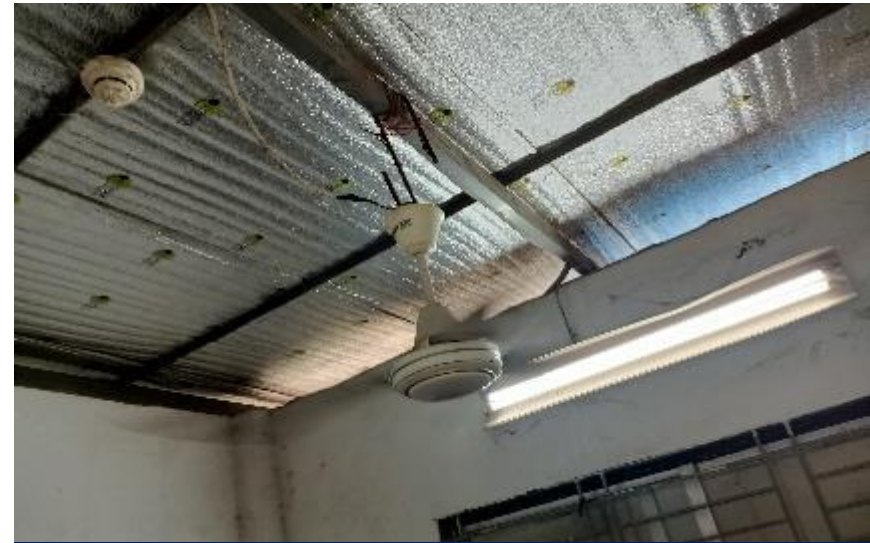
Driver Rest Room

Apparently inadequate connections were observed at the lightweight roof of the single storied Sheds. The building engineer to check the connection adequacy of the lightweight roof against the uplift pressure of wind.
