# Liberty Knitwear Ltd. Unit-2 (Extension 2)

10 July 2023

# Observations

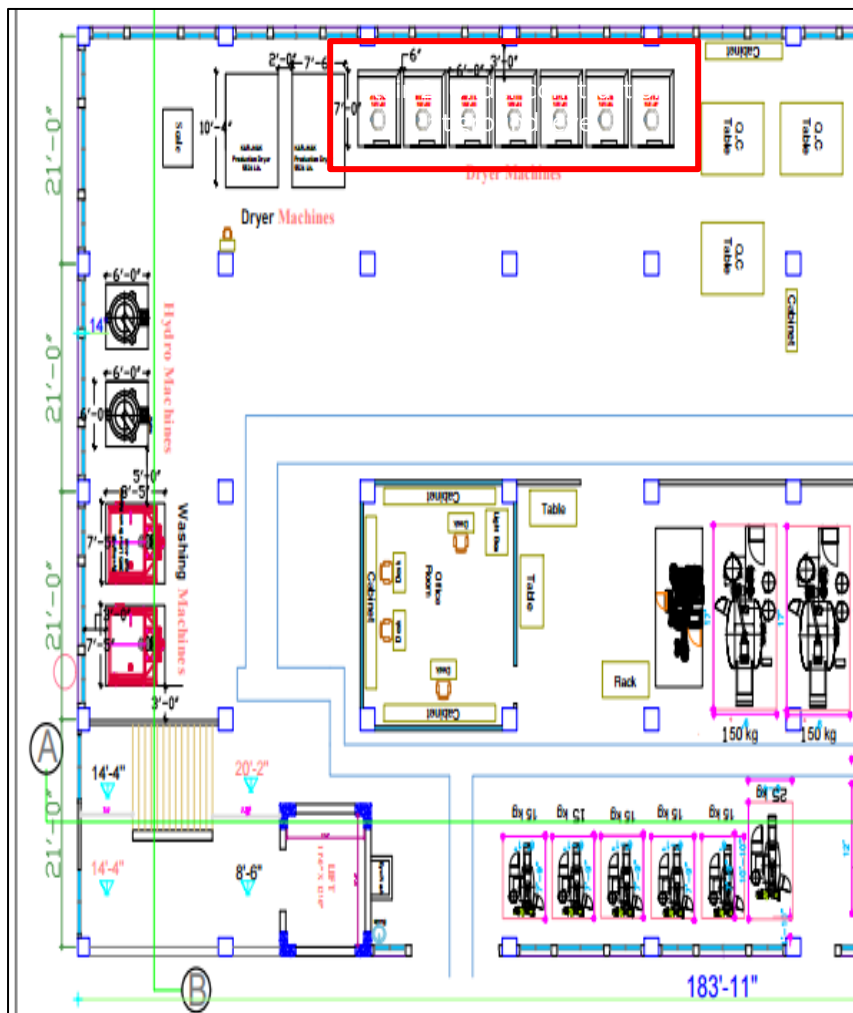
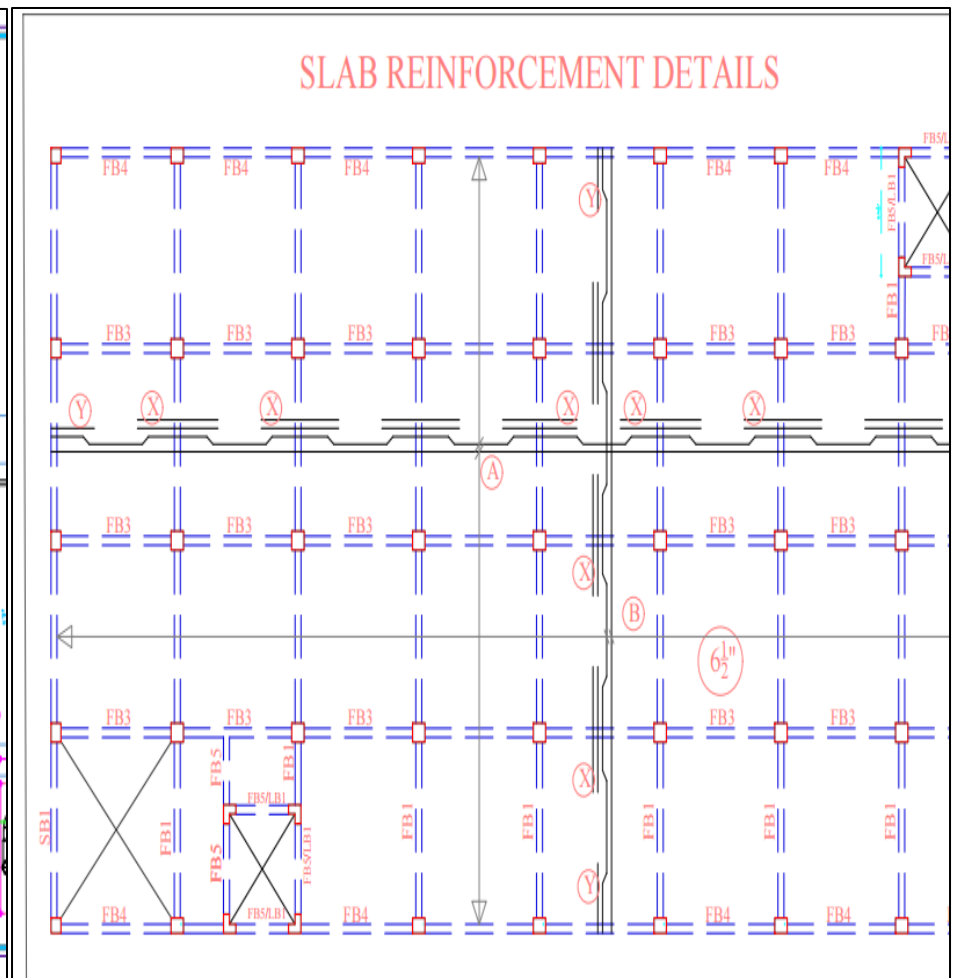
# **Lack of information in As-Built Drawing**

Floor level from EGL and built-up height in toilet block area is not mentioned in architectural drawing.

Grade slab and floor slab reinforcement detailing is missing in as-built structural drawing. The building engineer is required to survey the structures and prepare accurate as-built drawings. Submit the drawing to the RSC for review.

| Item No. | Observation | Recommended Action Plan | Recommended Timeline |
|---|---|---|---|
| 01 | Lack of information in As-Built Drawing (West Tower Building) | Building engineer is required to survey the structure and produce accurate as-built architectural & structural drawings. | 6-weeks |

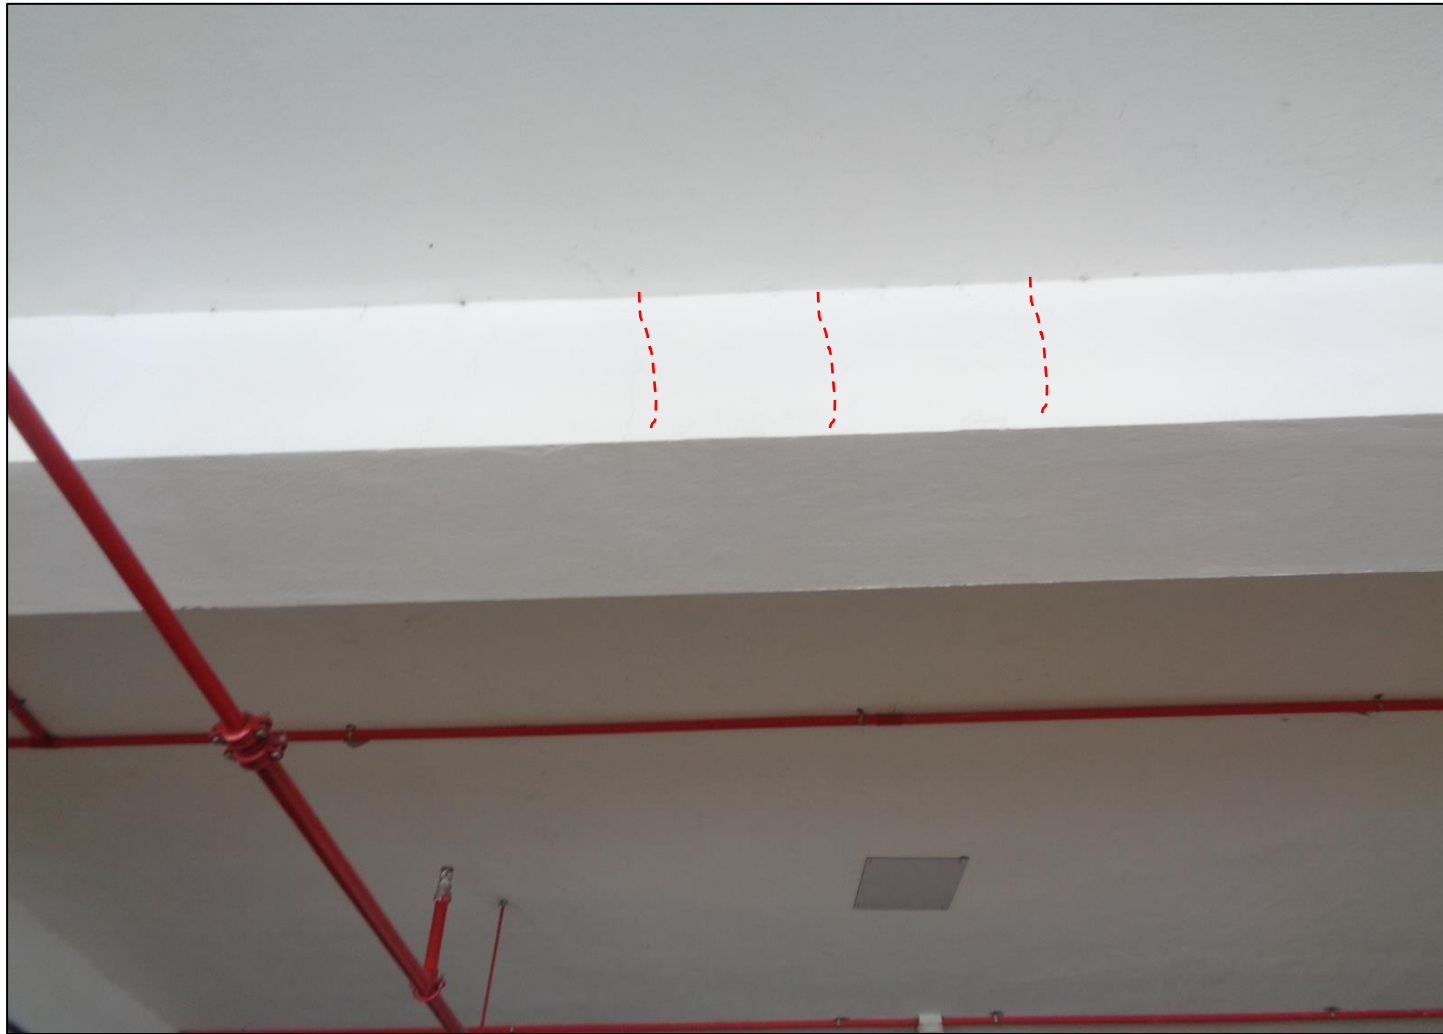
## **Cracks on Roof Beam**

Cracks on roof beam

Hairline cracks were observed on roof beams. . Building engineer is required to investigate the cracks and carry out suitable repair work as per recommendation of investigation report.

| Item No. | Observation | Recommended Action Plan | Recommended Timeline |
|---|---|---|---|
| 04 | Cracks on Roof Beam. (West Tower Building) | Building engineer is required to investigate the cracks and carry out suitable repair work as per recommendation of investigation report. | 6-weeks |

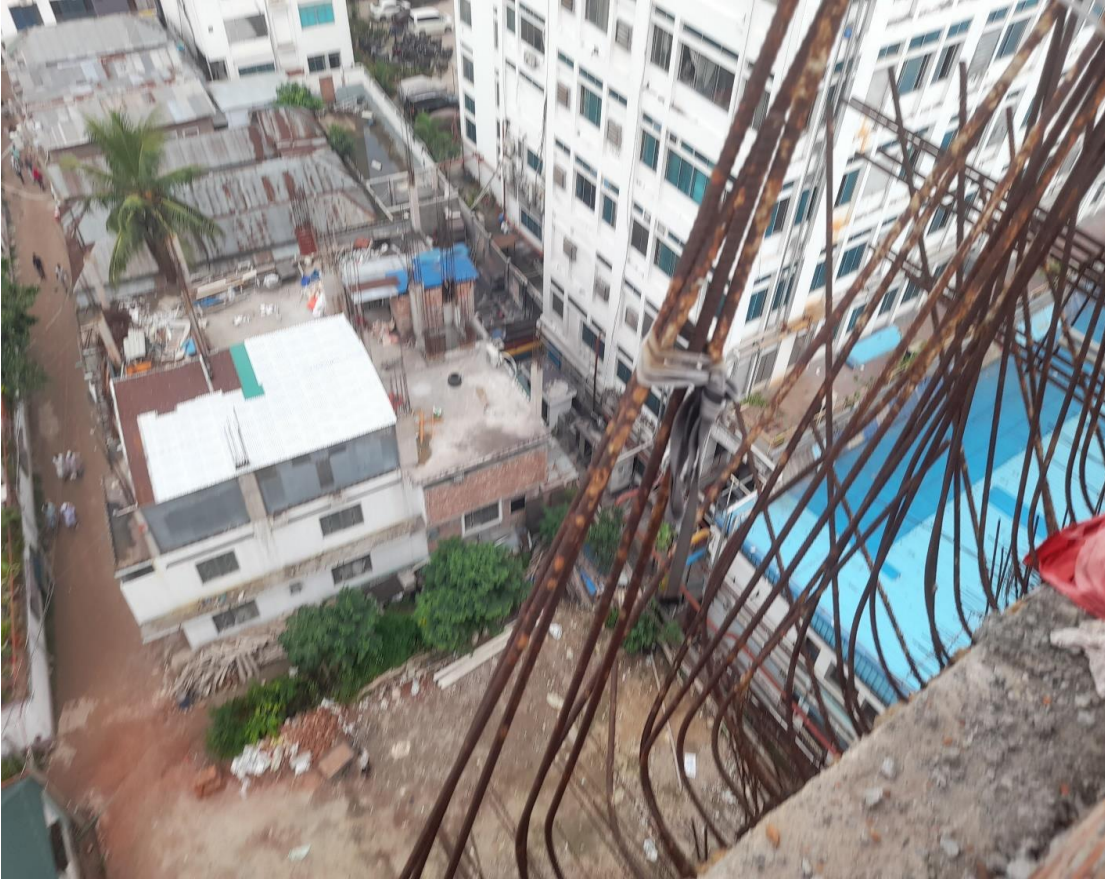
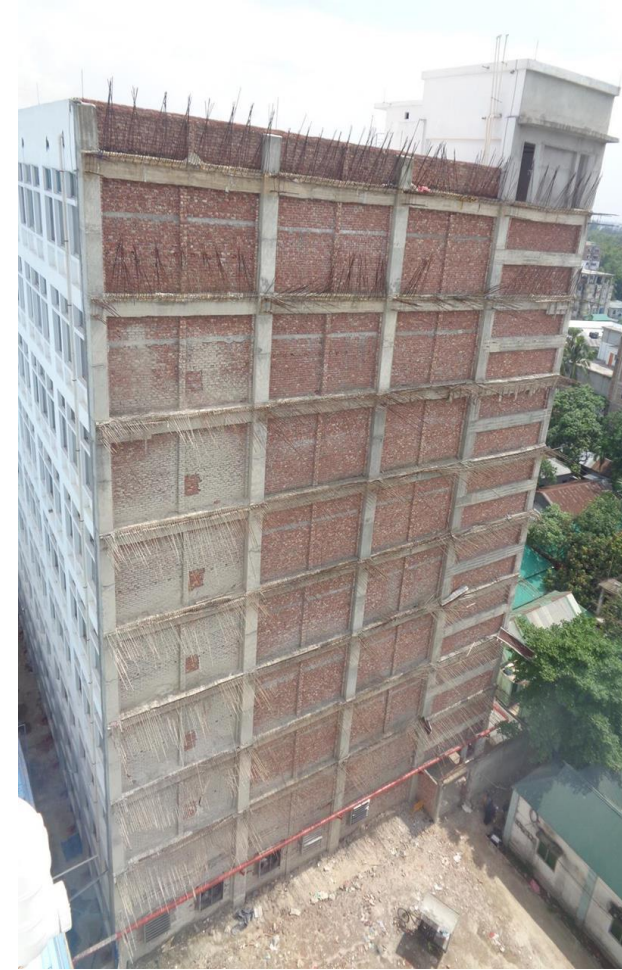
**Exposed reinforcement left at roof level**

Exposed reinforcement is left at roof level & staircase which was prone to corrosion. Building engineer is required to provide rust proof paint on exposed reinforcement to protect from corrosion.

| Item No. | Observation | Recommended Action Plan | Recommended Timeline |
|---|---|---|---|
| 05 | Exposed reinforcement left at roof level. (West Tower Building) | Building engineer is required to remove the corrosion and apply suitable anti-corrosive coating to the affected rebars. | 6-months |

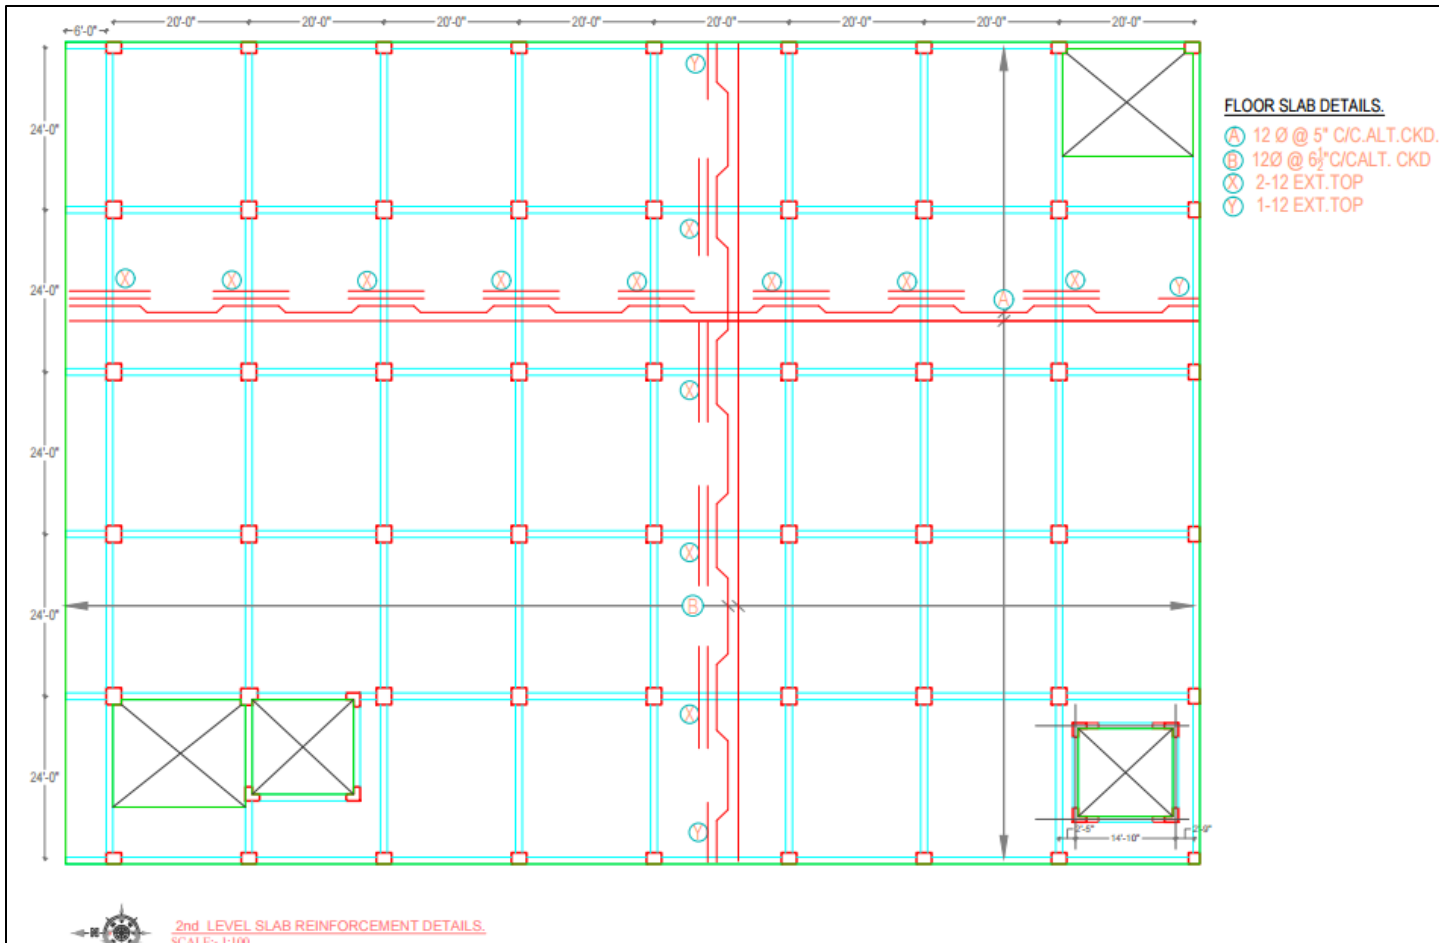
## **Lack of information in As-Built Drawing**

Slab thickness is not mentioned. Grade Slab thickness and rebar detailing is not shown. Building engineer is required to resurvey the whole structure and update as-built drawing accordingly.

| Item No. | Observation | Recommended Action Plan | Recommended Timeline |
|---|---|---|---|
| 06 | Lack of information in As-Built Drawing (Yarn Building) | Building engineer is required to survey the structure and produce accurate as-built architectural & structural drawings. | 6-weeks |

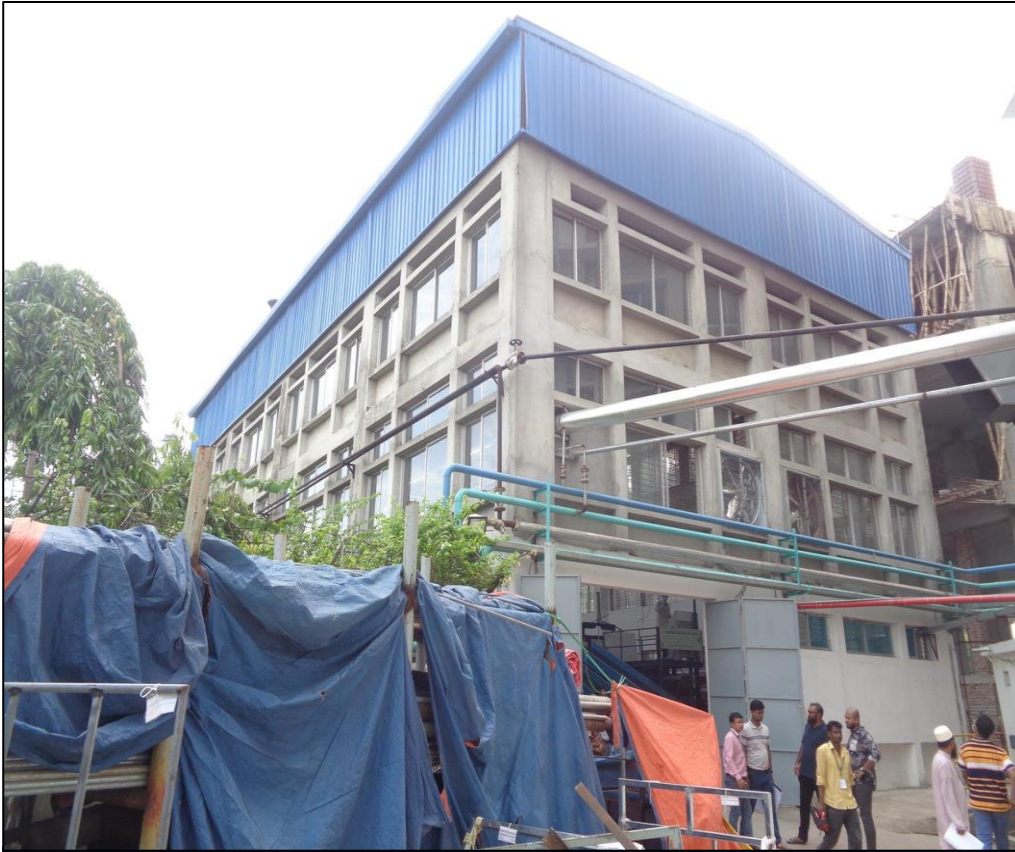
**Jhut Boiler Shed**

As per BNBC, every building or structure designed shall have its design documents prepared in accordance with the provision of Section 1.9.1. The design document shall include a design report, and a set of structural drawings, which shall be prepared in compliance with section 1.9.1.1 and section 1.9.1.2 as per BNBC. At the time of inspection, design report was not available which is required to be prepared in compliance with with BNBC (section 1.9.1).

| Item No. | Observation | Recommended Action Plan | Recommended Timeline |
|---|---|---|---|
| 09 | Absence of design report. (Jhut Boiler Shed) | Building engineer is required to prepare a design report in compliance with BNBC (part-6, section 1.9.1.1). | 6-weeks |

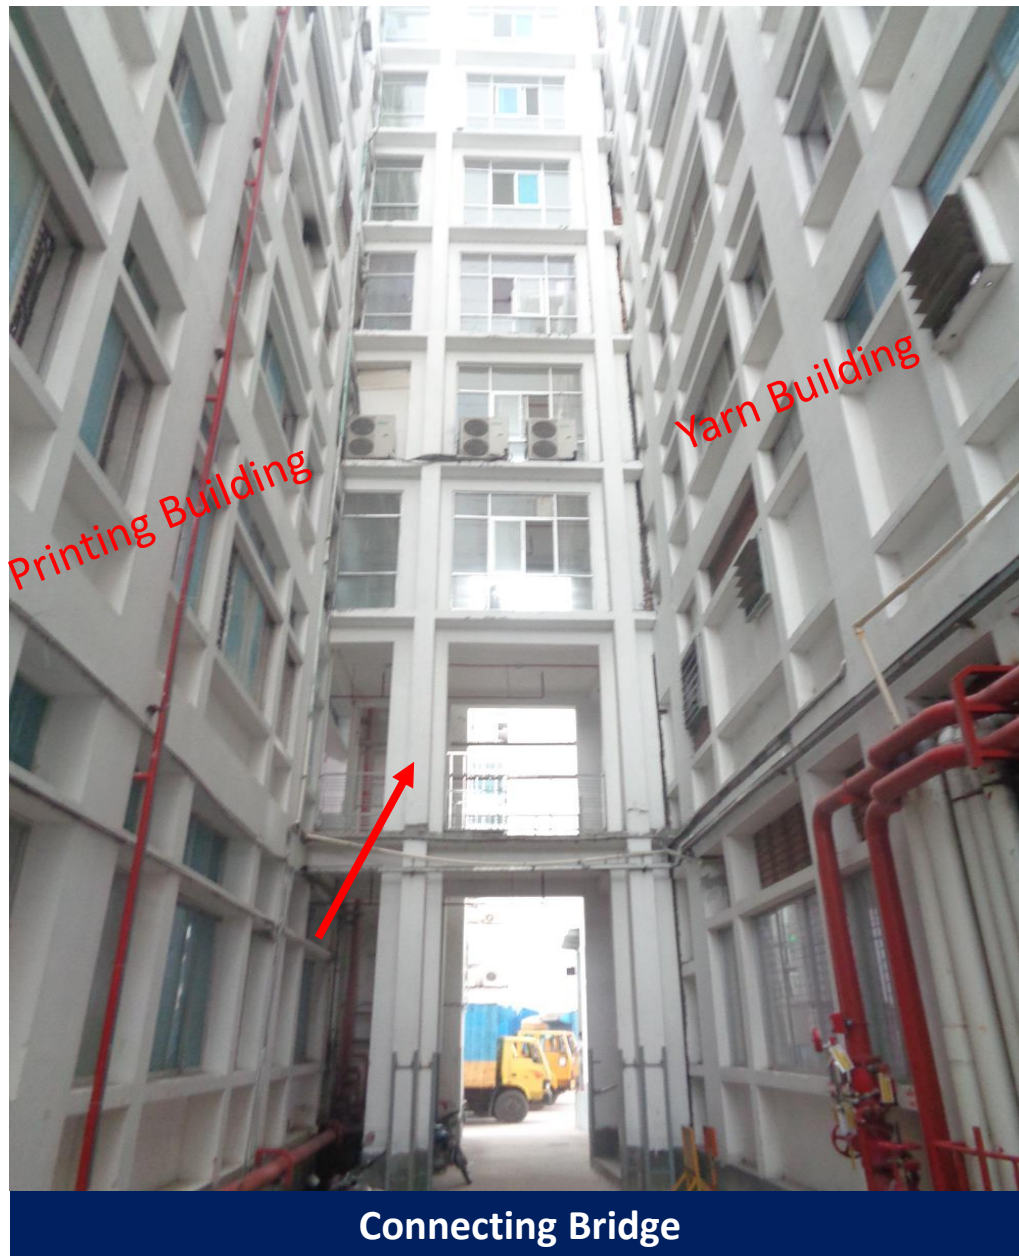
# Absence of design report

As per BNBC, every building or structure designed shall have its design documents prepared in accordance with the provision of Section 1.9.1. The design document shall include a design report, and a set of structural drawings, which shall be prepared in compliance with section 1.9.1.1 and section 1.9.1.2 as per BNBC. At the time of inspection, design report was not available which is required to be prepared in compliance with with BNBC (section 1.9.1).

| Item No. | Observation | Recommended Action Plan | Recommended Timeline |
|---|---|---|---|
| 11 | Absence of design report.<br>(Connecting Bridge) | Building engineer is required to prepare a design report in compliance with BNBC (part-6, section 1.9.1.1). | 6-weeks |
