# DK Global Fashion Wear Ltd.

H#330/1, West Souldubi, Kashimpur, Gazipur

17 July 2023

# Observation

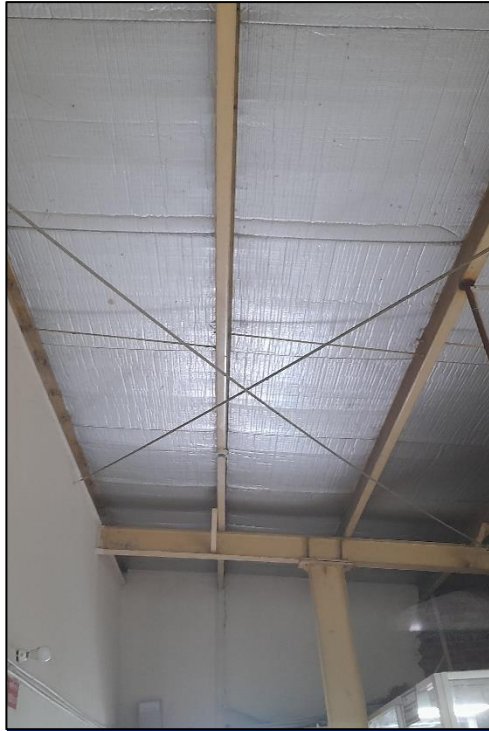
Roof & wall bracing provided

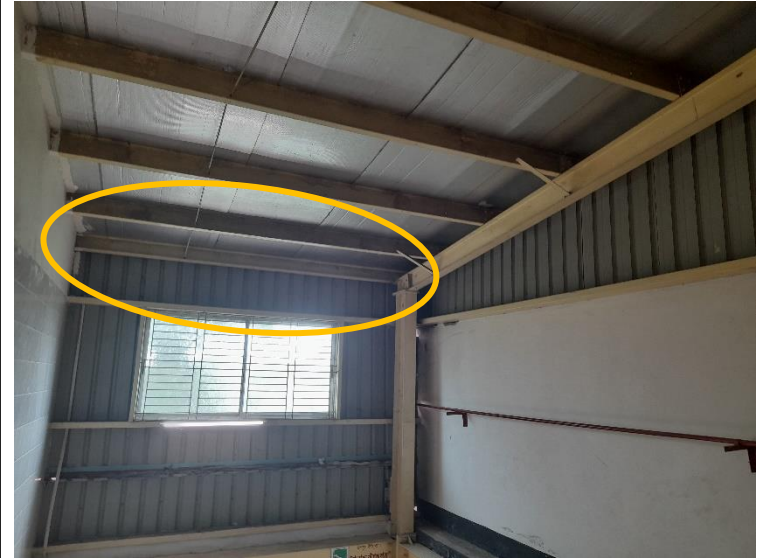
Compression strut missing in gable frame

Roof and wall bracing were provided at some location. However, compression strut was missing in gable frames to transfer the lateral load therefore lateral stability system of the shed is apparently incomplete. Building engineer is required to check the lateral stability system of the structure and suggest necessary remedial actions accordingly.

| Item No. | Observation | Recommended Action Plan | Recommended Timeline |
|---|---|---|---|
| 01 | Lack of lateral stability system. (Production Building) | Building engineer is required to check the lateral stability of the structure and suggest necessary remedial actions accordingly. | 6-weeks |
| 02 | Lack of lateral stability system. (Production Building) | Implement suggested remediation work if required. | 6-months |

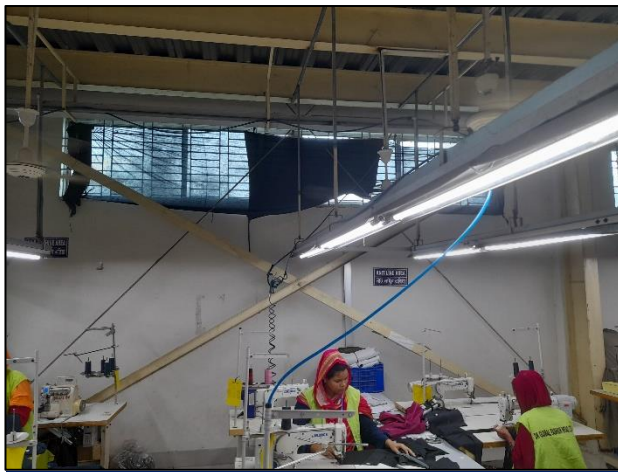
Angle bracing (Ground Floor)

In bracing layout plan, only horizontal and vertical cable bracing was shown. However, no information was available regarding vertical angle bracing on ground floor. In addition, elevation view and connection details of bracings were also not present in the as-built structural drawing. The building engineer is required to survey the whole structures and prepare accurate as-built drawings accordingly.

| Item No. | Observation | Recommended Action Plan | Recommended Timeline |
|---|---|---|---|
| 03 | Lack of information in the as-built drawings. (Production Building) | The building engineer is required to survey the structure and prepare accurate as-built drawing. | 6-weeks |

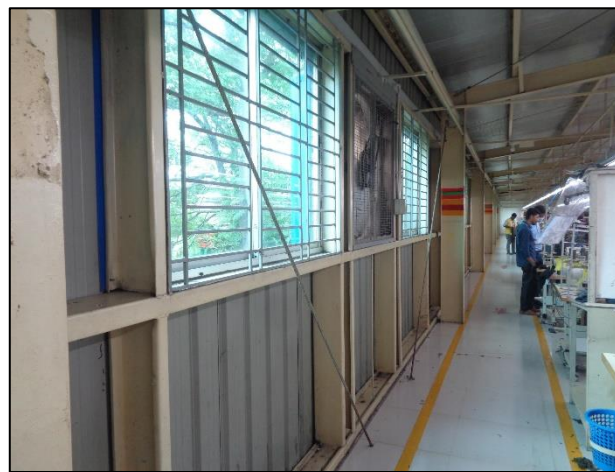
Cable bracing (1st Floor)

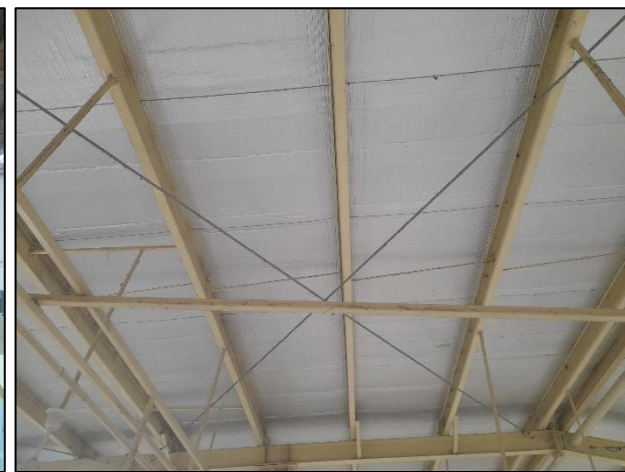
Roof bracing

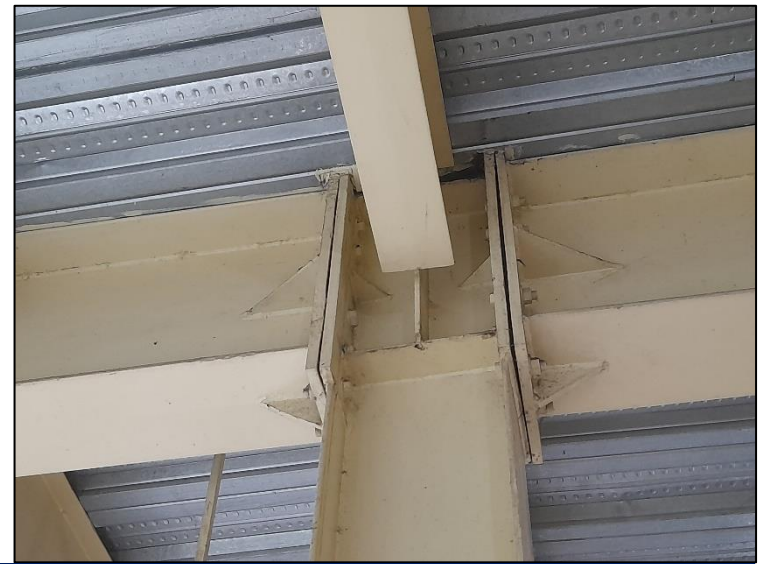
Significant gap in steel connection plates in different location

Significant gap in steel connection plates of rafter & column was found at different locations of the structure. Building engineer is required to survey the whole structure & identify the locations of the connection gaps. Factory engineer is also required to assess the reason of connection gap & provide proper remediation. Factory is required to follow recommendation of remediation suggested by the engineer.

| Item No. | Observation | Recommended Action Plan | Recommended Timeline |
|---|---|---|---|
| 04 | Significant gap in connection at several location. (Production Building) | Building engineer is required to repair the gap in connections with a suitable method. | 6-weeks |

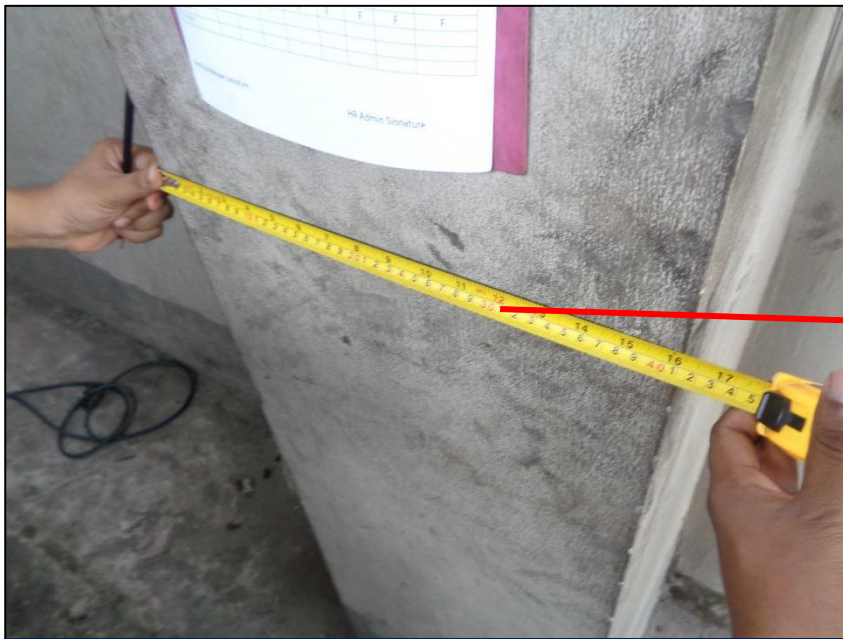
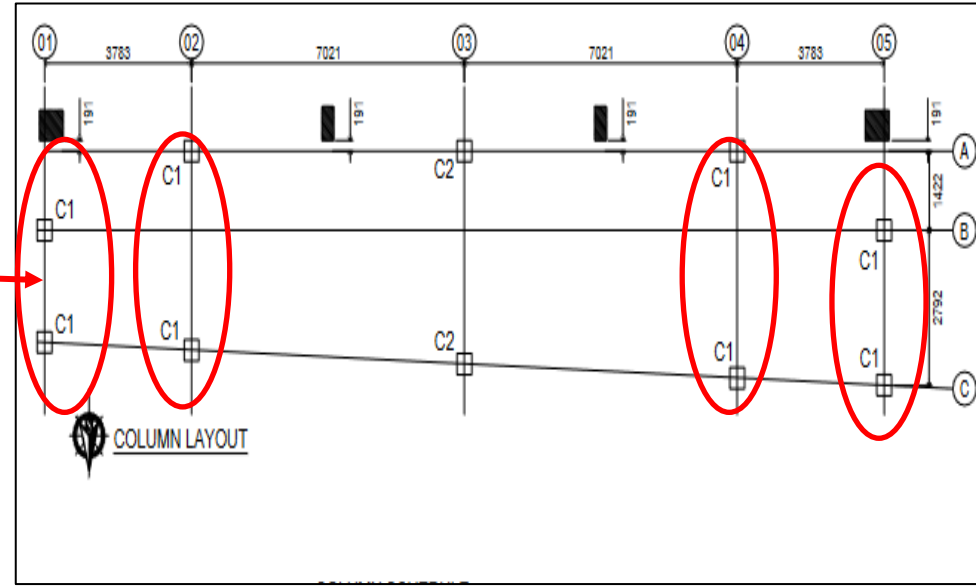
C6 column was measured 450 mm instead of 500 mm

In column schedule C1 column dimension was shown 425X425 mm. However, during inspection, all C1 columns were measured 375X375 mm. The building engineer is required to survey the whole structures and prepare accurate as-built drawings accordingly.

| Item No. | Observation | Recommended Action Plan | Recommended Timeline |
|---|---|---|---|
| 05 | Discrepancies in the as-built drawings. (Utility Building) | The building engineer is required to survey the structure and prepare accurate as-built drawing. | 6-weeks |

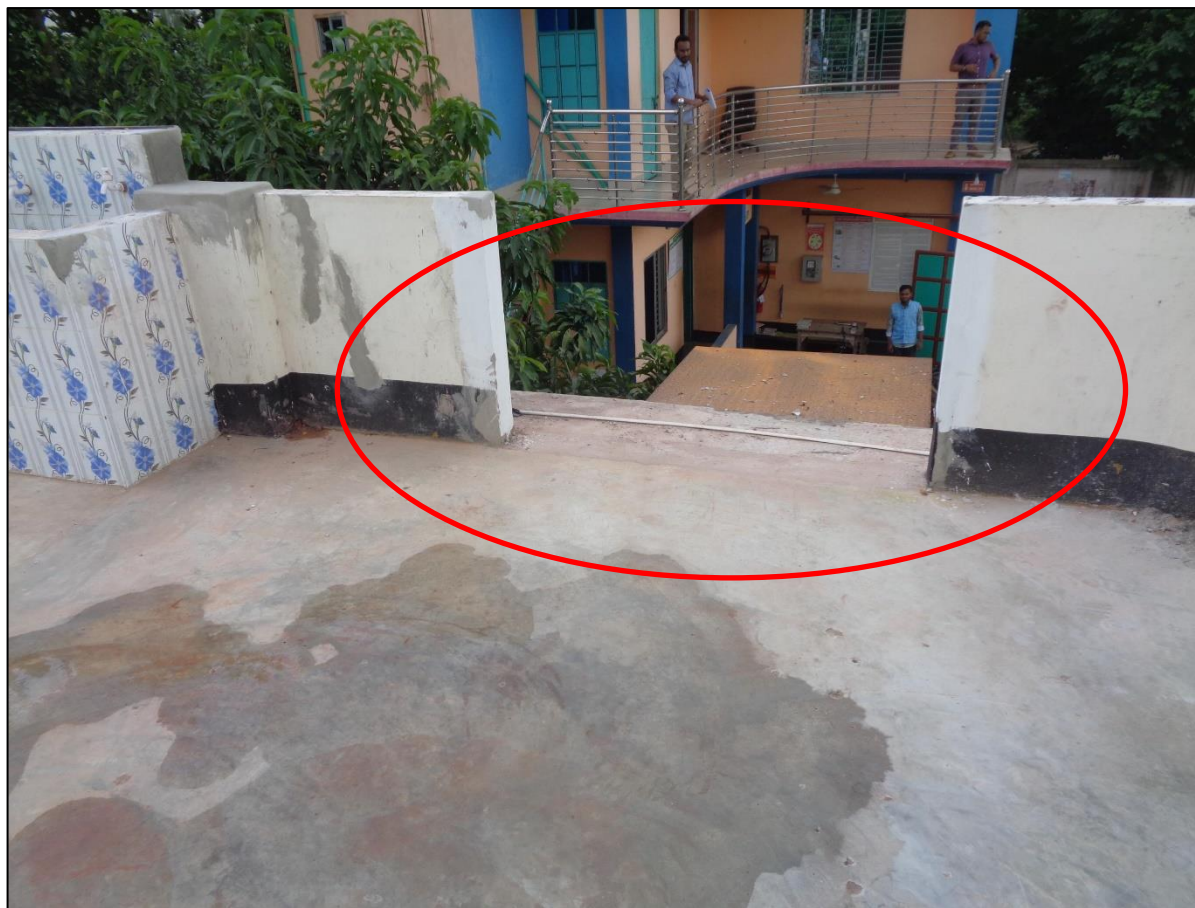
Opening at parapet wall

There were an opening area in parapet wall on canteen building roof which may cause falling hazard. The factory is required to provide adequate barrier/railing/walls on the opening area to protect possible falling hazard.

| Item No. | Observation | Recommended Action Plan | Recommended Timeline |
|---|---|---|---|
| 06 | Lack of fall protection (Canteen Building) | Building engineer is required to provide adequate barrier/walls on the opening area of the roof to protect possible falling hazard. | 6-weeks |

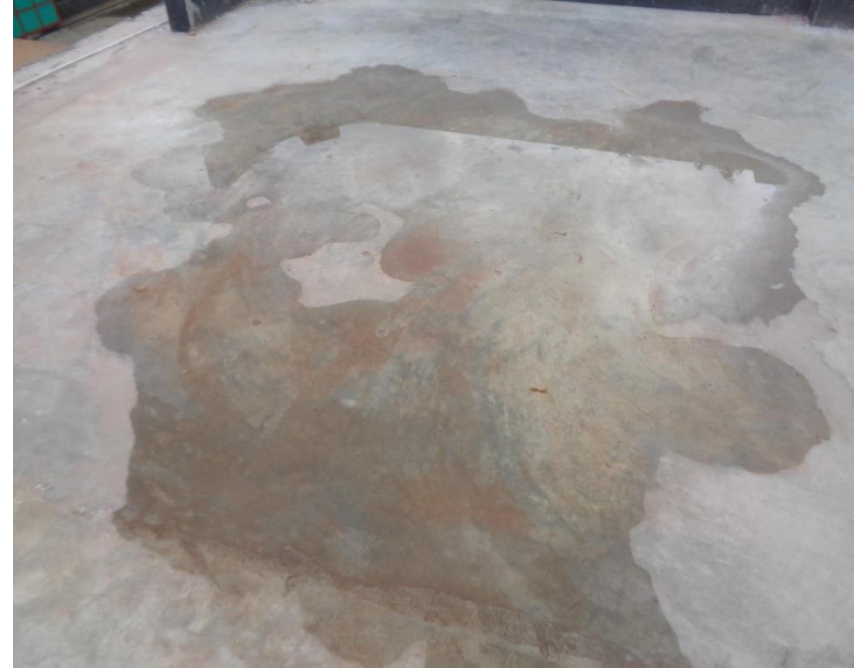
MCAC roof of Canteen Building

Water proofing was not applied on the roof. The roof is made of brick aggregate concrete. The building engineer is required to apply the water proofing layer on the current roof with proper slope.

| Item No. | Observation | Recommended Action Plan | Recommended Timeline |
|---|---|---|---|
| 07 | Lack of water proofing at MCAC roof (Canteen Building) | The building engineer is required to apply the water proofing layer on the current roof with proper slope. | 6-weeks |

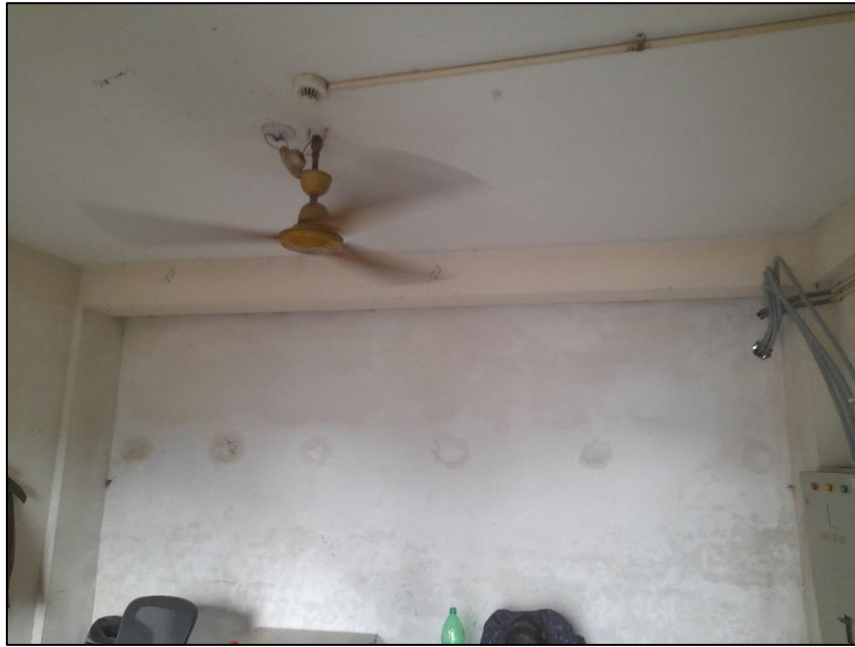
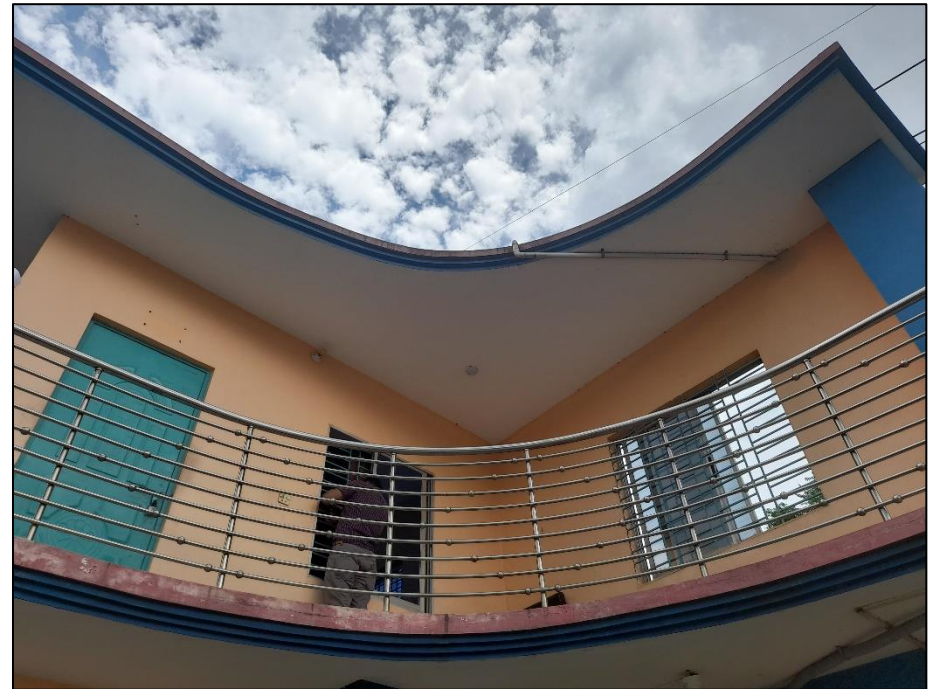
Security Guard Room

As per BNBC, every building or structure designed shall have its design documents prepared in accordance with the provision of Section 1.9.1. The design document shall include a design report, and a set of structural drawings, which shall be prepared in compliance with section 1.9.1.1 and section 1.9.1.2, part-6 of BNBC. At the time of inspection, no as-built drawings and design documents were available which are required to be prepared in compliance with section 1.9.1.1 (part-6, BNBC).

| Item No. | Observation | Recommended Action Plan | Recommended Timeline |
|---|---|---|---|
| 08 | Lack of as-built drawings and design documents. (Security Guard Room) | Building engineer is required to prepare the design documents including a design report, and a set of structural drawings in compliance with section 1.9.1.1 and section 1.9.1.2, part-6 of BNBC and submit it to RSC for review. | 6-weeks |
| 09 | Lack of as-built drawings and design documents. (Security Guard Room) | Carry out remedial works (if any) after reviewed by the RSC. | 6-months |

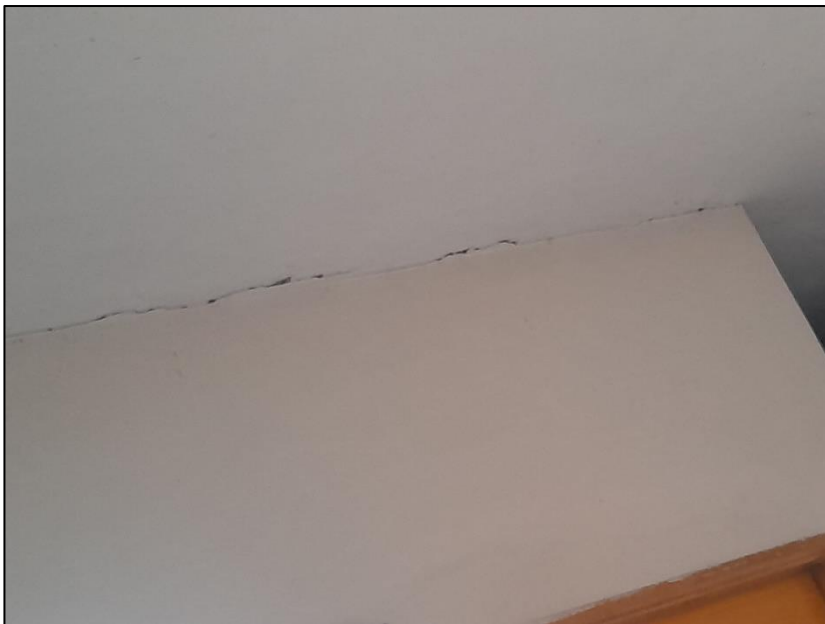
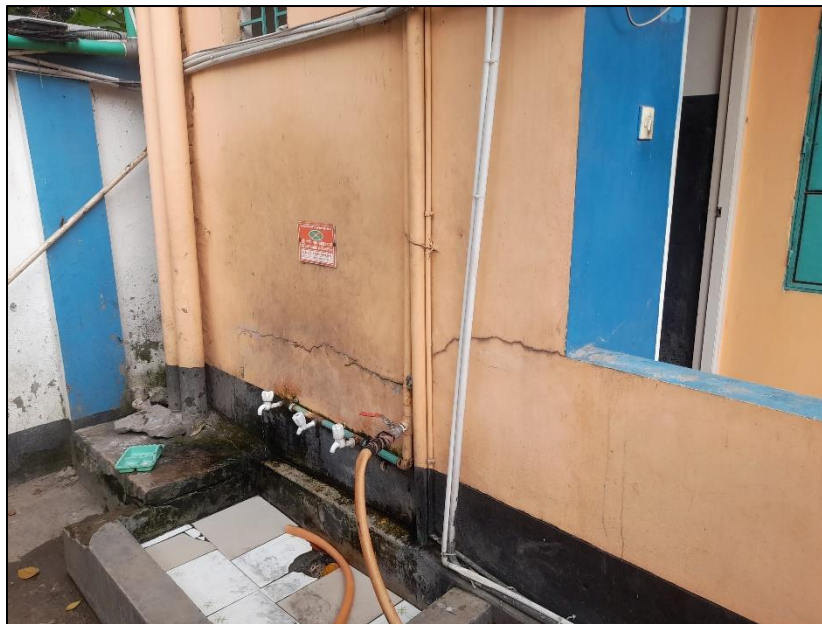
Cracks on masonry walls

Building engineer is required to investigate the cause of wall cracks and repair with a suitable method.

| Item No. | Observation | Recommended Action Plan | Recommended Timeline |
|---|---|---|---|
| 10 | Cracks on masonry wall. (Security Guard Room) | Building engineer is required to investigate the cause of wall cracks and repair with a suitable method. | 6-weeks |

| Item No. | Observation | Recommended Action Plan | Recommended Timeline |
|---|---|---|---|
| 11 | Cracks on masonry wall. (Security Guard Room) | Building engineer is required to investigate the cause of wall cracks and repair with a suitable method. | 6-months |

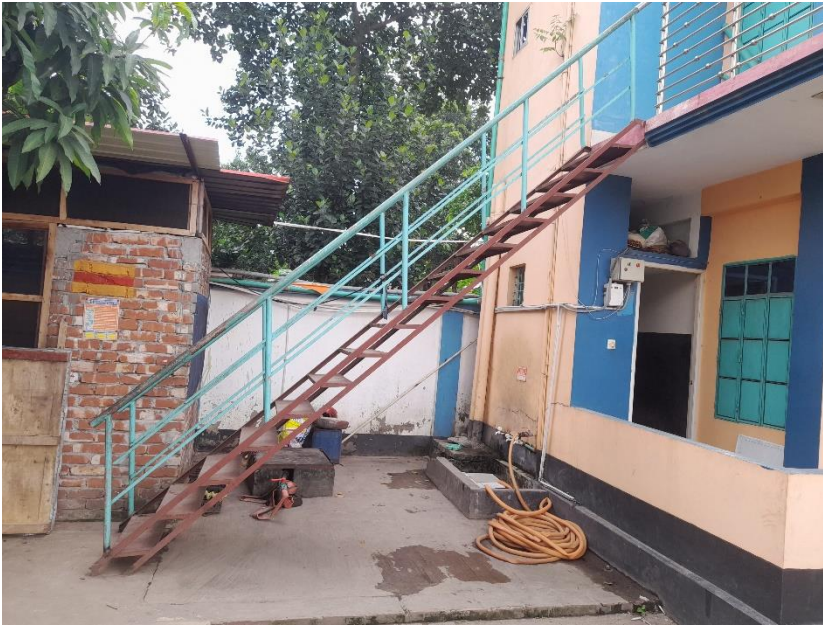
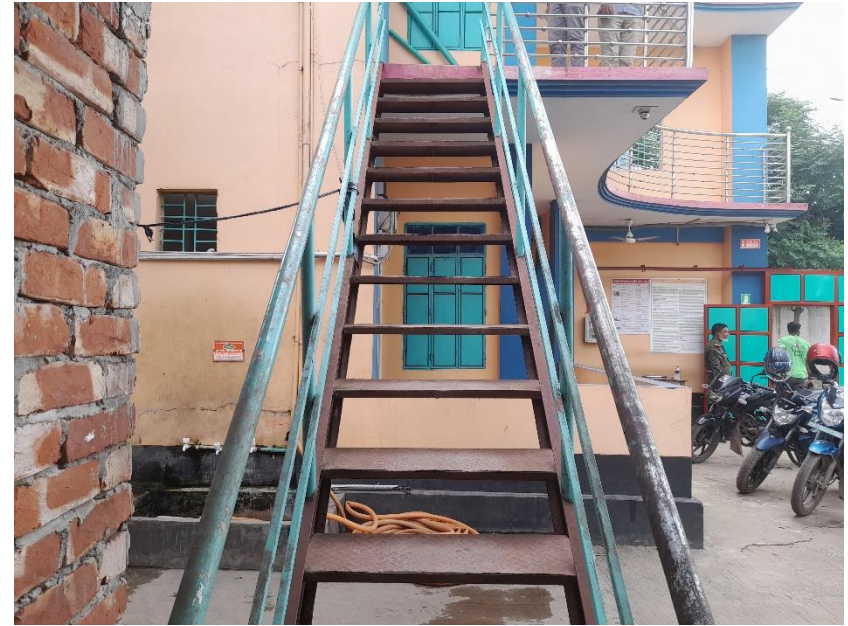
Non-engineered steel stair

Both Shed-1 and Shed-2 were appeared to be non engineered due to lack of apparent load path, poor connection and apparently inadequate member size. Building engineer is required to check the connection adequacy for uplift forces as part of EA otherwise replace with engineered structure.

| Item No. | Observation | Recommended Action Plan | Recommended Timeline |
|---|---|---|---|
| 12 | Apparently non engineered steel stair. (Security Guard Room) | Building engineer is required to check the connection adequacy for uplift forces as part of EA otherwise replace with engineered structure. | 6-weeks |
| 13 | Apparently non engineered steel stair. (Security Guard Room) | Carry out remedial works (if any) after reviewed by the RSC. | 6-months |
