# Nafa Apparels Ltd. (Extension)

20 August 2023

# Observations

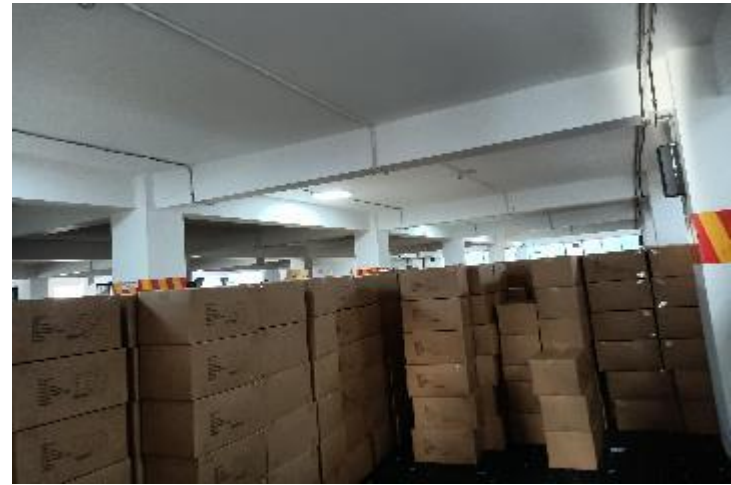
Currently, the first floor of the building is being allotted for finished cartoon store. As per BNBC, the minimum floor live load for light storage is 6 kN/m<sup>2</sup> (125 psf). But the storage (first floor) area of the building is designed for 5 kN/m<sup>2</sup> live loads. Moreover, the factory has provided some concrete cylinder test report from column, but which are not comply with the frequency of BNBC requirement.

Storage on first floor

The building engineer is required to revise the storage live load limit and related design documents based on BNBC requirement.

| Item No. | Observation | Recommended Action Plan | Recommended Timeline |
|---|---|---|---|
| 01 | Load plan & design report not comply with BNBC requirements.<br>(New 06 Storied RCC Building) | Building engineer is required to revise the storage live load limit and related design documents based on BNBC requirement. | 6-weeks |

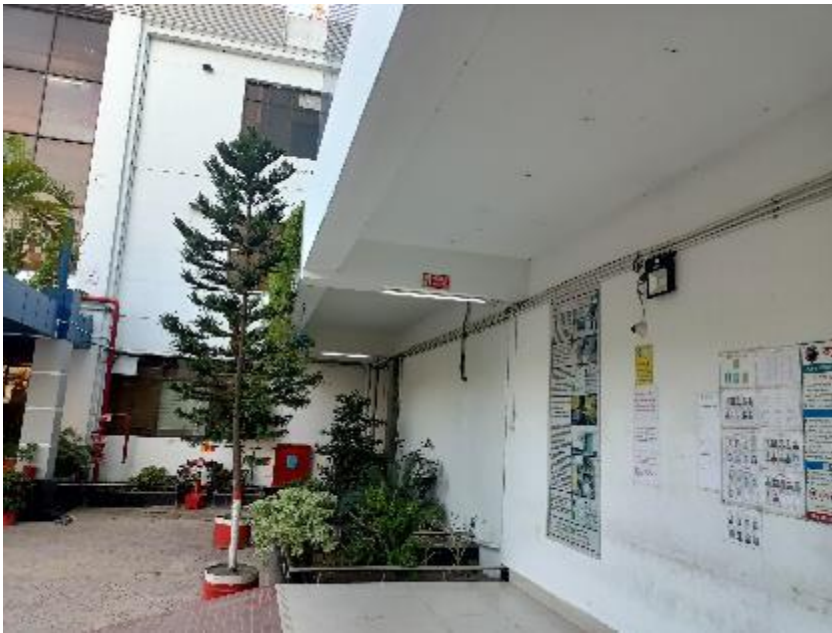
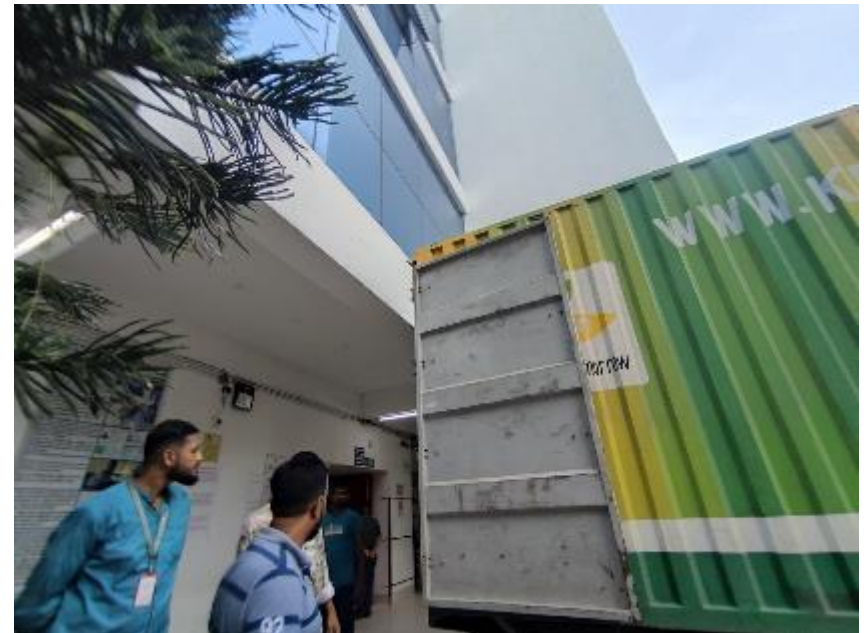
Beams adjacent of driveway of loading unloading area is susceptible to vehicle impact. The factory engineer is required to take necessary measures to prevent the vehicle impact.

Beams adjacent of driveway of loading unloading

| Item No. | Observation | Recommended Action Plan | Recommended Timeline |
|---|---|---|---|
| 06 | Beam susceptible to vehicle impact.<br>(New 06 Storied RCC Building) | Building engineer is required to take necessary action to prevent the vehicle impact in the beams. | 6-weeks |

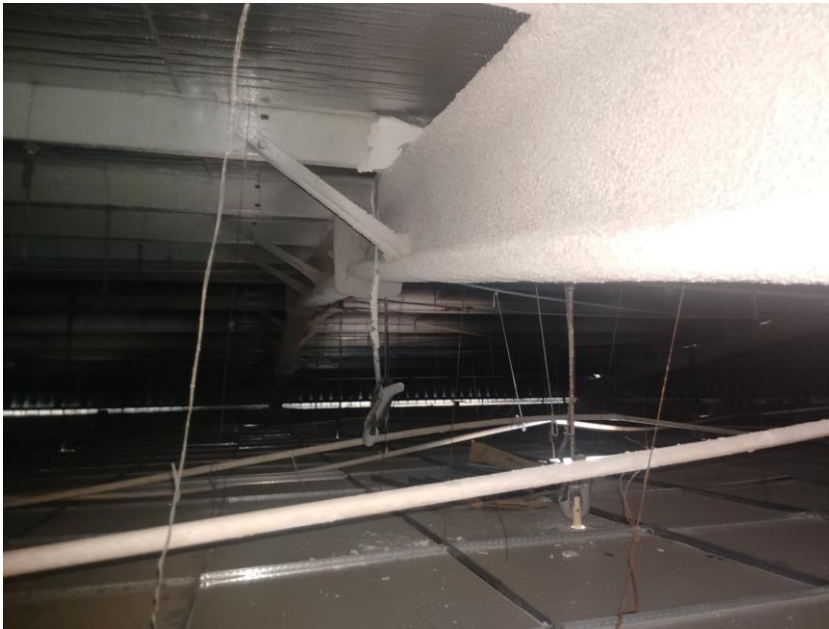
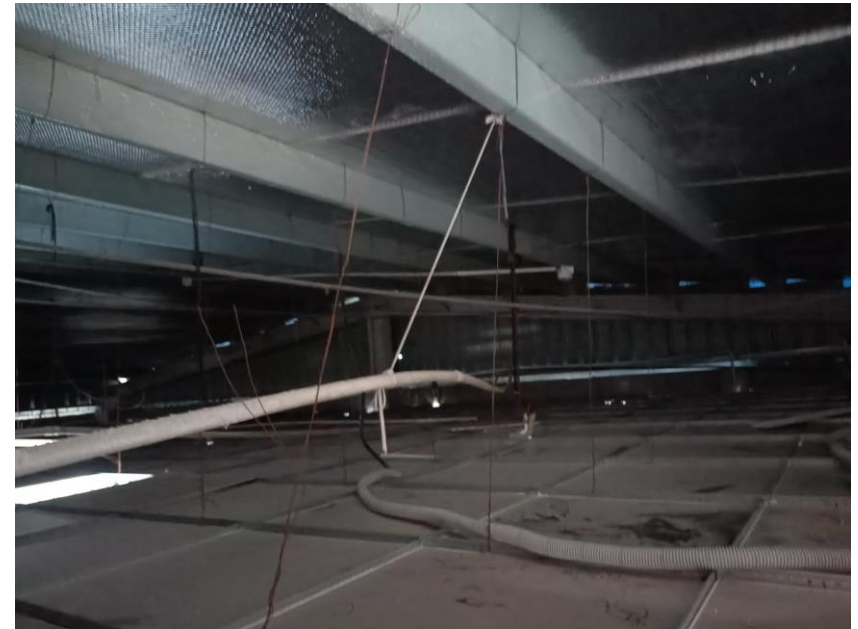
Only horizontal cable bracing were found on site. But other load transfer media compression strut were not observed along perpendicular direction of portal frame. Therefore, lateral stability system of the shed is apparently incomplete. Building engineer is required to check the lateral stability of the structure.

No-compression strut

| Item No. | Observation | Recommended Action Plan | Recommended Timeline |
|---|---|---|---|
| 07 | Incomplete stability system.<br>(Roof Shed) | Building engineer is required to check the lateral stability of the structure. | 6-weeks |
| 08 | Incomplete stability system.<br>(Roof Shed) | Implement remediation work if required. | 6-months |

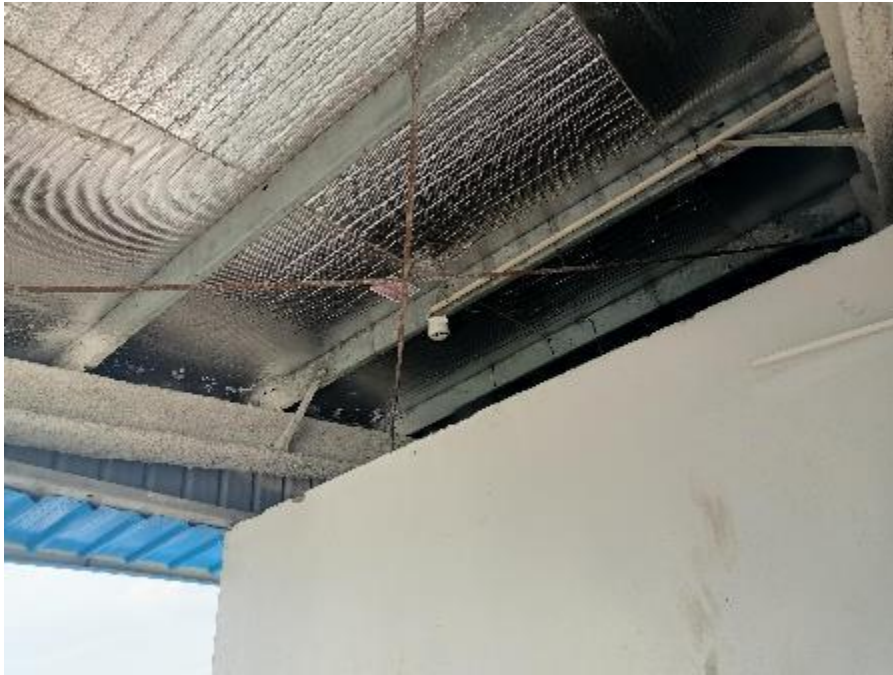
Loose cable bracings were found. Building engineer is required to carry out suitable remedial works and tighten the loose bracing where necessary.

Loose cable bracing

| Item No. | Observation | Recommended Action Plan | Recommended Timeline |
|---|---|---|---|
| 09 | Loose cable bracing. (Roof Shed) | Tighten the loose bracing where necessary. | 6-weeks |

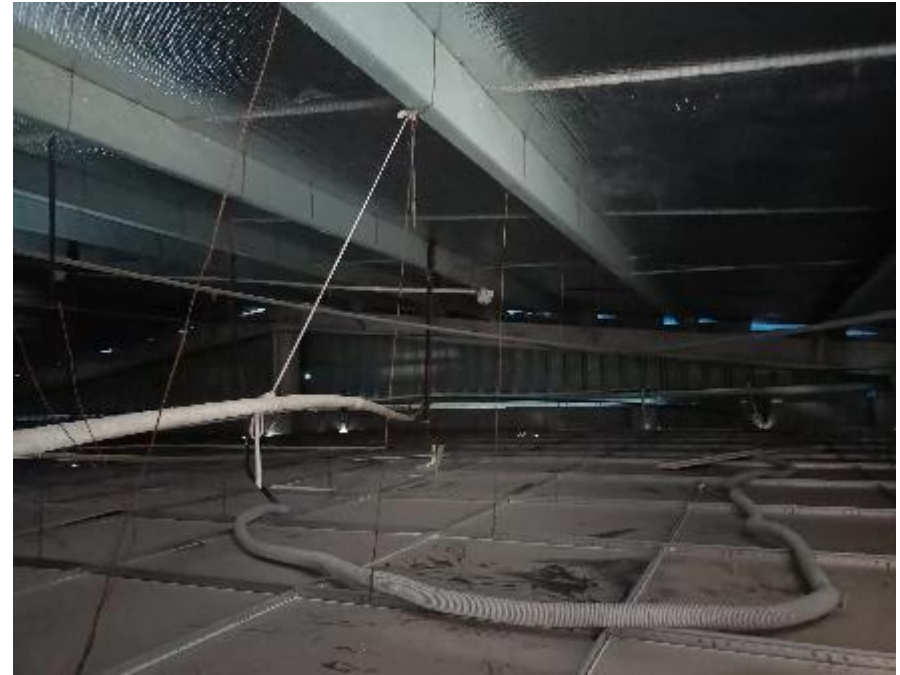
Loose cable bracing

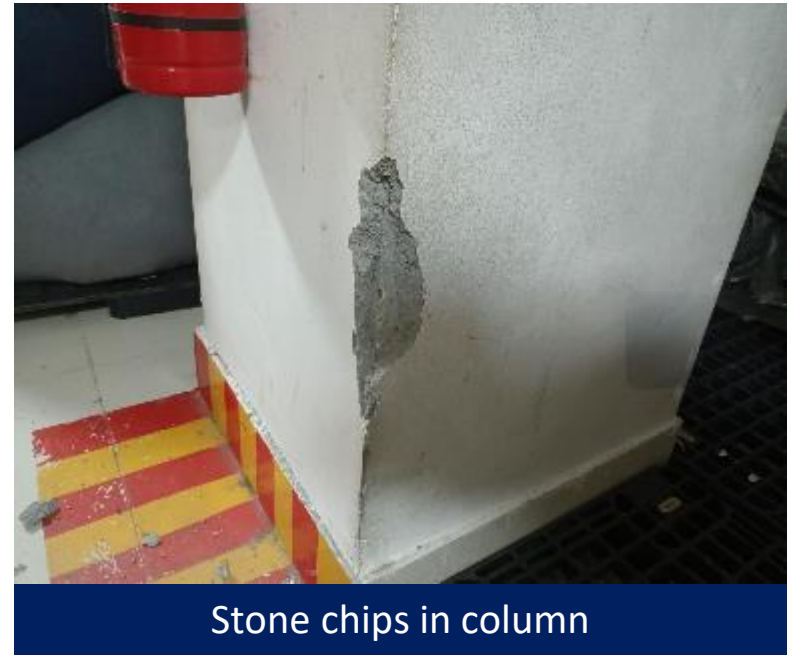
Stone chips in column
