# Arunima Sportswear Ltd (Extension)

Holding-08/63/4, Road No-01, Ward-08, Block-D, Zirabo, Ashulia, Savar, Dhaka

27 August 2023

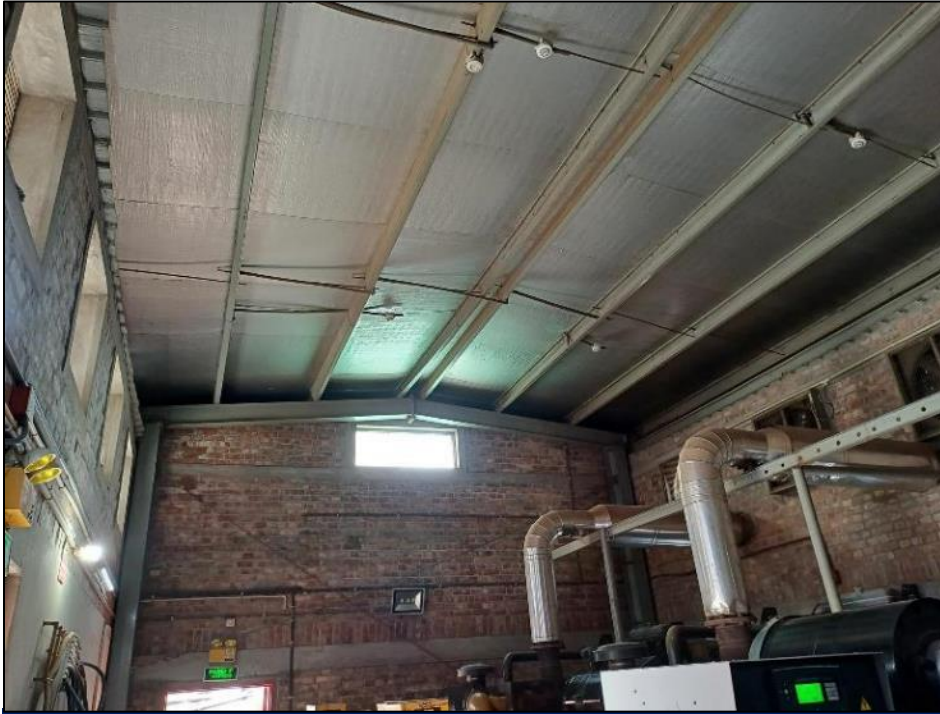
**Lack of lateral stability**

No load transfer media/roof bracing is provided

Stability is provided only by frame action and vertical bracing in some locations. However, roof bracing and load transfer media are not provided from frame to frame to transfer the lateral load therefore lateral stability system of the shed is apparently incomplete. Building engineer is required to check the lateral stability system of the structure and suggest necessary remedial actions accordingly.

| Item No. | Observation | Recommended Action Plan | Recommended Timeline |
|---|---|---|---|
| 01 | Lack of lateral stability (Block E- Single Storied Compressor & Office building) | Building engineer is required to check the lateral stability system of the structure. | 6-weeks |
| 02 | Lack of lateral stability (Block E- Single Storied Compressor & Office building) | Carry out suggested remedial works if required. | 6-months |

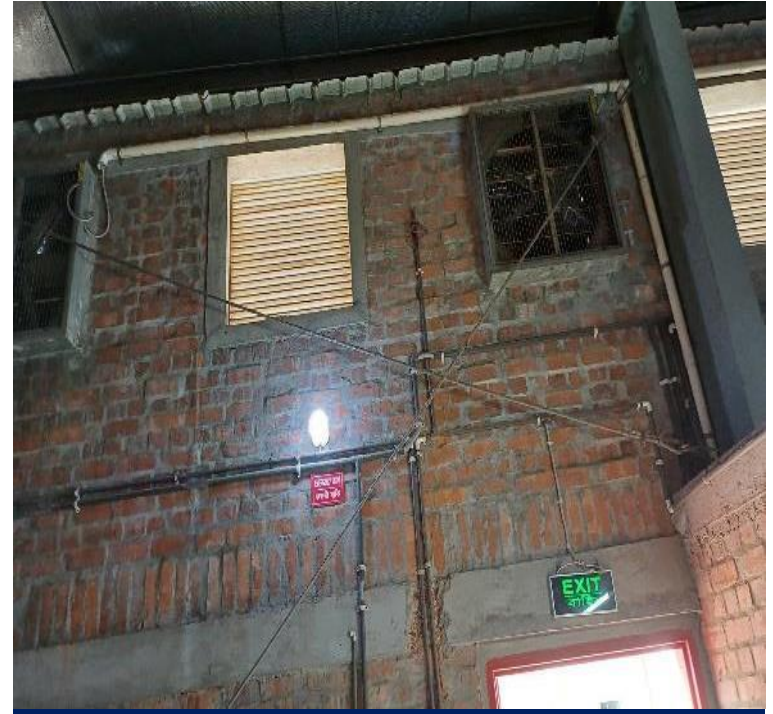
Eccentric vertical bracing

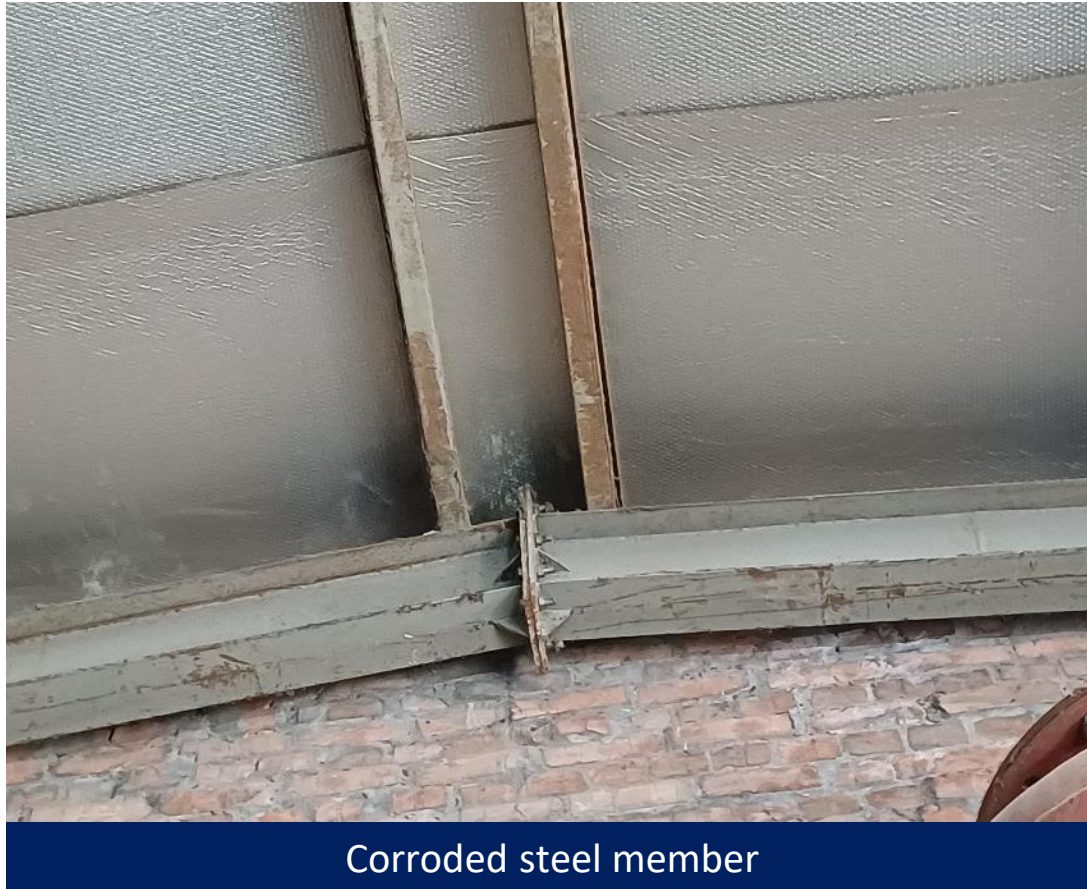
## **Corrosion on steel member**

Corrosion found in steel members at several locations. Building engineer is required to identify all corroded member, remove the corrosion and apply suitable anti-corrosive coating to the affected steel members.

| Item No. | Observation | Recommended Action Plan | Recommended Timeline |
|---|---|---|---|
| 03 | Corrosion in steel member. (Block E- Single Storied Compressor & Office building) | Building is required to identify all corroded member, remove the corrosion and apply suitable anti-corrosive coating to the affected steel members. | 6-weeks |

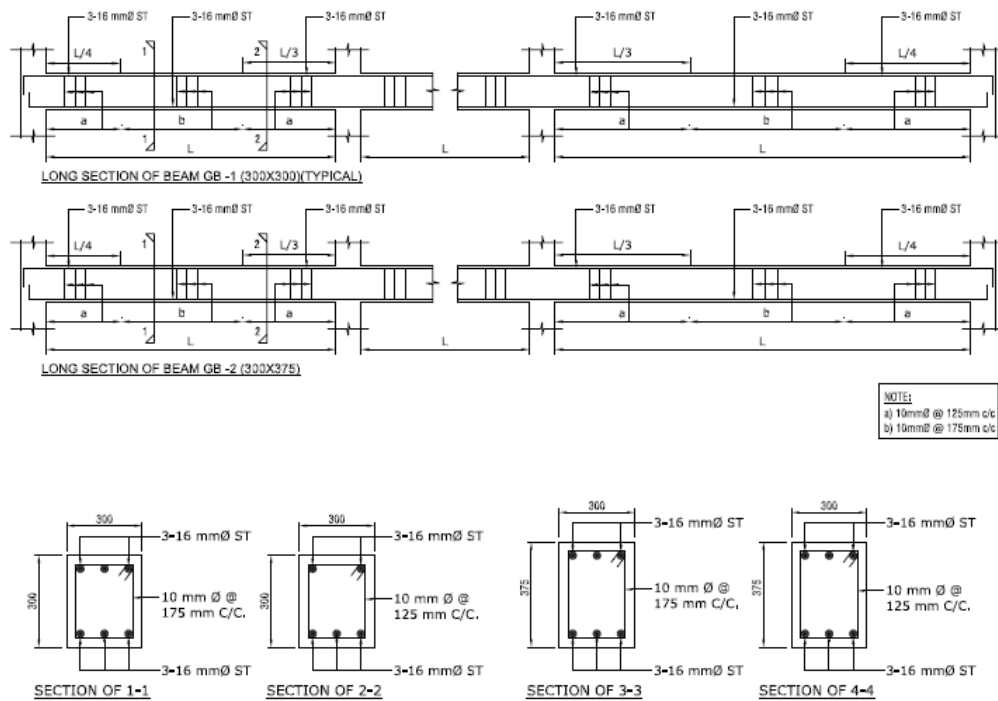
Detail seismic load calculation not included in the design report.

Response modification co-efficient factor  $R$  considered for Special steel concentrically braced frames, but no calculation provided in the design report.

In grade beam adequacy check the provided existing top rebar shows 1.33 in<sup>2</sup>. However, the as-built drawing shows 0.933 in<sup>2</sup>. Building engineer is required to review the design of marginally overstressed grade beams.

| Item No. | Observation | Recommended Action Plan | Recommended Timeline |
|---|---|---|---|
| 05 | Inconsistencies in design report & inadequate structural members. (Block G ) | Building engineer is required to review the design of marginally overstressed grade beams & foundation. | 6-weeks |

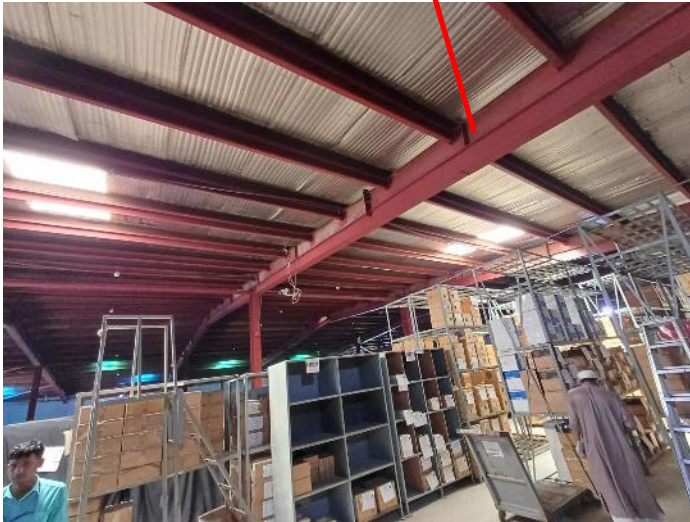
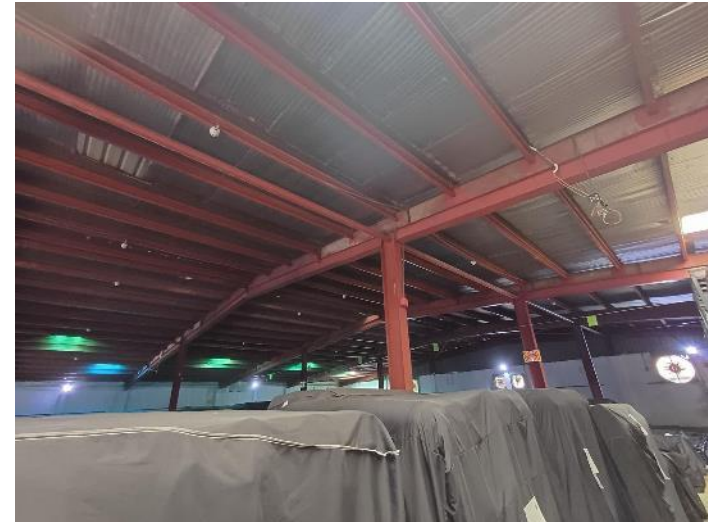
### Unsupported long rafter

The rafter unsupported length is much higher considering the size of rafter section, which can cause local buckling failure in the rafter. The building Engineer is required to check the capacity of the rafter for local buckling failure.

| Item No. | Observation | Recommended Action Plan | Recommended Timeline |
|---|---|---|---|
| 07 | Inconsistencies in design report & inadequate structural members. (Block G ) | Building engineer is required to check the member and connection adequacy. | 6-weeks |

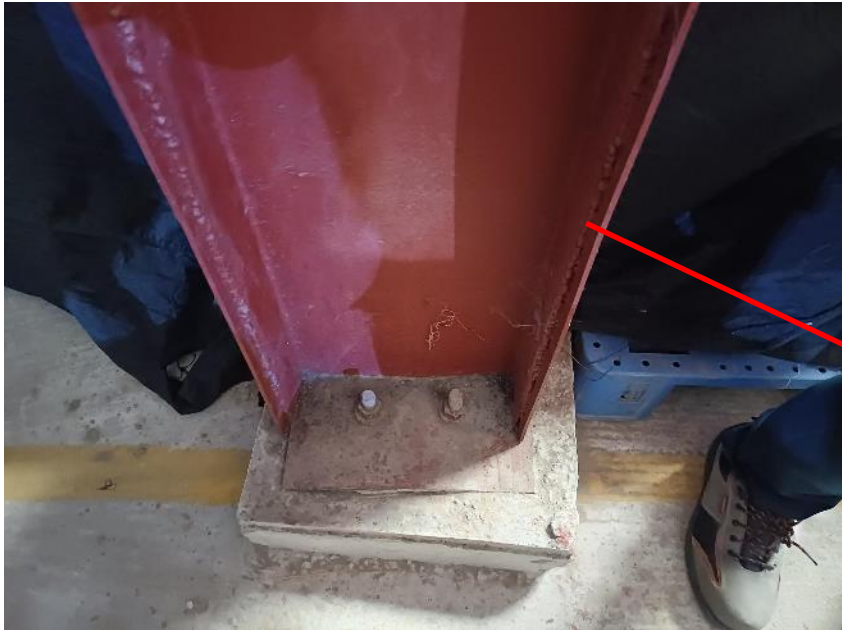
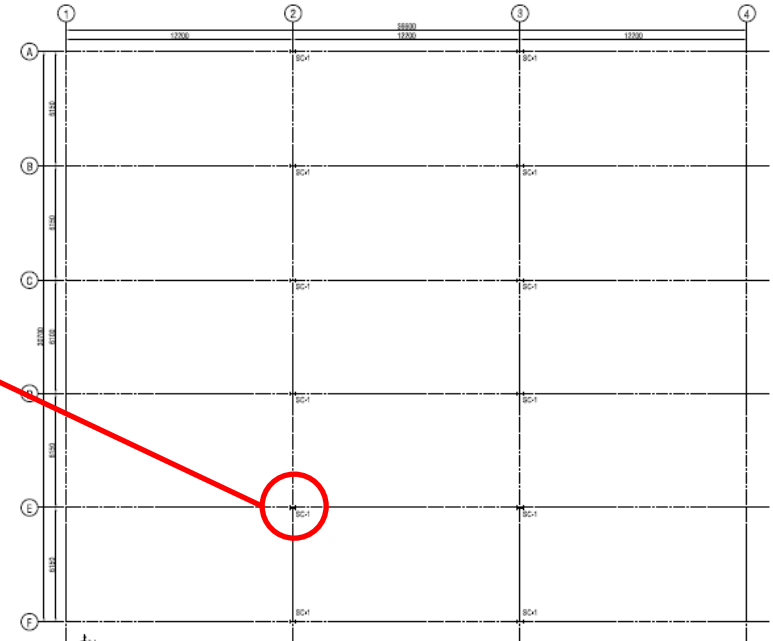
## Inadequate base plate connection

Column connection with base plate found apparently inadequate in grid E-2. Building Engineer is required to check the base plate connection with steel column.

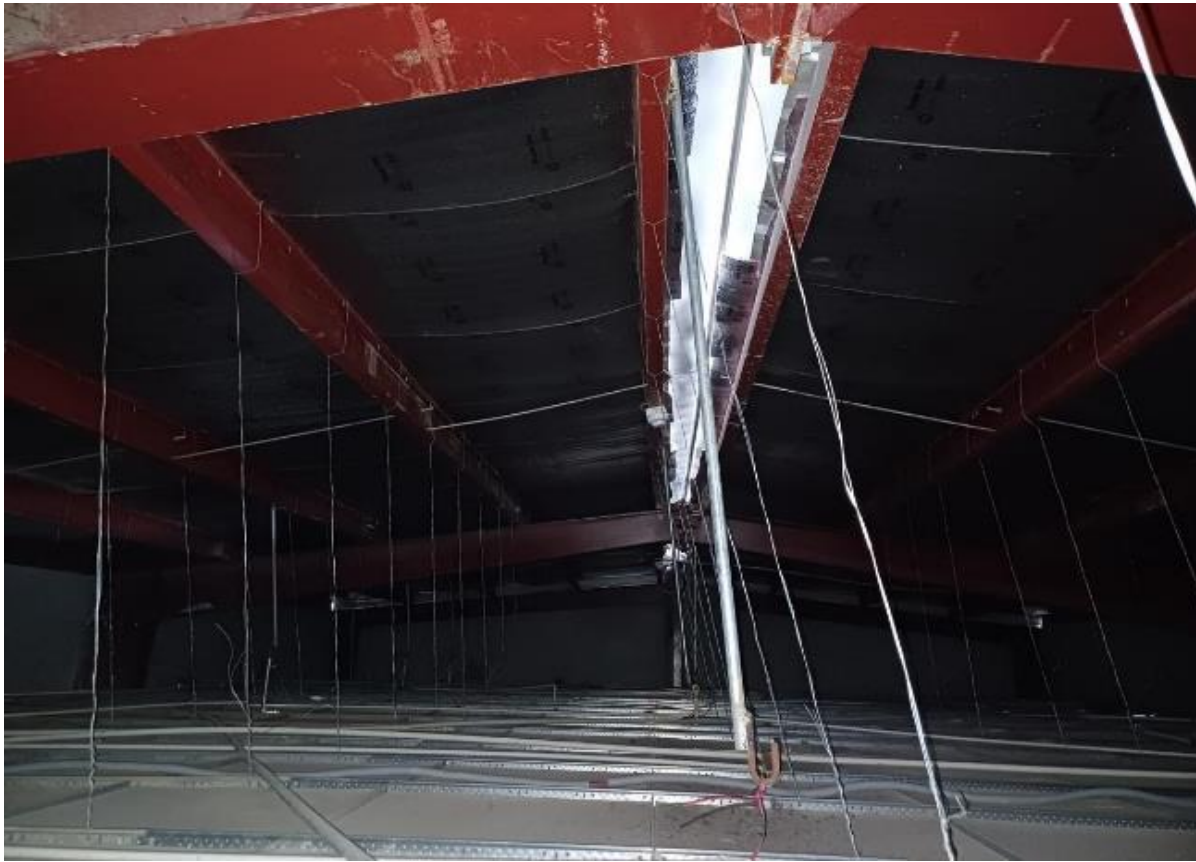
**Lack of lateral stability**

No load transfer media/bracing system is provided

Stability is provided through frame action only and load transfer media/bracing system is not provided for the structure. Building engineer is required to check the lateral stability system of the structure.

| Item No. | Observation | Recommended Action Plan | Recommended Timeline |
|---|---|---|---|
| 09 | Lack of lateral stability (Block H2-Single storied day care & medical shed) | Building engineer is required to check the lateral stability system of the structure. | 6-weeks |
| 10 | Lack of lateral stability (Block H2-Single storied day care & medical shed) | Carry out suggested remedial works if required. | 6-months |

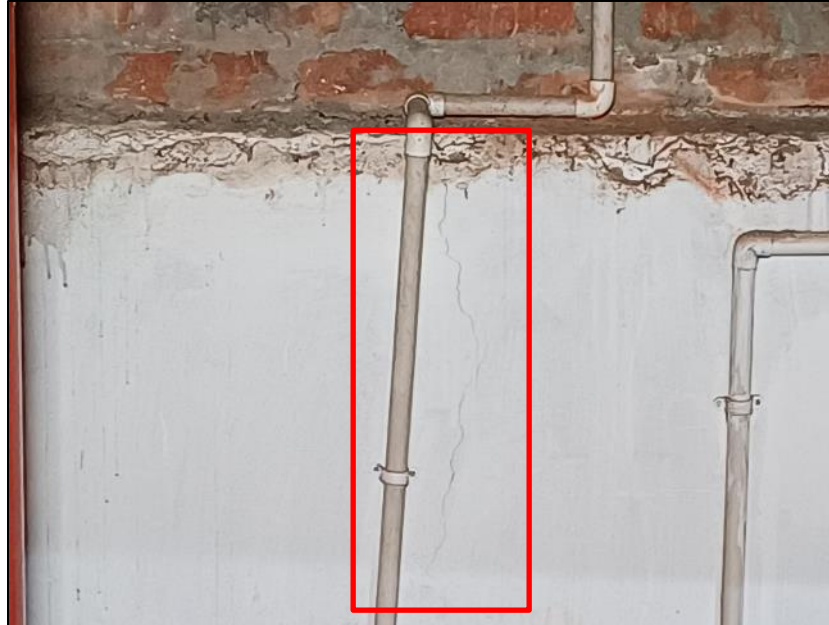
**Crack on retaining wall**

Retaining Wall Crack

Crack observed in the retaining wall. Building engineer is required to investigate the reason of crack and repair as per suggestion of investigation report.

| Item No. | Observation | Recommended Action Plan | Recommended Timeline |
|---|---|---|---|
| 11 | Crack on retaining wall (Block L-Fire pump room). | Building engineer is required to investigate the reason of crack and repair as per suggestion of investigation report. | 6-weeks |
