# FASHION FLASH LTD (Extension)

149, Shah Kabir Mazar Road, Azampur, Uttara, Dhaka  
(23.867832N, 90.412555E)  
4 September 2023

# Observation

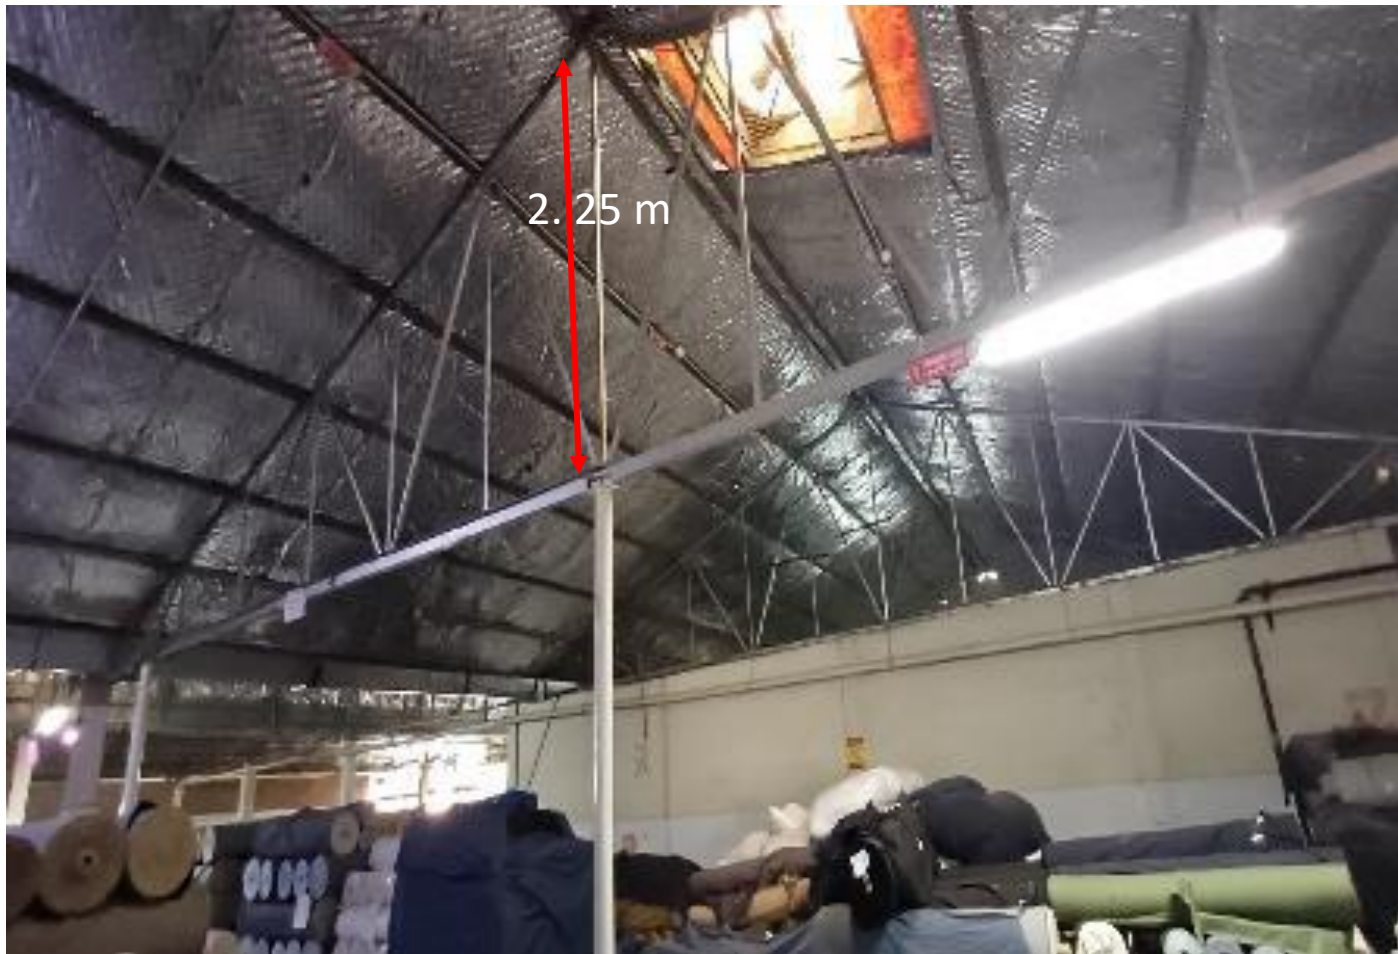
**Lack of stability of roof truss**

Absence of load transfer media (strut) and load resisting (bracing) system

No horizontal bracing and compression strut was found in the roof which indicates the lack of lateral stability of the roof trusses. Also, the truss member sizes seem to be inadequate. The building engineer is required to carry out Engineering Assessment (EA) to check the overall stability of the structure for lateral loading and suggest necessary remedial action accordingly.

| Item No. | Observation | Recommended Action Plan | Recommended Timeline |
|---|---|---|---|
| 01 | Lack of stability of roof truss. (Shed-1) | The building engineer is required to carry out Engineering Assessment (EA) to check the overall stability of the structure for lateral loading and suggest necessary remedial action accordingly. | 6-weeks |
| 02 | Lack of stability of roof truss. (Shed-1) | Carry out suggested remedial works. | 6-months |

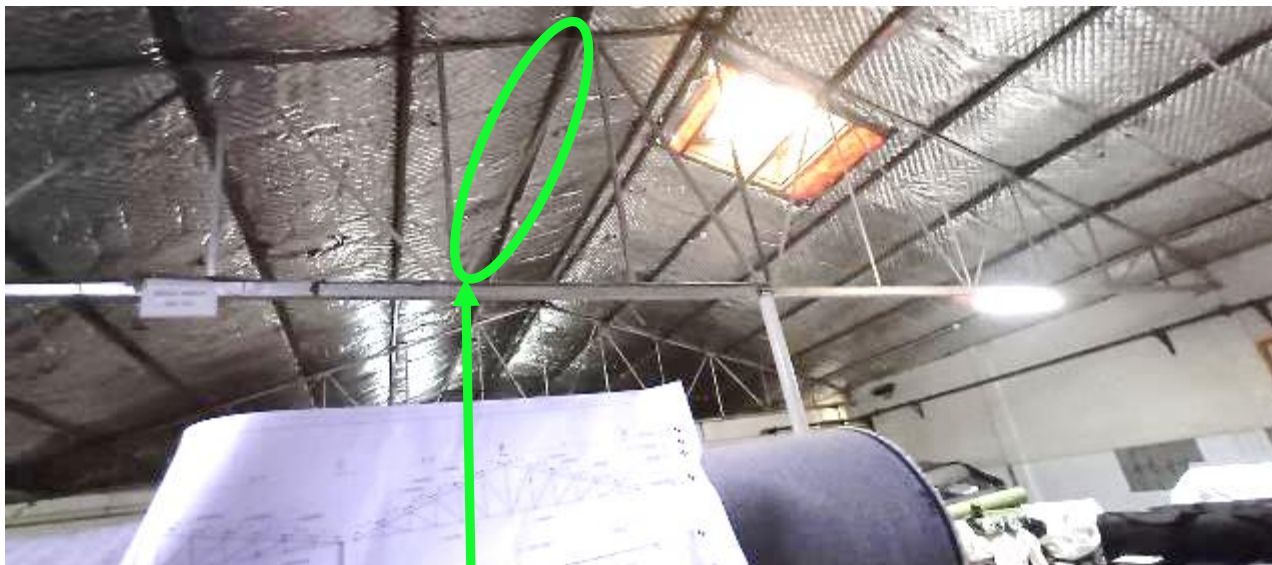
The orientation of diagonal chords not matched with provided drawing

Mismatch found in truss member arrangement. Also, connection details were missing in the provided drawing.

The building engineer is required to survey the whole structure and prepare as-built drawing as per on-site condition.

| Item No. | Observation | Recommended Action Plan | Recommended Timeline |
|---|---|---|---|
| 03 | Discrepancies and missing information in the provided drawing. (Shed-1) | Factory engineer is required to survey the whole structure and prepare as-built drawing as per on-site condition. | 6-weeks |

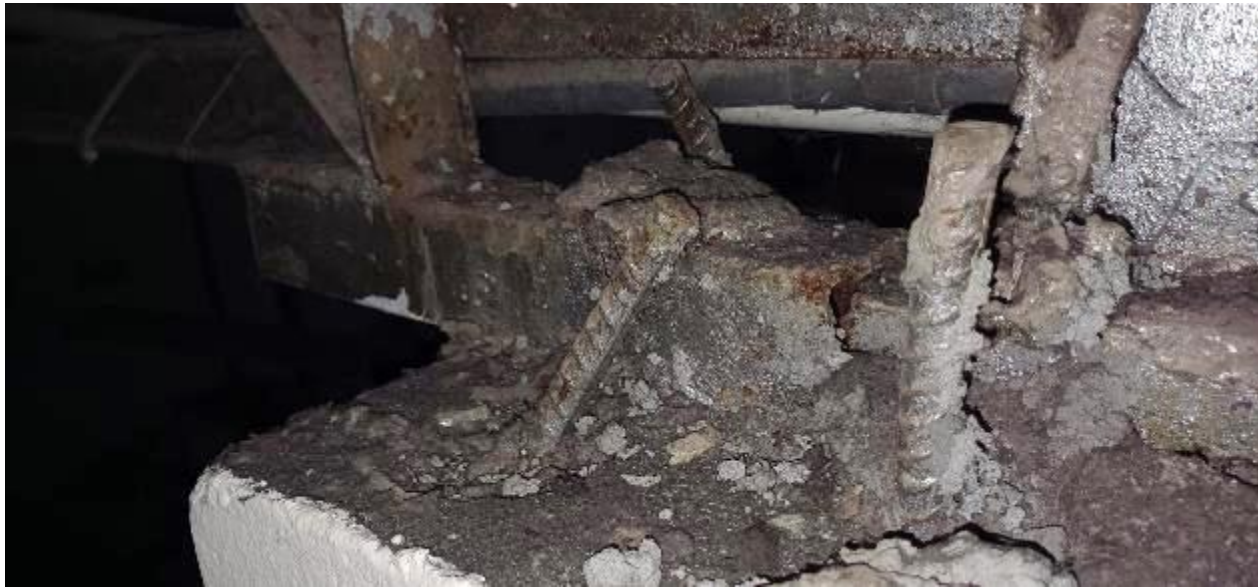
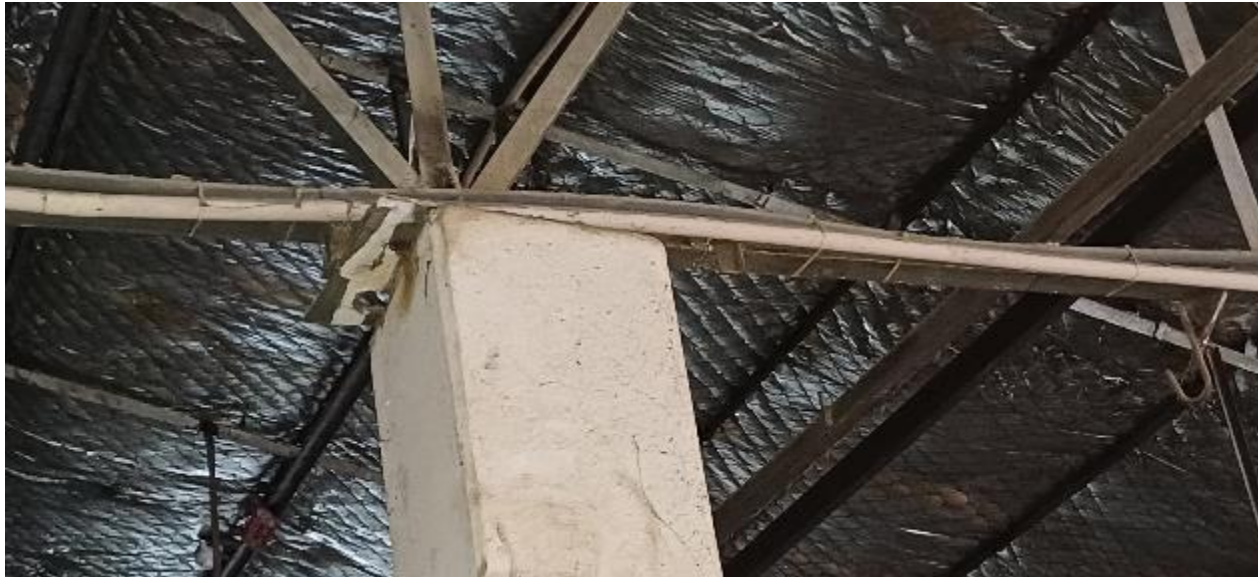
Connection of roof truss to RC column

Connection between steel members and RC column was apparently inadequate. No baseplate found for RC column to steel truss connection and truss members were welded arbitrarily with column rebar. Also, the truss was connected eccentrically to the RC column.

The building engineer is required to check the connection adequacy as part of Engineering Assessment (EA) and suggest proper alternatives.

| Item No. | Observation | Recommended Action Plan | Recommended Timeline |
|---|---|---|---|
| 04 | Apparently inadequate connection. (Shed-1) | The building engineer is required to check the connection adequacy as part of Engineering Assessment (EA) and suggest proper alternatives. | 6-weeks |
| 05 | Apparently inadequate connection. (Shed-1) | Carry out suggested remedial works. | 6-months |

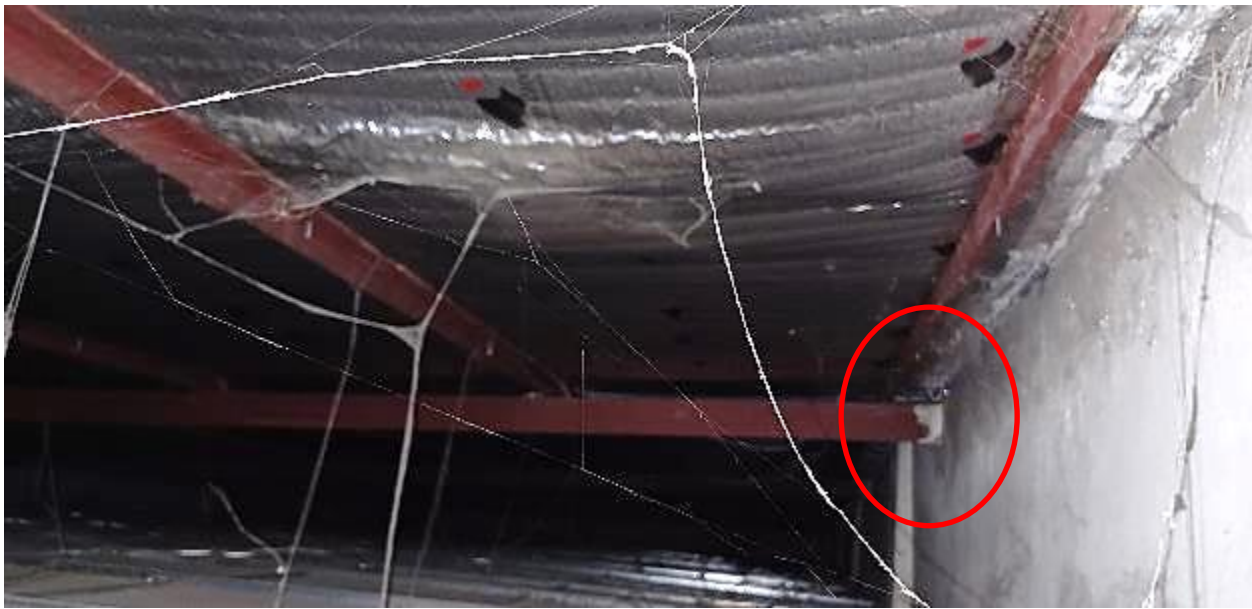
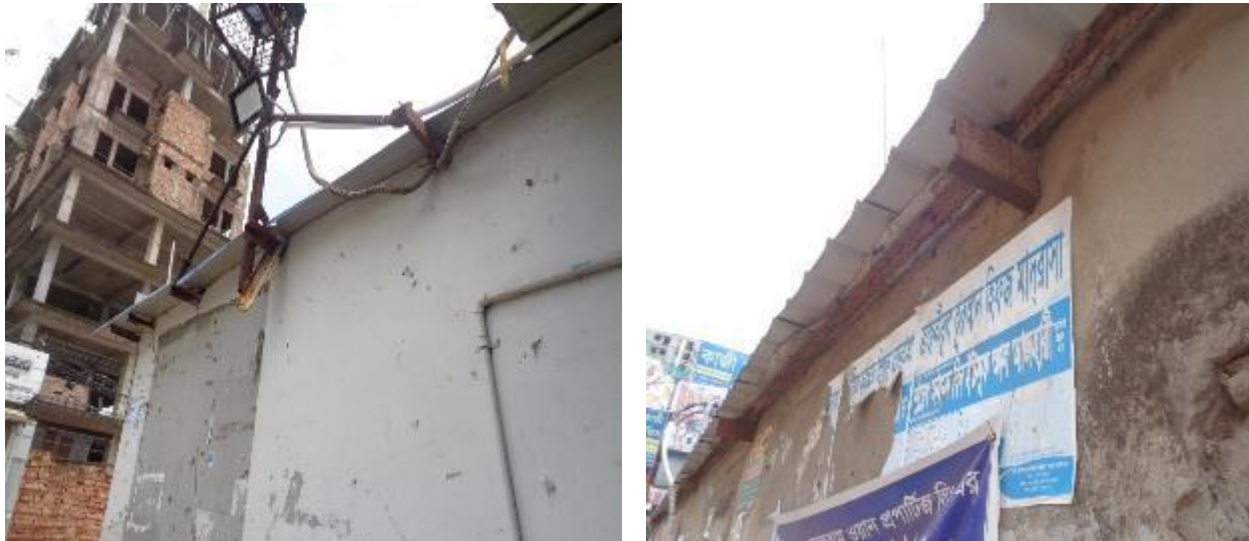
Connection of steel members and brick wall

Steel members inserted into the brick walls which appeared to be inadequate. The building engineer is required to check the connection between the steel members & brick walls and suggest necessary alternatives.

| Item No. | Observation | Recommended Action Plan | Recommended Timeline |
|---|---|---|---|
| 06 | Apparently inadequate connection. (Medical Shed) | The building engineer is required to check the connection between the steel members & brick walls and suggest necessary alternatives. | 6-weeks |
| 07 | Apparently inadequate connection. (Medical Shed) | Carry out suggested remedial works. | 6-months |

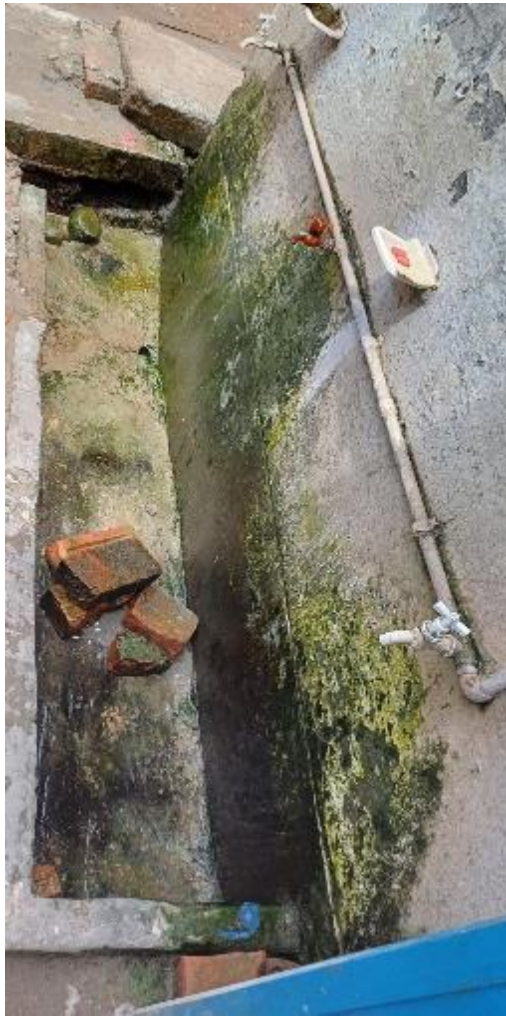
Dampness on wall at west

The building engineer is required to investigate the cause of cracks as well as source of dampness and suggest proper remedial actions accordingly.

| Item No. | Observation | Recommended Action Plan | Recommended Timeline |
|---|---|---|---|
| 08 | Dampness and cracks on brick wall. (Medical Shed) | The building engineer is required to investigate the cause of wall cracks as well as source of dampness and carry out proper remedial works accordingly. | 6-weeks |

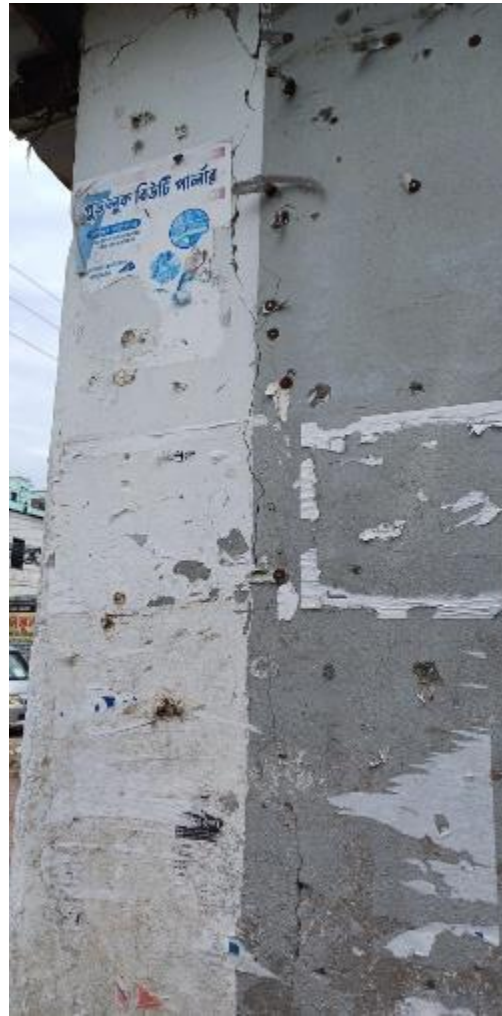
Crack on brick wall

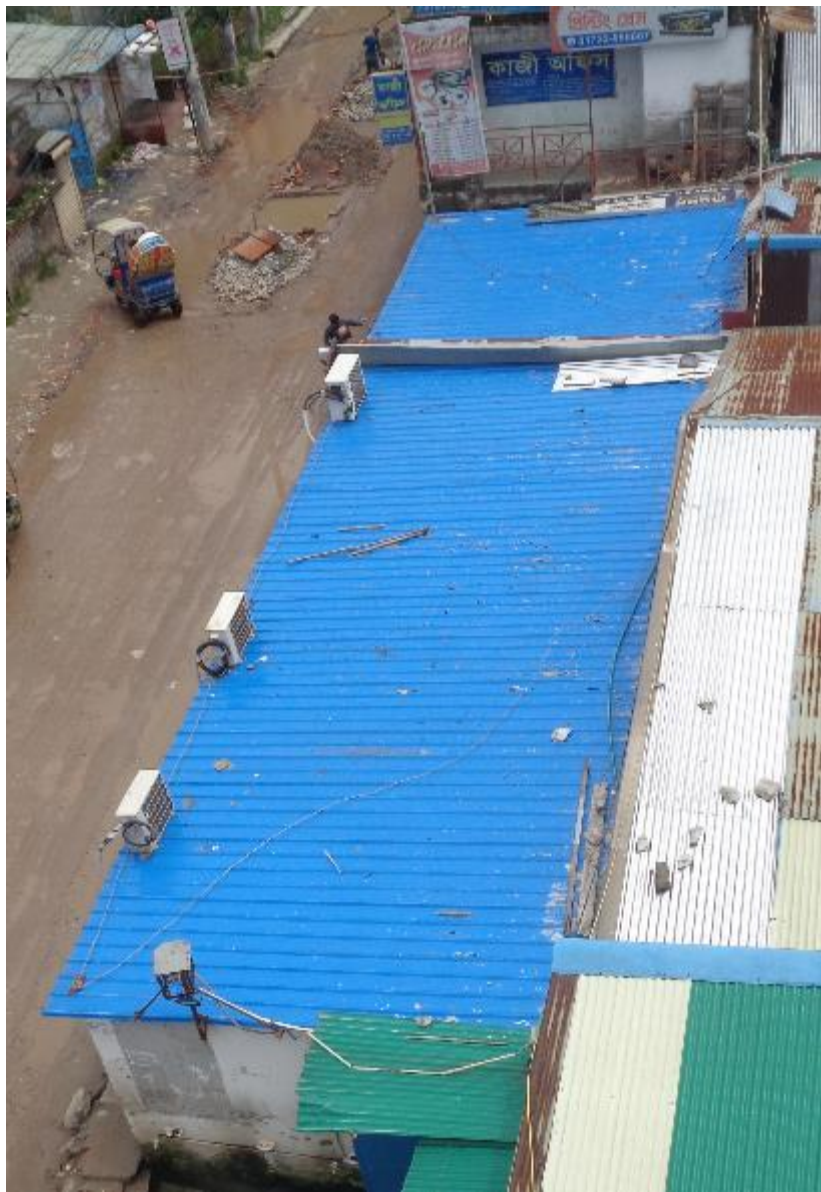
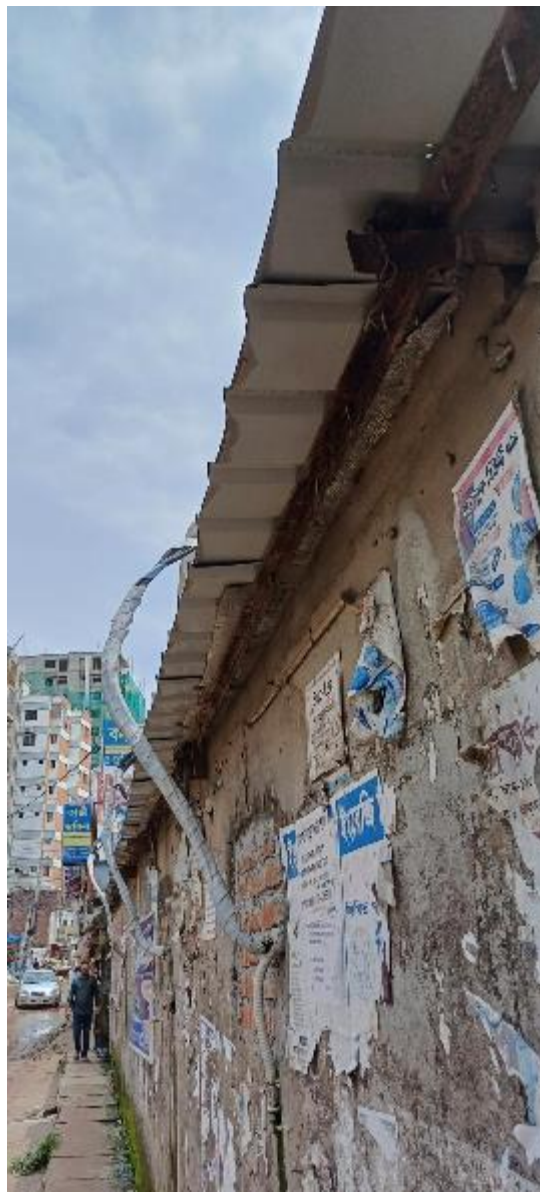
Medical Shed

At the time of inspection, approval drawing from local authority was not available for the Medical Shed. Factory is required to collect approval from the local authority for the structure.

| Item No. | Observation | Recommended Action Plan | Recommended Timeline |
|---|---|---|---|
| 09 | Absence of approval from local authority. (Medical Shed) | The factory is required to collect building permit from the local authority for the Medical Shed. | 6-months |
