# Shinest Apparels Ltd. (Extension)

217/1, Beribadh, Mohammadpur, Dhaka.

8 August 2023

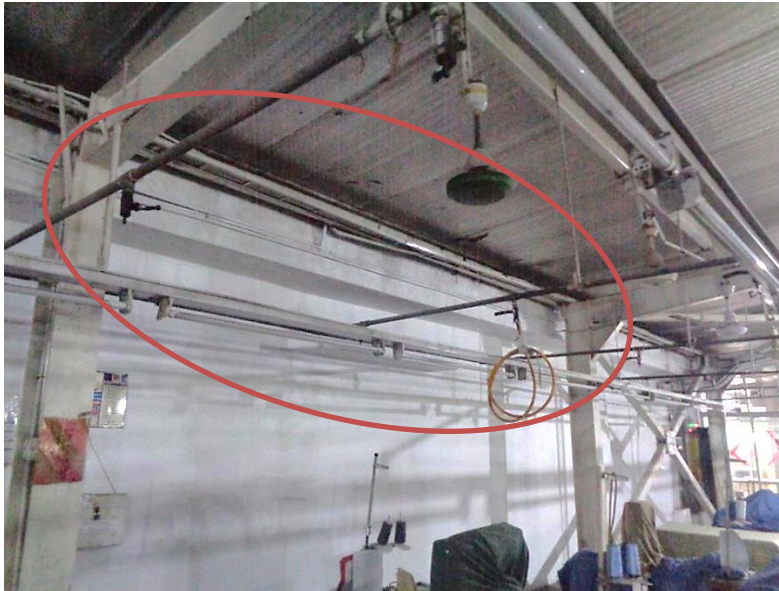
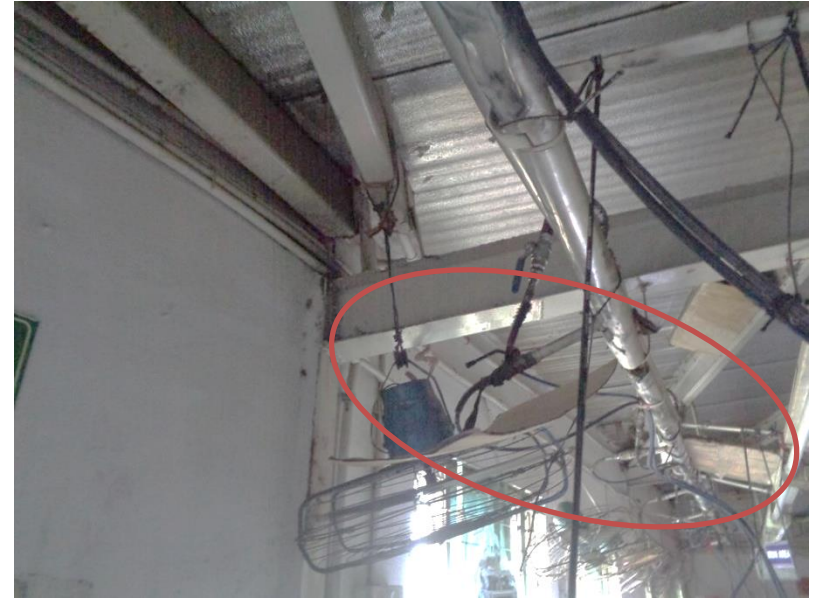
Missing compression strut along long direction

Compression struts were missing along long direction in 3<sup>rd</sup> floor. The lateral load path is incomplete in long direction. Building engineer is required to check the stability system of the structure for lateral loading and suggest necessary remedial actions where required.

| Item No. | Observation | Recommended Action Plan | Recommended Timeline |
|---|---|---|---|
| 01 | Lack of lateral stability system. (Building-2) | Building engineer is required to check the lateral stability of the structure and suggest necessary remedial actions accordingly. | 6-weeks |

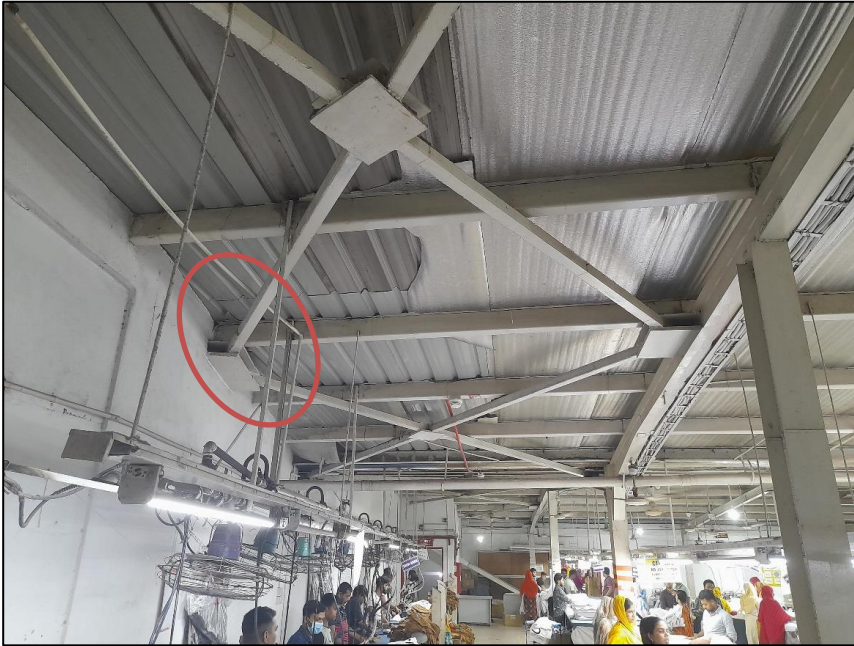
Connection plates inserted into adjacent RC building instead of steel edge rafter

Connection details of sub-beam with brick wall doesn't match with provided structural drawing. Building engineer is required to check the presence of edge rafter and update the as-built drawing as per onsite condition.

| Item No. | Observation | Recommended Action Plan | Recommended Timeline |
|---|---|---|---|
| 03 | Discrepancies in as-built drawing. (Building-2) | The building engineer is required to survey the structure and prepare accurate as-built drawings. | 6-weeks |

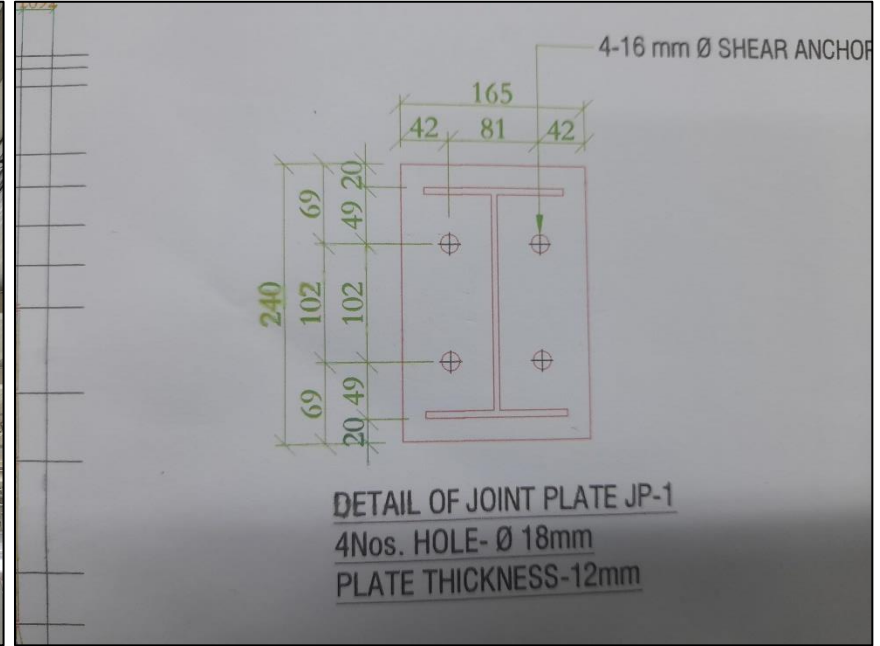
Connection details shown in structural drawing

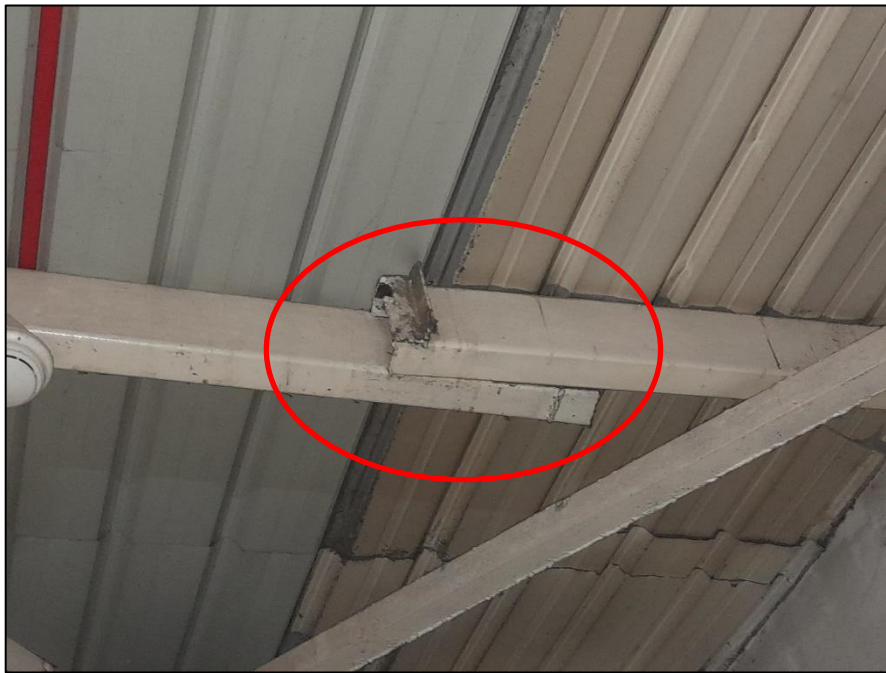
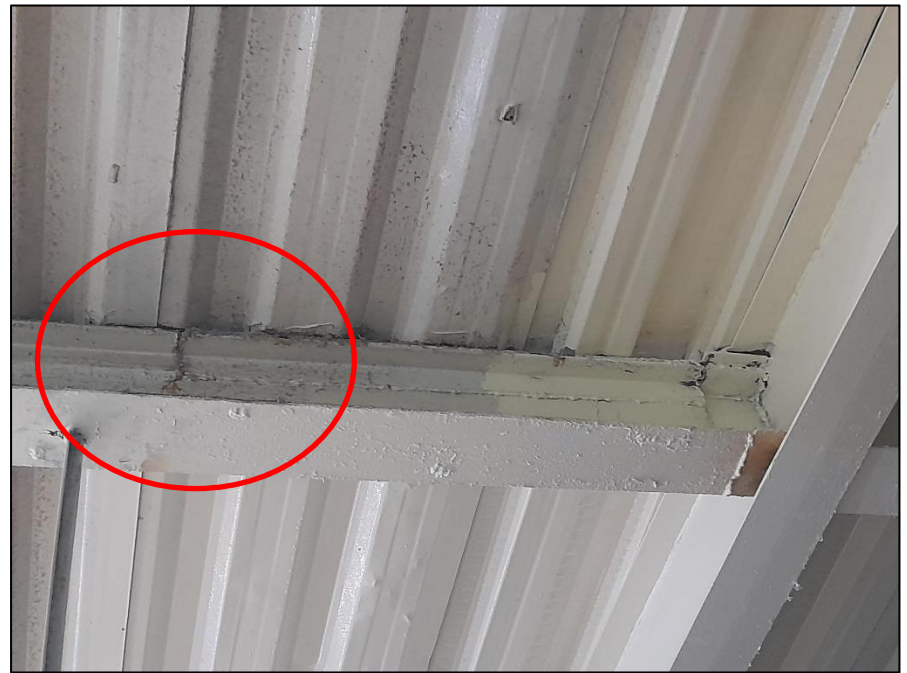
improper connections

During inspection, improper connection between different steel members was observed. In addition, lack of continuity plate in rafter-to-rafter connection was also observed.

The building engineer is required to check the connections adequacy as part of EA and repair all the steel members with proper remedial methodology.

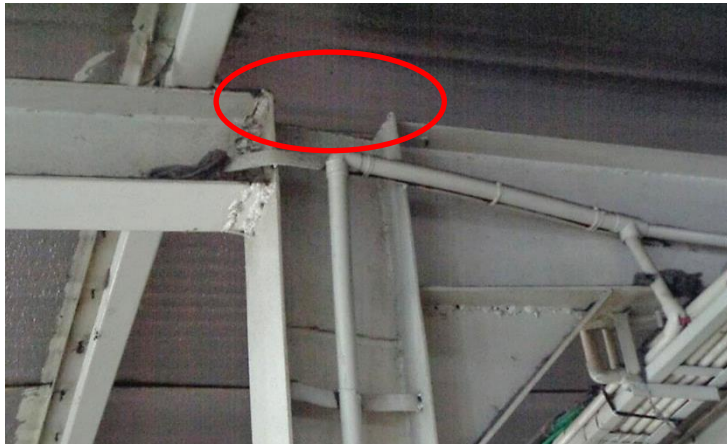
Lack of continuity plate

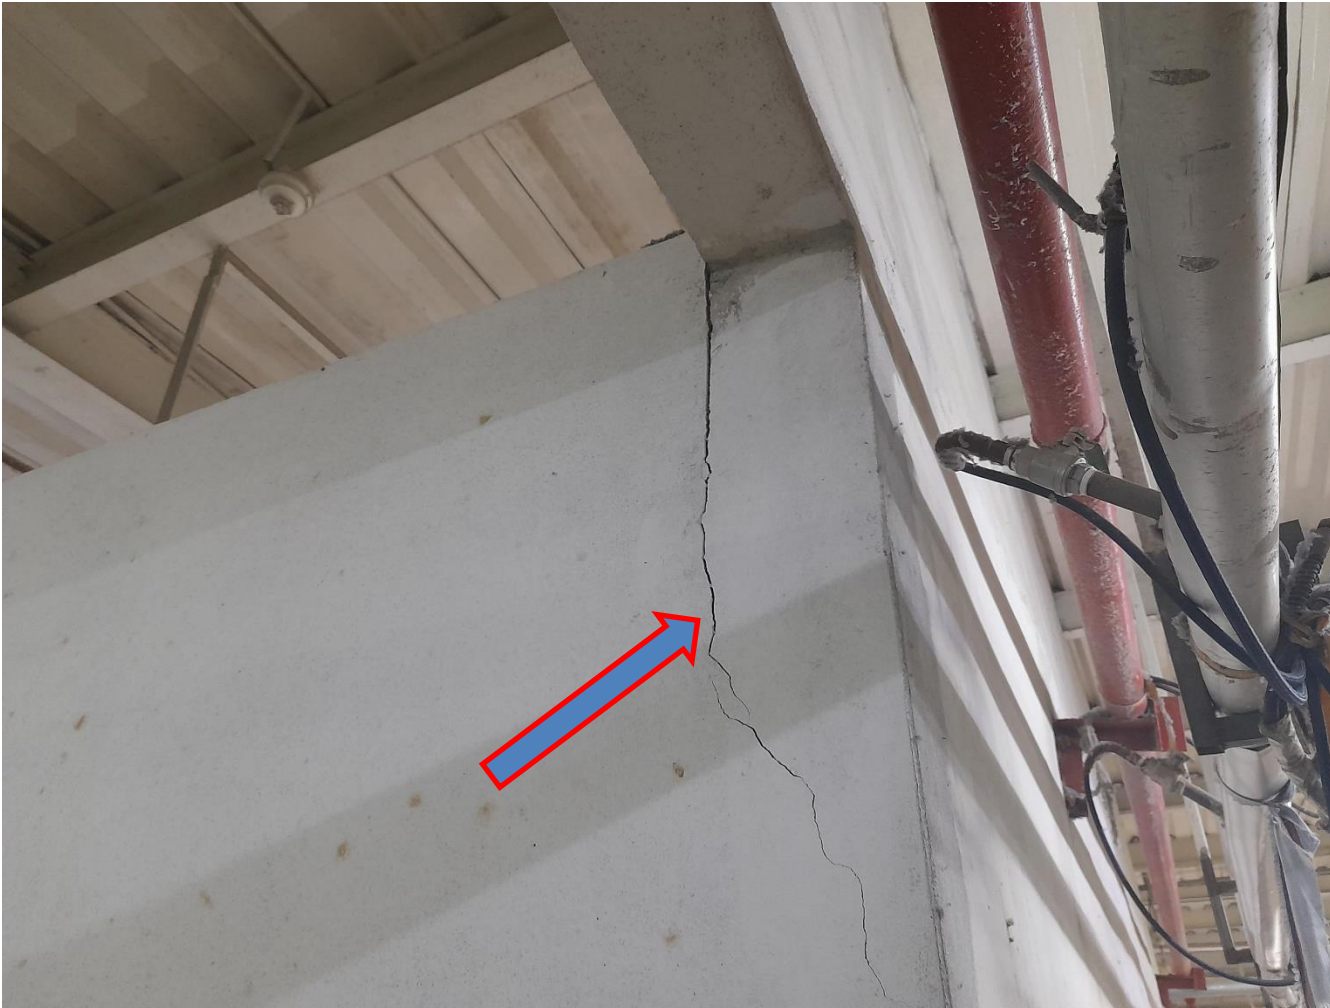
Crack observed in brick walls. The building engineer is required to identify the reason of crack and carry out suitable remedial works.

Crack in brick walls

| Item No. | Observation | Recommended Action Plan | Recommended Timeline |
|---|---|---|---|
| 06 | Crack in brick walls. (Building-2) | The building engineer is required to identify the reason of crack and carry out suitable remedial works. | 6-weeks |

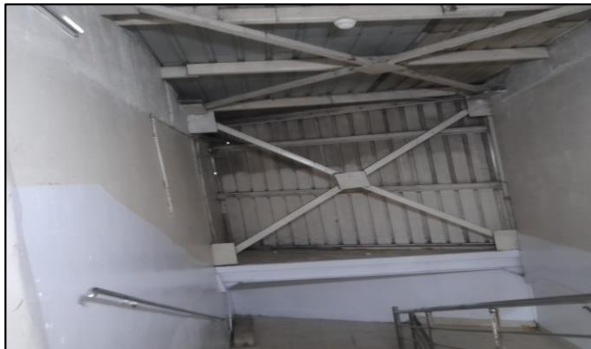
Bracing on 3<sup>rd</sup> floor not shown in the retrofitting drawing

The building engineer is required to survey the structure, prepare accurate as-built drawing and revise the design report based on updated as-built drawing.

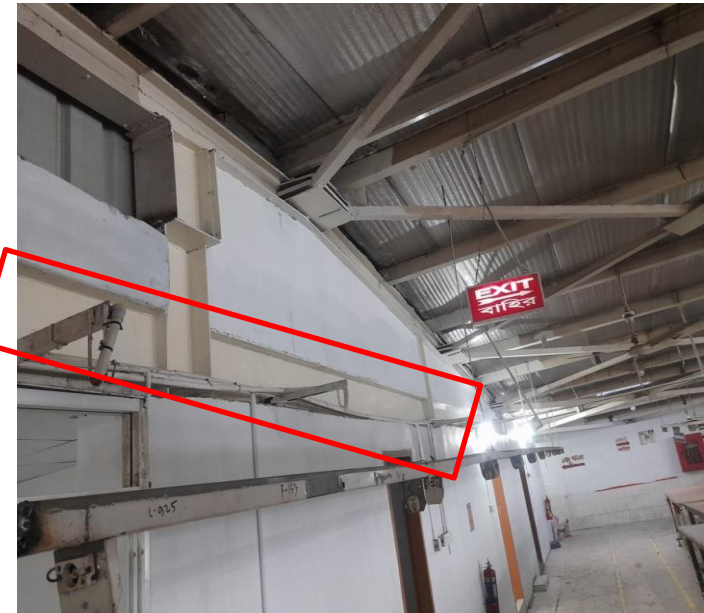
Beam of Grid-11: Not retrofitted

However, the building engineer is required to survey the structure, prepare accurate as-built drawing and revise the design report based on updated as-built drawing.

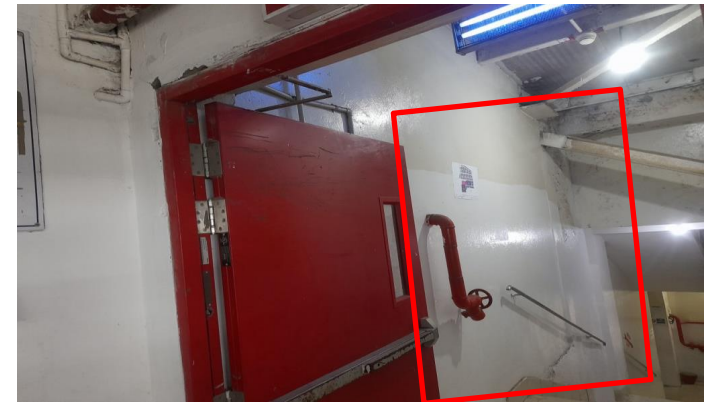
Vertical bracing at Grid-1-E~F near to 3<sup>rd</sup> floor stair could not identified.

Undocumented bracings of 3<sup>rd</sup> floor shall be incorporated in the drawing. Also, the presence of bracing at grid 1-E~F near stair zone to be investigated.

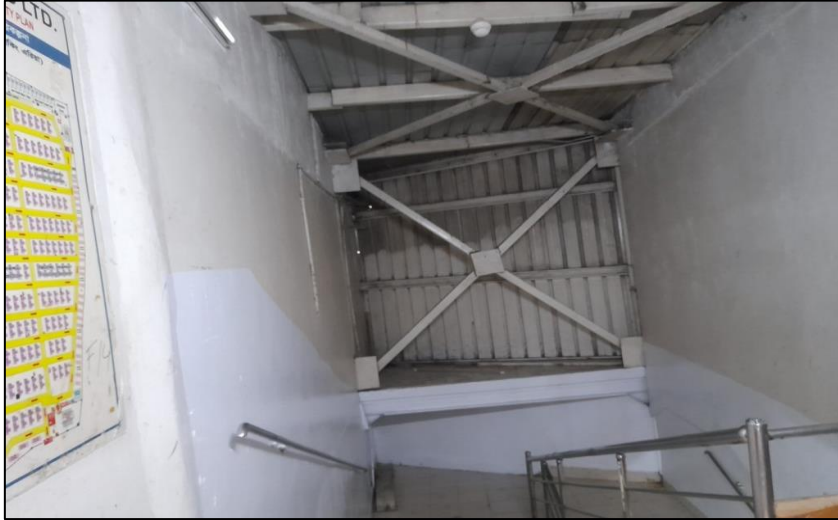
Bracing on 3<sup>rd</sup> floor not shown in the retrofitting drawing

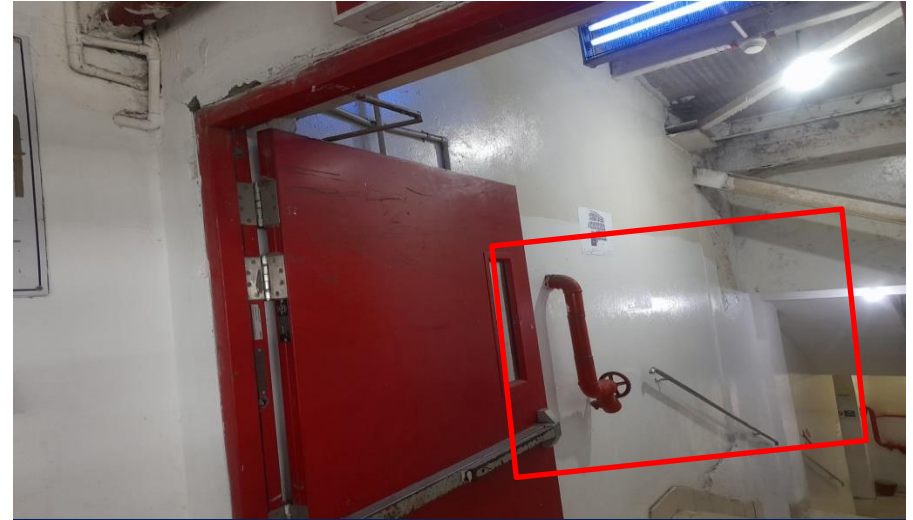
Wall bracing at Grid-1-E~F near to 3<sup>rd</sup> floor stair not found during the inspection.

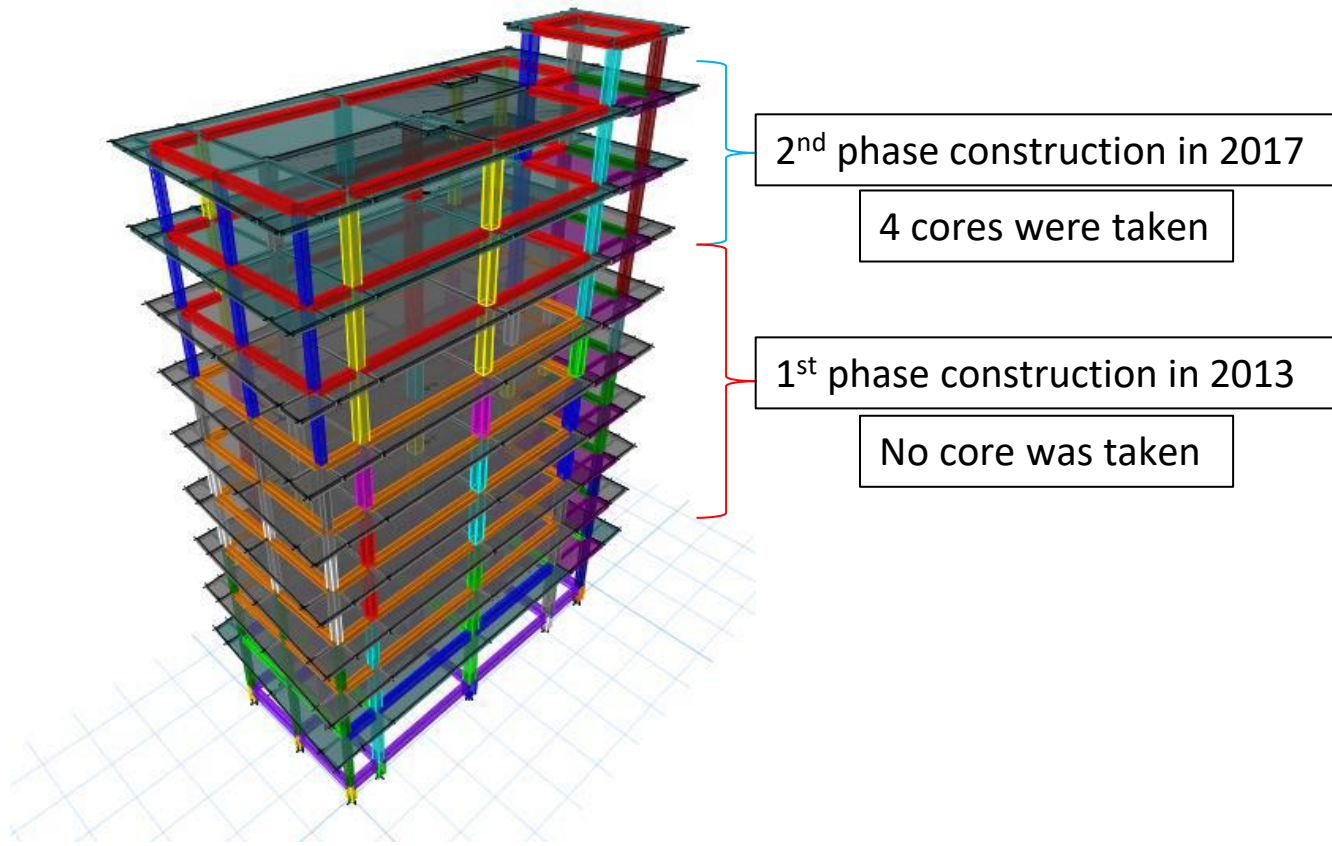
The building was constructed in two phases. The first phase construction was completed in 2013 and second phase construction was completed in 2017. 4 sets of concrete core test report from the columns of second phase construction.

The building engineer is required to take another 4 cores from the column of first phase construction. And revise the design report based on in-situ material strength.

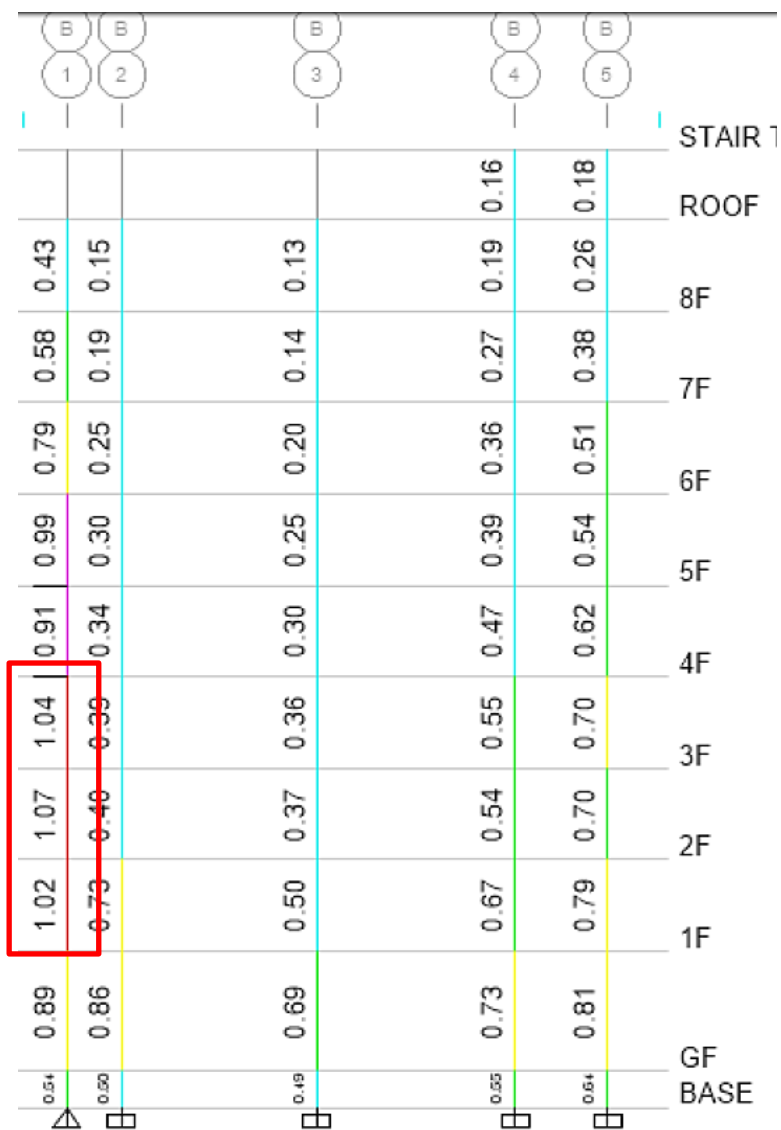
Figure 4.2.4: Condition of Column in Grid B

Stress ratio of column in design report

In the Design Report, RC material property considered  $f_y=72.5\text{ksi}$  (500 MPa) &  $f_c'=5.3\text{ksi}$  (36.6 MPa)

However, in the design report stress ratio of some column are exceeds normal design limit (PMM ratio > 1.00). Factory engineer is required to re-check the analysis and provide necessary alternative accordingly.

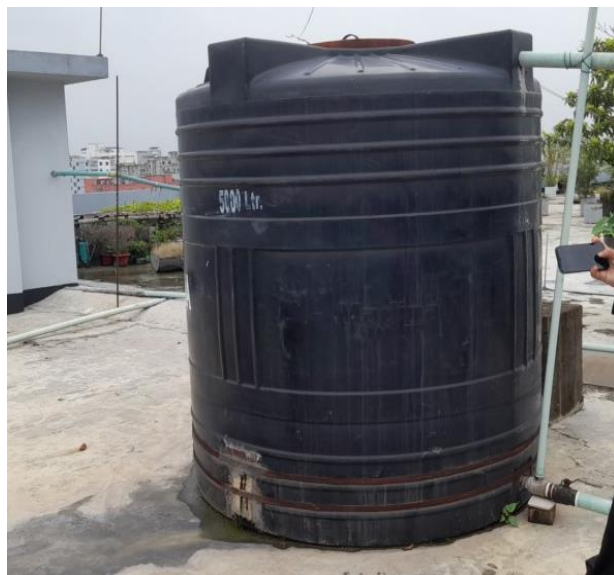
5000L water tanks on Roof

Water tank load and toilet wall & floor built-up loads are not considered in the drawings, floor load plan and design report.

The building engineer is required to incorporate the water tank and floor built-ups in the as-built drawing & floor load plan and revise the design report accordingly.

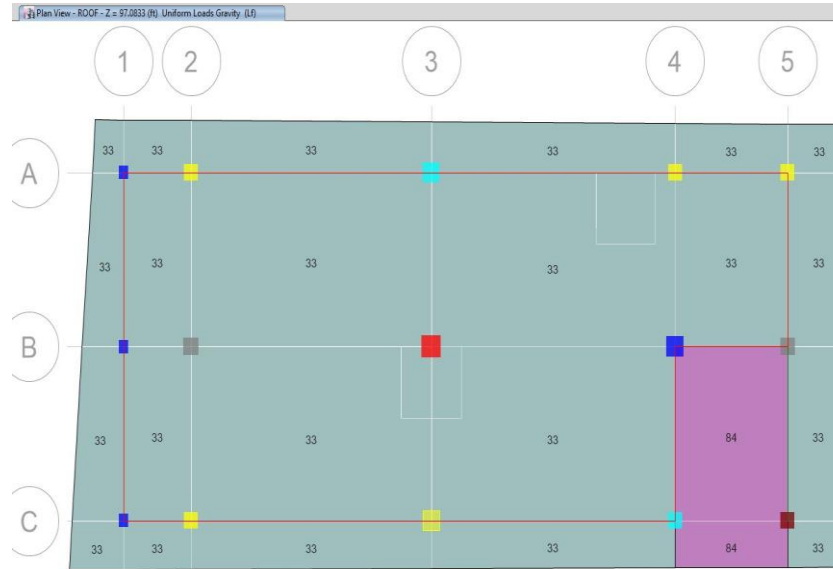
Roof load without water tank load

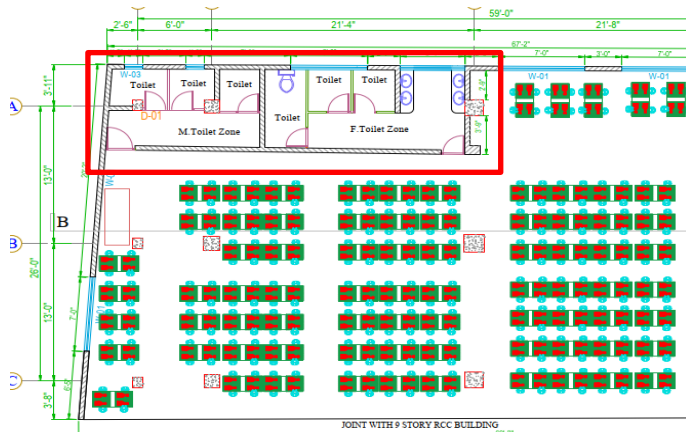
Toilet zone location on several floors

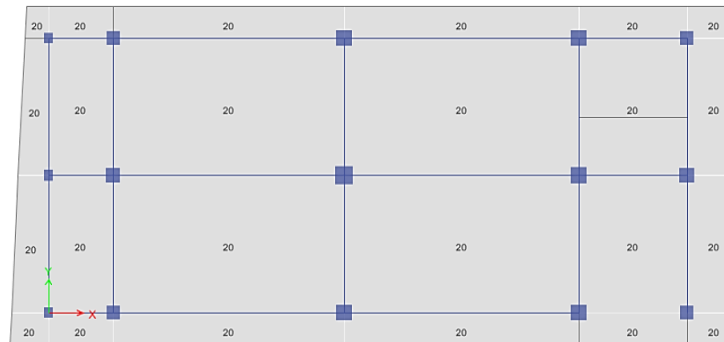
Figure 3.8.1: Applied Floor Finish in Typical Floor (20psf)

Only 1 kPa (20 psf) floor finish load considered in the model

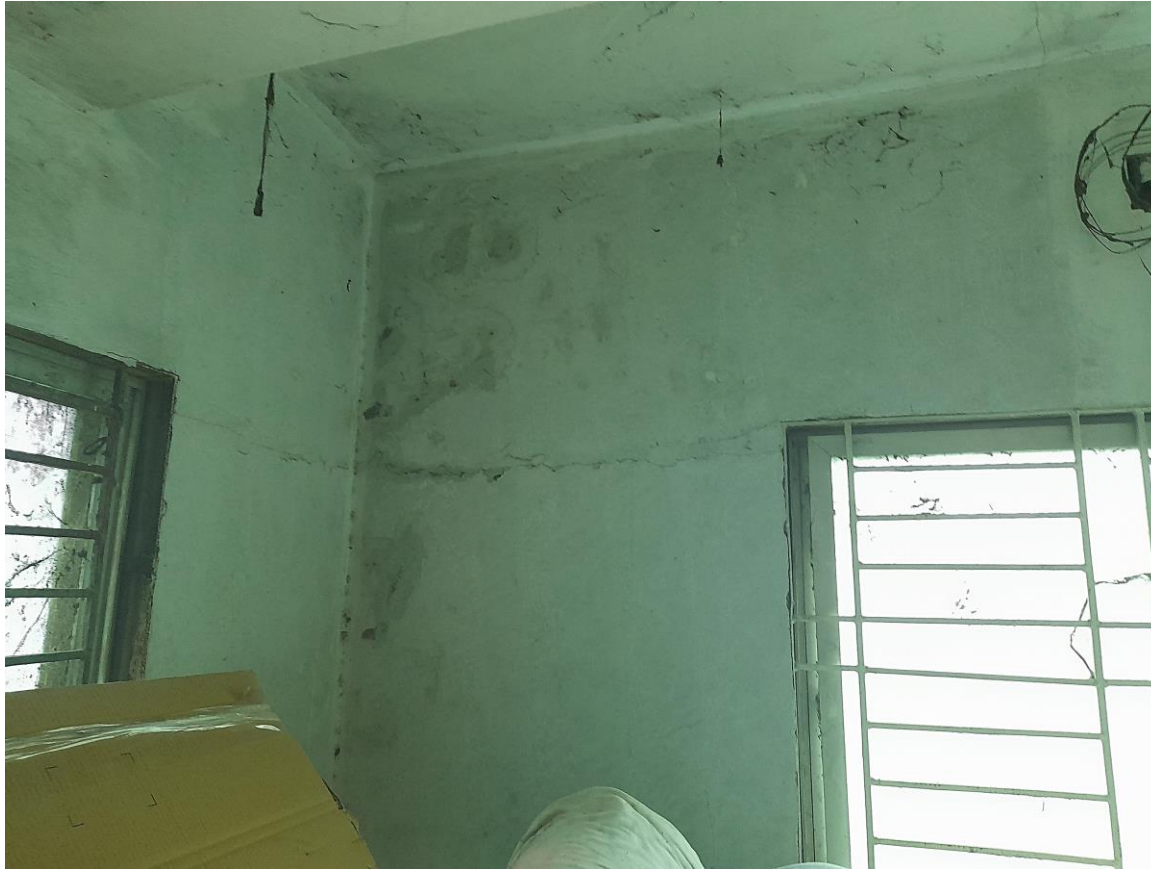
Dampness & crack on peripheral brick wall

During the inspection, dampness & non-structural crack observed on the peripheral wall. Factory engineer is required to repair cracks and dampness with the suggestion of the building engineer.

| Item No. | Observation | Recommended Action Plan | Recommended Timeline |
|---|---|---|---|
| 11 | Dampness & crack on peripheral brick wall. (Building-3A (9 Storied RC Building)) | Factory is required to repair the dampness and non-structural cracks with the suggestion of the building engineer. | 6-weeks |

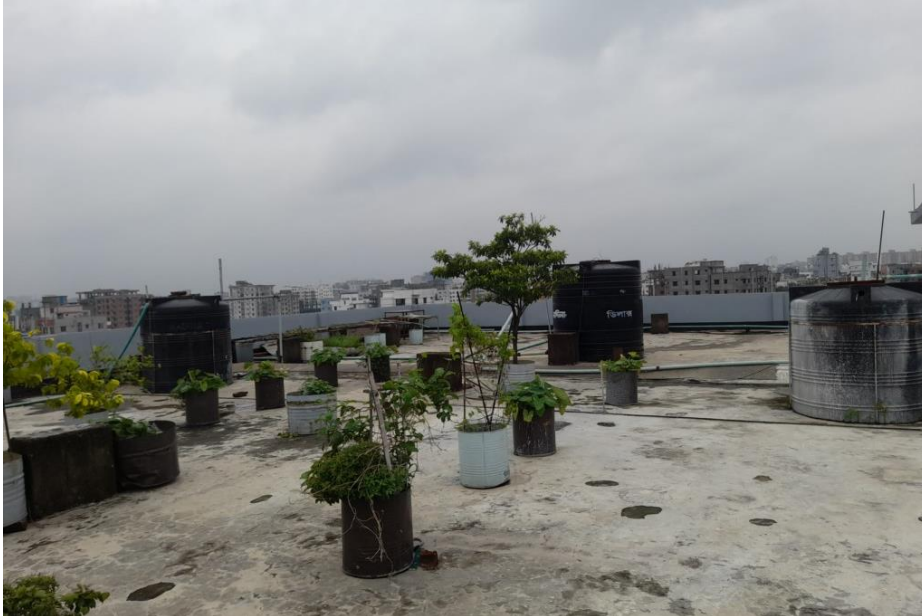
Two water tanks and gardening on the roof

In the design report and drawing roof live load was shown 33 psf (1.5 kPa). Two water tanks and gardening loads are not considered in the load plan and design report.

The building engineer is required to incorporate all the roof loads in drawing, load plan & design report.

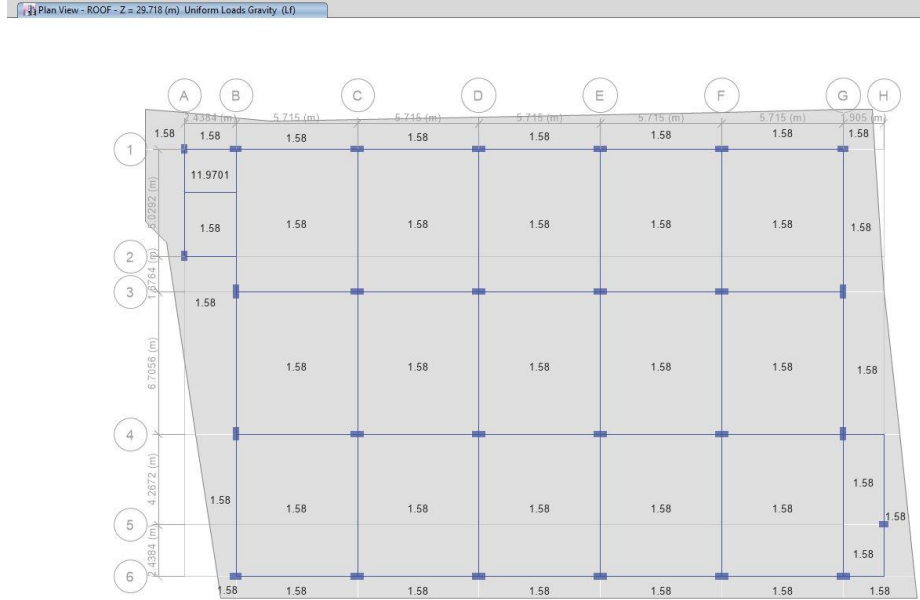
Roof load plan without tanks and gardening loads

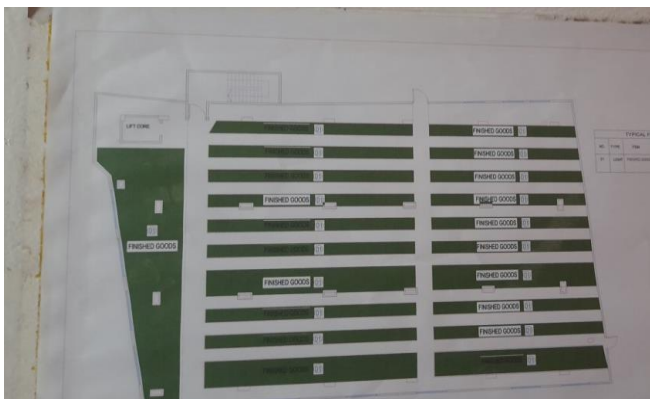
Maximum floor live load 2 kPa in the posted load plan

For storage area only 2 kPa (42 psf) floor live load is considered in the design and prepared floor load plan accordingly. But as per BNBC-2006 minimum storage live load is 6 kPa (125 psf). However, during the inspection at 2<sup>nd</sup> & 3<sup>rd</sup> floor storage live load was measured more than **3 kPa**.

The building engineer is required to revise the storage live load limit plan considering BNBC requirement and revise the structural analysis and design report accordingly.

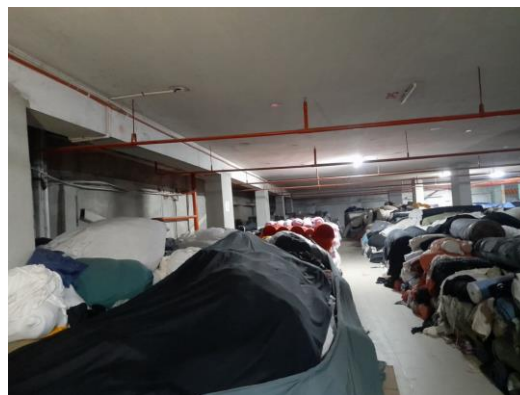
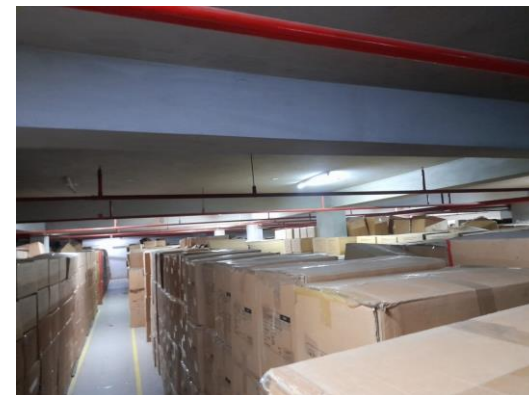
Loading on 2<sup>nd</sup> & 3<sup>rd</sup> floor was found around 4 kPa

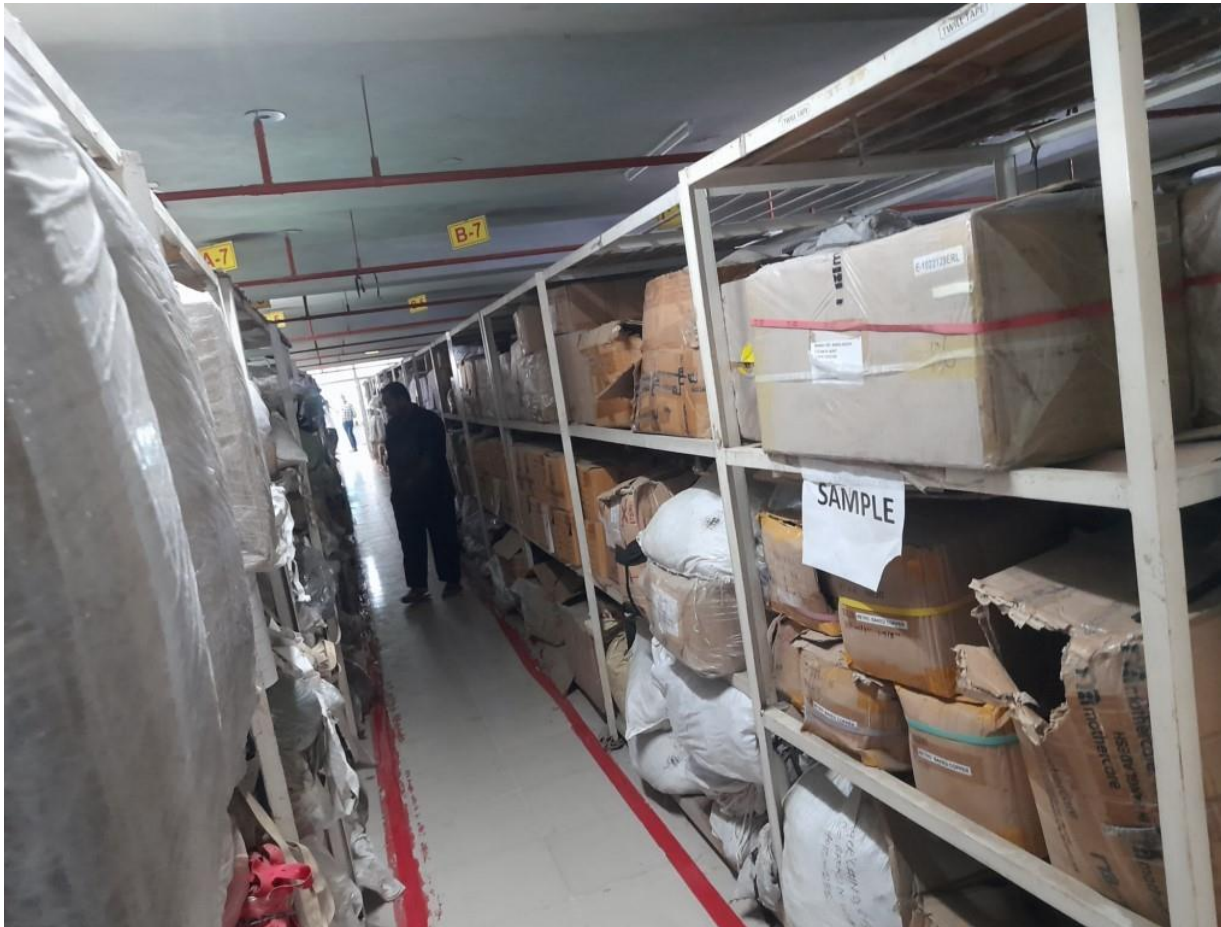
Storage rack found within the building without braced/anchored

Non-structural elements suspended from, attached to, or resting atop the structure shall be adequately anchored and braced to resist earthquake forces. Factory is required to brace/anchor all non-structural elements.

| Item No. | Observation | Recommended Action Plan | Recommended Timeline |
|---|---|---|---|
| 20 | Non-structural elements found unbraced/not anchored.<br>(Building-3B (Extension)) | Factory is required to brace/anchor all non-structural elements. | 6-weeks |

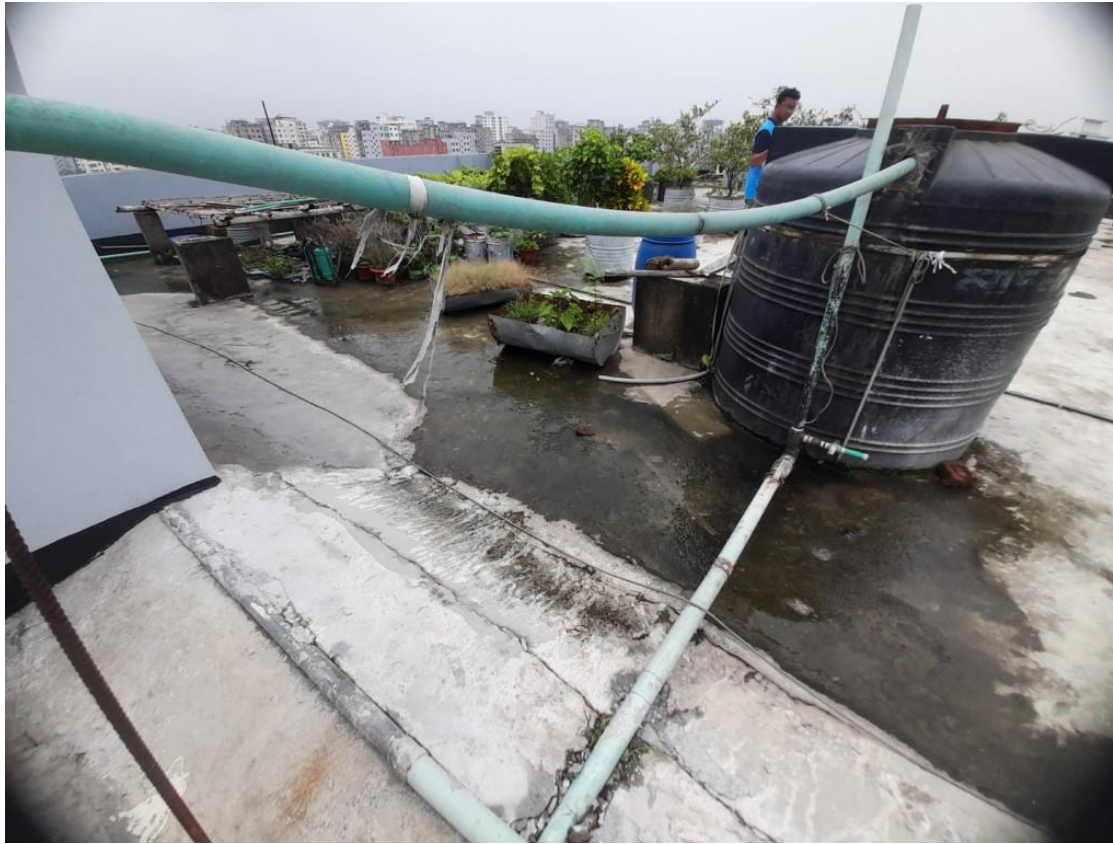
Water ponding on roof slab due to poor drainage system

Water ponding on roof slab due to poor drainage system. Aggregate of slab casting was observed as brick chips. Factory is required to improve drainage system and apply water proofing layer on roof slab.

| Item No. | Observation | Recommended Action Plan | Recommended Timeline |
|---|---|---|---|
| 21 | Water ponding on roof.<br>(Building-3B (Extension)) | Factory is required to improve drainage system and apply water proofing layer on the roof slab. | 6-weeks |

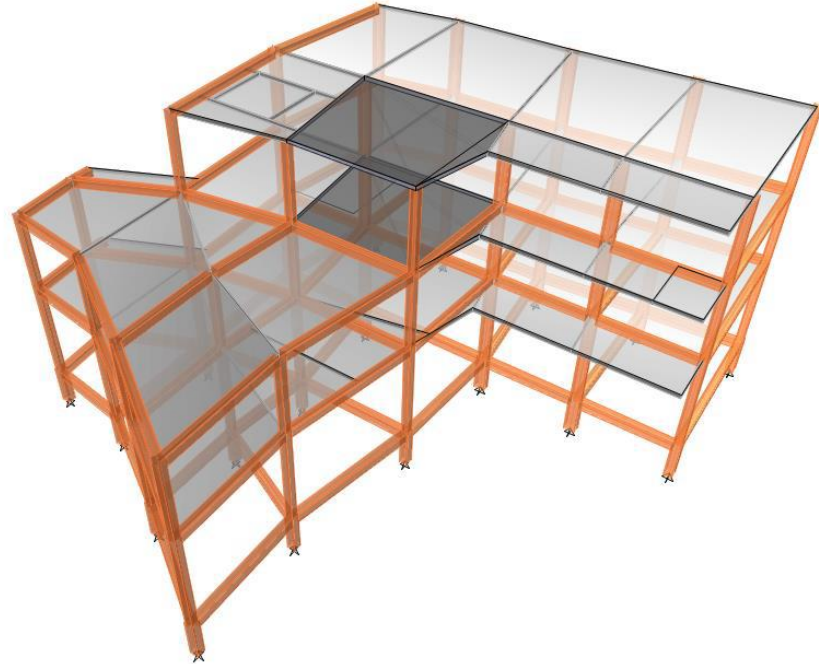
Irregular building shape and flat slab system

The building shape is irregular building shape and framing is column-flat slab system. Displacement check has not been incorporated in the design report. The building engineer is required to revise the design report for the lateral displacement check.

| Item No. | Observation | Recommended Action Plan | Recommended Timeline |
|---|---|---|---|
| 22 | Design report to be revised.<br>(Building-4) | The building engineer is required to revise the design report for the slab punching and lateral displacement check. | 6-weeks |
