# Arbella Fashion Limited

6 August 2023

# Observation

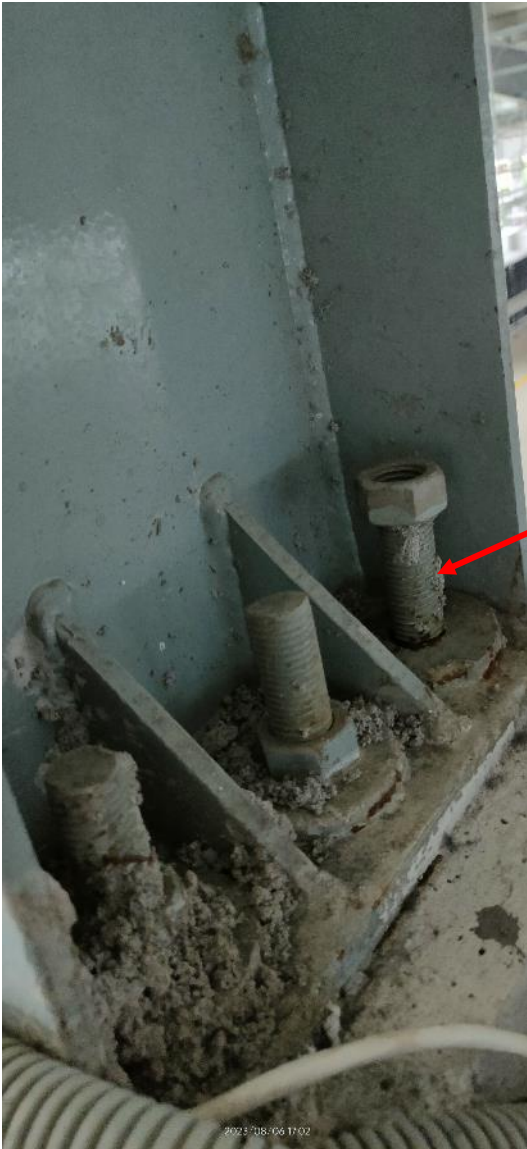
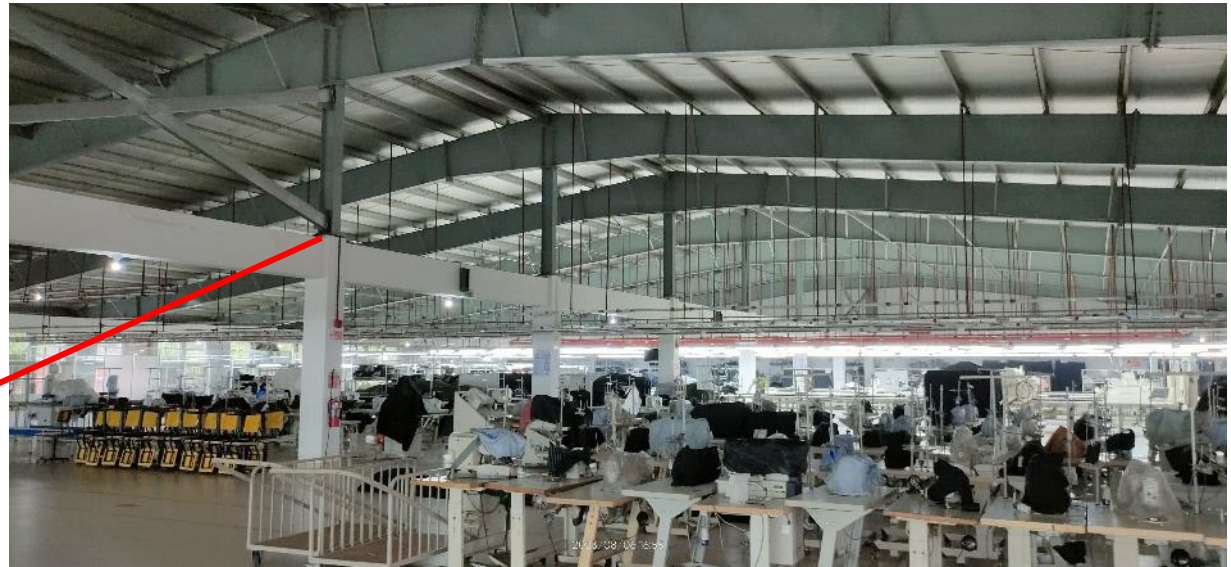
**Loosen bolt in baseplate**

Loose bolt in baseplate

## Observation: Building-1 (Factory Building)

The factory is required to check all the connections and tight the loose bolt accordingly.

| Item No. | Observation | Recommended Action Plan | Recommended Timeline |
|---|---|---|---|
| 01 | Loosen bolt in baseplate.<br>Building-1 (Factory Building) | The factory is required to check all the connections and tight the loose bolt accordingly. | 6-weeks |

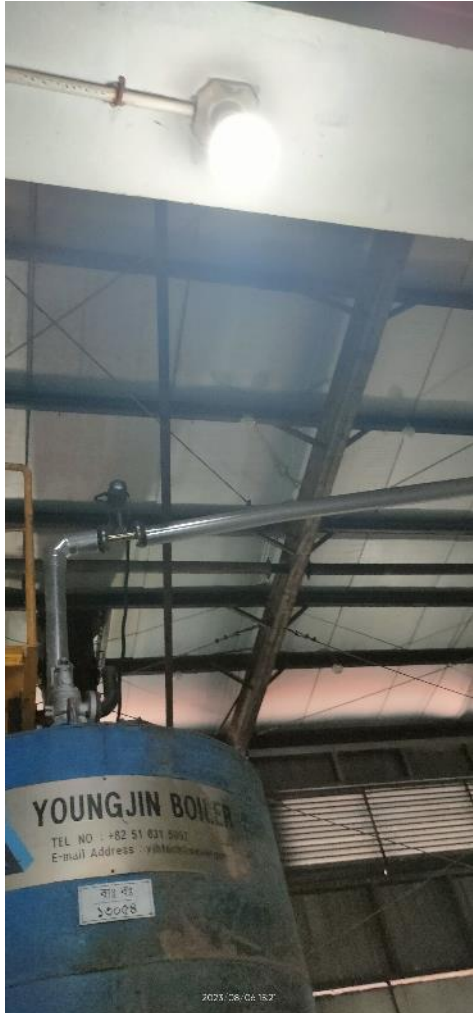
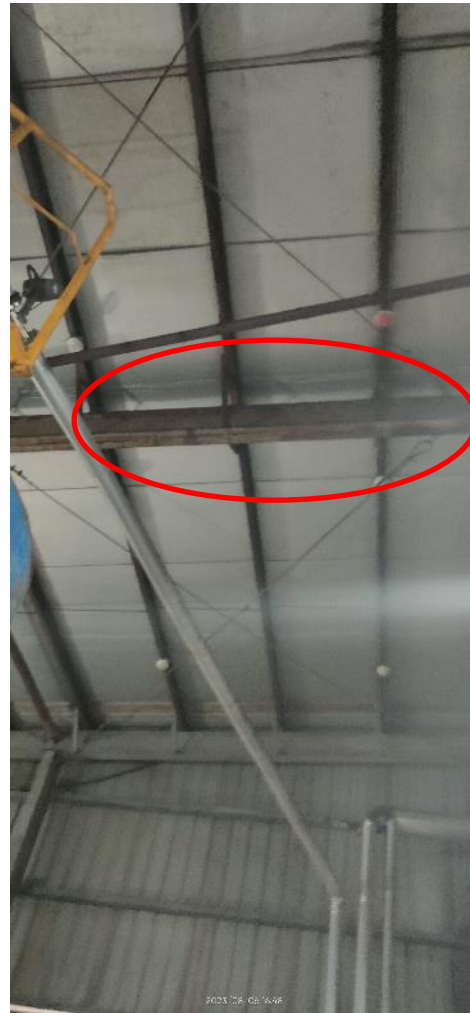
# **Corrosion in steel member**

Corrosion observed in the steel rafter. The factory is required to provide corrosion resistance coating to the steel members.

Corrosion in steel part of Building-3 (Boiler Building)

| Item No. | Observation | Recommended Action Plan | Recommended Timeline |
|---|---|---|---|
| 02 | Corrosion in steel member.<br>Building-3 (Boiler Building) | The factory is required to provide corrosion resistance coating to the steel members. | 6-weeks |

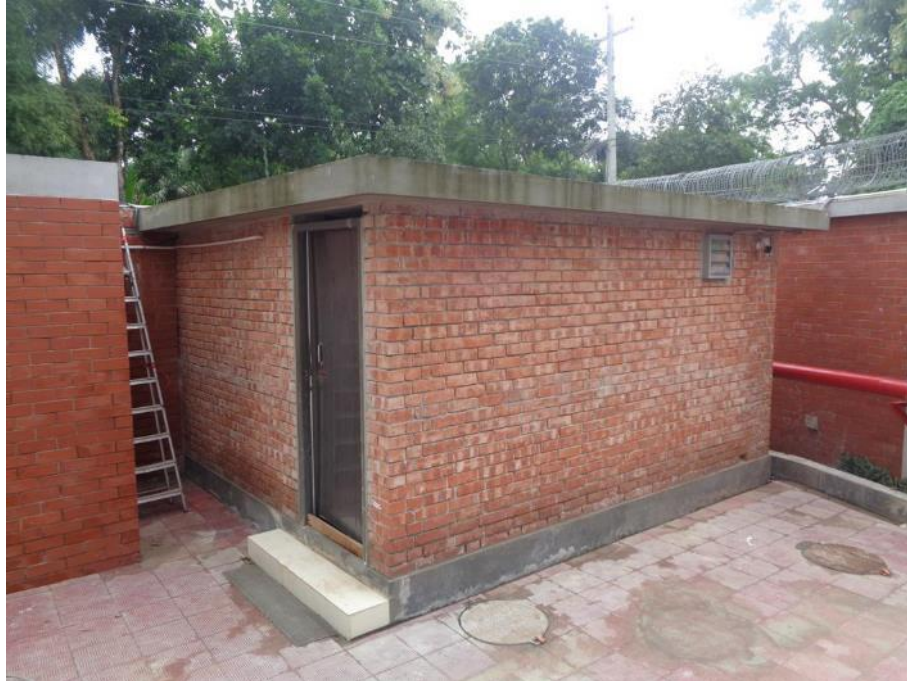
# Undocumented structure

Undocumented structure

## Observation: Building-7 (Rest Room)

The building engineer is required to prepare as-built drawing for the building.
