# Comfit Composite Knit Ltd (Extensions 2)

Gorai, Mirzapur, Tangail  
(24.163342, 90.419976)  
8 May 2023 & 30 May 2023

# Building Information

# Observations

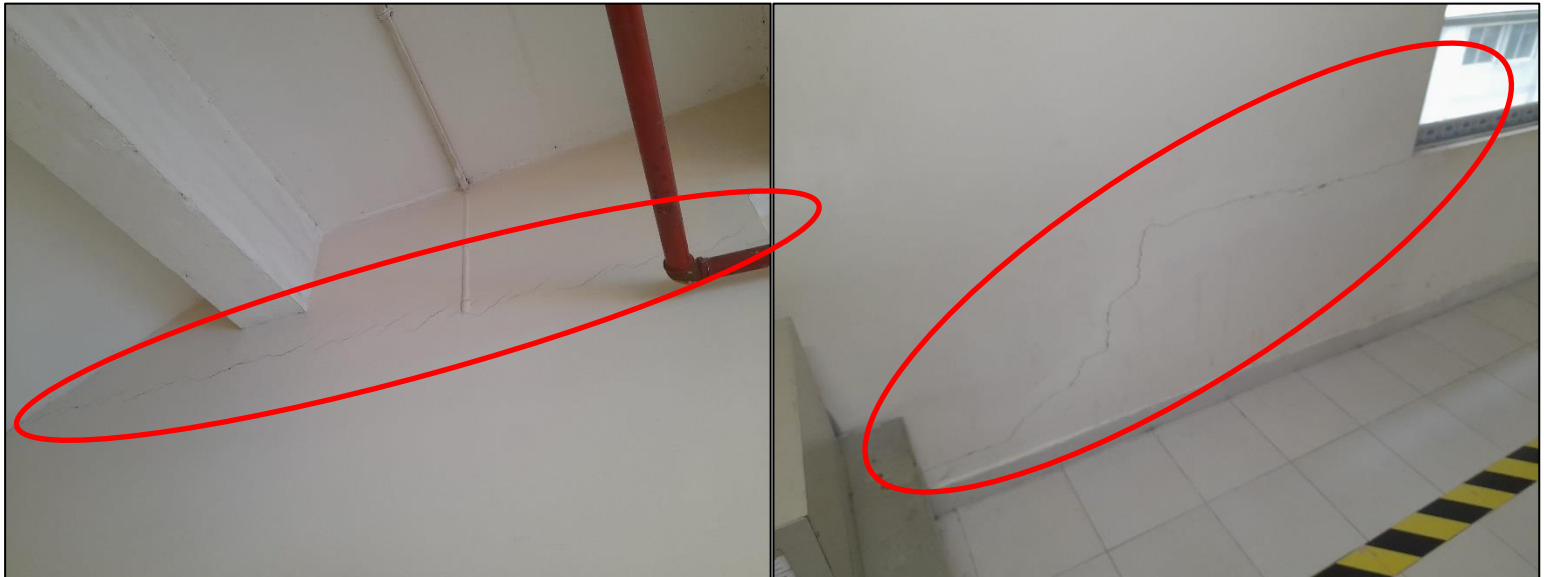
**Crack on brick wall**

Crack was observed on brick wall at several locations

Factory engineer is required to repair the cracked surface with a suitable method.

| Item No. | Observation | Recommended Action Plan | Recommended Timeline |
|---|---|---|---|
| 04 | Crack on brick wall (Banana Leaf Building) | Building engineer is required to check the reason of crack and repair the cracked surface with a suitable method. | 6-weeks |

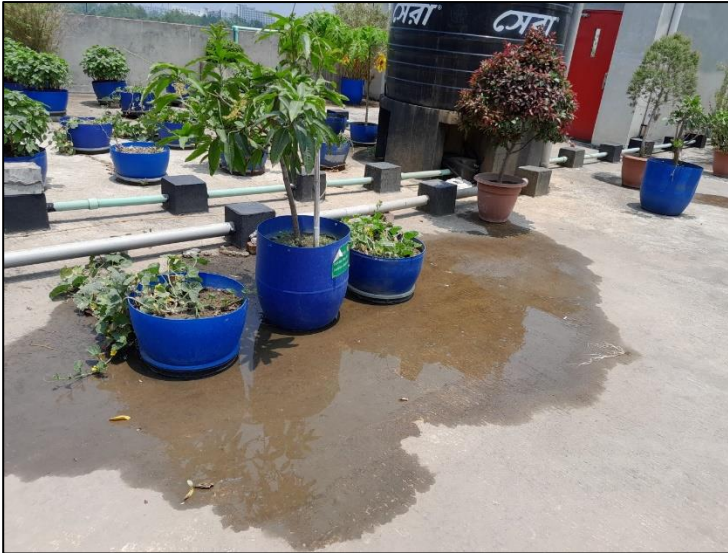
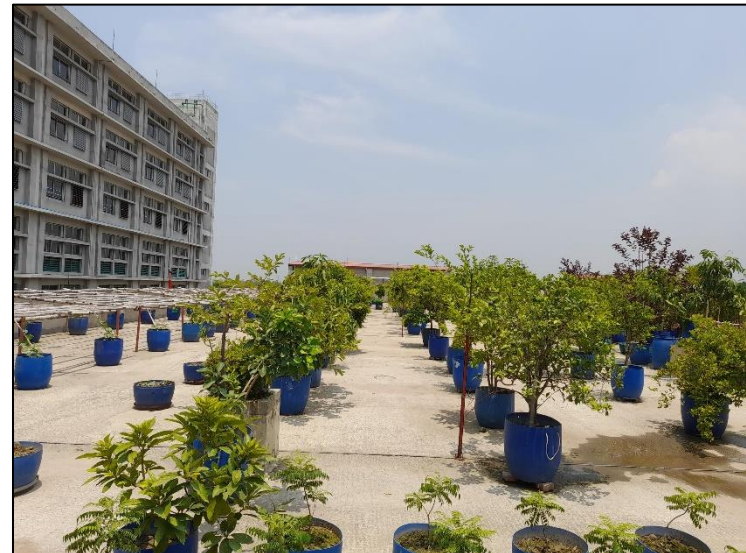
## **Water ponding on roof slab**

Water ponding on roof slab

Water ponding was observed on roof slab. Factory is required to improve drainage system on roof slab.

| Item No. | Observation | Recommended Action Plan | Recommended Timeline |
|---|---|---|---|
| 05 | Water ponding on roof slab (Banana Leaf Building) | Factory is required to improve the roof drainage system with adequate slope and water outlets. | 6-weeks |

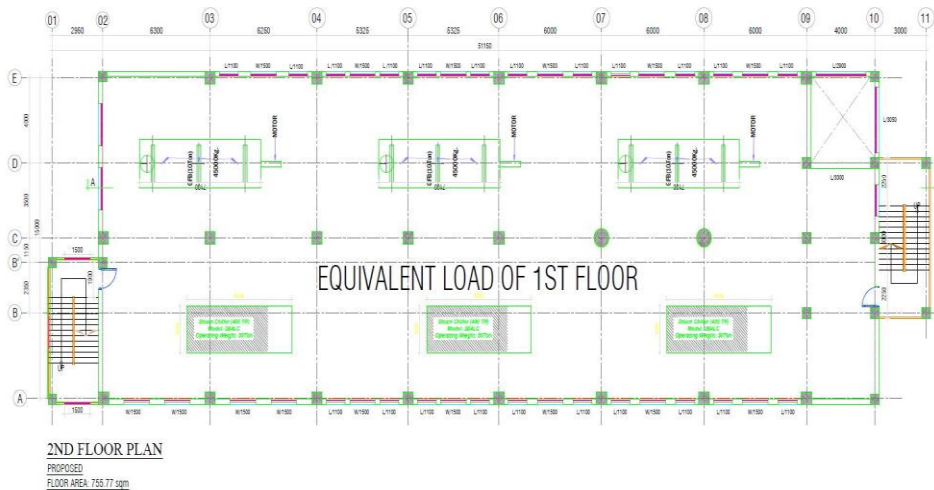
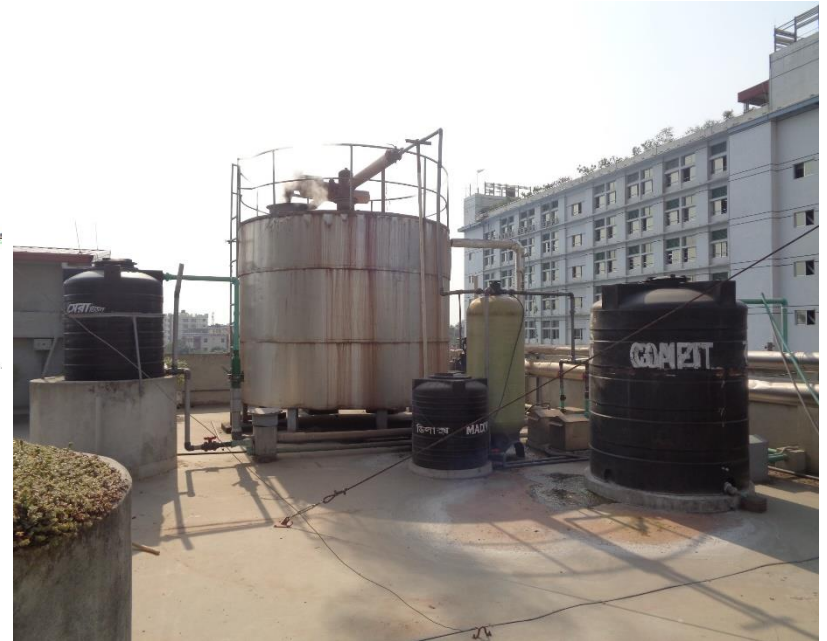
## **Discrepancy in as-built drawing**

Water tanks are not shown in existing roof layout

Proposed second floor is being used as existing roof and water tanks with other elements are not shown in layout. Building engineer is required to update the existing roof layout and load plan.

| Item No. | Observation | Recommended Action Plan | Recommended Timeline |
|---|---|---|---|
| 13 | Discrepancy in as-built drawing. (Utility Building-2) | Building engineer is required to update the existing roof layout and load plan drawings. | 6-weeks |

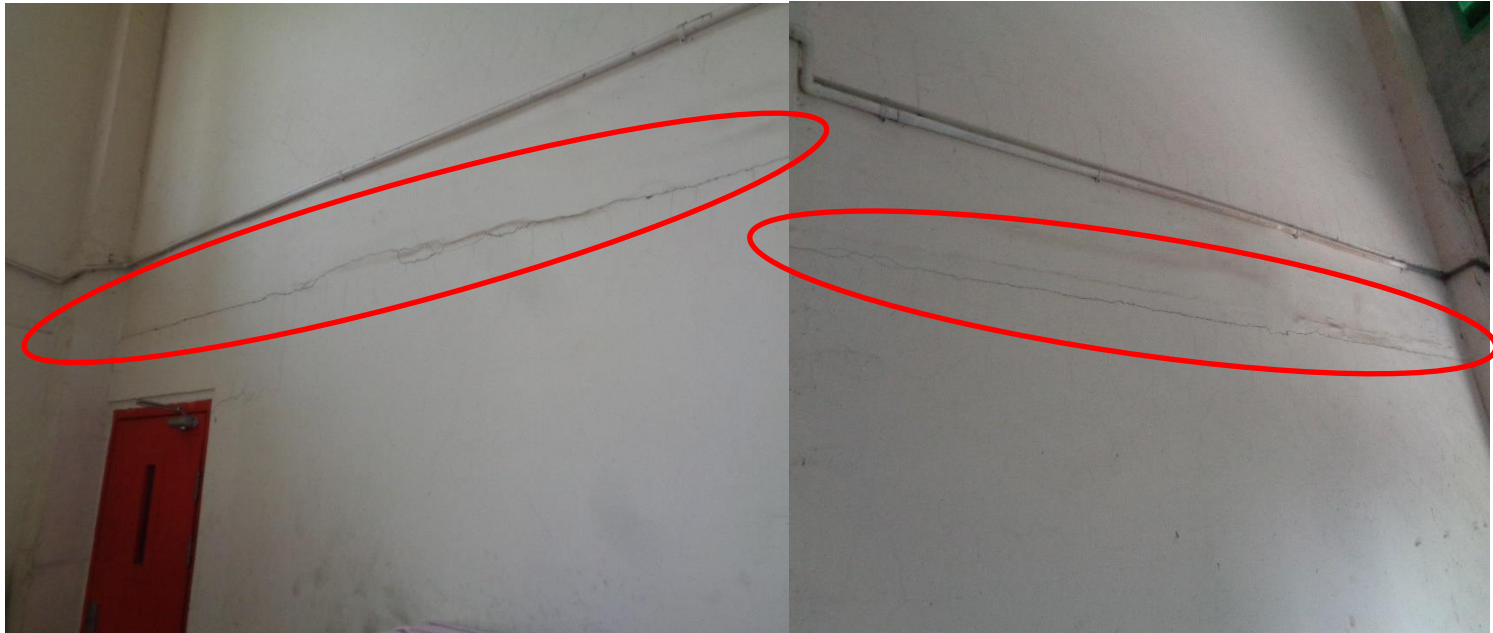
**Crack on brick wall**

Crack was observed on brick wall at several locations

Factory engineer is required to identify the reason of crack and repair the cracked surface with a suitable method.

| Item No. | Observation | Recommended Action Plan | Recommended Timeline |
|---|---|---|---|
| 14 | Crack on brick wall (Utility Building-2) | Factory engineer is required to identify the reason of crack and repair the cracked surface with a suitable method. | 6-weeks |

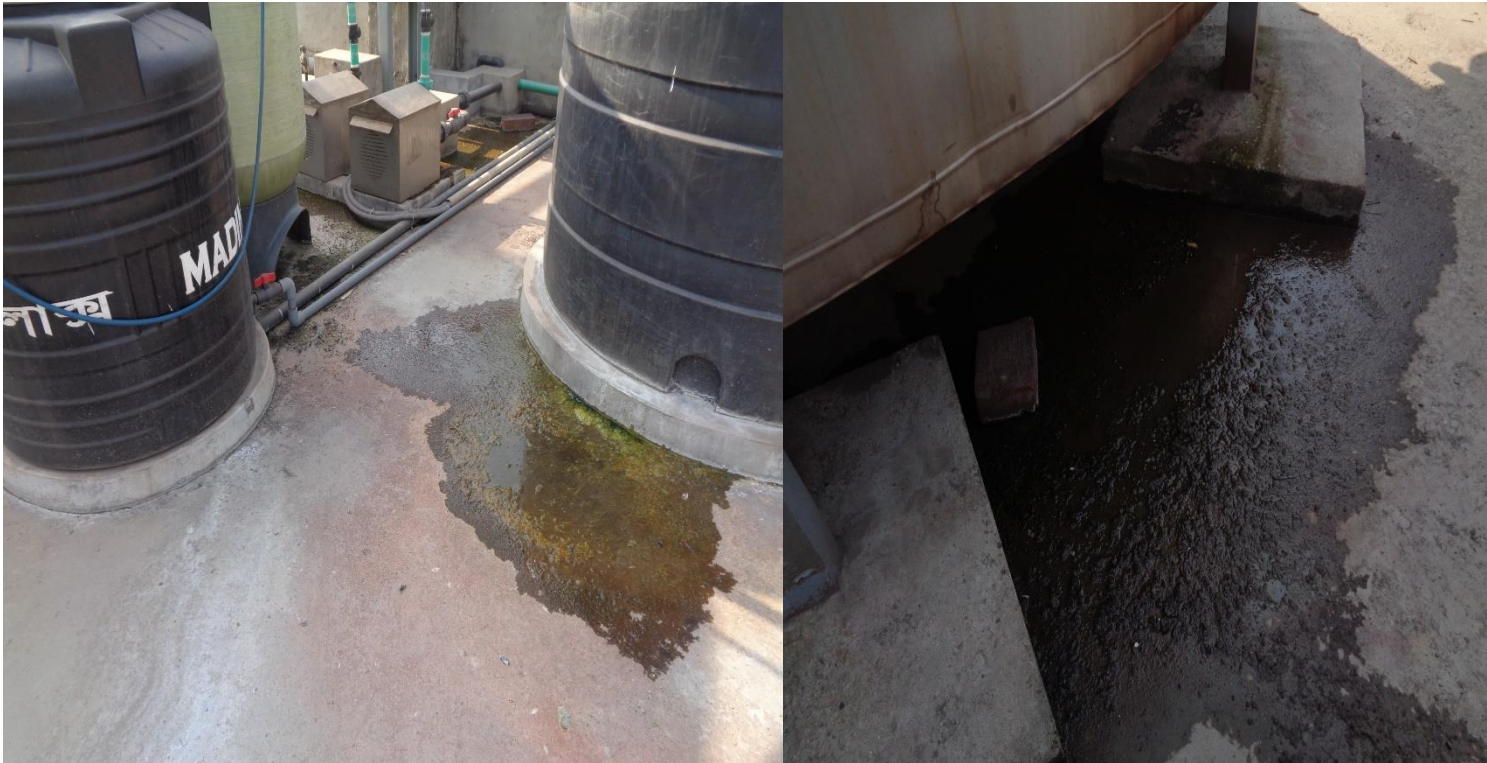
## **Dampness on roof slab**

Dampness on roof slab

Dampness and vegetation were observed on roof slab. Factory is required to improve drainage system on roof slab.

| Item No. | Observation | Recommended Action Plan | Recommended Timeline |
|---|---|---|---|
| 15 | Dampness on roof slab (Utility Building-2) | Factory is required to improve the roof drainage system. | 6-weeks |

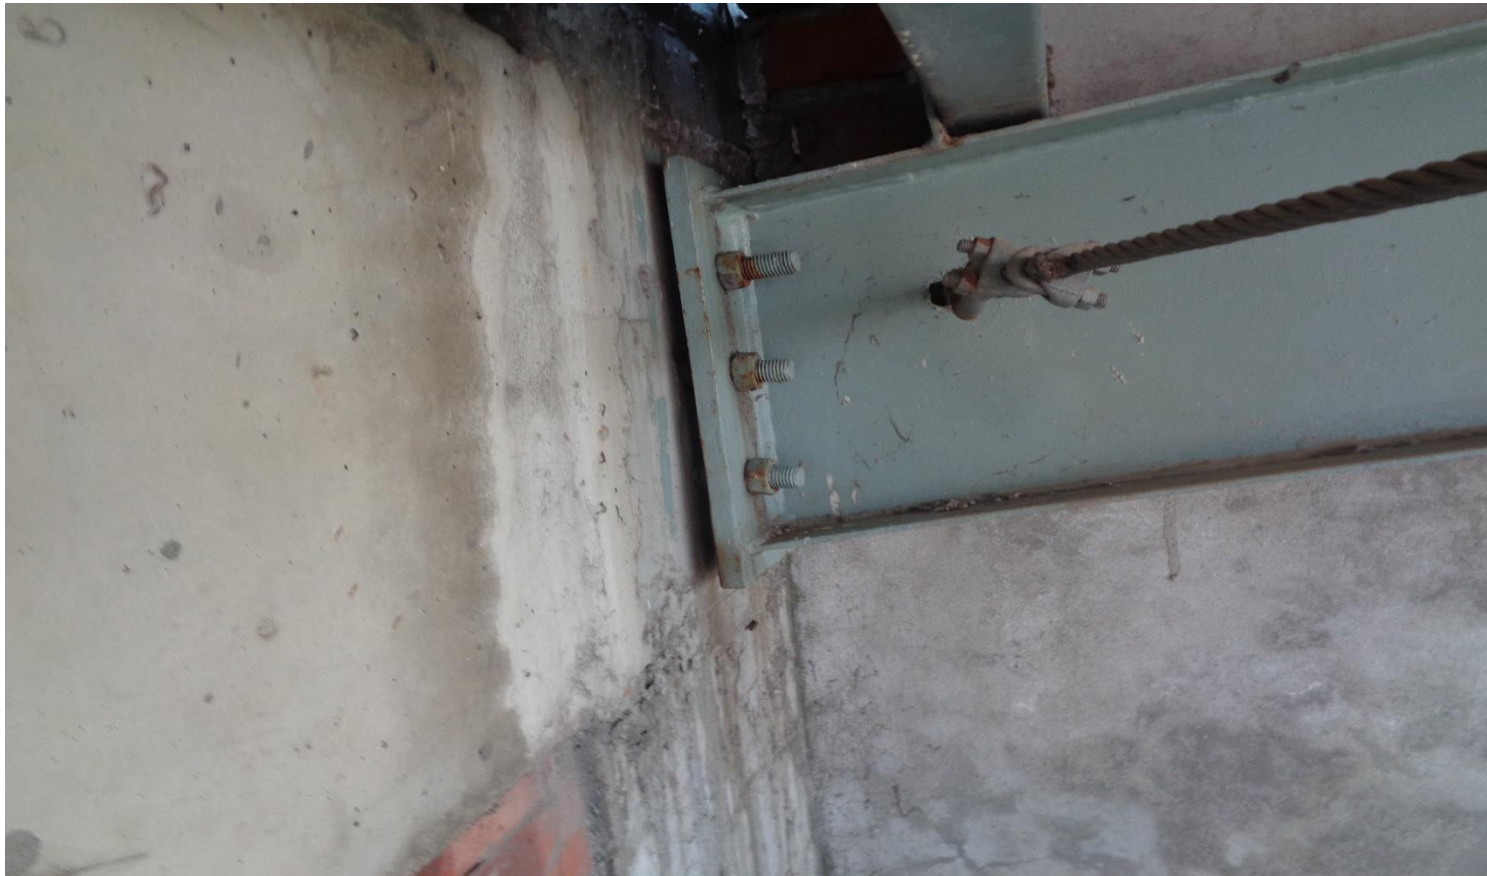
**Gap in connection**

Gap was observed in connection between RC and steel member

Gap was observed in connection of steel member. Building engineer is required to repair the gaps with a suitable method.

| Item No. | Observation | Recommended Action Plan | Recommended Timeline |
|---|---|---|---|
| 16 | Gap between RC and Steel member connection (Utility Building-2) | Factory engineer is required to repair the gaps with a suitable method. | 6-weeks |

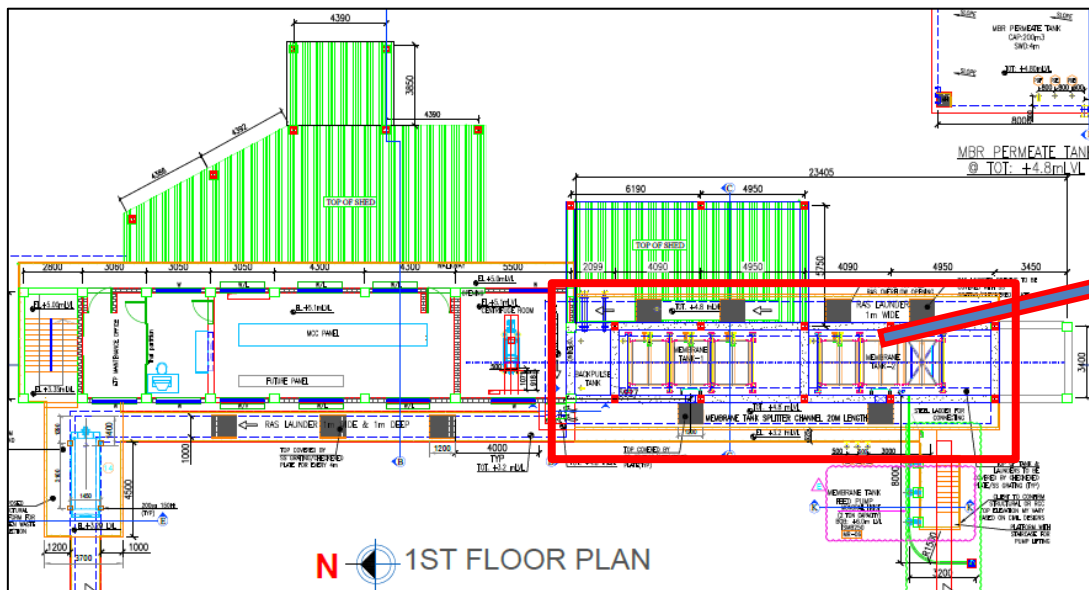
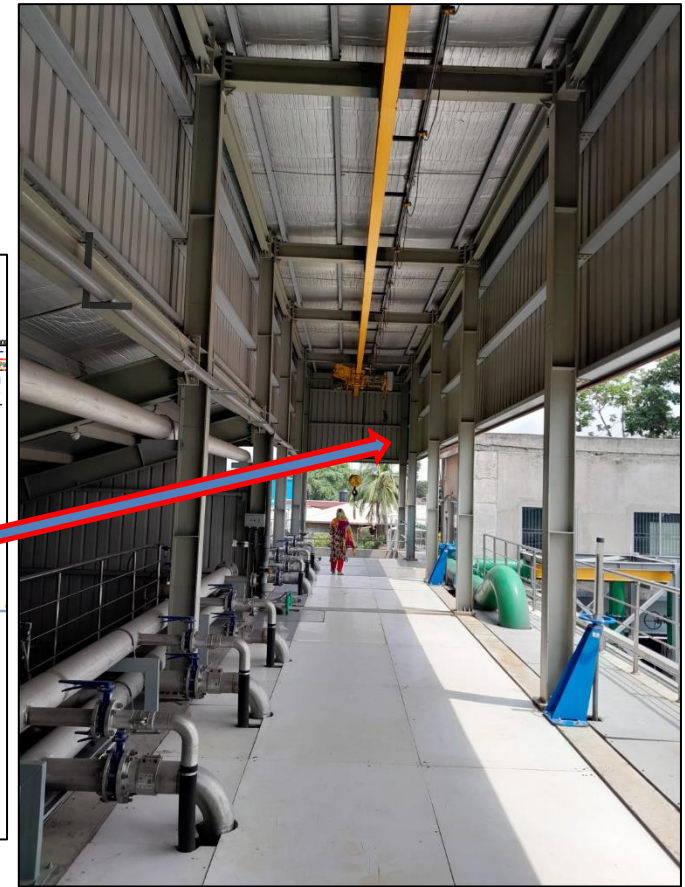
# **Falling Hazard at 1<sup>st</sup> floor level in ETP Extension Building**

No restricted boundary on the 1<sup>st</sup> floor slab level.

In some portion of 1<sup>st</sup> floor area wooden board is installed instead of any engineered slab system to carry enough human live load at a time. Factory is required to restrict access to hazardous area to avoid possible falling hazard.

| Item No. | Observation | Recommended Action Plan | Recommended Timeline |
|---|---|---|---|
| 17 | Falling Hazard at 1st floor level (ETP Extension Building) | Factory is required to restrict access to hazardous area to avoid possible falling hazard. | 6-weeks |
