# Parkstar Apparel Ltd. (Extension)

Kunia, K.B. Bazar, Gazipur Sadar, Gazipur.

04<sup>th</sup> September 2023

1. Six Storied Extension Building (G+5)

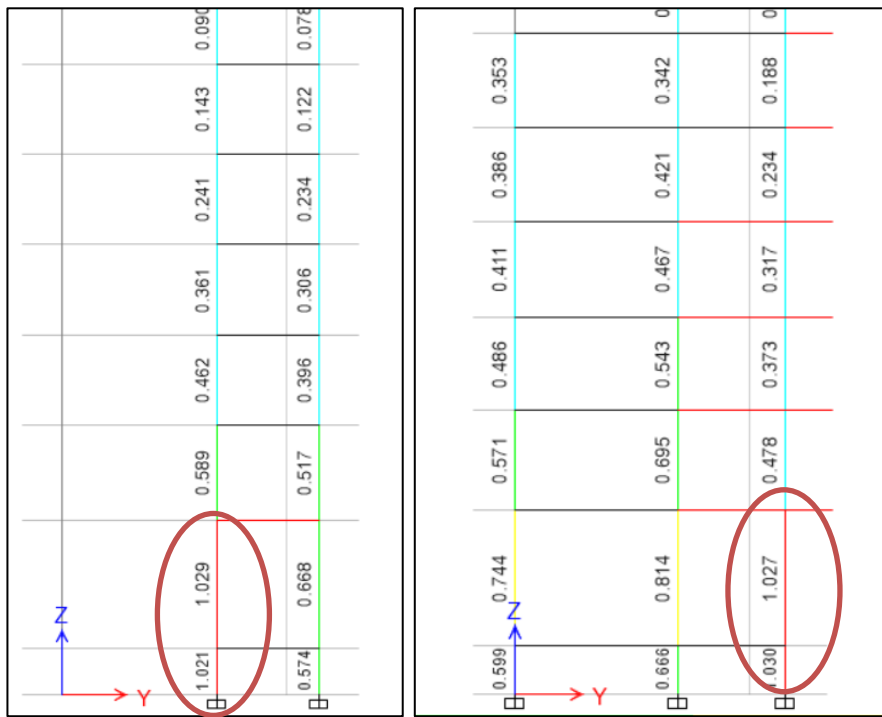
Overstress column in FEA model

A Detail Engineering Assessment Report (DEA) was available on site which doesn't include any connection adequacy of retrofitted steel beams with RC columns. In FEA model RC OHWT load was not assigned, and some marginally overstressed columns were also observed. Building engineer is required to update the FEA model and design report by including the connection adequacy and other requirements as per BNBC.

| Item No. | Observation | Recommended Action Plan | Recommended Timeline |
|---|---|---|---|
| 01 | Design report needs to be updated. (Six storied Extension Building) | Building engineer is required to update the FEA model and design report including the connection adequacy and all requirements as per BNBC. | 6-weeks |

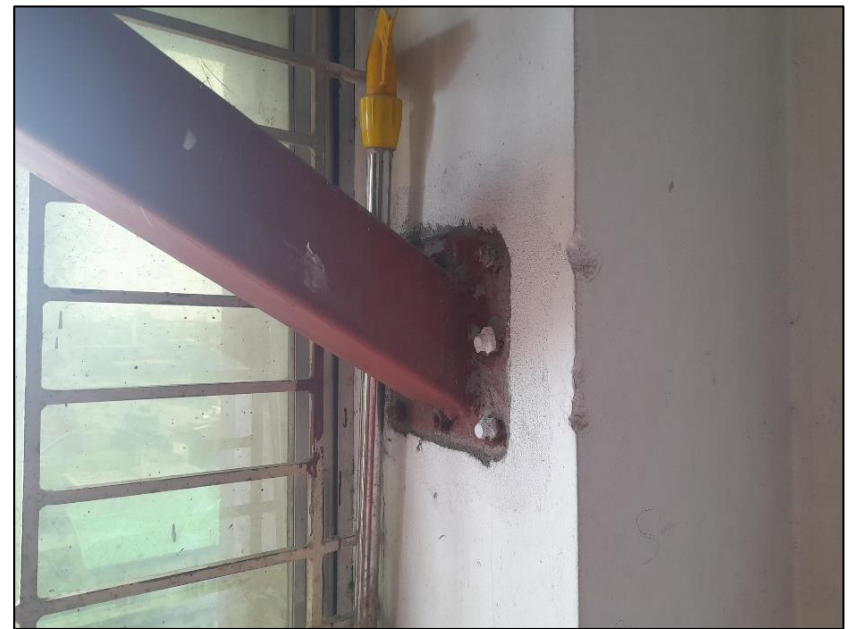
Retrofitted steel beam

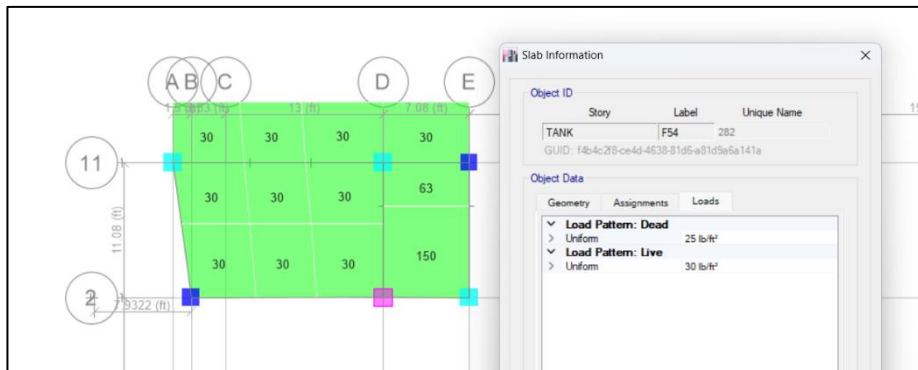
RC OHWT load not assigned in FEA

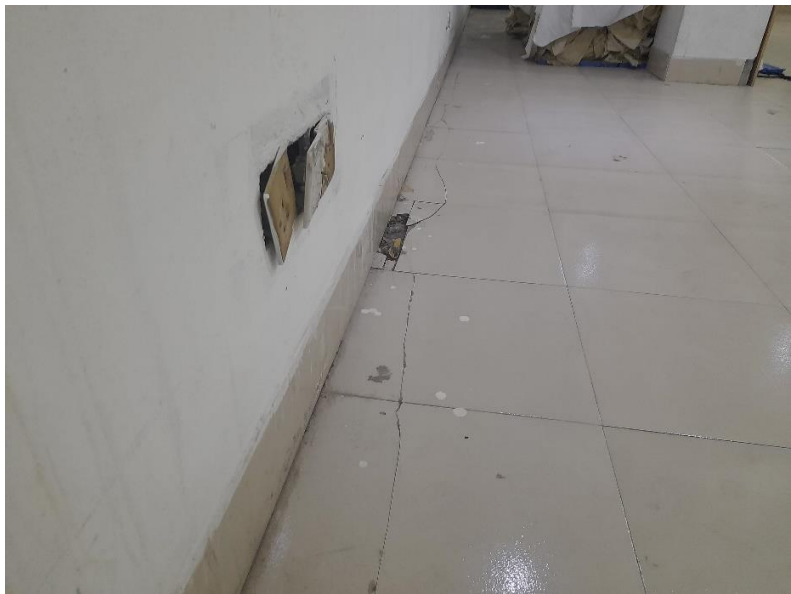
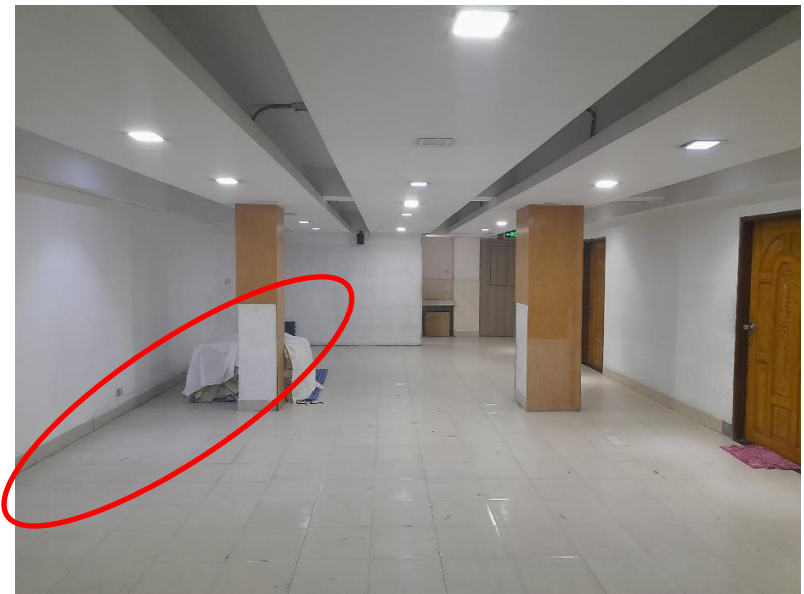
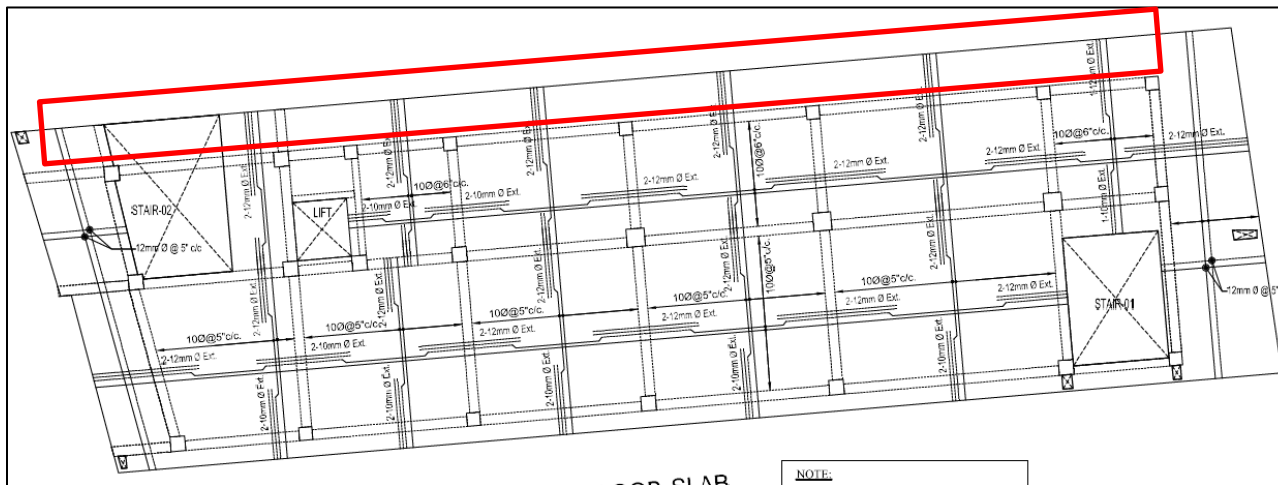
Cracks on slab was observed along the movement joint between Seven storied RC Building and Six storied Extension Building.

Cracks on slab along the movement joints

Building engineer is required to check the gap between two buildings and provide necessary calculation in the design report. Investigate the type of filling material along movement joint and suggest necessary remediation accordingly.

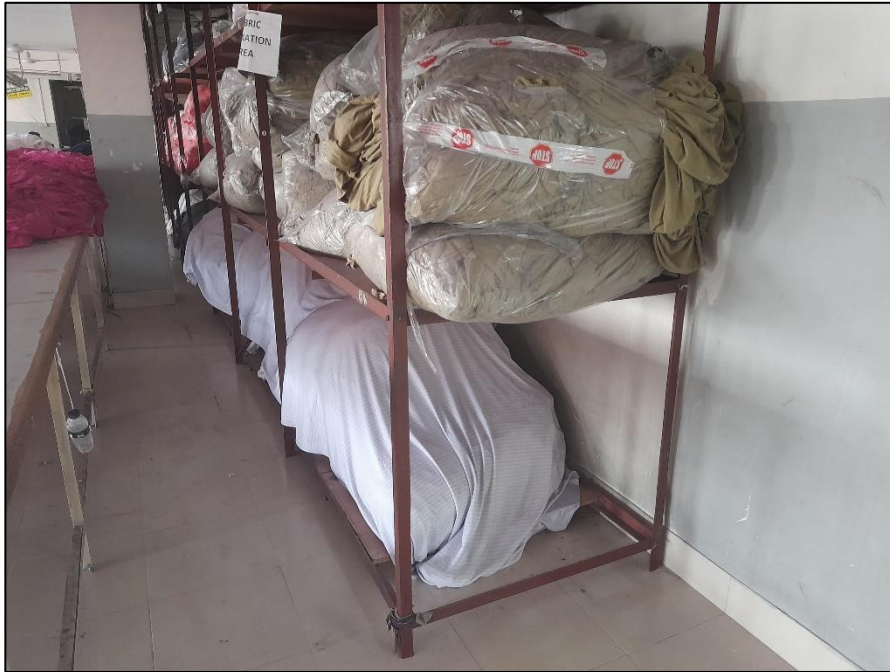
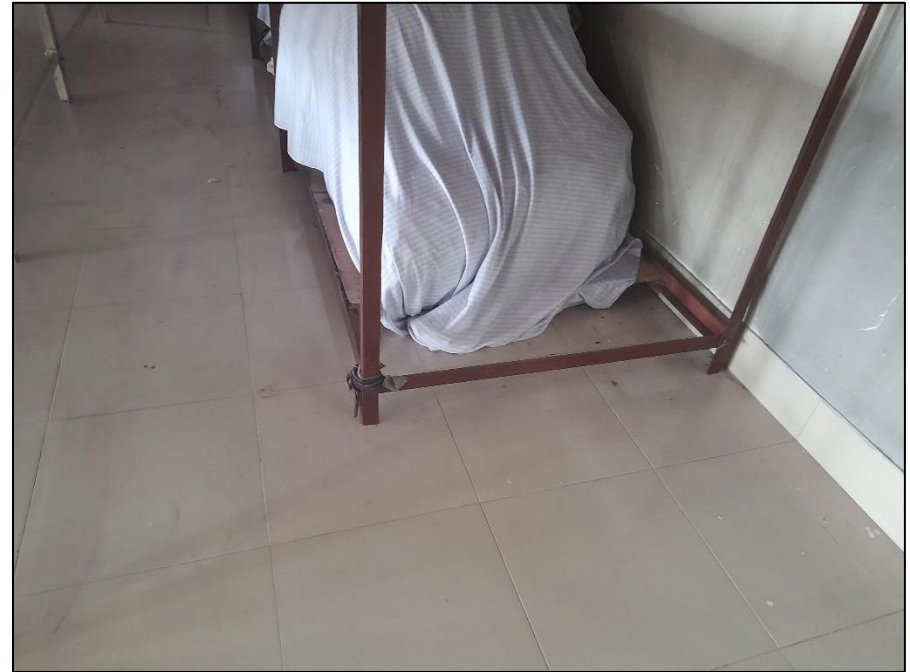
Storage racks were found not anchored

Some steel storage racks on different floors were found non-anchored. Factory is required to anchor all non- structural elements within the factory to avoid falling hazard during seismic event.

| Item No. | Observation | Recommended Action Plan | Recommended Timeline |
|---|---|---|---|
| 05 | Non-structural elements not anchored (Six storied Extension Building) | Factory is required to anchor all non-structural elements within the factory premises. | 6-weeks |
