# **FIRE SAFETY INSPECTION REPORT**

## **Shinest Apparels Ltd. (Extension)**

**Factory ID: 24734**

## Fire Safety Inspection Summary Report

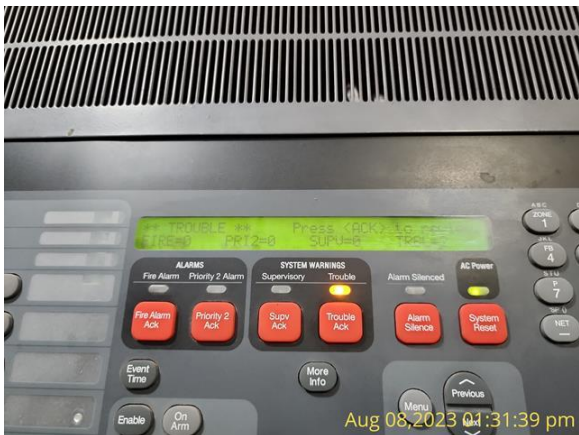
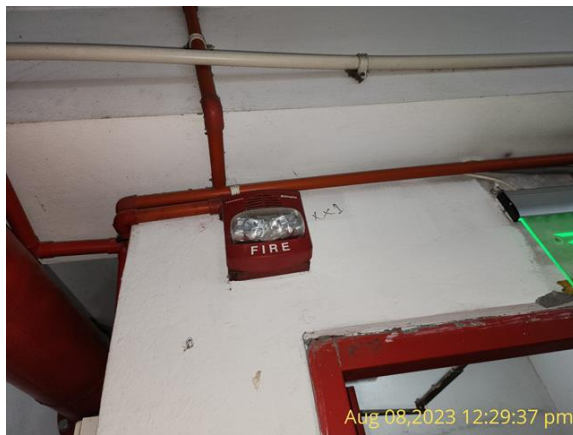
| No. | Category | Finding | Recommendation | Remediation<br>Timeframe |
|---|---|---|---|---|
| F-1 | Fire Protection | The fire alarm and detection system installation requires detailed review to confirm compliance with NFPA 72 and RSC Technical Guidelines (Standard).<br>(All buildings) | Submit as-built drawings, testing records, equipment certification and other relevant documentation to the RSC for review and then approval/acceptance test. | Drawing<br>Within 2 months<br>Install/<br>Modification<br>Within 4 months |

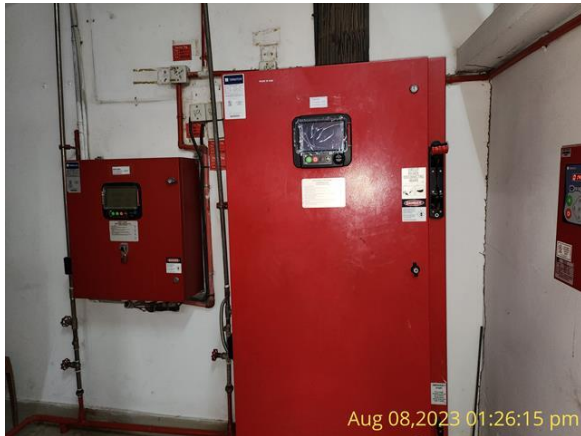
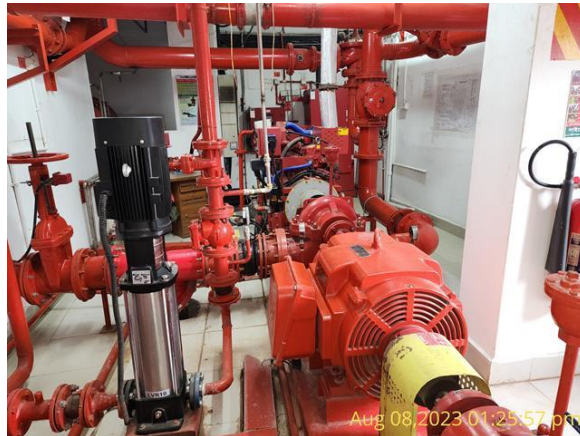
| No. | Category | Finding | Recommendation | Remediation<br>Timeframe |
|---|---|---|---|---|
| F-2 | Fire Protection | The fire pump set installation requires detailed review to confirm compliance with NFPA 20 and RSC Technical Guidelines (Standard). | Submit as-built drawings, testing records, equipment certification and other relevant documentation to the RSC for review and then approval/acceptance test. | Drawing<br>Within 2 months<br>Install/<br>Modification<br>Within 4 months |

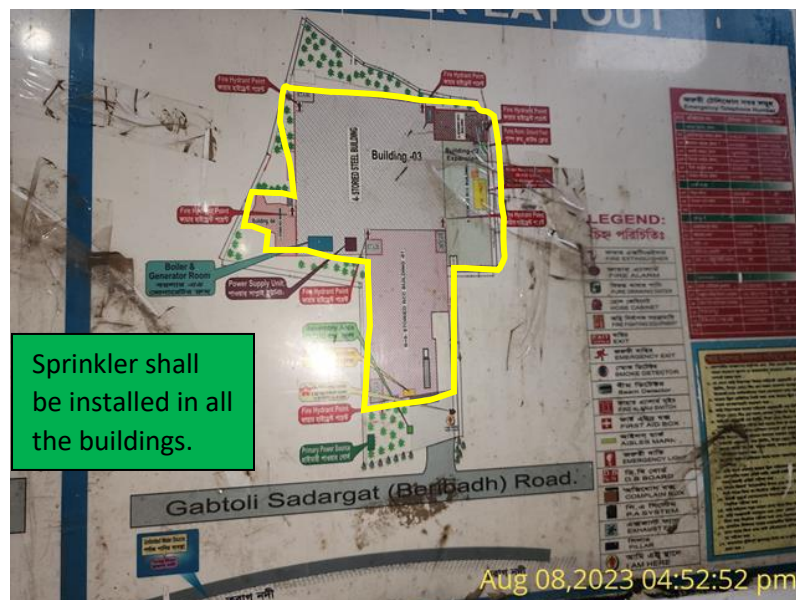
| F-3 | Fire Protection | Fire sprinkler system shall be installed throughout the buildings as the buildings are interconnected to each other where production and egress facilities are shared. | Install automatic sprinkler protection throughout the buildings in accordance with NFPA 13 and RSC Technical Guidelines (Standard). | Drawing Within 2 months<br>Install Within 6 months |

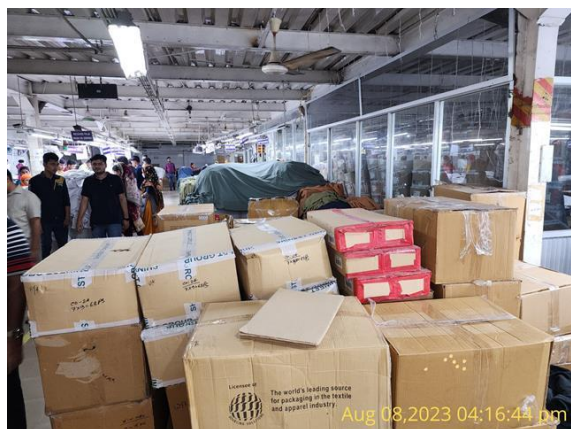
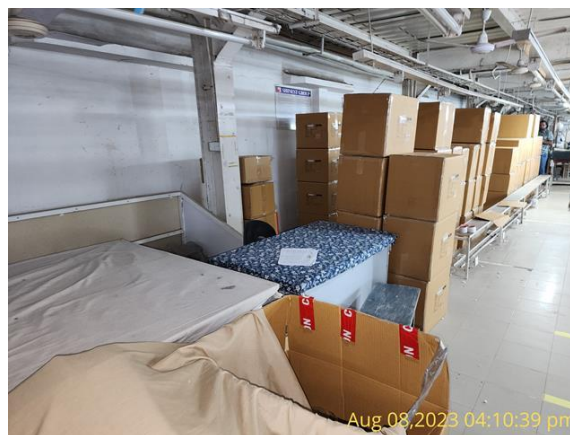
| F-5 | Fire Rated Construction | Areas used for combustible storage open to the factory are not properly defined and/or not within limits. (Building-2 –1st & 3rd floor) | <p>Provide defined storage areas and limit the storage arrangement as follows:</p> <p>Maximum height of 2.45m (8 ft) and maximum area of 23 m<sup>2</sup> (250 ft<sup>2</sup>).</p> <p>If sprinkler protected: maximum height of 3.66m (12 ft) and maximum area of 93m<sup>2</sup> (1000 ft<sup>2</sup>).</p> <p>Separate the areas of unenclosed combustible storage by a minimum clear distance of 3 m (10 ft).</p> <p>Areas shall limit within 10% of entire floor area.</p> | Within 3 months |

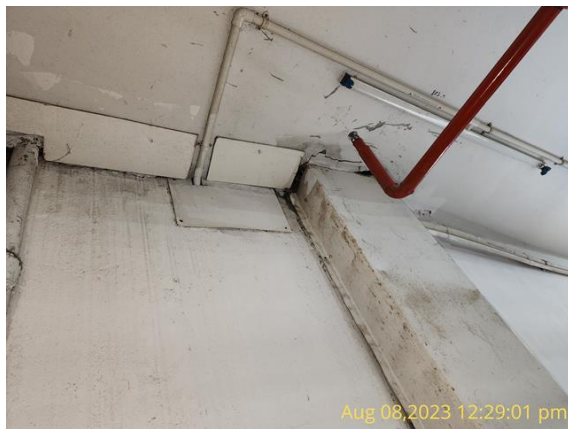
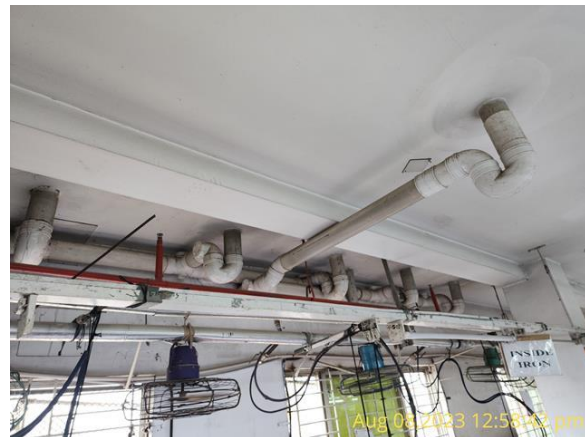
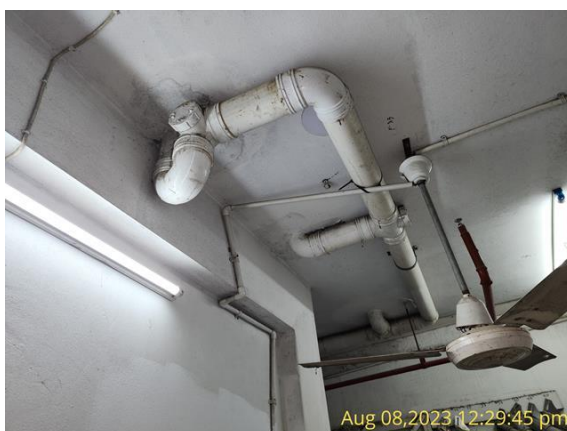
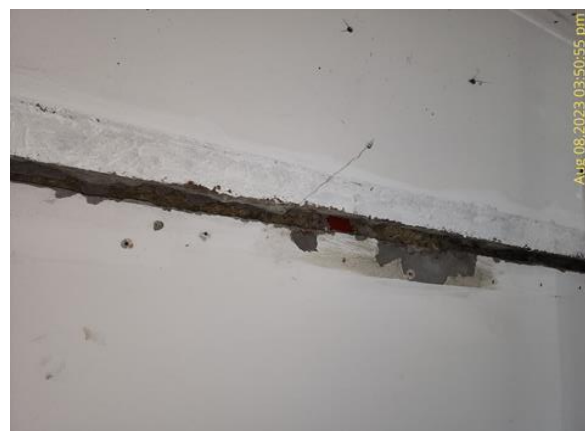
| F-6 | Fire Rated Construction | <p>Unsealed utility pipes, electric riser penetration located in the fire-rated floor/ceiling assemblies</p> <p>Also building expansion joints were not protected in building-3 (previously installed which found damaged) and in between buildings.</p> | <p>Penetrations of fire resistive rated assemblies shall be protected with listed through penetration fire stop system tested in Accordance with ASTM E814 in Accordance with RSC 4.7 with a minimum 3-hr fire rating at building-3 and 2-hr at building-2 &amp; 4.</p> | Within 3 months |

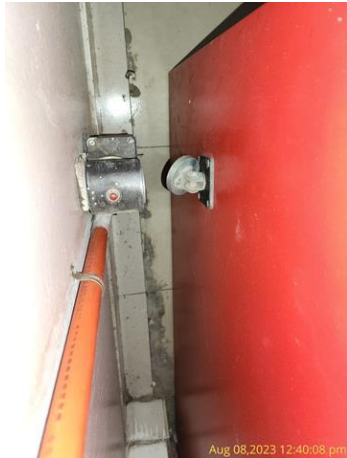
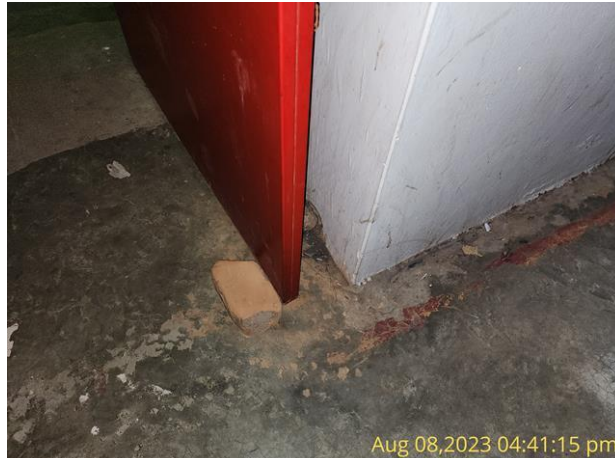
| F-7 | Fire Rated Construction | Exit doors are provided with 3 hr fire rated doors however fire door accessories are not working as required. (All building) | <p>Separate the exit stairs from work areas and other building spaces on all floor levels by minimum 2- hr fire-rated construction. Provide minimum 1.5- hr fire rated doors and seal all unprotected openings and penetrations to maintain the fire separation (10" wall).</p> <p>Ensure that all fire doors are self-closing and positive latching, and are provided with fire exit (panic) hardware where serving production floors or assembly occupancies.</p> <p>If fire doors are required to be held open for functional reasons, provide automatic-closing devices tied to the fire alarm system.</p> <p>Once fire doors are installed, every door in a stair enclosure serving more than 5 stories shall be provided with re-entry unless it meets RSC 6.8.3.1.</p> | Within 1 month |

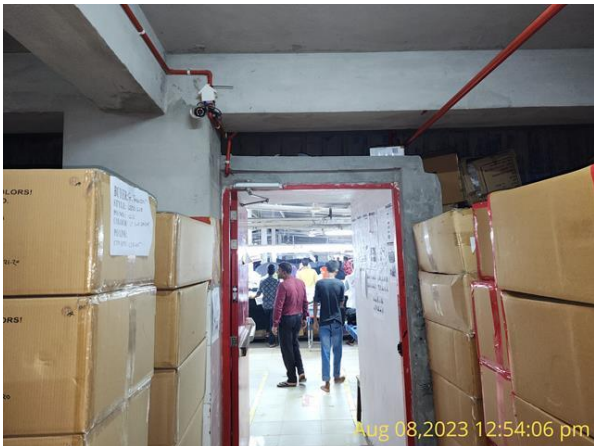
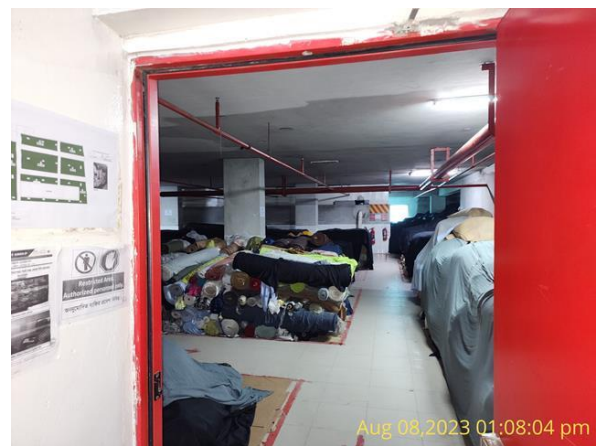
| F-9 | Fire Rated Construction | Storage/ storage rooms discharges directly into the exit stair enclosures.<br>(Building-3 – 1 <sup>st</sup> , 2 <sup>nd</sup> and 3 <sup>rd</sup> floor and one stair was shared with building-2). | <p>Openings from exit enclosure to storage room, generator, basements, transformer boiler and similar normally unoccupied spaces shall be provided with a vestibule with fire rated construction and openings as per RSC Technical Guidelines (Standard) 6.14.3.</p> <p>Provide a 1.5 hr. fire rated door on the exit stair side and a 1-hr. fire rated door on the storeroom/storage side. Ensure that the fire rating of the vestibule construction matches that of the exit stair enclosure.</p> | Within 3 months |

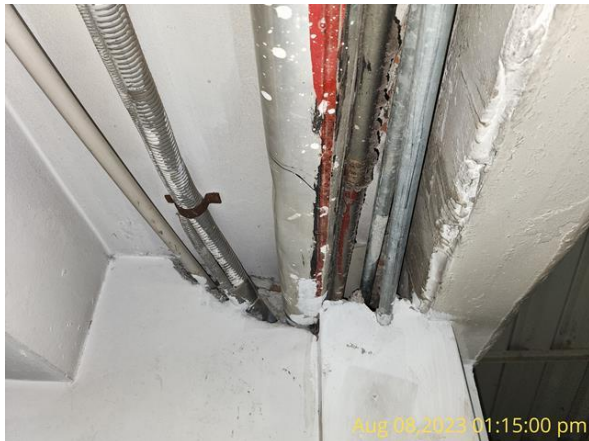
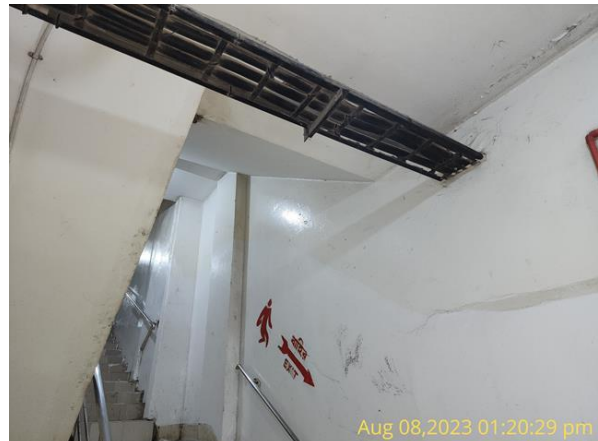
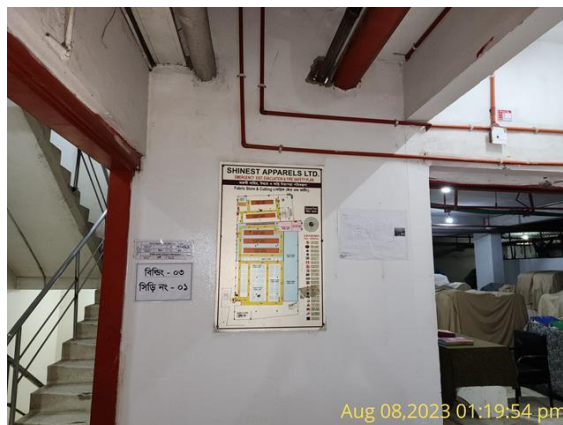
F-10 Fire Rated Construction

Unsealed penetrations and openings are located in exit stair enclosures and separation walls. (Building 2 and 3)

Seal all penetrations and openings in exit stair enclosure and separation walls to maintain the required fire separation. Penetration is prohibited into and through an exit enclosure. Re-route the cable channels.

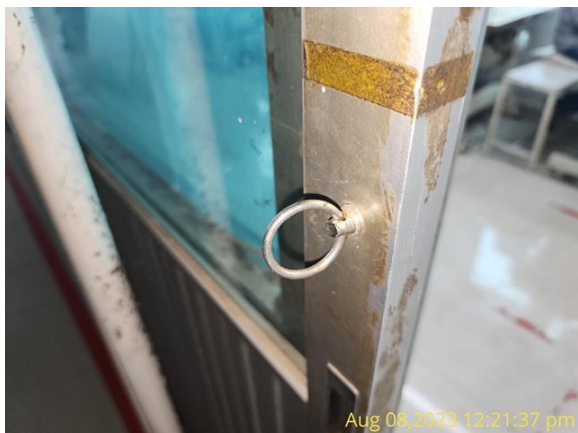
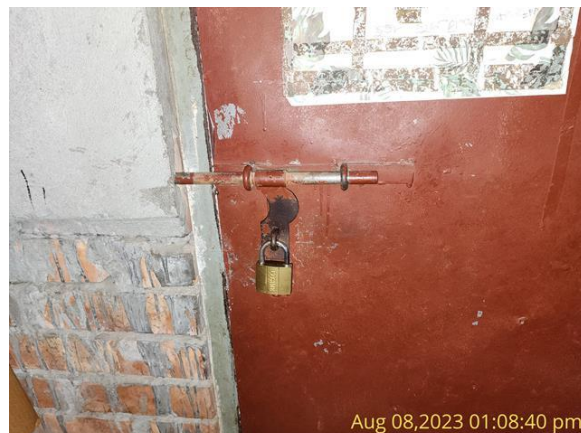
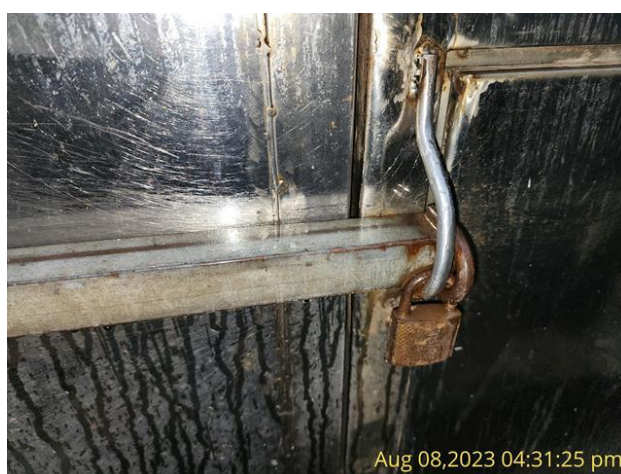
| F-13 | Egress | Egress gates on the top floor sample section 1st floor store and main exit of building-3 provided with locking features. | Remove locking features from all egress gates.<br><br>If locks are required for security reasons, utilize special door locking features complying with ACCORD standard 6.8.2. | Immediately |

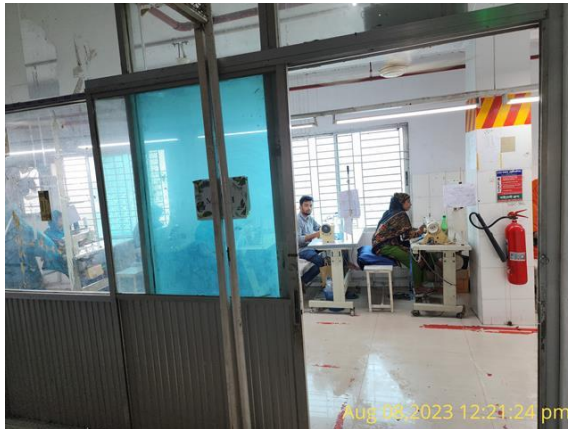
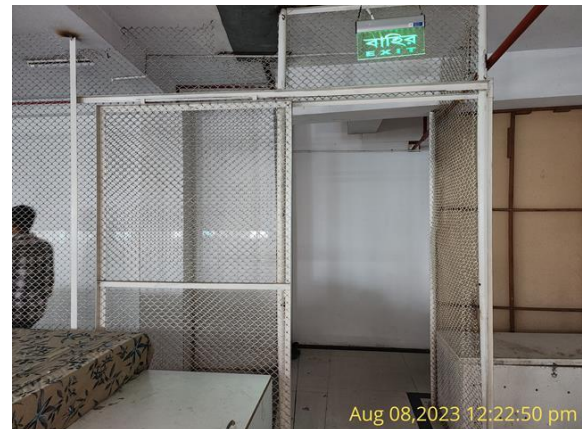
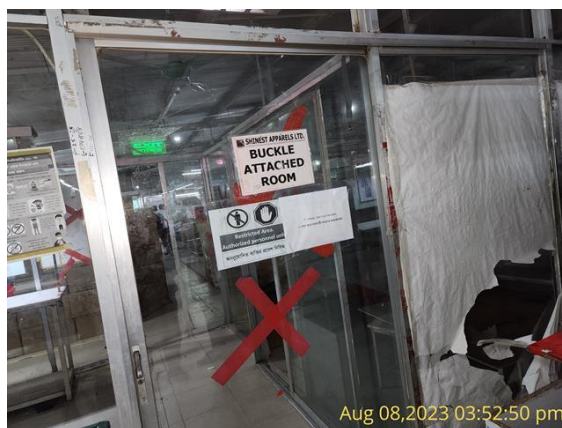
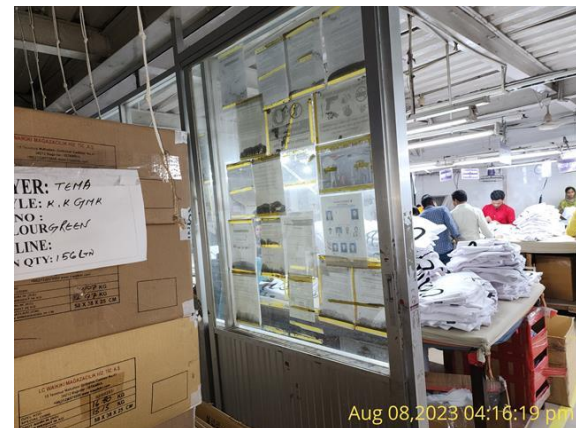
| F-14 | Egress | Sliding gates provided at top floor sample section of building-3 and packing sections of building-2. | <p>Replace all gates, sliding Doors and rolling shutters along the means of egress with side-hinged, swinging egress doors.</p> <p>If locks are required for security reasons, utilize special door locking features complying with NFPA 101.</p> | Within 1 month |

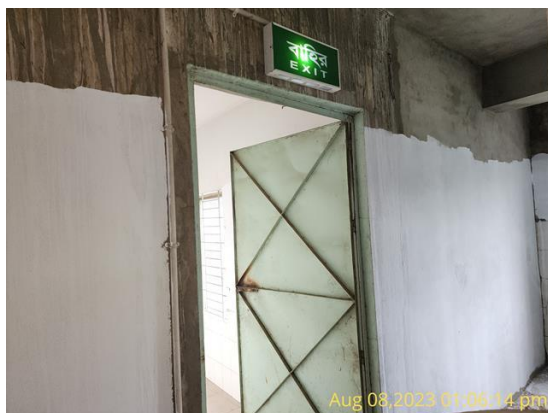
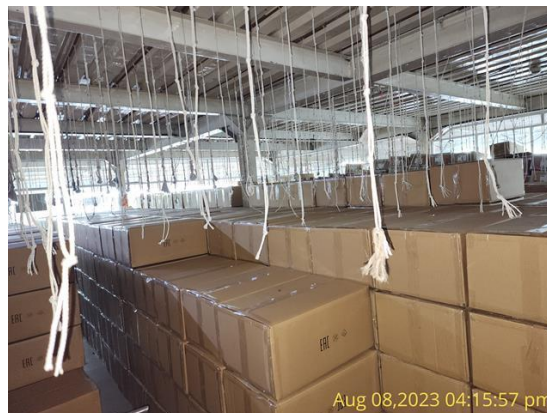
| F-15 Fire Rated Construction | Room on the 2nd floor at building-3 and 1st floor at building-2 used for combustible storage is not separated by a minimum 1-hr fire-rated construction. | Provide dedicated storage rooms separated by minimum 1-hr fire-rated construction. | Within 3 months |

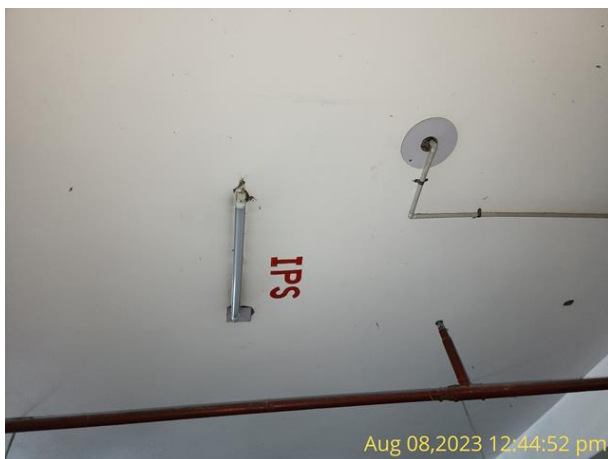
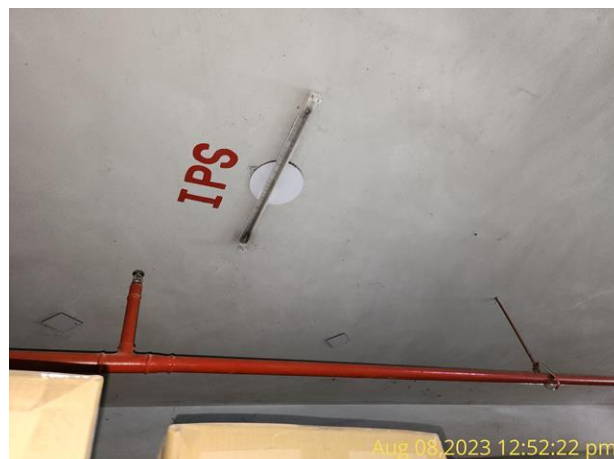
F-17 Egress Lighting

Emergency lighting did not function in test mode (burned out, broken, etc.).  
(All building)

Regularly test the emergency lighting system on each floor and replace/repair lights as needed.

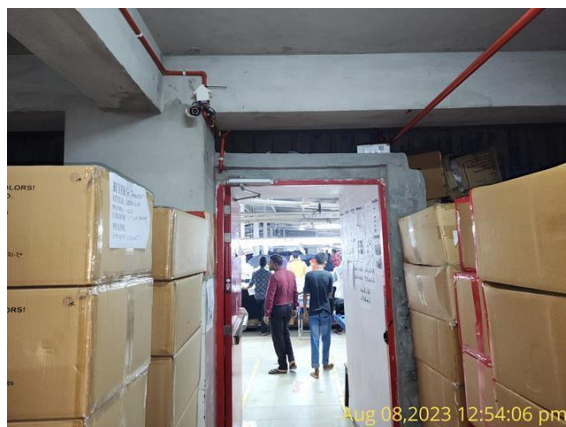
| F-18 | Egress Lighting | Exit signage was not provided at all the exits / along the path of egress / in a readily visible location. | Provide exit signs above all building exits to the exterior, all doors to the exit stairs and along all paths of travel where a change of direction is not obvious (directional sign). | Within 1 month |

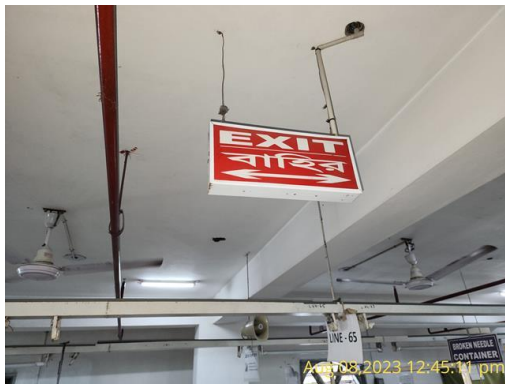
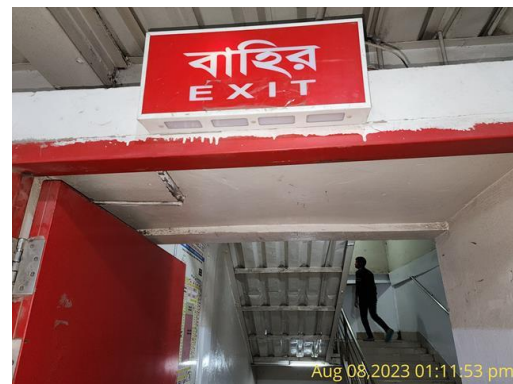
| F-19 | Egress Lighting | Exit signage was not illuminated (burned out, broken, etc.) and some were not illuminating as required. (All building). | Regularly inspect all exit signage and replace/install lights as needed to illuminate signs. The source of illumination shall provide not less than 50 lux at the illuminated surface with a contrast of not less than 0.5. Approved self-luminous signs which provide evenly illuminated letters having a minimum luminance of 0.2 cd/m <sup>2</sup> may also be used. | Within 1 month |

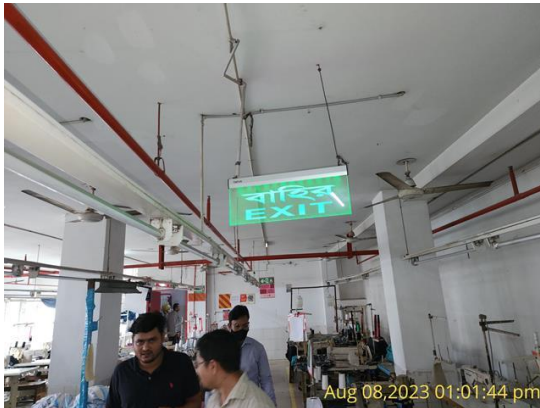
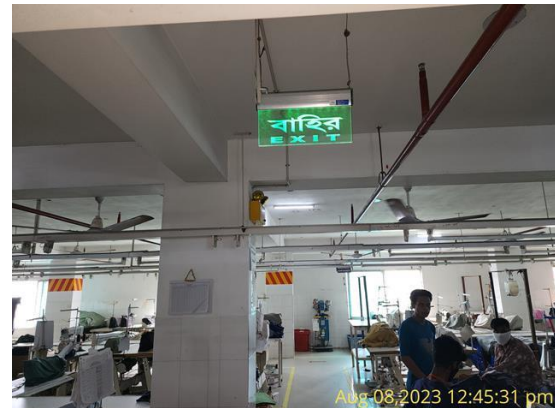
| F-20 | Egress Lighting | Exit signs were placed in areas that were not exits. | Remove exit signs from noted areas to avoid confusion from actual exits. | Within 3 months |

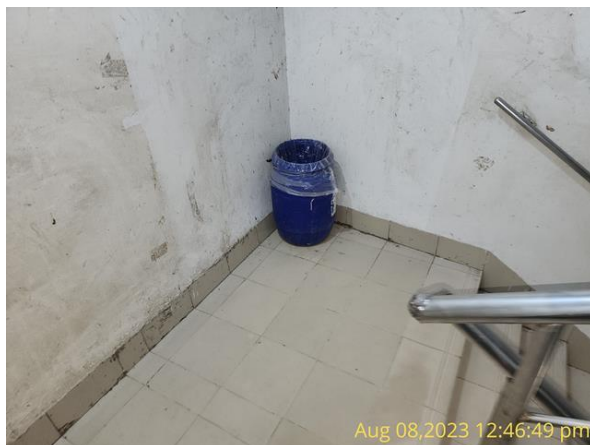
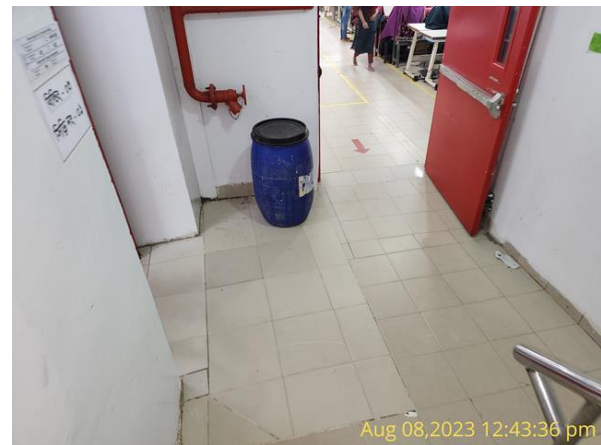
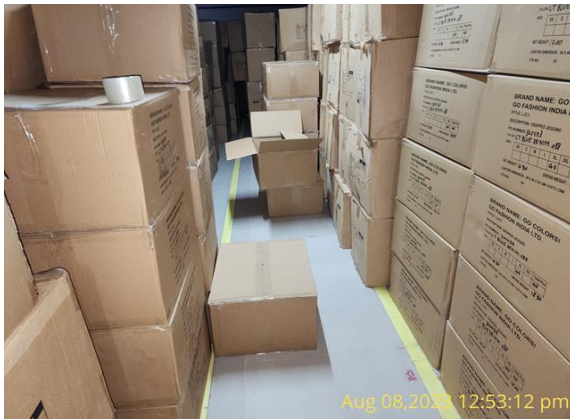
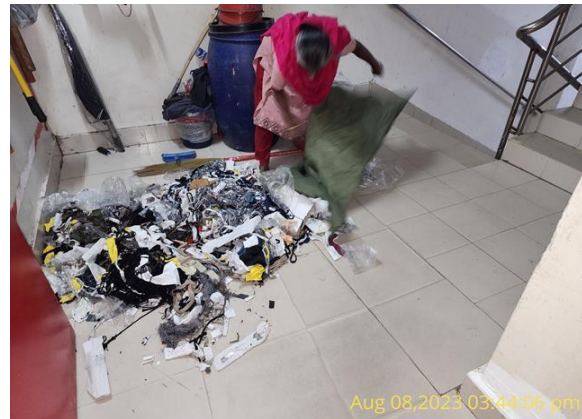
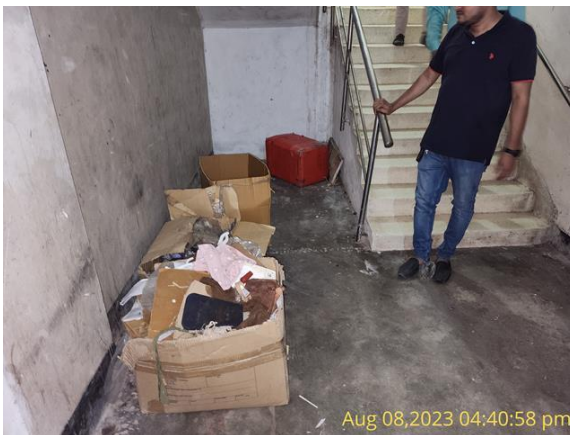
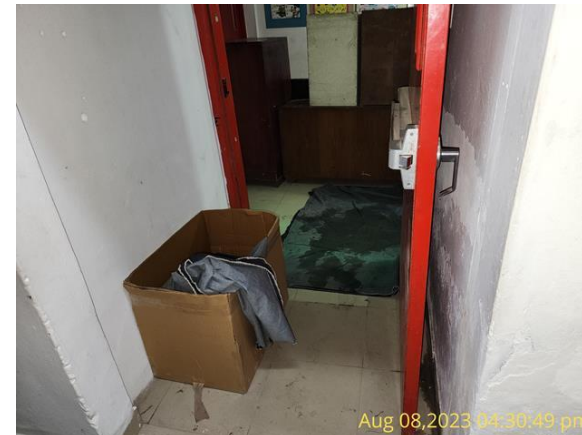
| F-22 | Egress | Storage was located in the exit stairs aisles. (All building). | Remove all storage from exit stairs and aisles. Egress facility shall be kept free. | Immediately |

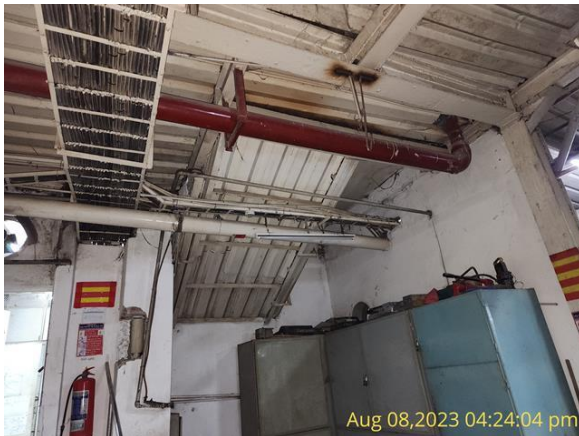
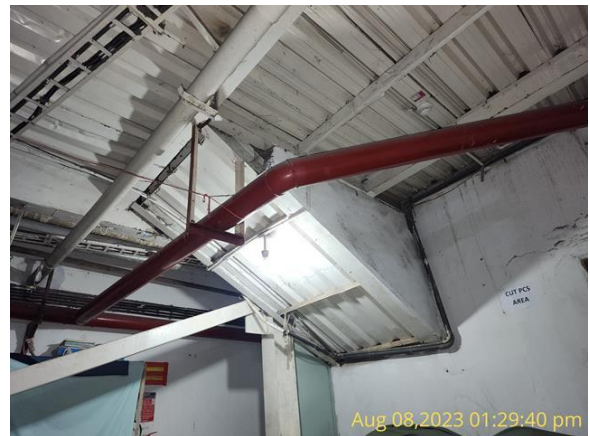
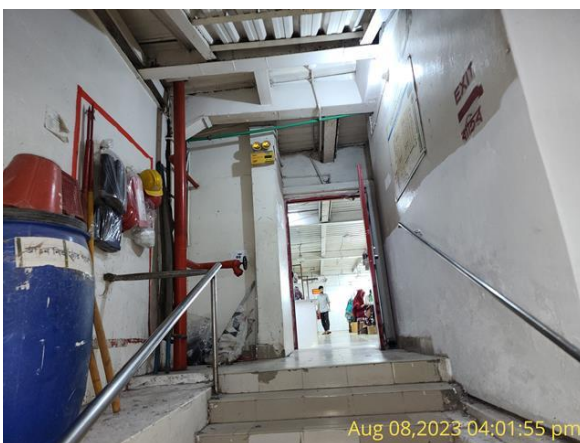
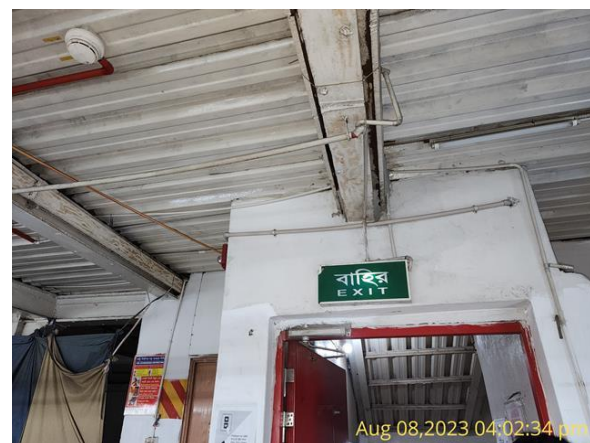
| F-24 | Fire Rated Construction | The exit stairwell stairs are non-rated and not enclosed in fire rated construction due to non rated beam, column and deck slab. (Building-2). | Provide 2-hr fire rated stairwell enclosure on each floor level.<br>Or<br>Provide 2-hr fire rated coating on the steel structural materials to meet RSC 6.3.1.2.2. | Within 6 months |

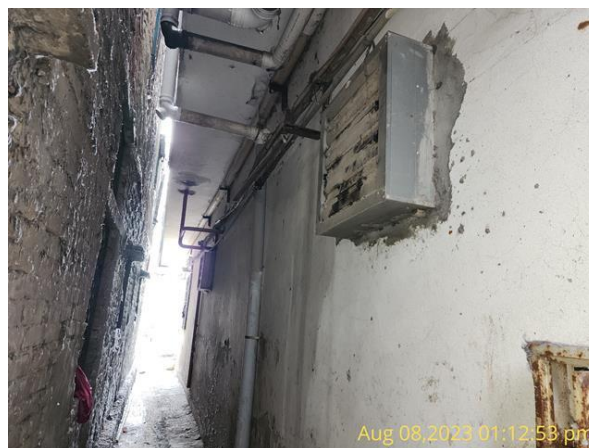
| F-25 | Fire Rated Construction | The exit discharge path serving the [S-W stair] is less than 10 ft wide and is not separated from the building interior (Building2). | Seal all penetrations and openings to the interior of the building along the discharge path to provide a minimum 1-hr fire separation. | Within 3 months |

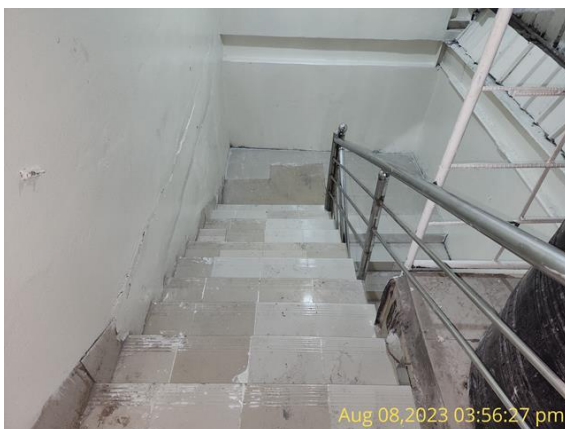
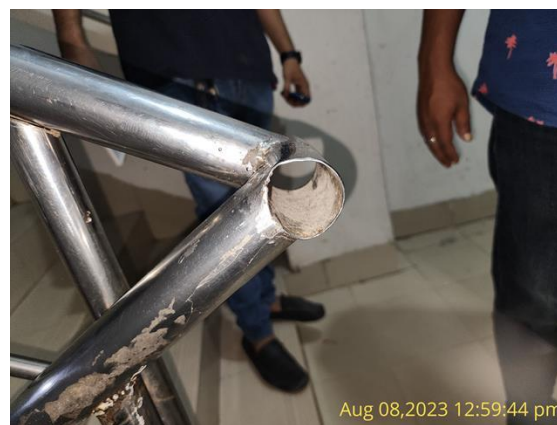
| F-27 | Egress | Handrails are not provided on both sides of N-E exit stairs at building 2.<br>Also handrailing have some hole likely to cause hand/finger injury. | Provide handrails on both sides of the exit stair. New handrails shall have a minimum height of 865 mm (34 in.) and a maximum height of 965 mm (38 in.) as measured from the leading edge of the tread.<br>Intermediate handrails shall be provided when the stair width exceeds 2.2 m (87 in.) .<br><br>Provide continuous handrail on both side of exit stair without any opening/hole in the handrail. | Within 1 months |

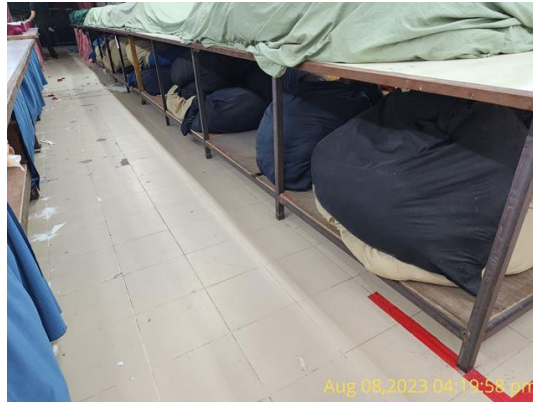
| F-28 | Fire Rated Construction | Storage was found underneath the cutting tables at building-2. | Remove storage materials underneath the cutting tables. | Within 1 months |

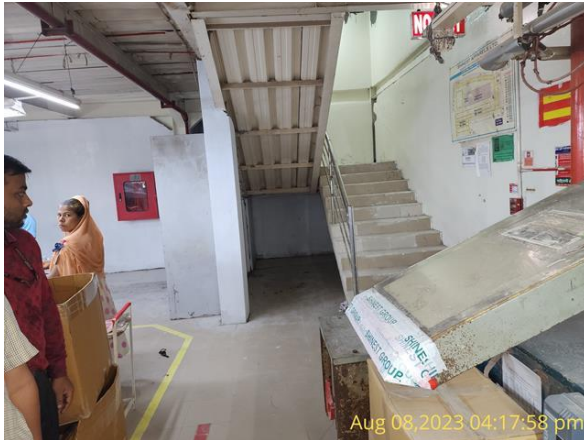
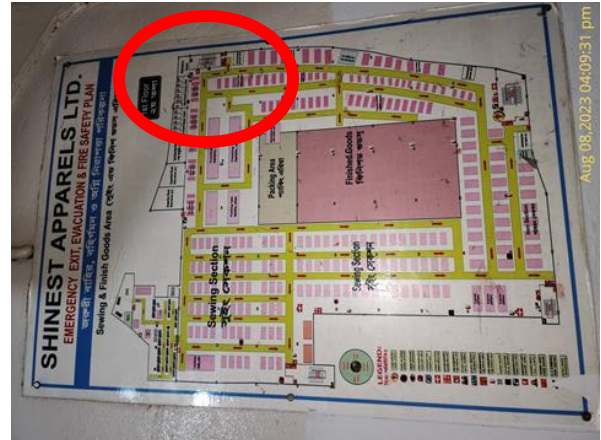
| F-30 | Egress | N-E stair do not discharge directly to the outside, discharges in the 1st floor. (Building-2). | <p>Modify stair to discharge directly to outside.</p> <p>Or Provide 2-hr fire-rated exit passageway leading directly to outside (vestibules to separate any storage areas).</p> <p>Or Provide sprinkler protection for discharge floor in accordance with NFPA 13 meeting RSC 6.17.3 (all 4 options shall meet).</p> | Within 4 months |

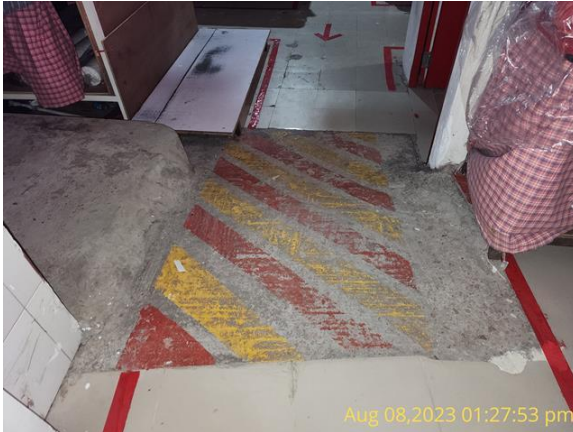
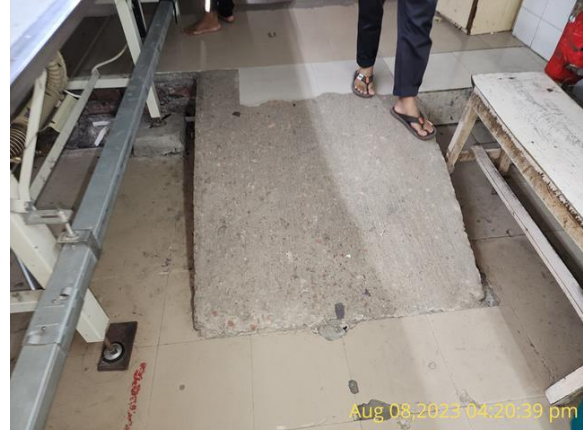
| F-32 | Egress | The running slopes throughout ground floor does not comply with RSC standard. | Reconfigure the slopes in a way that comply with RSC 6.3.4.2. | Within 3 months |
