# Teen Age Modern Fashion – Extension

Purbohati, Hemayetpur, Savar, Dhaka-1340.

05 September 2023

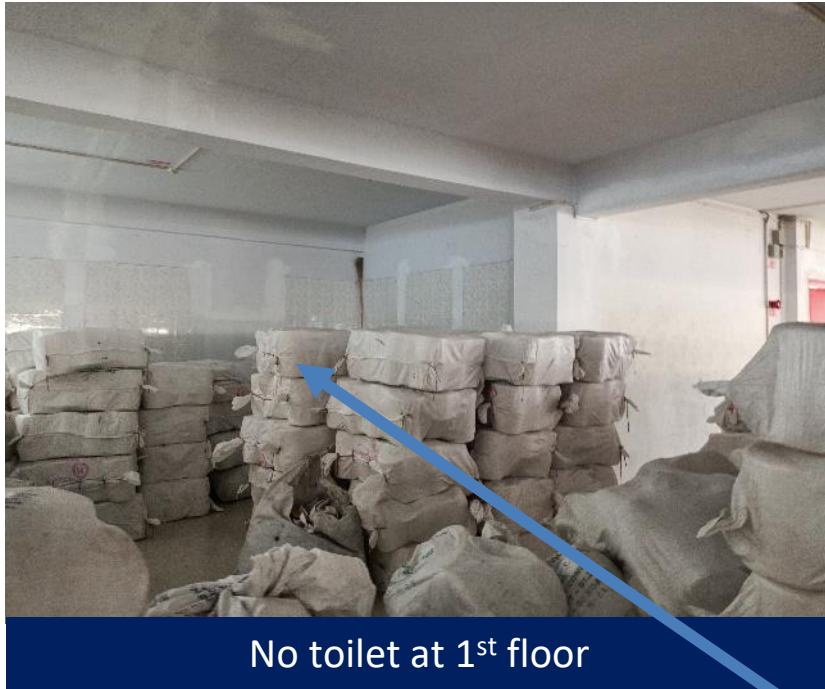
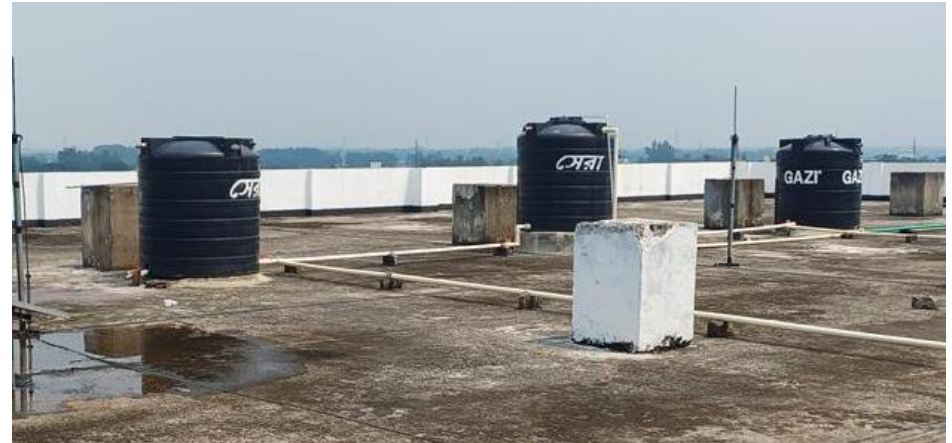
Undocumented water tank

Roof layout not found in the provided as-built drawings. Undocumented plastic water tanks were found on the roof. Moreover, toilet zone of 1<sup>st</sup> and 5<sup>th</sup> floor not matched with the provided floor layout. Building engineer is required to revise the as-built drawing as per onsite condition and submit to RSC.

| Item No. | Observation | Recommended Action Plan | Recommended Timeline |
|---|---|---|---|
| 01 | Mismatches in as built drawings. (Production Building) | Factory engineer is required to survey the structure and prepare accurate as-built drawings. | 6-weeks |

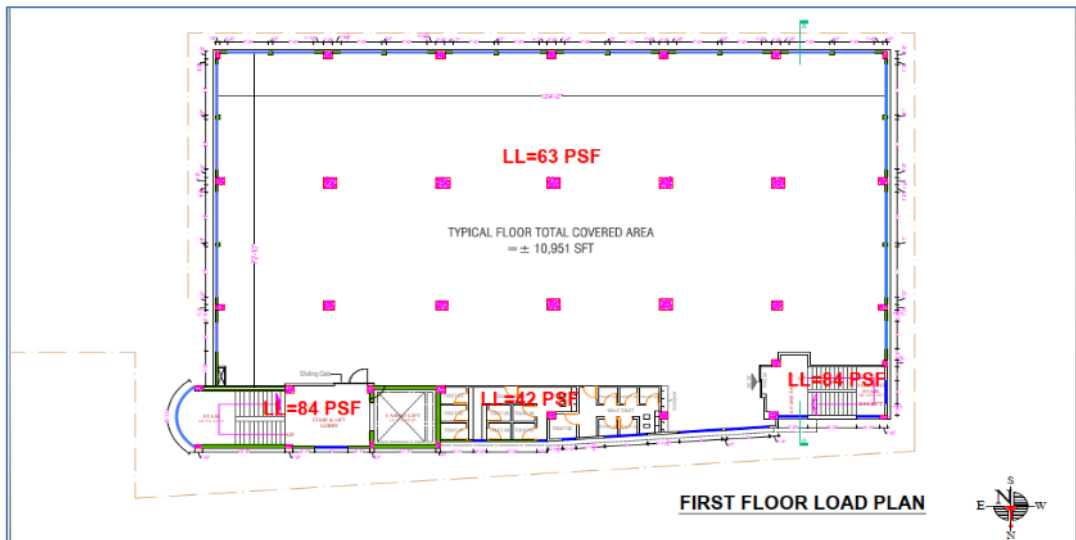
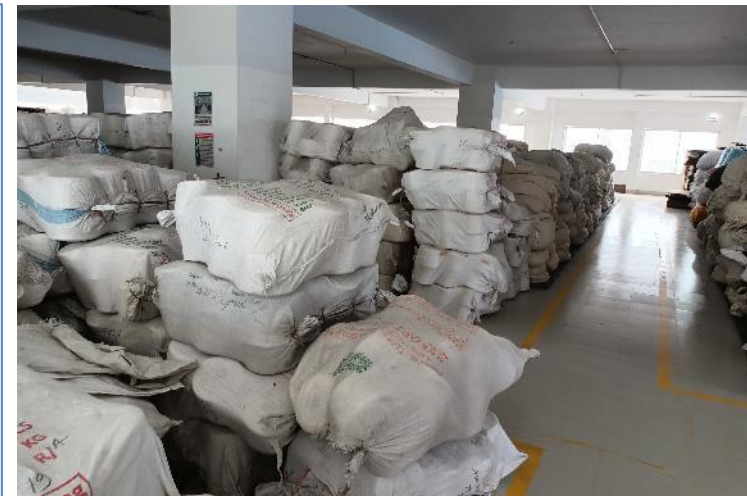
Storage on first floor

The first floor of the building is allotted for storage. As per BNBC, the minimum floor live load for storage is 6 kN/m<sup>2</sup> (126 psf). But the first floor of the building is designed for 3 kN/m<sup>2</sup> live loads. Factory engineer is required to revise the load plan and related design documents based on BNBC requirement.

| Item No. | Observation | Recommended Action Plan | Recommended Timeline |
|---|---|---|---|
| 02 | Load plan and design report not comply with BNBC requirements. (Production Building) | Factory engineer is required to revise the live load limit and related design documents based on BNBC requirement. | 6-weeks |

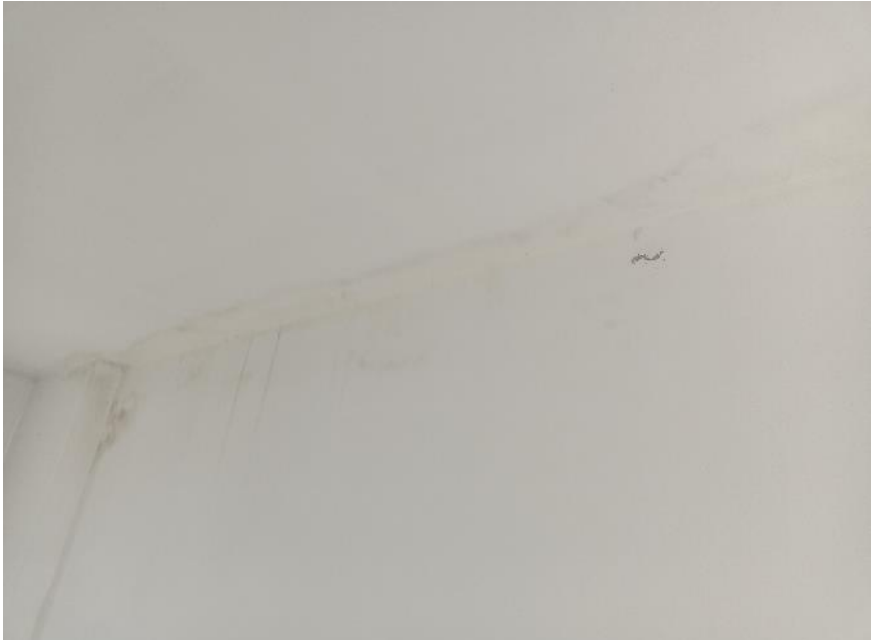
Dampness on slab soffit

Dampness on ceiling of stair top was observed. Factory engineer is required to repair the damp areas with suitable method.

| Item No. | Observation | Recommended Action Plan | Recommended Timeline |
|---|---|---|---|
| 06 | Dampness at ceiling of stair top. (Production Building) | Factory engineer is required to repair the damp areas with suitable method. | 6-weeks |

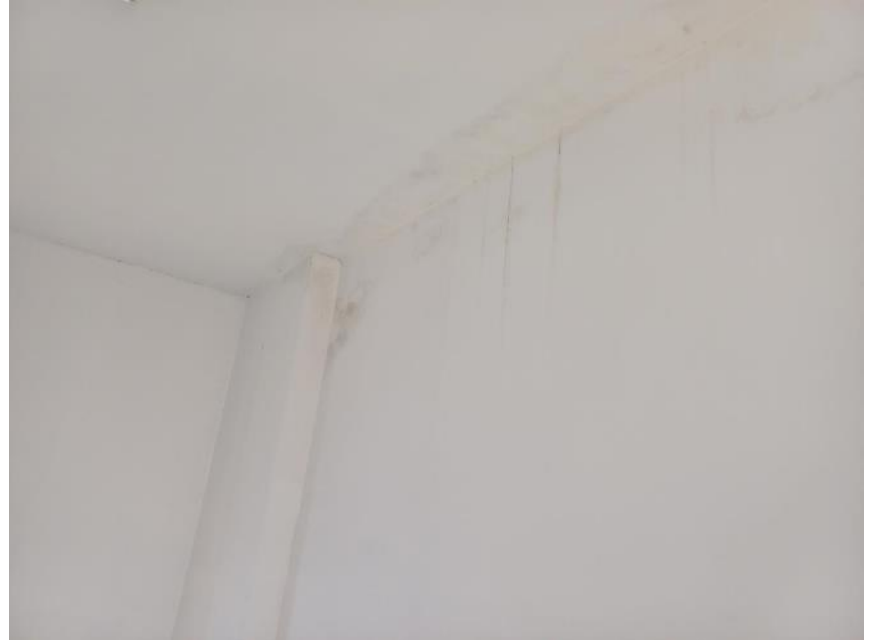
Dampness on slab soffit

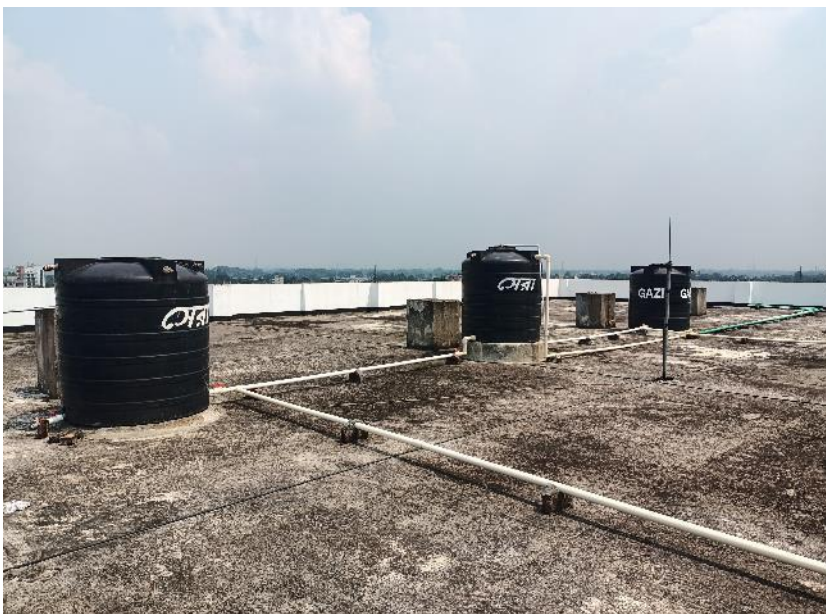
Plastic water tank not braced

Some racks on different floors and rooftop plastic water tanks are not anchored or braced to resist lateral (earthquake) forces. The factory is required to anchor/brace all non-structural elements adequately to resist earthquake forces.

| Item No. | Observation | Recommended Action Plan | Recommended Timeline |
|---|---|---|---|
| 07 | Racks and plastic water tanks not anchored or braced. (Production Building) | Factory engineer is required to adequately anchor/brace all non-structural elements to resist earthquake forces to comply with the BNBC. | 6-weeks |

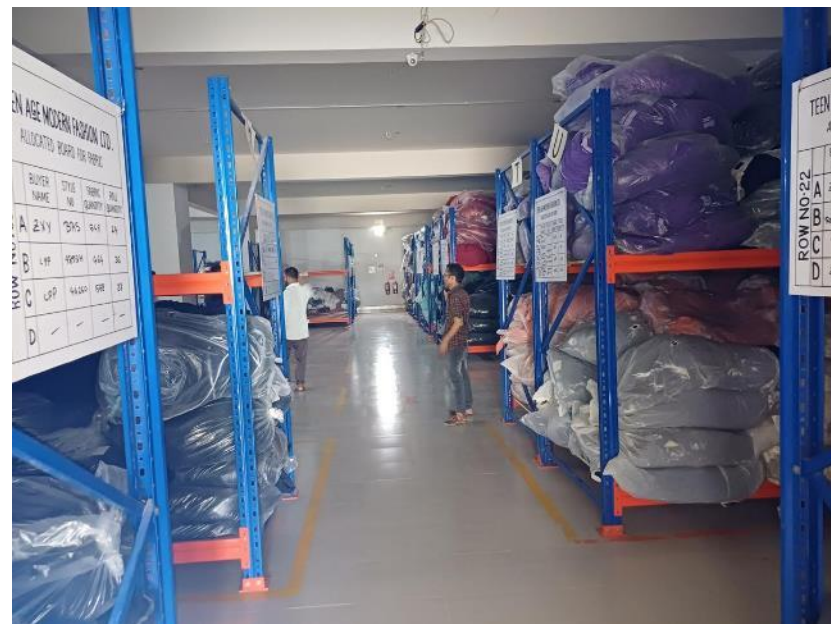
Non-anchored storage rack at several floors

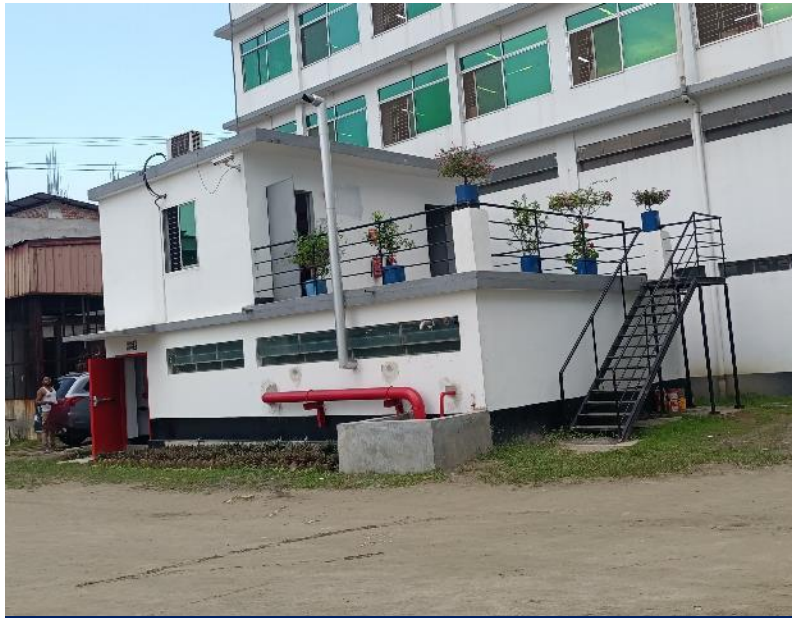
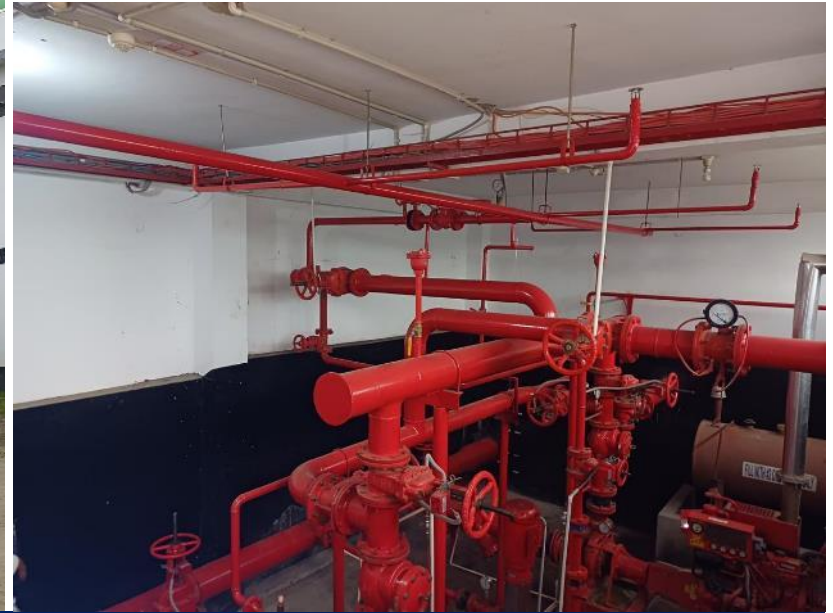
Fire Command & Pump Room

As per BNBC, every building or structure designed shall have its design documents prepared in accordance with the provision of Section 1.9.1. The design document shall include a design report, and a set of structural drawings, which shall be prepared in compliance with section 1.9.1.1 and section 1.9.1.2, part-6 of BNBC. At the time of inspection, no design report and as-built drawing was available which are required to be prepared in compliance with section 1.9.1.1 (part-6, BNBC).

| Item No. | Observation | Recommended Action Plan | Recommended Timeline |
|---|---|---|---|
| 08 | Lack of design report and as-built drawing. (Fire Command & Pump Room) | Factory engineer is required to prepare the design documents including a design report, and a set of structural drawings in compliance with BNBC and submit it to RSC for review. | 6-weeks |

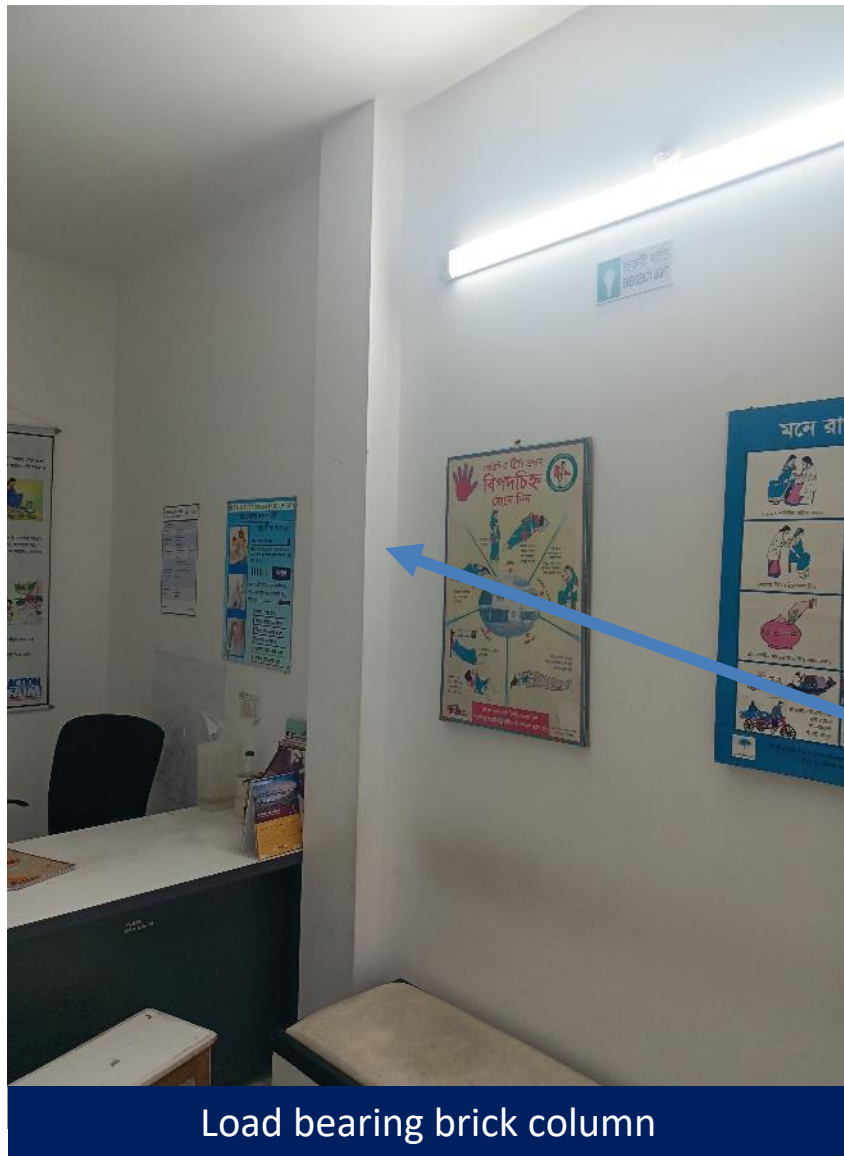
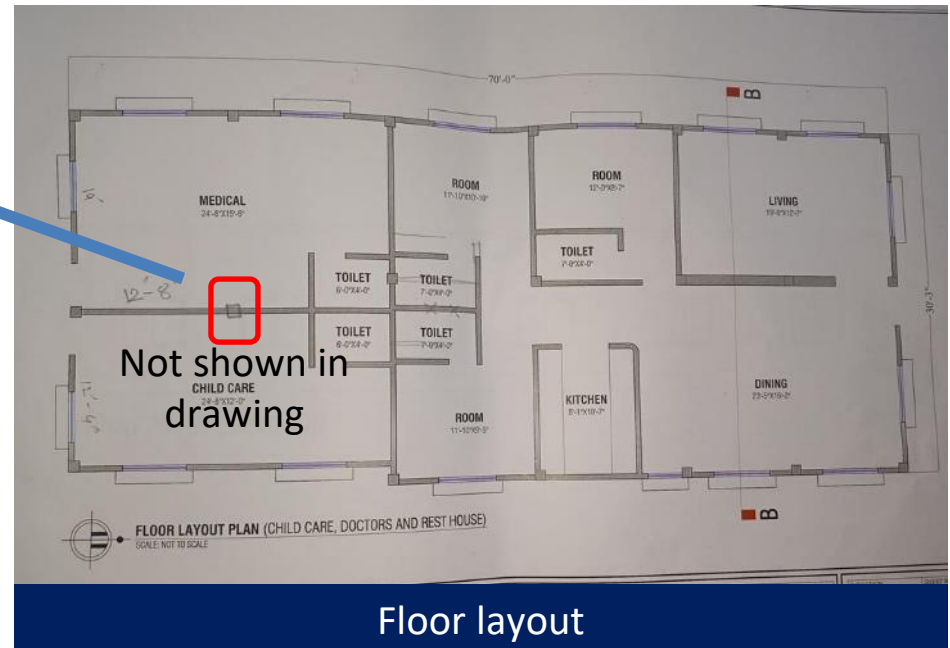
Slab details not found in the provided as-built drawings. Also brick column layout not matched with the as-built condition. Factory engineer is required to revise the as-built drawing as per onsite condition and submit to RSC.

| Item No. | Observation | Recommended Action Plan | Recommended Timeline |
|---|---|---|---|
| 10 | Inconsistencies in as built drawings. (Childcare, Doctor's & Rest House) | Factory engineer is required to prepare a full set of structural drawings in compliance with BNBC and submit it to RSC for review. | 6-weeks |

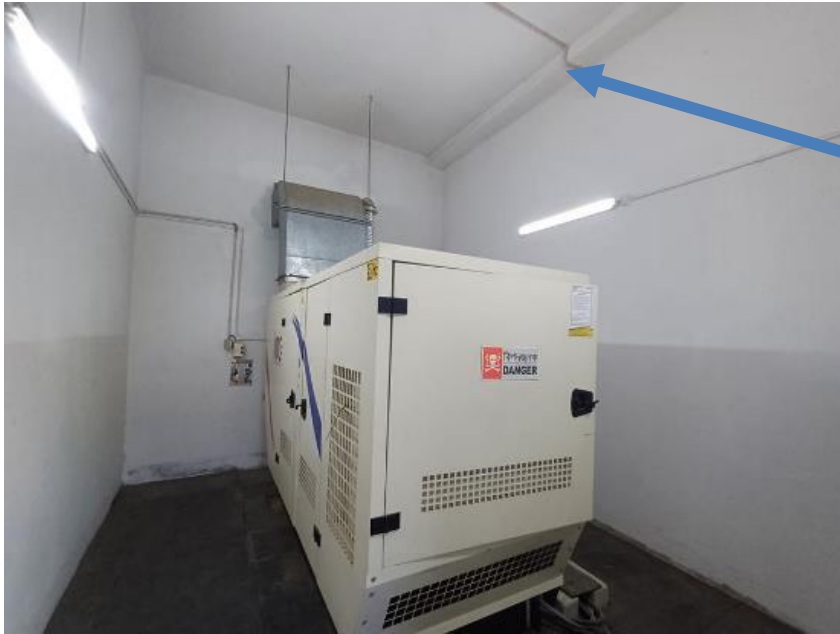
Beam on site

Beam sizes are not matched with the provided as-built drawings. As per drawings the down stand of the beam is shown 250 mm (10 inch). But onsite down stand was found 125 mm (5 inch). Building engineer is required to revise the as-built drawing as per onsite condition and submit to RSC.

| Item No. | Observation | Recommended Action Plan | Recommended Timeline |
|---|---|---|---|
| 11 | Beam size mismatch in drawings. (Utility Building) | Factory engineer is required to survey the structure and prepare as-built drawings mentioning actual size and dimension. | 6-weeks |

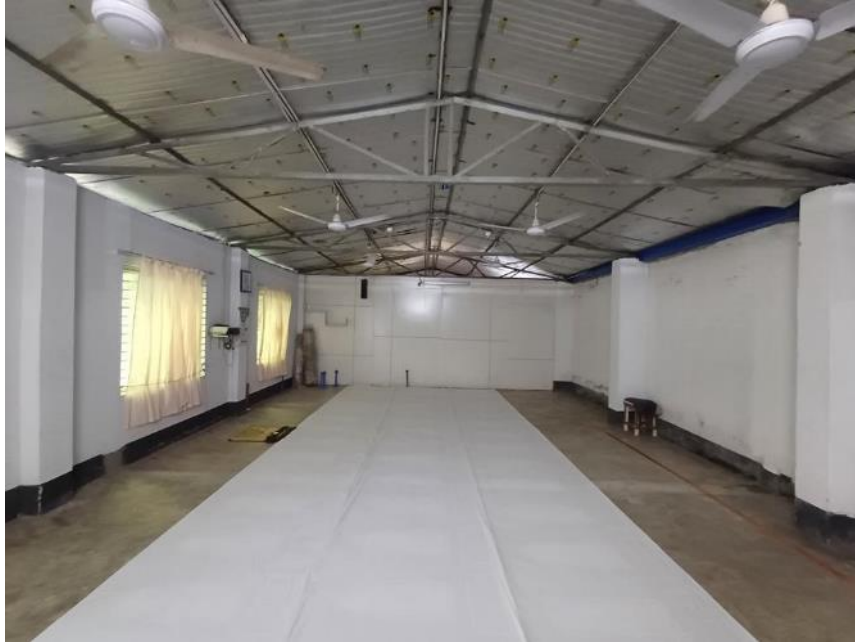
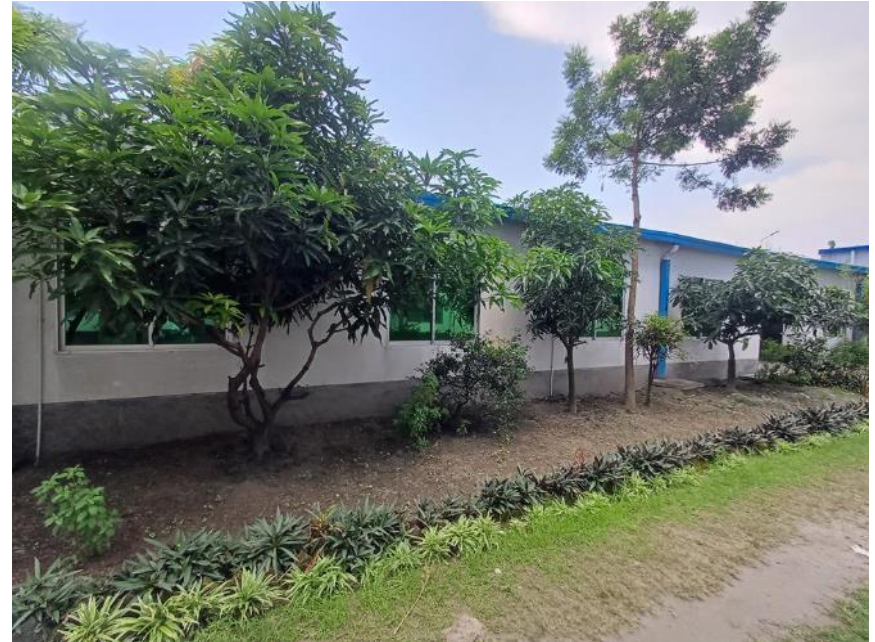
Structural drawings were not found for the Mosque, Staff Dining . The factory engineer is required to survey the whole structure and prepare full set of as-built drawing in compliance in compliance with section 1.9.1.2, part-6 of BNBC.

| Item No. | Observation | Recommended Action Plan | Recommended Timeline |
|---|---|---|---|
| 12 | Lack of structural drawings. (Mosque, Staff Dining) | Factory engineer is required to prepare the as-built structural drawing in compliance with section 1.9.1.1 as per BNBC. | 6-weeks |

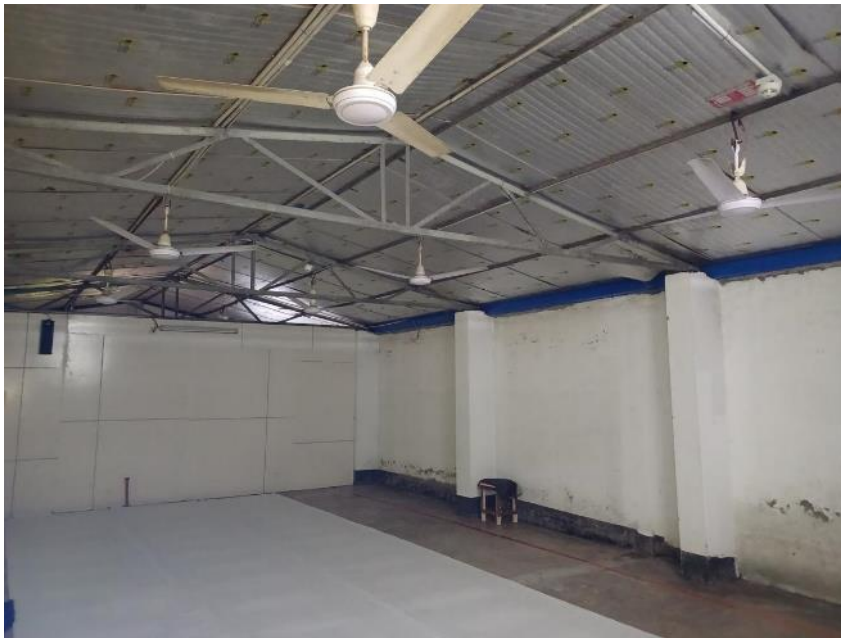
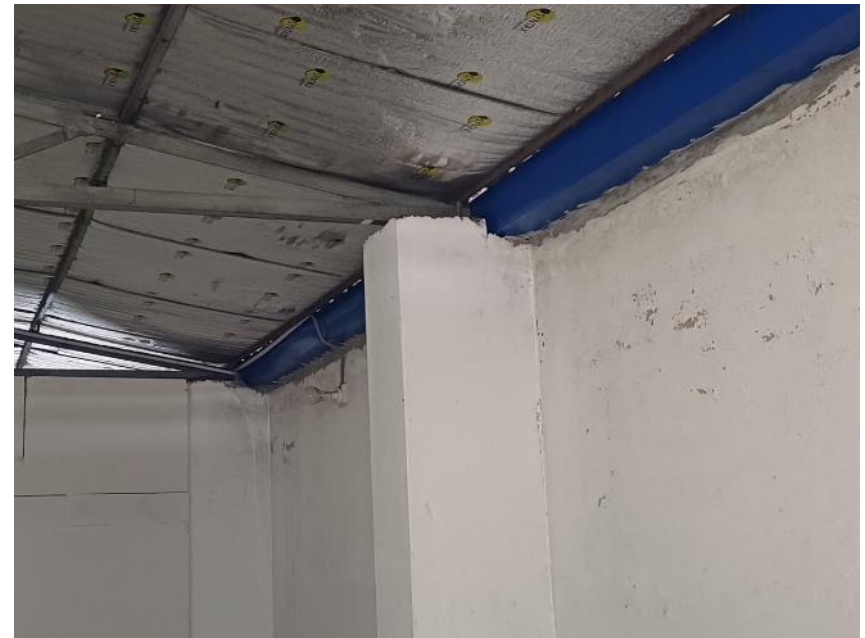
Apparently inadequate connections were observed at the lightweight roof of the single storied Sheds. The building engineer to check the connection adequacy of the lightweight roof against the uplift pressure of wind.

Truss frame

Truss frame connection with column

| Item No. | Observation | Recommended Action Plan | Recommended Timeline |
|---|---|---|---|
| 13 | Apparently non-engineered connection. (Mosque, Staff Dining) | Factory engineer is required to check the connection of the steel roof for the uplift pressure of wind. | 6-weeks |

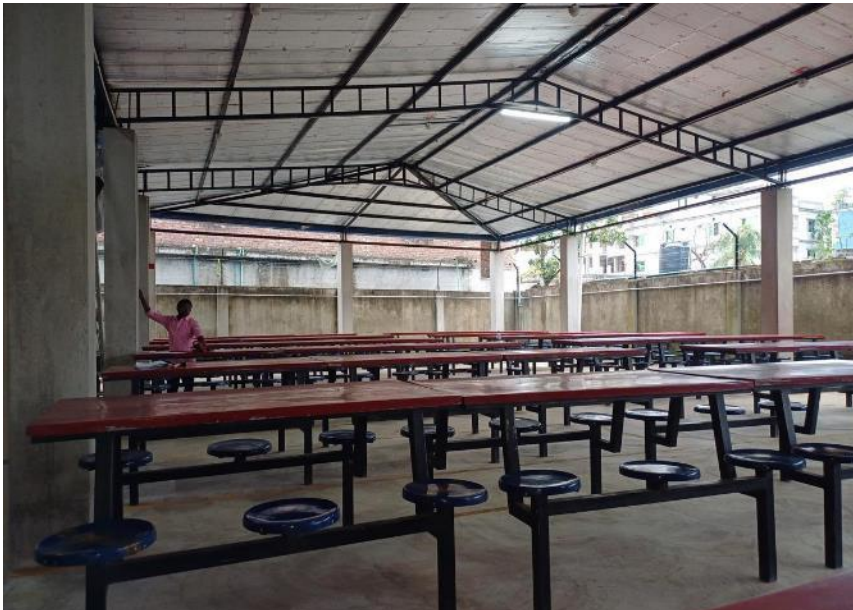
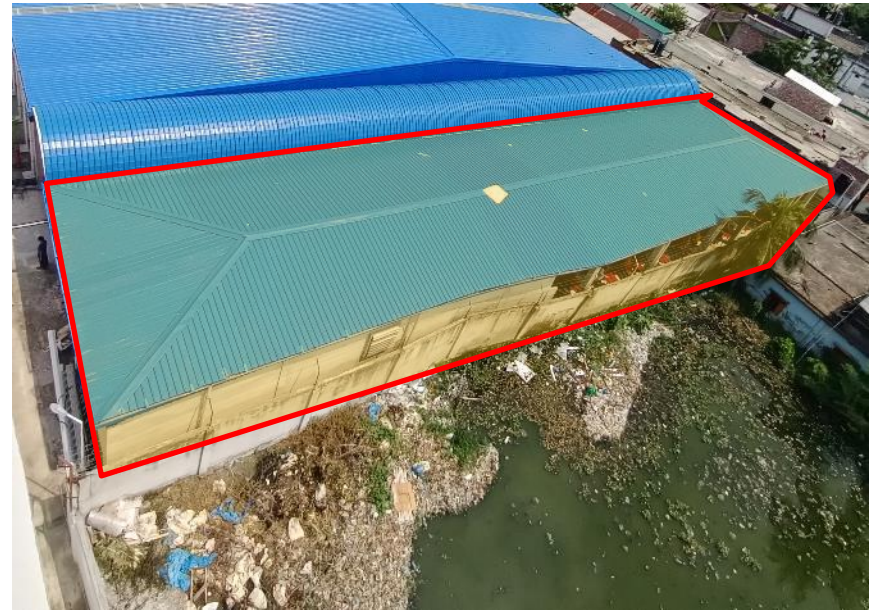
Worker Dining

Structural and architectural drawings were not found for the Worker Dining. Only a column layout was provided for the structure which was not matched with on-site condition. The factory engineer is required to survey the whole structure and prepare full set of as-built drawing in compliance in compliance with section 1.9.1.2, part-6 of BNBC.

| Item No. | Observation | Recommended Action Plan | Recommended Timeline |
|---|---|---|---|
| 15 | Lack of drawings [structural & architectural]. (Worker Dining) | Factory engineer is required to prepare the as-built drawing in compliance with BNBC. | 6-months |

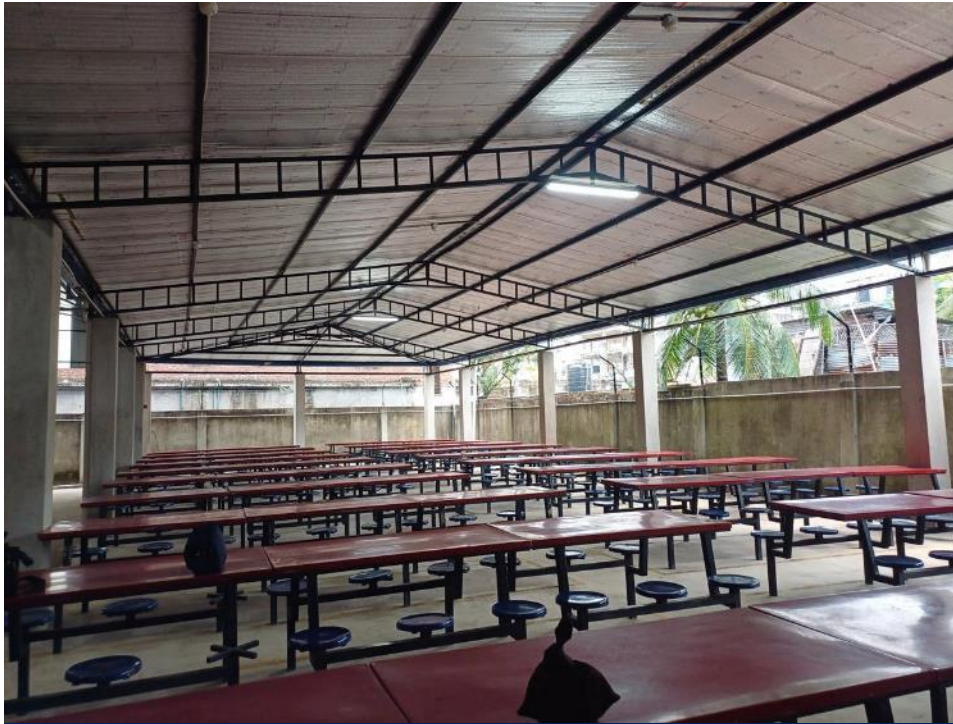
No load transfer media along long direction

Load transfer media is not provided along long direction for this shed. Therefore, lateral stability system of the shed is apparently incomplete. Factory engineer is required to check the lateral stability of the structure.

| Item No. | Observation | Recommended Action Plan | Recommended Timeline |
|---|---|---|---|
| 16 | Lack of lateral stability. (Worker Dining) | Factory engineer is required to check the lateral stability of the structure. | 6-weeks |

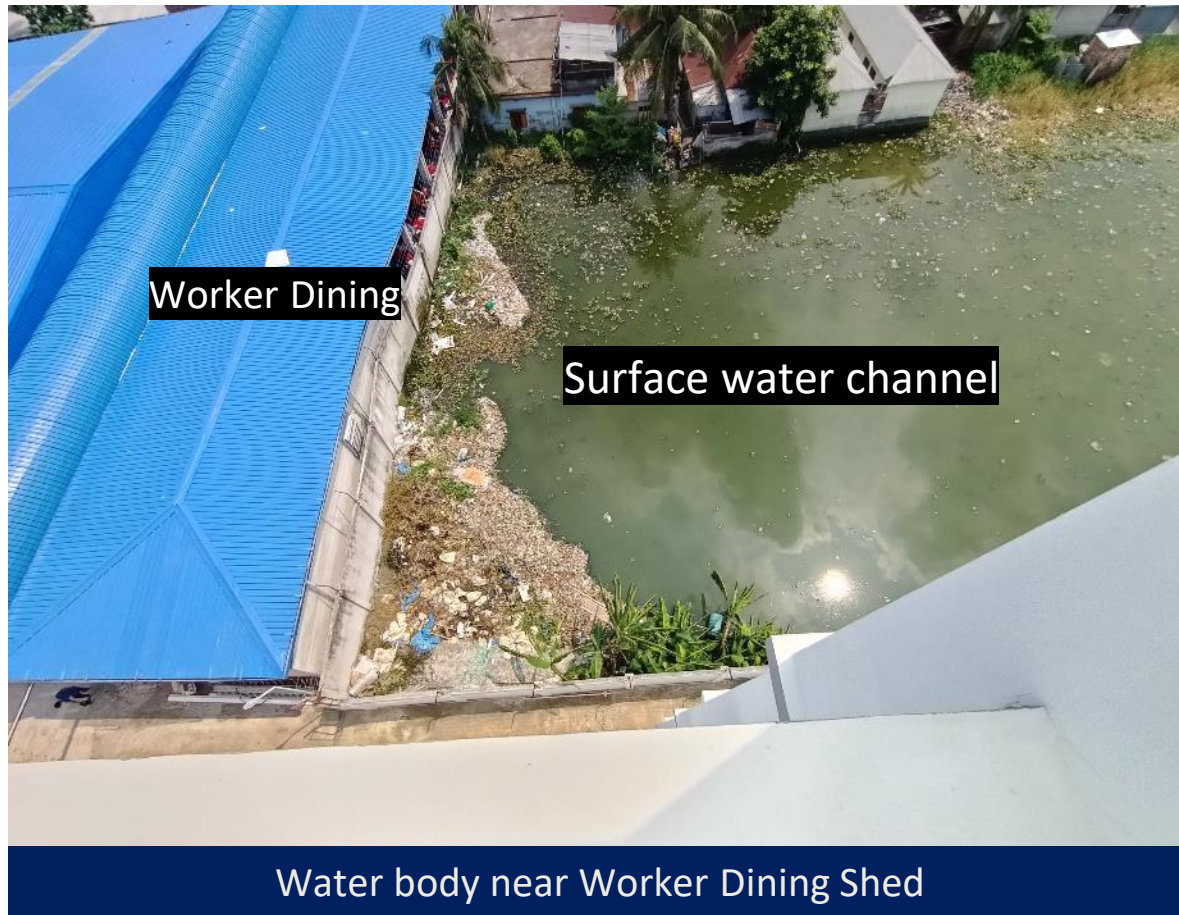
Lake is very close to structure. Building engineer to check the footing adequacy considering high flood level and take necessary steps to prevent soil erosion during high flood.

| Item No. | Observation | Recommended Action Plan | Recommended Timeline |
|---|---|---|---|
| 18 | Proximity of Surface water channel. (Worker Dining) | Investigate the position on footing, water body, actual soil condition and check the foundation adequacy based on in-situ soil bearing capacity. | 6-weeks |

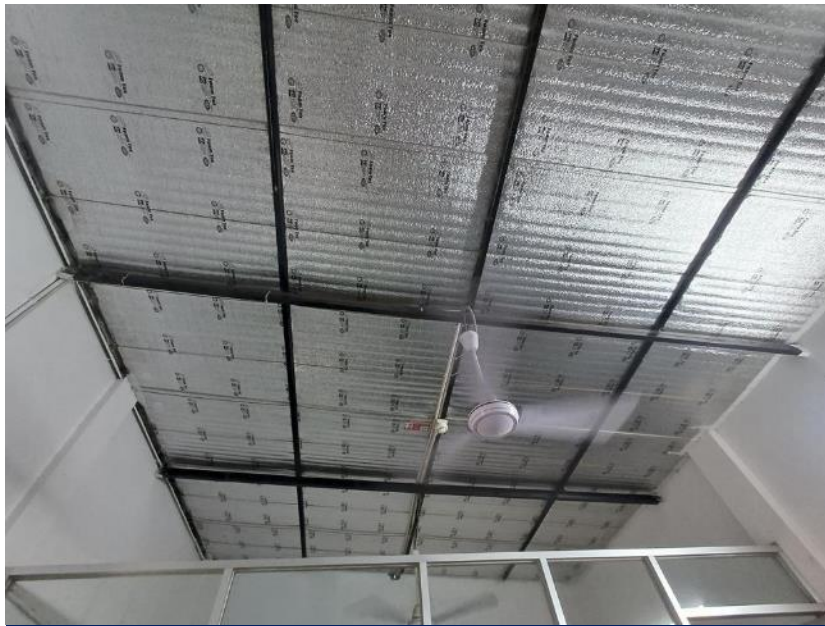
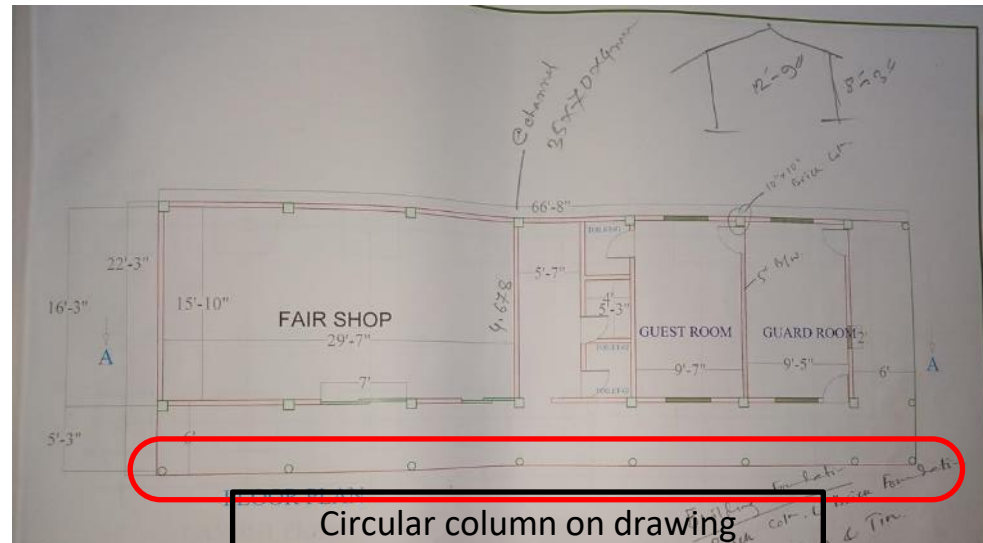
Framing of the structure

Floor layout

Framing and connection details not found in the provided as built drawings. Moreover, circular columns are shown in the drawings, but on-site square brick columns were found. The factory engineer is required to survey the whole structure and prepare full set of as-built drawing in compliance in compliance with section 1.9.1.2, part-6 of BNBC.

| Item No. | Observation | Recommended Action Plan | Recommended Timeline |
|---|---|---|---|
| 20 | Incomplete in as built drawings. (Fair Shop& Guard Room) | Factory engineer is required to prepare the as-built structural drawing in compliance with BNBC. | 6-weeks |

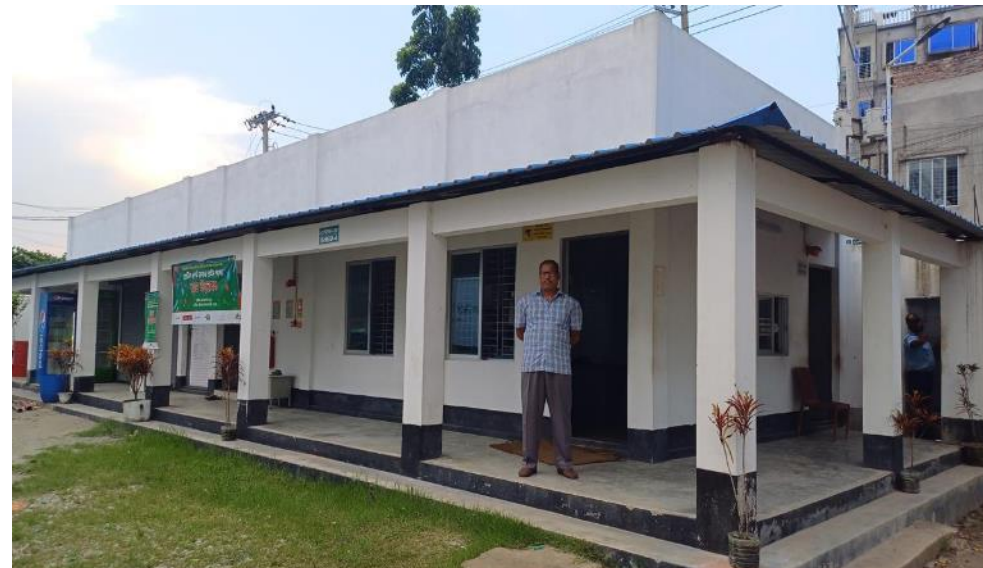
Squire brick column

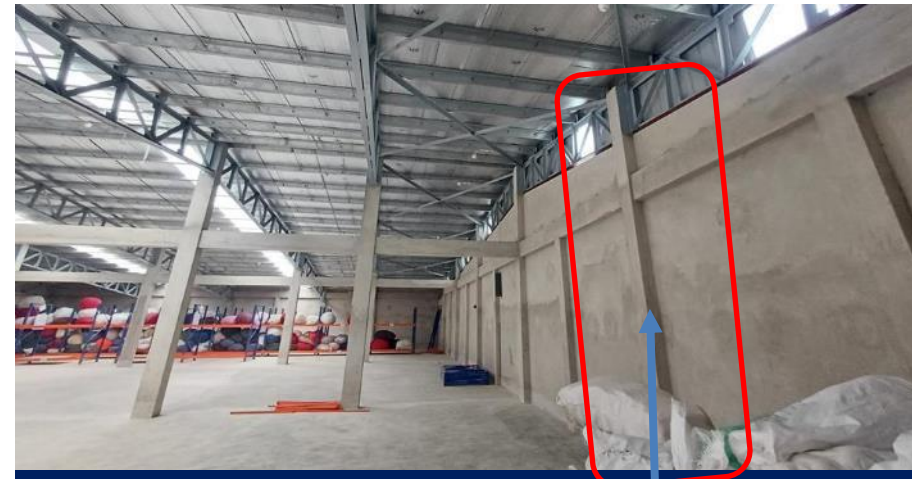
Connection details were not found in the drawings. Provided connection details were incomplete and not fully match with as-built condition. Moreover, additional RC column were found on end grid. No foundations details were found for those column. The Factory engineer required to revise the as-built drawings as per on-site condition. Also, check the connection adequacy of the frame and load path & structural integrity for the additional column.

Additional RC column

| Item No. | Observation | Recommended Action Plan | Recommended Timeline |
|---|---|---|---|
| 22 | Fabric & Accessories Shed. (Fabric & Accessories Shed) | Check the connection adequacy of the frame and load path & structural integrity for the additional column. | 6-weeks |

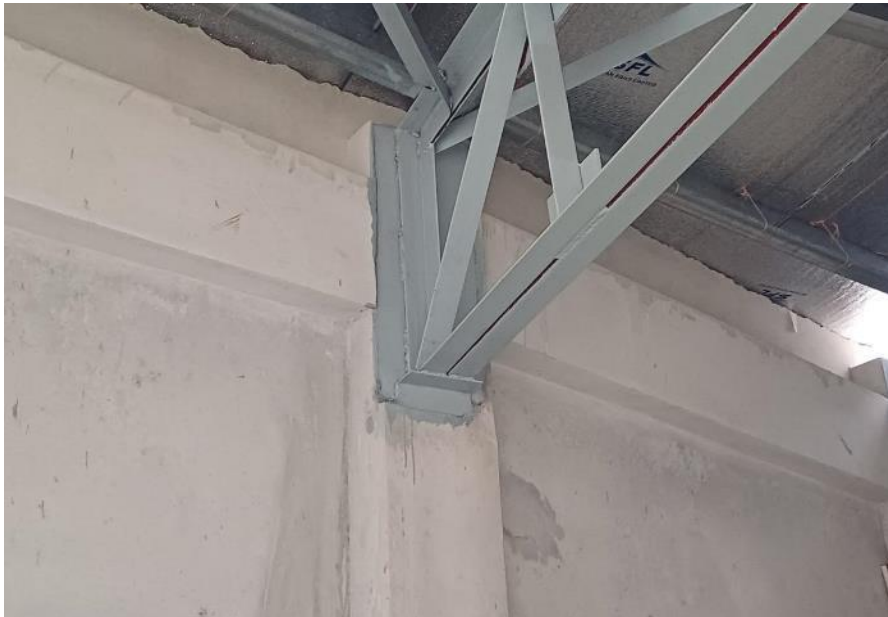
Truss connection with RC column

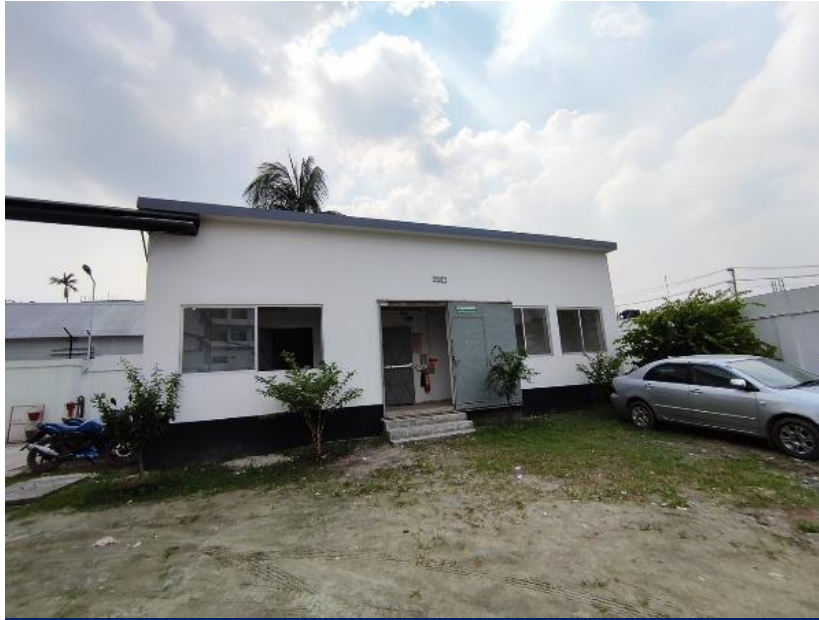
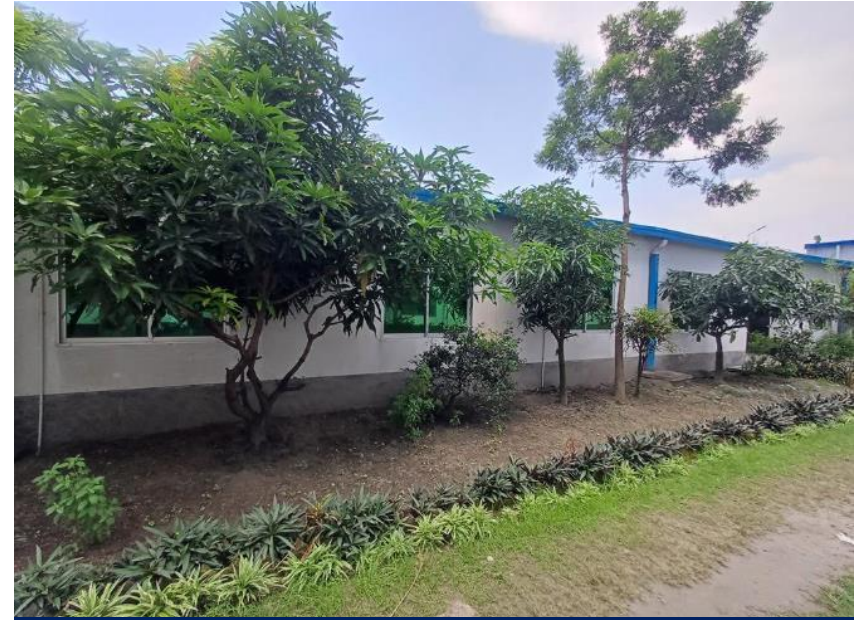
At the time of inspection, no approval drawing from local authority was available for Utility Building and Worker Dining. Factory engineer is required to seek approval from the local authority for these structures.

| Item No. | Observation | Recommended Action Plan | Recommended Timeline |
|---|---|---|---|
| 24 | Missing approval drawing from local authority. (Utility Building, Worker Dining) | Factory engineer is required to seek and collect approval from the local authority for the structures. | 6-months |
