# Fair Design Printing LTD.

Shi-140/1, Chandpara, Bashon Sorok, Gazipur Sodor  
(23.973972, 90.357666)  
05 September 2023

# Buildings Information

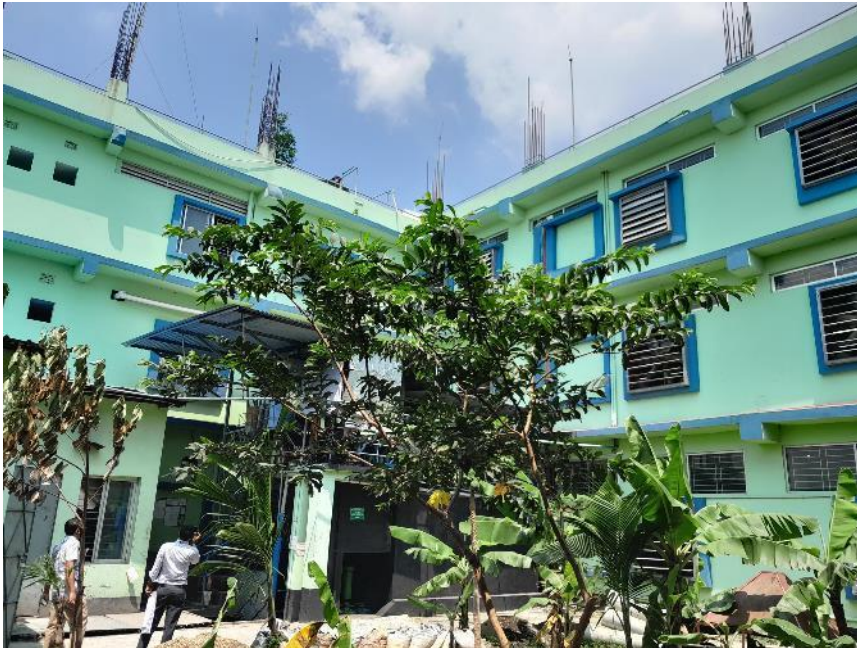
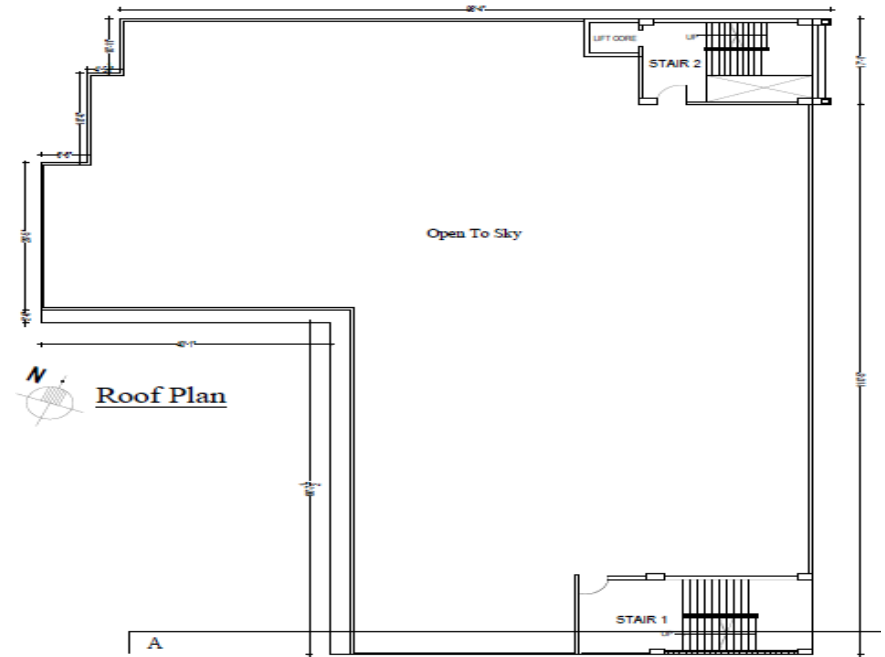
Main Factory Building

**Structural irregularity check not included in  
the design report**

As per building plan, it has an irregular shape which induced torsion into the structure. Also, there is re-entered corner in the building. Building engineer is required to check all type of irregularities & incorporate it in the software-based FEA model & design report.

Building plan

| Item No. | Observation | Recommended Action Plan | Recommended Timeline |
|---|---|---|---|
| 01 | Structural irregularity check not included in the design report. (Main Factory Building) | Building engineer is required to check all type of irregularities & incorporate in the software-based FEA model & DEA report. | 6-weeks |
| 02 | Structural irregularity check not included in the design report. (Main Factory Building) | Carry out suggested remedial works where necessary. | 6-months |

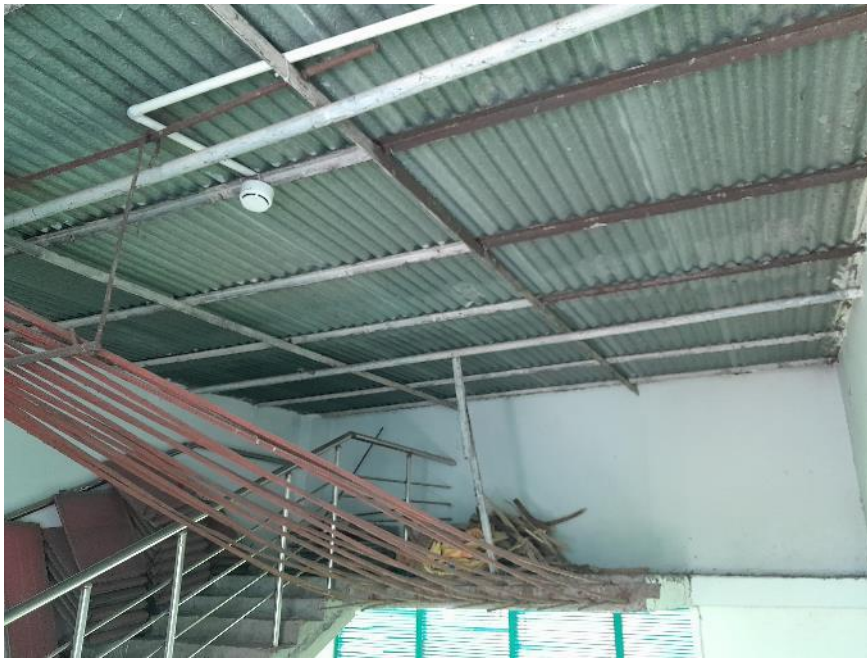
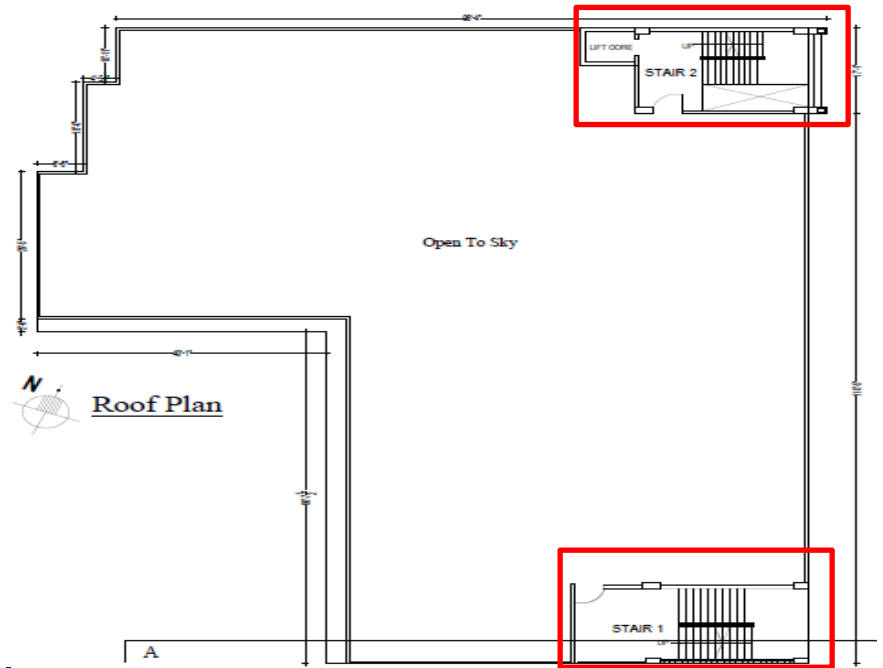
## **Non-Engineered lightweight steel roof on staircase**

Non engineered staircase roof

Light weight steel roof resting on the peripheral brick walls. The connection between steel roof & brick wall is apparently non-engineered. The building engineer is required to check the adequacy of stair roof connection against uplift force.

| Item No. | Observation | Recommended Action Plan | Recommended Timeline |
|---|---|---|---|
| 03 | Non-Engineered lightweight steel roof on staircase. (Main Factory Building) | Check the adequacy of the members and connections against uplift forces. | 6-weeks |
| 04 | Non-Engineered lightweight steel roof on staircase. (Main Factory Building) | Carry out suggested remedial works where necessary. | 6-months |

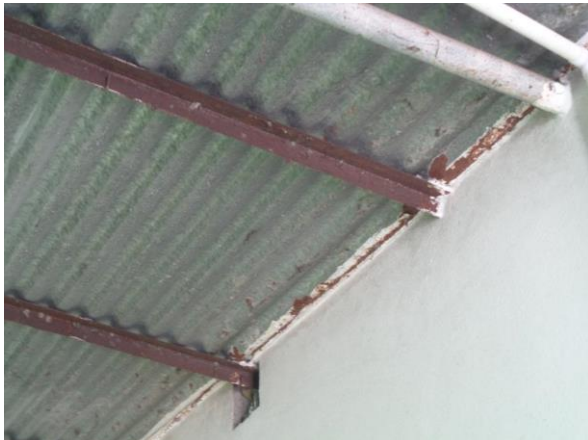
Steel angle member resting on the brick wall

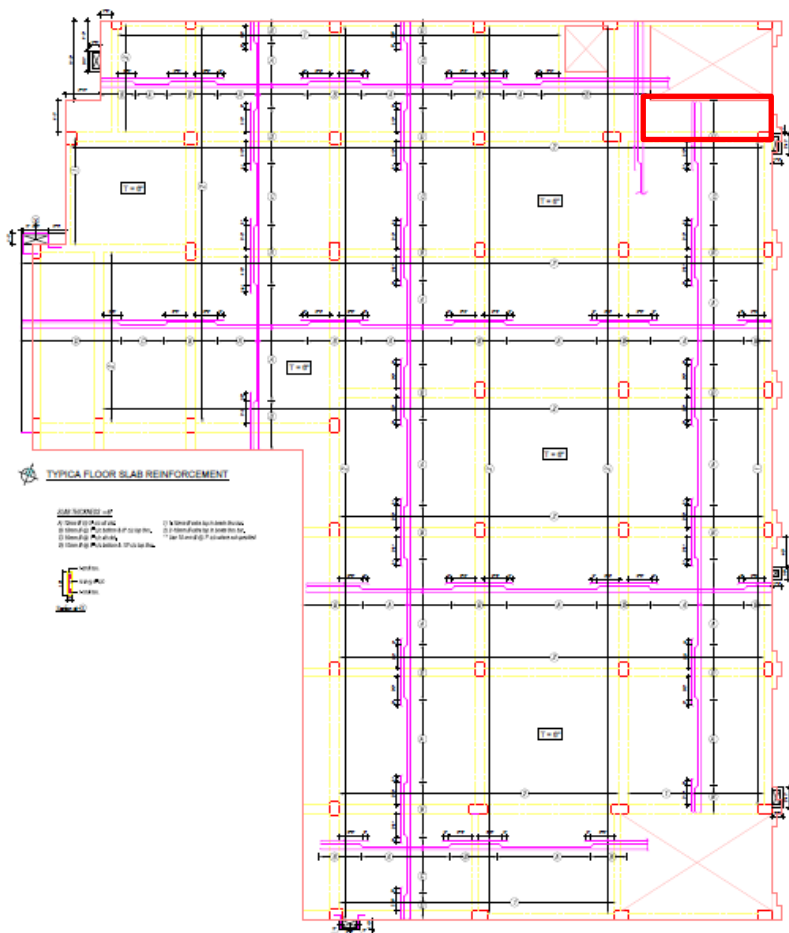
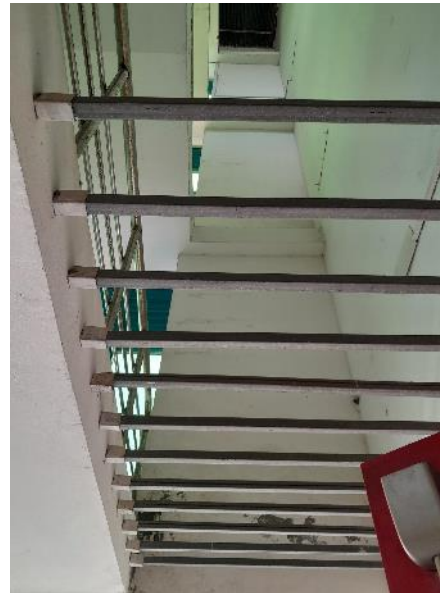
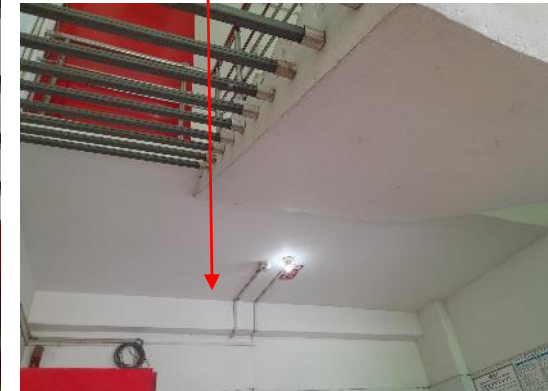
Slab reinforcement layout

Mismatch found in beam layout and slab reinforcement layout at stair portion; and void portion was not shown in as built drawing. Also marked beam was not in position as per as-built drawing. Building engineer is required to survey the full structure and update the as built drawing and design report accordingly.

| Item No. | Observation | Recommended Action Plan | Recommended Timeline |
|---|---|---|---|
| 05 | Inconsistency and lack of information in as-built drawing. (Main Factory Building) | Building engineer is required to survey the full structure and update the as built drawing and design report accordingly. | 6-weeks |

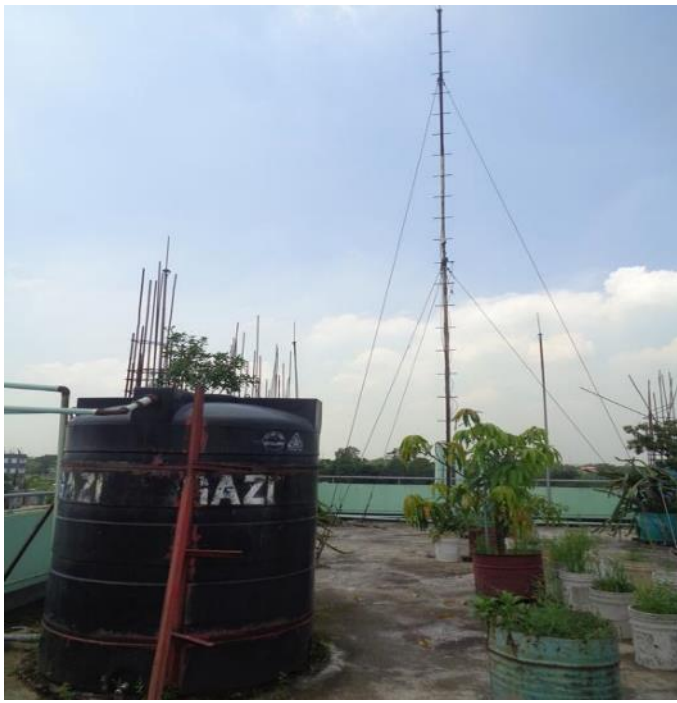
During inspection, two plastic water tanks at roof floor and two canopies at ground floor were found which has not shown in as-built drawing. Building engineer is required to incorporate all loading elements in the drawing, floor load and revise the design report accordingly.

| Item No. | Observation | Recommended Action Plan | Recommended Timeline |
|---|---|---|---|
| 06 | Inconsistency and lack of information in as-built drawing.<br>(Main Factory Building) | Building engineer is required to update the floor load plan based on BNBC requirement. | 6-weeks |
| 08 | Inconsistency and lack of information in as-built drawing.<br>(Main Factory Building) | Implement floor load plan | 6-months |

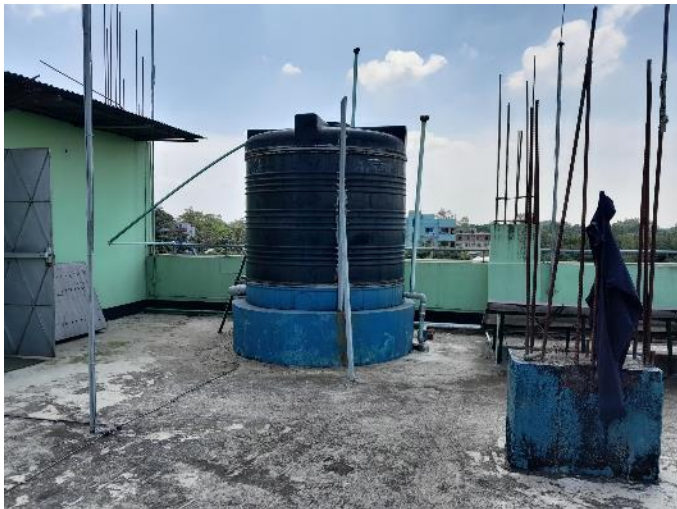
Undocumented water tank and telecom mast at roof

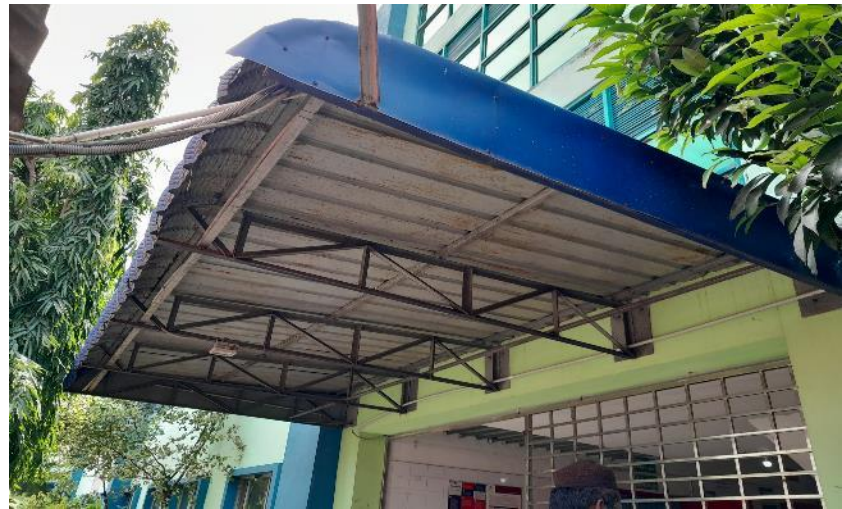
Undocumented canopy

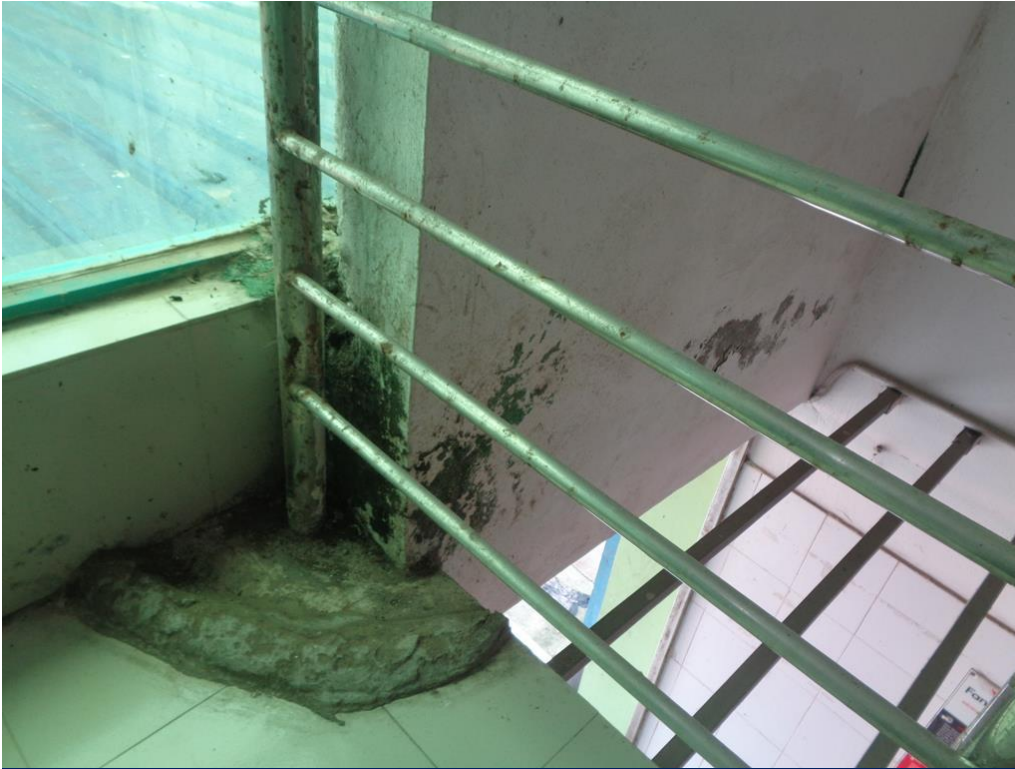
Dampness at peripheral brick wall

Dampness was found on brick wall at stair of north side. Building engineer is required to investigate the reason of dampness and carry out proper remedial measure.

| Item No. | Observation | Recommended Action Plan | Recommended Timeline |
|---|---|---|---|
| 09 | Dampness on brick wall. (Main Factory Building) | Building engineer is required to investigate the reason of dampness and carry out proper remedial measure. | 6-months |

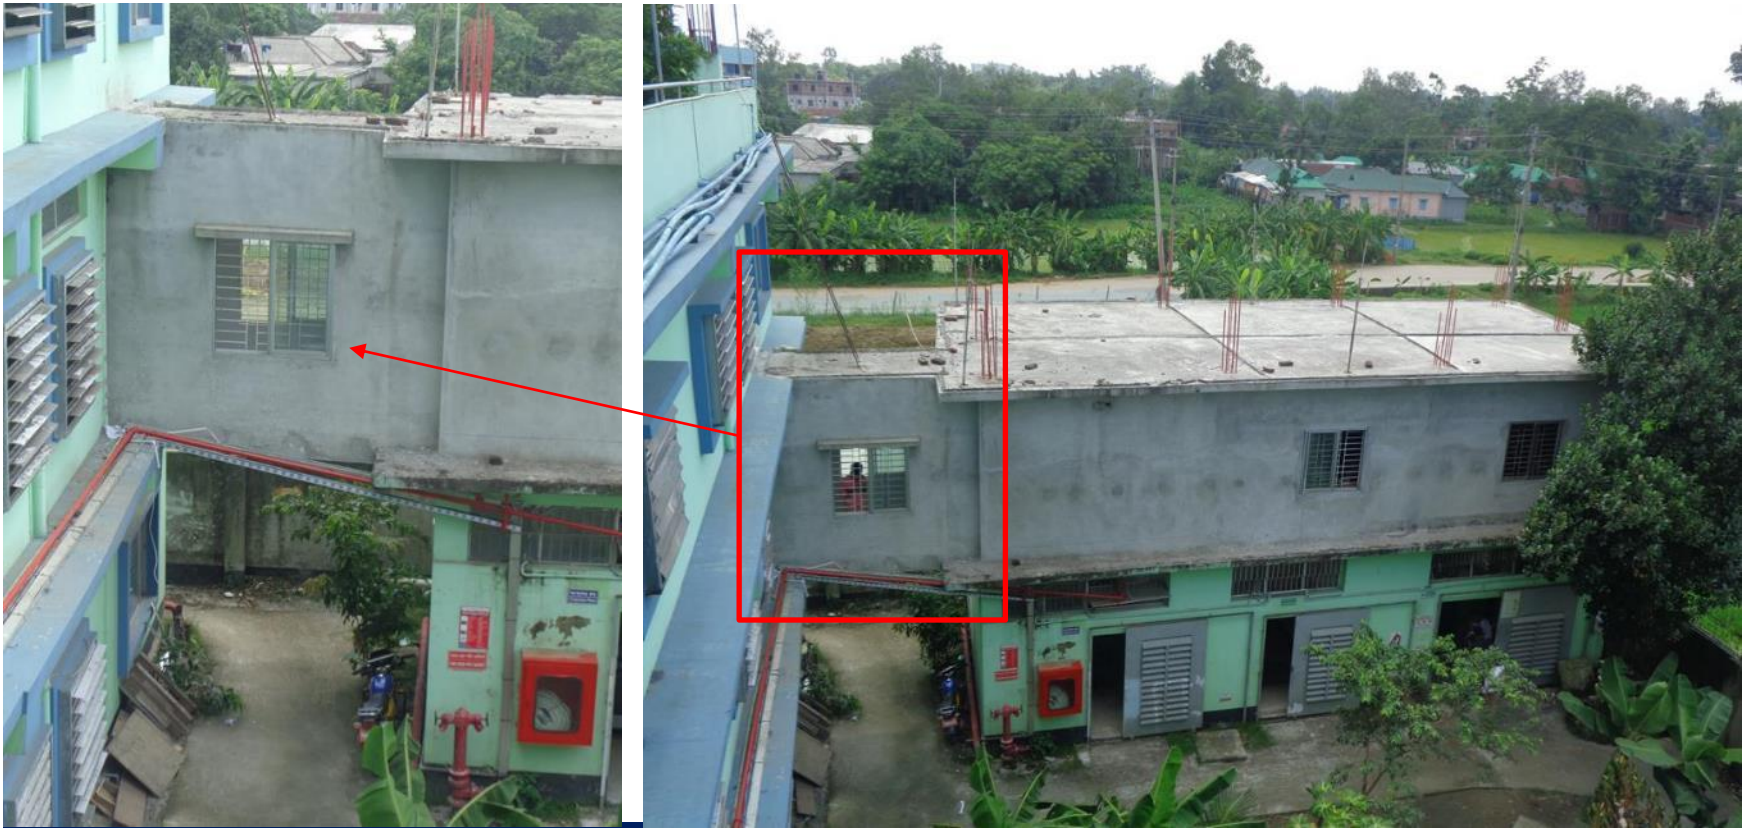
Main factory building and utility building structurally connected by slab

Main Factory Building and Utility building was found structurally connected with the extended RC slab. As per design documents no information was mentioned about this connection. Building engineer is required to check the seismic design provision of the connecting slab.

| Item No. | Observation | Recommended Action Plan | Recommended Timeline |
|---|---|---|---|
| 10 | Seismic design provision of connecting slab. (Main Factory Building & Utility Building) | Building engineer is required to check the seismic design provision of the connecting slab. | 6-weeks |

| Item No. | Observation | Recommended Action Plan | Recommended Timeline |
|---|---|---|---|
| 11 | Seismic design provision of connecting slab. (Main Factory Building & Utility Building) | Carry out suggested remedial works where necessary. | 6-months |

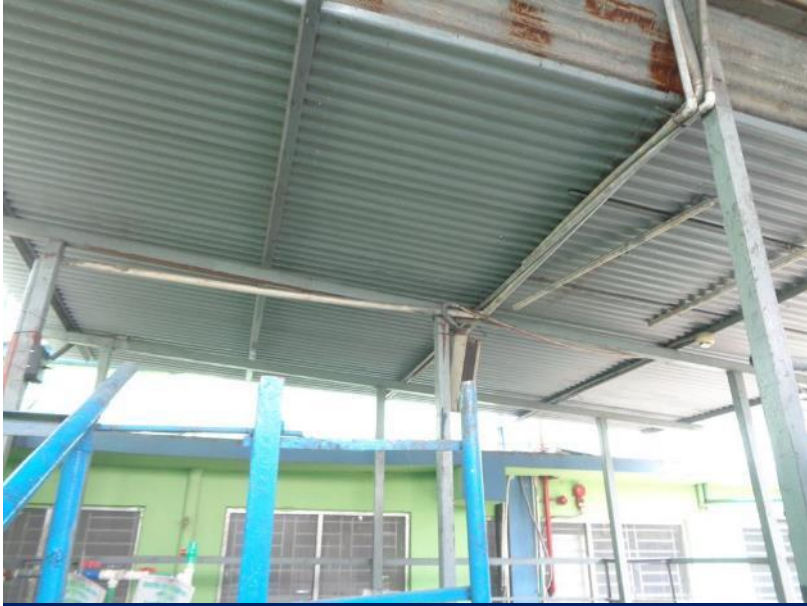
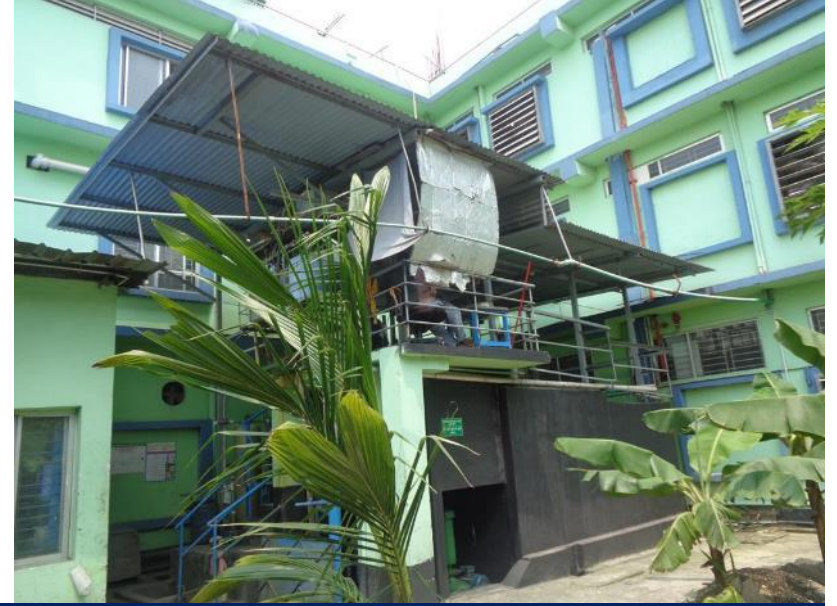
ETP

## **Non-engineering roof shed**

Apparently non-engineered connection was observed in the lightweight roof shed. No obvious lateral stability was provided. Building engineer is required to check the adequacy of roof connection against uplift force.

| Item No. | Observation | Recommended Action Plan | Recommended Timeline |
|---|---|---|---|
| 12 | Non-engineering roof shed. (ETP) | Building engineer is required to check the adequacy of roof connection against uplift force. | 6-weeks |
| 13 | Non-engineering roof shed. (ETP) | Carry out suggested remedial works where necessary. | 6-months |

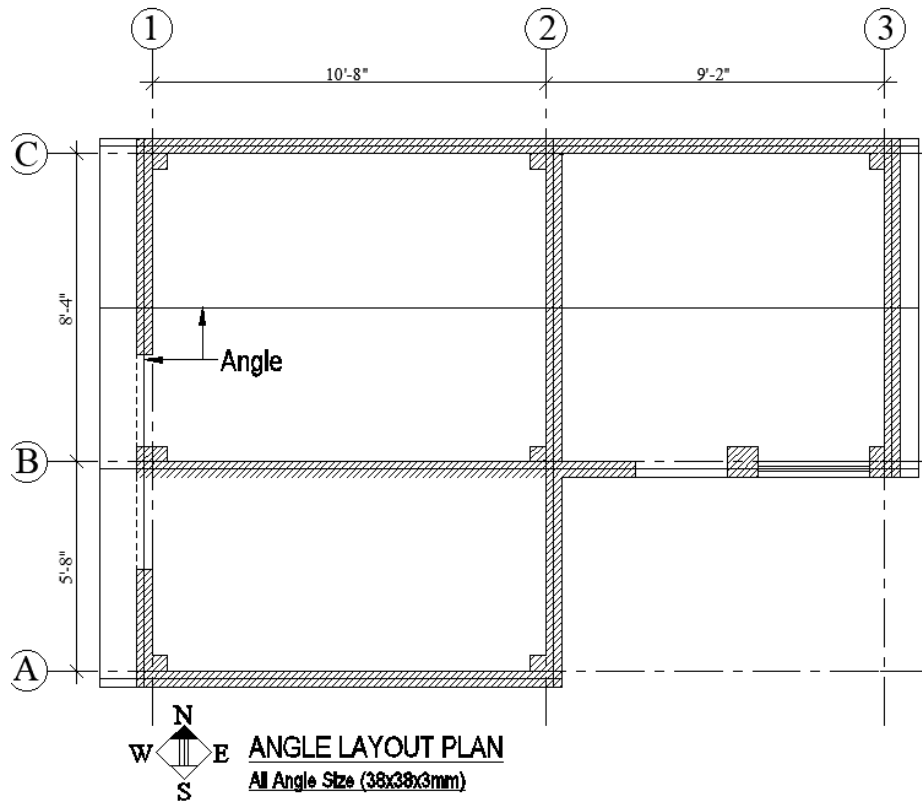
Rafter layout plan

During inspection mismatch was found in rafter layout. 5 channel rafter was found in roof where 4 angle rafter was shown in the provided drawing. Also, connection details was found missing. Building engineer is required to survey the full structure and produce accurate as-built drawing.

| Item No. | Observation | Recommended Action Plan | Recommended Timeline |
|---|---|---|---|
| 14 | Mismatch in as-built drawing. (ETP Storeroom) | Building engineer is required to survey the full structure and produce accurate as-built drawing. | 6-weeks |

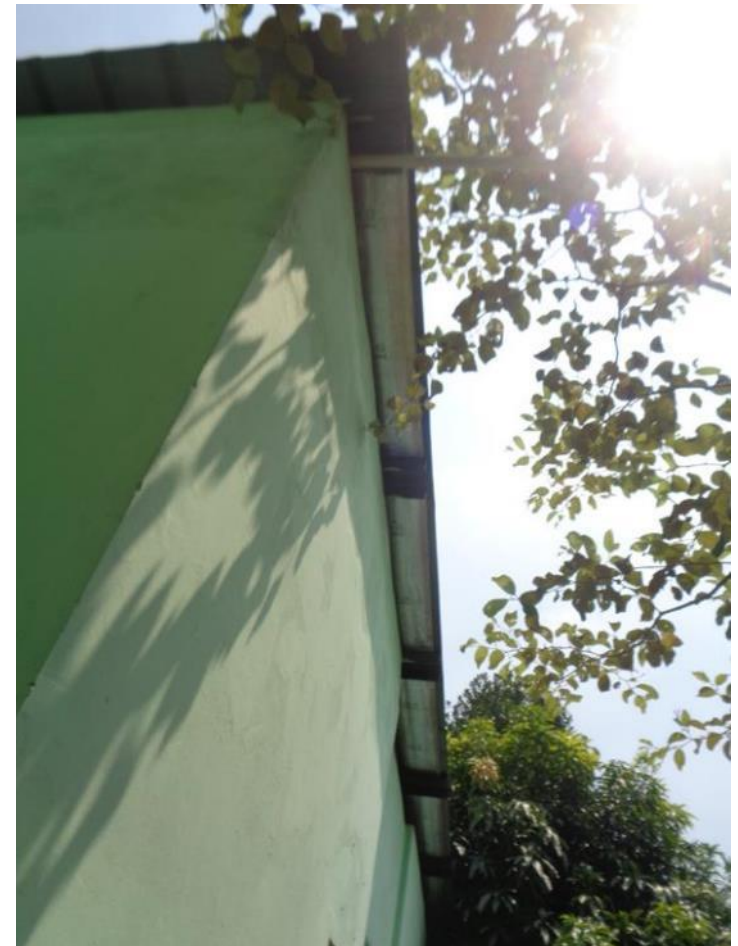
Onsite 5 nos rafter at roof.

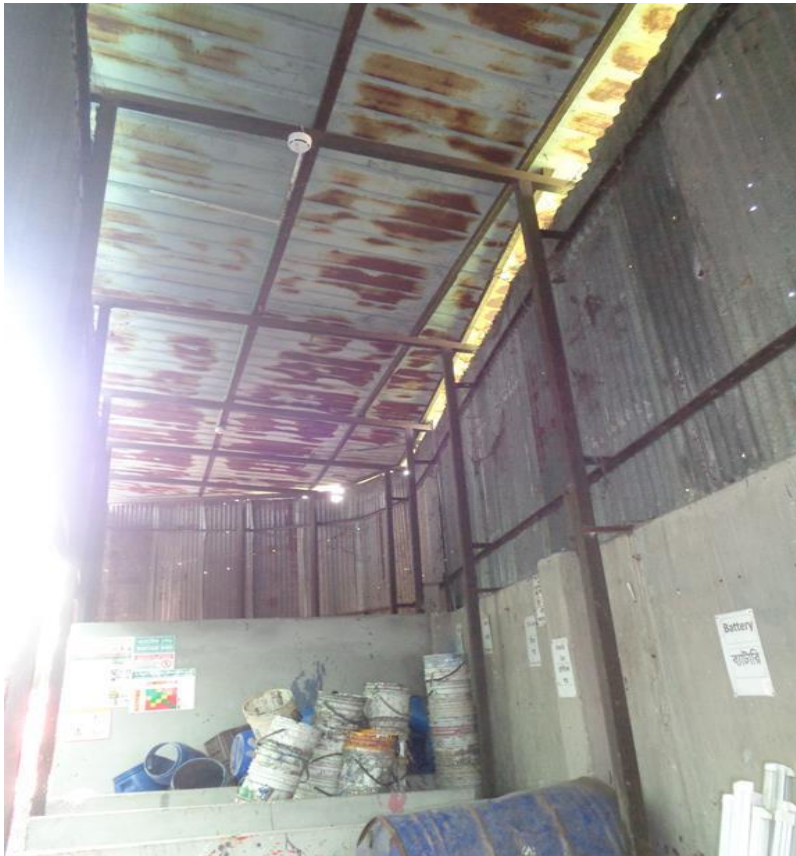
ETP dry sludge storeroom farming system.

As-built drawing was found for single storied ETP dry sludge storeroom. During inspection, no bracing was found installed as per the bracing layout of as-built drawing. No obvious lateral stability system was observed. Building engineer is required check the lateral stability of the structure and suggest proper remedial actions.

| Item No. | Observation | Recommended Action Plan | Recommended Timeline |
|---|---|---|---|
| 15 | Lack of lateral stability. (ETP Sludge Storeroom) | Building engineer is required to check the adequacy of roof connection against uplift force. | 6-weeks |

| Item No. | Observation | Recommended Action Plan | Recommended Timeline |
|---|---|---|---|
| 16 | Lack of lateral stability. (ETP Sludge Storeroom) | Carry out suggested remedial works where necessary. | 6-months |

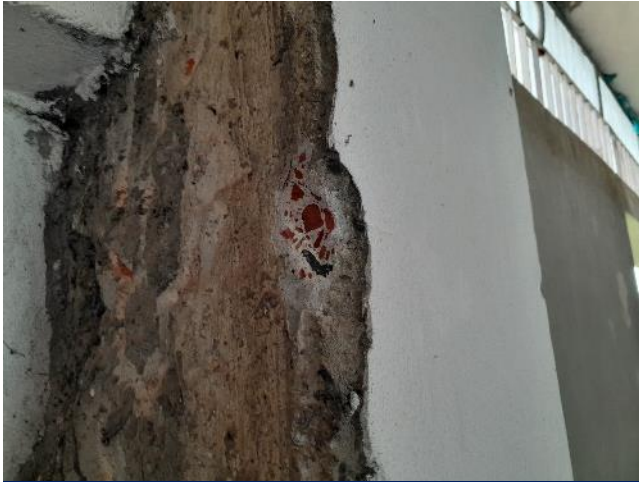
Brick aggregate in column of  
Utility Building

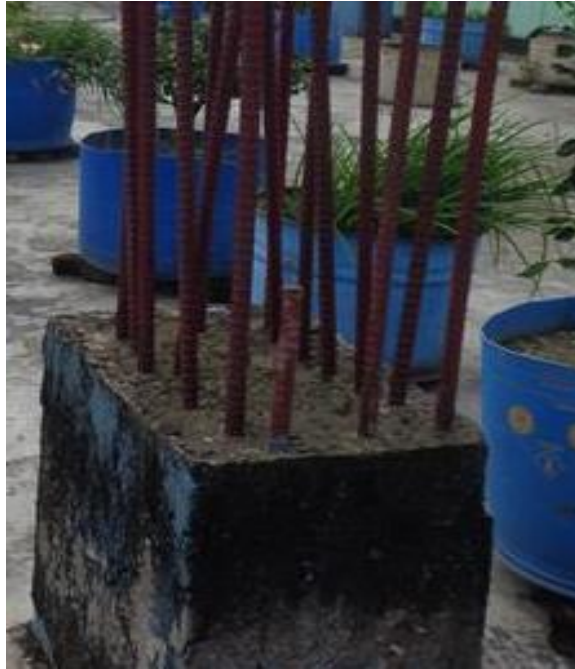
Exposed rebar on roof to  
confirm quantity
